**Final  
Remedial Investigation Report  
of the  
Cauterskill Road Site  
Catskill, New York**

**September 1999**

**NEW YORK STATE DEPARTMENT OF ENVIRONMENTAL CONSERVATION**  
50 Wolf Road  
Albany, New York 12233-5027

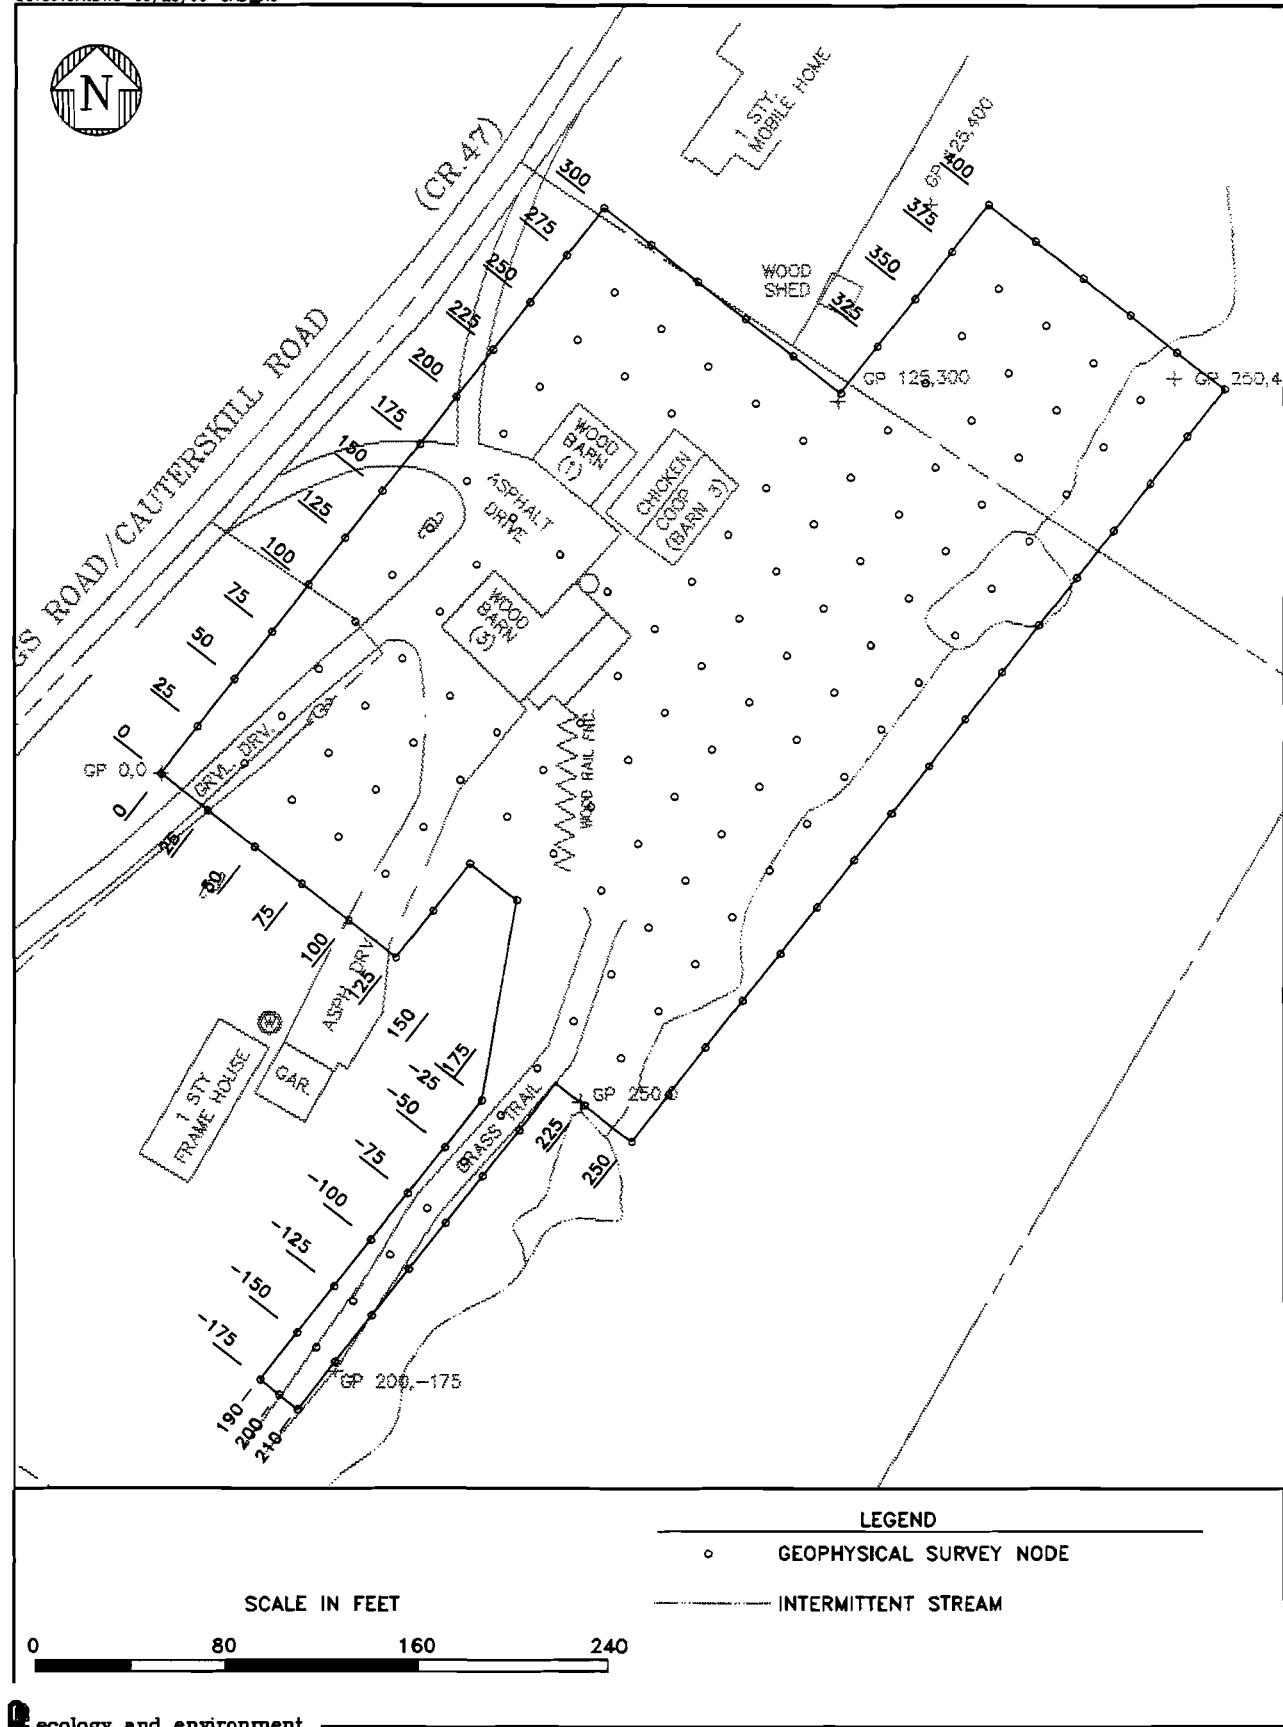
Figure 2-1  
GEOPHYSICAL SURVEY LOCATION MAP  
CAUTERSKILL ROAD, CATSKILL, NEW YORK

A geophysical survey was performed at the Cauterskill Road site by an E & E geotechnical team on December 14, 1998. The survey was performed using a Geonics Ltd. Model EM31-MK2 ground conductivity meter and an EG & G Geometrics Model G-856 proton precession magnetometer. The ground conductivity meter was used to identify changes in soil/rock conductivity resulting from natural geohydrologic or unnatural conditions (i.e., man-made) such as buried drums, wastes and debris, or possibly a contaminant plume. The magnetometer was used to identify changes in the earth's magnetic field due to the presence of buried ferromagnetic objects (i.e., drums, tanks, etc.).

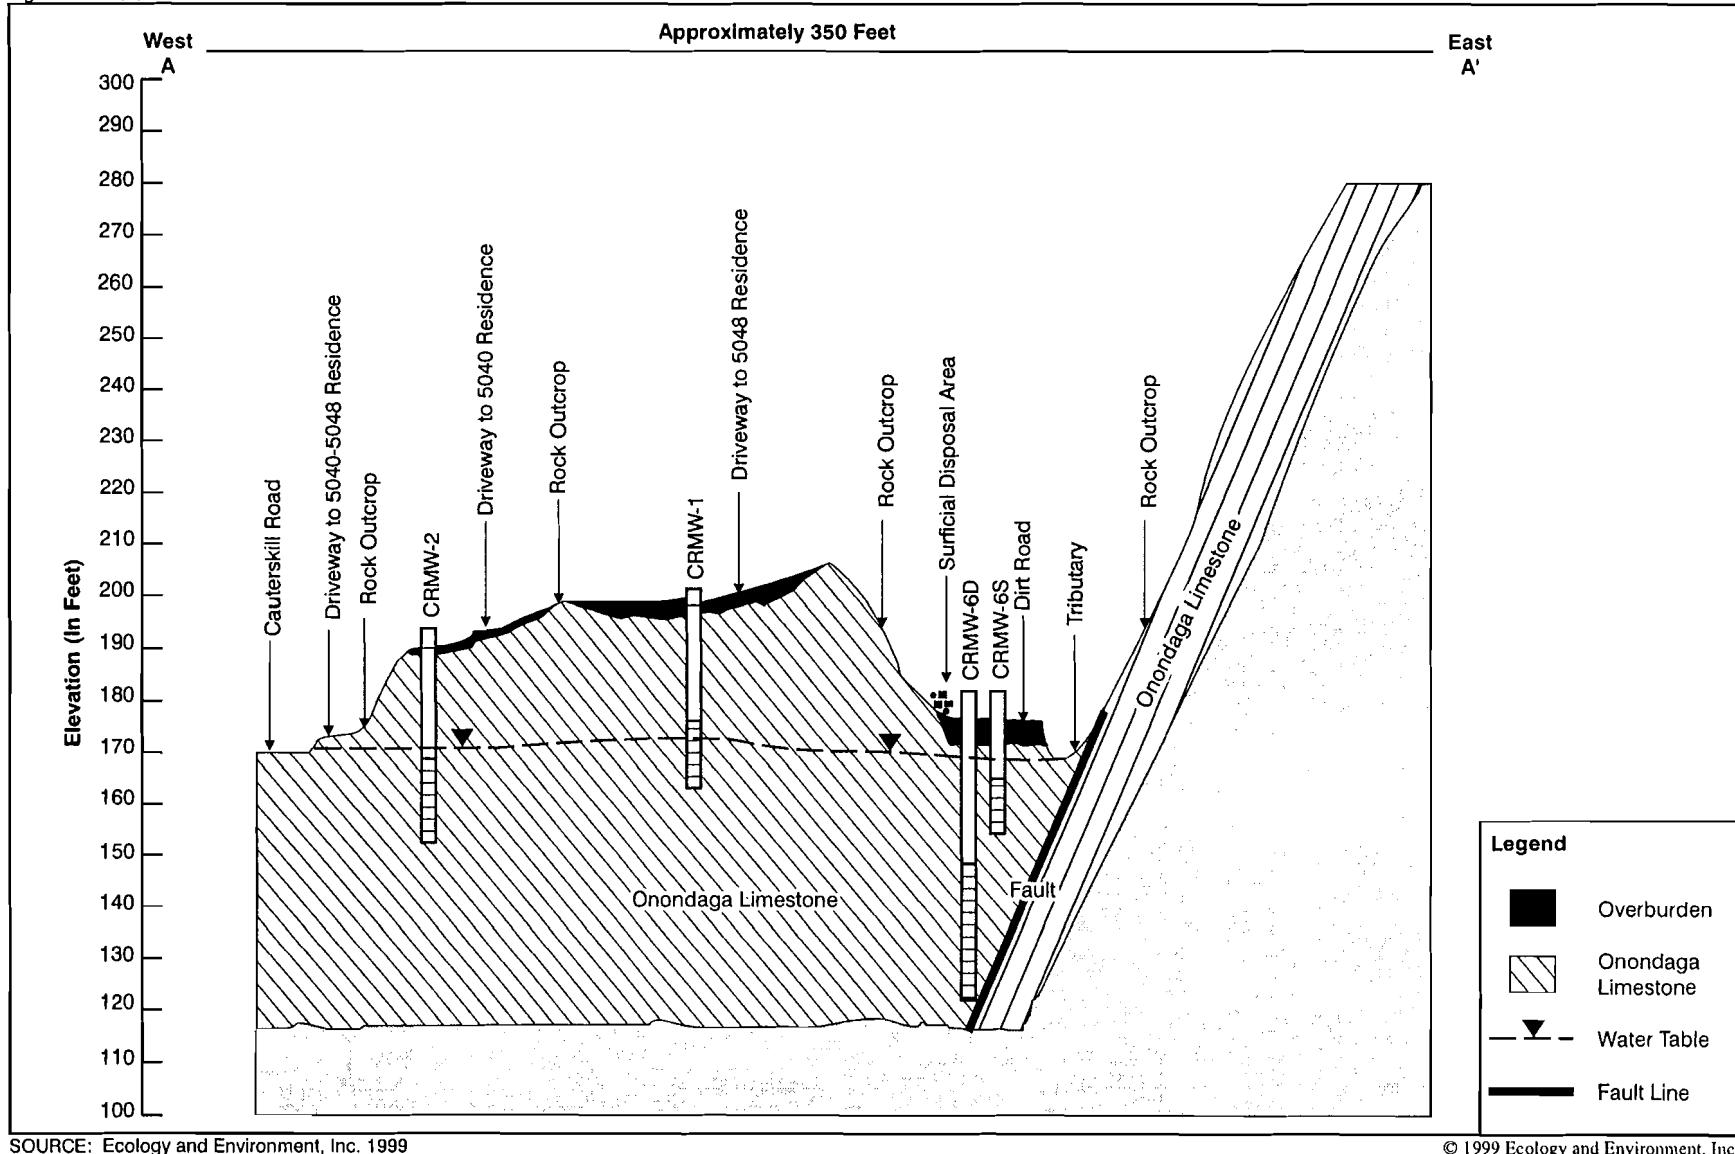
Figure 3-1 GENERALIZED SITE CROSS SECTION  
CAUTERSKILL ROAD SITE

Bedrock consisted of dark gray, fractured Onondaga limestone with black chert nodules and calcite mineralization. The Oriskany sandstone that lies beneath the Onondaga formation was not observed at the site. Rock cores were obtained from two of the monitoring well boreholes (CRMW-1 and CRMW-2) from 4.9 to 21.3 feet BGS and 5.5 to 16.5 feet BGS, respectively. The completion of the drilling for these wells and CRMW-3 through CRMW-6 was performed using a combination of air rotary/air hammering techniques. Drilling methods outlined in the work plan (E & E 1998) were changed due to significant drill water loss to formation fractures while coring. The rock chips generated during air rotary/air hammering were all consistent in color and composition to depths of up to 58 feet BGS. The cores exhibited a good to excellent RQD (see Table 2-8), indicating competent, massively bedded cherty limestone. Beds are dipping 28° to 45°, and fractures are generally parallel to bedding planes. Some fractures exhibited

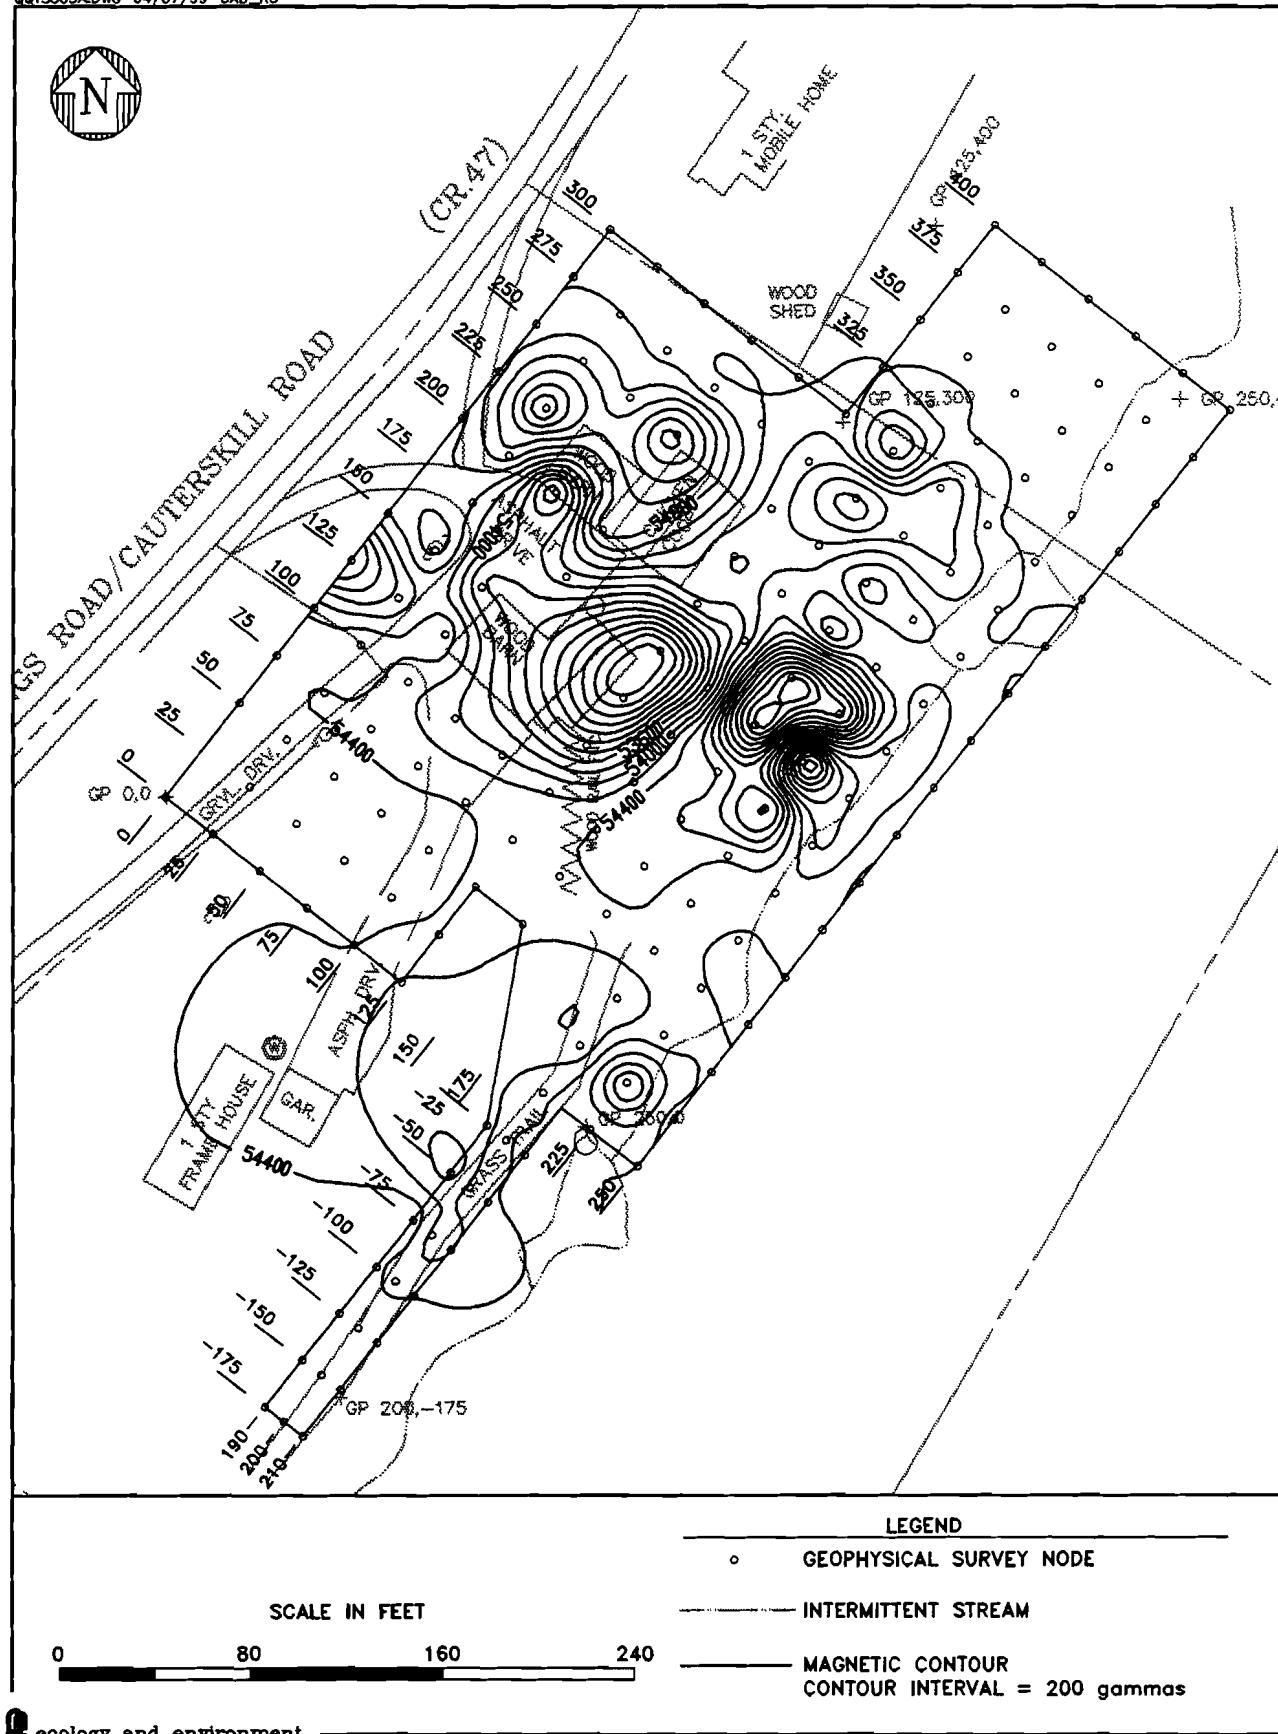
Figure 5-1  
TOTAL EARTH'S MAGNETIC FIELD  
CAUTERSKILL ROAD, CATSKILL, NEW YORK

The magnetic data indicates several anomalous areas. The anomalies in the central portion of the grid were caused by cultural interference. However, magnetic anomalies along the embankment in the northern and eastern portions of the site were caused by buried ferromagnetic objects. The EM31 confirmed the magnetic results along the embankment, and pinpointed five point source anomalies which are from unknown sources. The objects represented by

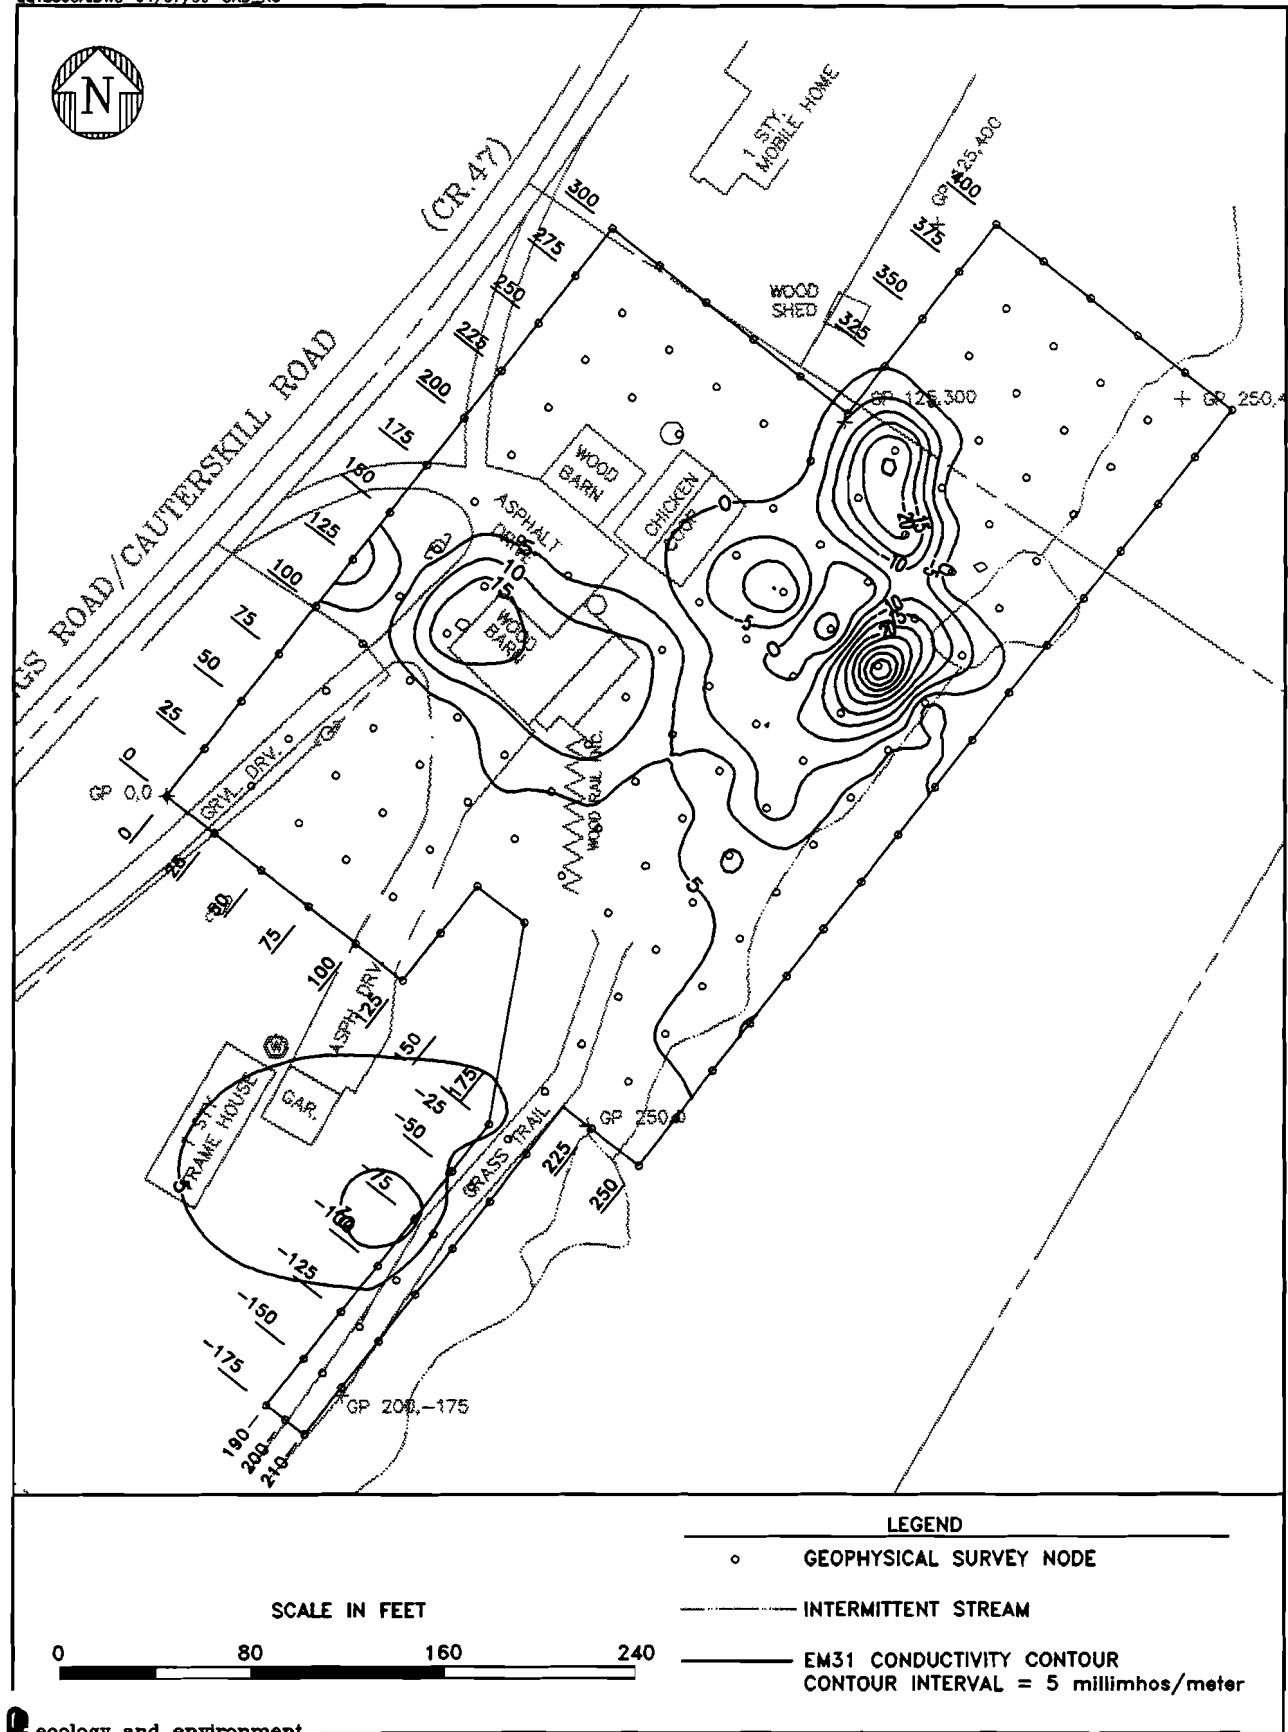
Figure 5-2  
EM31 CONDUCTIVITY  
VERTICAL DIPOLE 1  
CAUTERSKILL ROAD, CATSKILL, NEW YORK  
5-59

The ground conductivity and in-phase surveys conducted at the site also revealed several anomalous areas generally coinciding with

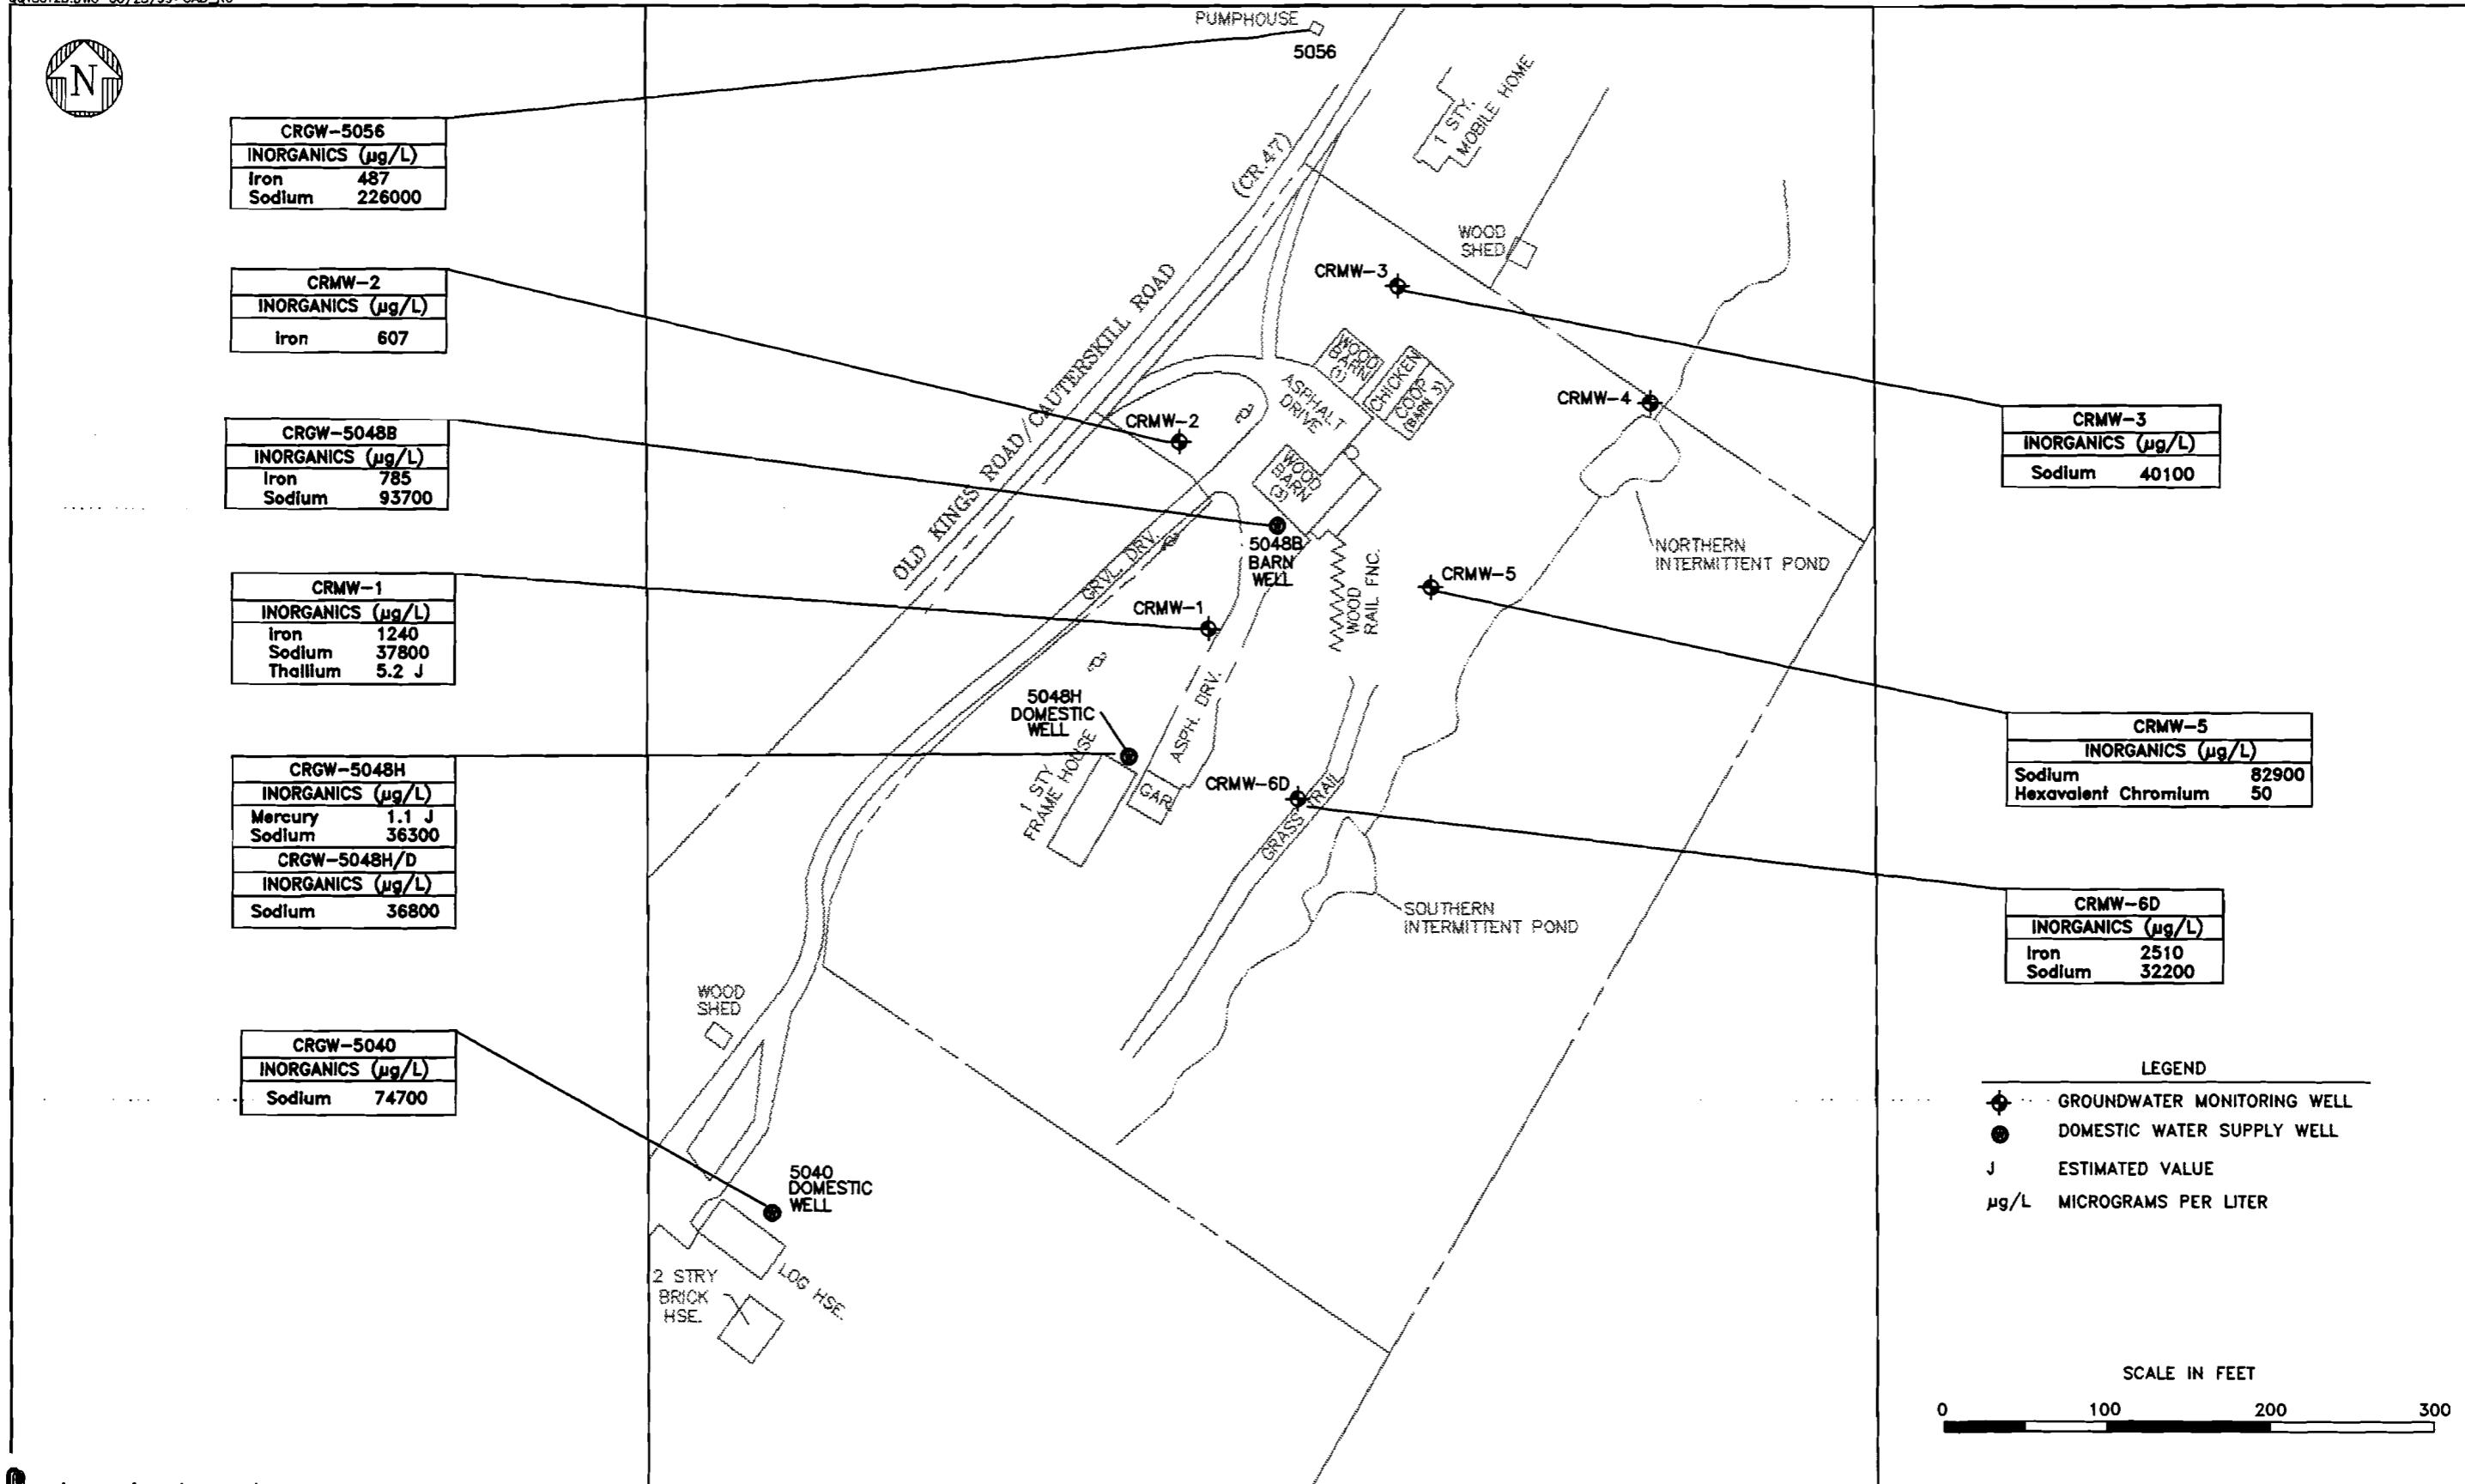
Figure 5-13 GROUNDWATER SAMPLE RESULTS EXCEEDING SCREENING CRITERIA CAUTERSKILL ROAD CATSKILL, NEW YORK

Four existing residential wells (5040, 5048B, 5048H, and 5056) were sampled. The residential wells were purged prior to sampling as described in Section 2.7.3. Well 5048B has a total measured depth of 179 feet BGS, 5048H was measured to be greater than

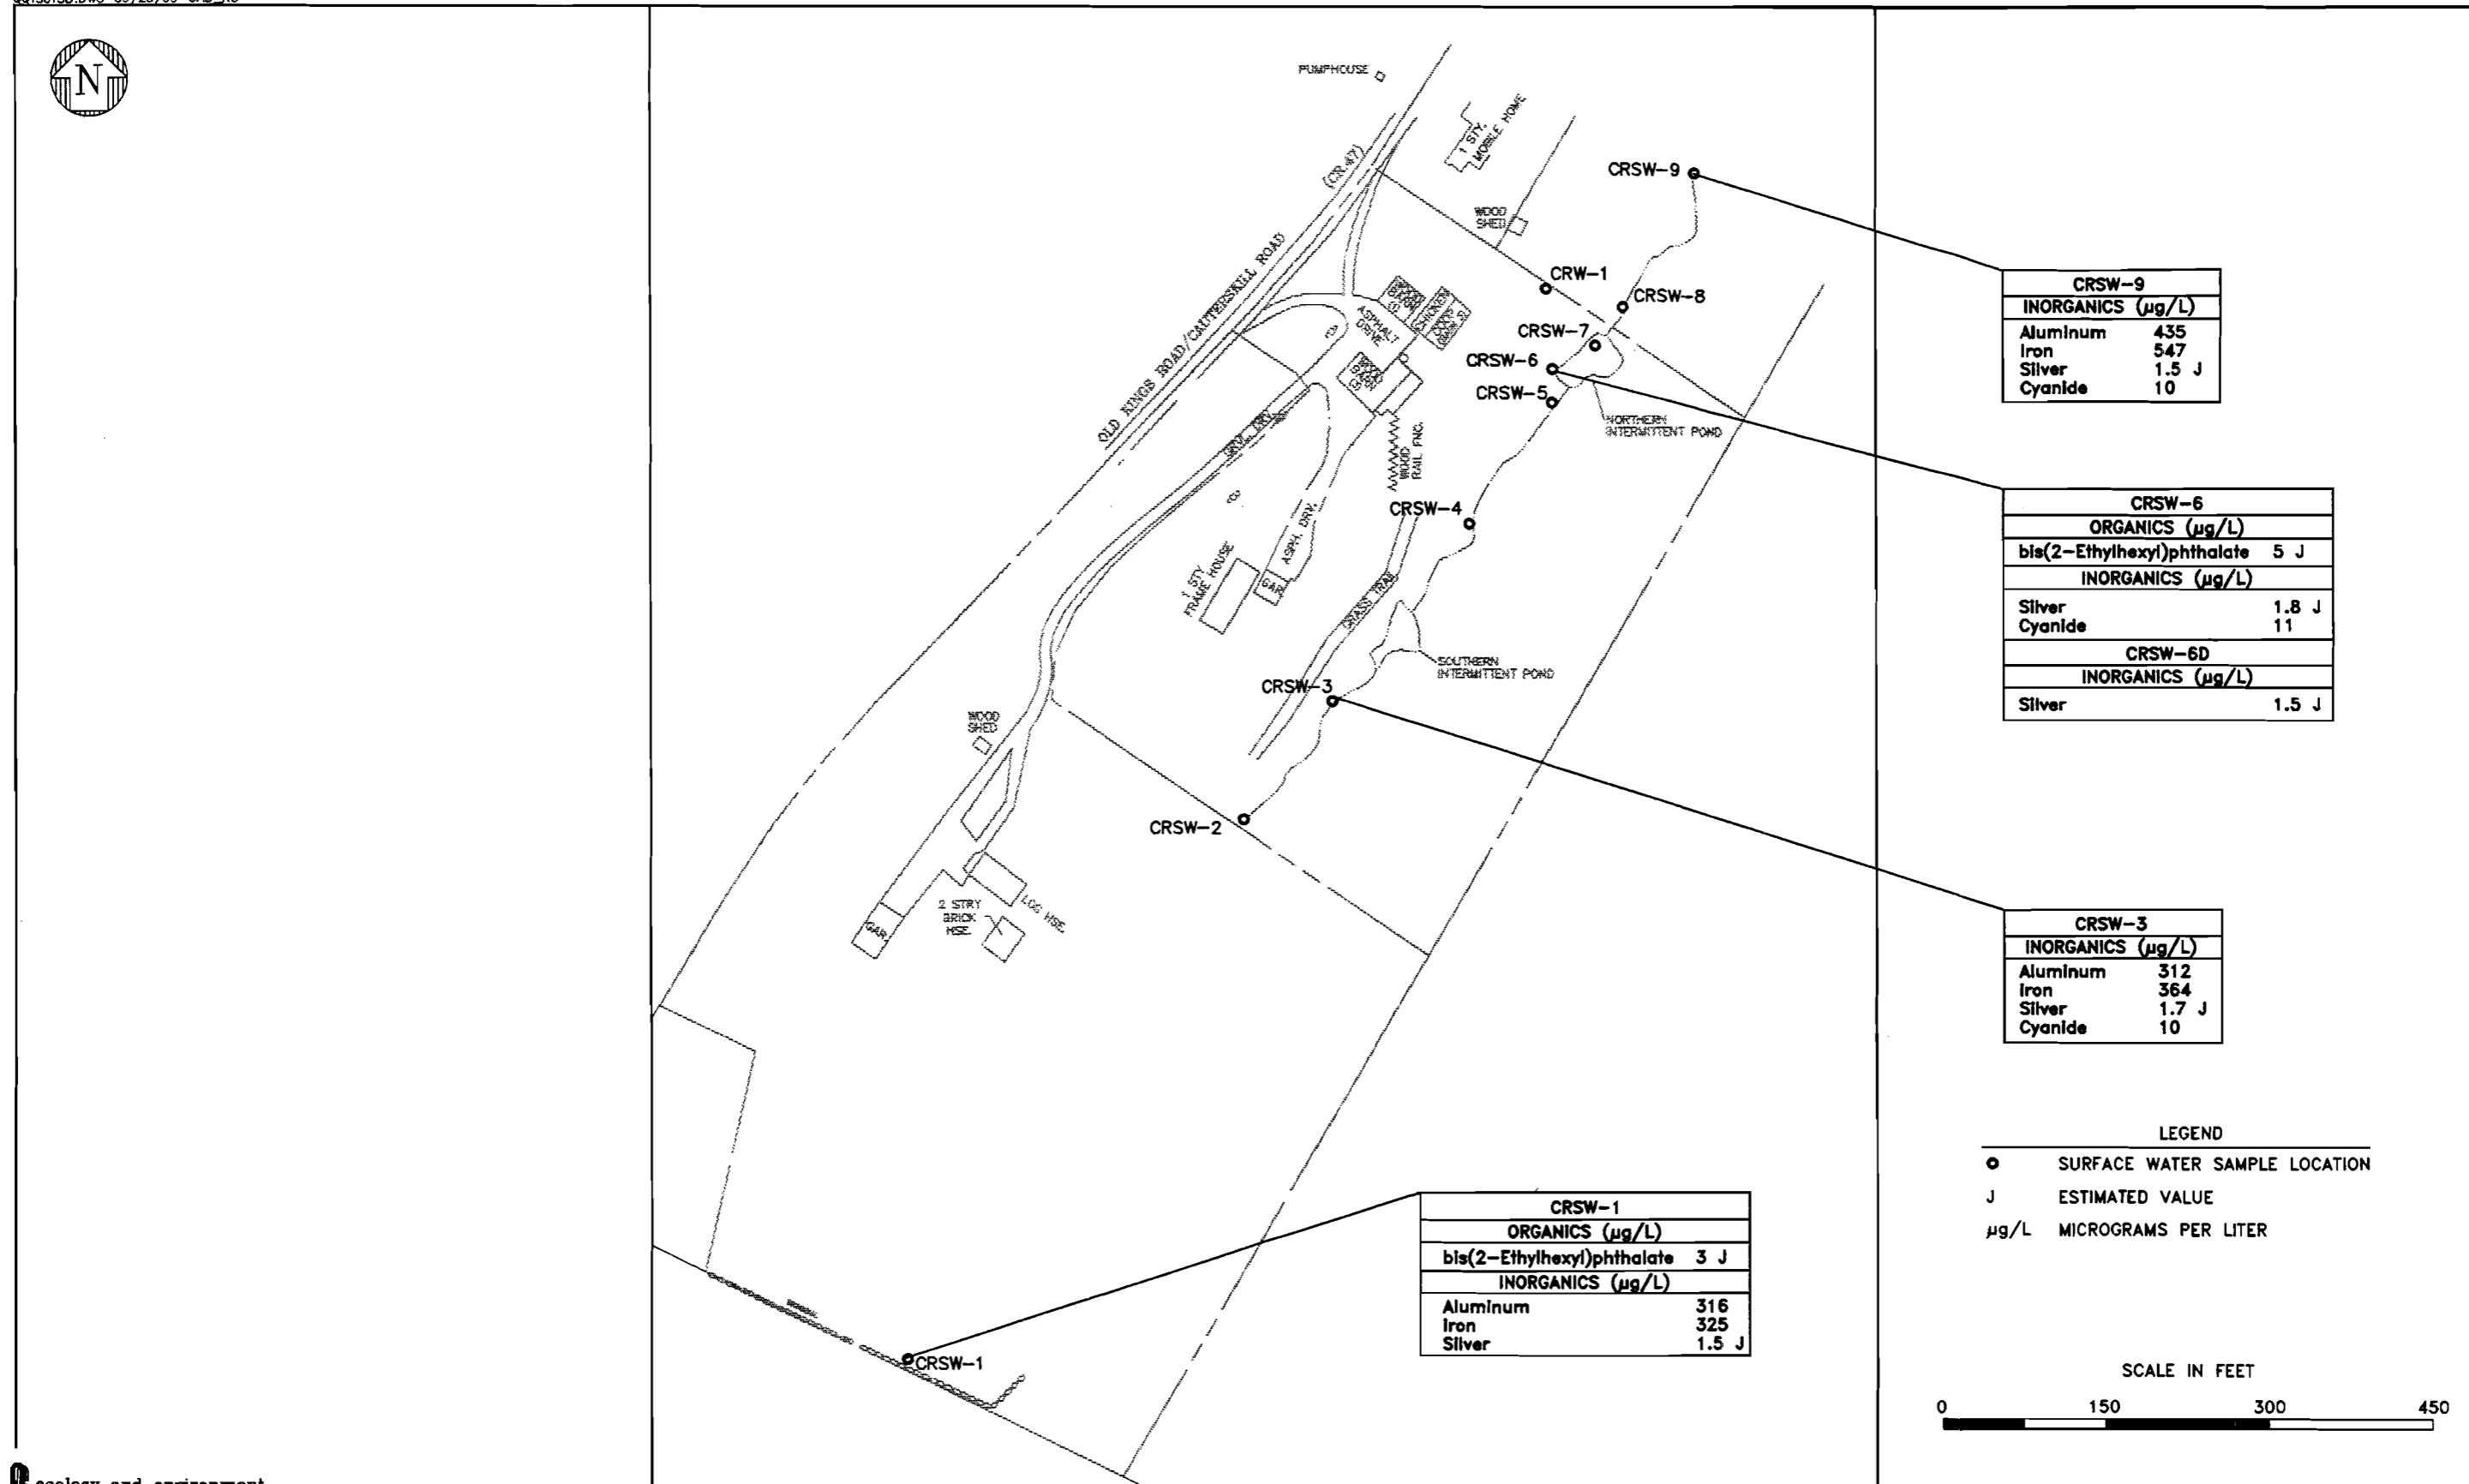
Figure 5-14a SURFACE WATER SAMPLE RESULTS  
EXCEEDING SCREENING CRITERIA  
(PHASE I RI)  
CAUTERSKILL ROAD  
CATSKILL, NEW YORK

Surface water samples CRSW-1, CRSW-3, CRSW-6, and CRSW-9 were analyzed for TCL VOCs, TCL SVOCs, TCL pesticides and PCBs, TAL metals, hexavalent chromium, cyanide, and hardness; surface water samples CRSW-2, CRSW-4, CRSW-5, CRSW-7, CRSW-8, and CRSW-9; and CRSW-11 and CRSW-12 were tested for PAHs, Pest/PCBs, TAL metals, hexavalent chromium, cyanide, and hardness (see Table 5-12). Field chemistry measurements of pH, temperature, conductivity, and turbidity are summarized in Table 2-11. The positive analytical results for the surface water samples are summarized in Table 5-5.

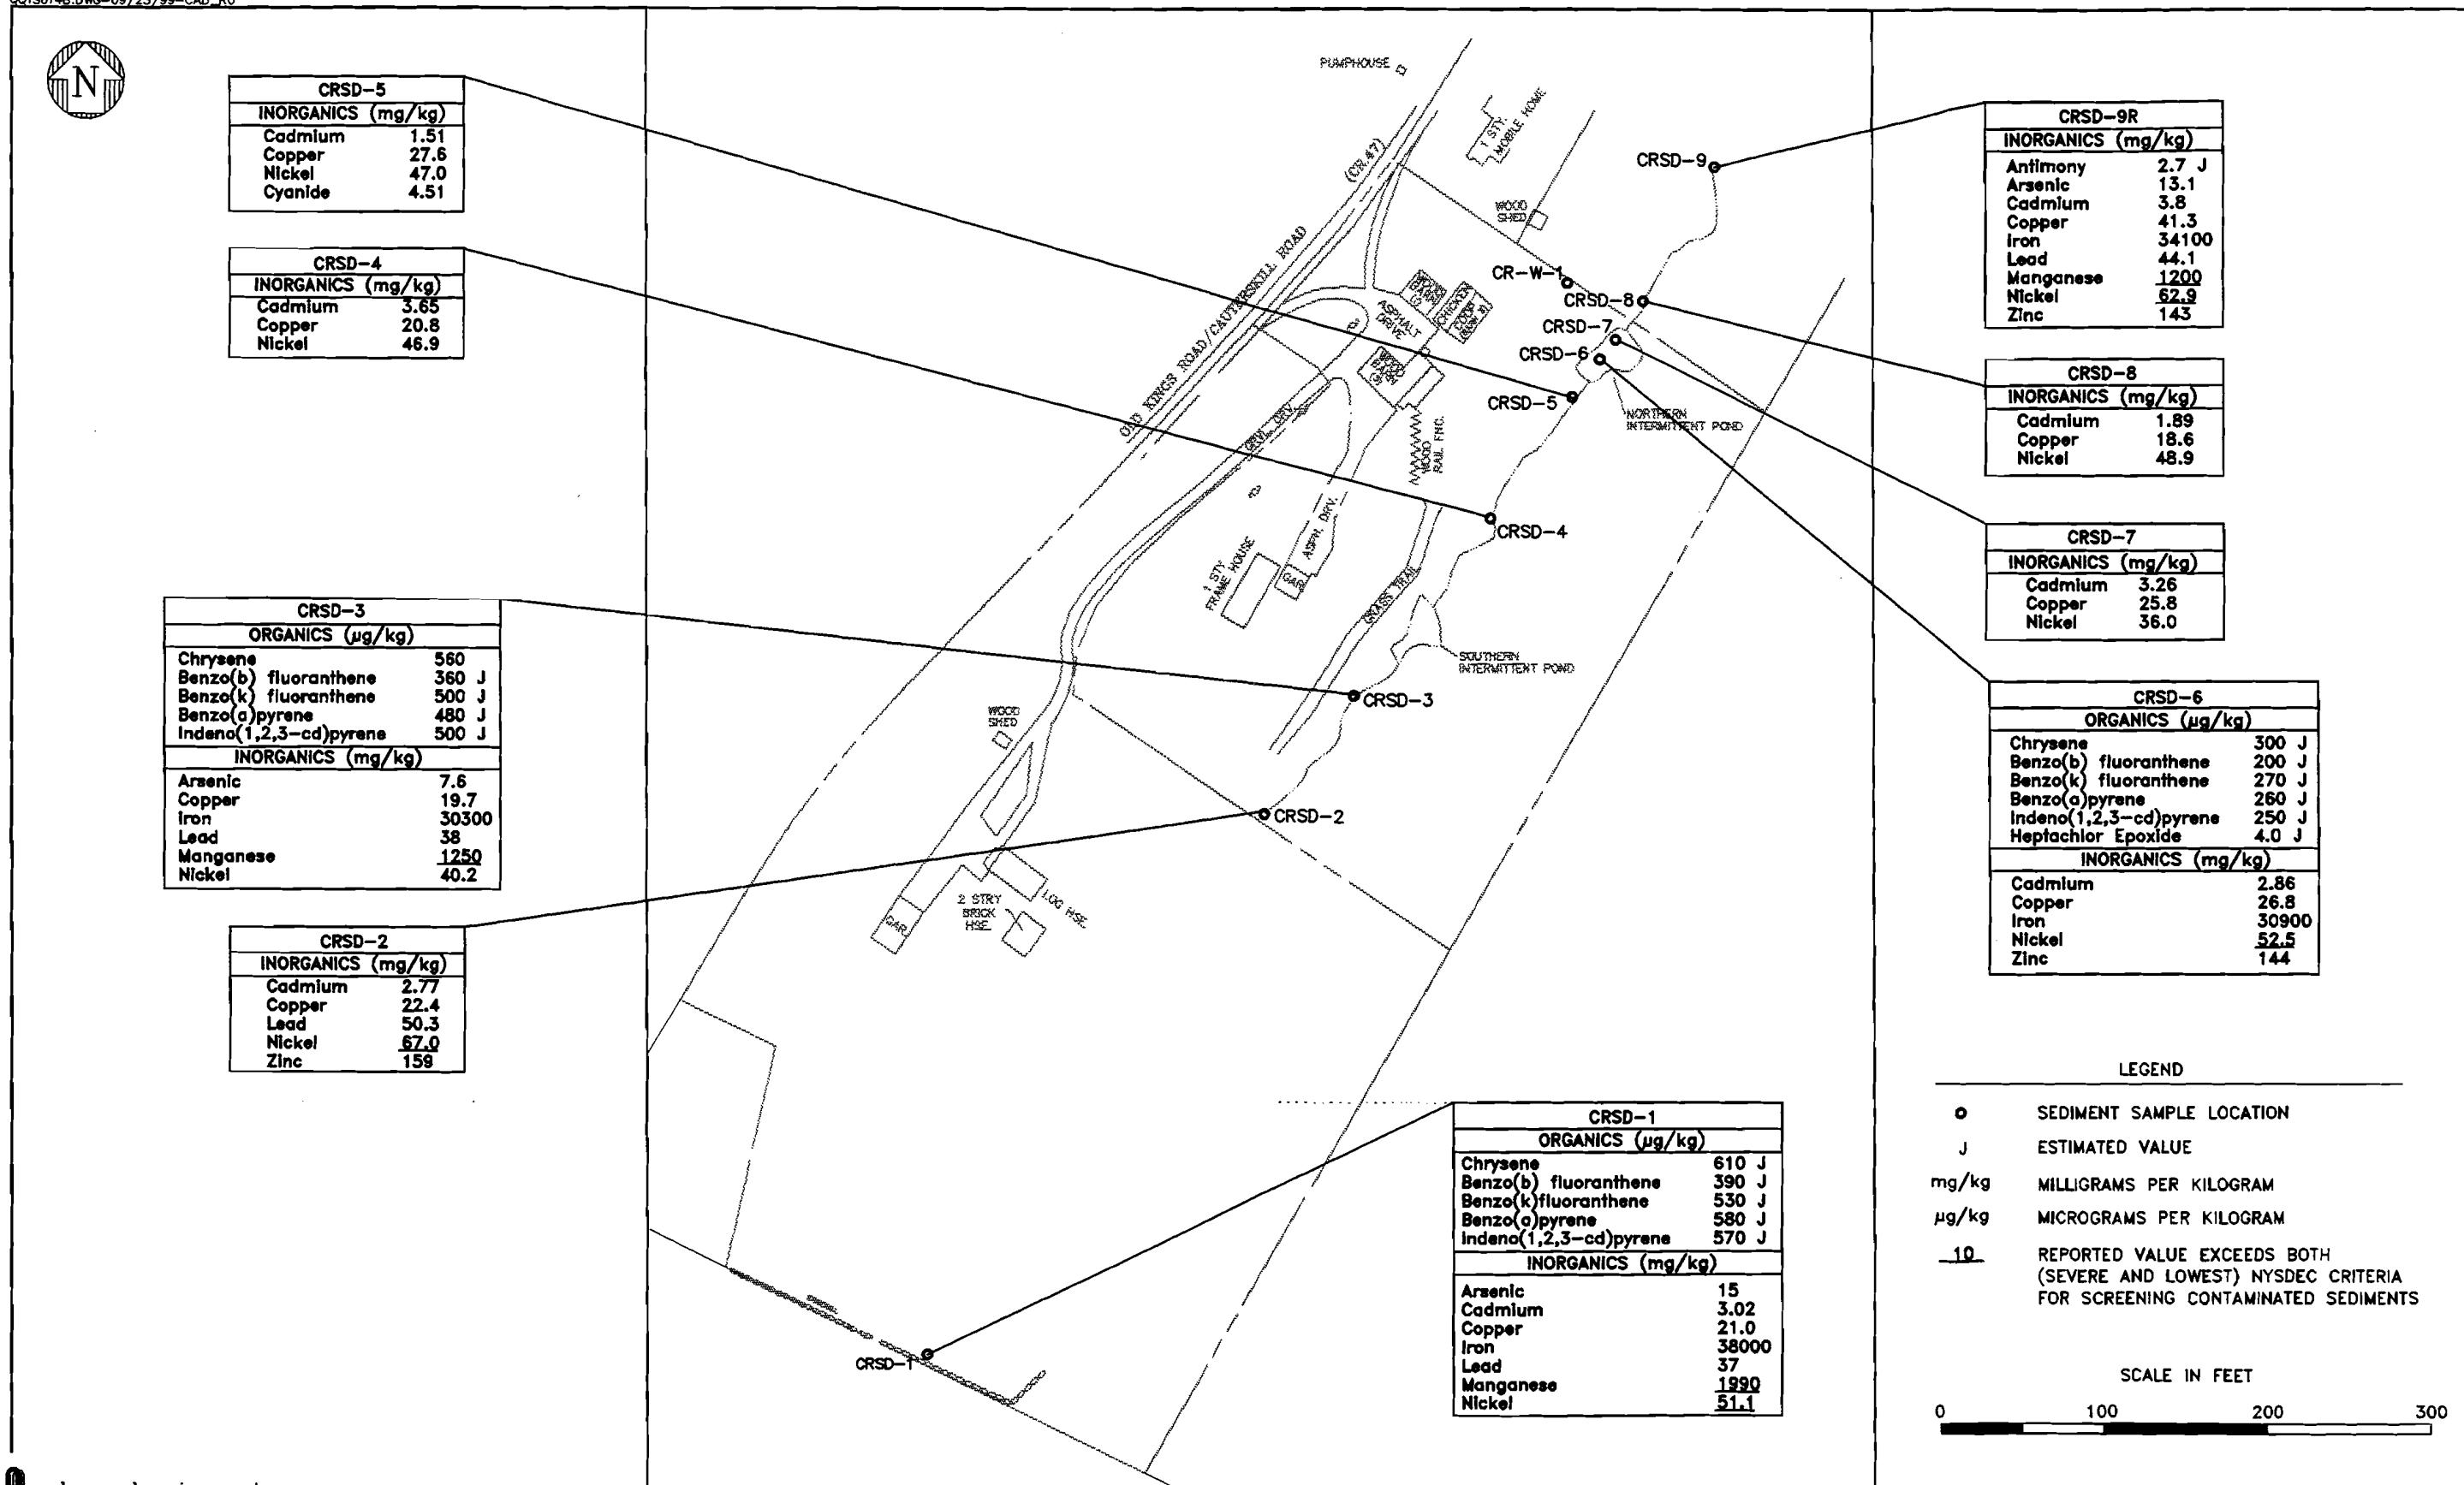
Figure 5-15a SEDIMENT SAMPLE RESULTS EXCEEDING SCREENING CRITERIA (PHASE I RI) CAUTERSKILL ROAD

Ten metals (antimony, arsenic, cadmium, chromium [total], copper, iron, lead, manganese, nickel, and zinc) were detected above lowest effect levels (see Table 5-6b and Figures 5-15a and 5-15b). Three of these nine metals (iron, manganese and nickel) also exceeded the severe effect levels. Iron exceeded both screening levels in CRSD-12 and CRSD-15; manganese exceeded both screening levels in samples CRSD-1, CRSD-3, CRSD-9R, and CRSD-10; nickel exceeded both levels in samples CRSD-1, CRSD-6, CRSD-9R, CRSD-10 and CRSD-11. Additionally, nickel levels in the remaining samples were up to 4.3 times greater than the lowest effect level. With the exception of iron, none of the metals exceeding screening criteria were detected above Class C standards in the corresponding surface water samples.
