**Final  
Remedial Investigation Report  
of the  
Cauterskill Road Site  
Catskill, New York**

**September 1999**

**NEW YORK STATE DEPARTMENT OF ENVIRONMENTAL CONSERVATION**  
50 Wolf Road  
Albany, New York 12233-5027

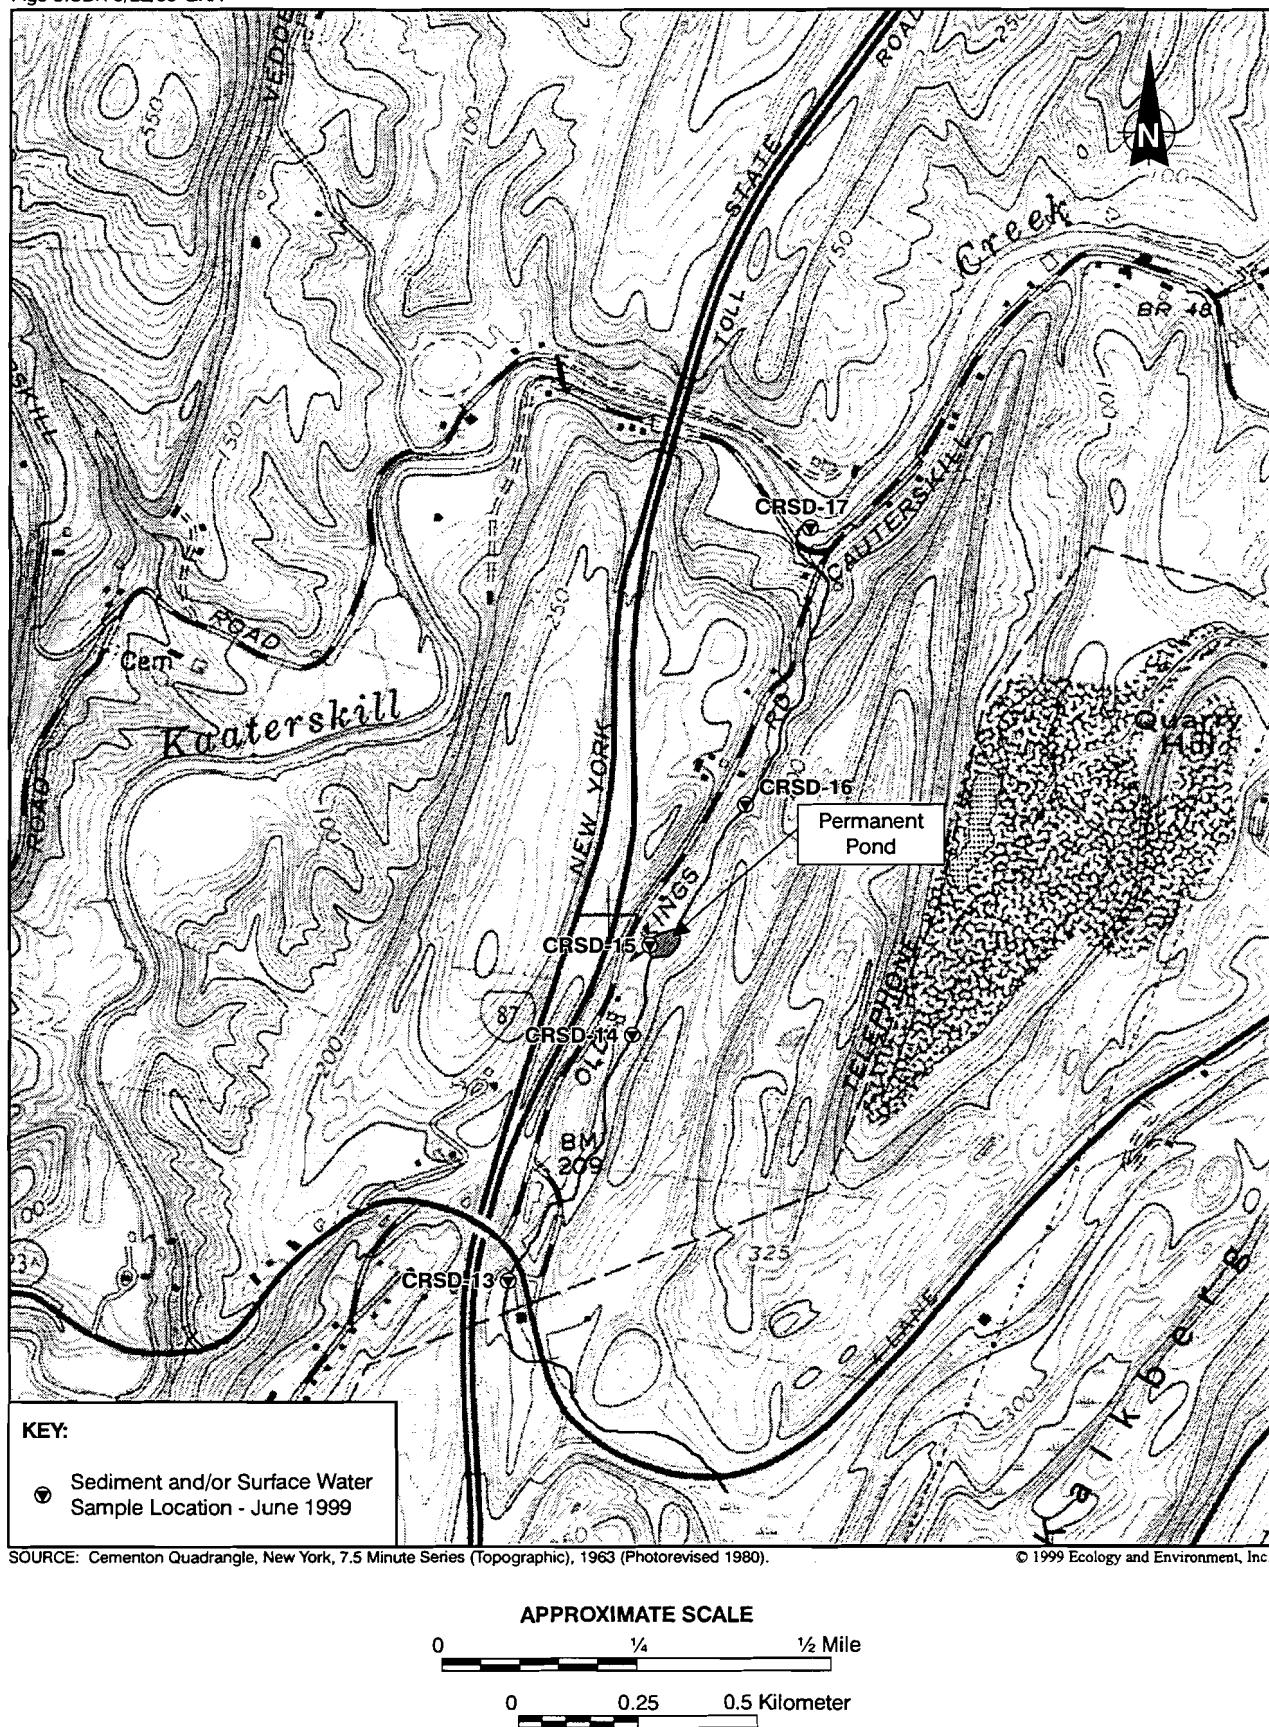
Figure 6-3 JUNE 1999 SAMPLING LOCATIONS ON TRIBUTARY TO KAATERSKILL CREEK

Toxicity tests were conducted with sediment from the tributary to determine if the elevated levels of metals and PAHs pose a risk to benthic life. A 10-day growth and survival test with *Hyalella azteca*, a common freshwater amphipod species, was conducted with sediment from each location. The test method is described in USEPA (1994) and ASTM (1995). Table 6-11 summarizes the test results. The test report is included in Appendix G.

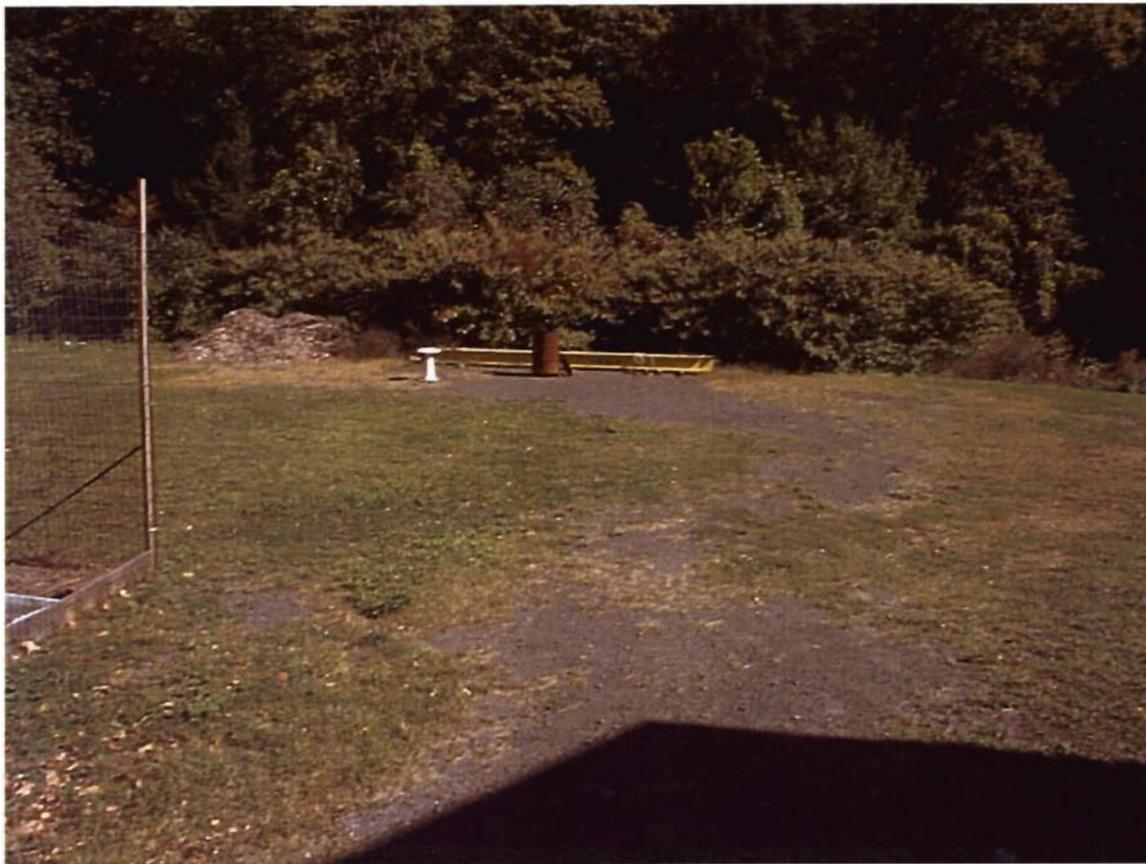
Photo	Date	Description
CR-1	9/ /98	View to east of site entrance way.
CR-2	9/ /98	View to northeast of alleged disposal area.
CR-3	9/ /98	White-powder waste exposed along embankment on west side of creek.
CR-4	9/ /98	Empty sodium cyanide drum along embankment on west side of creek.
CR-5	1/7/99	View to northeast of pickup truck, front end from CRTP-9.
CR-6	1/8/99	Vat and auto engine parts from CRTP-9.
CR-7	1/8/99	View to east of vats and spoils from CRTP-9.
CR-8	1/27/99	HX rock core from CRMW-1 (4.6 to 15.7 feet BGS).
CR-9	1/27/99	HX rock core from CRMW-1 (15.7 to 21.5 feet BGS).
CR-10	1/27/99	HX rock core from CRMW-2 (5 to 16.5 feet BGS).
CR-11	1/27/99	View to south of CRSW-1 location.
CR-12	1/27/99	View to south of CRSW-2 location.
CR-13	1/27/99	View to north of CRSW-3 location from the southern site pond.
CR-14	1/27/99	View to north of CRSW-5 location.
CR-15	1/27/99	View to north of CRSW-6 location from the disposal area spring on the west bank of the tributary.

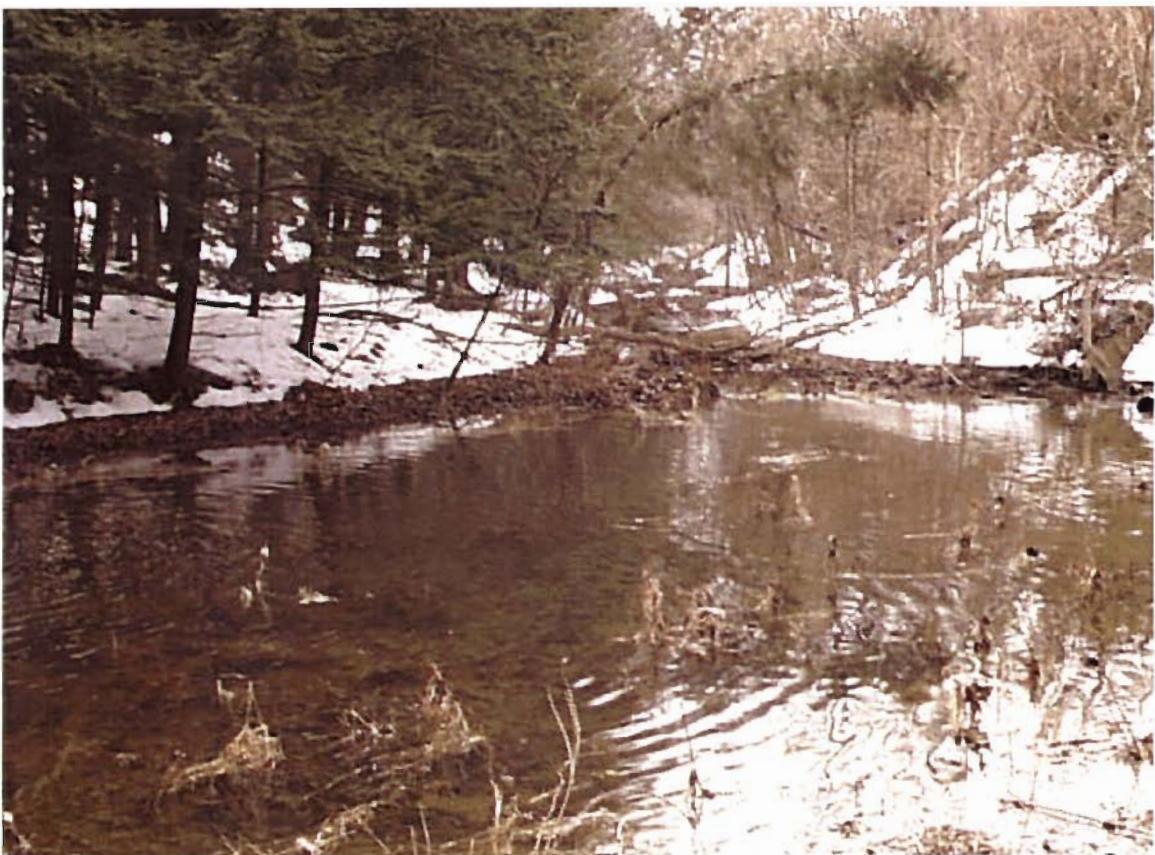
CR-16	1/27/99	View to south of the CRSW-7 location from northern site pond.
CR-17	1/27/99	View to north of CRSW-8 location.
CR-18	1/27/99	View to north of CRSW-9 location.
CR-19	1/29/99	View to east of strike/dip location No. 2 on the east side of Cauterskill Road.
CR-20	1/29/99	View to southeast of strike/dip location No. 12 on the ridge east of the site.
