Appendix B

Representative Photographs

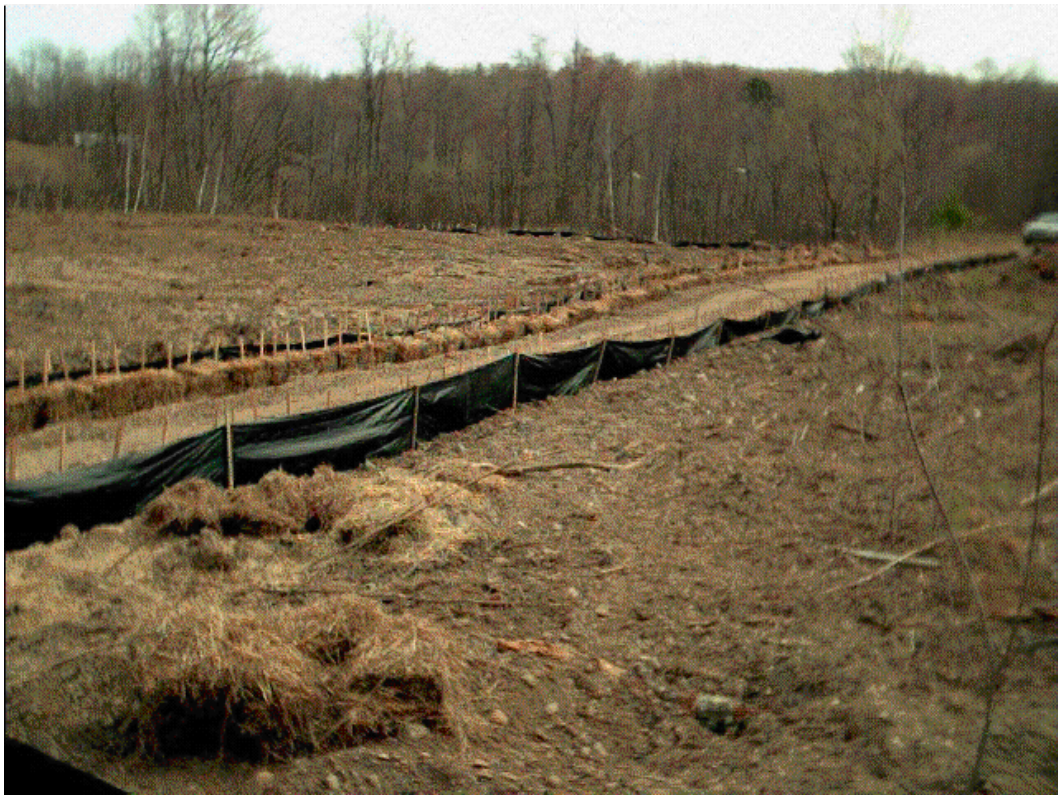
(Photo # 4-23-5) April 23, 2001 – Staging area after clearing and grubbing and silt fencing was installed. View toward the northeast.

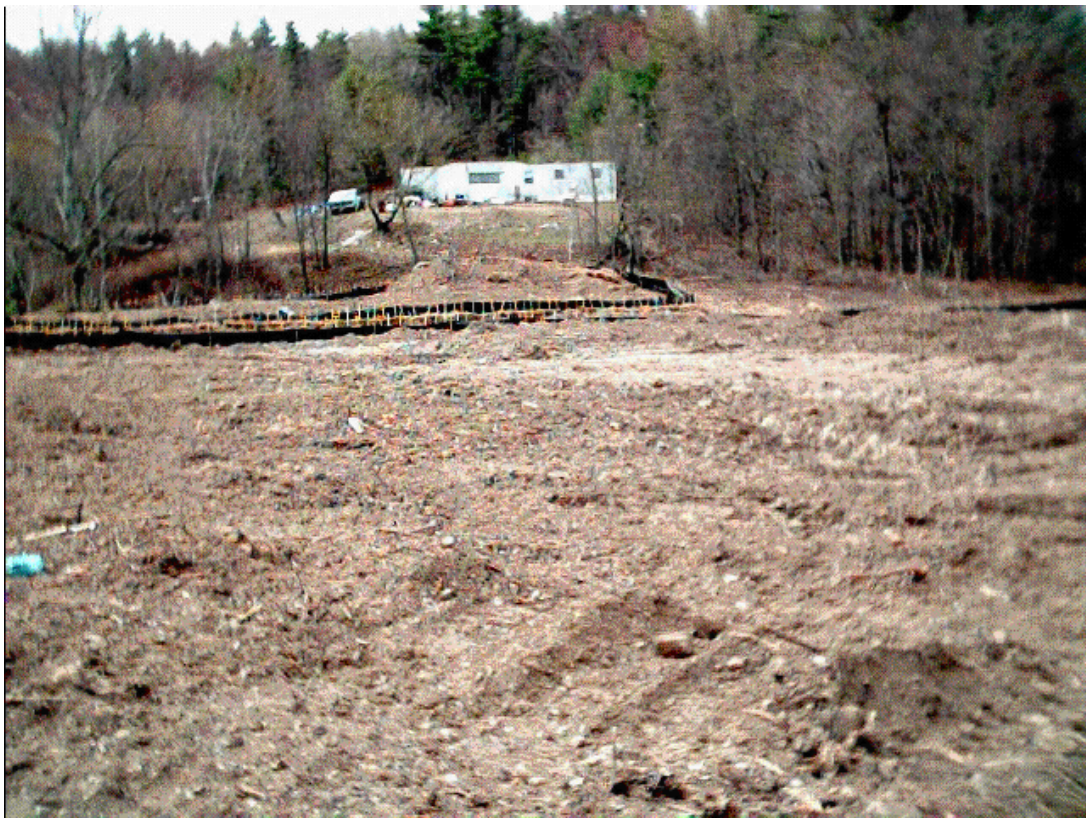
(Photo # 4-23-13) April 23, 2001 – Staging area and MRP Spoil Banks after clearing and grubbing and silt fencing was installed. Original location of house trailer on the Spoil Banks. View toward the south.

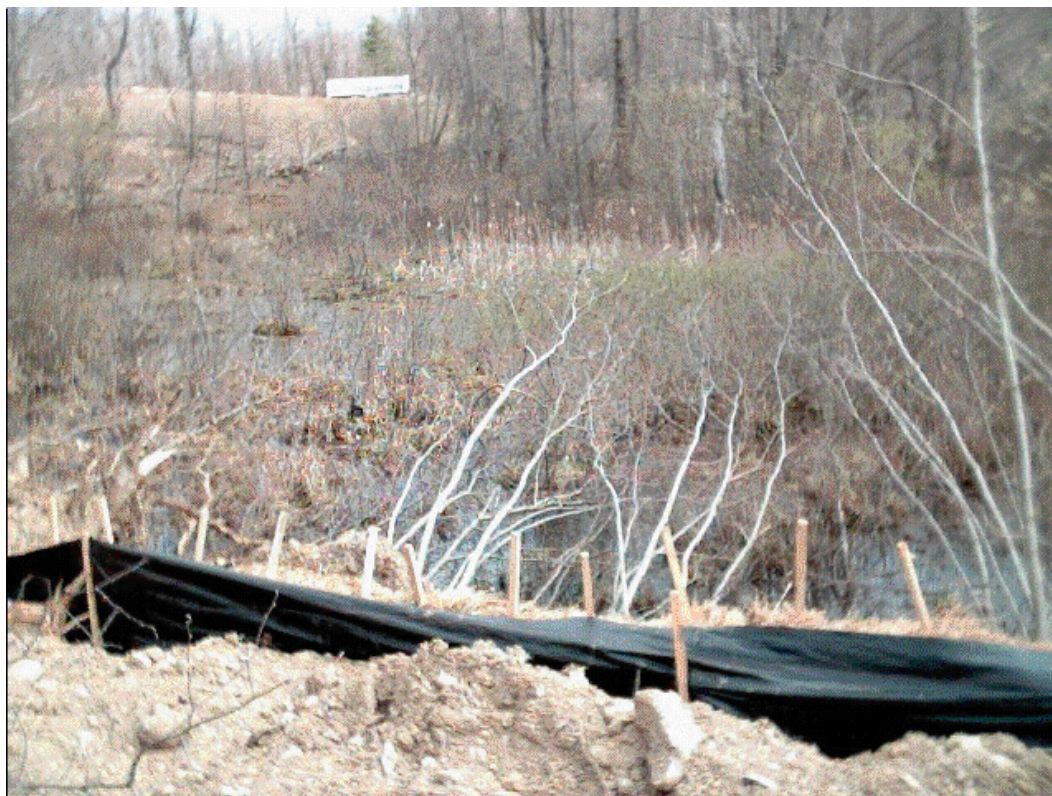
(Photo # 4-23-14) April 23, 2001 – Existing conditions at LLA. View toward the northeast.

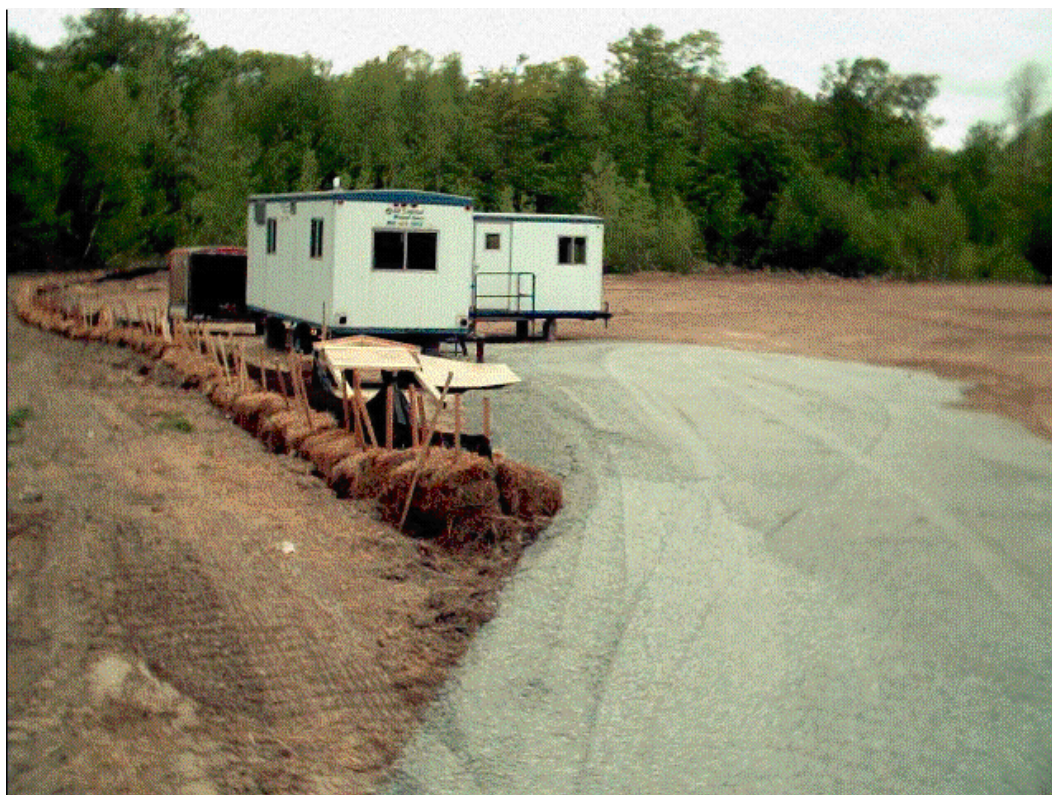
(Photo # 5-16-7) May 16, 2001 – Set up of the office trailers, parking area, and staging area. View toward the west.

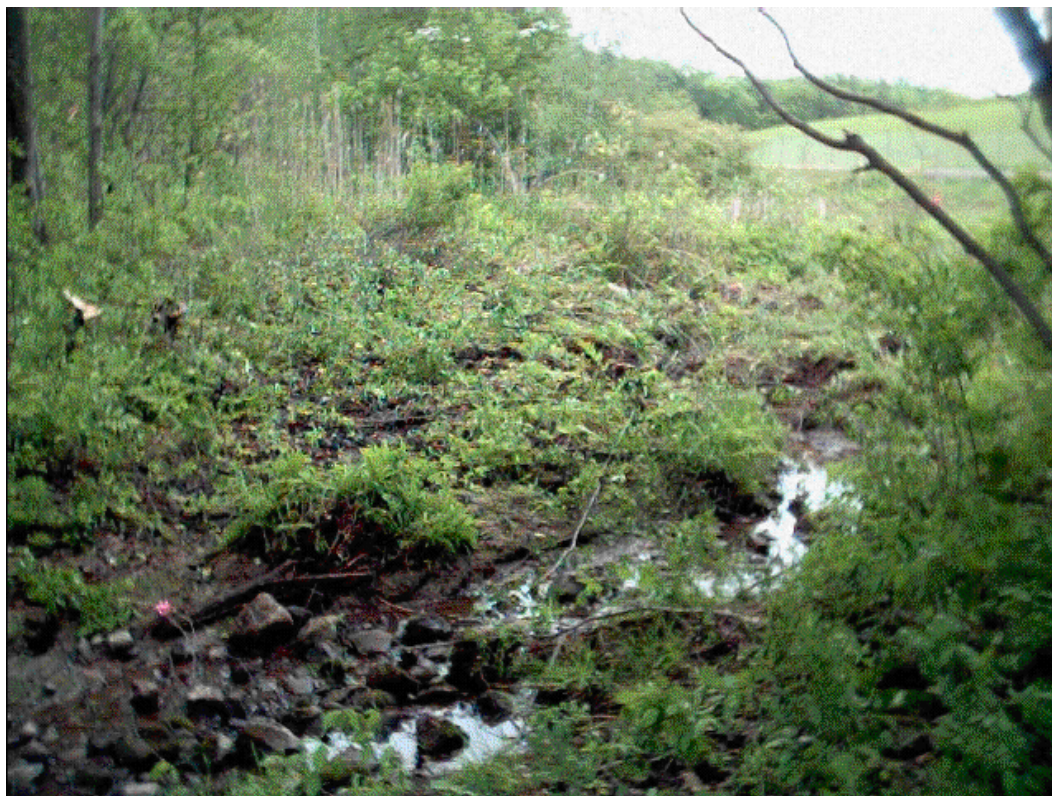
(Photo # 5-24-5) May 24, 2002 – Existing conditions at NWDD. View toward the east.

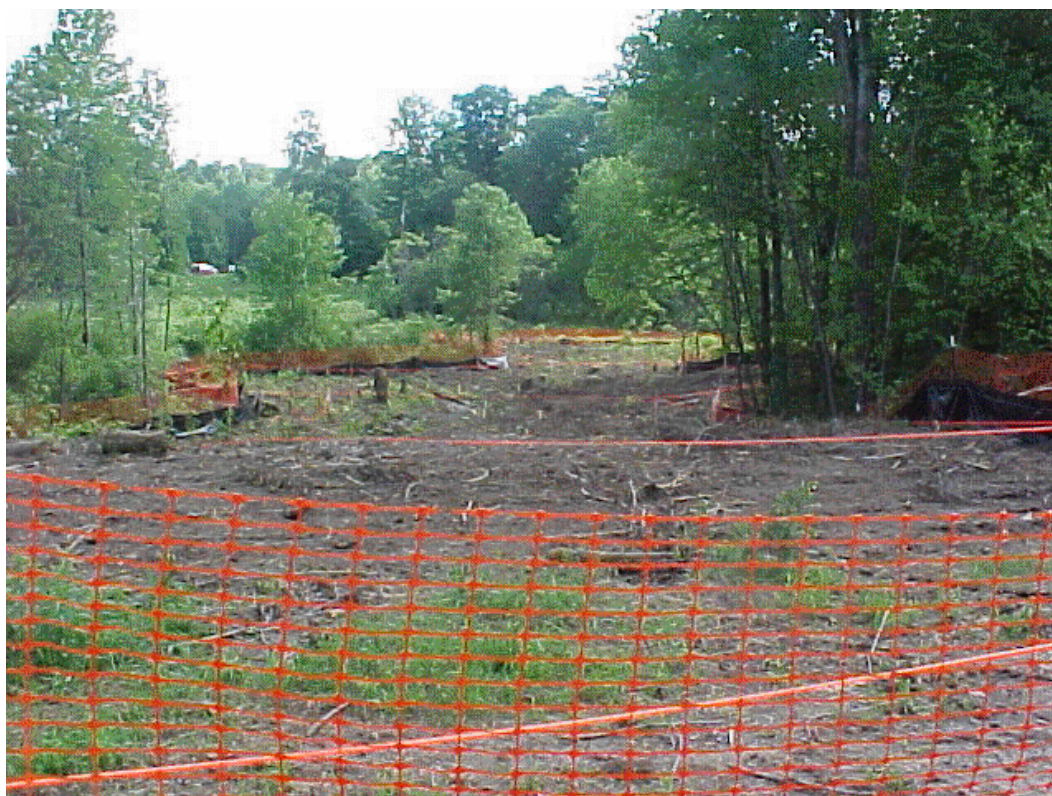
(Photo # 6-6-MVC-004F) June 6, 2001 – Clearing and grubbing completed at the NWDD; silt and construction fencing installed; excavation limits surveyed, staked, and marked with a string line. View toward the northeast.

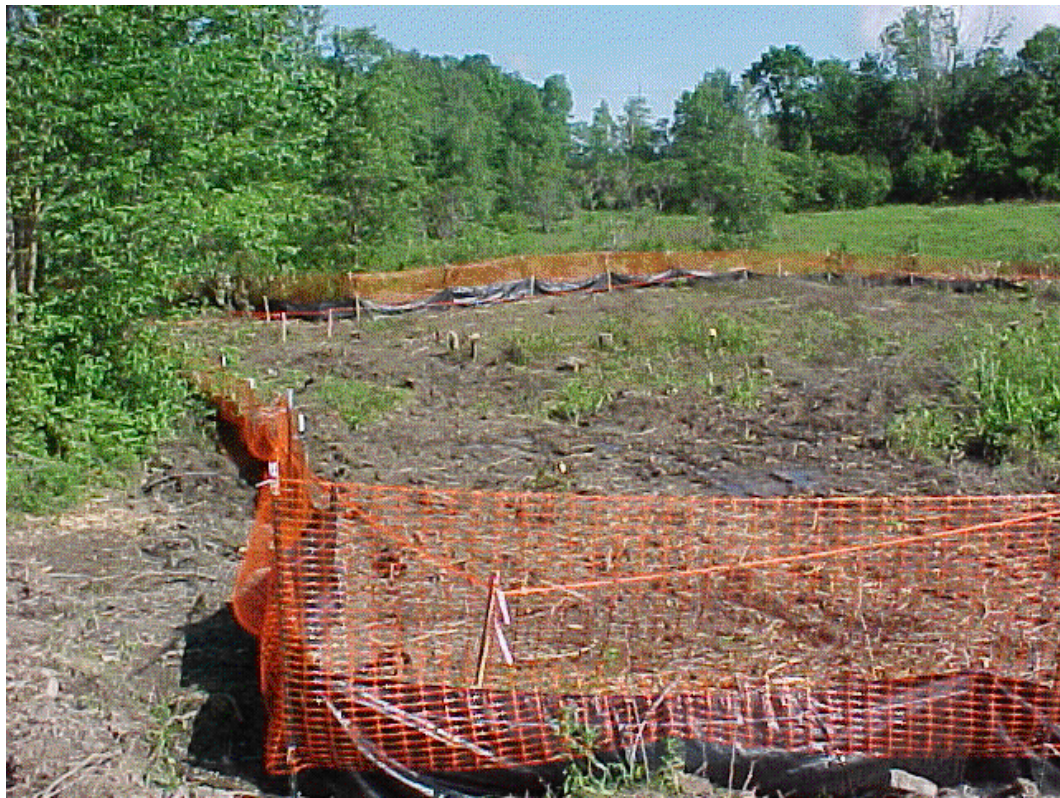
(Photo # 6-6-MVC-005F) June 6, 2001 – Clearing and grubbing completed at the NWDD; silt and construction fencing installed; excavation limits surveyed, staked, and marked with a string line. View toward the southeast.

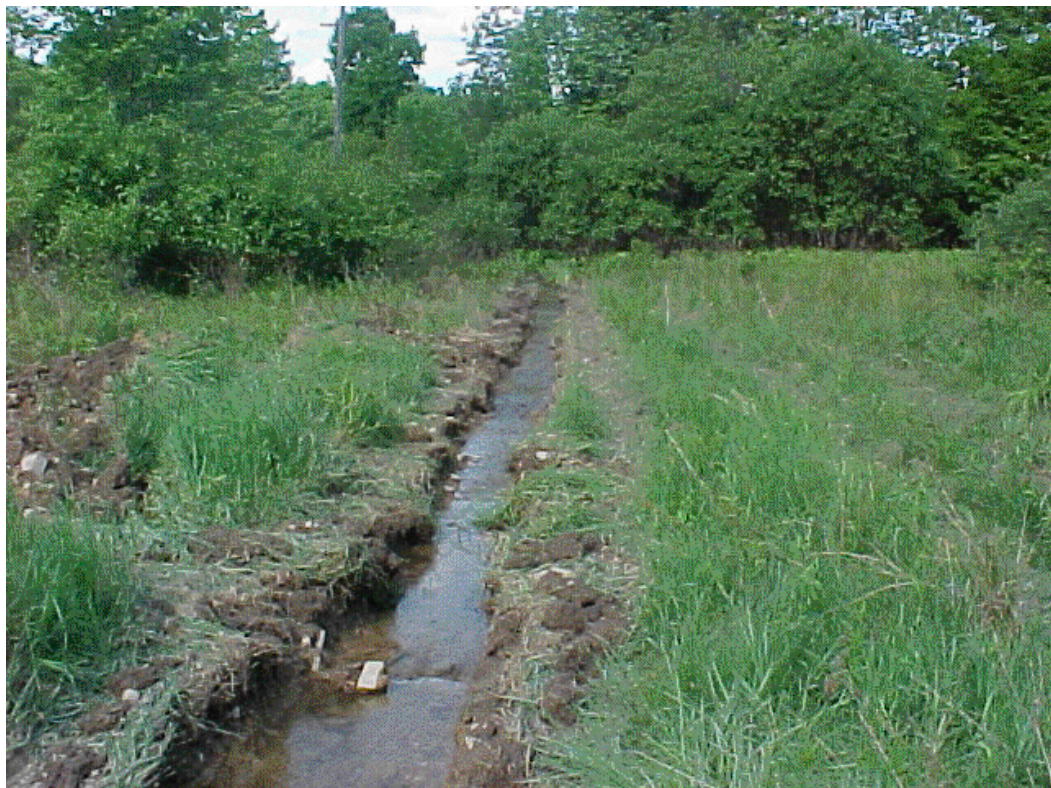
(Photo # 6-6-MVC-010F) June 6, 2001 – Construction of the passive temporary diversion ditch north of the NWDD. View toward the west.

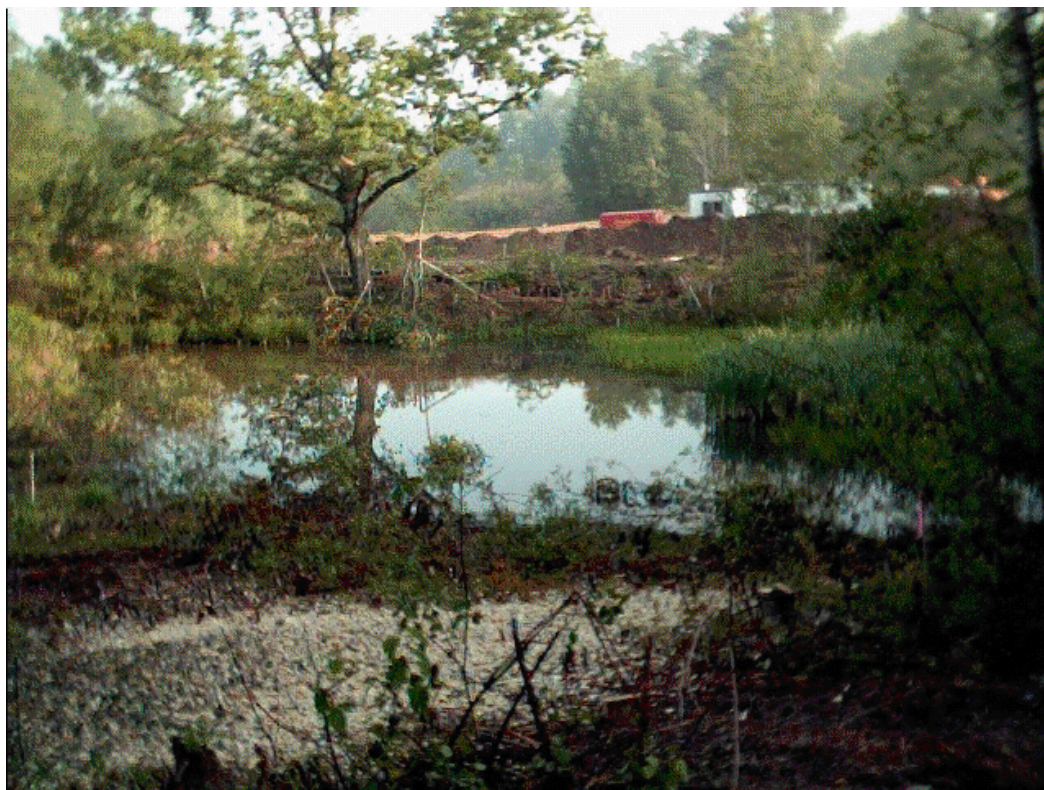
(Photo # 6-14-5) June 14, 2001 – MRP prior to dewatering and excavation activities. View toward the northwest.

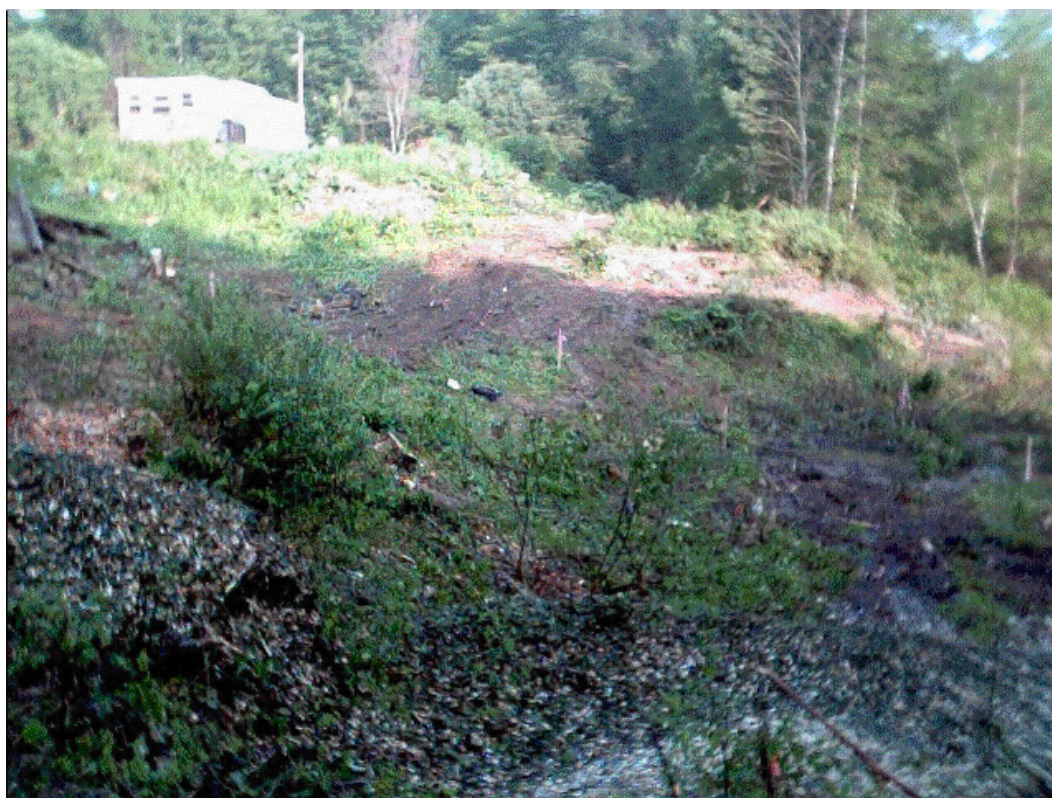
(Photo # 6-14-6) June 14, 2001 – Pre-excavation conditions at MRP Spoil Banks. Clearing and grubbing completed. Excavation limits surveyed and staked. View toward the west.

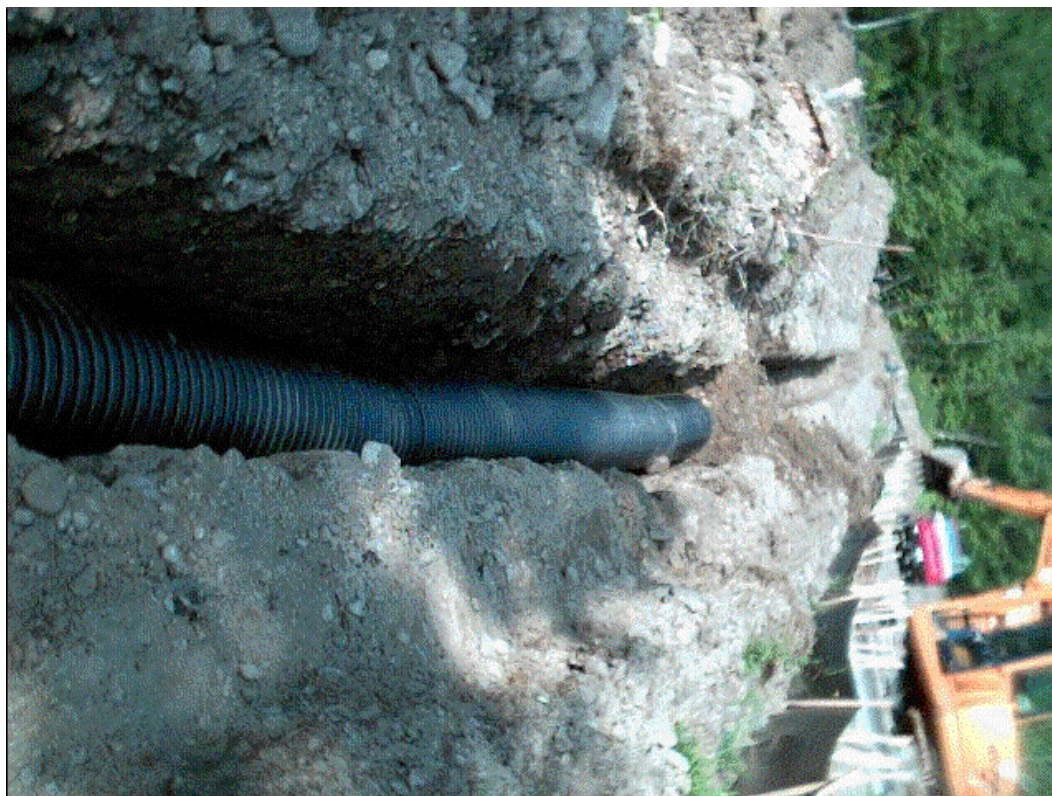
(Photo # 6-14-12) June 14, 2001 – Installation of piping in the temporary passive diversion ditch north of MRP.
View toward the west.

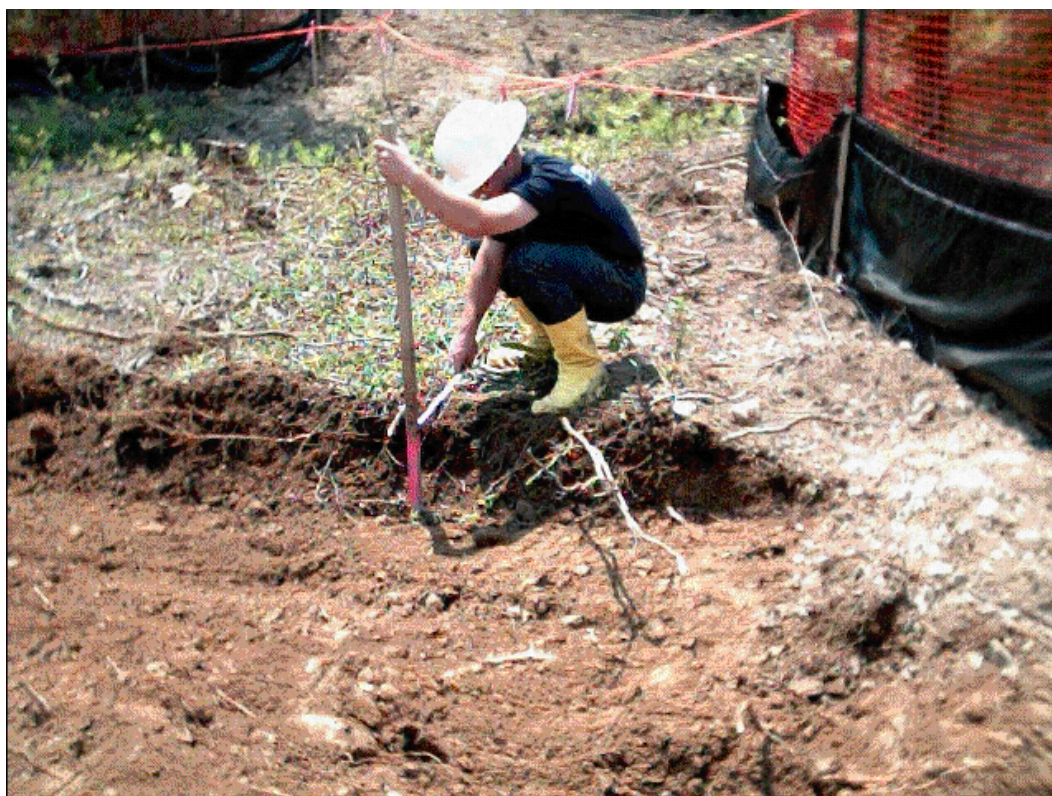
(Photo # 6-20-5) June 20, 2001 – Real-time verification of a one foot excavation in the east end of the NWDD.

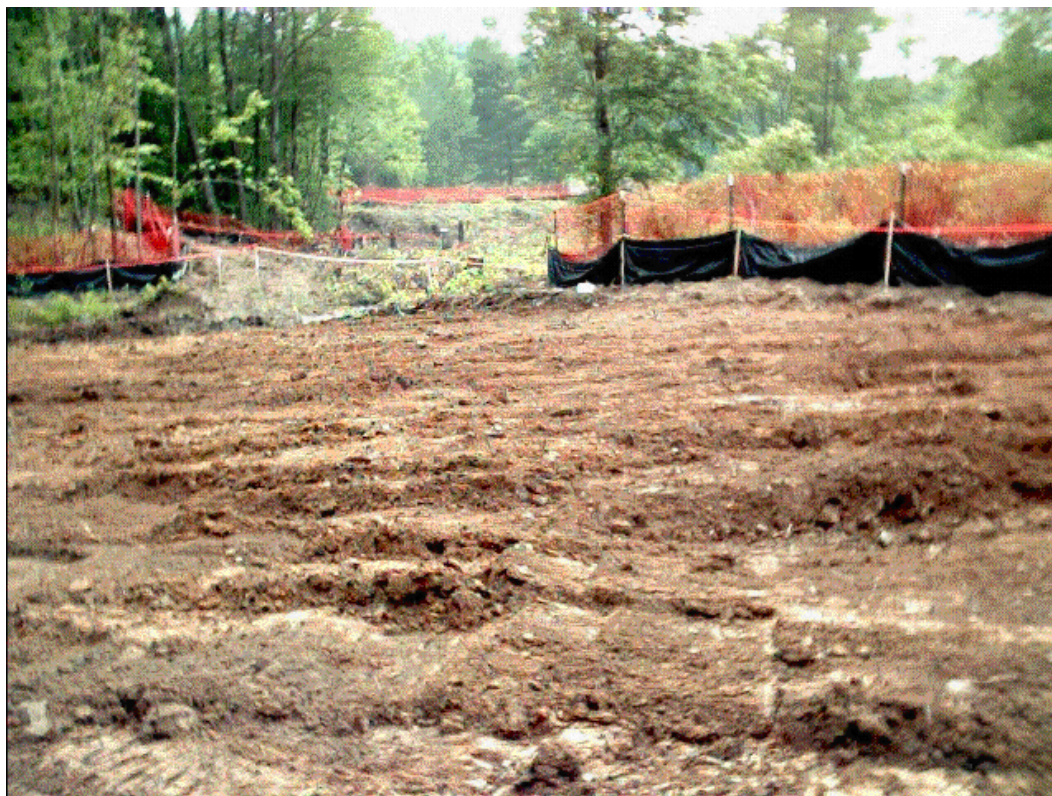
(Photo # 6-20-10) June 20, 2001 – Completion of a one foot excavation in the east end of the NWDD. View toward the west.

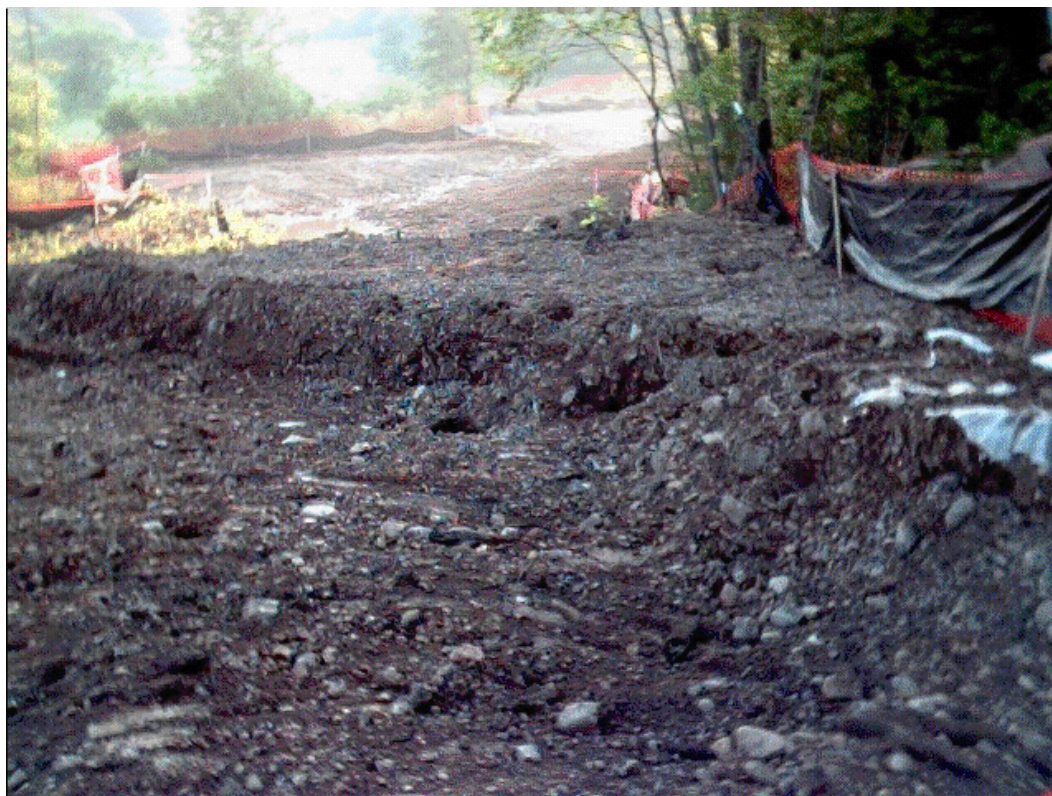
(Photo # 6-28-1) June 28, 2001 – Completion of a two foot excavation in the NWDD. Additional completed areas of excavation in the NWDD are shown in the background. View toward the east.

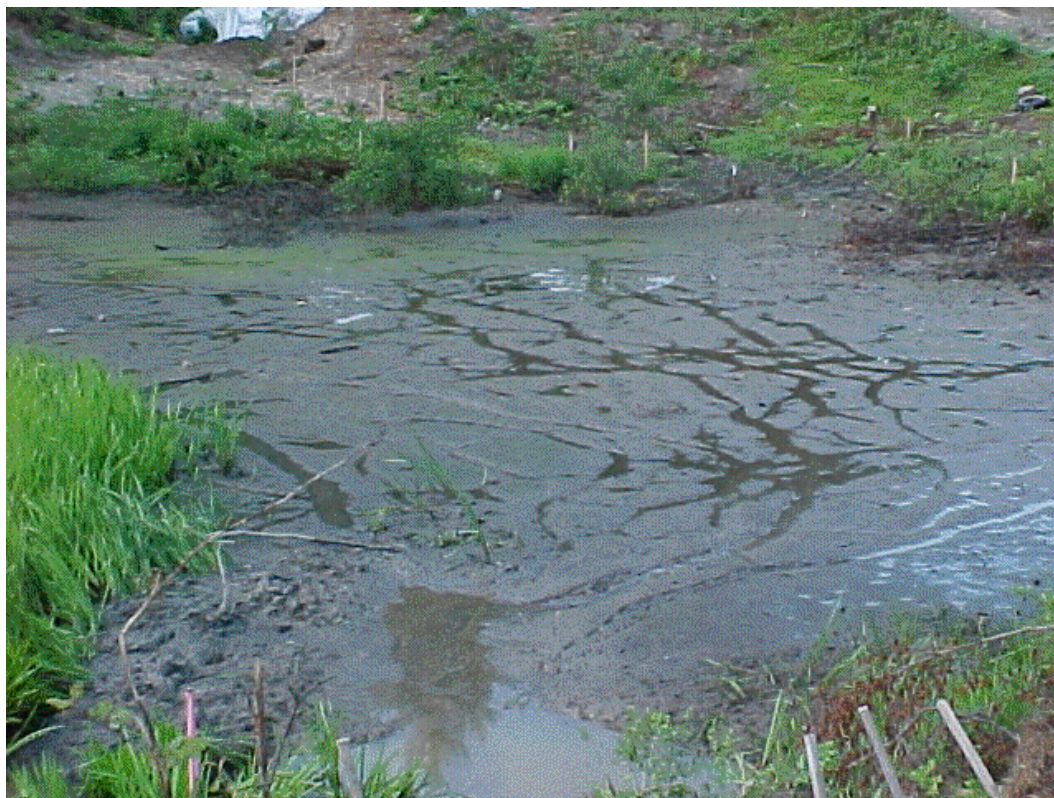
Photo # 7-10-MVC-001F
July 10, 2001 – Dewatering of MRP; upper soft materials. View toward the south.

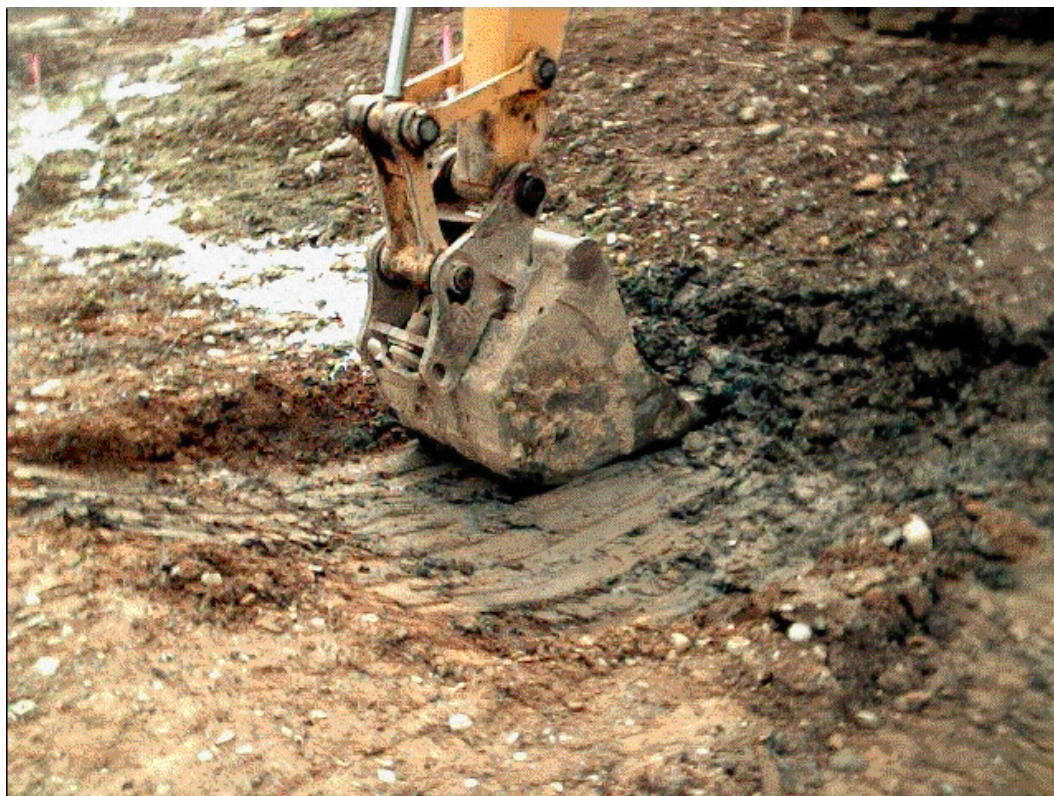
(Photo # 7-18-3) July 18, 2001 – Excavation of 1 foot of material from a 6-foot by 6-foot area in NWDD to address NYSDEC post-excavation sampling results.

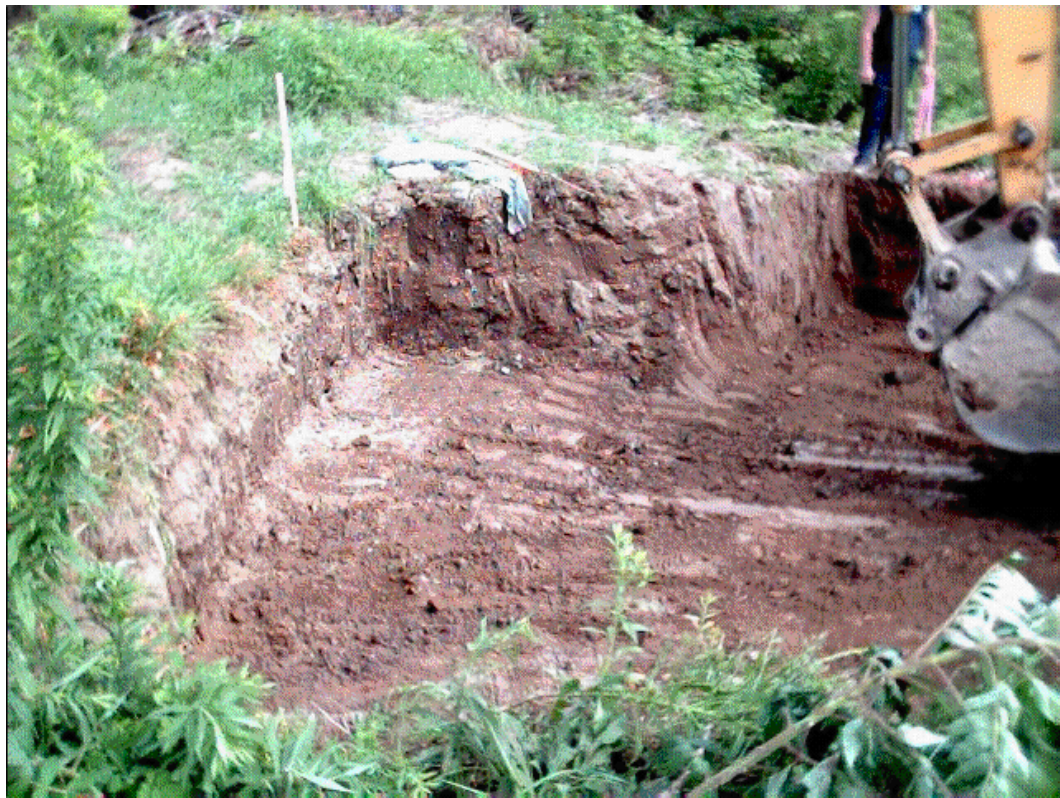
(Photo # 7-19-1) July 19, 2001 – Beginning excavation at the MRP Spoil Banks. View toward the northwest.

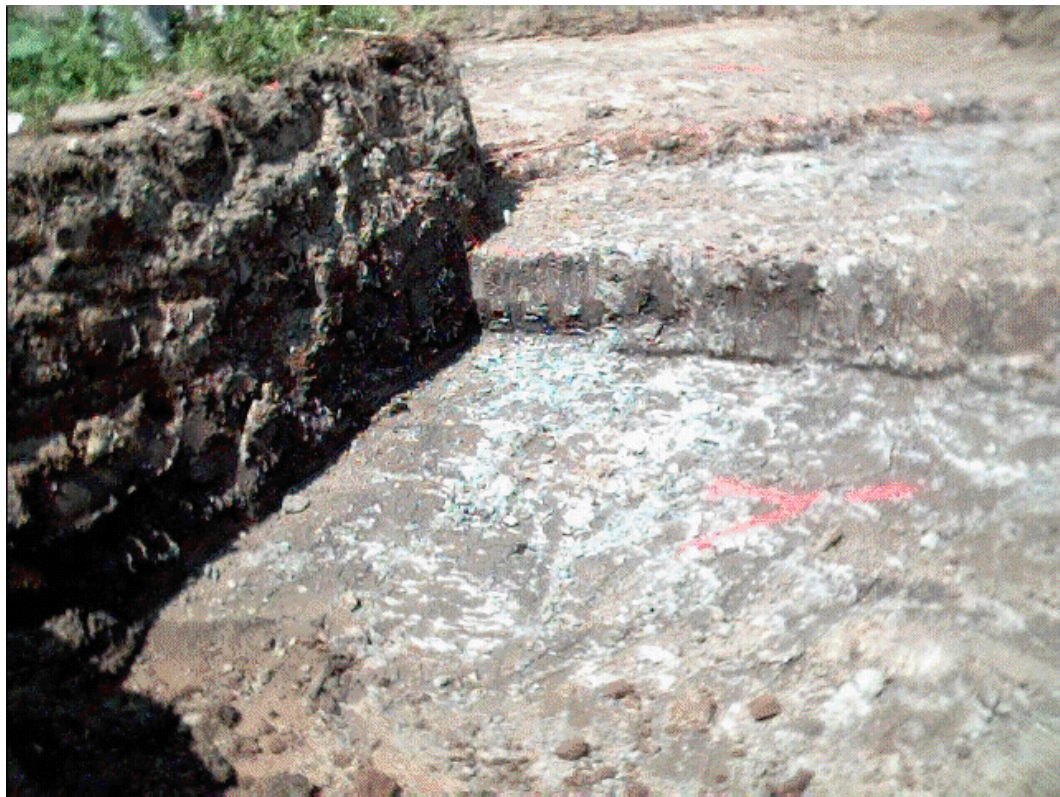
(Photo # 7-23-1) July 23, 2001 – Completion of excavation at a 4-, 5-, and 7-foot depths at the MRP Spoil Banks. View toward the west.

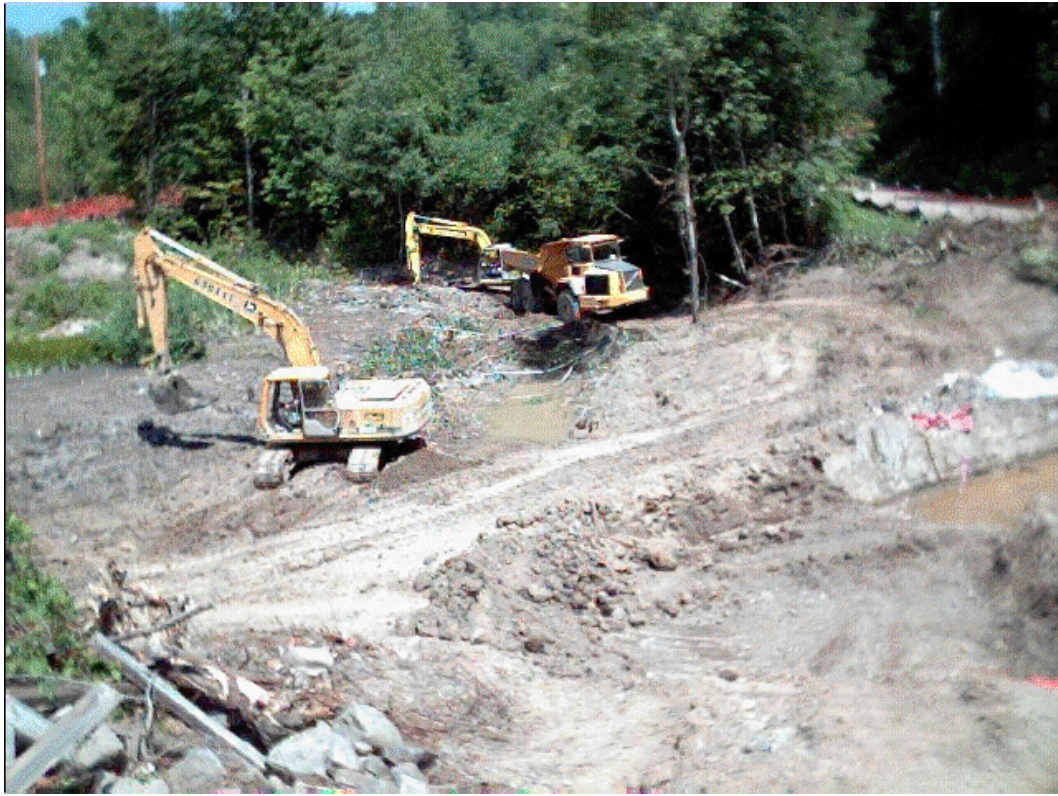
(Photo # 8-8-13) August 8, 2001 – Excavation of the south side of MRP. View toward the east.

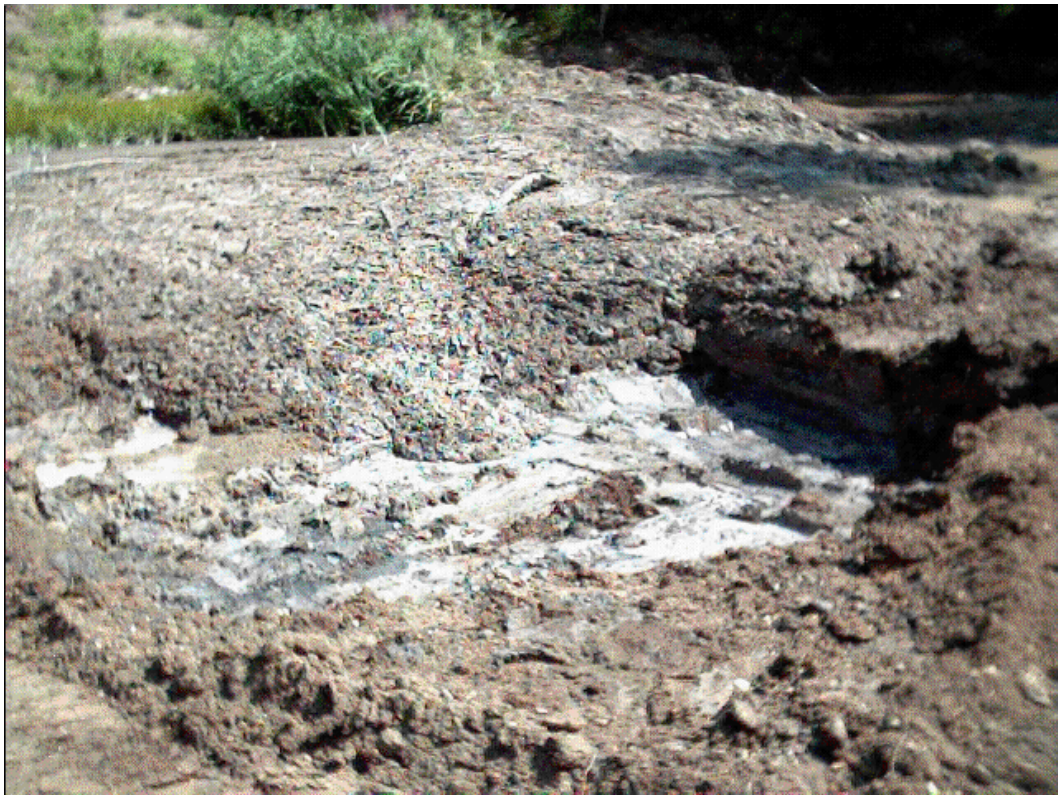
(Photo # 8-14-7) August 14, 2001 – Excavation of MRP upper soft materials to the underlying clay layer. View toward the northeast.

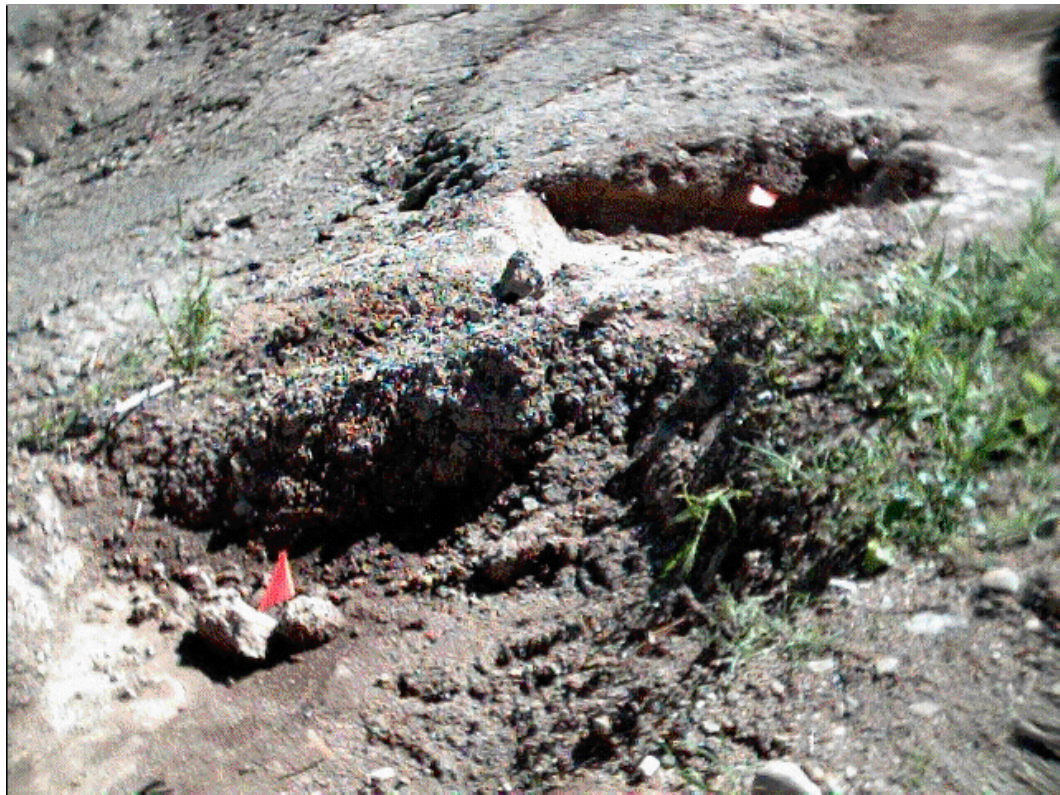
(Photo # 9-5-4) September 5, 2001 – Excavations of from 6-foot by 6-foot areas on the MRP Spoil Banks to address NYSDEC post-excavation soil sampling results.

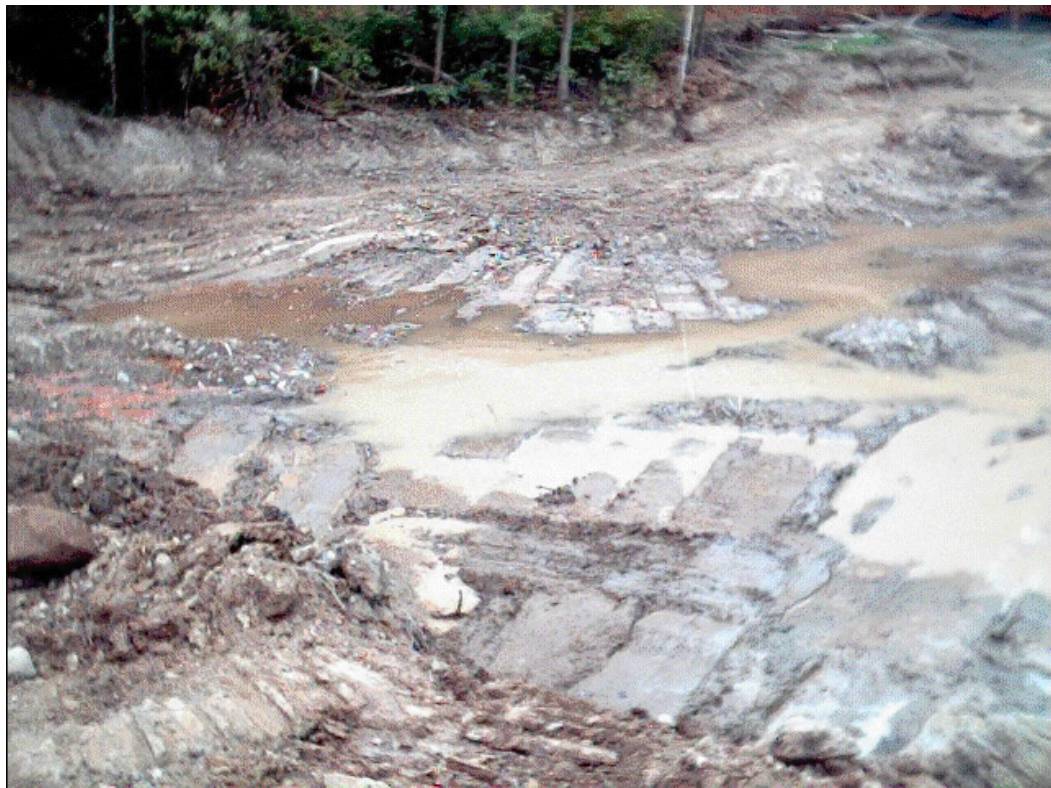
(Photo # 9-10-1) September 10, 2001 – Excavation completed at MRP. View toward the southeast.

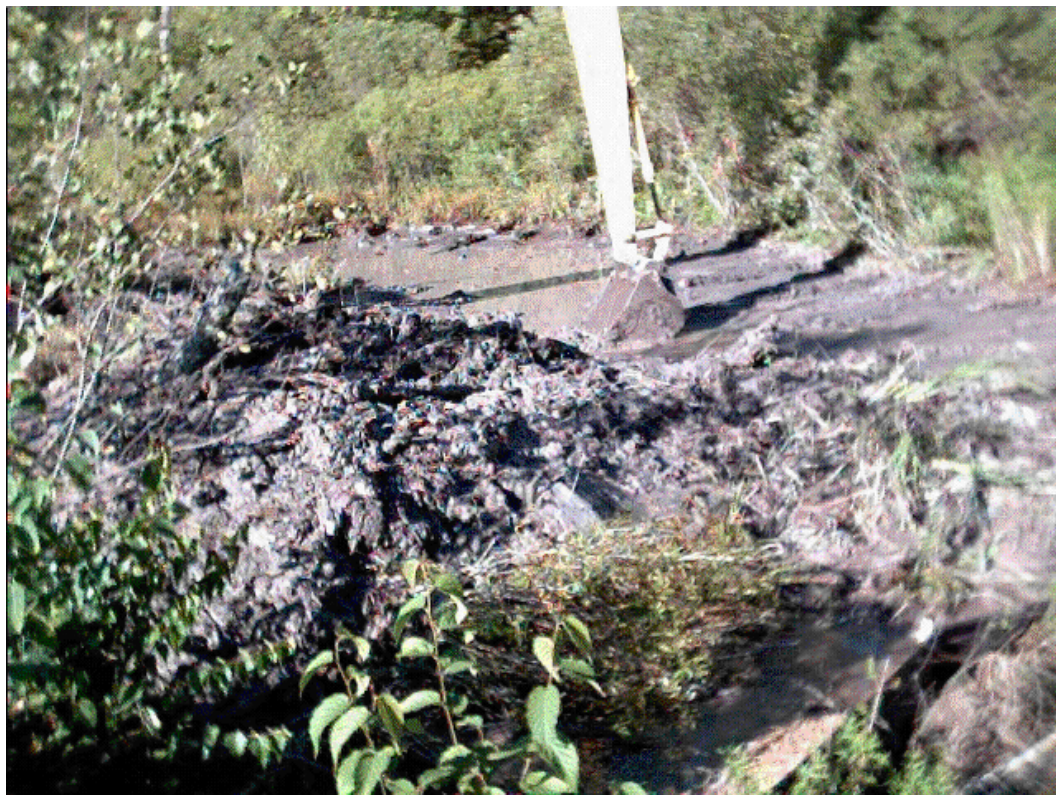
(Photo # 9-17-4) September 17, 2001 – Excavation at LLA. View toward the northeast.

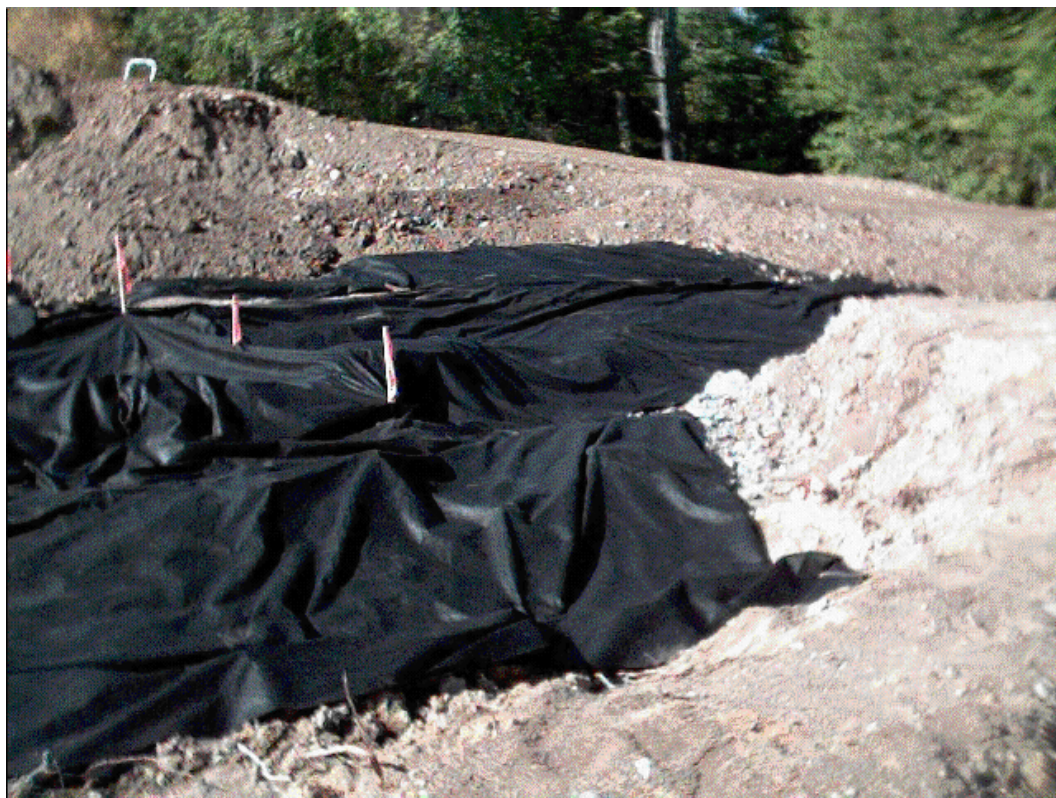
(Photo # 9-19-3) September 19, 2001 – Installation of a geotextile to act as a marking layer in the base of excavations. View toward the southwest.

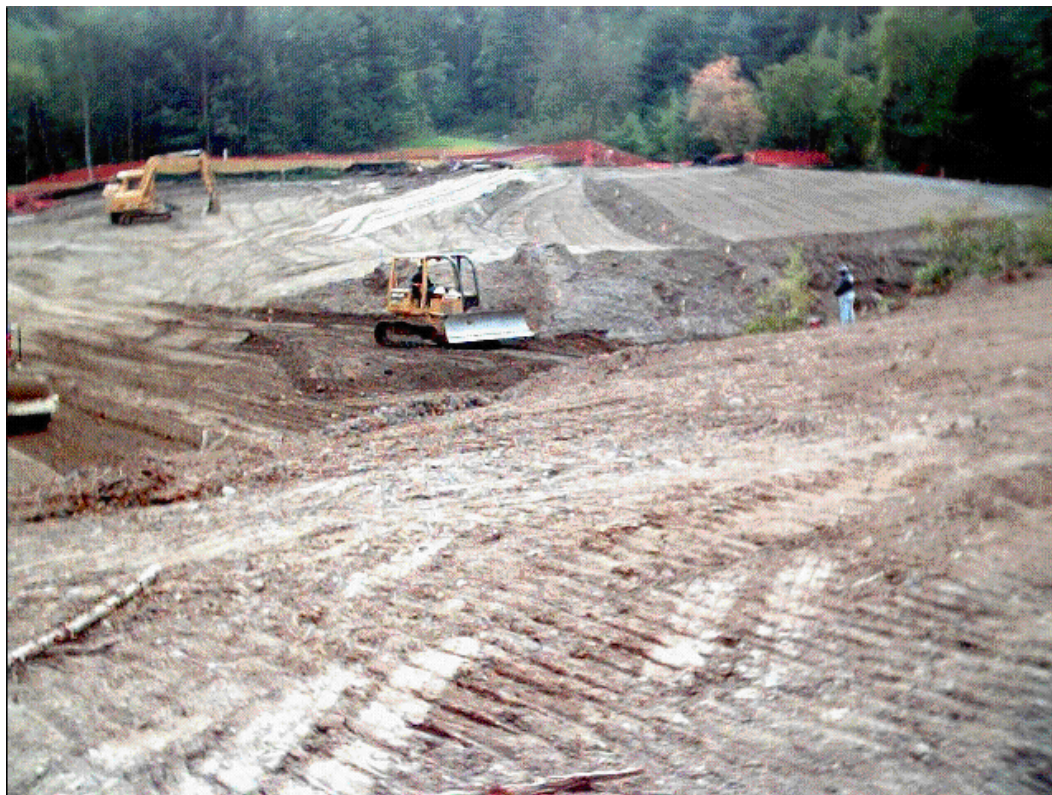
(Photo # 9-24-2) September 24, 2001 – Backfilling MRP and MRP Spoil Banks. View toward the southwest.

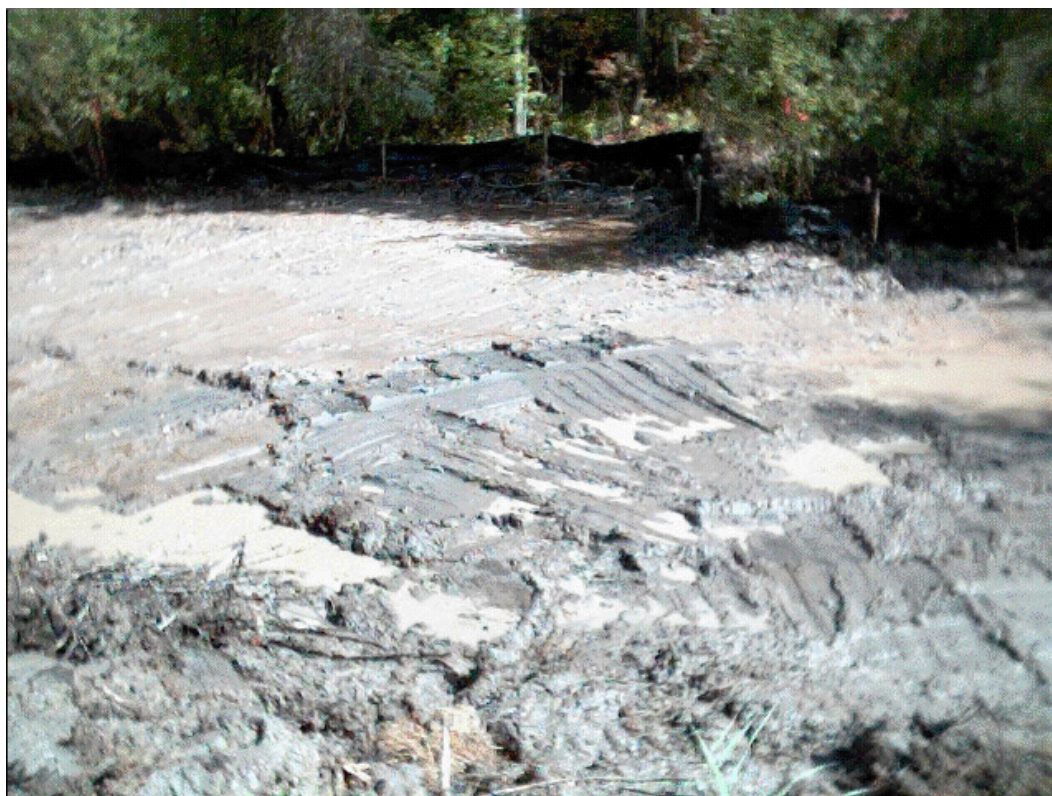
(Photo # 10-1-2) October 1, 2001 – Completion of excavation at the LLA. View toward the northeast.
