Appendix B

Representative Photographs

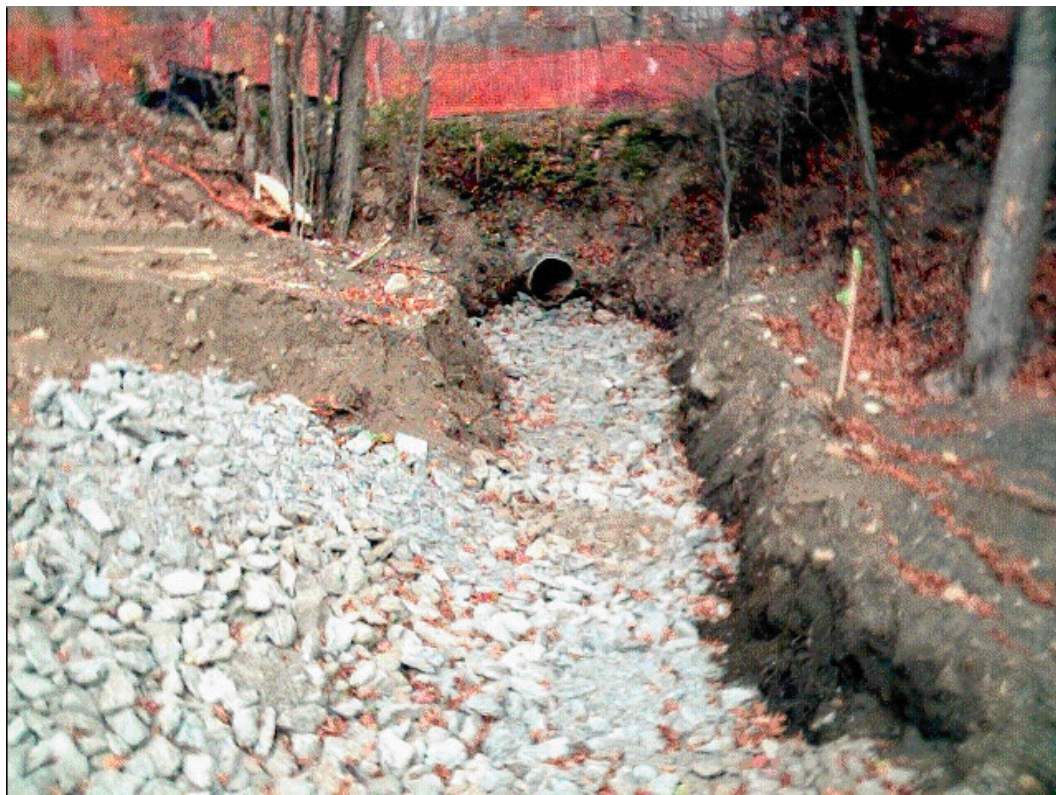
(Photo # 10-22-2) October 22, 2001 – Permanent diversion ditch inlet. View toward the northeast.

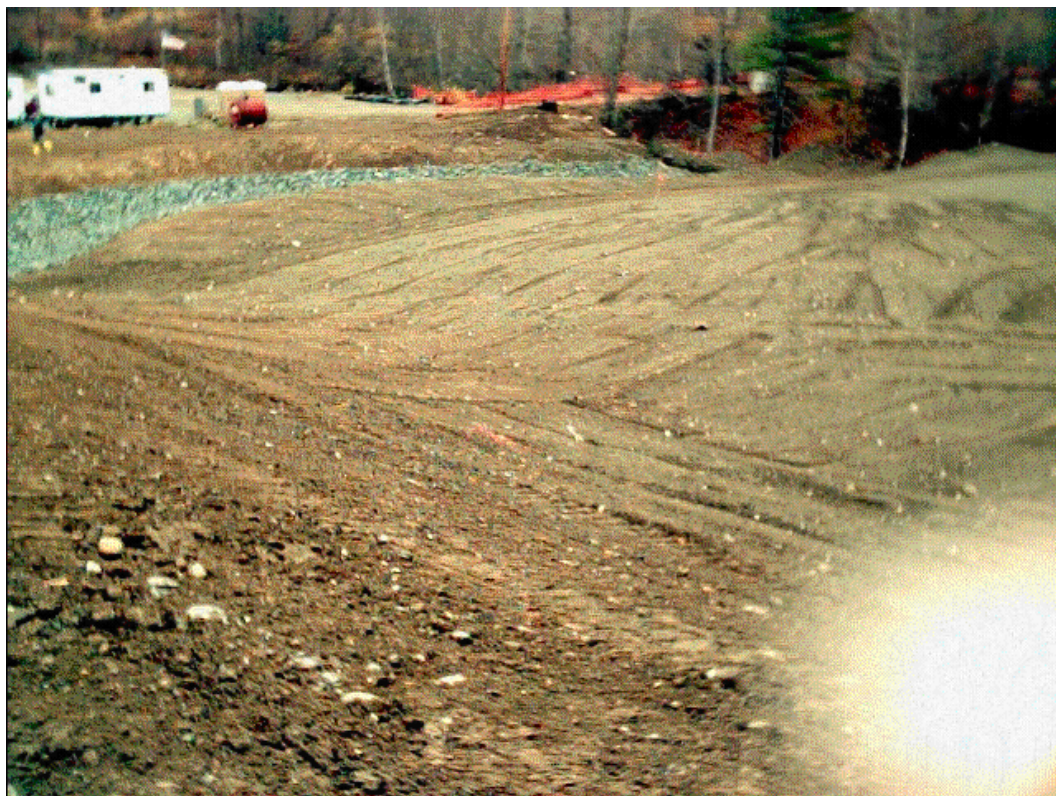
(Photo # 11-5-2) November 5, 2001 – Backfilled and graded MRP; rip-rap installed in the permanent diversion ditch. View towards the northeast.

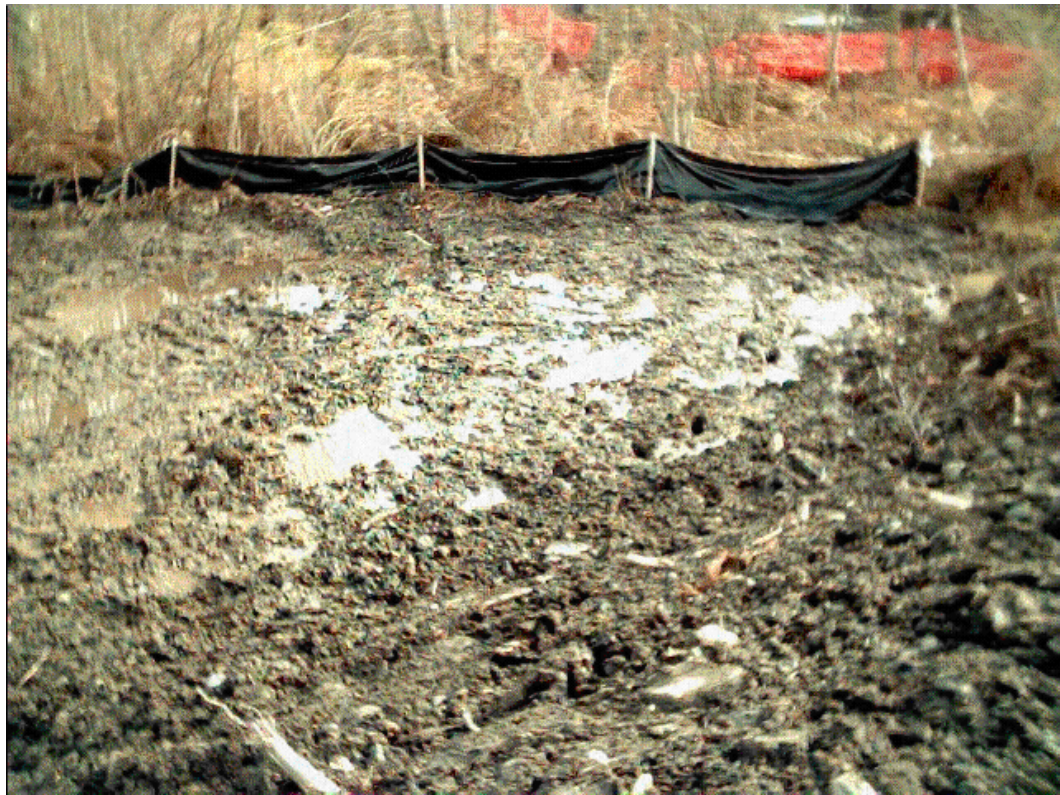
(Photo # 11-21-10) November 21, 2001 – Topsoil installed in the LLA. View toward the southeast.

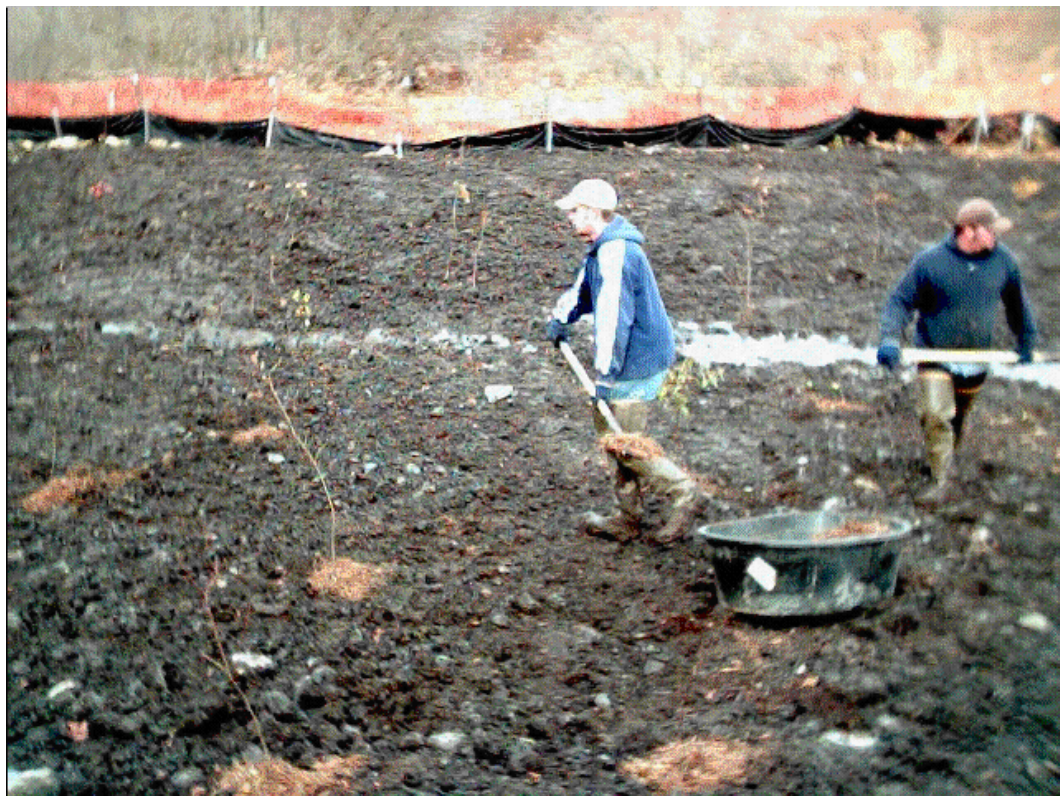
(Photo # 11-21-8) November 21, 2001 – Topsoil installed in the NWDD; planting of the wetlands. View toward the north.

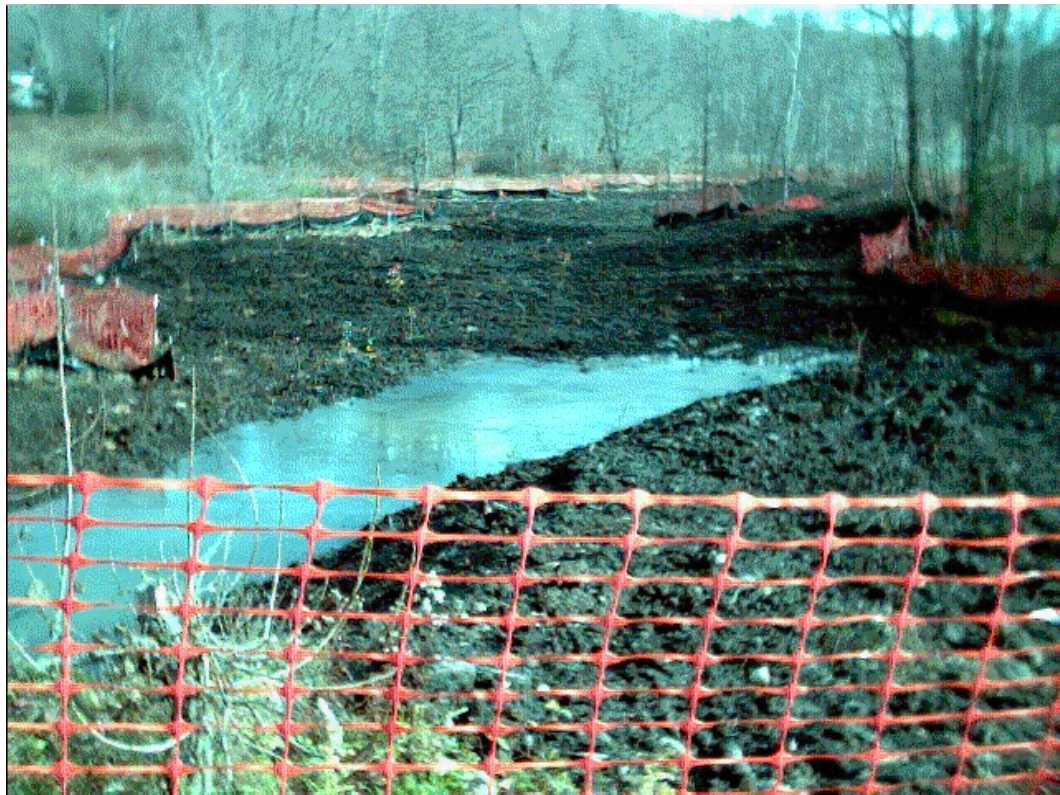
(Photo # 11-21-13) November 21, 2001 – Topsoil and planting completed in the NWDD. View toward the east.
