# Area 28 Remedial Action Completion Report Loeffel Site Environs Operable Unit 3

**Loeffel Site Environs Nassau, New York**

October 2004

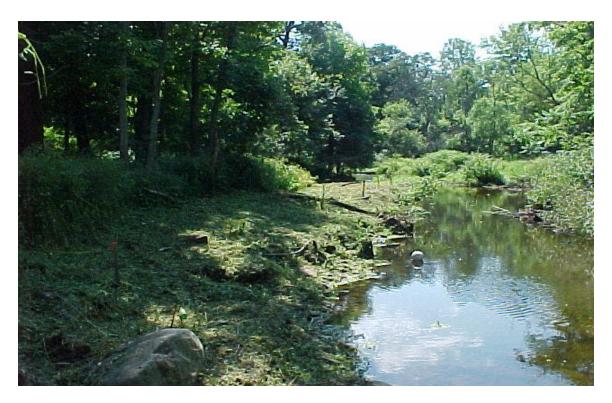
August 19, 2003 - Southern View: Cleared area along the eastern bank of the Valatie Kill

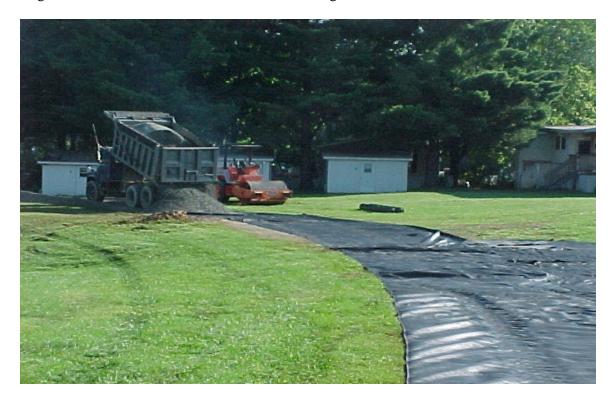
August 20, 2003 - Northeastern View: SLC building the access road

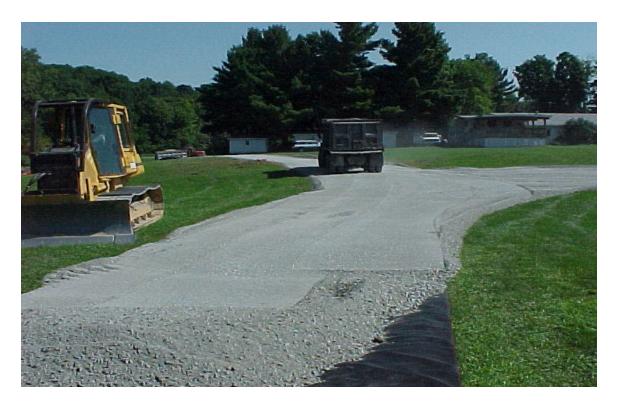
$August\ 20,\ 2003-Northeastern\ View:\ SLC's\ continued\ progress\ with\ construction\ of\ the\ access\ road$

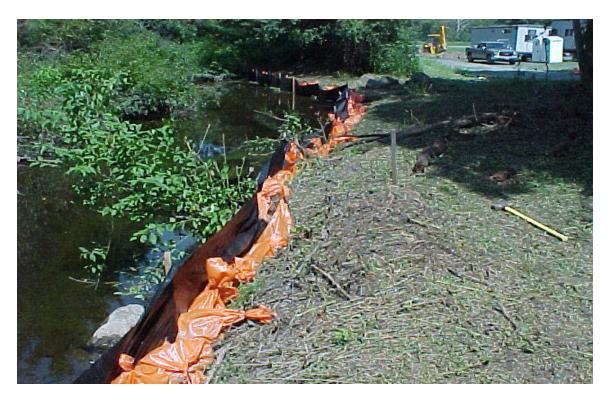
August 20, 2003 – Northern View: Silt fence anchored with sand bags

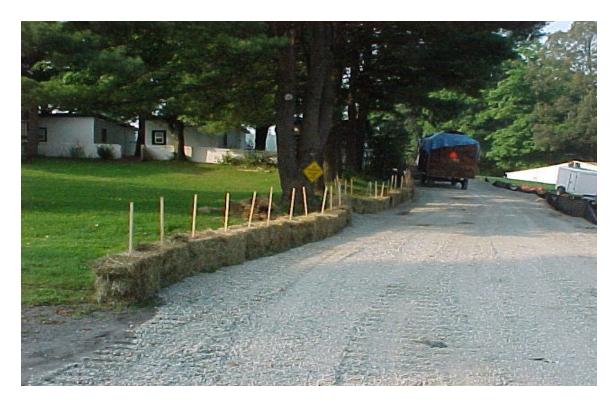
August 22, 2003 – Southern View: SLC installed hay bales along the eastern perimeter of the access road adjacent to the caretaker's home

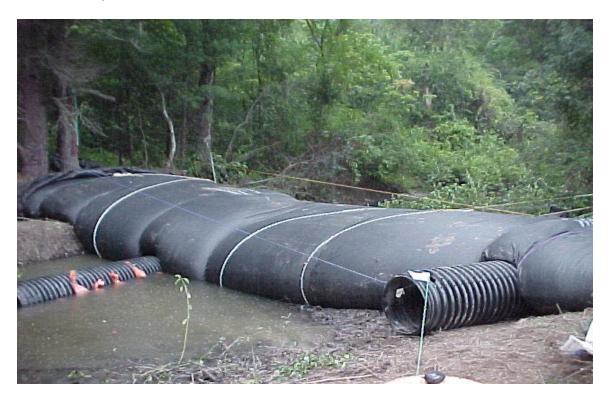
September 3, 2003 – Northwestern View: Bladder dam installed

On October 27, 2003 extraordinarily heavy rains caused the bladder dam to move from its installed position and become damaged beyond repair. As of that date, all materials designated for removal and disposal had been removed from the Site, and all areas had been backfilled. Following this date, localized diversion methods were used, as needed, for the remainder of the RA.

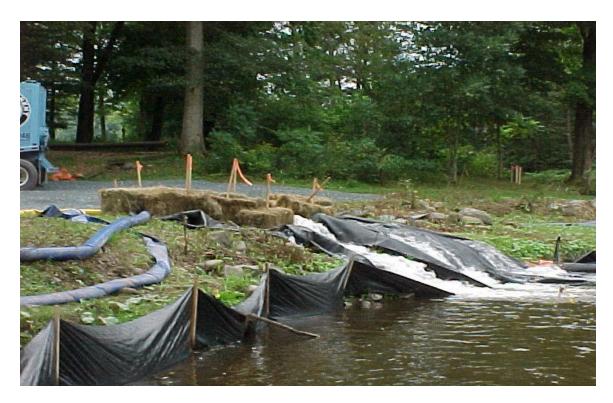
September 3, 2003 – Southeastern View: SLC's, initial, temporary water diversion discharge off the eastern bank of the Valatie Kill, NYSDEC approved

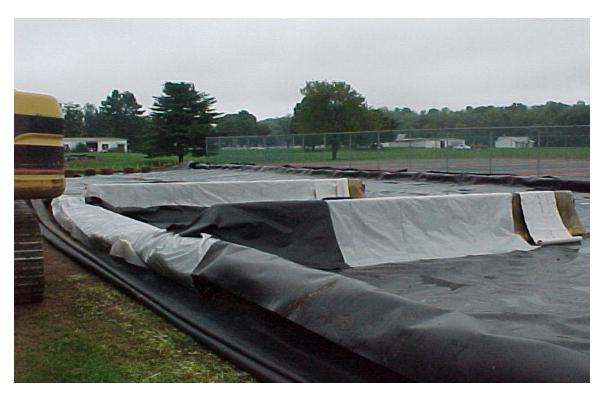
September 4, 2003 – Northeastern View: Installing jersey barriers on the MSDP to serve as a driveway ramp

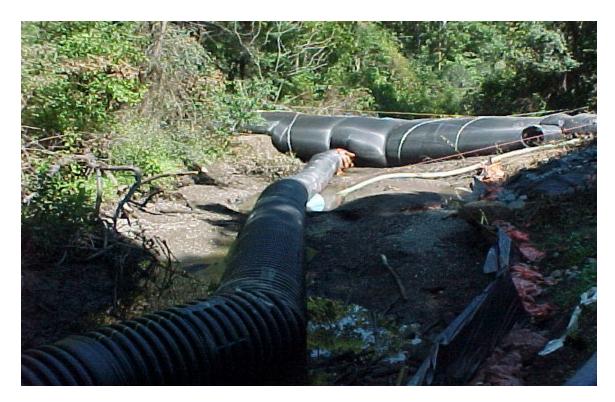
September 9, 2003 – Northwestern View: Dewatering of area downstream of dam

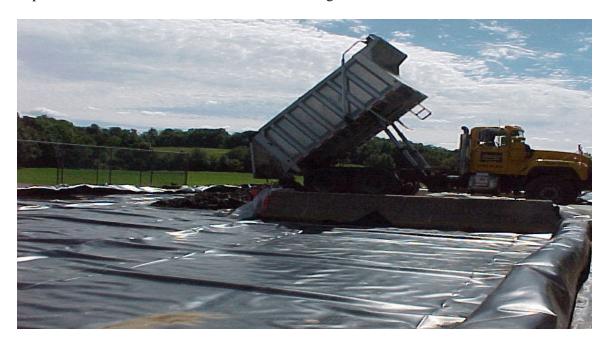
September 9, 2003 - Southeastern View: SLC placing excavated material on MSDP

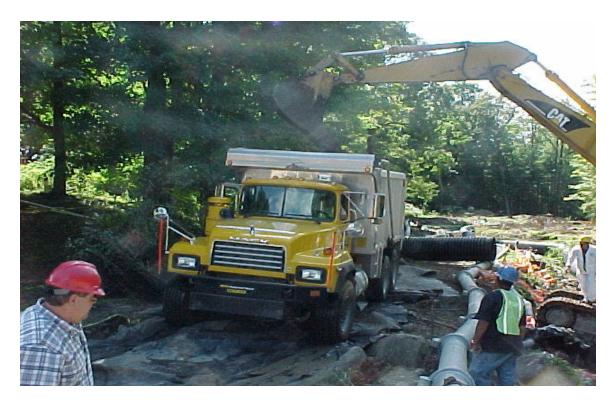
September 9, 2003 – Southern View: SLC direct-loading excavated material from polygon NA-60 onto dump-truck

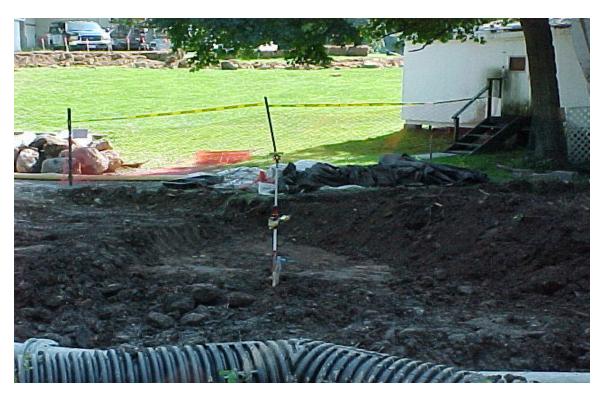
September 10, 2003 – Northeastern View: Excavation of polygon SA-97 with a confirmatory sample point in the center

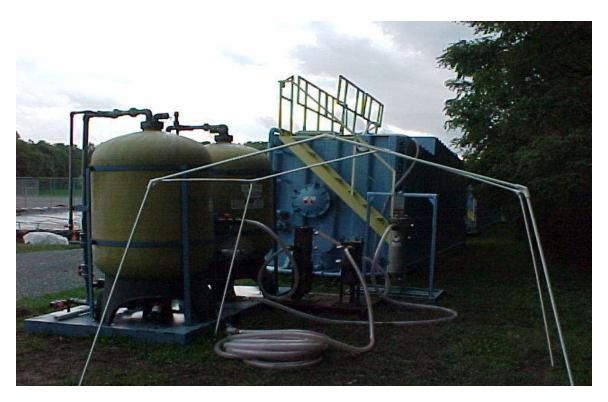
September 23, 2003 – Southwestern View: Construction of water treatment system

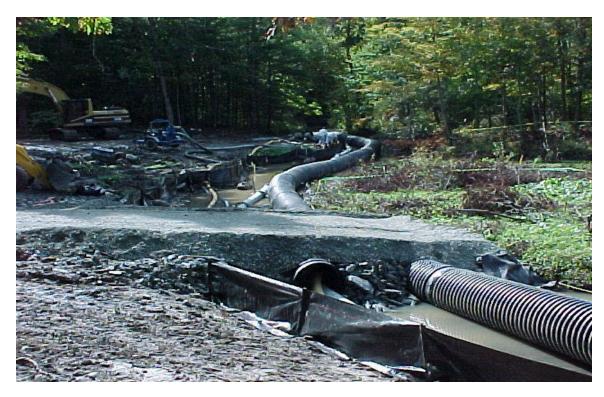
October 2, 2003 – Southwestern View; SLC completed installation of the temporary access road extending across the Valatie Kill for access to NA polygons

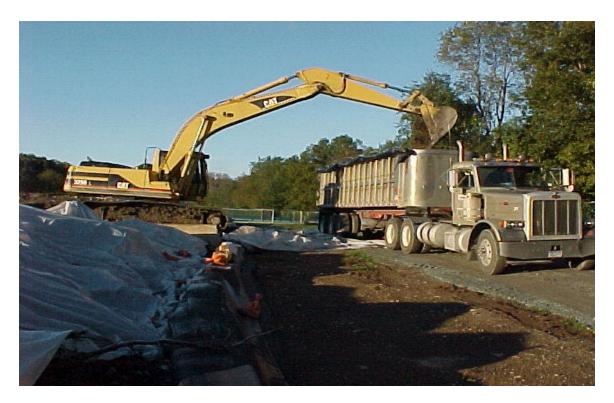
October 3, 2003 – Southwestern View: loading out material from MSDP

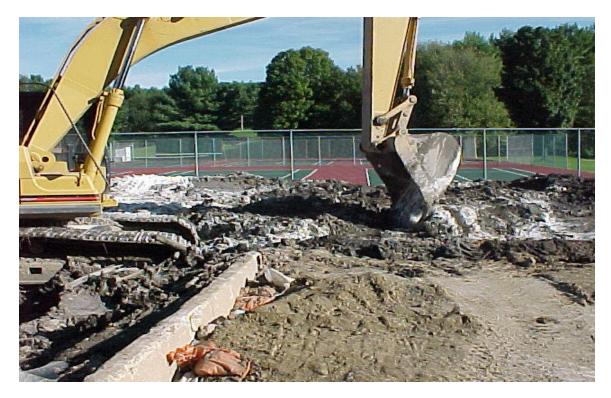
October 7, 2003 – Eastern View: SLC mixing lime with material on MSDP for stabilization purposes (Lime proved to be an inadequate stabilizing material and after this photograph was taken, cement kiln dust successfully replaced lime as the stabilization material)

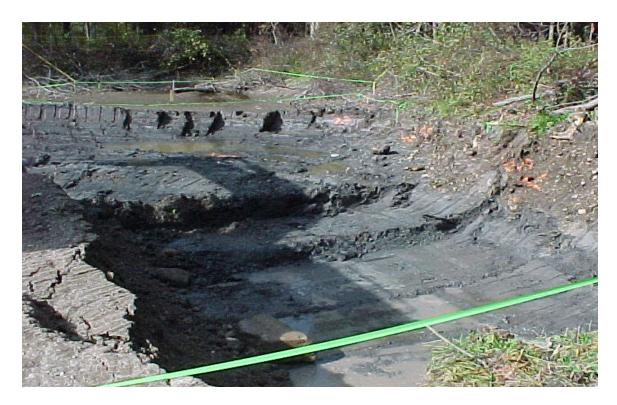
October 9, 2003 – Western View: SLC excavation of polygon NA-70 (North Section); SLC excavation of TSCA material (2.5-3.5~feet) in polygon NA-61

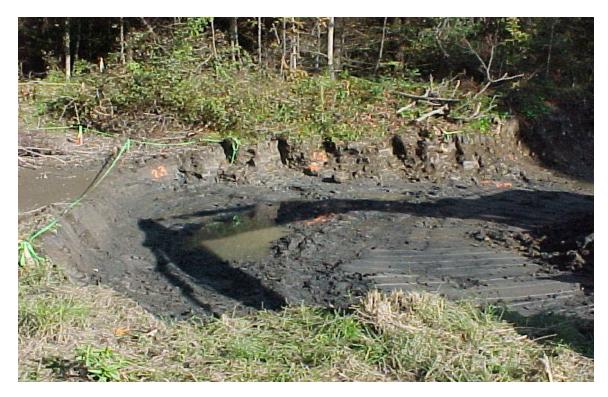
October 9, 2003 – Northeastern View: Excavation of polygon NA-61

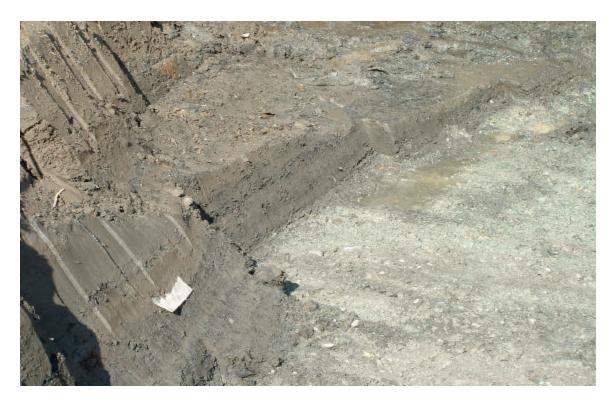
October 10, 2003 – Example of refusal interval in northern section of NA-70 at 5 feet bgs

Indicates that the polygon was not excavated to depth due to equipment refusal as noted on page 3-2 in the table Polygon Excavation Depths - Altered Due to Equipment Refusal.'

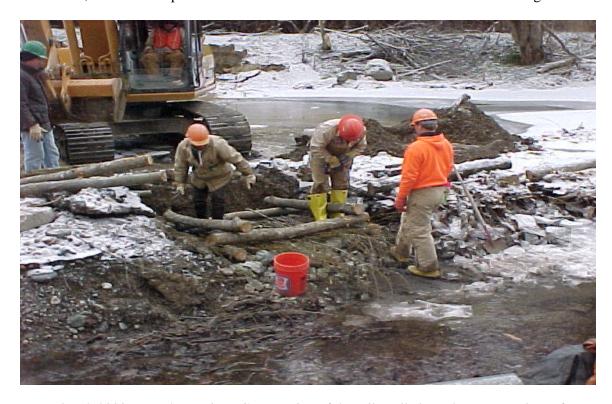
December 4, 2003 – Northern View; Construction of the crib wall along the eastern edges of polygons NA-71 and NA-78 and along the western edges of polygons SB-47 and SB-48

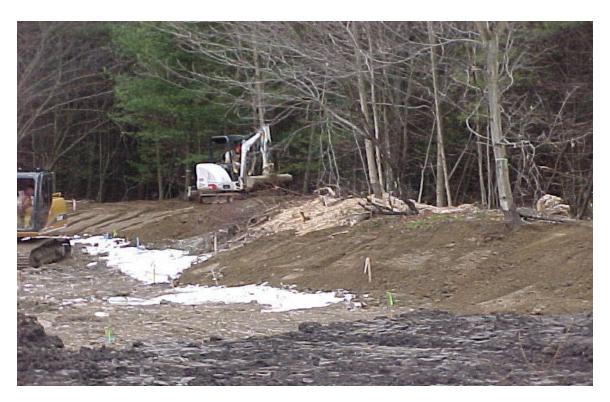
December 5, 2003 – Northwestern View; SLC installed topsoil on bank above wetland for soft armor and installation in the area of polygons NA-62, NA-70, NA-61, and NA-66

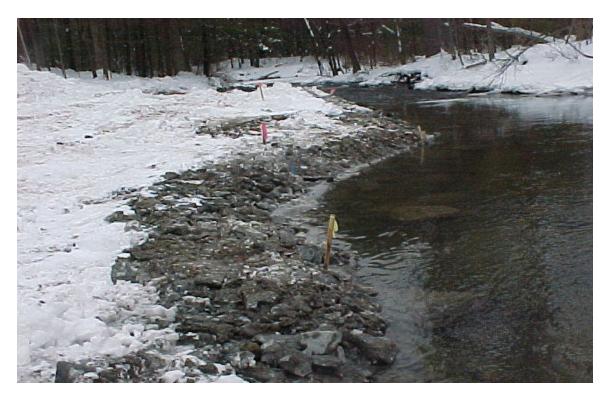
December 10, 2003 – Western View; SLC completed installation of hard armor on the eastern bank at downstream end of Area 28 along polygon NA-75

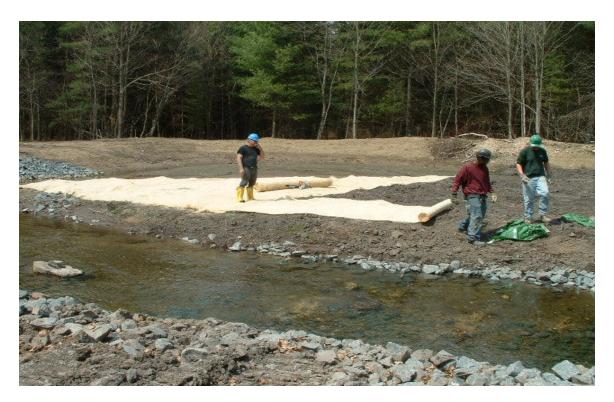
April 22, 2004 – Wetland restoration in polygons NA-75, NA-76, NA-65, and NA-66

In spring 2004, replacement wetland soil was placed to final grades in the restored wetland and vegetation was planted in both the wetland and on the recently restored banks. Wetland seed was applied at a rate of 16 pounds per acre. After seeding, a biodegradable erosion control fabric (North American Green C125BN) was installed over the entire wetland as well as the intermediate armored banks (as described below) to provide erosion protection from storm flow prior to vegetation establishment. Wetland shrubs were planted through the erosion control blanket. Species and planting densities for vegetation in the enhanced wetland are presented on Figure 9. Details of the wetland vegetation seeding and planting methodologies are presented in the MP-02210 – Wetland Restoration (provided with the RFP [BBL, 2002a]).

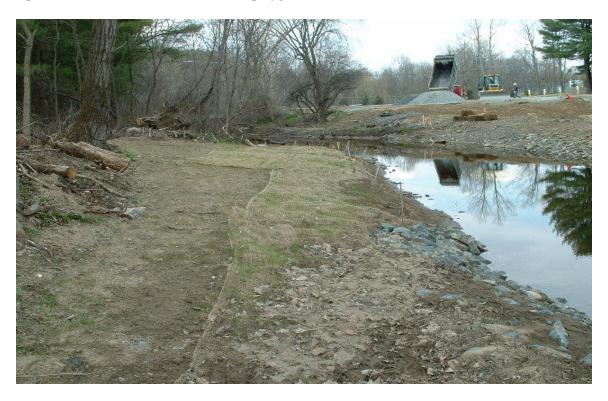
April 22, 2004 - Soft armor, post-construction in polygons NA-75, NA-76, NA-65, and NA-66

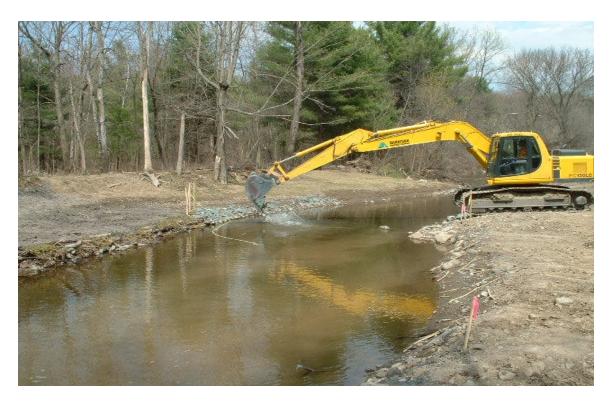
April 22, 2004 – Construction of the transverse bar near polygon SB-39

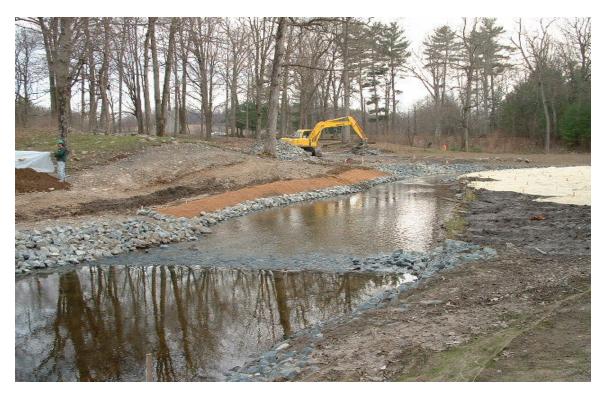
April 22, 2004 – Foreground: Completed transverse bar in polygon SB-39. Background: Intermediate armor installed along the edges of NA-85 and SA-91

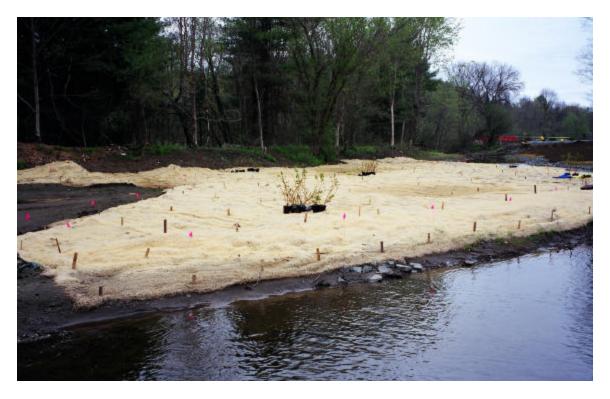
May 6, 2004 - Final restoration at polygons NA-75, NA-76, NA-65, and NA-66

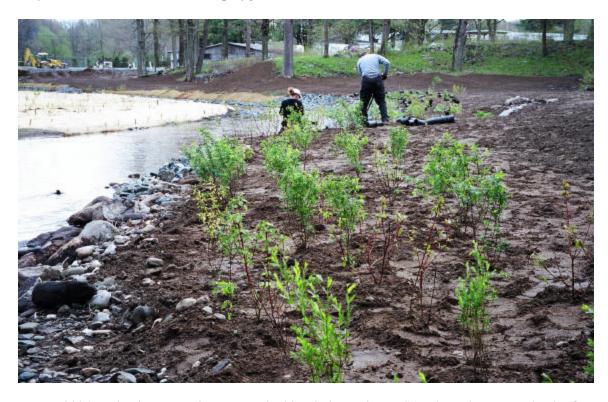
May 6, 2004 – Planting trees along streambed bordering polygon SA-72 on the eastern bank of the Valatie Kill
