DATA SUMMARY REPORT FOR TRIBUTARY T11A REMOVAL ACTION UNDER PARAGRAPH 47.f

Dewey Loeffel Landfill Superfund Site
Nassau, New York

May 2018

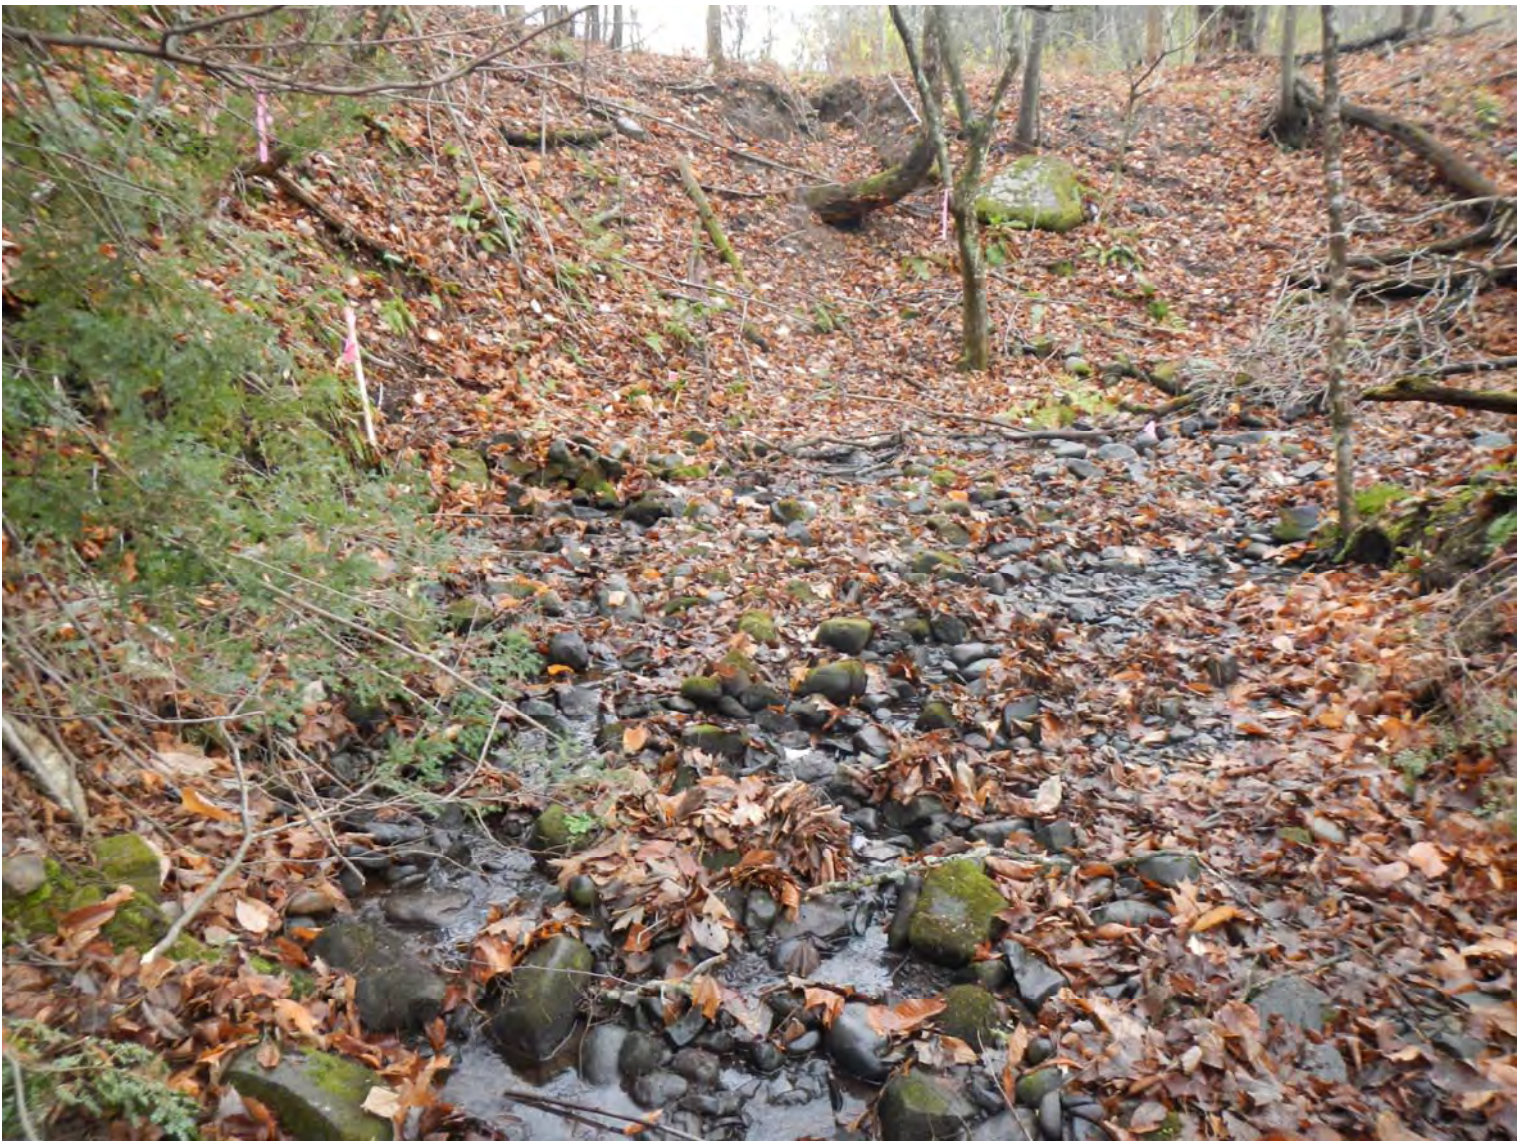
Feature	Type	Condition	Current Function	Notes
ES-1	Rock Bendway Weir	Partially Intact	Low-Moderate	Two of the three weirs are partially intact. Downstream weir is blown out. Bed has naturally braided with larger materials. Redesign would require more frequent weirs or deflector structures (e.g., root wads, rock piles) to move flow off bank.
ES-2	Rock Vortex Weir	Mostly Intact	Moderate-High	Channel flow centered. Minimal disruption to downstream/upstream banks. Redesign to higher potential storm event/bankfull elevation.
ES-3	Rock Check Dam	Intact	Moderate-High	Some downstream erosion on left bank. Needs a transition area and toe protection to redirect flows towards that way in confined area.
ES-4	Log Check Dam	Intact	Low-Moderate	Flow undermined above structure. Nine-inch drop to pool elevation, possible fish barrier. Some upstream erosion on right bank. Redesign would require consideration for fish passage.

Photo No. 1	Date 11/2/2017
Direction Photo Taken: Upstream	
Description: ES-1 Rock Bendway Weir

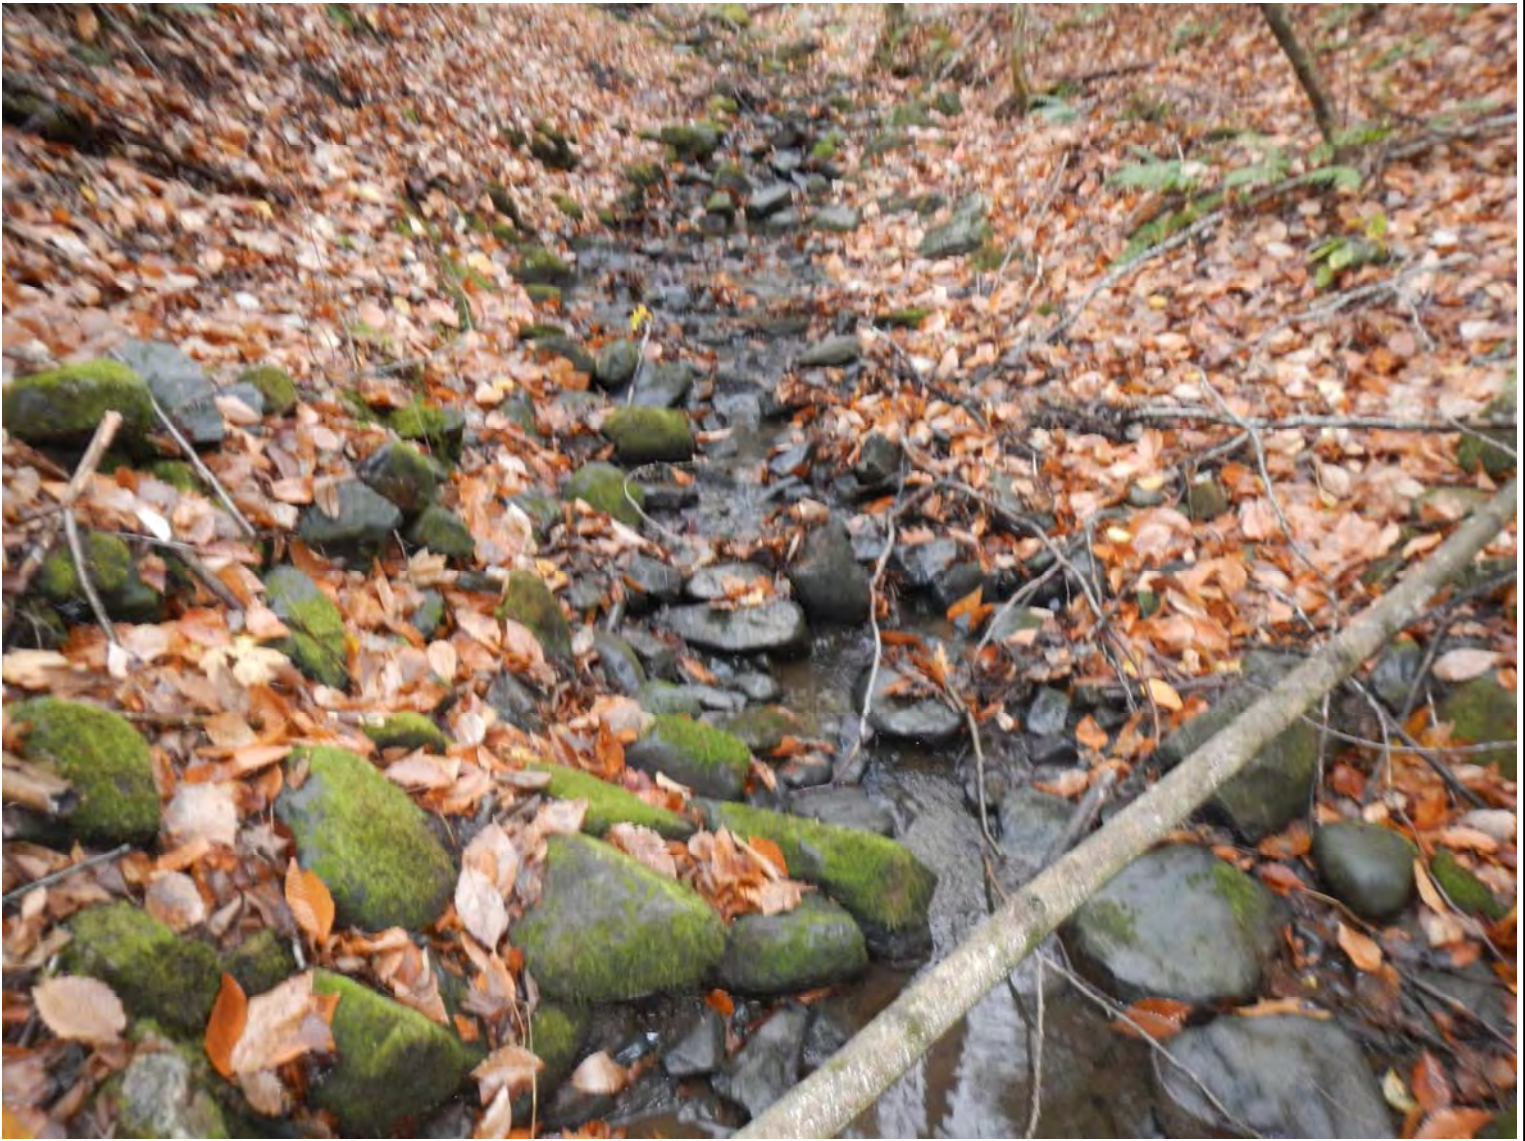
- The placement of rock vortex weirs is important for the long-term stability and function of Tributary T11A. The original design objective of the rock vortex weir was to converge flow into the center of the channel and develop a scour pool below the structure. These design objectives have been fairly met from the past restoration. Additional consideration to structure design at bankfull or higher conditions for stability should be evaluated for future implementation within Tributary T11A. Use of rock vortex weirs in the current restoration design may be enhanced to allow additional fish passage at base-flow or low-flow conditions, and increased bank and bank toe protection during high-flow events through different design configurations (e.g., J-Hook vane). Potential usage and placement in Tributary T11A will be based on areas that may require grade control, are transitional areas with slope changes, require bank stability, or are within an outer meander of the stream.

Photo No. 2	Date 11/2/2017
Direction Photo Taken: Upstream	
Description: ES-2 Rock Vortex Weir

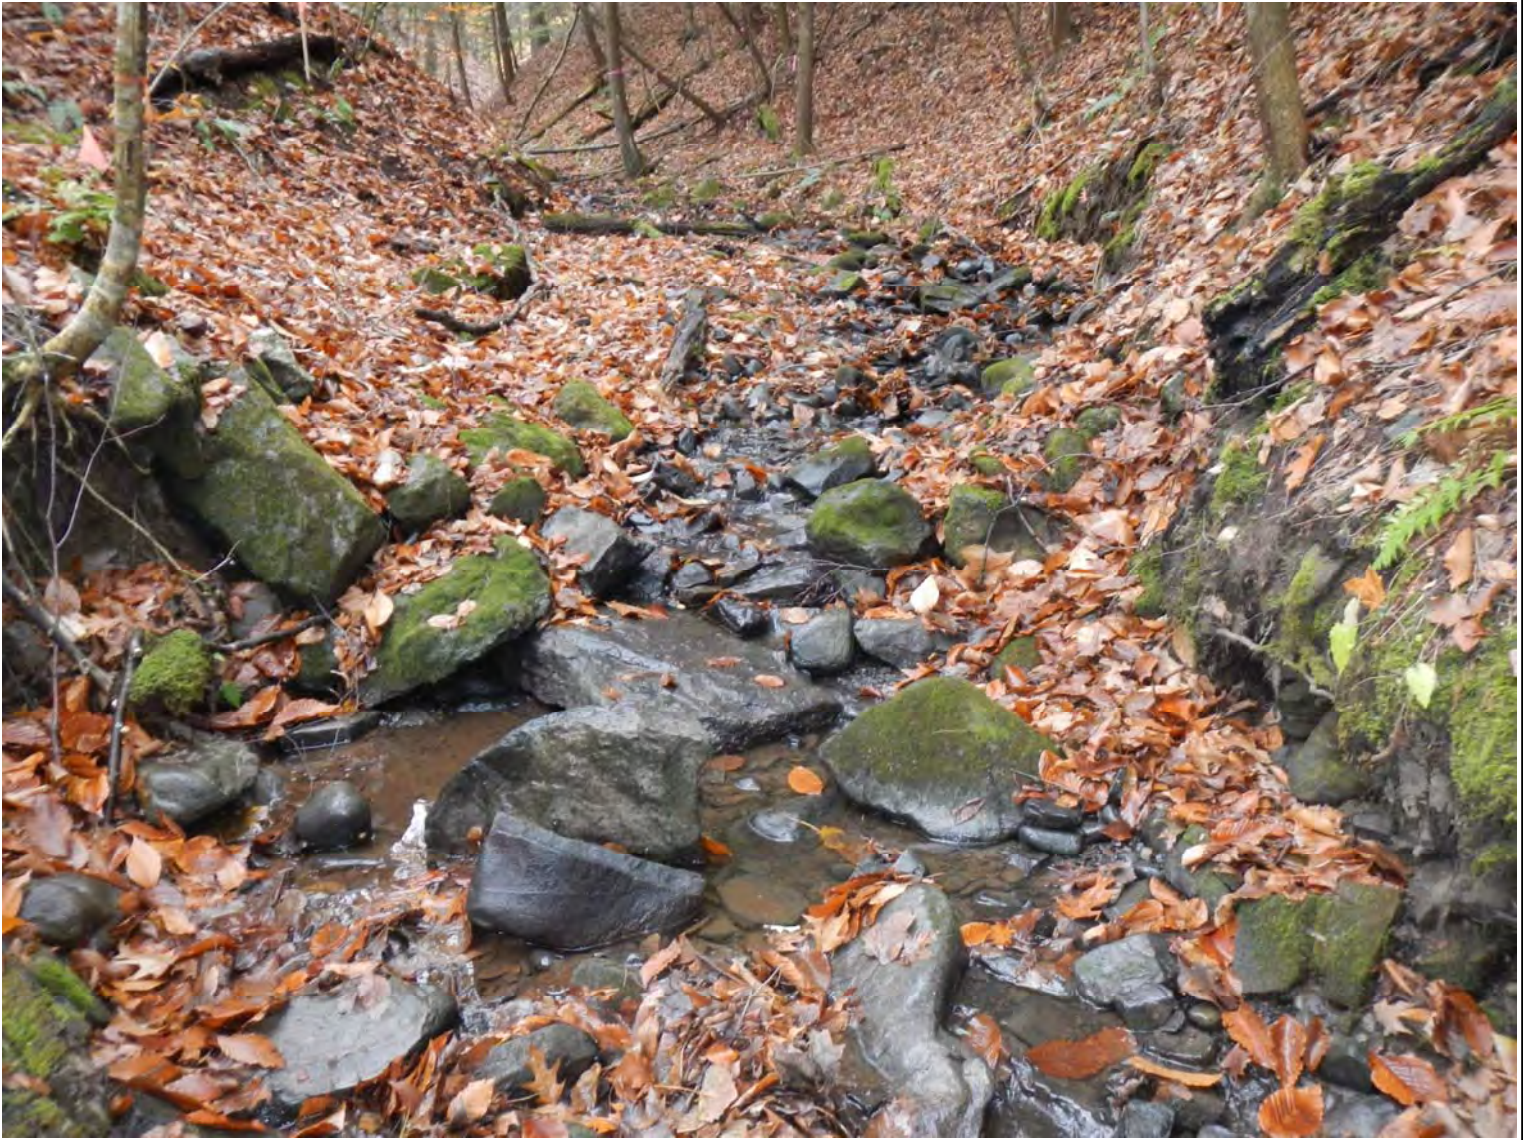
Photo No. 3	Date 11/2/2017
Direction Photo Taken: Upstream	
Description: ES-3 Rock Check Dam

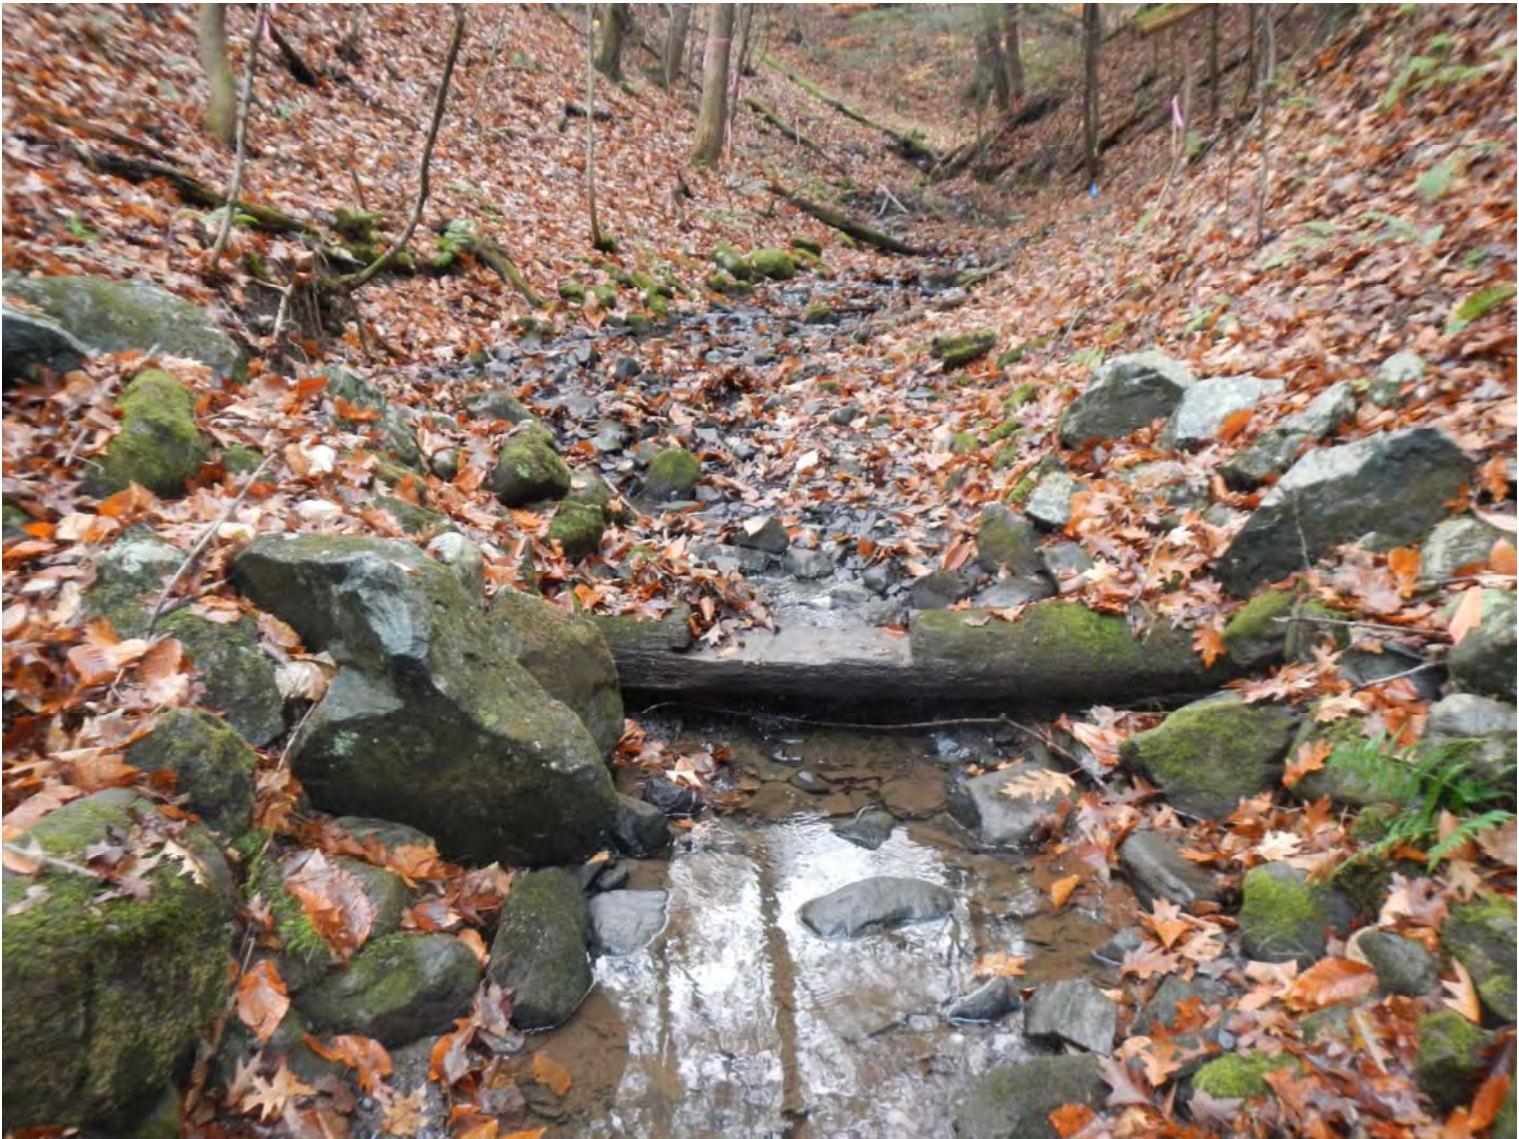
Photo No. 4	Date 11/2/2017
Direction Photo Taken: Upstream	
Description: ES-4 Log Check Dam

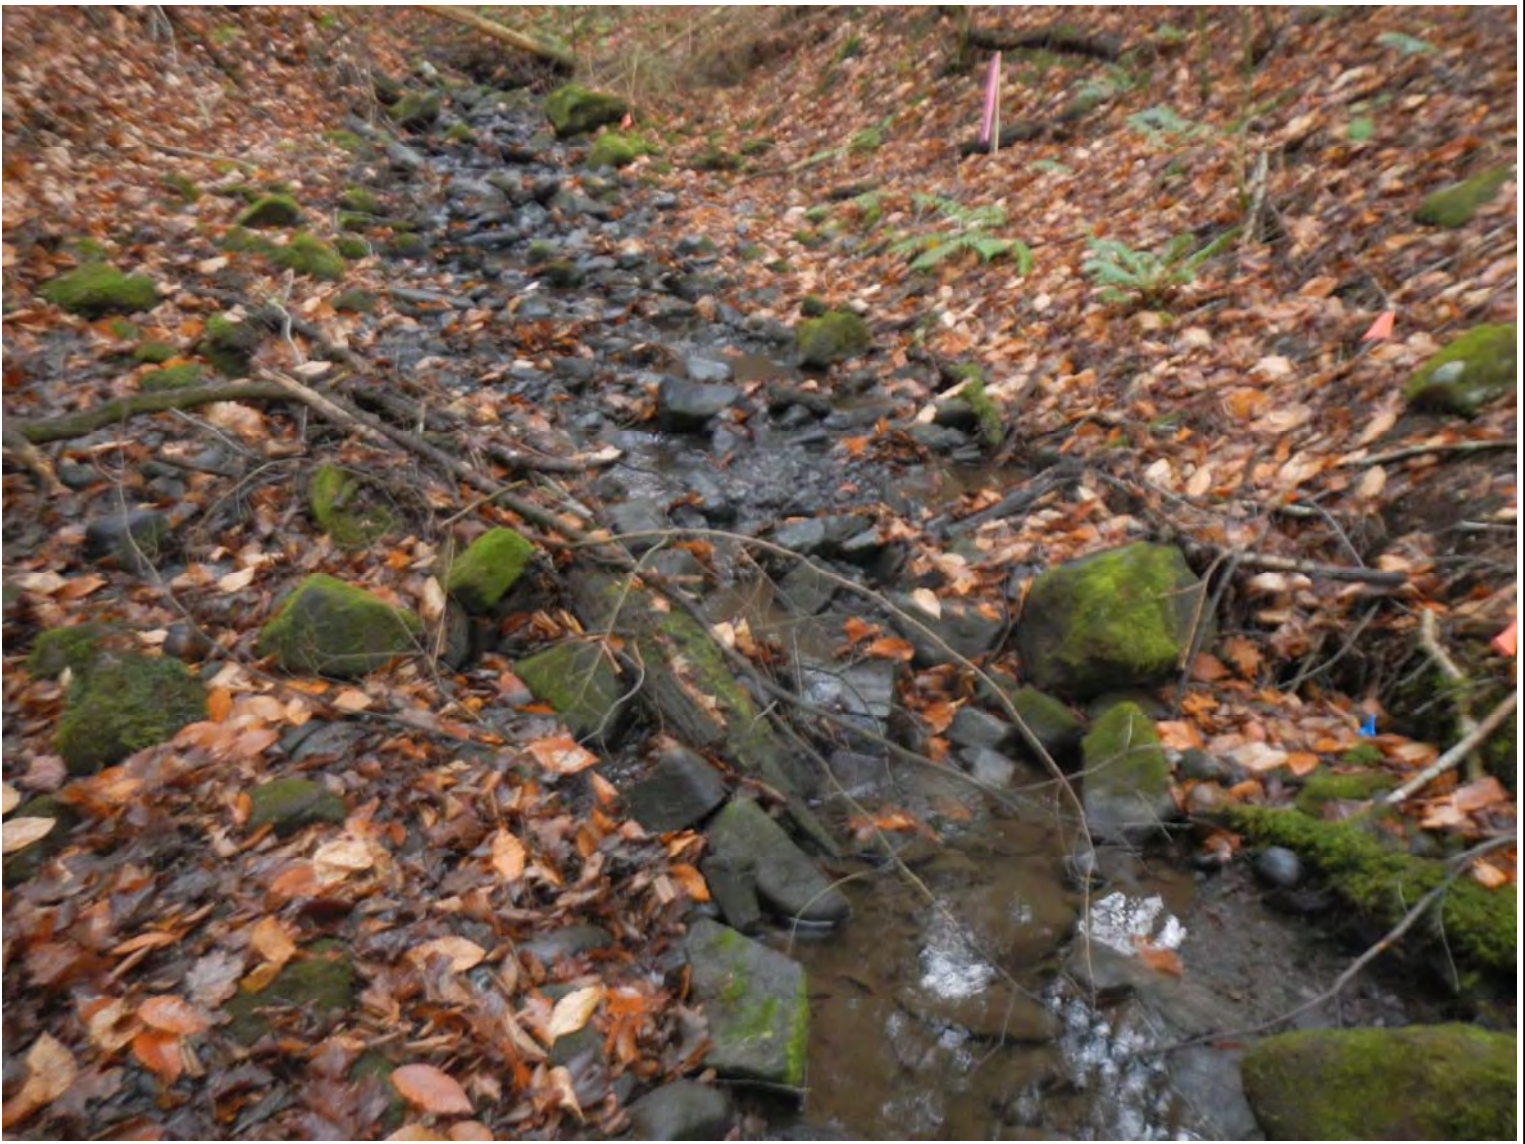
ES-5	Step-Pool Complex	Mostly Intact	Moderate-High	Most steps intact (4 of 5 in good condition), small pools evident, grade stable.

Photo No. 5	Date 11/2/2017
Direction Photo Taken: Upstream	
Description: ES-5 Step Pool Complex

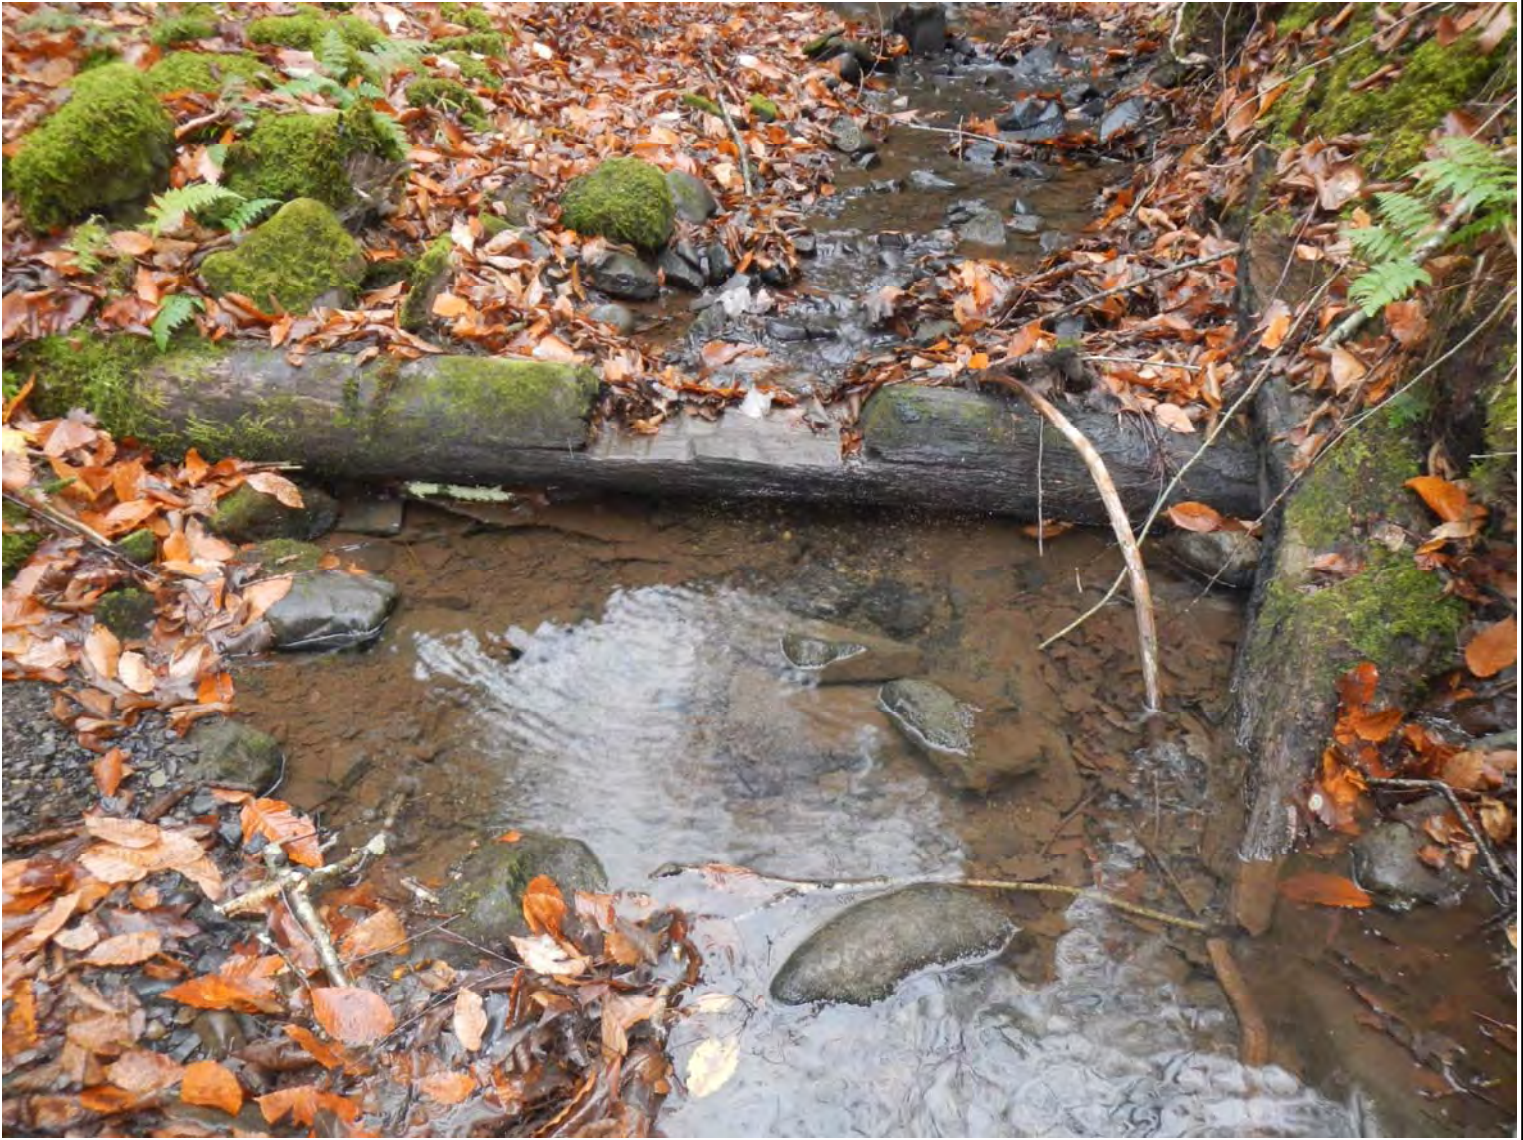
Photo No. 7	Date 11/2/2017
Direction Photo Taken: Upstream	
Description: ES-7 Log Check Dam

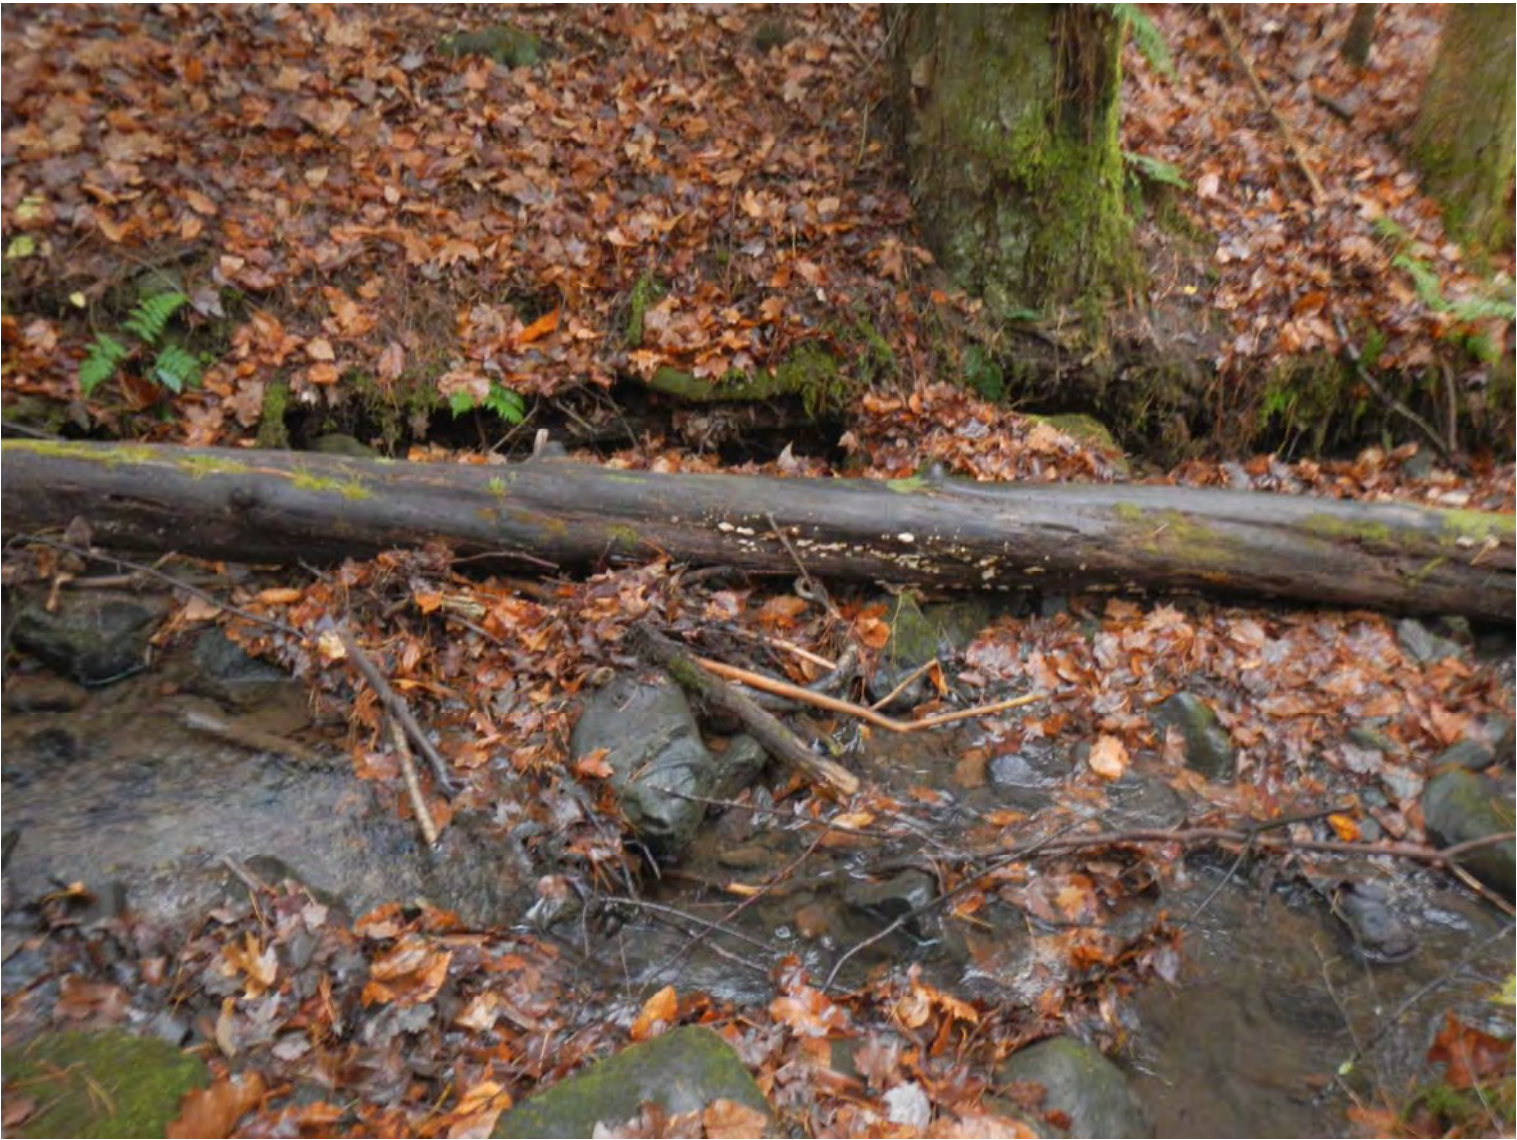
Photo No. 10	Date 11/2/2017
Direction Photo Taken: Left Bank	
Description: LWD protection to help prevent erosion.

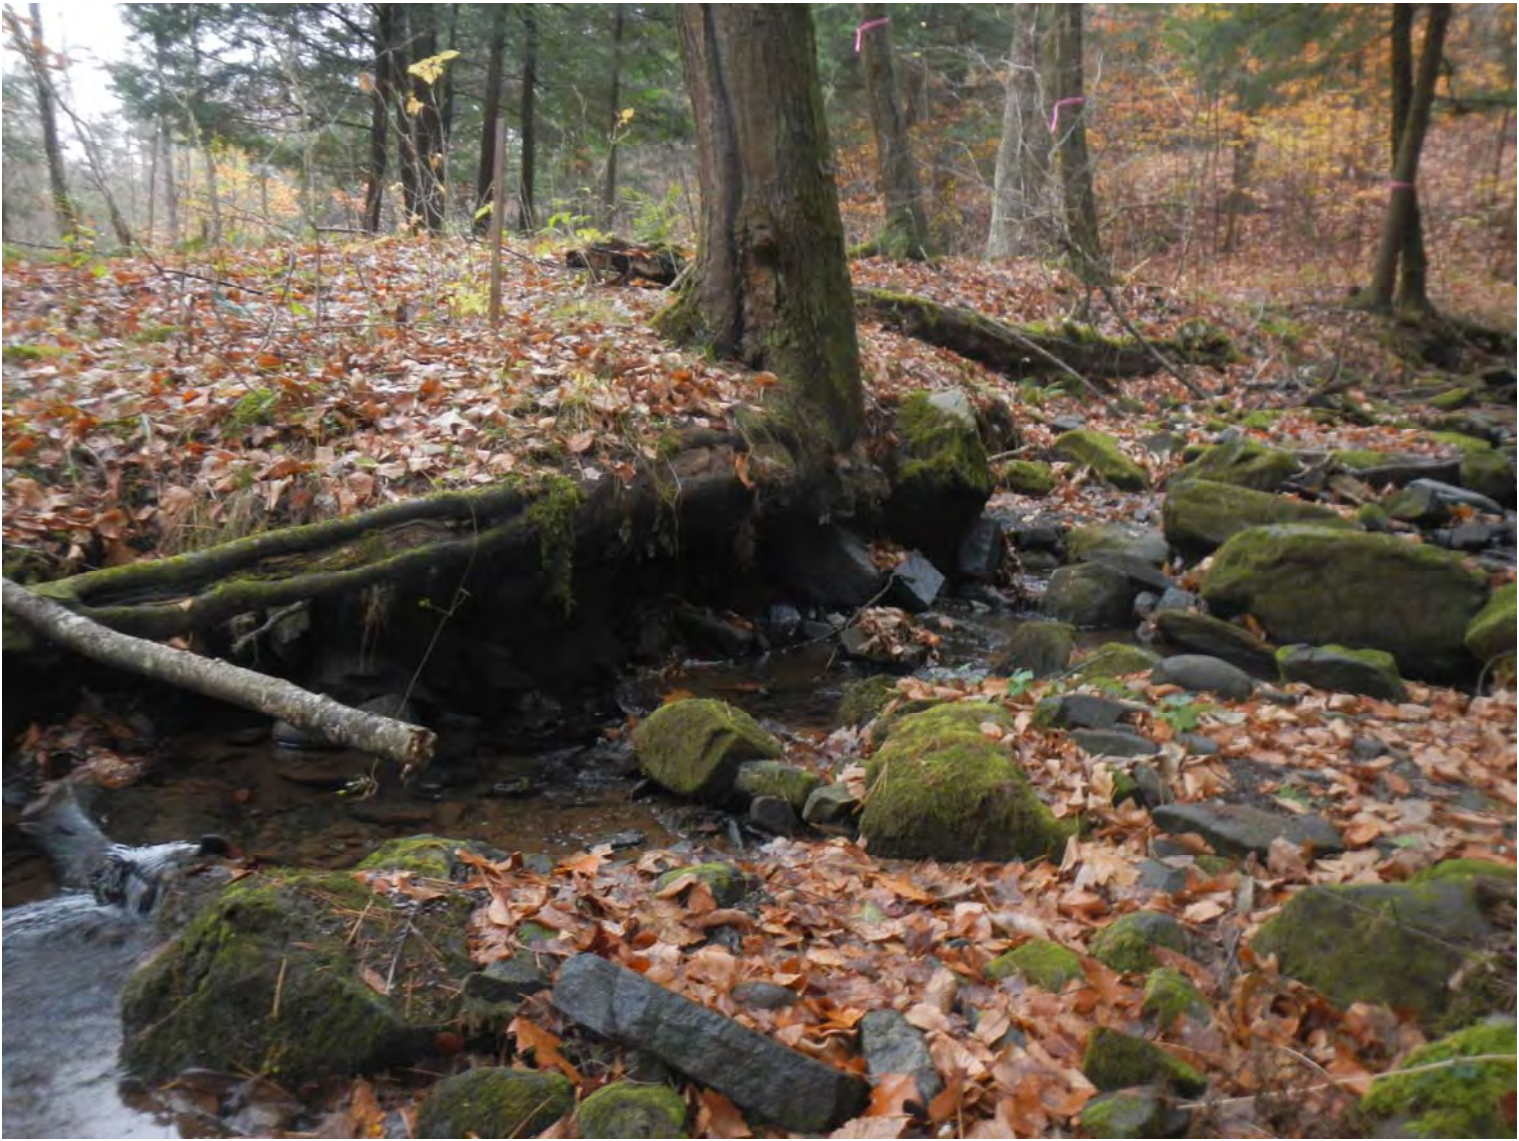
Photo No. 11	Date 11/2/2017
Direction Photo Taken: Right Bank	
Description: Large root wad providing shade and cover.

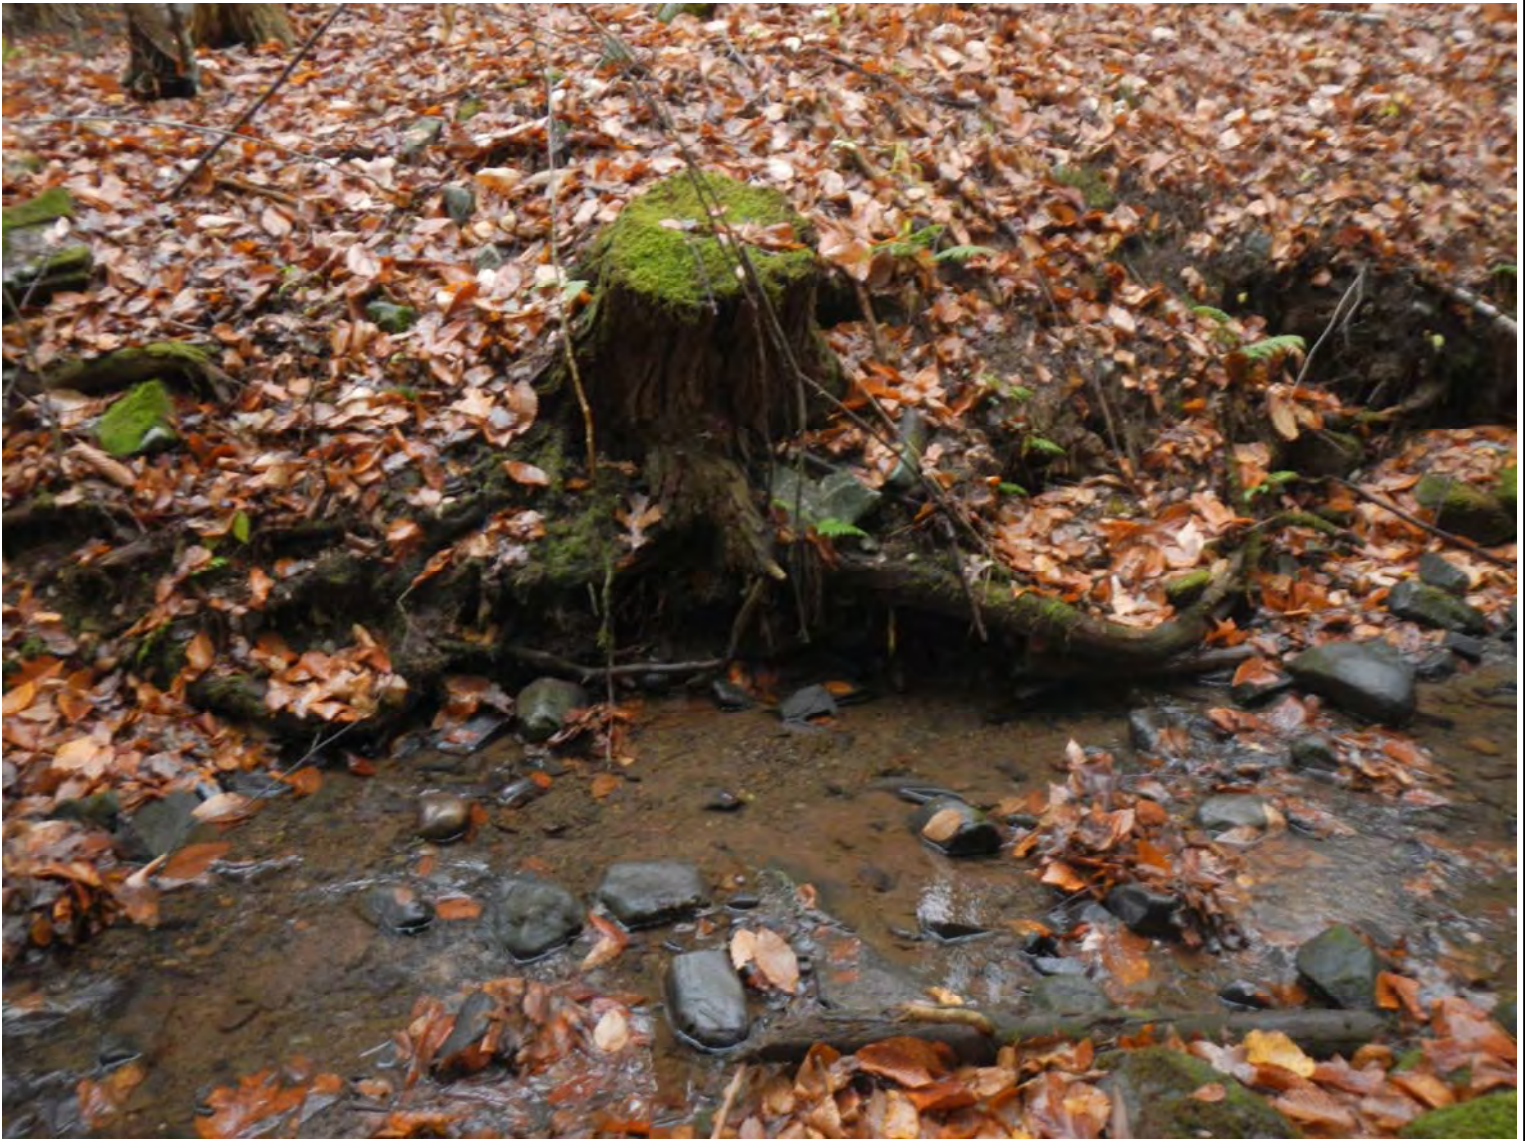
Photo No. 12	Date 11/2/2017
Direction Photo Taken: Right Bank	
Description: Functional root wad providing bank stability on right bank.

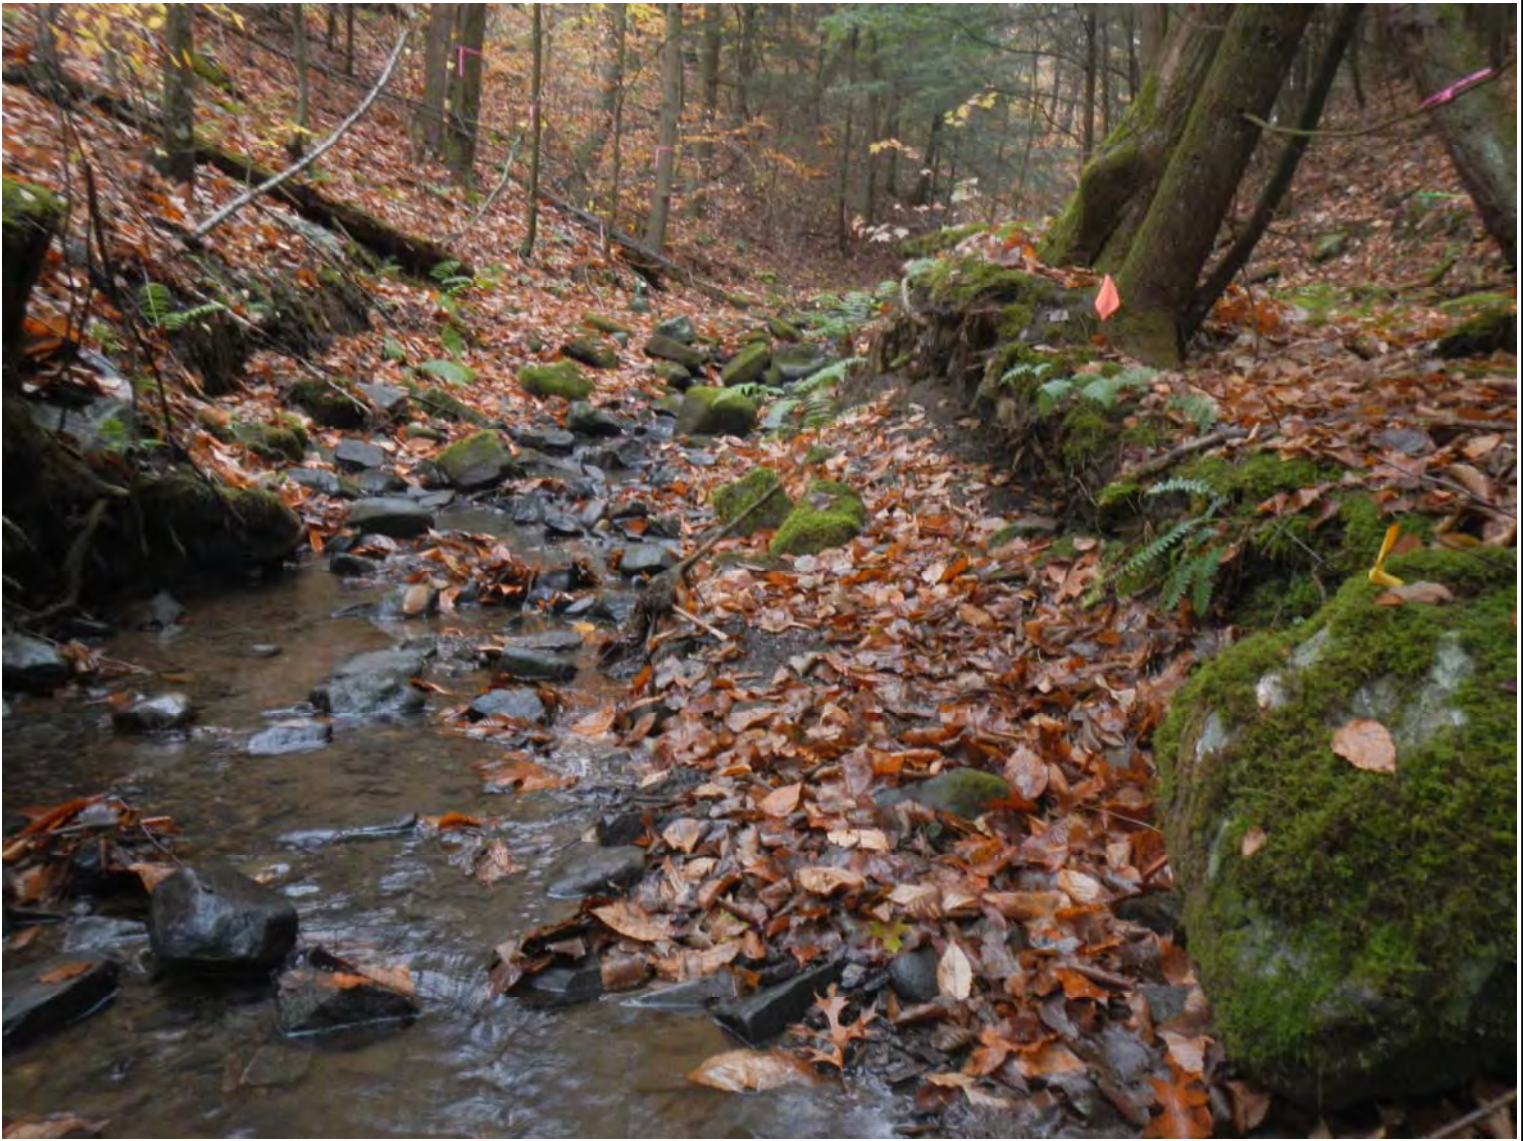
Photo No. 13	Date 11/2/2017
Direction Photo Taken: Upstream	
Description: Erosional area under root wad above constriction on left bank.

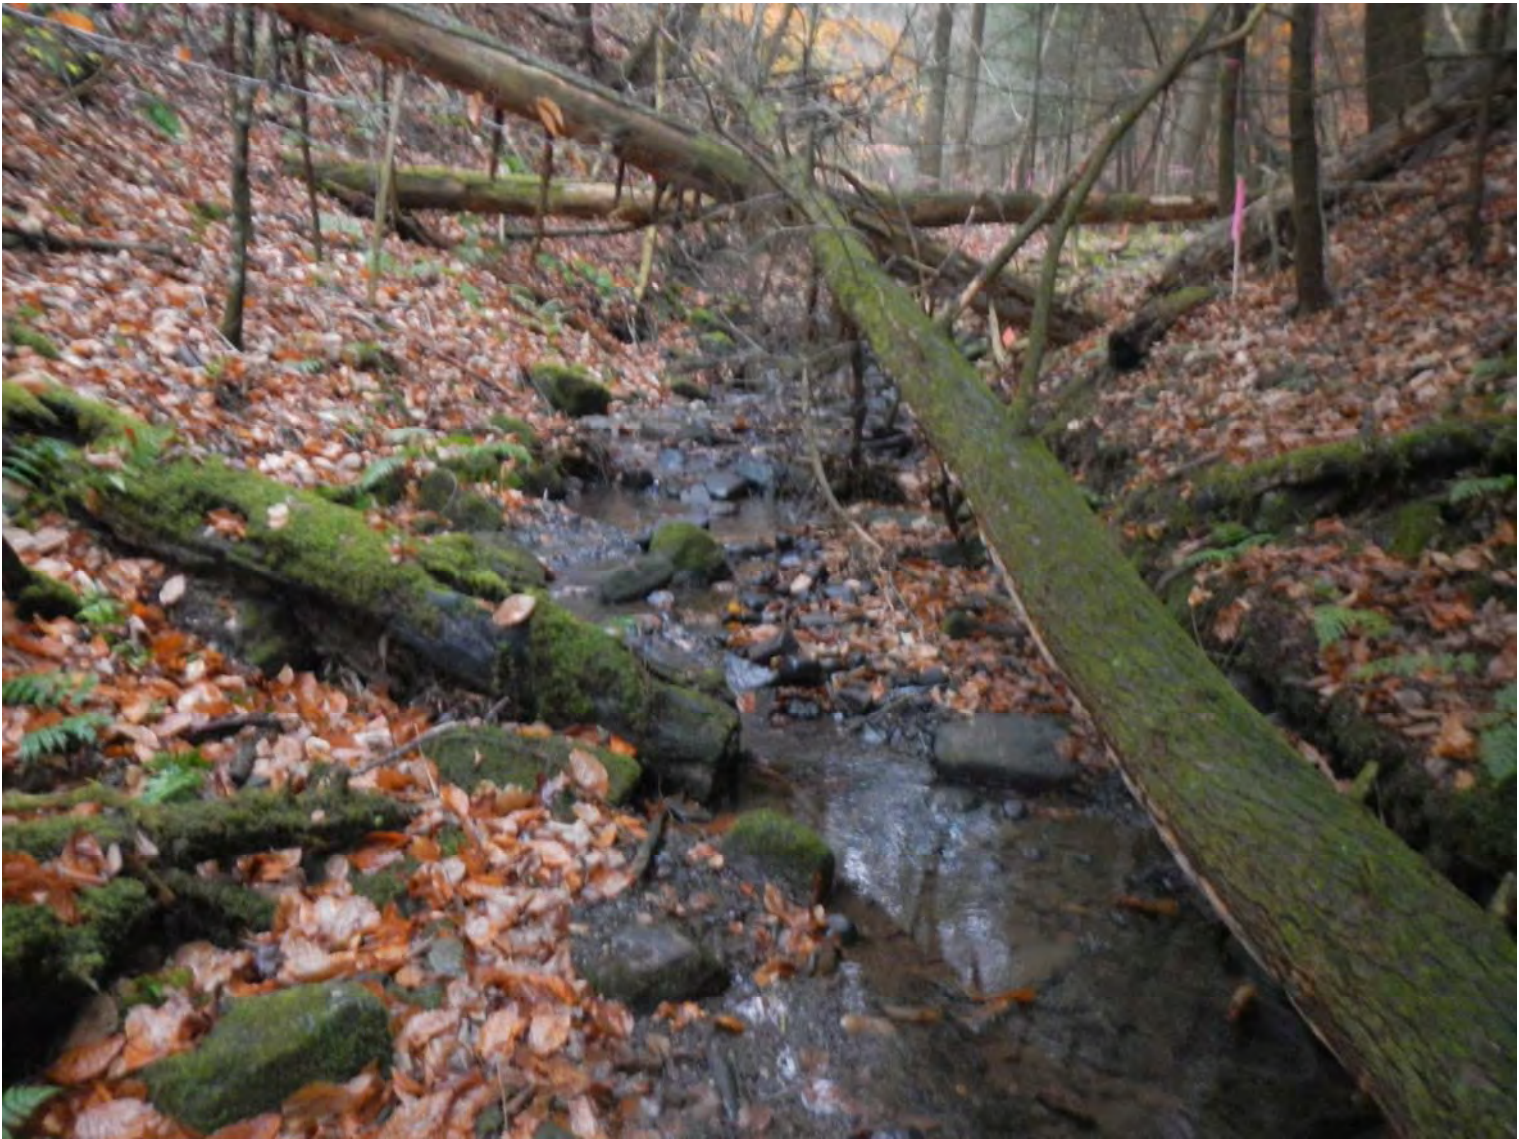
Photo No. 14	Date 11/2/2017
Direction Photo Taken: Upstream	
Description: LWD functioning as cover and substrate.

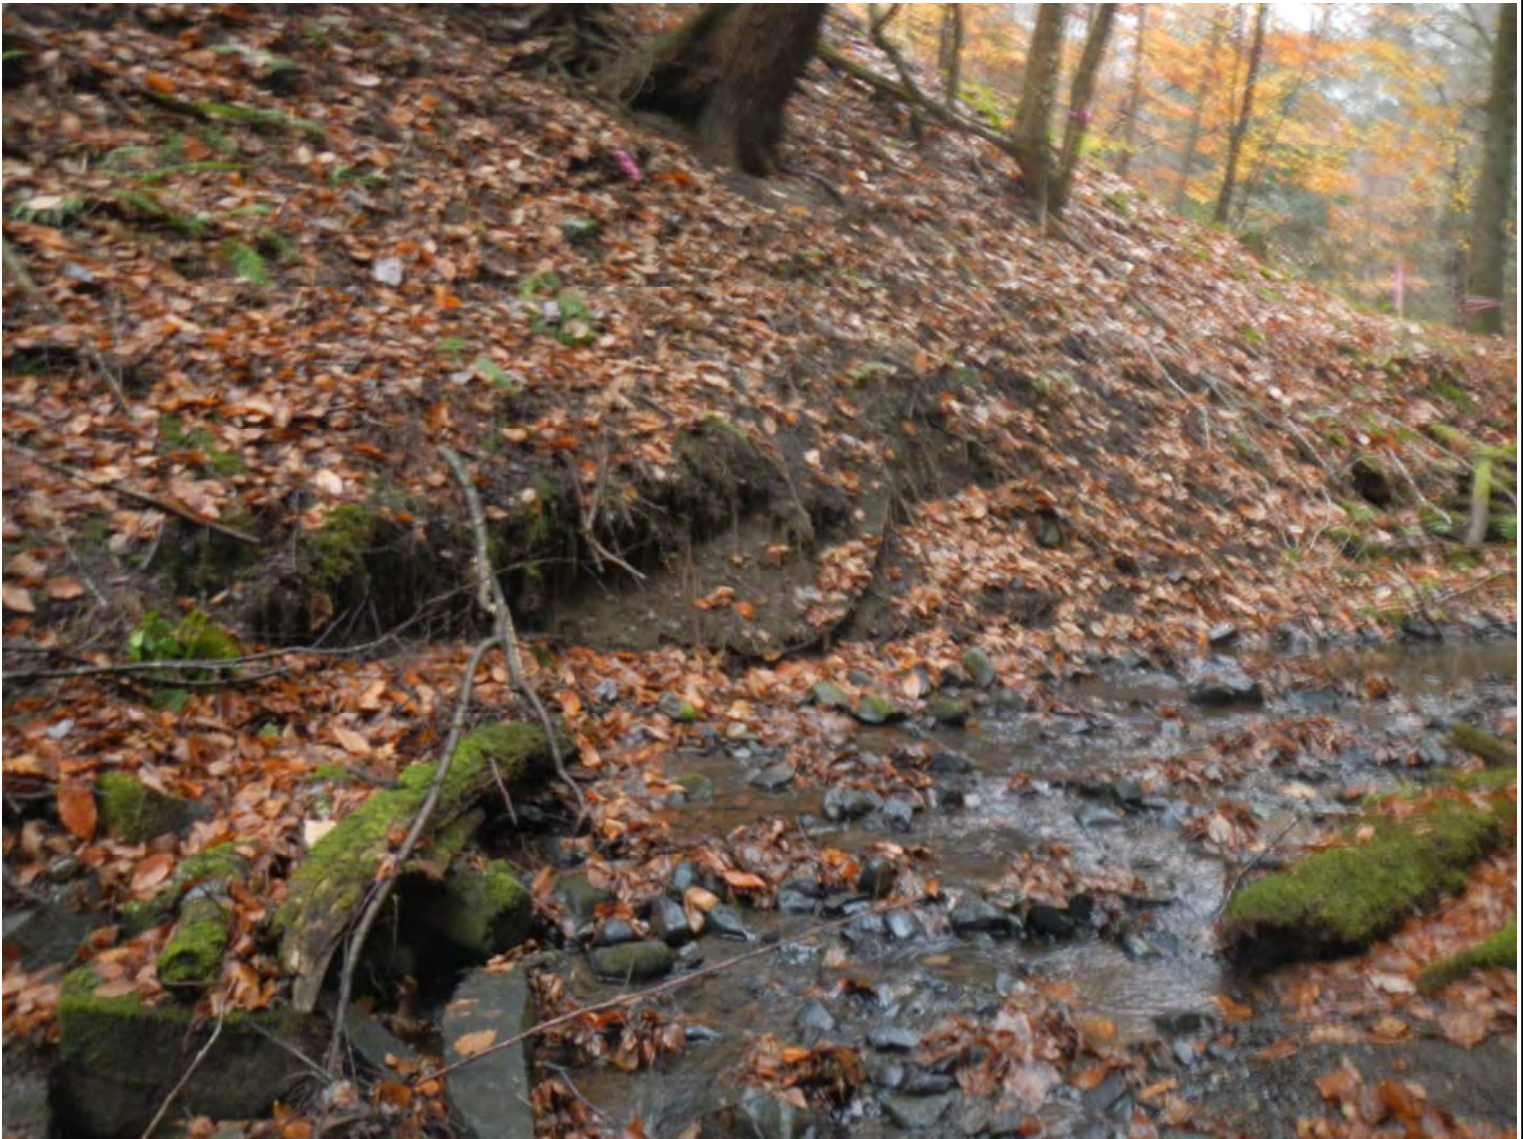
Photo No. 15	Date 11/2/2017
Direction Photo Taken: Upstream	
Description: Right bank erosion area; potential area for bendway weir.
