DATA SUMMARY REPORT FOR TRIBUTARY T11A REMOVAL ACTION UNDER PARAGRAPH 47.f

Dewey Loeffel Landfill Superfund Site
Nassau, New York

May 2018

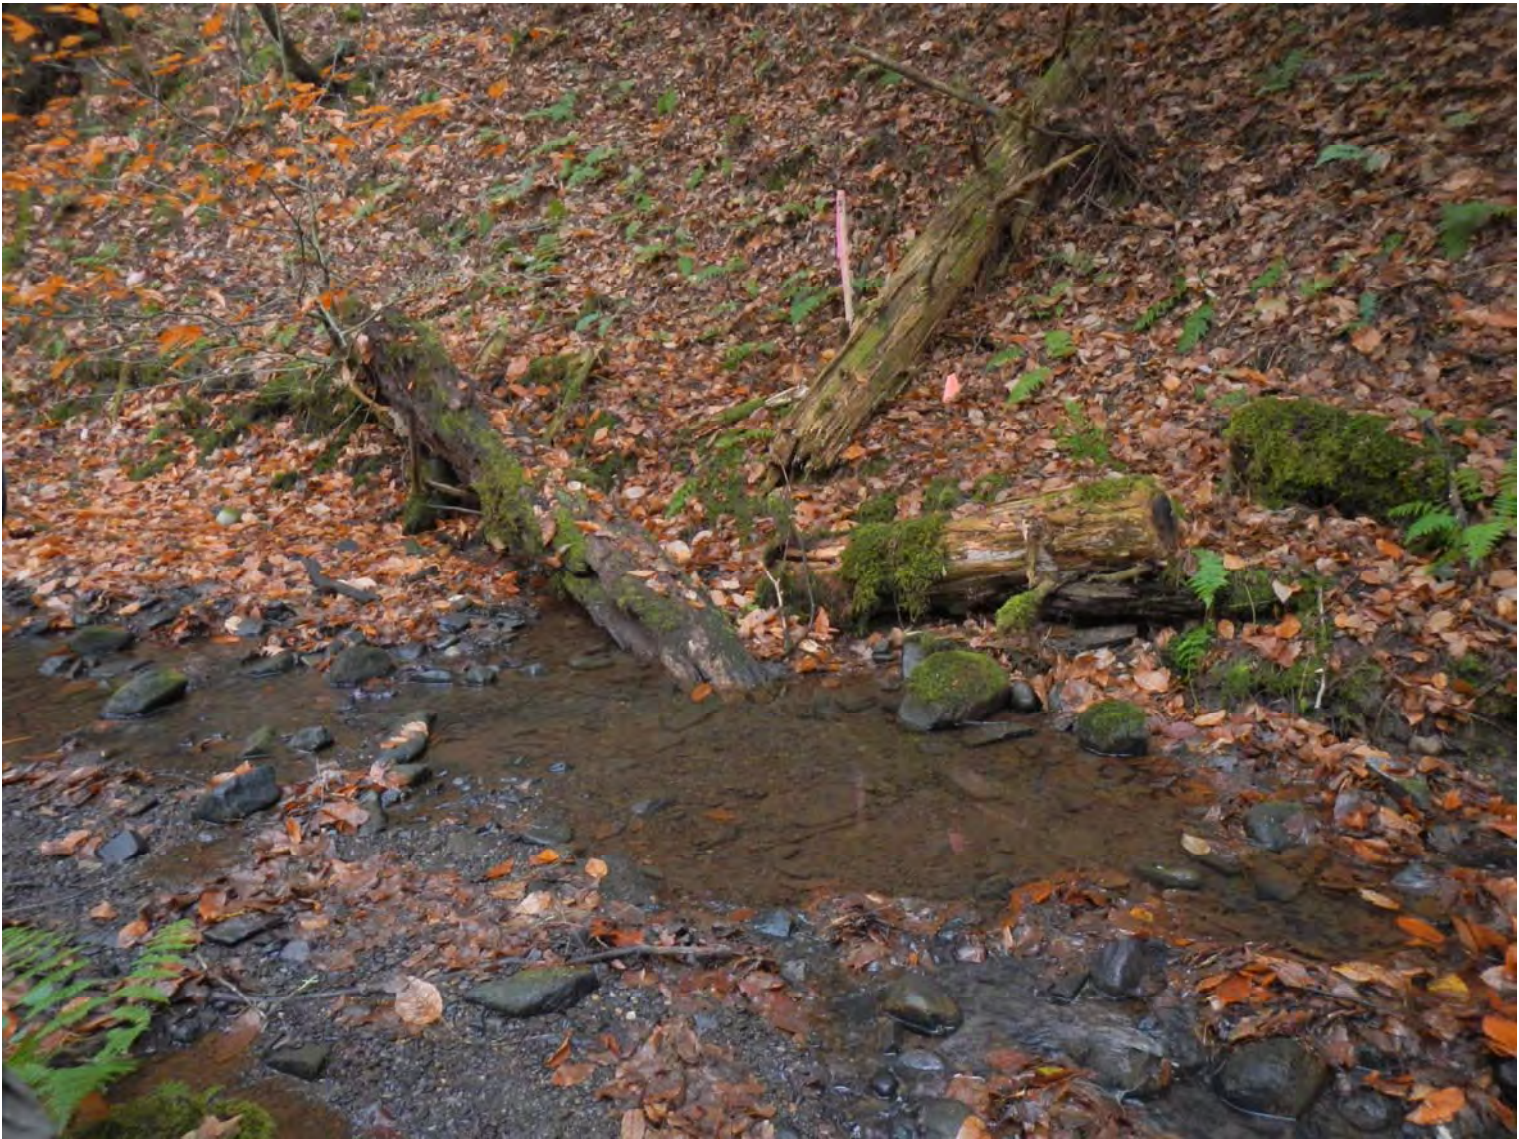
Photo No. 16	Date 11/2/2017
Direction Photo Taken: Left Bank	
Description: LWD acting as toe protection and cover.

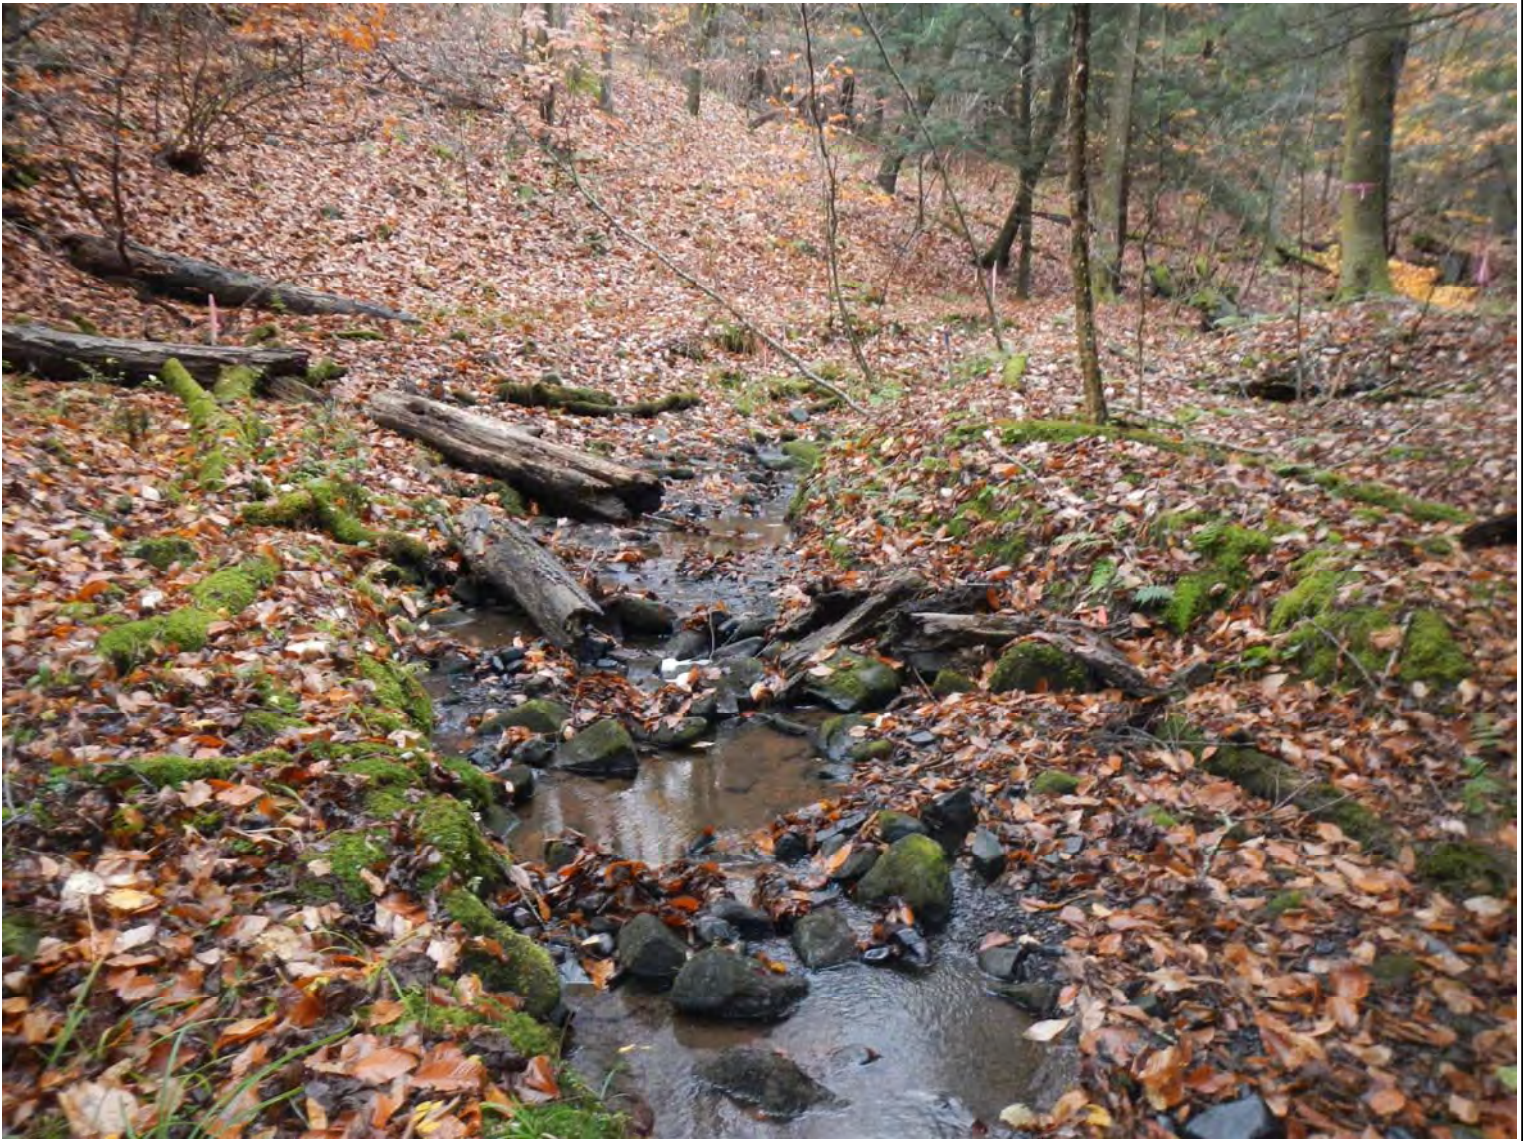
Photo No. 17	Date 11/2/2017
Direction Photo Taken: Downstream	
Description: LWD on right bank providing substrate and bank protection during high flows.

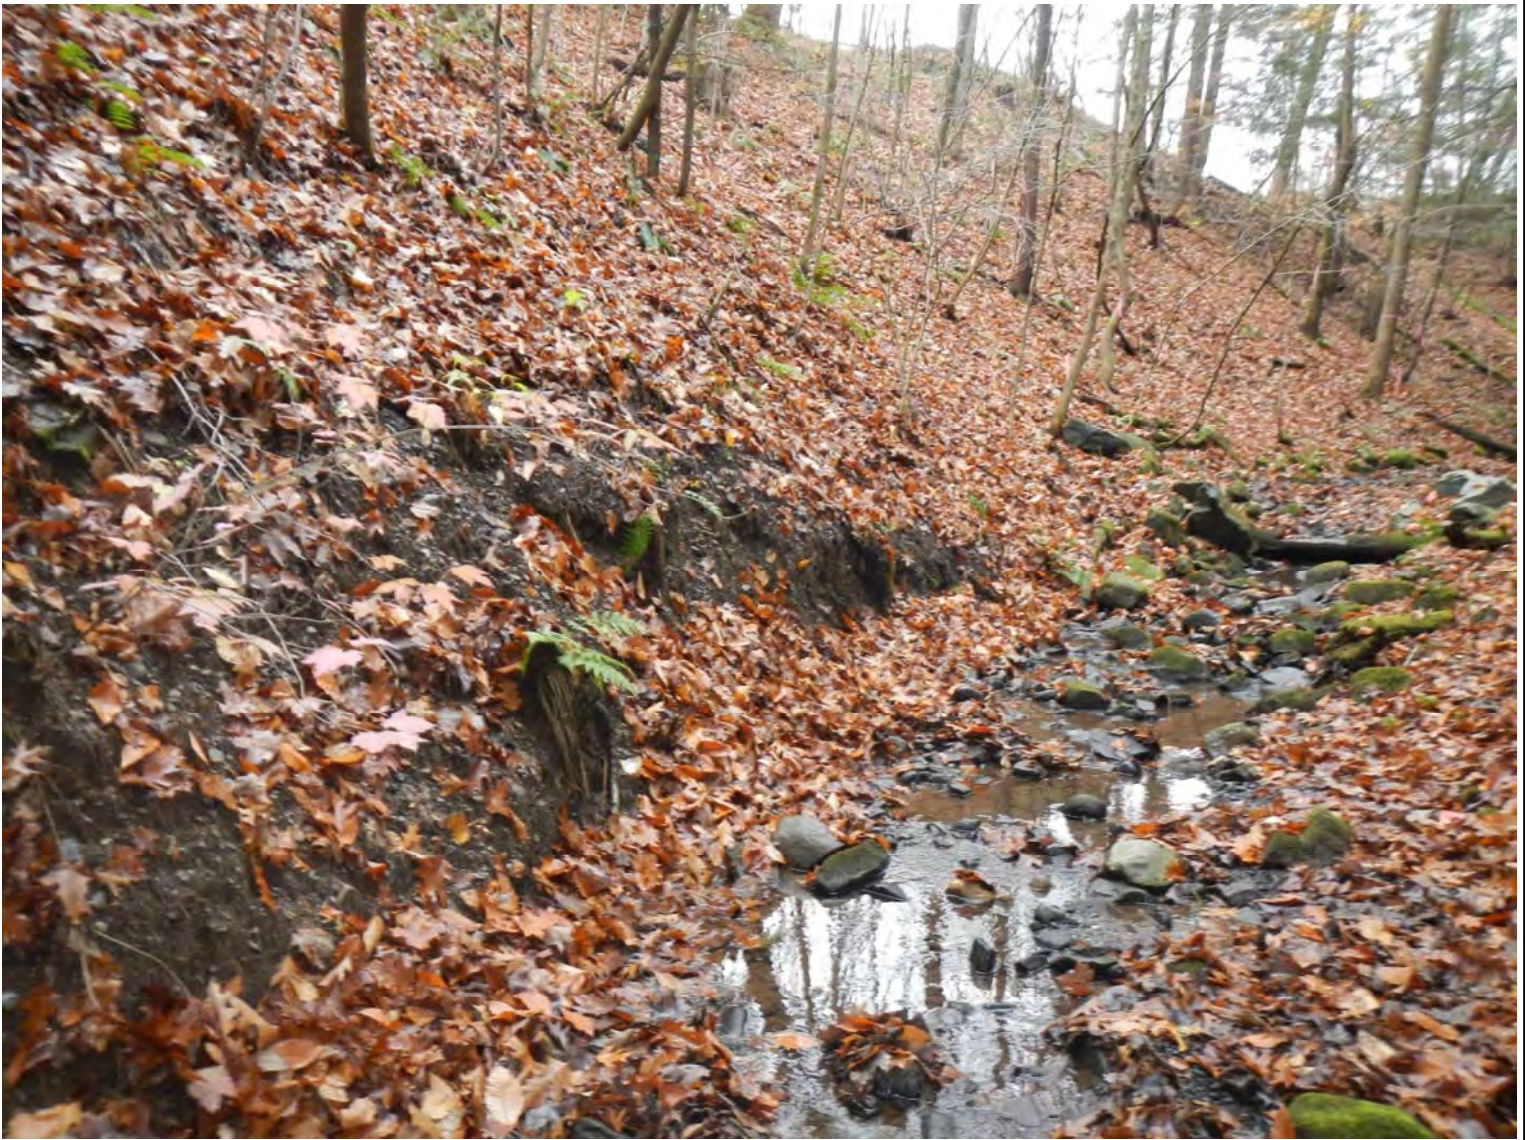
During the qualitative SVAP assessment, a significant amount of bank erosion was observed. Generally, along stream bends, stretches approximately 5 to 20 feet long had vertically shorn banks that were often undercut by the stream by several inches. Locations and sizes of coarse woody debris were anecdotally noted along the corridor. Generally, these were fallen or downed logs along the banks of the stream. Sizes of these logs ranged from 3 to 18 inches in diameter and were generally between 5 to 15 feet long. Bank erosion was significantly less in areas where woody debris had accumulated. In some instances, the downed debris led to accumulation of sediment and smaller debris within the channel. At times, fallen logs within the stream channel created natural step-pool complexes. Photos and descriptions of stream conditions are in Appendix B3.

Photo No. 19	Date 11/2/2017
Direction Photo Taken: Upstream	
Description: Erosion on right bank and area for potential bank stabilization.
