Waste Removal Report

*Ingalls Avenue Site
Troy, New York*

*Prepared for
Niagara Mohawk Power Corporation*

August 1999

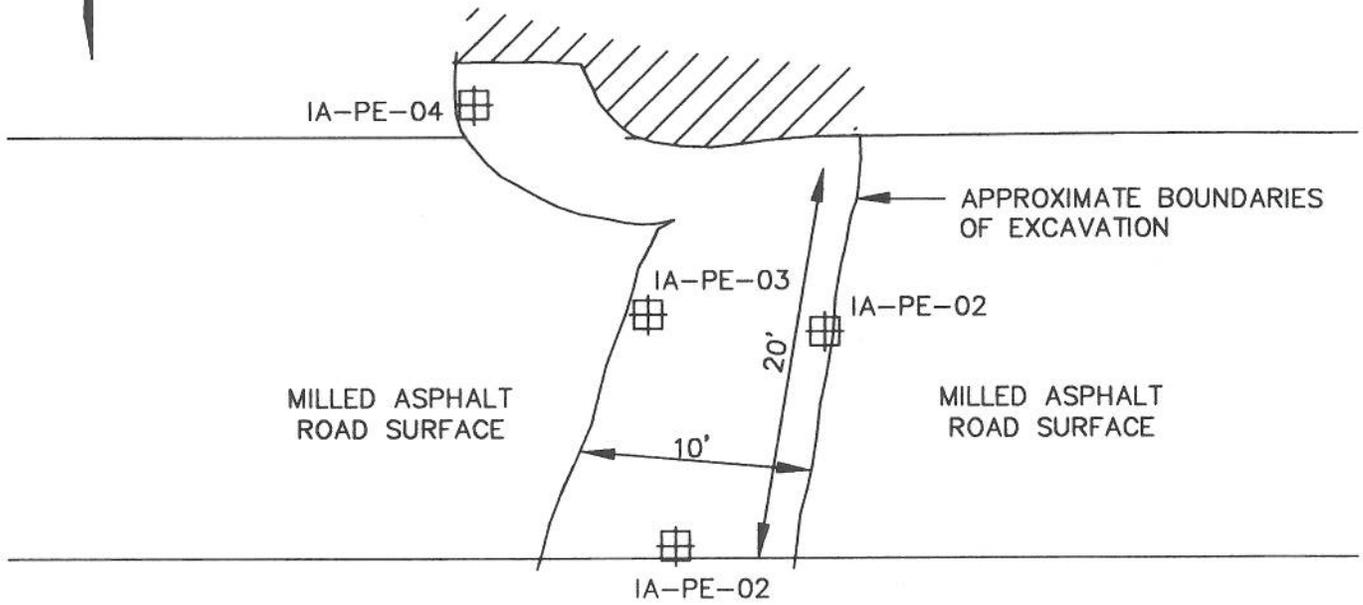
FIGURE 2
MAP OF EXCAVATION AND
POST-EXCAVATION SAMPLE LOCATION

Four post-excavation soil samples and a corresponding field blank sample were collected prior to backfilling at the Ingalls Avenue Site (Figure 2) and analyzed for BTEX, PAHs, and total cyanide. BTEX compounds exceeded NYSDEC soil cleanup criteria in only one of the post-excavation samples, IA-PE-03 (Appendix C, Table 2). Benzene (74 ug/kg) and total xylenes (2200 ug/kg) were detected in this sample. PAH concentrations in all four of the post-excavation samples exceeded NYSDEC soil cleanup criteria, ranging from 620 ug/kg (dibenz(a,h)anthracene in IA-PE-01) to 1,400,000 ug/kg (phenanthrene in IA-PE-02). Sample IA-PE-01, located at the southern extent of the excavation, had the lowest overall PAH concentrations, exceeding only six of the TAGM standards. Sample IA-PE-02, located at the northern extent of the excavation along the road bed, had the greatest overall PAH concentrations, exceeding all of the TAGM standards for the analyzed PAH compounds. Note that these analytical results for PAH compounds are not unexpected, given the milled-asphalt substrate of the Ingalls Avenue roadbed.

Total cyanide ranged among the four samples from 29.6 mg/kg (IA-PE-01) to 372 mg/kg (IA-PE-04). There is no NYSDEC TAGM soil cleanup criteria for cyanide.

POST EXCAVATION SAMPLE LOCATION

A total of four post-excavation samples (IA-PE-01 through IA-PE-04) were collected prior to backfilling at the Ingalls Avenue Site (see Figure 2) and analyzed for BTEX, PAHs, and total cyanide. A sample of the fill material used to backfill the excavation, and a field blank (IA-FB-21) collected by pouring laboratory-supplied deionized water over decontaminated sampling equipment were also submitted for the same analyses. The results of these analyses are presented in Appendix C, Tables 2, 3 and 4 and summarized in Section 3.0.

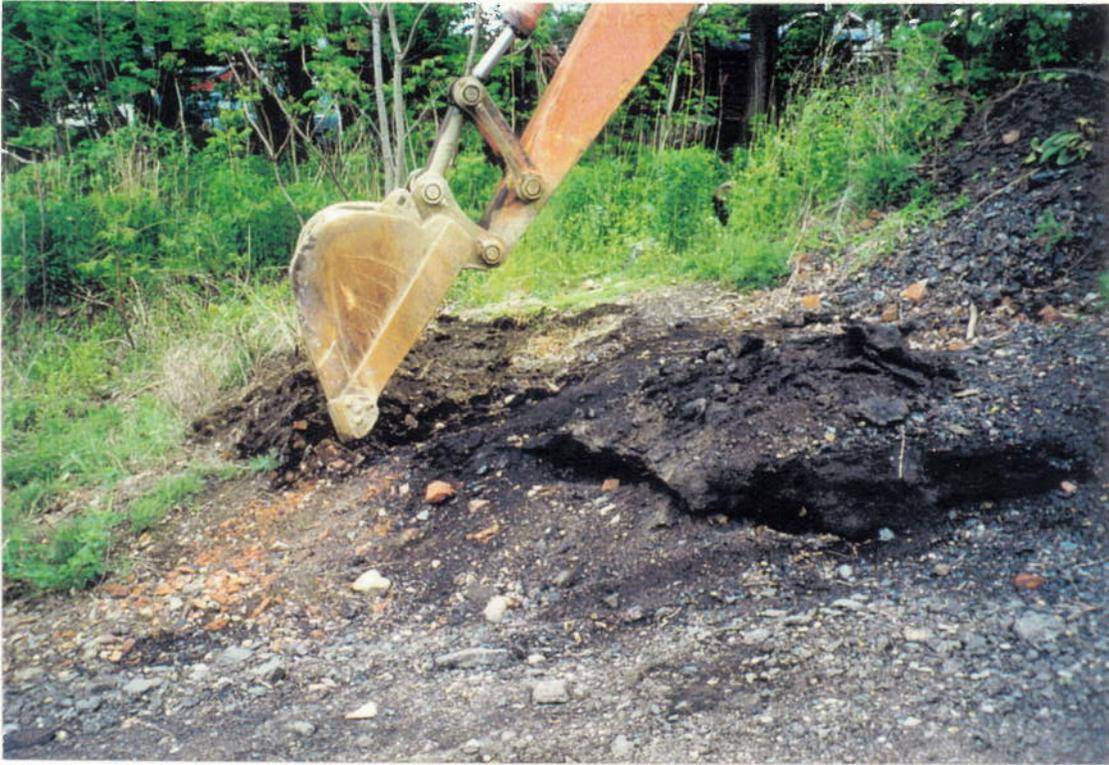
Photo 1: Mound of waste material on the north side of Ingalls Avenue right-of-way, Photograph facing north.

On October 19, 1998, Foster Wheeler Environmental Corporation (Foster Wheeler Environmental) personnel collected samples of the Ingalls Avenue waste material for chemical analysis. This material was exposed in a small mound on the north side of Ingalls Avenue (see Photograph 1), and in a layer approximately 0.5 feet thick along a section of the road. The mound was approximately 8 to 10 feet in diameter and approximately 2 feet thick. A layer of brown to light brown ash and clinker underlay the tarry material in the mound.

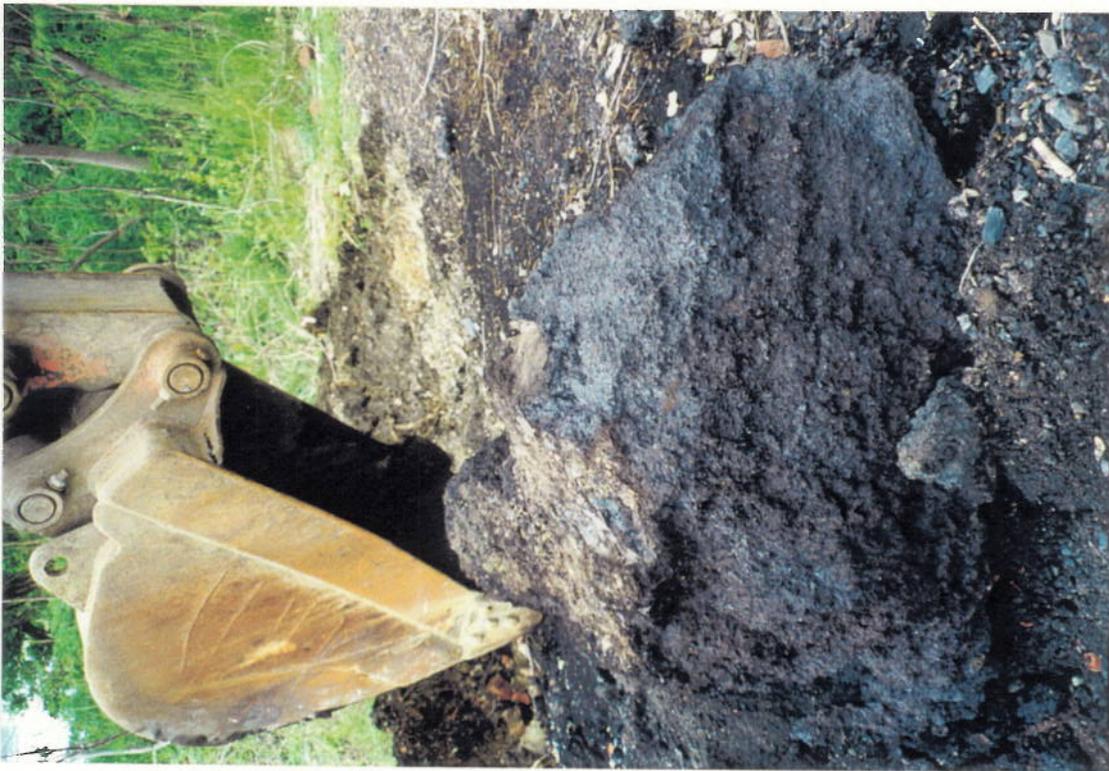
Photo 2: Waste material during excavation.

Neither the physical nature of the material, hard tar containing wood chips (Photograph 2), nor the analytical data substantiated a direct linkage to MGP-type impacts observed at the Troy (Smith Avenue) Site. Nevertheless, the Ingalls Avenue Site is an unsecured public right-of-way. Therefore, in December 1998, NMPC proposed a limited waste removal action to eliminate the surface exposures of this material from the public right-of-way. This proposal was approved in concept by the NYSDEC in a letter to NMPC dated January 4, 1999.

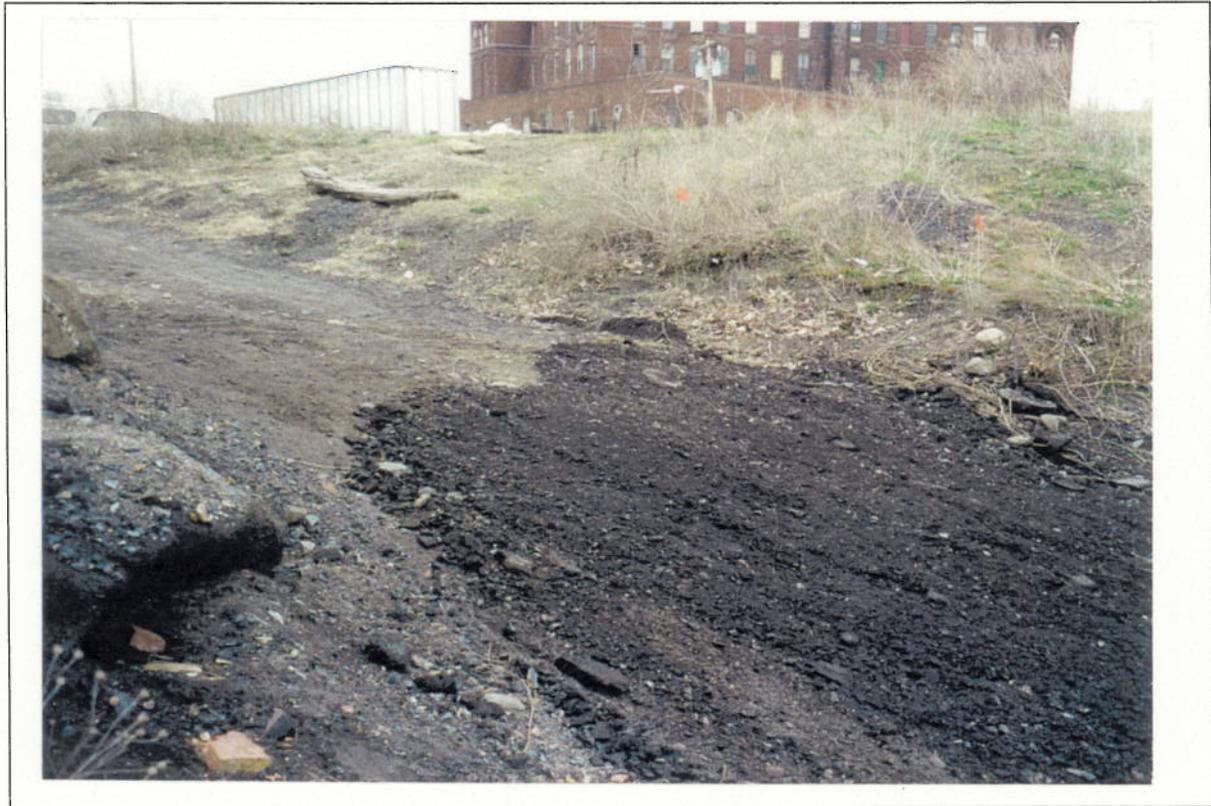
Photo 3: Ingalls Avenue Site prior to waste removal activities. Photograph, facing southeast, shows milled asphalt placed over road bed by the City of Troy.

On April 16, 1999, NMPC and Foster Wheeler Environmental met with NYSDEC at the Ingalls Avenue Site to discuss details of the proposed removal action. During this visit, City of Troy employees arrived to regrade the Ingalls Avenue extension to facilitate its use for access to the Hudson River. A layer of milled asphalt (waste material from road construction projects) was deposited on the ground surface to level and smooth the road bed (see Photographs 3 and 4). This milled asphalt is located within the area of the waste removal action. It was stated during this site visit that consideration of the high levels of polycyclic aromatic hydrocarbons (PAHs) in the milled asphalt would be necessary when determining the extent of remediation required for the site.

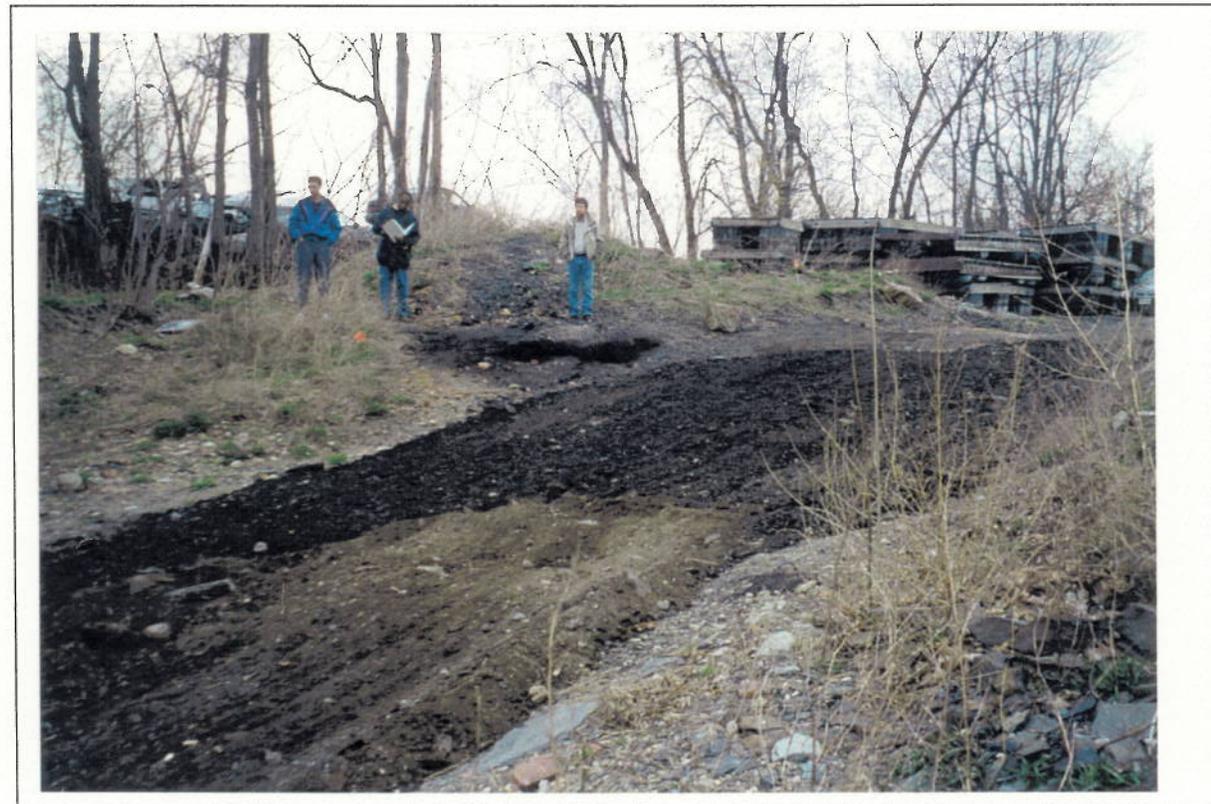
Photo 4: Ingalls Avenue Site prior to waste removal activities. Photograph, facing northeast, shows milled asphalt placed over road bed by the City of Troy.

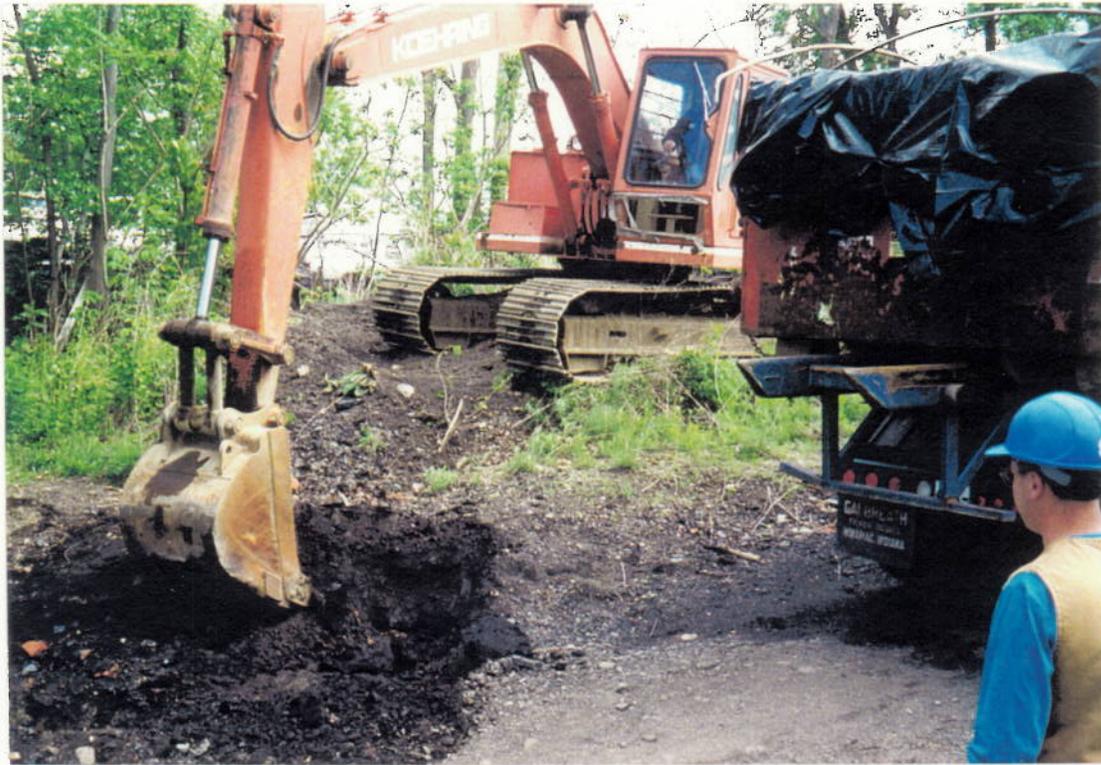
Photo 5: Excavation of waste material by trackhoe.

Excavation of the waste material was performed by West Central Environmental Corporation, with oversight by NMPC and Foster Wheeler Environmental. The material was excavated using a trackhoe excavator (Photograph 5), and loaded directly into a plastic-lined 30 yd³ roll-off container for transportation from the site. Pursuant to the work plan, the excavation was completed to a depth of approximately 2 feet below the ground surface along the southwestern side of the mound and across the road (Photographs 6 and 7). The total depth of the mound on the northern side of the road was approximately 3 to 4 feet. Excavation of the waste was continued until it was determined that the mass of waste removed was near the weight capacity of the roll-off container. As shown on the waste manifest (Appendix B) a total of approximately 28,000 pounds of waste material was removed for off-site disposal.

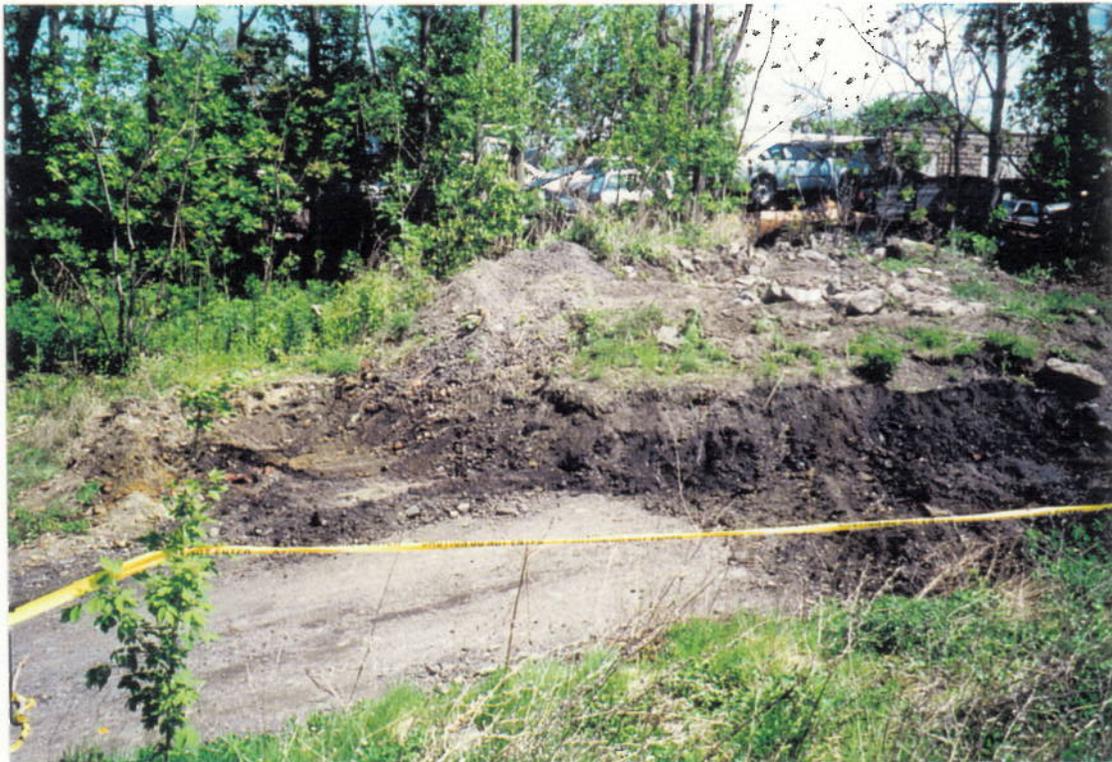
Photo 6: Ingalls Avenue Site after completion of excavation. Photograph facing north.

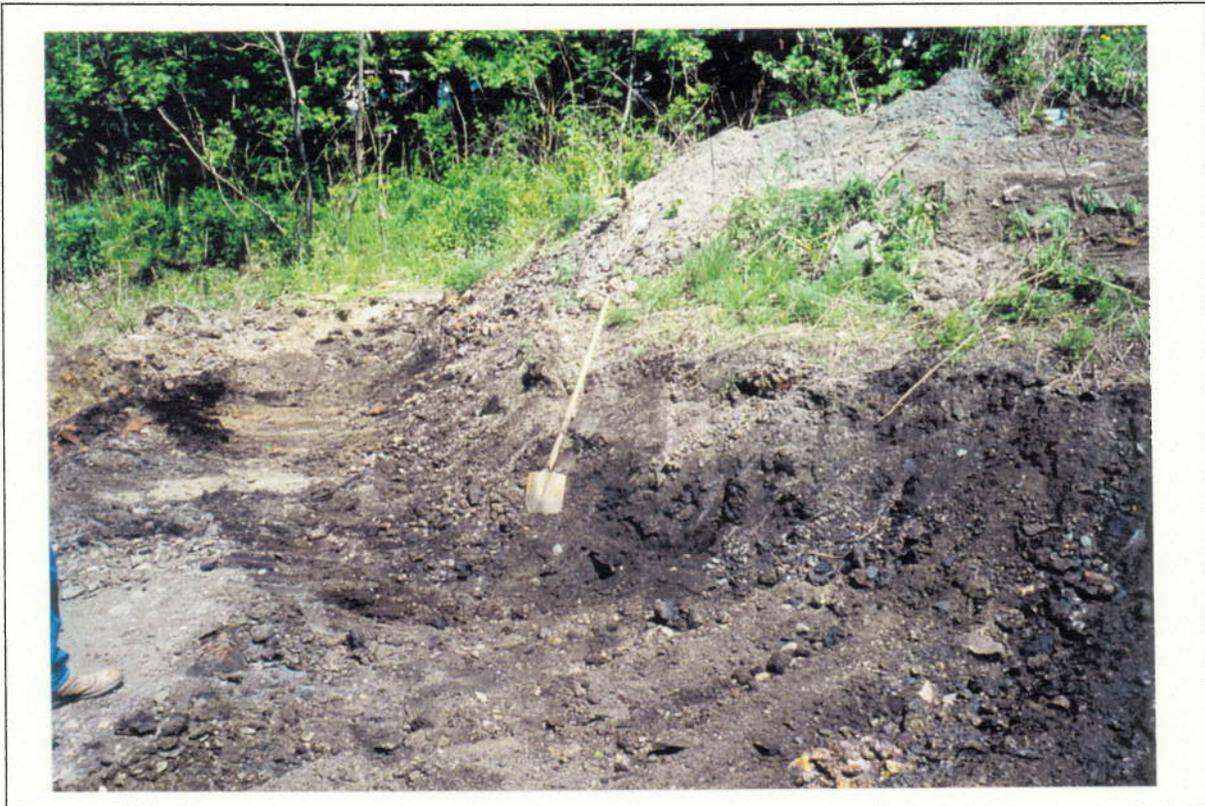
Photo 7: Ingalls Avenue Site after completion of excavation, showing prior location of mound of waste material. Photograph facing north.

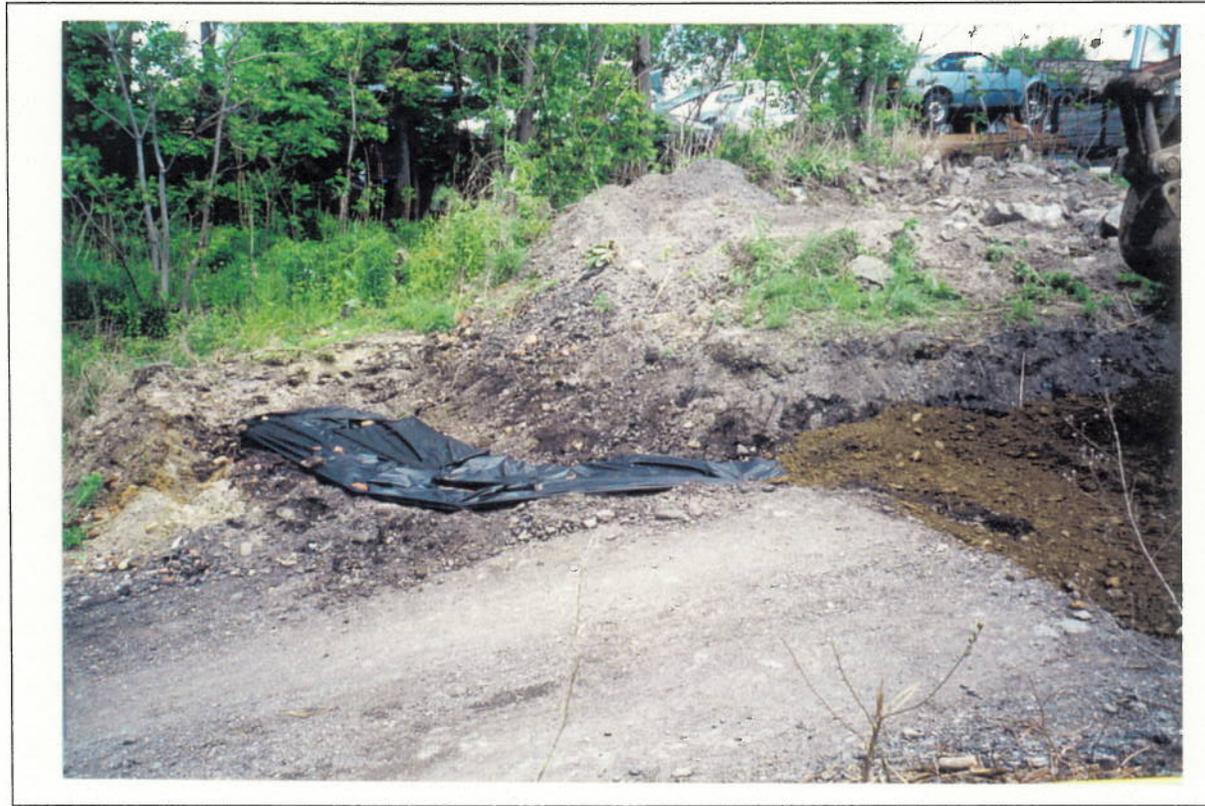
Photo 8: Placement of filter fabric in excavation prior to backfilling.

Prior to backfilling, permeable landscaping fabric was placed in the excavation to mark the limits of the excavation for future investigations or remediation that may be required (Photograph 8). The excavation was then backfilled with clean gravel supplied by West Central Environmental Corporation to restore the original grade (Photographs 9 and 10).

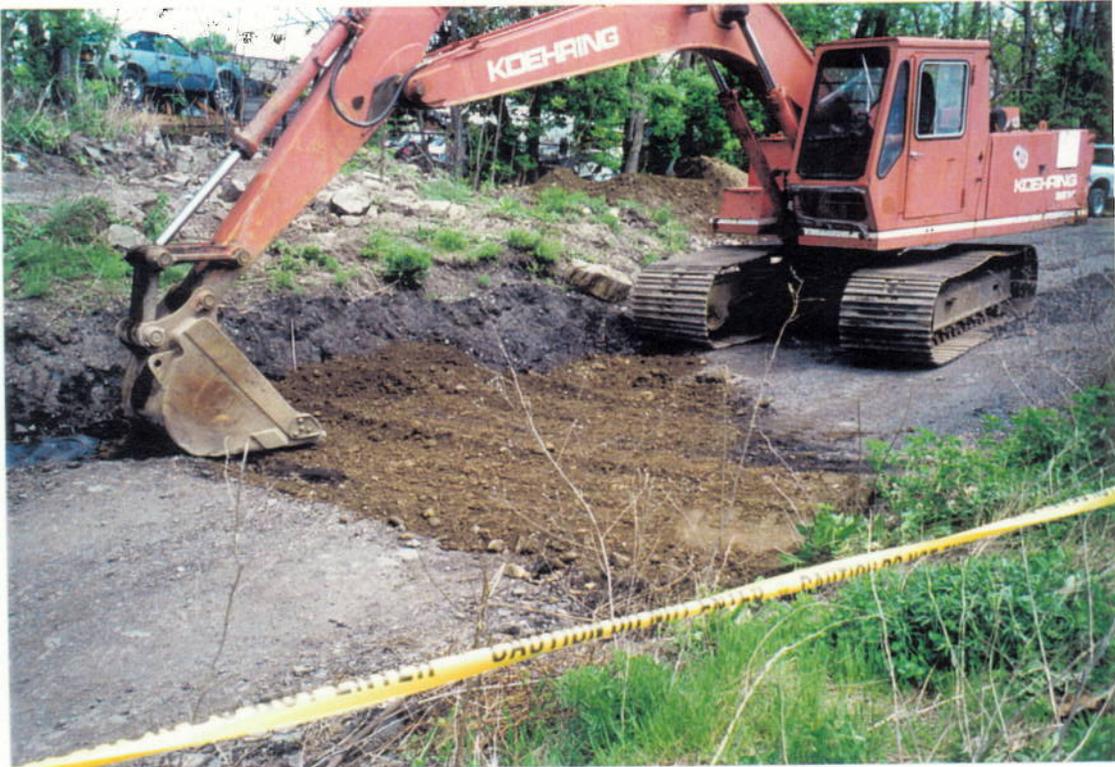
Photo 9: Backfilling of excavation.

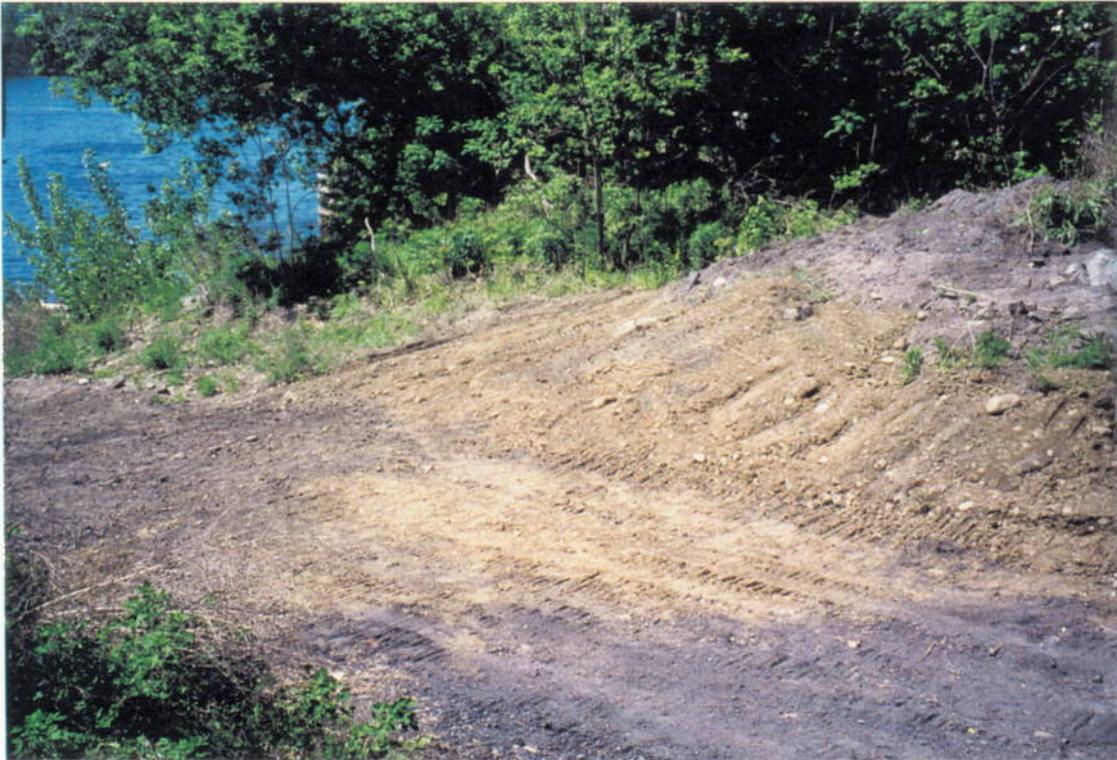
Photo 10: Ingalls Avenue Site, facing northwest, after completion of backfilling.
