Pre-Design Investigation Report

OU2 Ingalls Avenue Area Troy (Smith Avenue) Former MGP Site Troy, New York

NYSDEC Site # 442030

August 2017

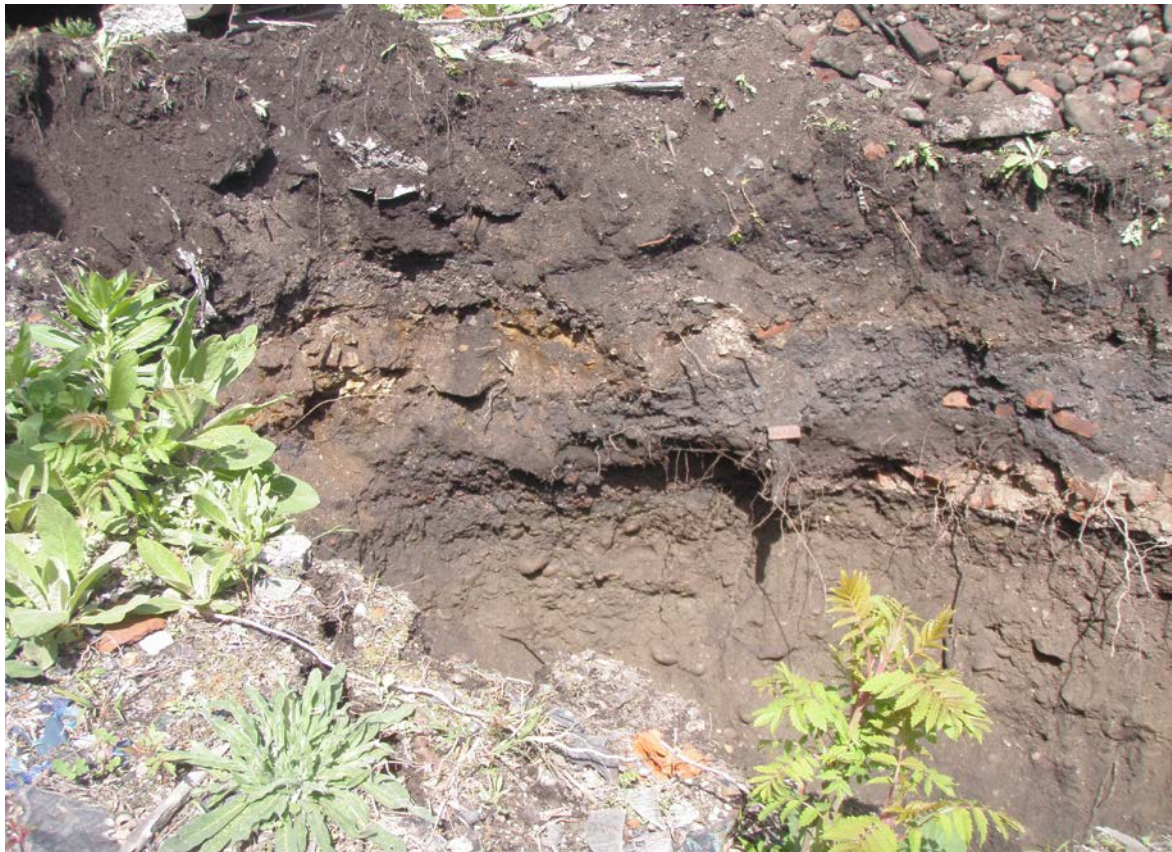
2				FILL	Fill Material: Red bricks mixed in brown sand matrix. White and gray ashes in horizontal layers. Glass, metal, cinders, slag mixed in brown sand matrix. Loose, moist.		
3	0.0			FILL	Fill Material: White and gray ashes in horizontal layers. Glass, metal, cinders, slag mixed in brown sand matrix. Loose, moist.		
4				FILL	Fill Material: White and gray ashes in horizontal layers. Glass, metal, cinders, slag mixed in brown sand matrix. Loose, moist.		
5	0.0	TP12(20) (4-5)					
6				SP - SM	(SP/SM) Narrowly Graded Sand with Silt and Gravel; 80% fine sand; 15% round and subround gravel; 5% rounded cobbles; - 5% non-plastic fines; moist; loose; dark brown.		
7	0.0						
8				SP - SM	(SP/SM) Narrowly Graded Sand with Silt and Gravel; 80% fine sand; 15% round and subround gravel; 5% rounded cobbles; - 5% non-plastic fines; moist; loose; dark brown.		
9	0.0						
10							
11	0.0			SP - SM	(SP/SM) Narrowly Graded Sand with Silt and Gravel; 80% fine sand; 15% round and subround gravel; 5% rounded cobbles; - 5% non-plastic fines; moist; loose; dark brown.

Visible Evidence of MGP-Related Purifier Residuals
