FINAL SITE CHARACTERIZATION WORK PLAN

Lydall Performance Materials (US), Inc. 12 Davis Street & Kokley Ave. (E of) Village of Hoosick Falls Rensselaer County, New York NYSDEC Site No. 442059

Project Number: BR0493

November 1, 2019

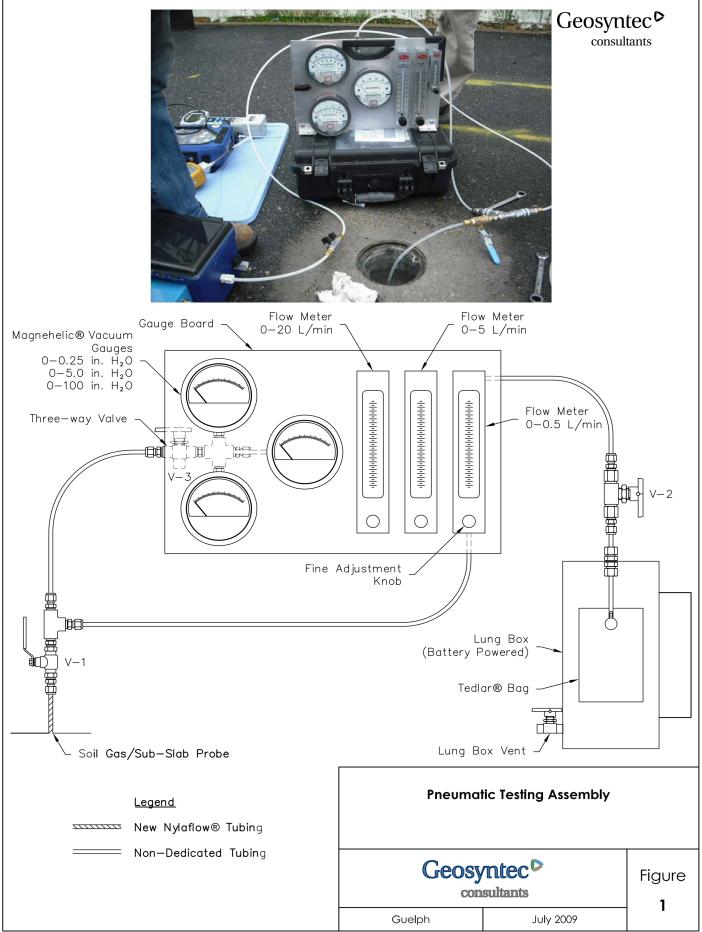
Pneumatic testing is the procedure for measuring the flow and vacuum, which can be used to calculate the soil gas permeability of the surrounding geologic materials.

To measure the soil gas flow and corresponding vacuum, the equipment will be assembled as shown on Figure 1. The fine adjustment knob on the rotameter will be closed. Valves V-1 and V-2 will be opened as the lung box is turned on. The fine adjustment knob is then slowly opened until there is a measurable flow of 100 milliliters per minute (mL/min). The corresponding vacuum, as well as the flow rate, will be recorded. The rotameters must be vertical to accurately measure flow. Depending on the gas permeability of the subsurface materials, it may be necessary to switch to a higher scale vacuum gauge (0-5 in H₂O or 0-100 in H₂O) using the three-way valve (V-3). Both flow and vacuum should be clearly measurable within the scales of the vacuum gauge and rotameter. The flow rate will be increased to 200 mL/min and the vacuum observed will be recorded. This will be repeated at a flow rate of 500 mL/min. The flow and vacuum readings will stabilize almost instantaneously; therefore, the total volume of soil gas removed during the flow and vacuum test will be typically less than 1 L.
