Route 203 Site

Nassau, New York

NYSDEC Site No.: 442064

INVESTIGATION/ FEASIBILITY STUDY WORK PLAN ROUTE 203 SITE

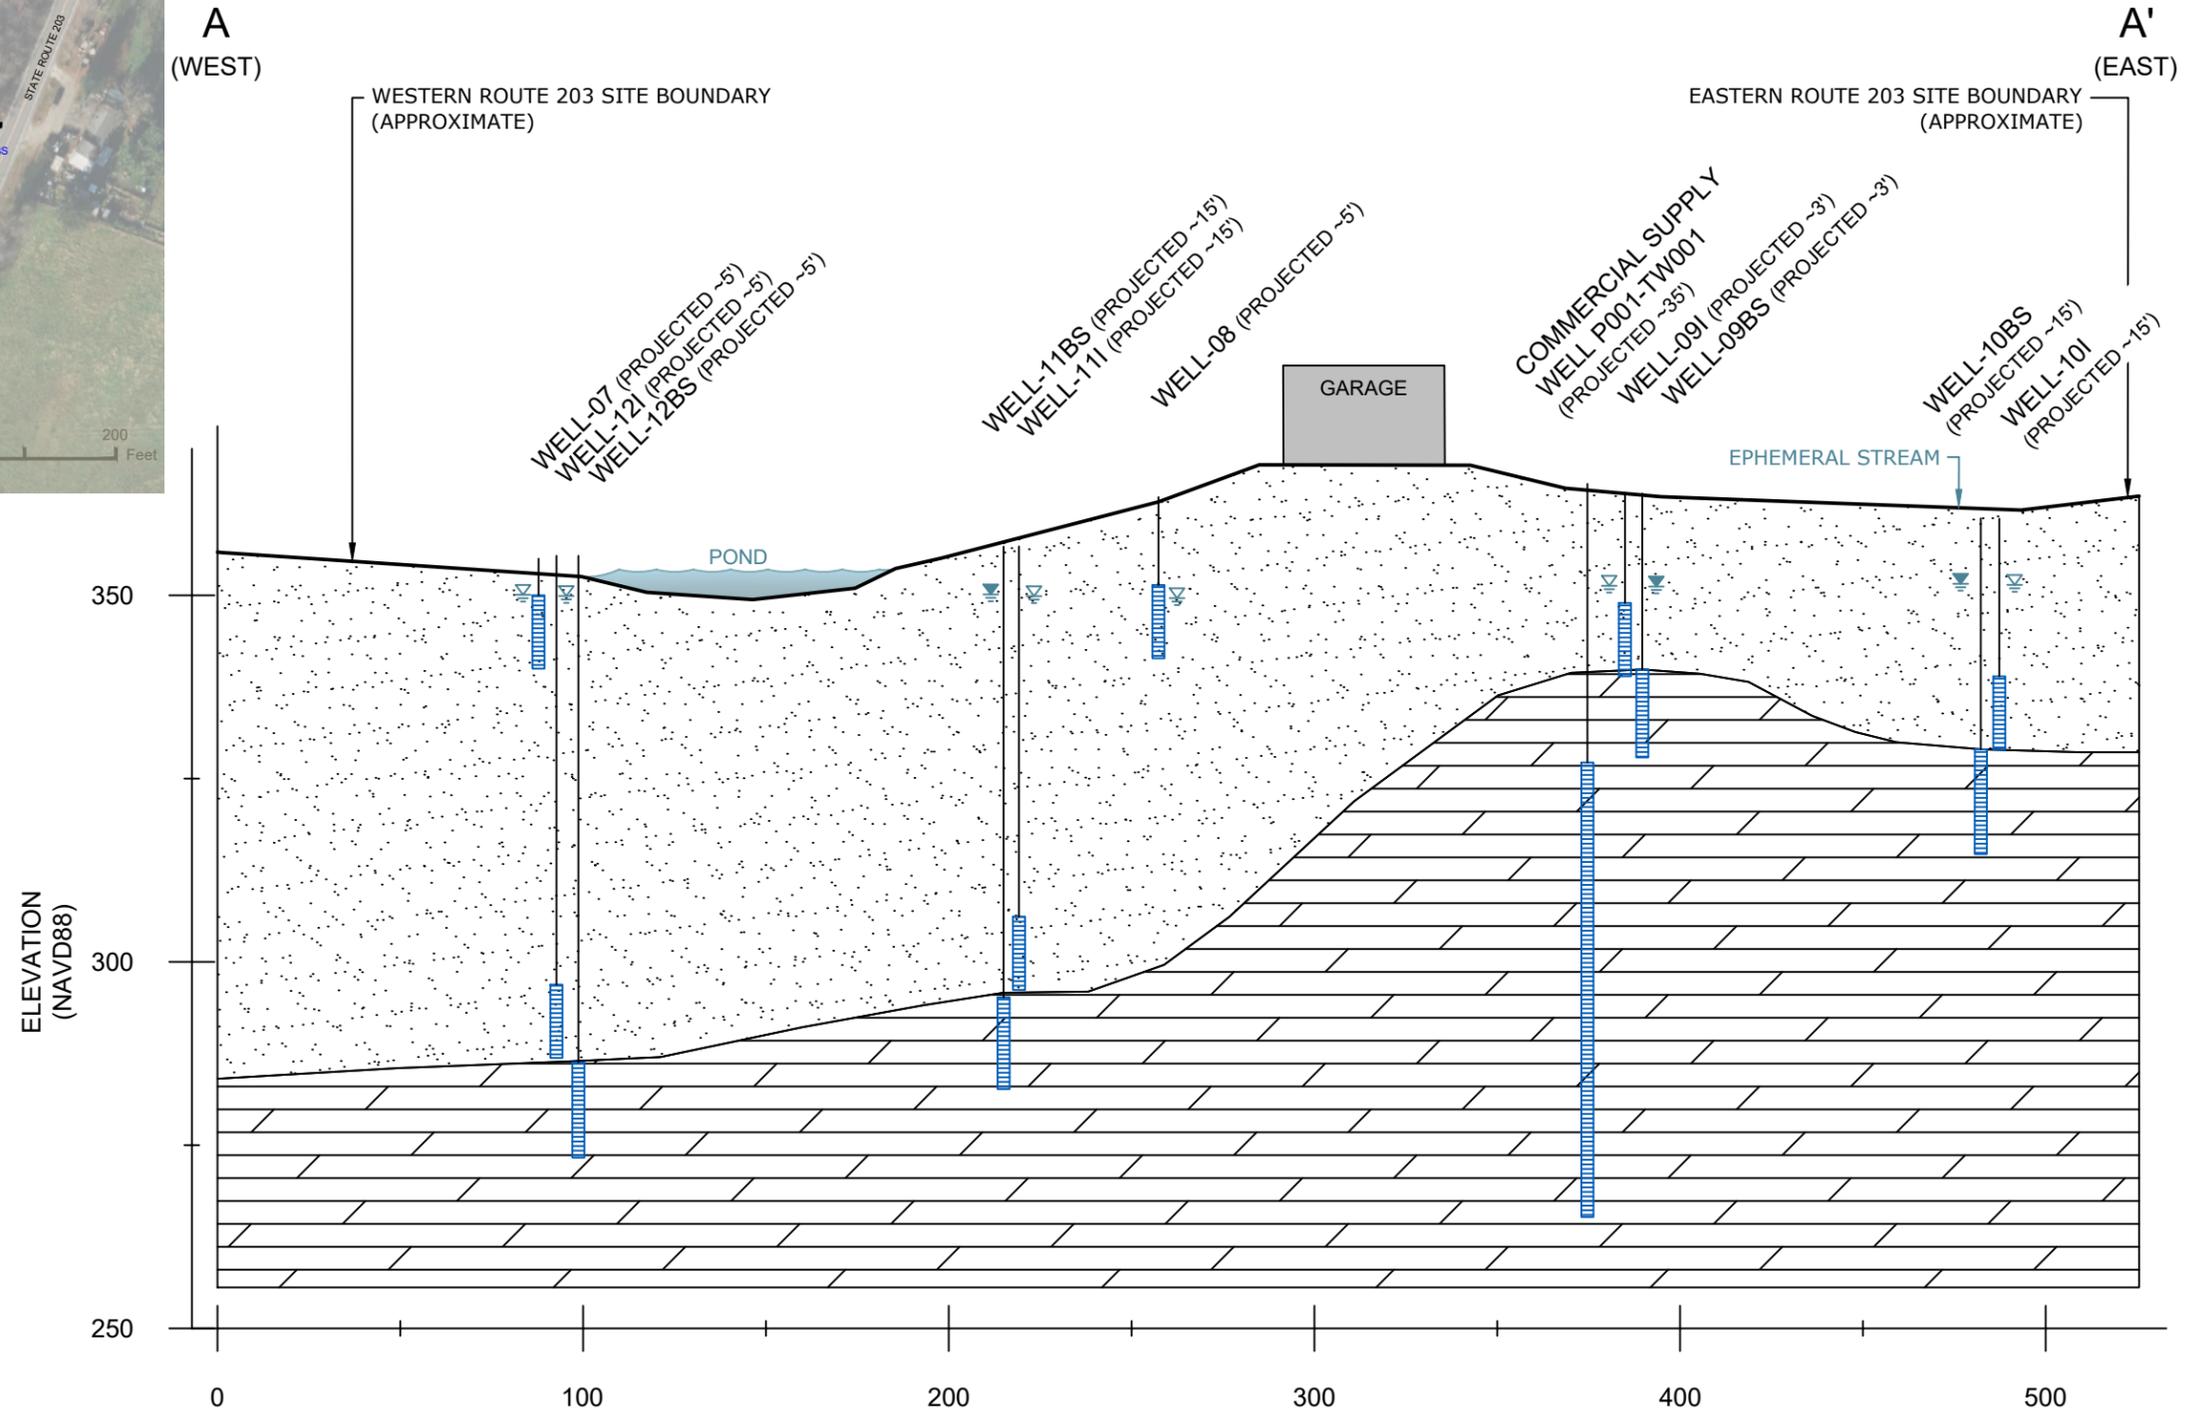
- NOTES:**
1. Ground surface topography derived from Rensselaer County 2016 LiDAR data collection, which was accessed on May 5, 2023, from <https://gis.ny.gov/elevation/lidar-coverage.htm>.
 2. Monitoring well elevations from Colliers Engineering & Design July 2022 field survey.
 3. Commercial supply well P001-TW001 construction based on W. Gordon Gould, Inc well record (top of bedrock information not available).
 4. NAVD88 designates North American Vertical Datum of 1988.
 5. Water elevation for Well-12BS not shown because water level had not fully recovered in well following installation and development.

- WATER ELEVATION ON JULY 5, 2022:**
- OVERBURDEN
 - SHALLOW BEDROCK

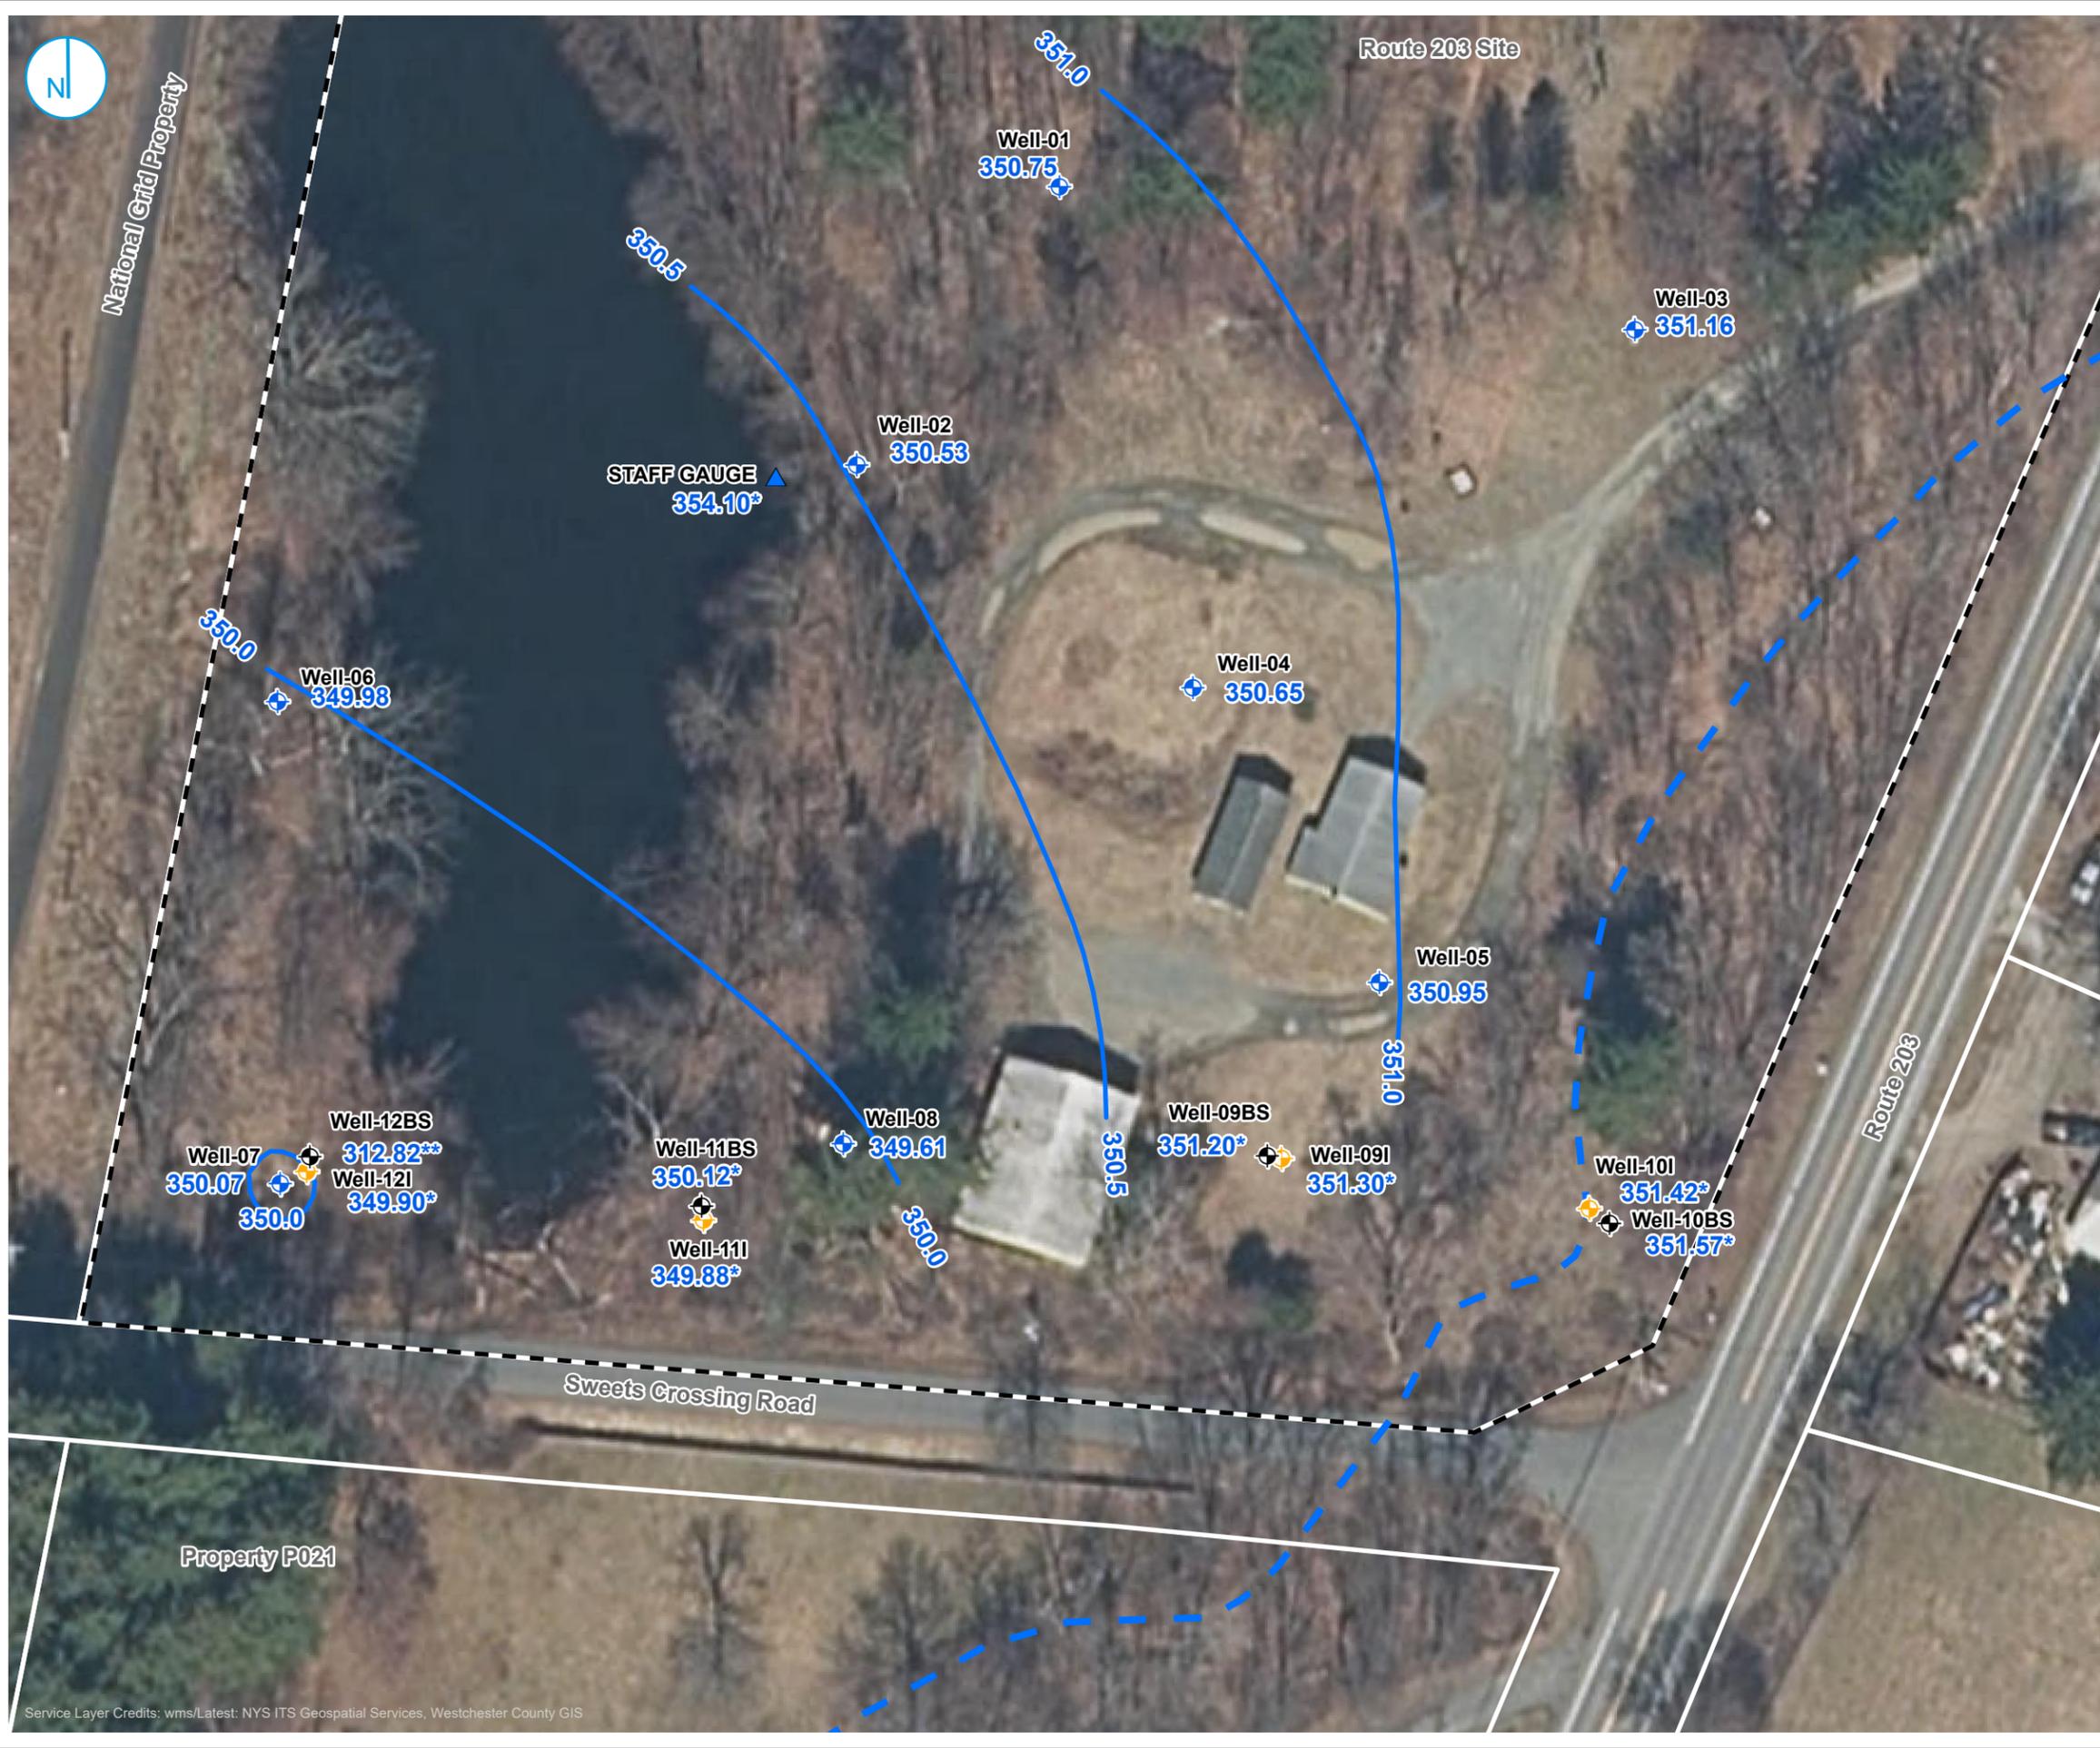
- Overburden Monitoring Well
- Deep Overburden Monitoring Well
- Bedrock Monitoring Well
- Staff Gauge
- Groundwater Contours - July 5, 2022
- Ephemeral Stream
- Route 203 Site

Notes:
 1. ** indicates the location was not used in contouring.
 2. *** indicates the location was not used in contouring and water level is artificially low due to slow well recovery.
 3. Rensselaer County parcel boundaries designated in white.

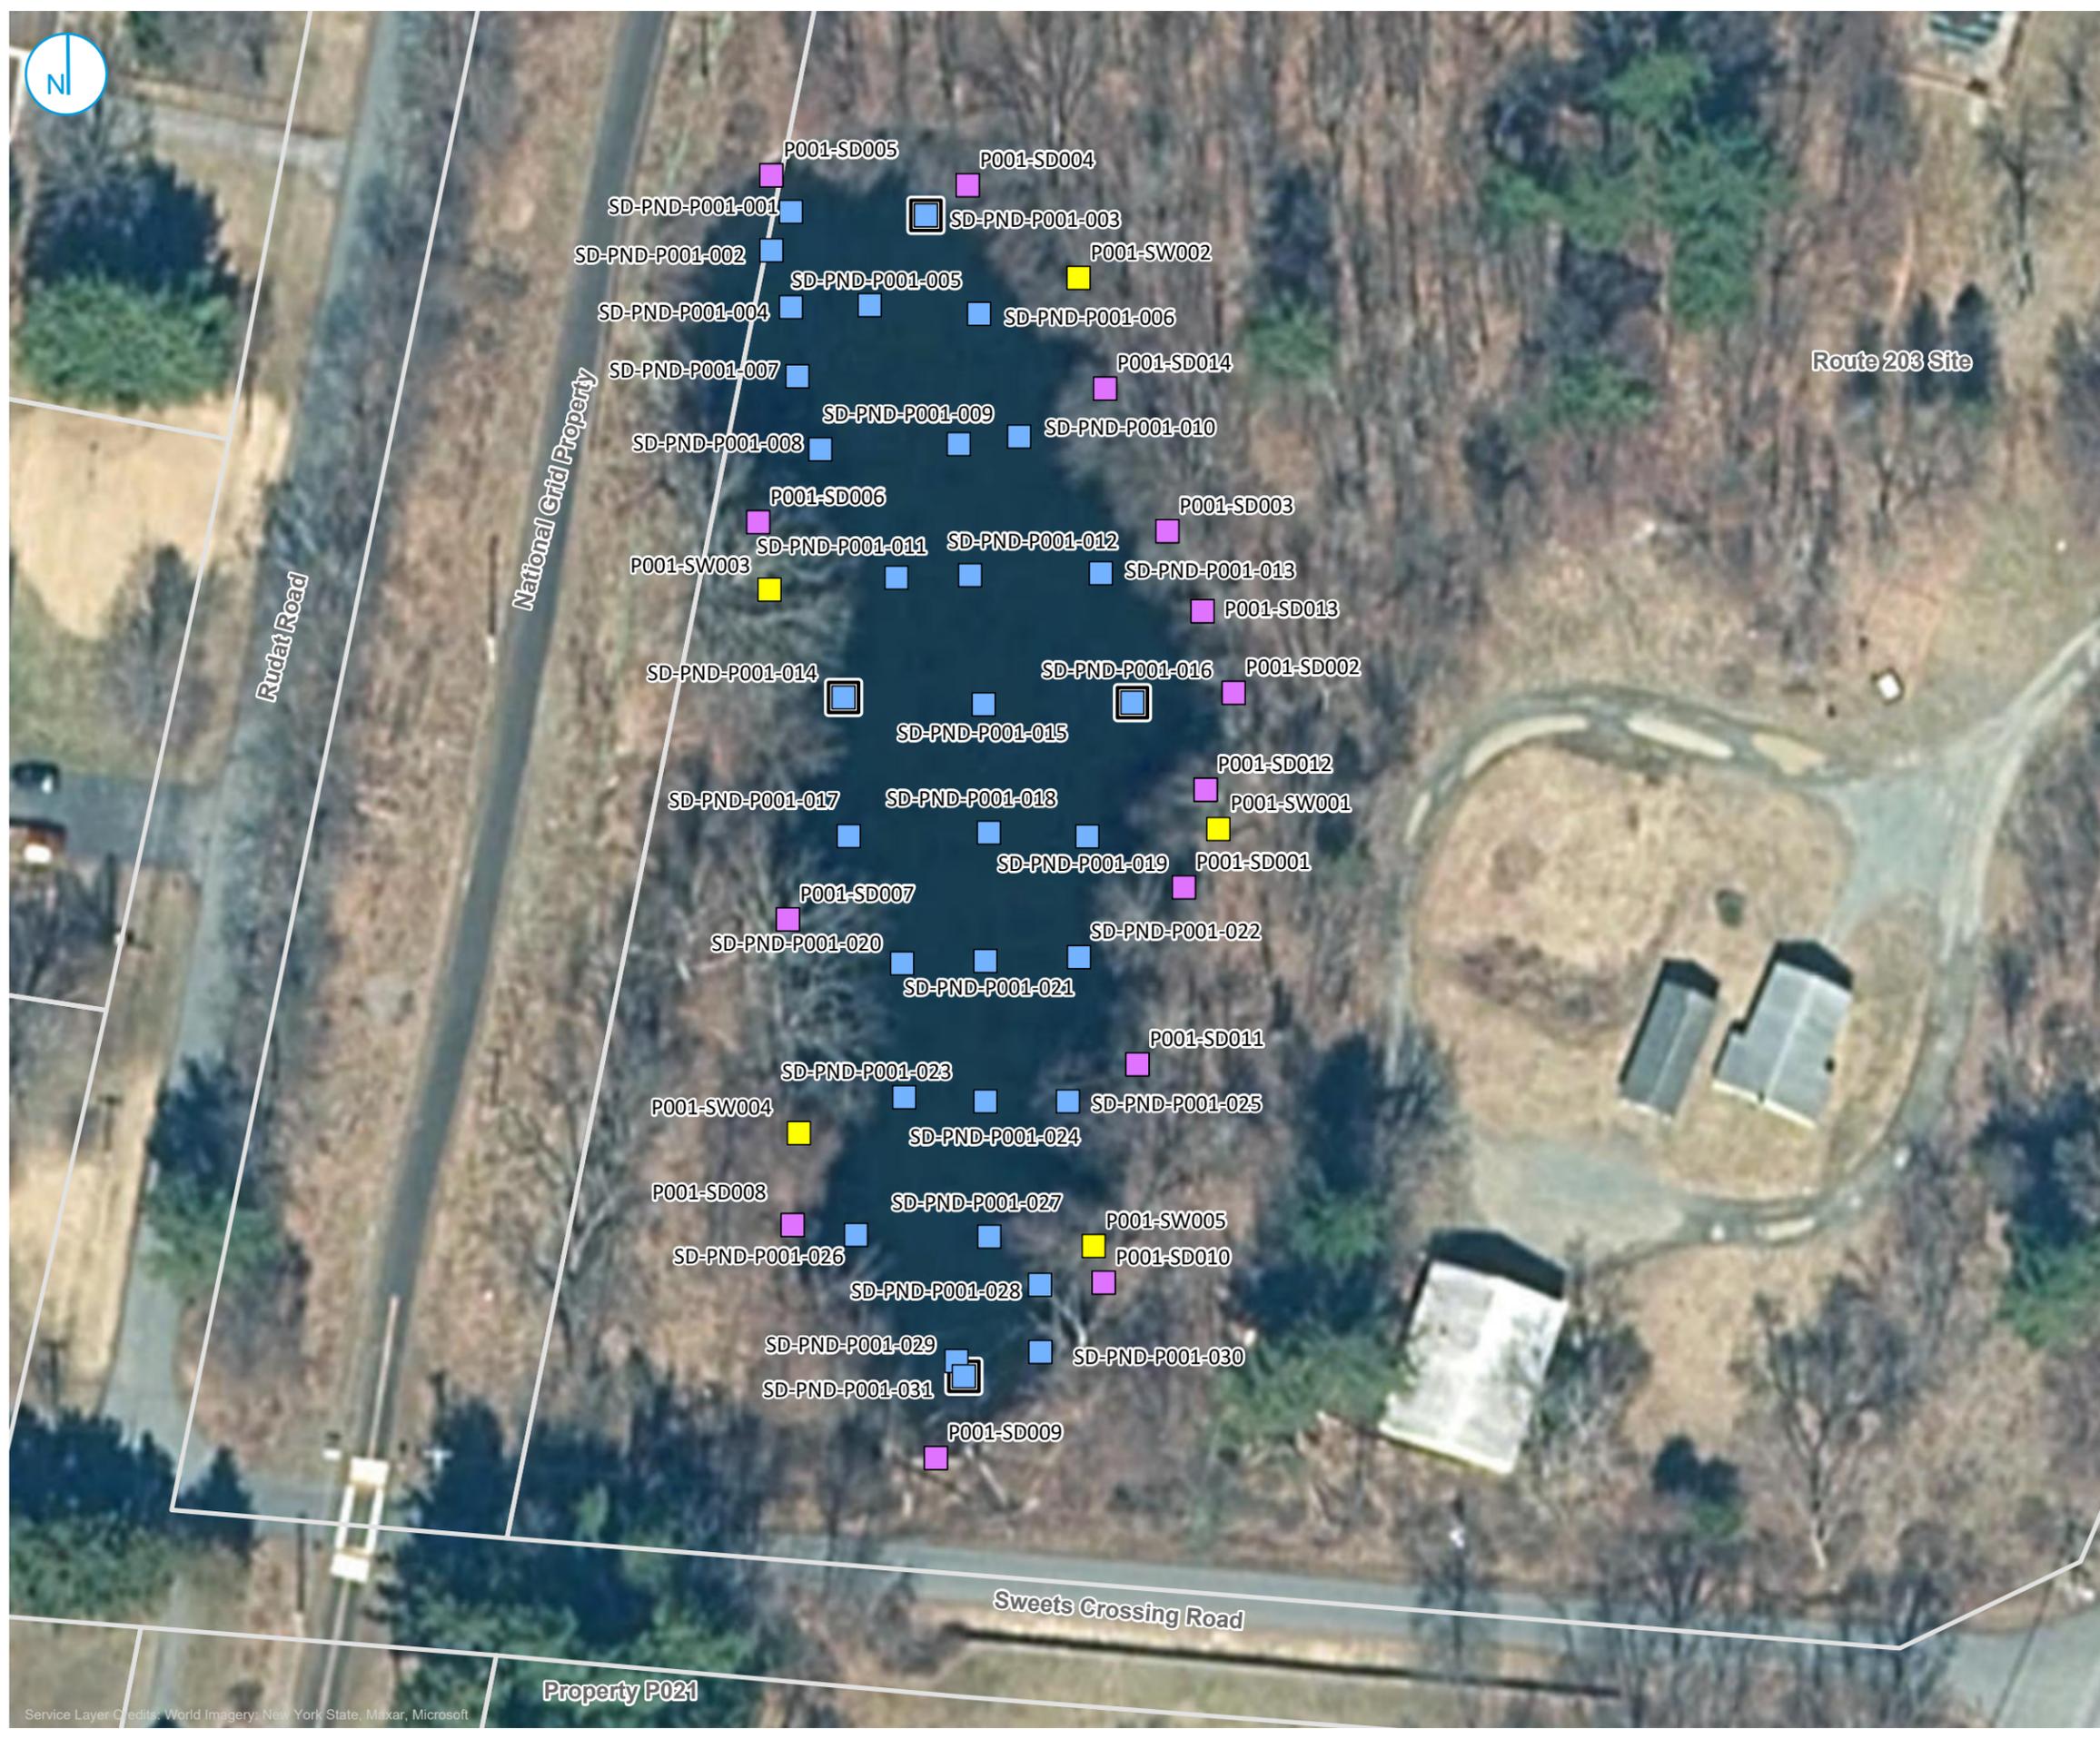
FIGURE 1-11

- USEPA Surface Water Sample Location
- USEPA Sediment Sample Location
- Removal Investigation Sediment Sample Location
- TCL/TAL Removal Investigation Sediment Sample Location
- Rensselaer County Parcel Boundary

Several VOCs were detected in one or more of the 30 sediment samples. BTEX compounds, cyclohexane and methylcyclohexane were commonly detected in the sediment samples. TCE and its biodegradation products cis-1,2-dichloroethene (cis-1,2-DCE) and vinyl chloride (VC) were not detected in any of the 30 sediment samples collected from the pond.

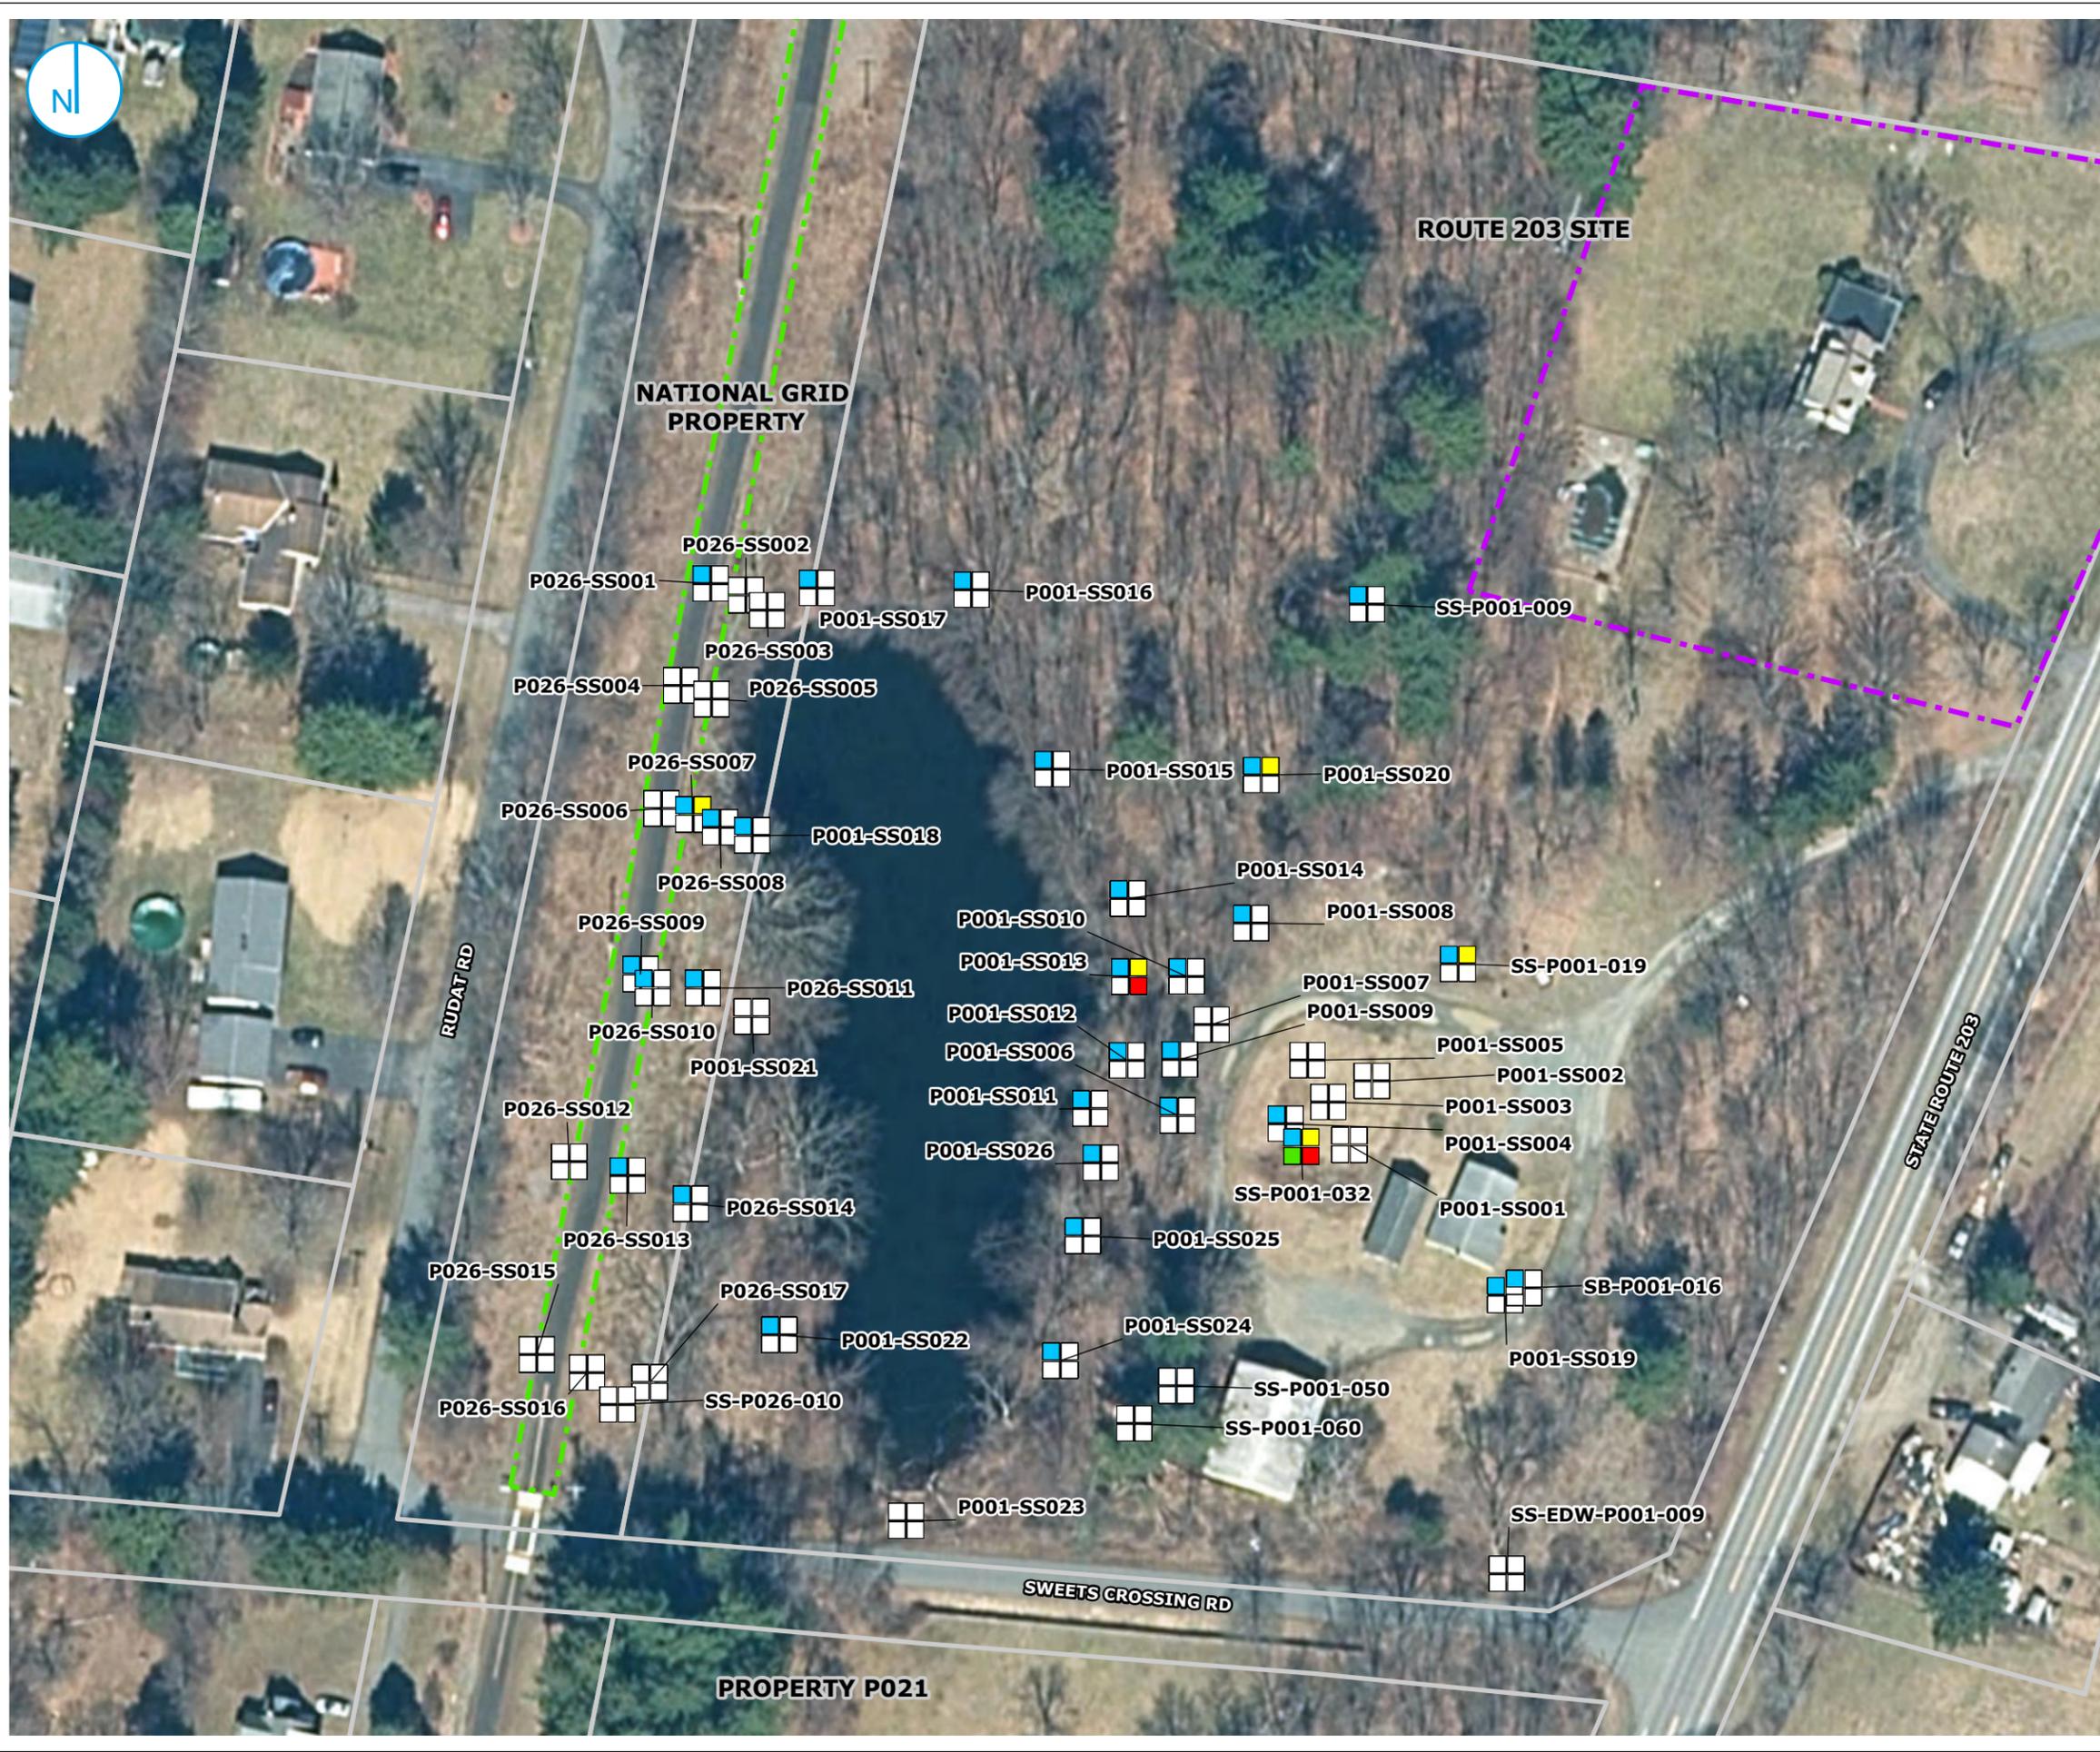
FIGURE 1-12a

- Notes:**
1. "VOC" indicates volatile organic compound.
 2. Surface soil designates all samples are collected from 0-2 feet below ground surface.
 3. Protection of groundwater, protection of ecological resources, commercial and industrial soil cleanup objectives (SCOs) are based on 6 NYCRR Part 375-6.8(b) restricted use SCOs.

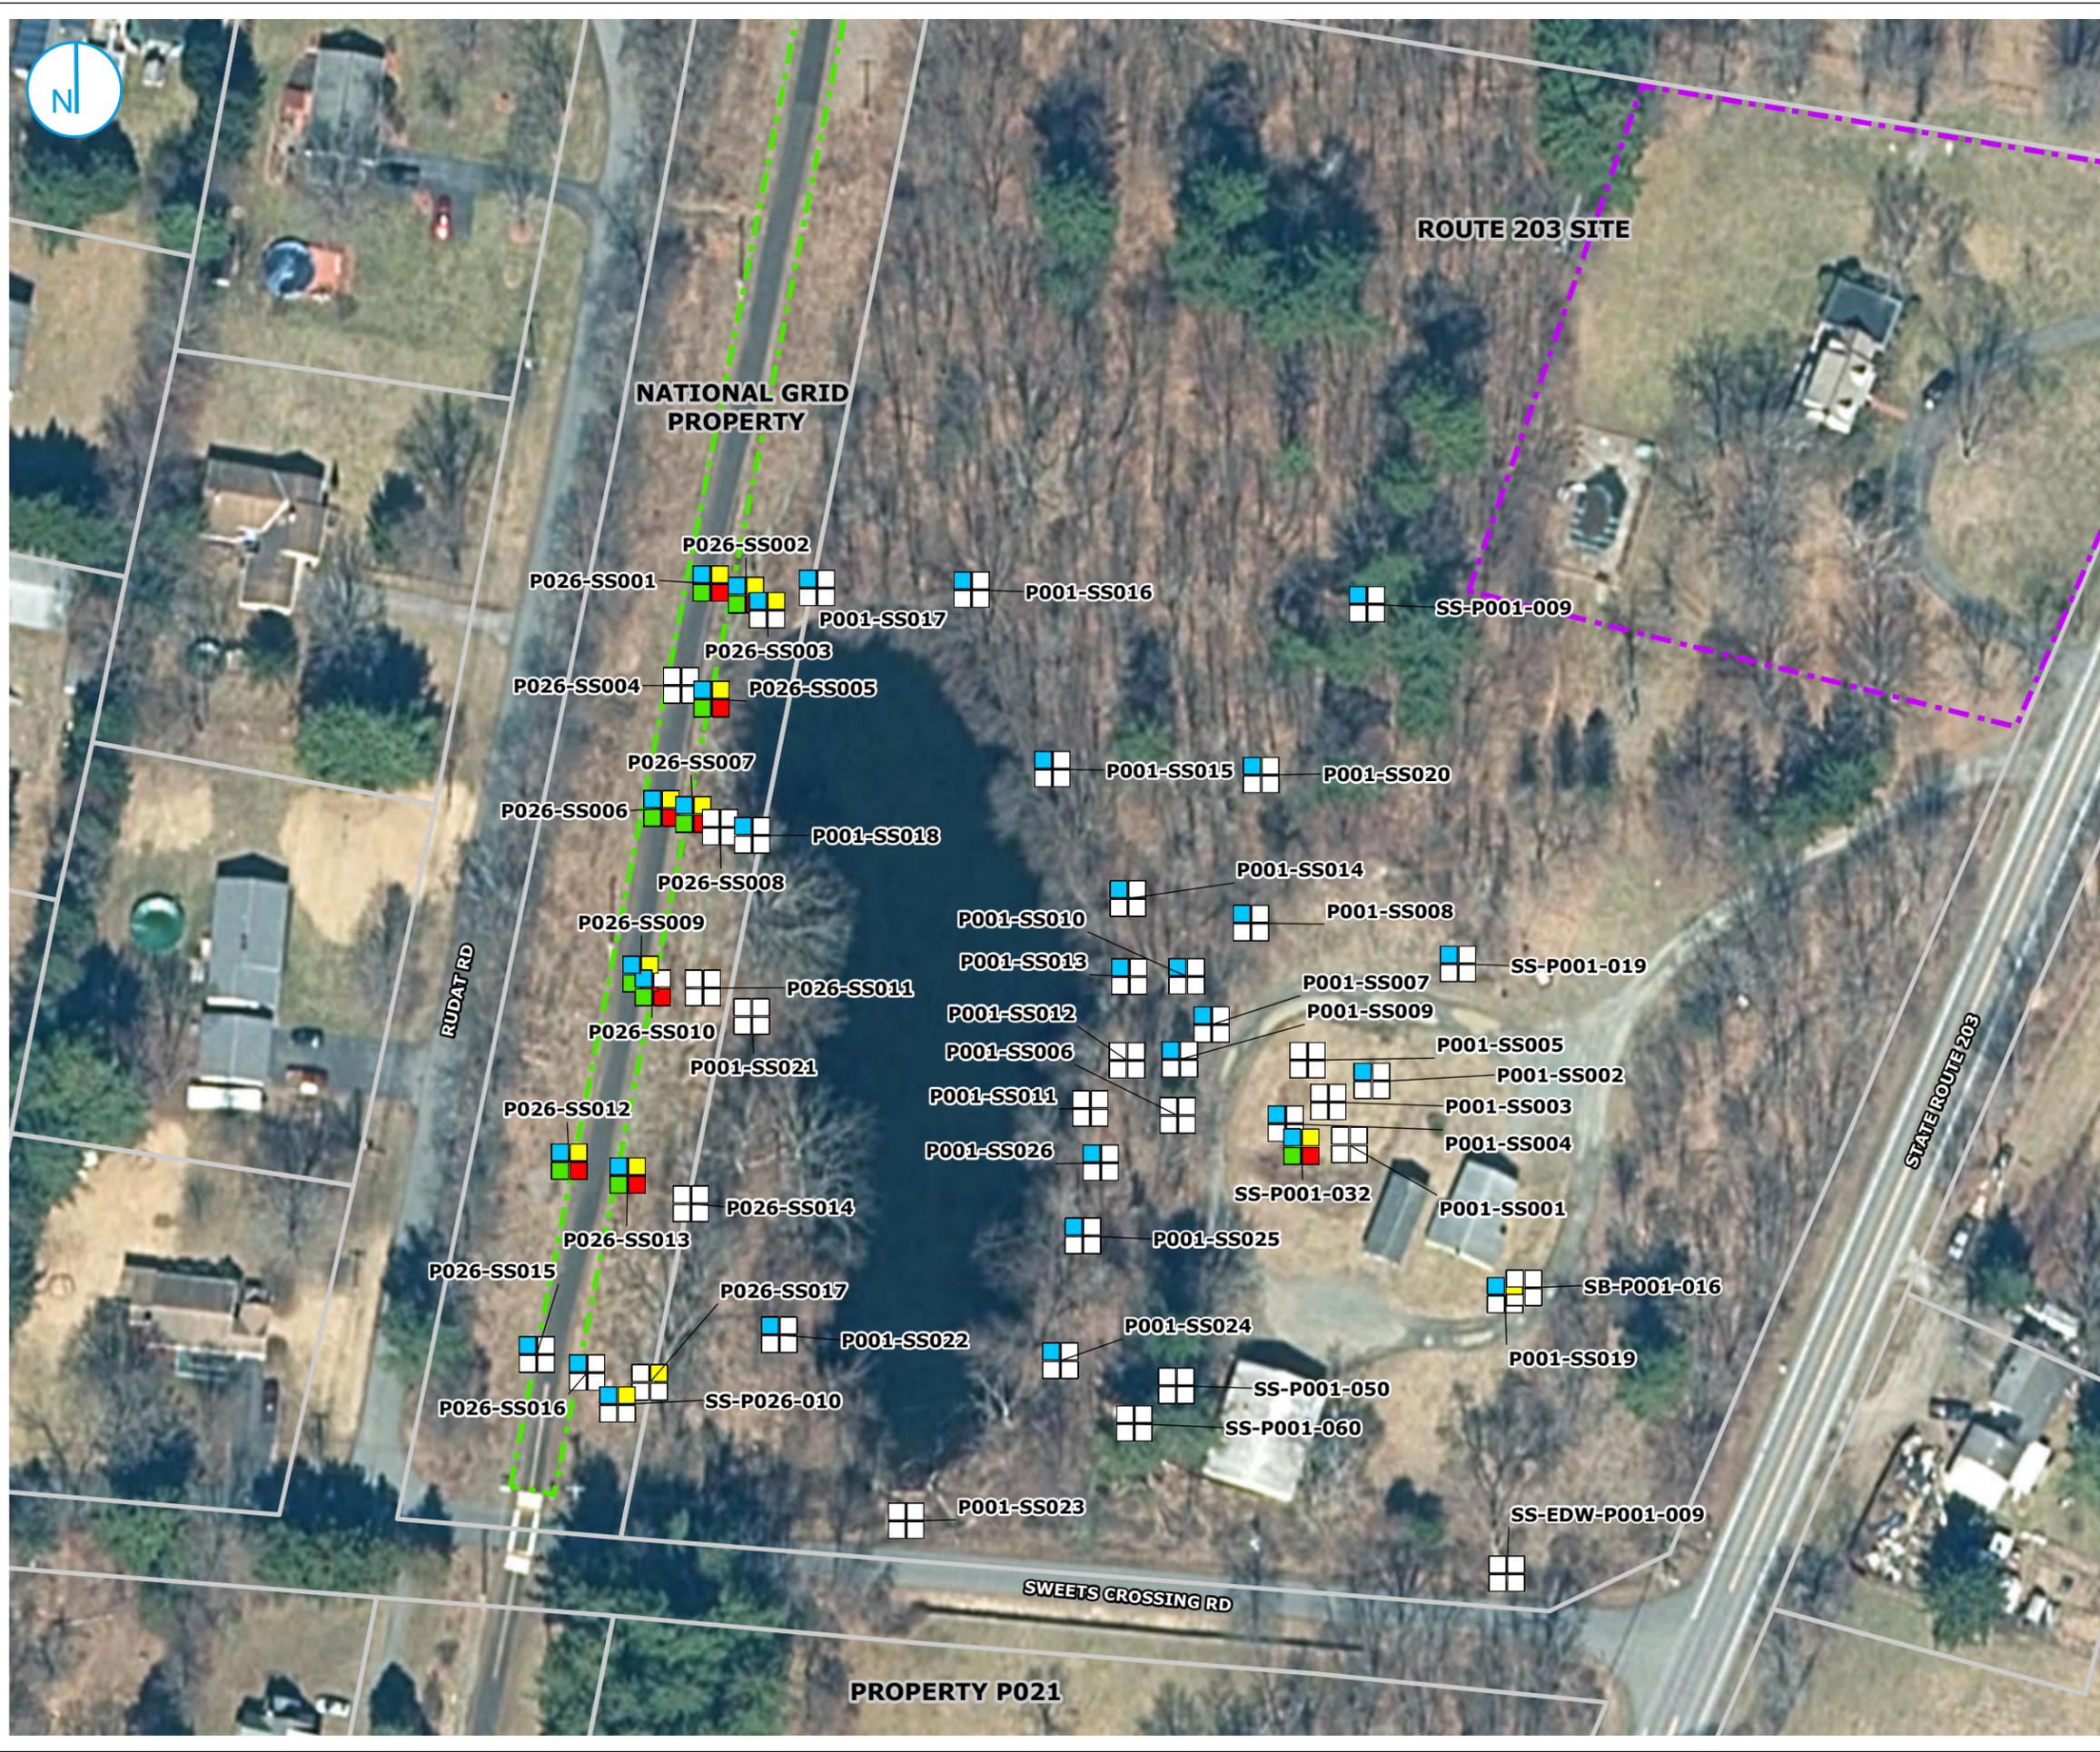
FIGURE 1-12b

- Notes:**
1. "SVOC" indicates semi-volatile organic compound.
 2. Surface soil designates all samples are collected from 0-2 feet below ground surface.
 3. Protection of groundwater, protection of ecological resources, commercial and industrial soil cleanup objectives (SCOs) are based on 6 NYCRR Part 375-6.8(b) restricted use SCOs.

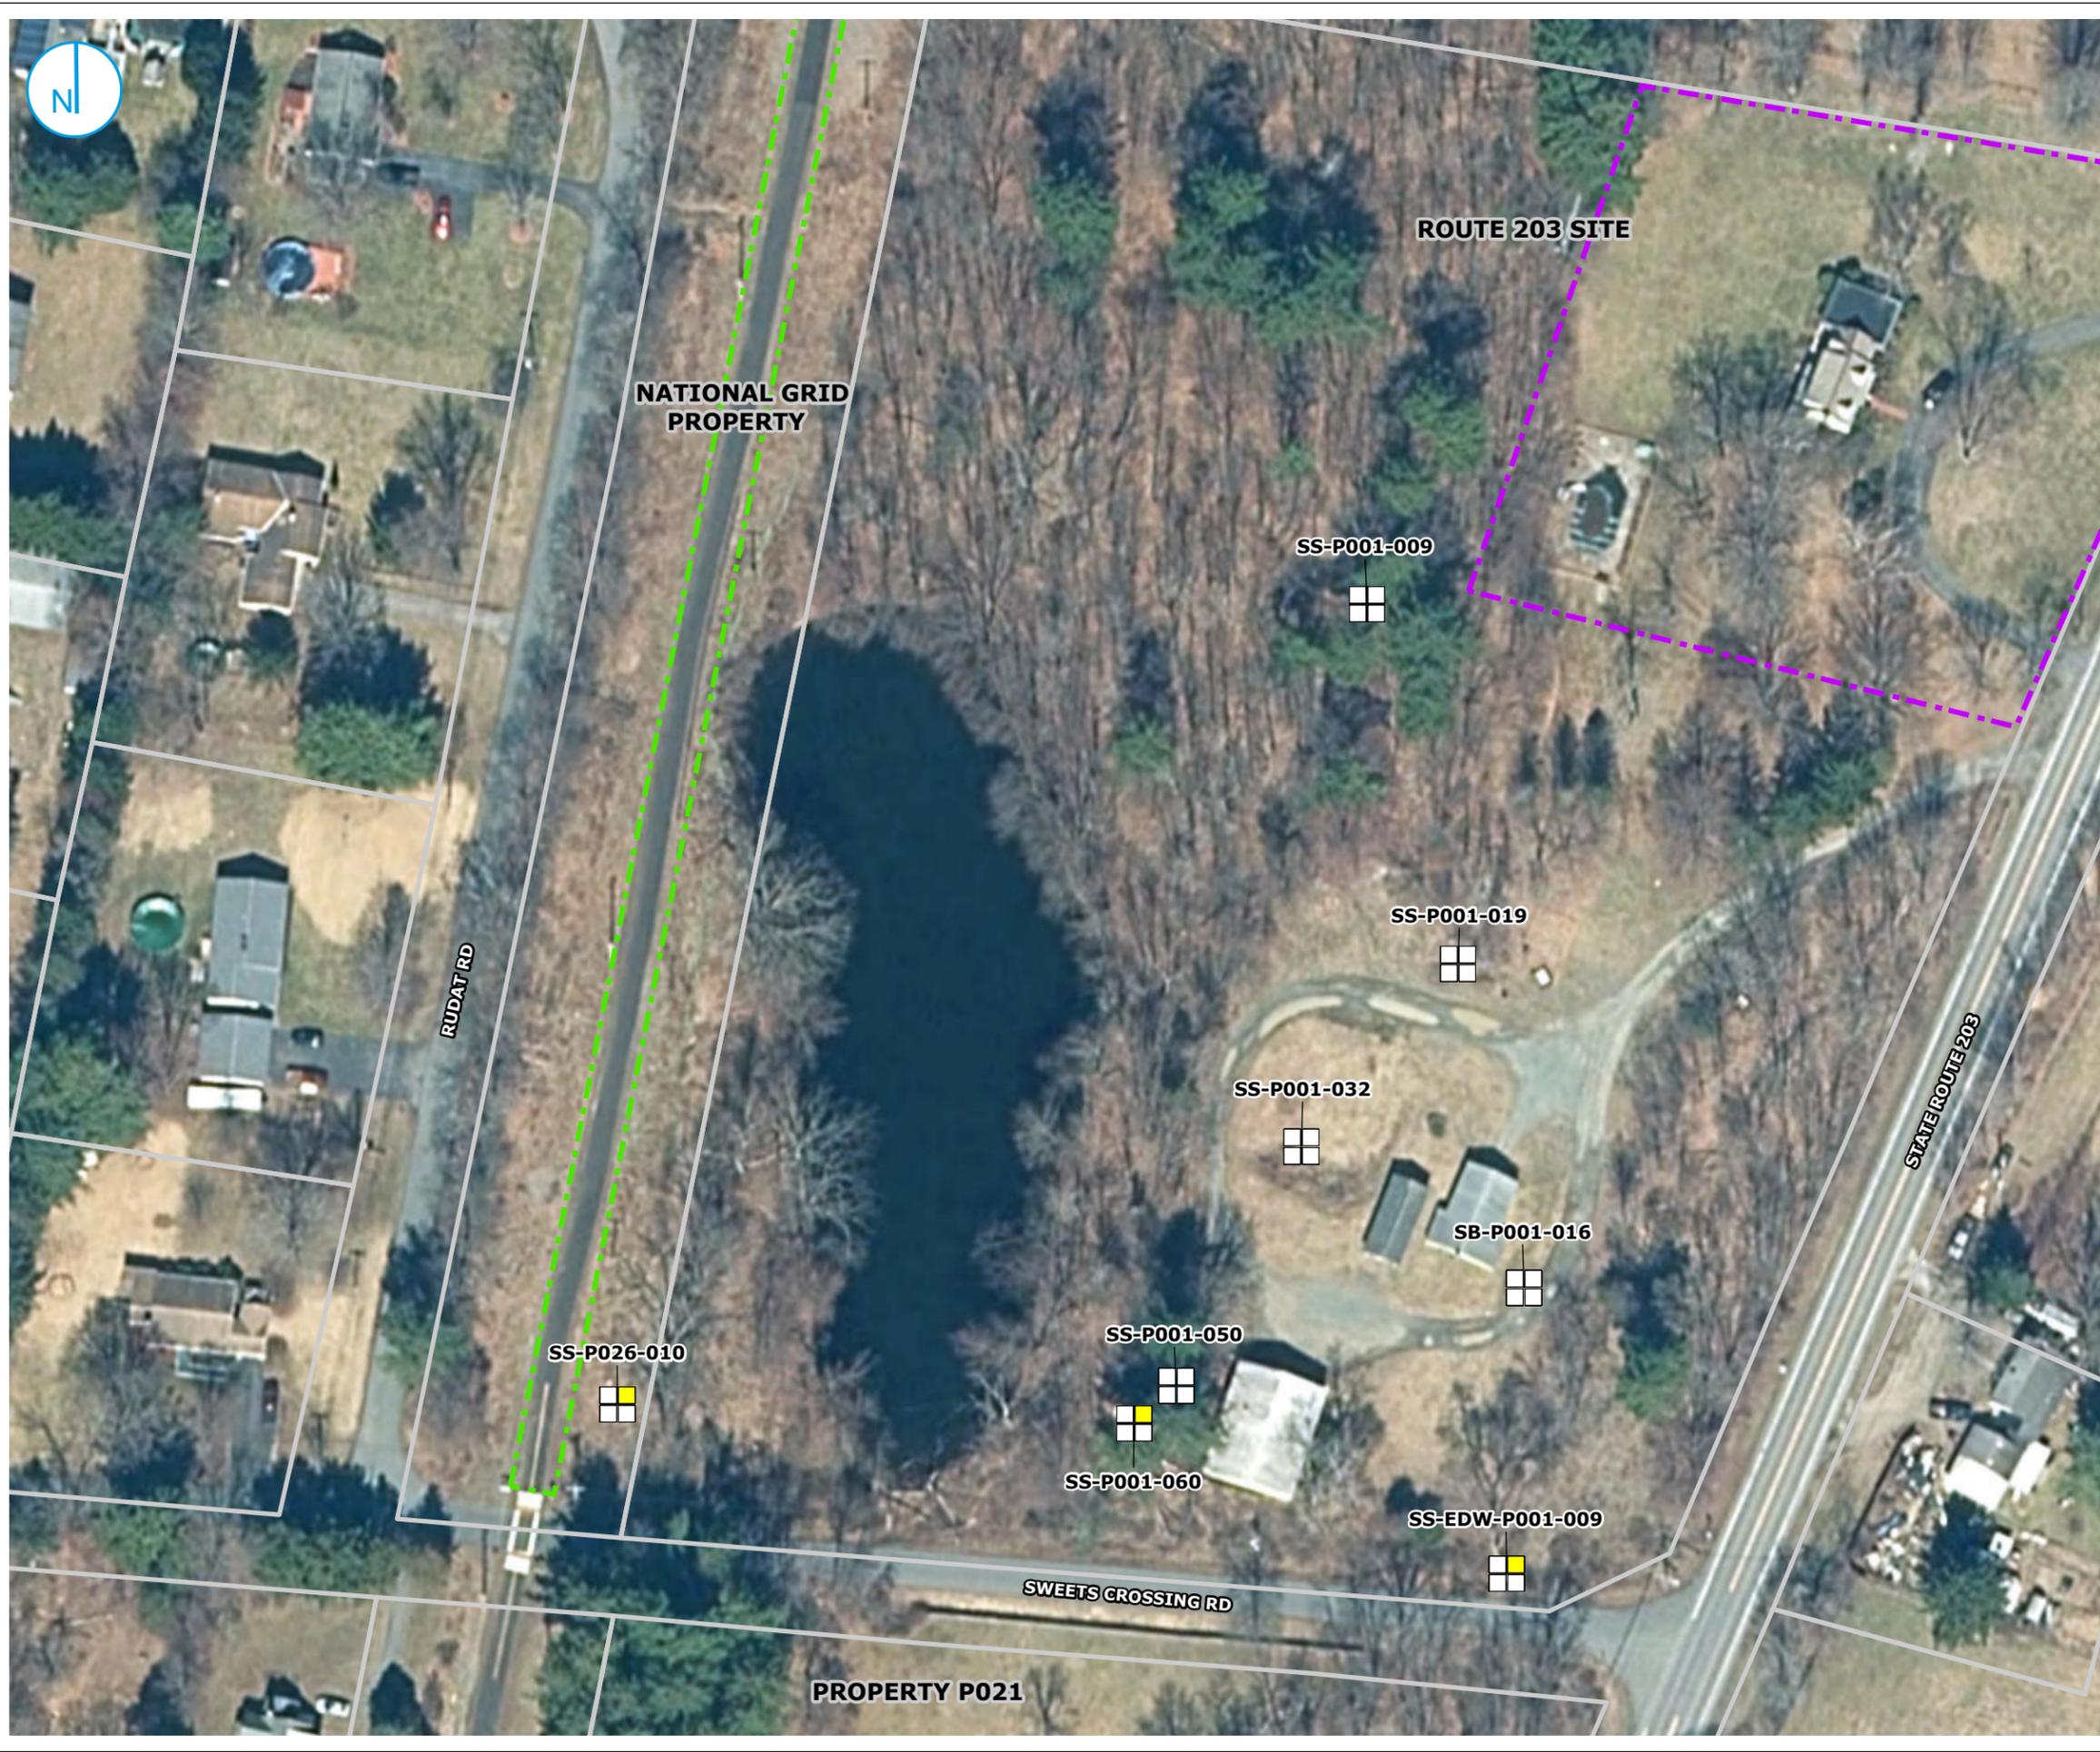
FIGURE 1-12c

EXCEEDS 6 NYCRR PART 375 SCOs
