Route 203 Site

Nassau, New York

NYSDEC Site No.: 442064

INVESTIGATION/ FEASIBILITY STUDY WORK PLAN ROUTE 203 SITE

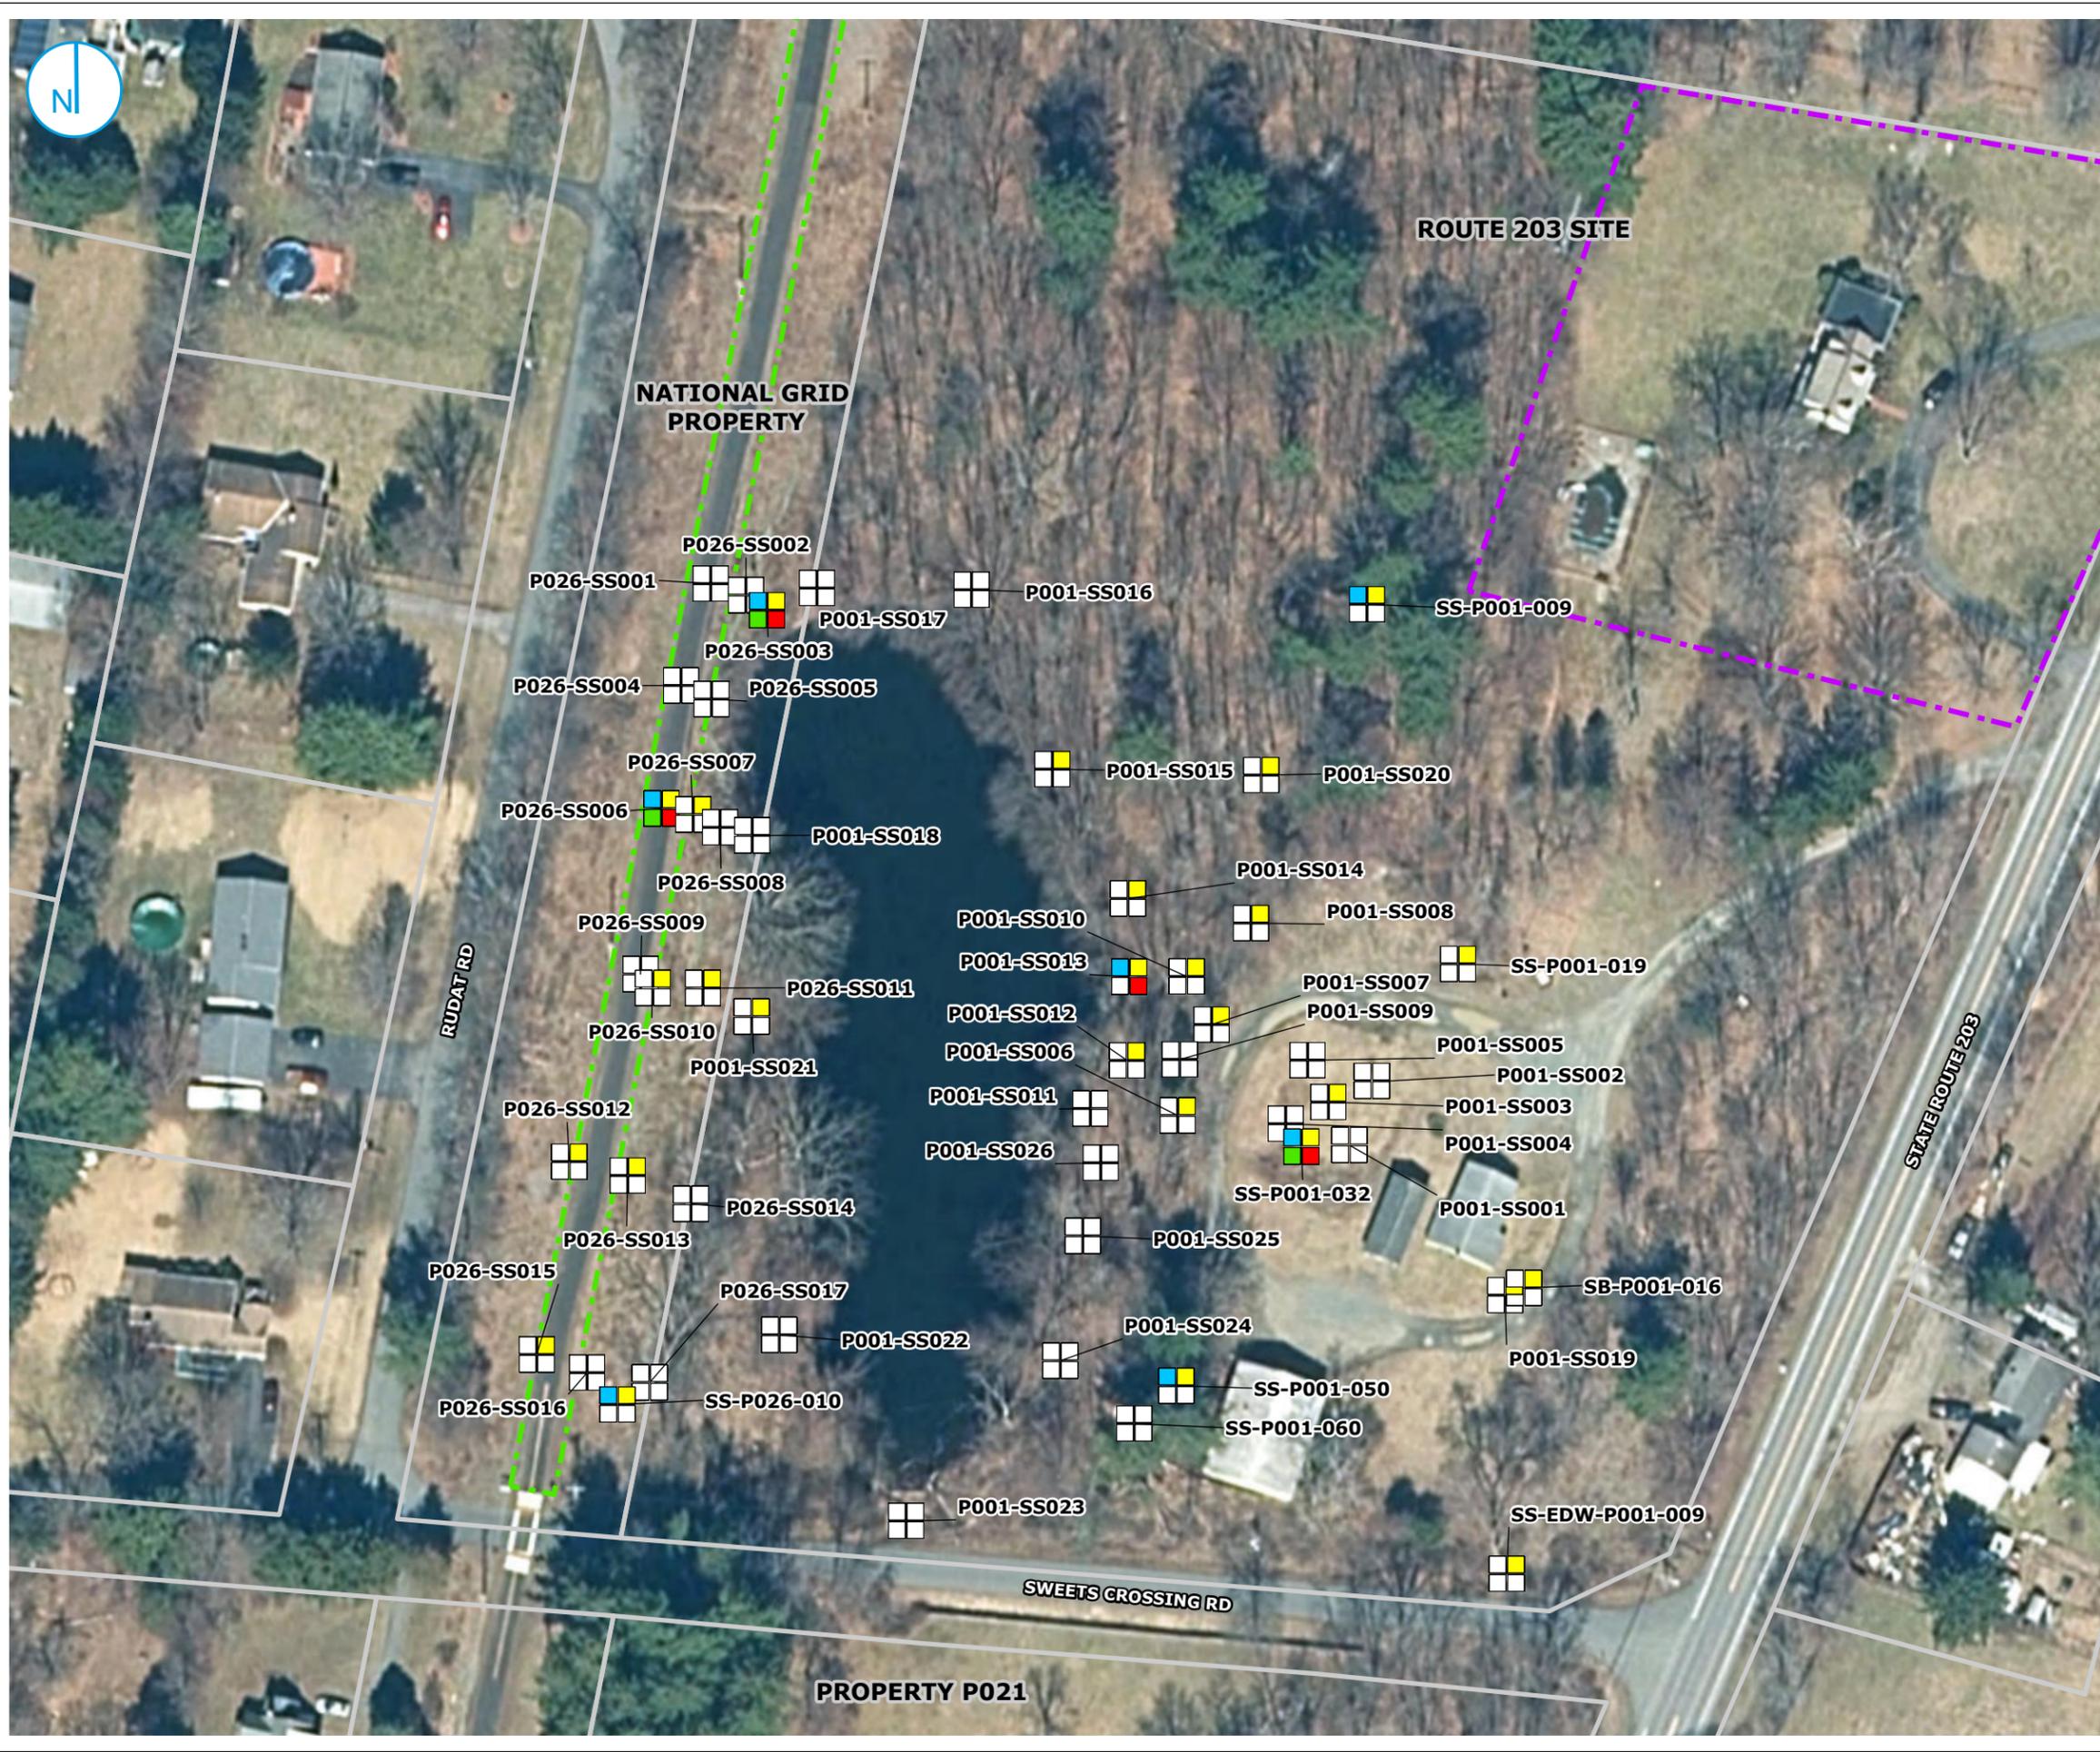
FIGURE 1-12d

EXCEEDS 6 NYCRR PART 375 SCOs

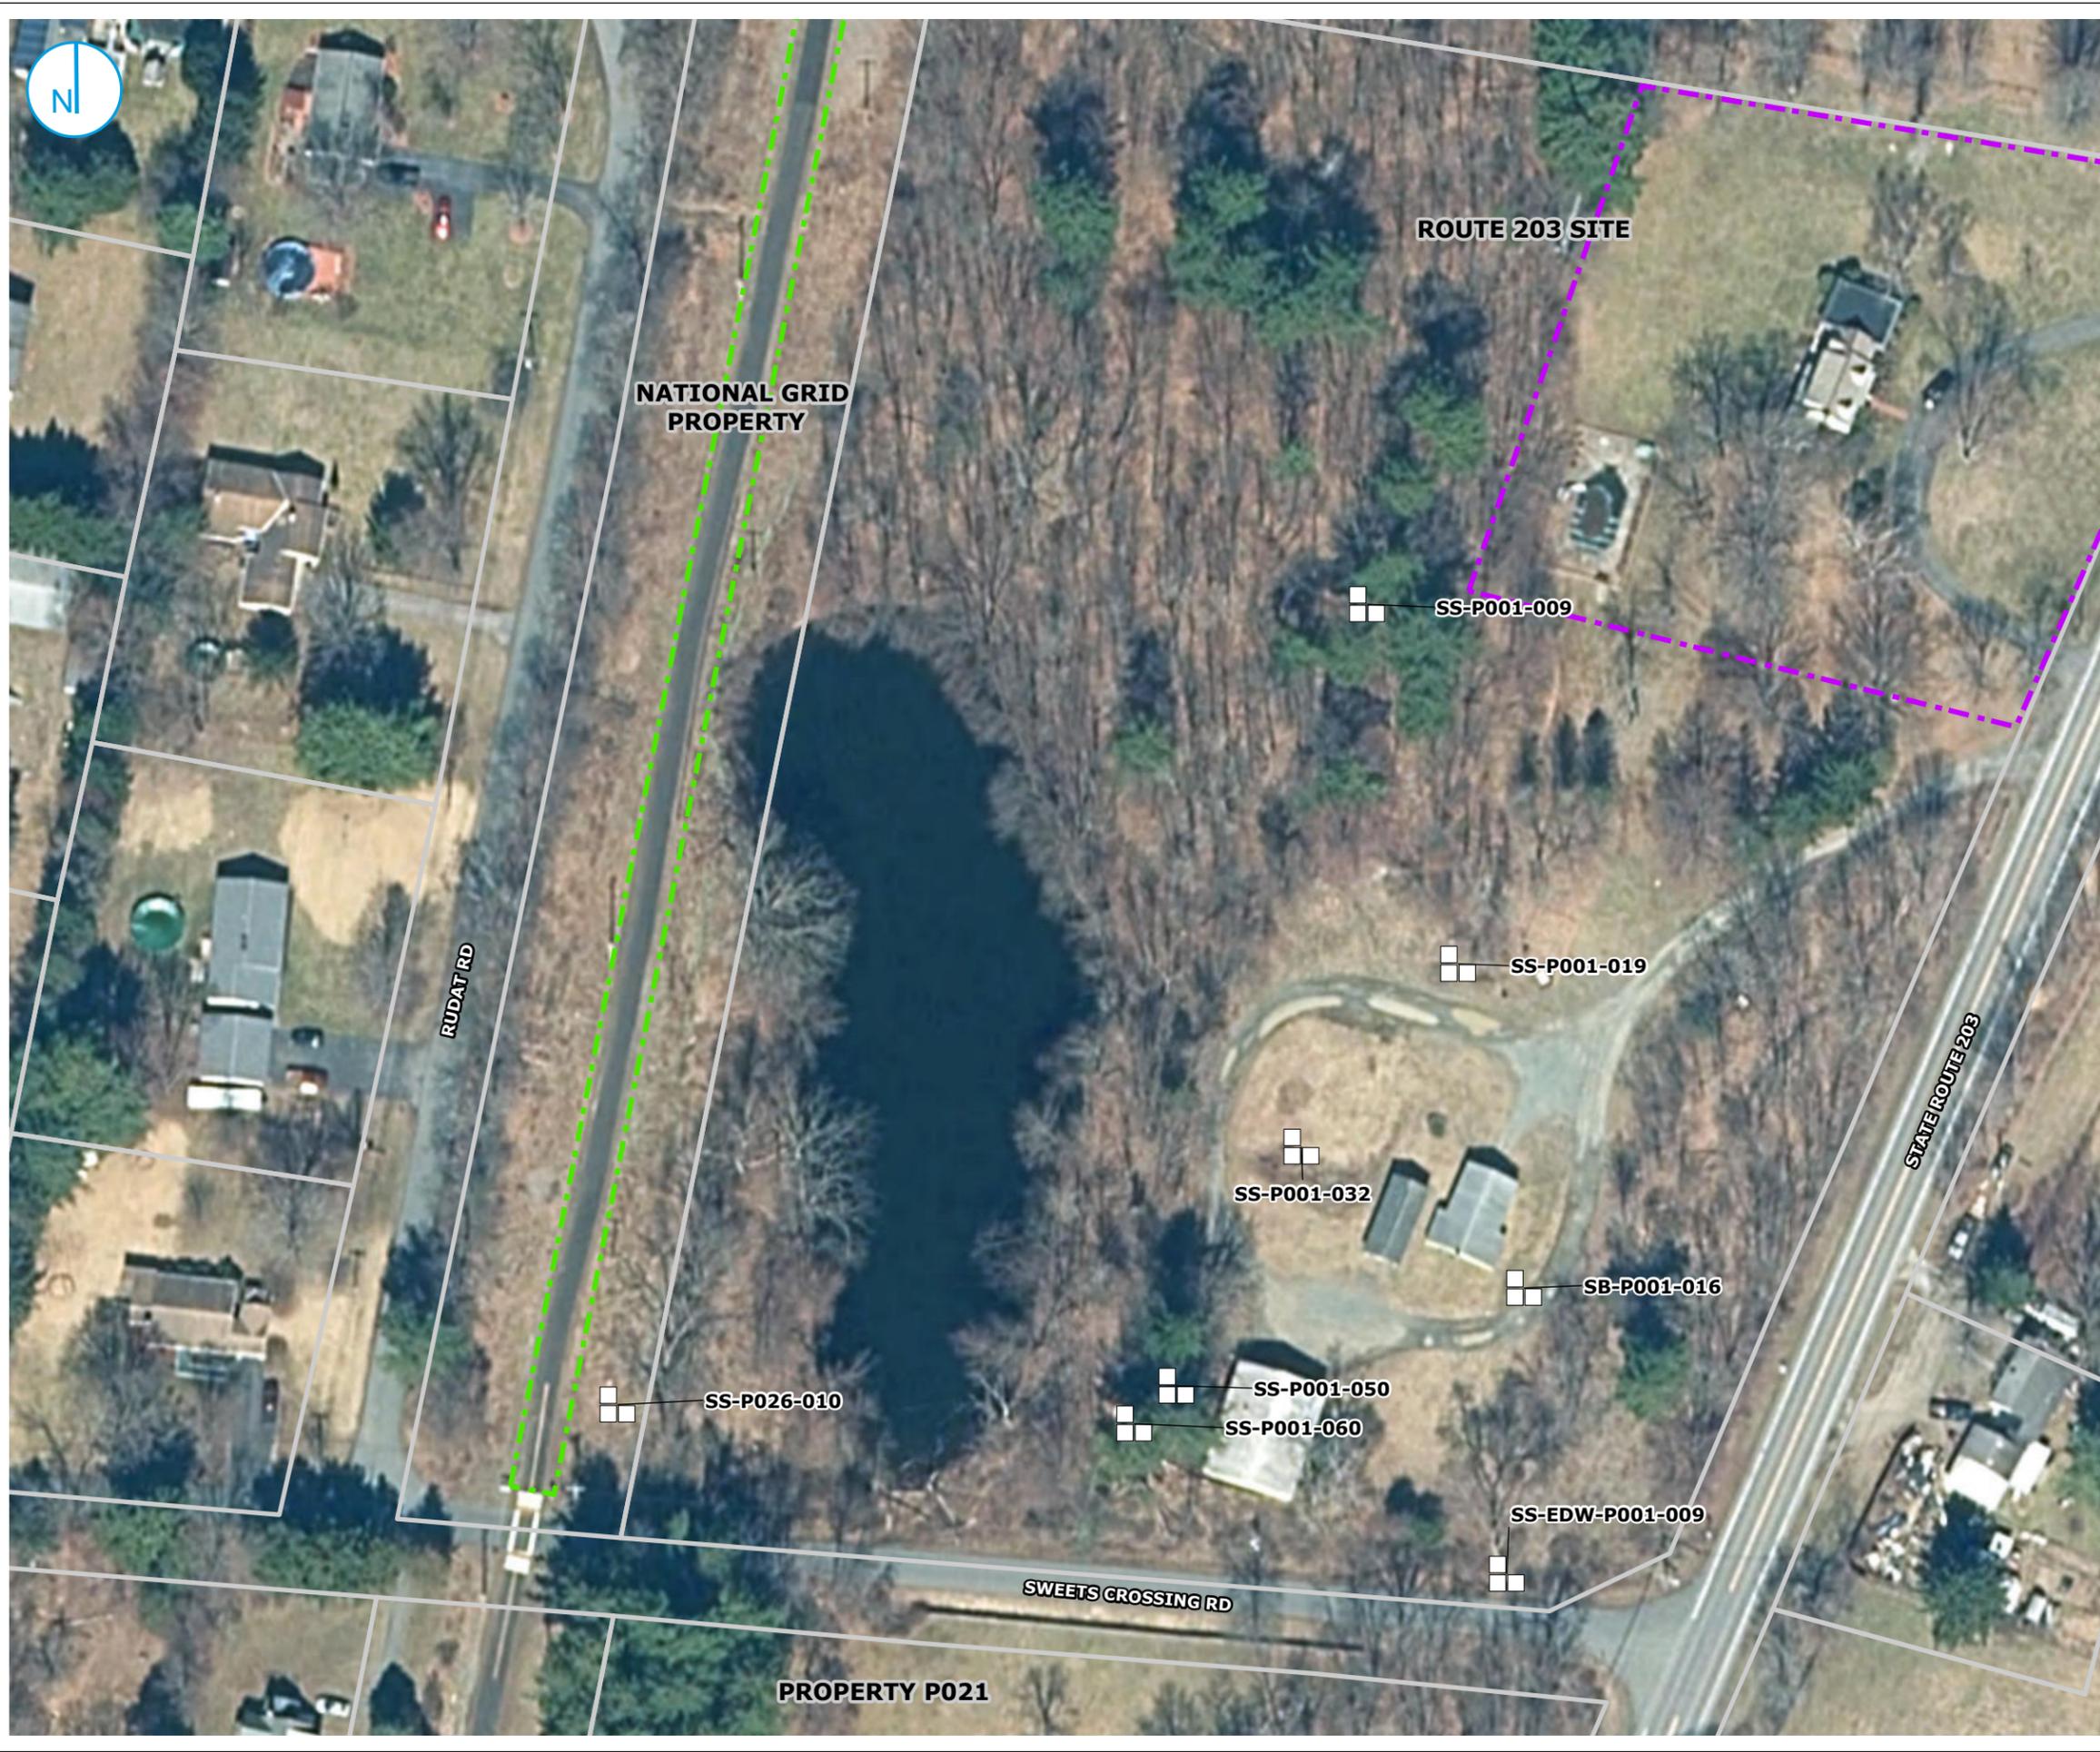
FIGURE 1-12f

EXCEEDS 6 NYCRR PART 375 SCOs

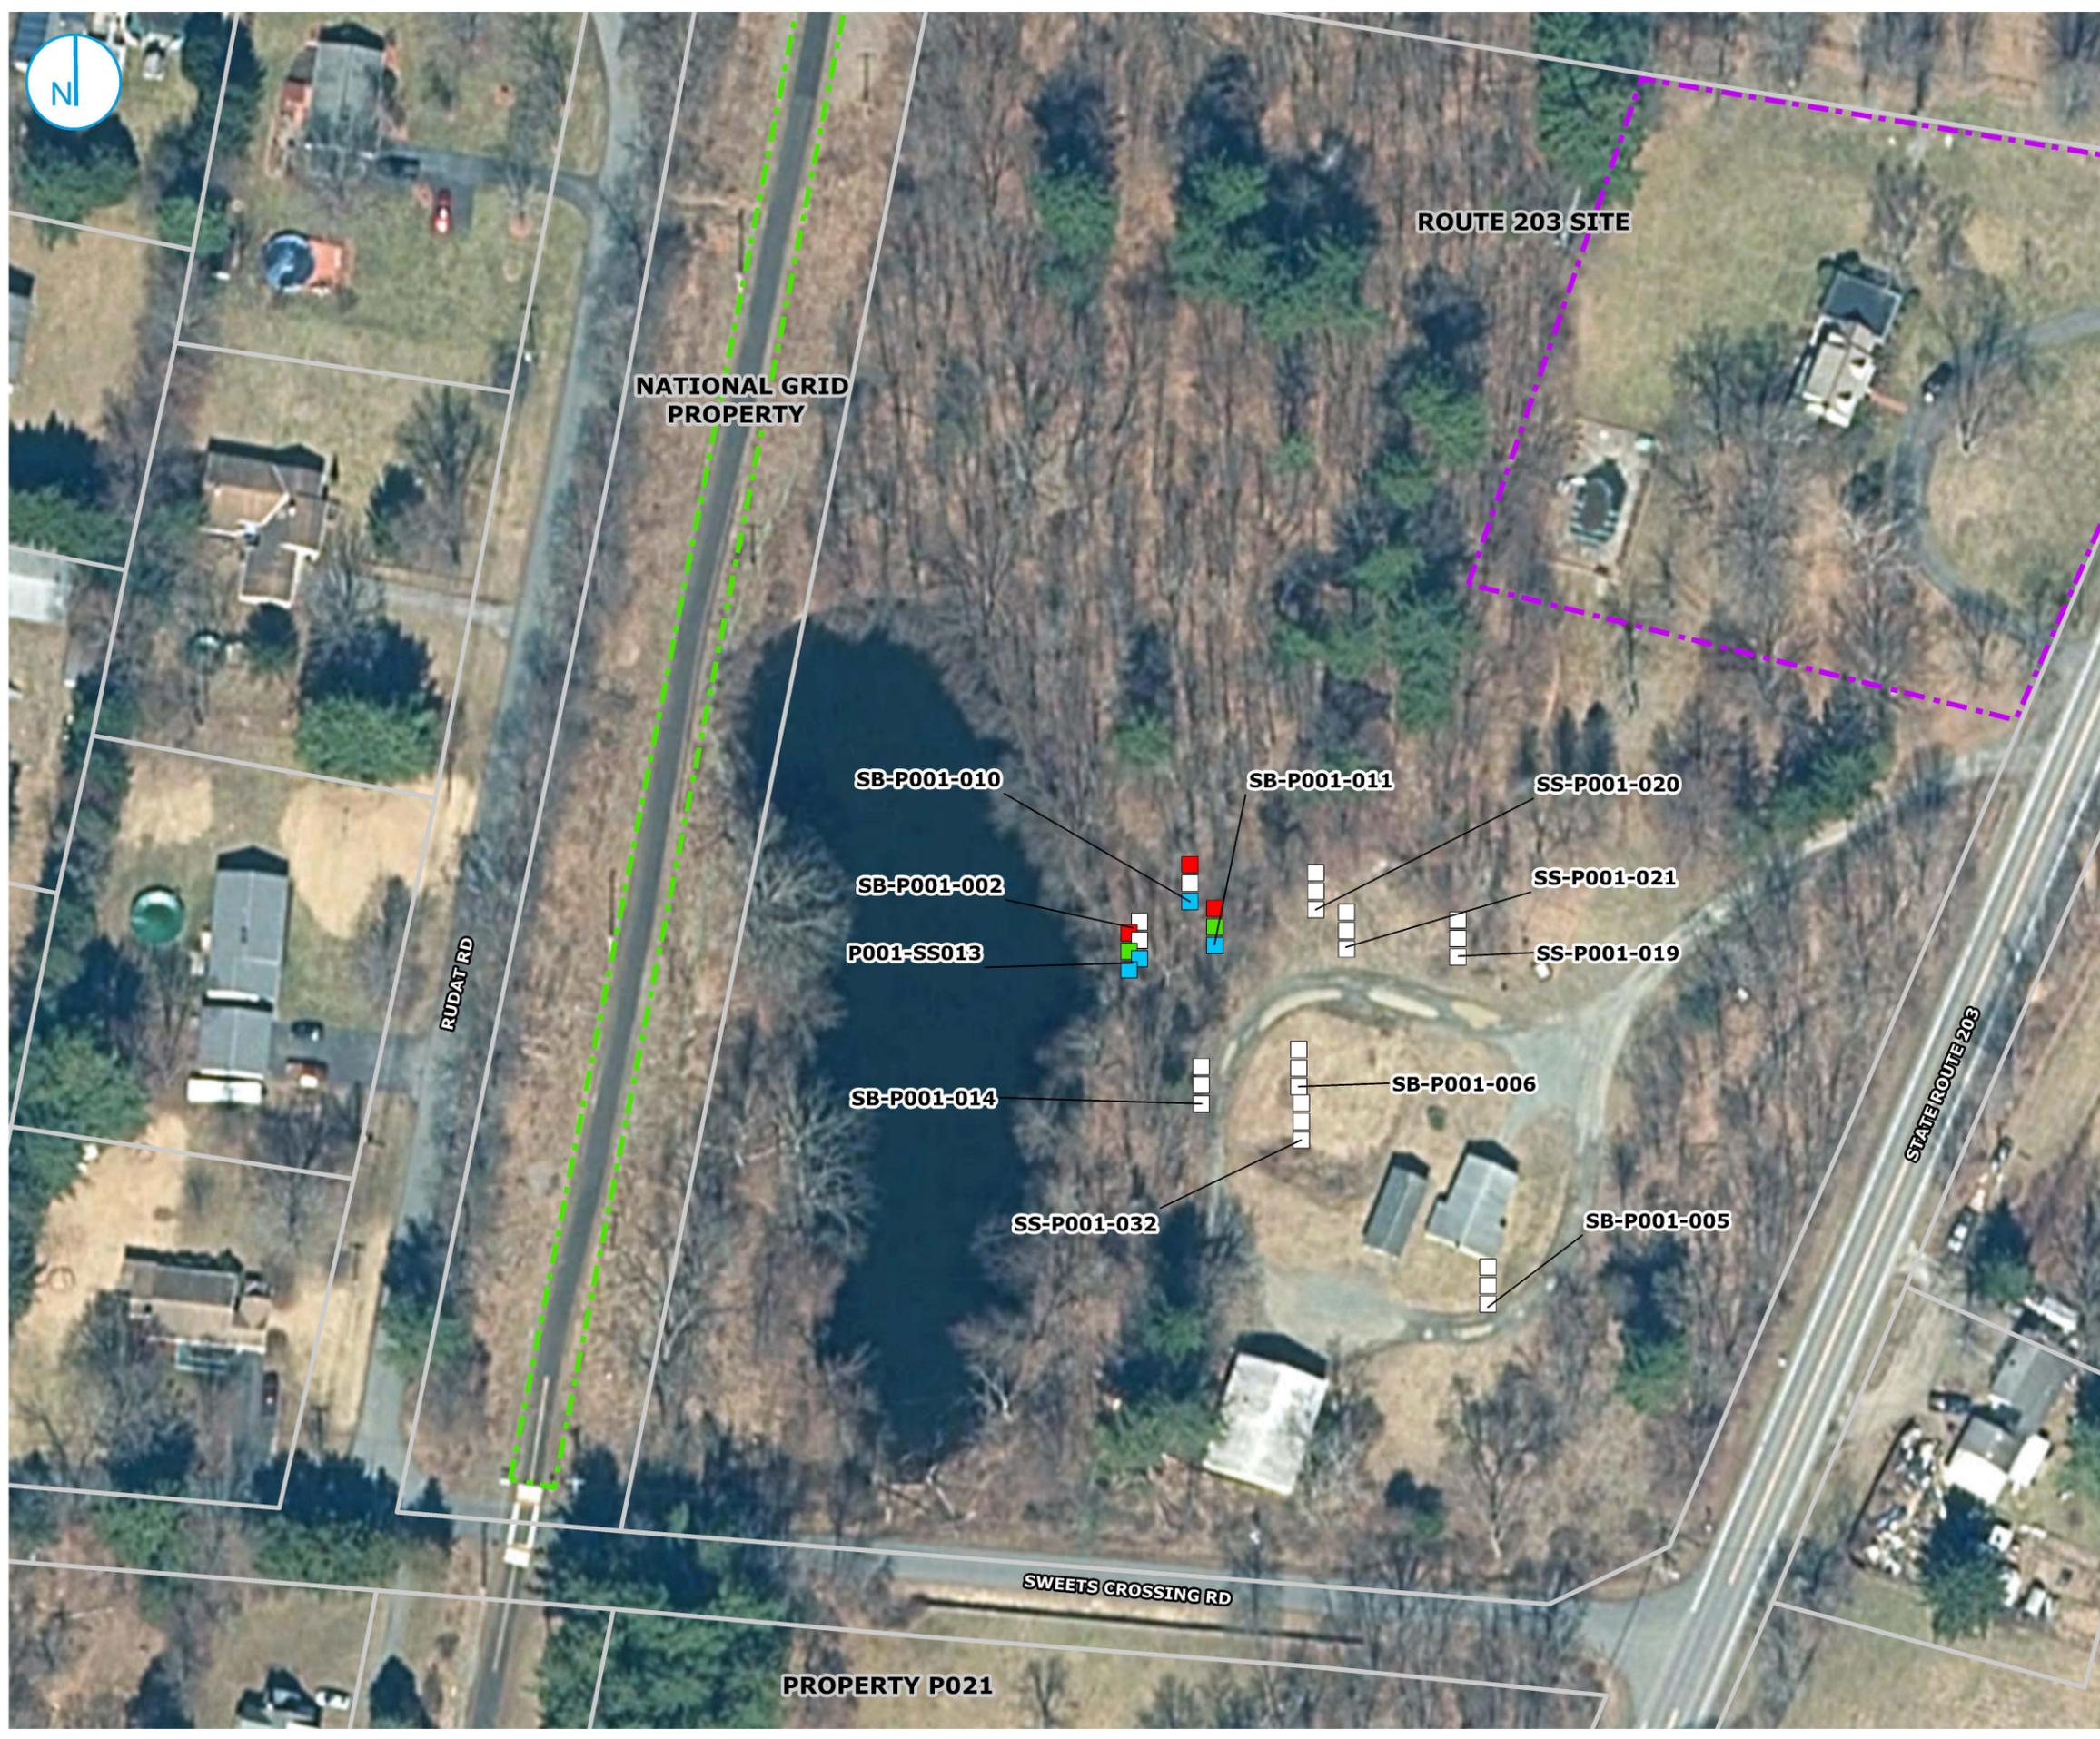
FIGURE 1-12g

EXCEEDS 6 NYCRR PART 375 SCOs

INDUSTRIAL COMMERCIAL
 PROTECTION OF GROUNDWATER

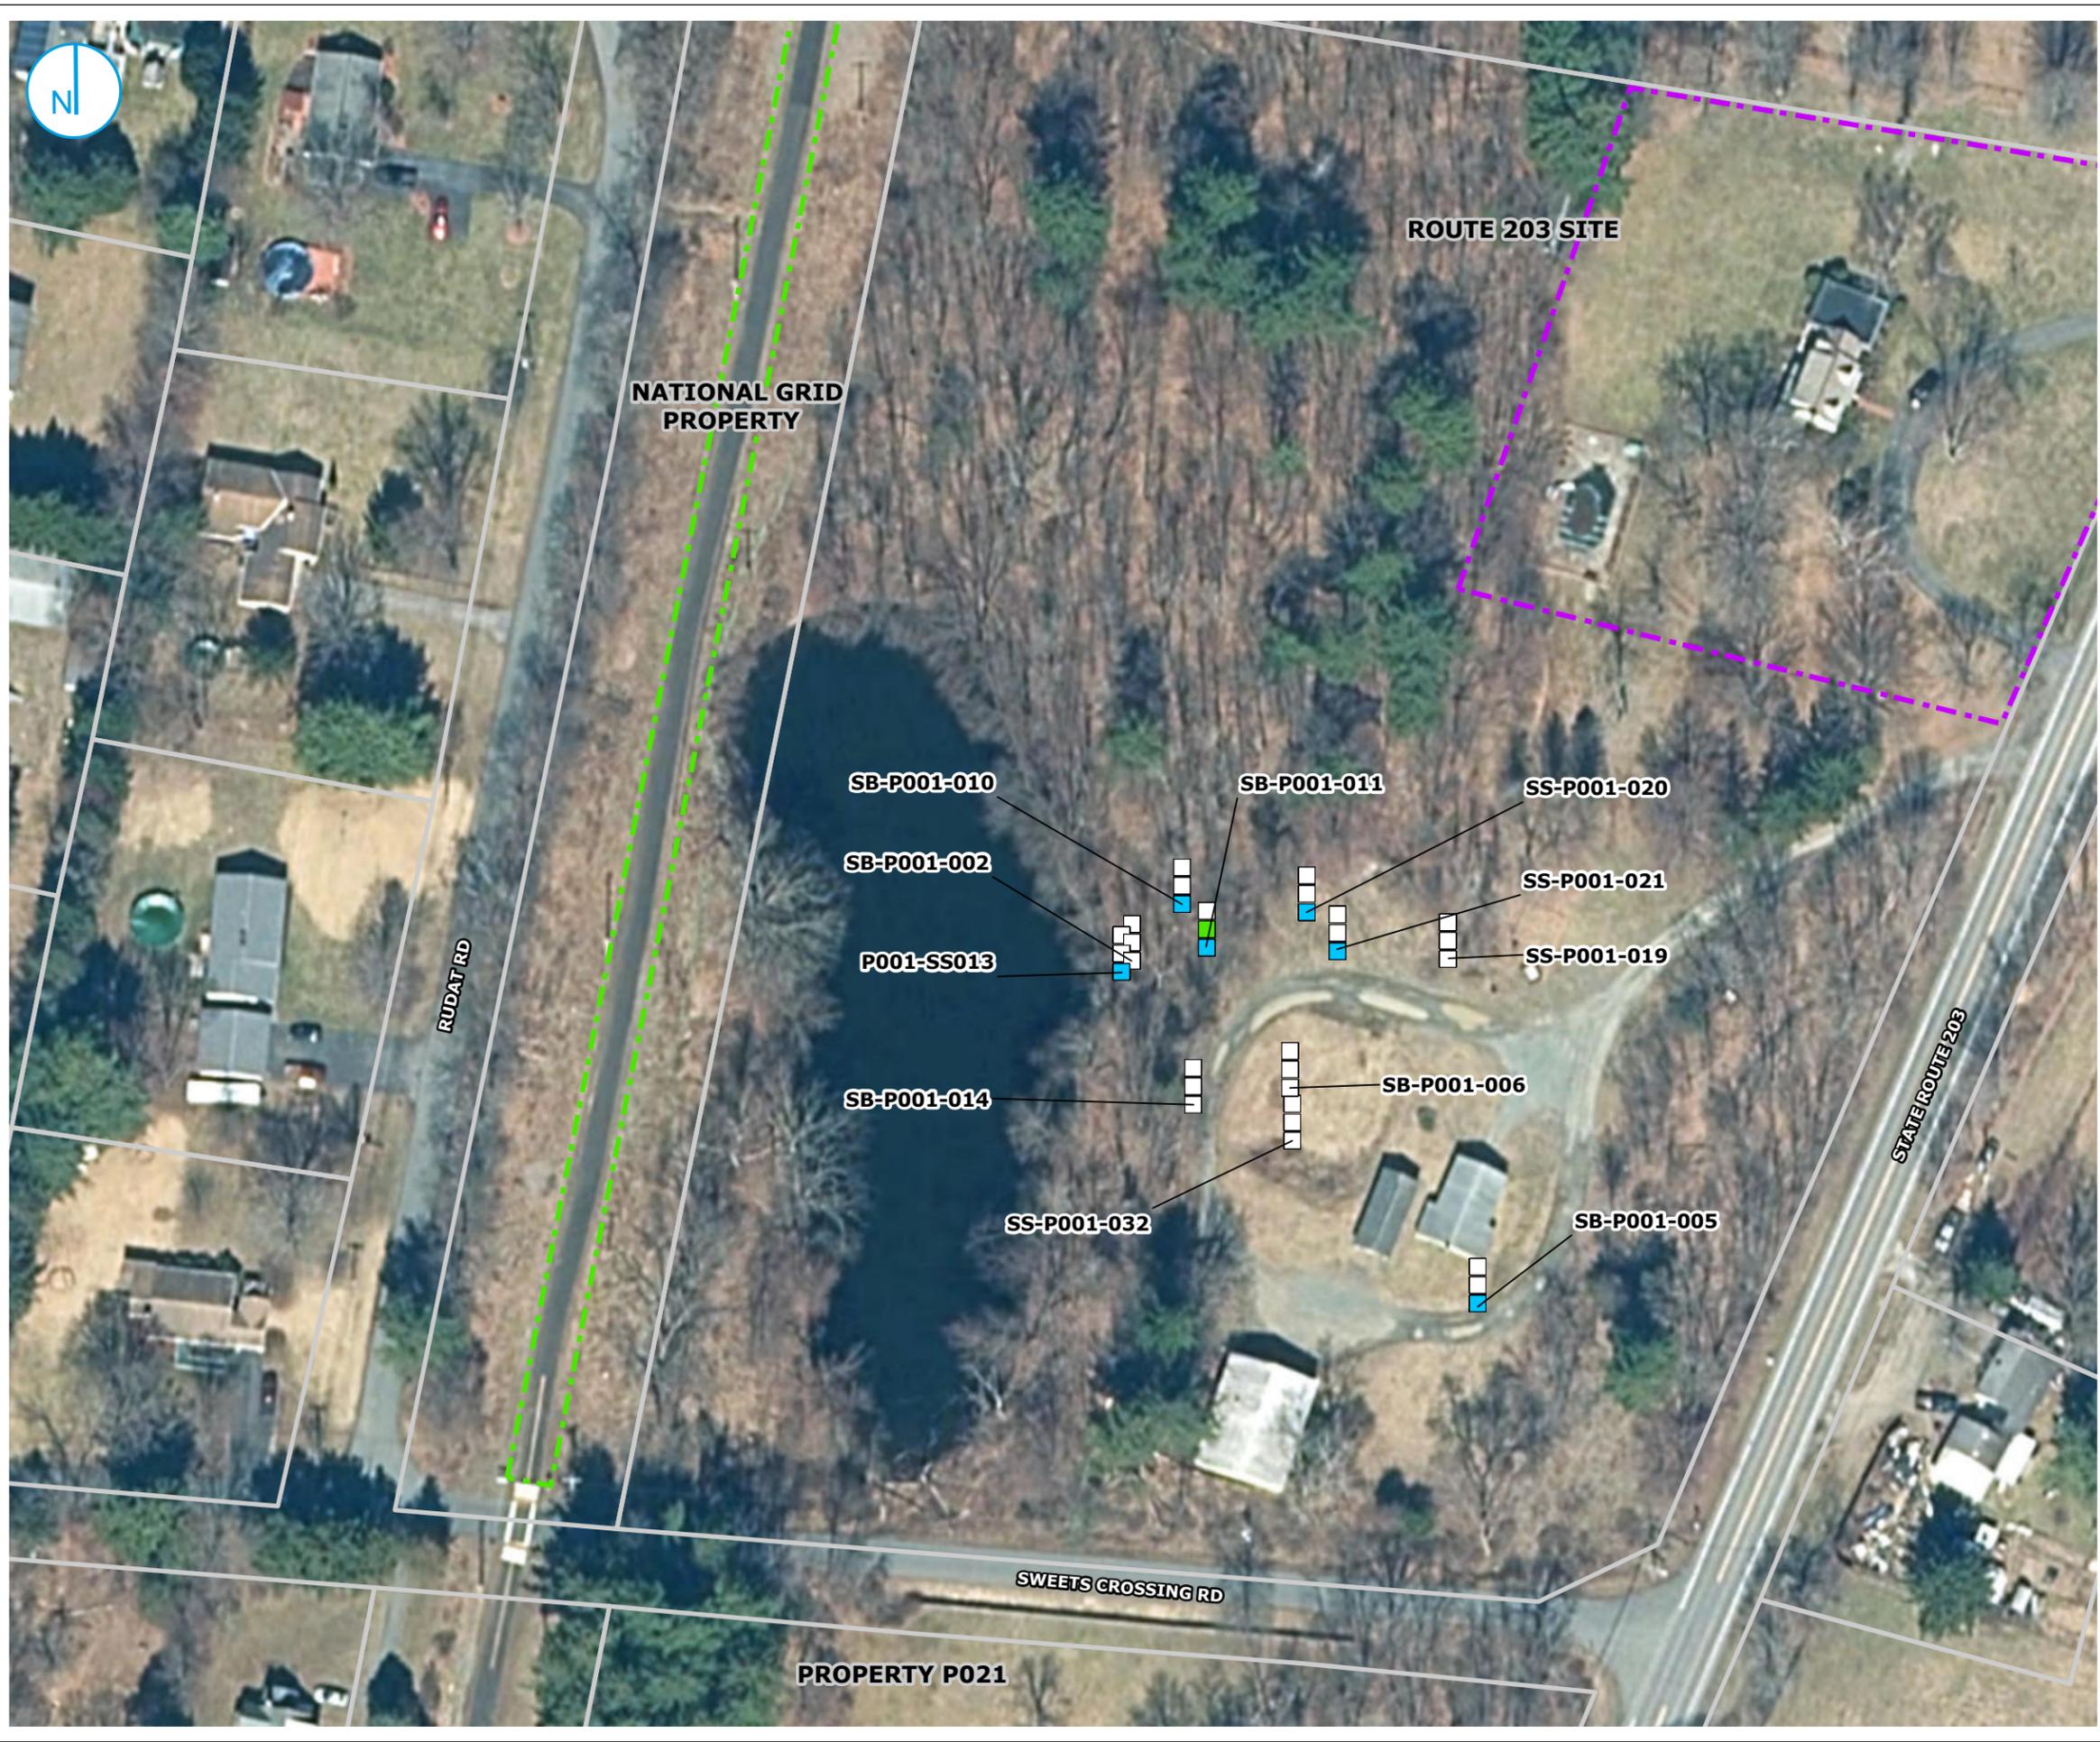
FIGURE 1-13a

EXCEEDS 6 NYCRR PART 375 SCOs

INDUSTRIAL — ■ — COMMERCIAL
■ — PROTECTION OF GROUNDWATER
■ — PROTECTION OF GROUNDWATER

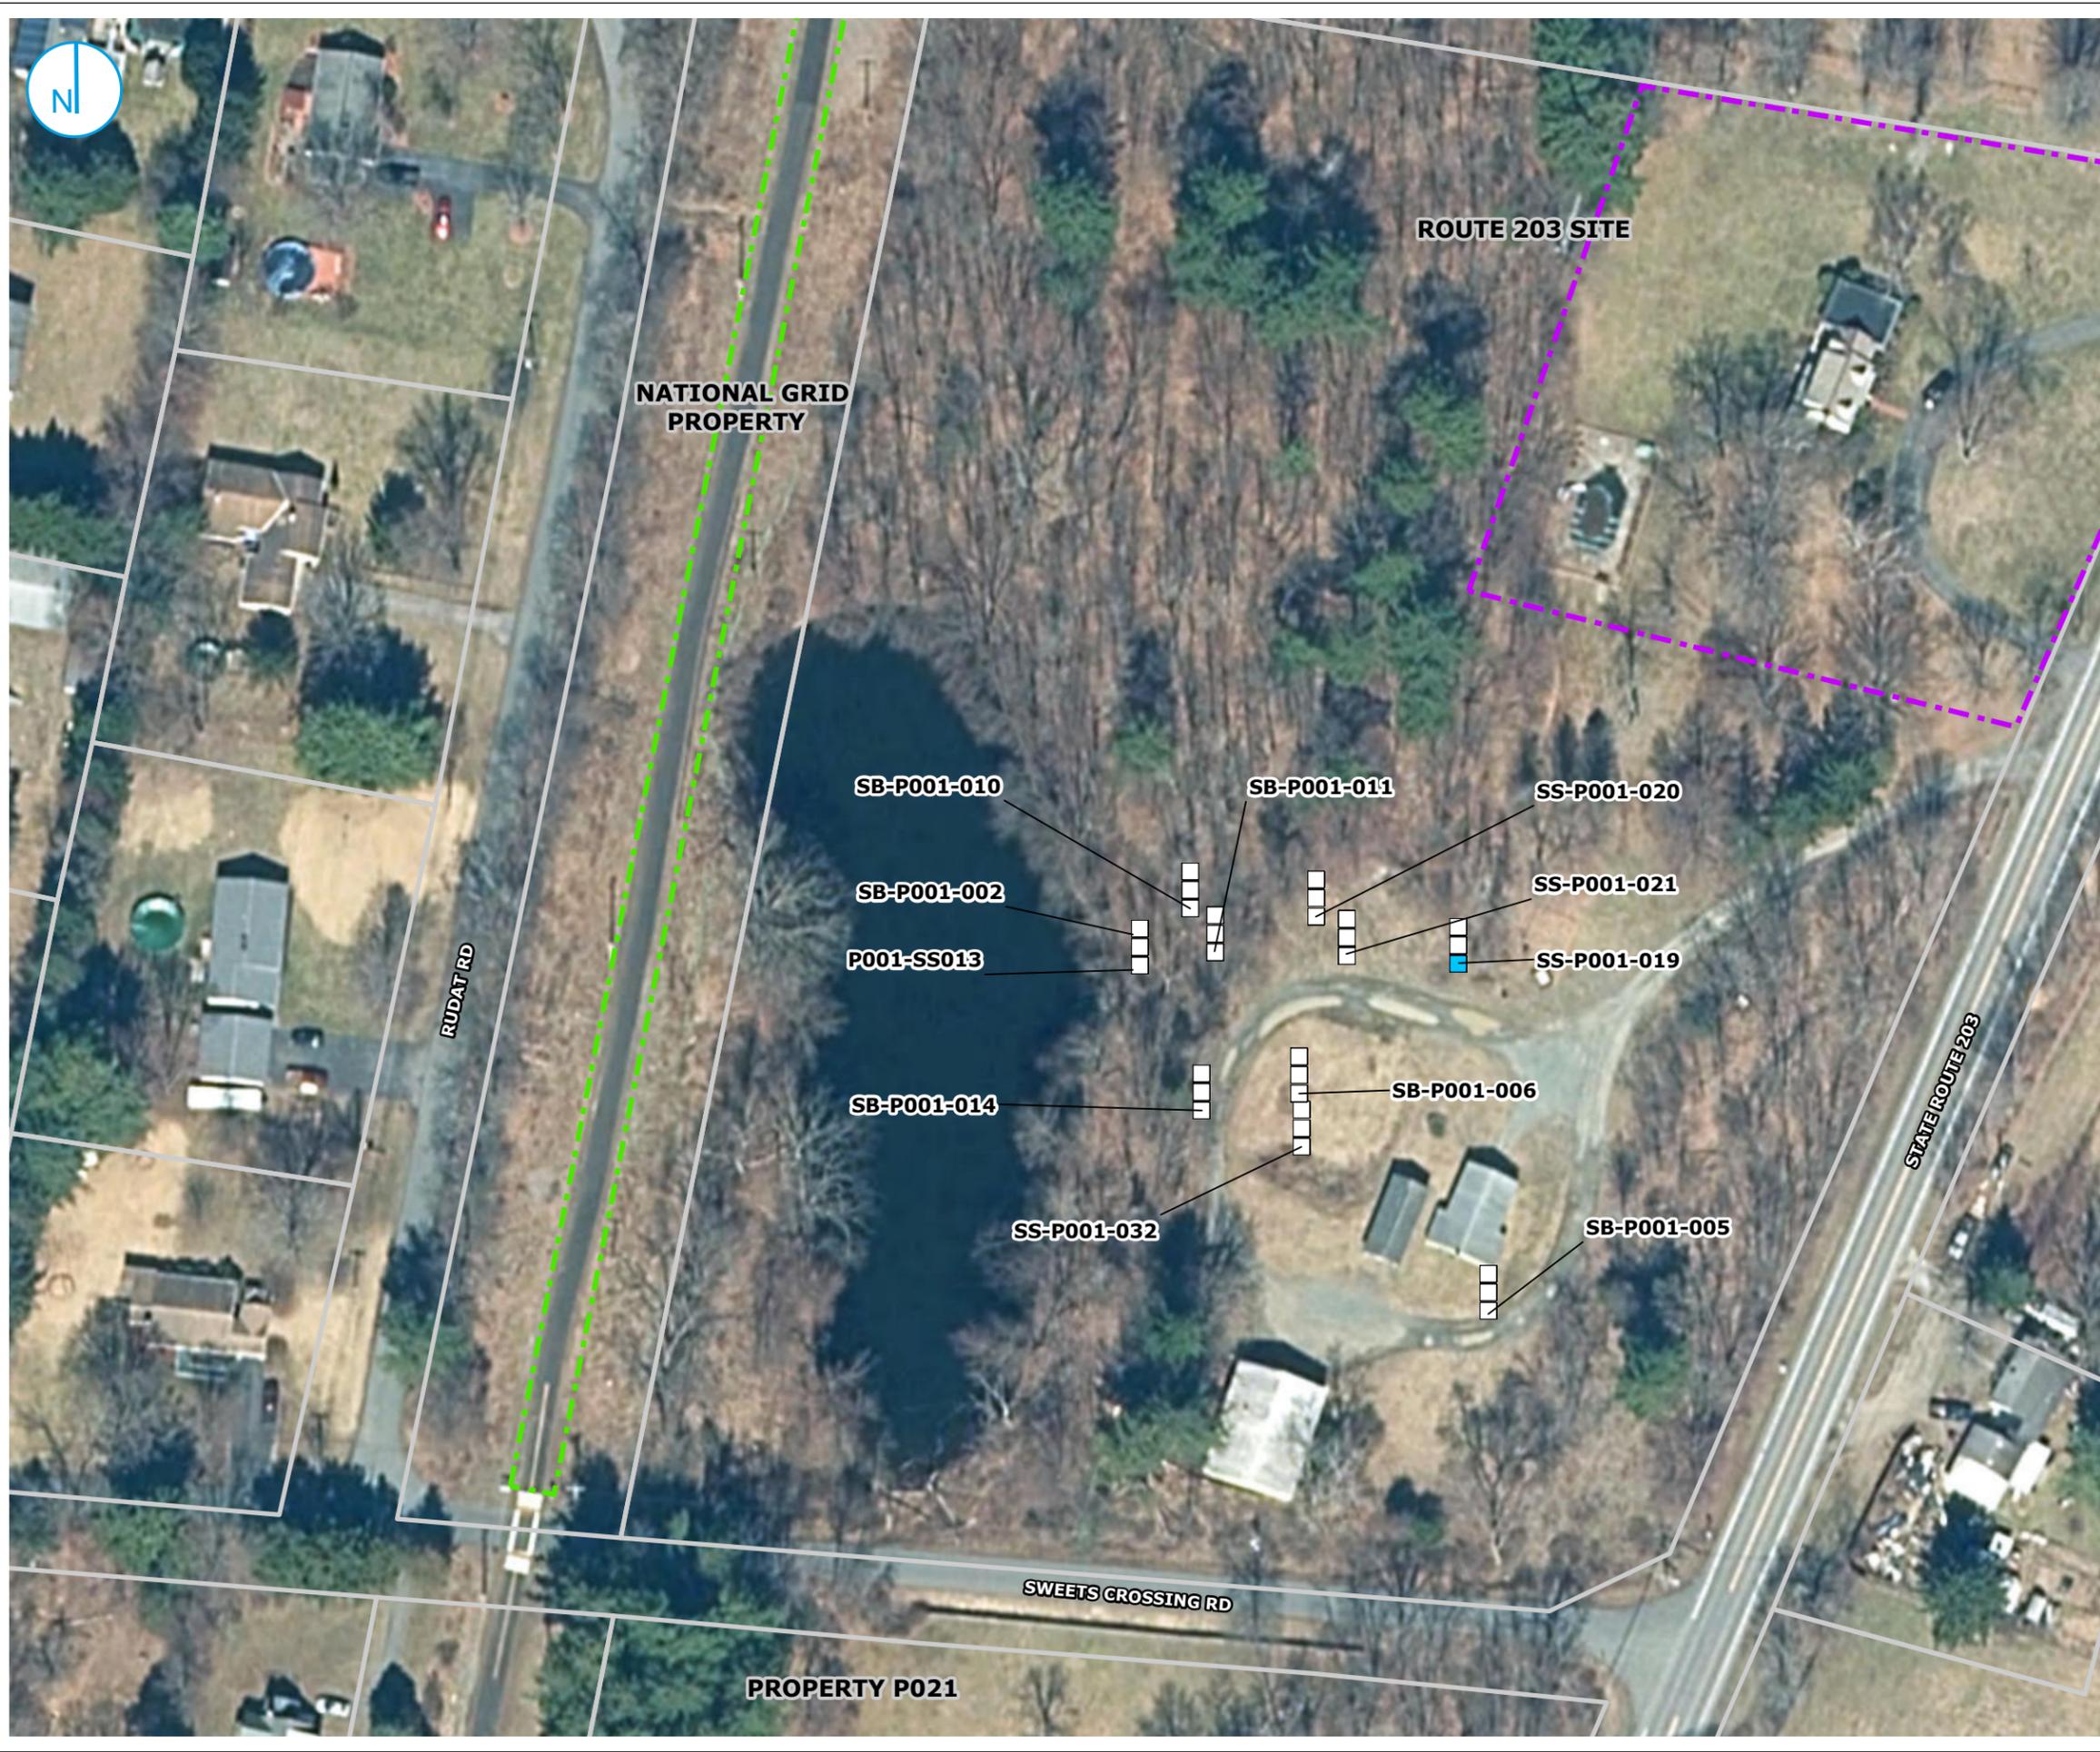
FIGURE 1-13c

EXCEEDS 6 NYCRR PART 375 SCOs

INDUSTRIAL — ■ — COMMERCIAL
■ — PROTECTION OF GROUNDWATER
■ — PROTECTION OF GROUNDWATER

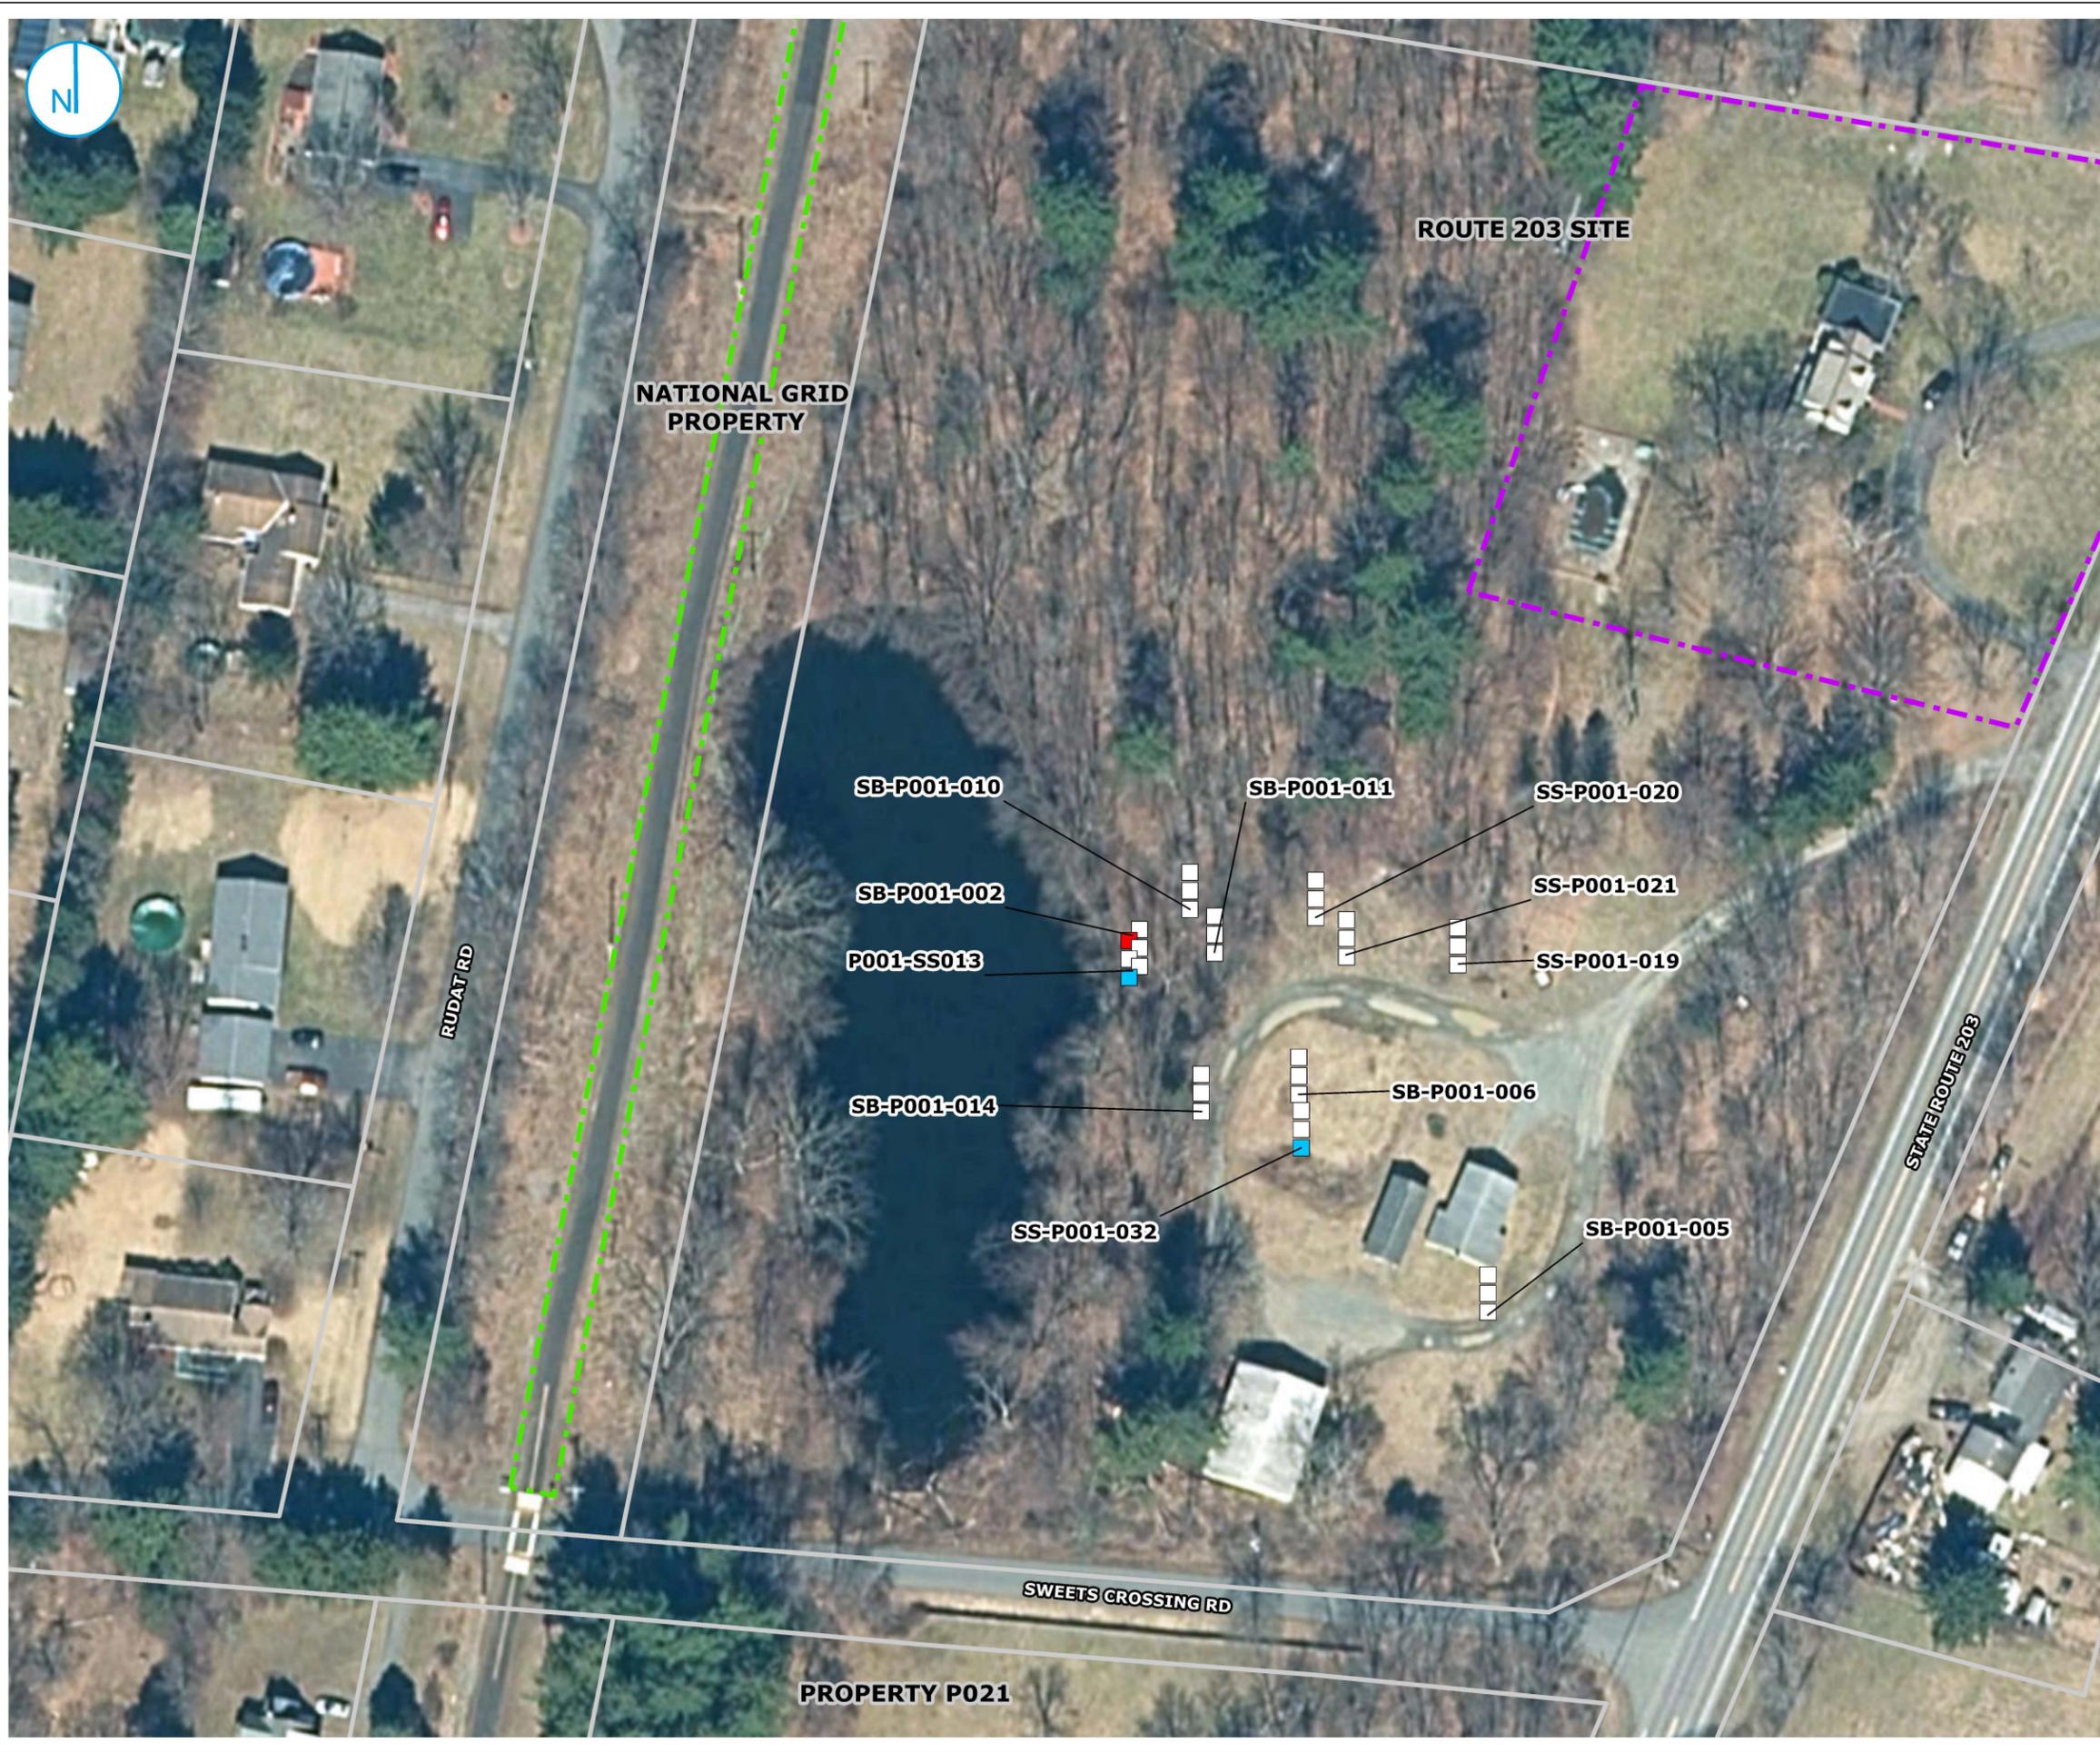
FIGURE 1-13d

EXCEEDS 6 NYCRR PART 375 SCOs

- INDUSTRIAL — ■ — COMMERCIAL
- INDUSTRIAL — ■ — PROTECTION OF GROUNDWATER
- INDUSTRIAL — ■ — PROTECTION OF GROUNDWATER
