Route 203 Site

Nassau, New York

NYSDEC Site No.: 442064

INVESTIGATION/ FEASIBILITY STUDY WORK PLAN ROUTE 203 SITE

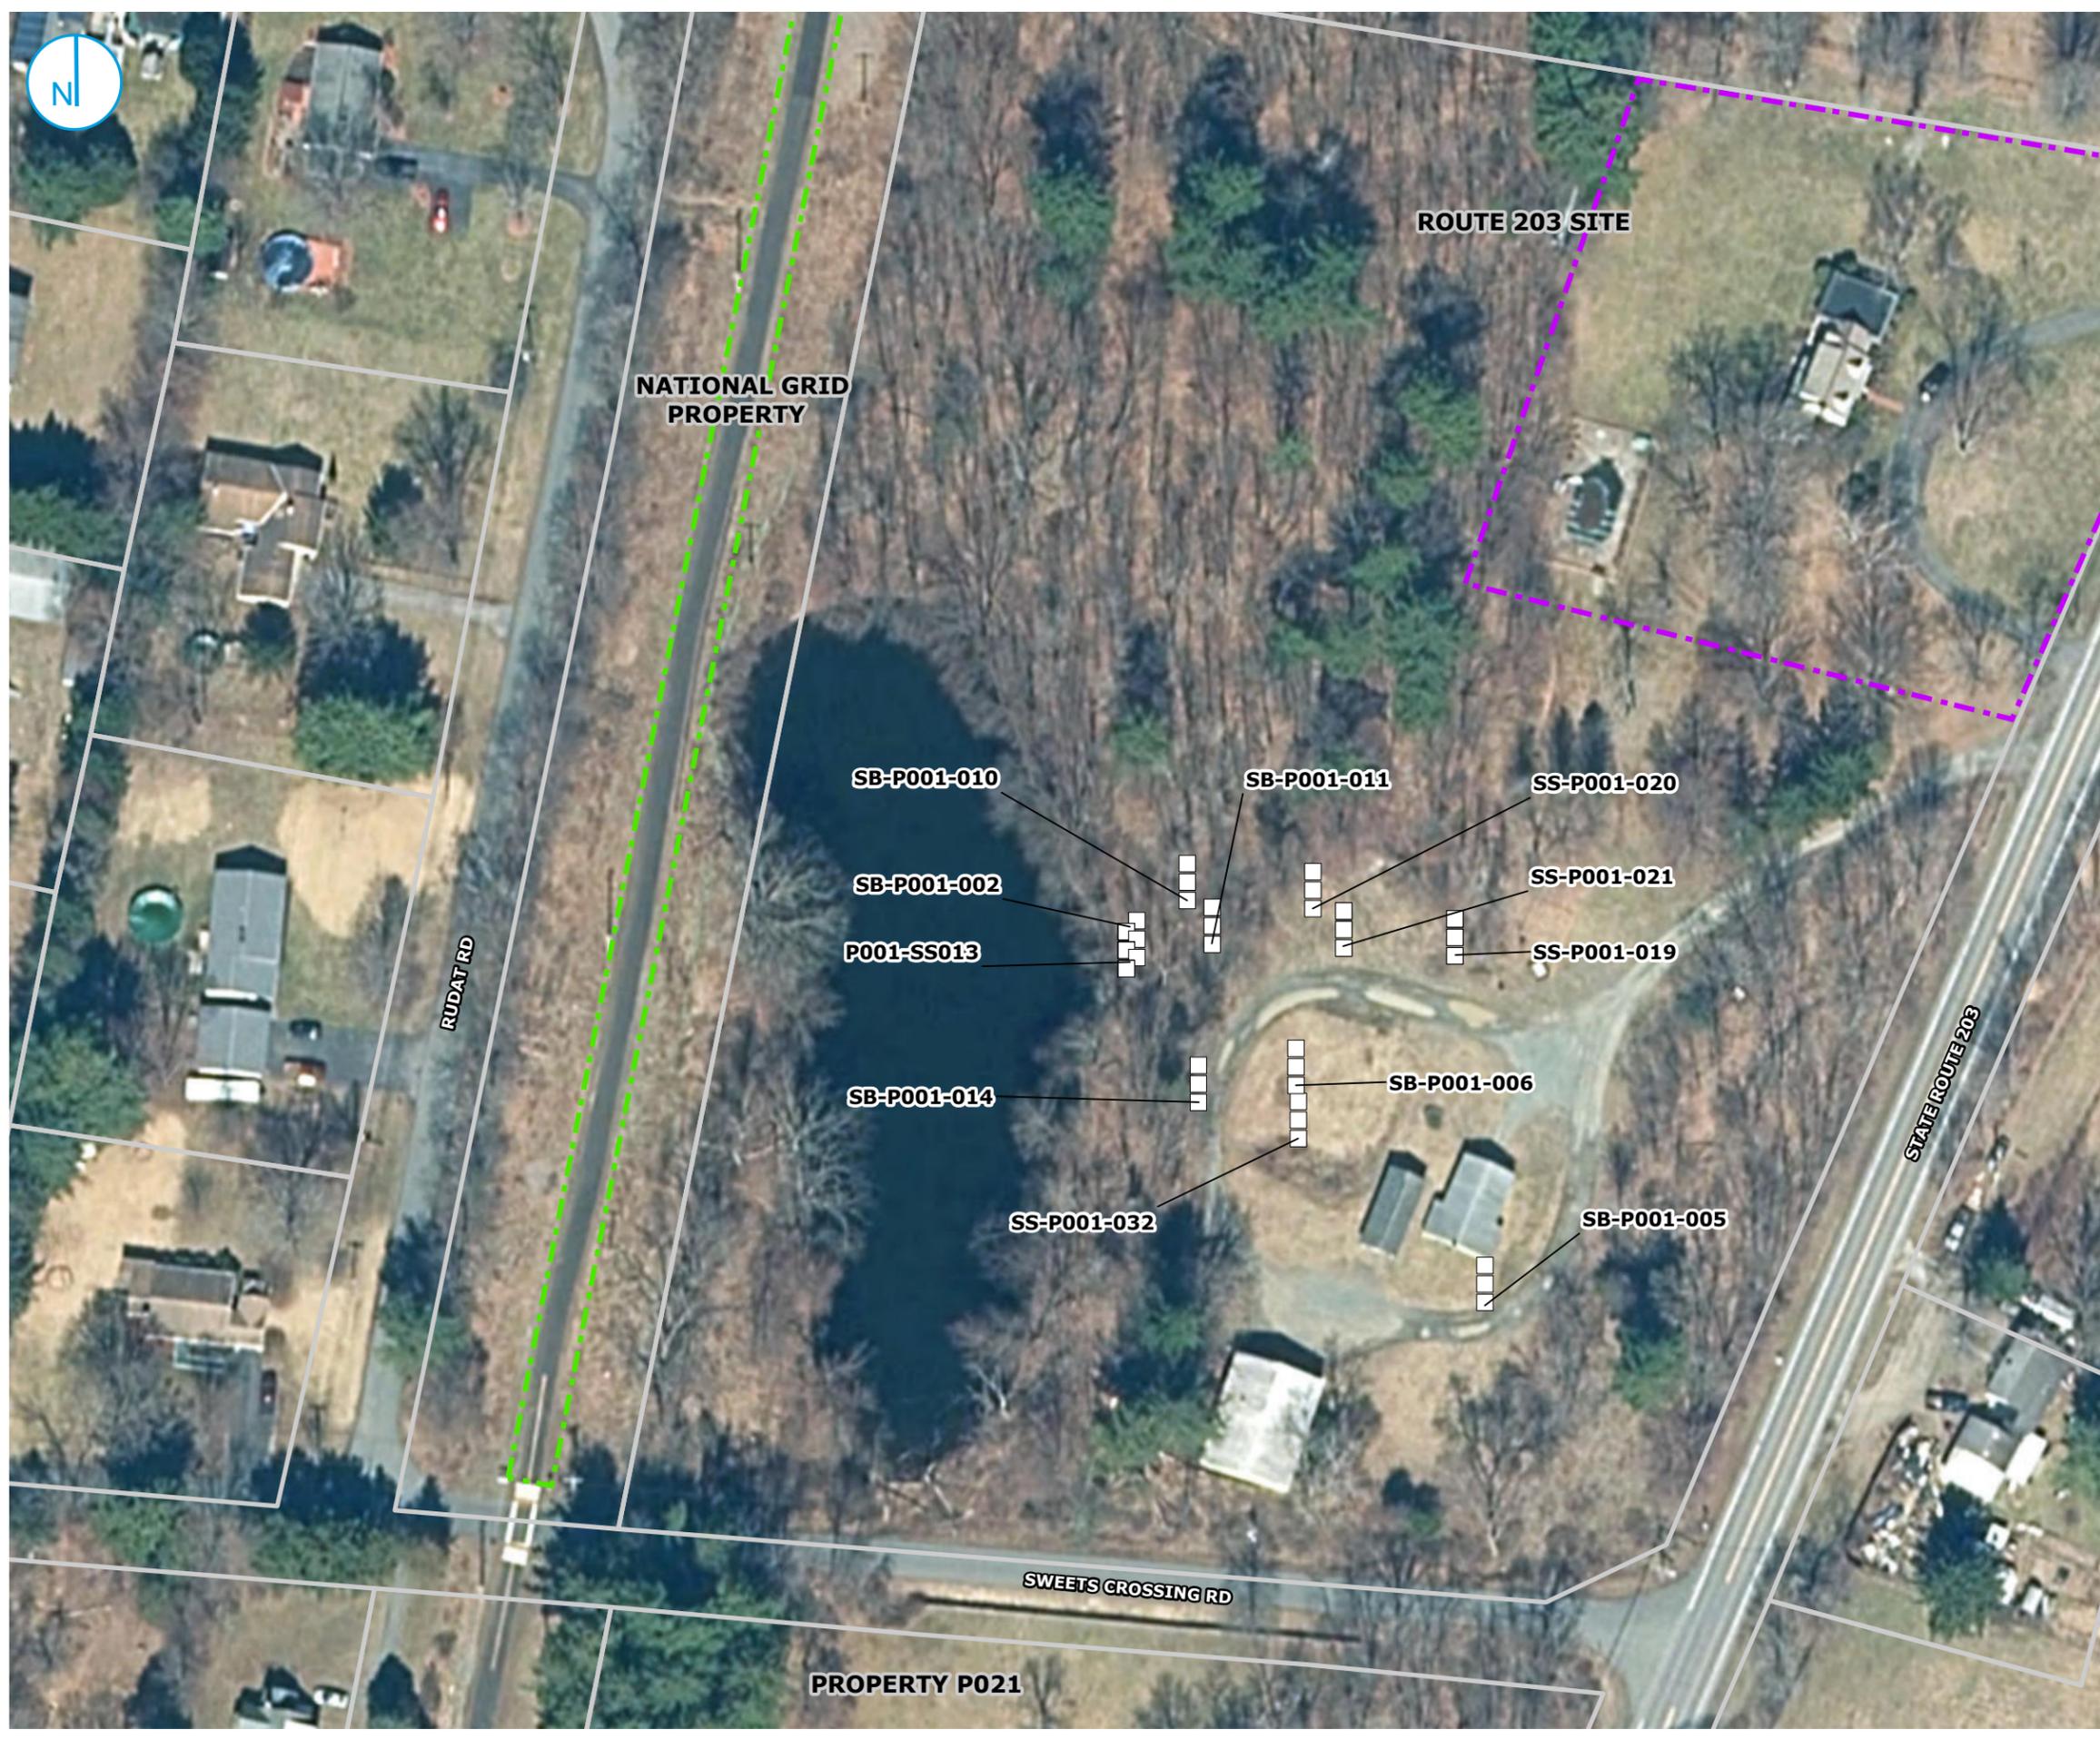
FIGURE 1-13e

EXCEEDS 6 NYCRR PART 375 SCOs

INDUSTRIAL — ■ — COMMERCIAL
■ — PROTECTION OF GROUNDWATER
■ — PROTECTION OF GROUNDWATER

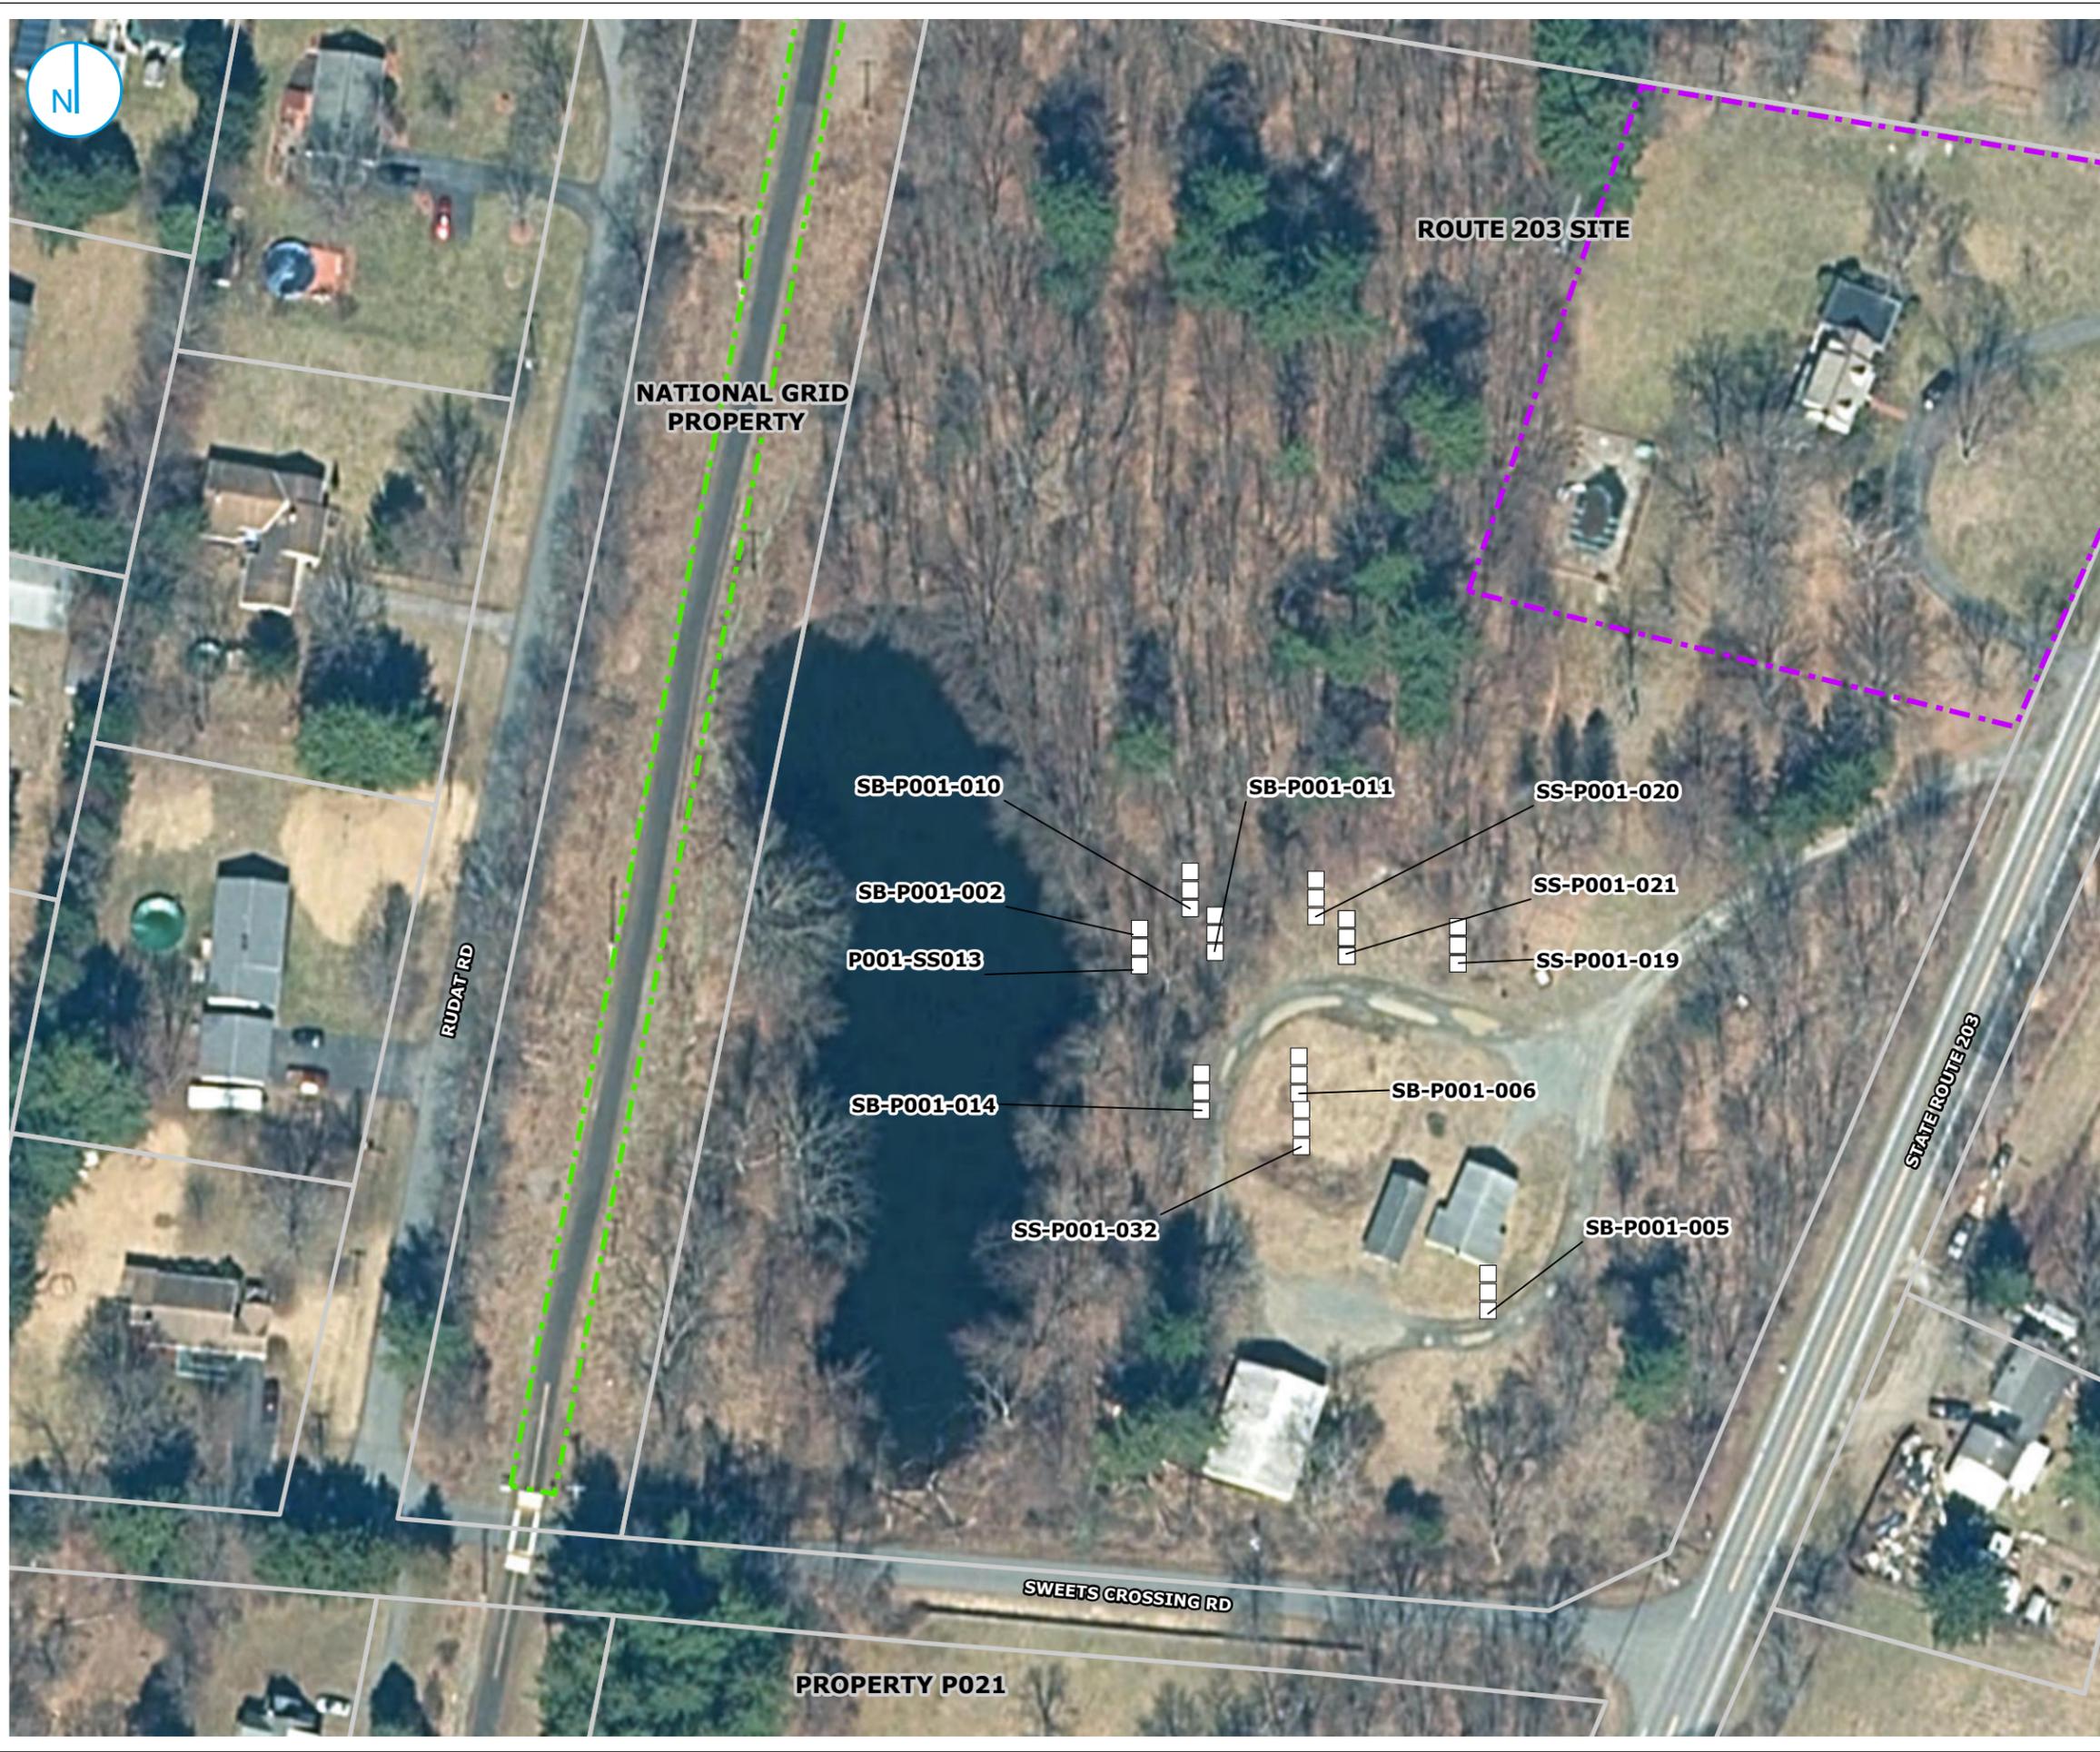
FIGURE 1-13f

EXCEEDS 6 NYCRR PART 375 SCOs

INDUSTRIAL — ■ — COMMERCIAL
■ — PROTECTION OF GROUNDWATER
■ — PROTECTION OF GROUNDWATER

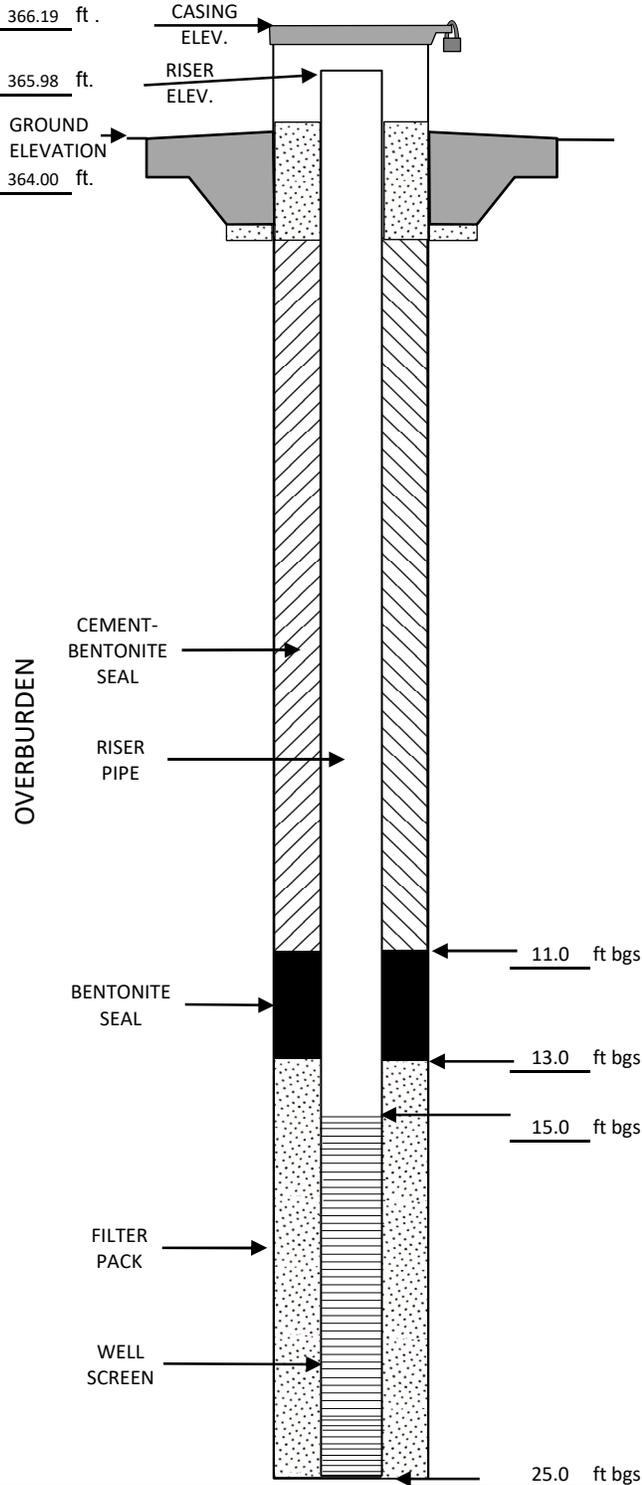
WELL CONSTRUCTION DETAIL (NOT TO SCALE)

Well Type: Monitoring Well
Static Water Level: 12.70 ft bgs
Measurement Point: Ground Surface

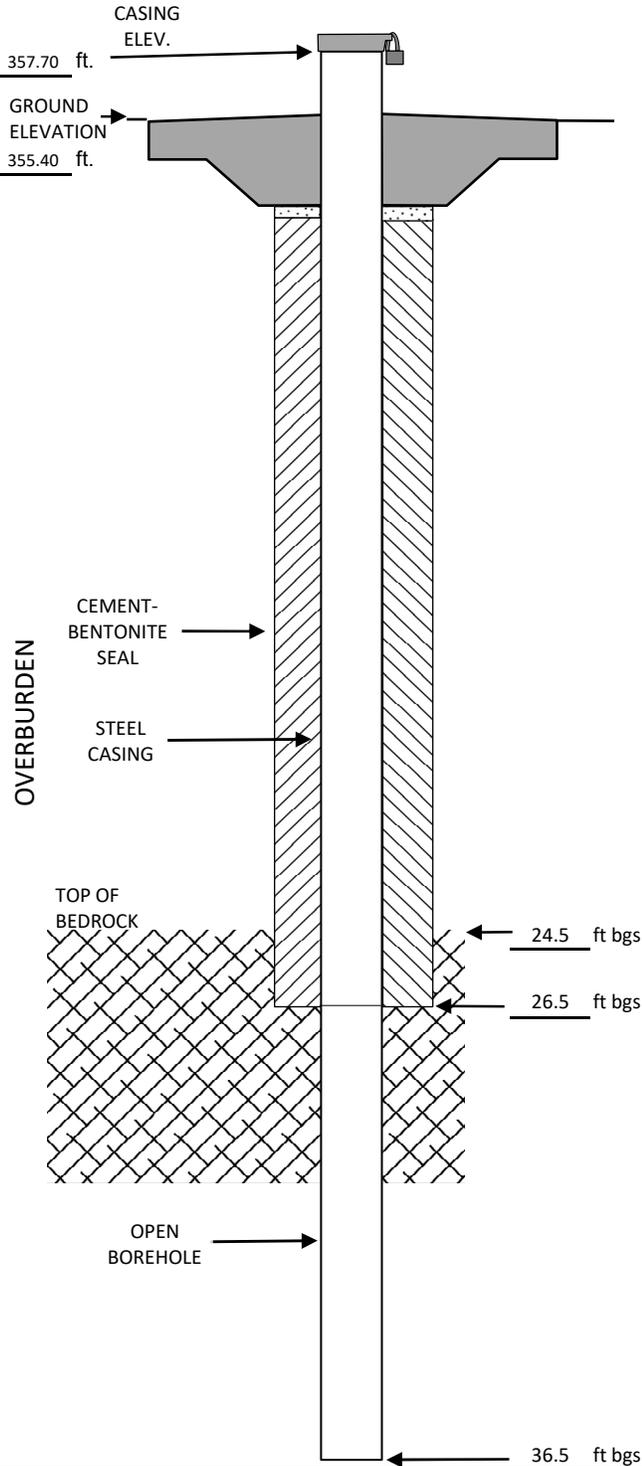
WELL CONSTRUCTION DETAIL (NOT TO SCALE)

Well Type: Monitoring Well
Static Water Level: 14.91 ft bgs
Measurement Point: Ground Surface

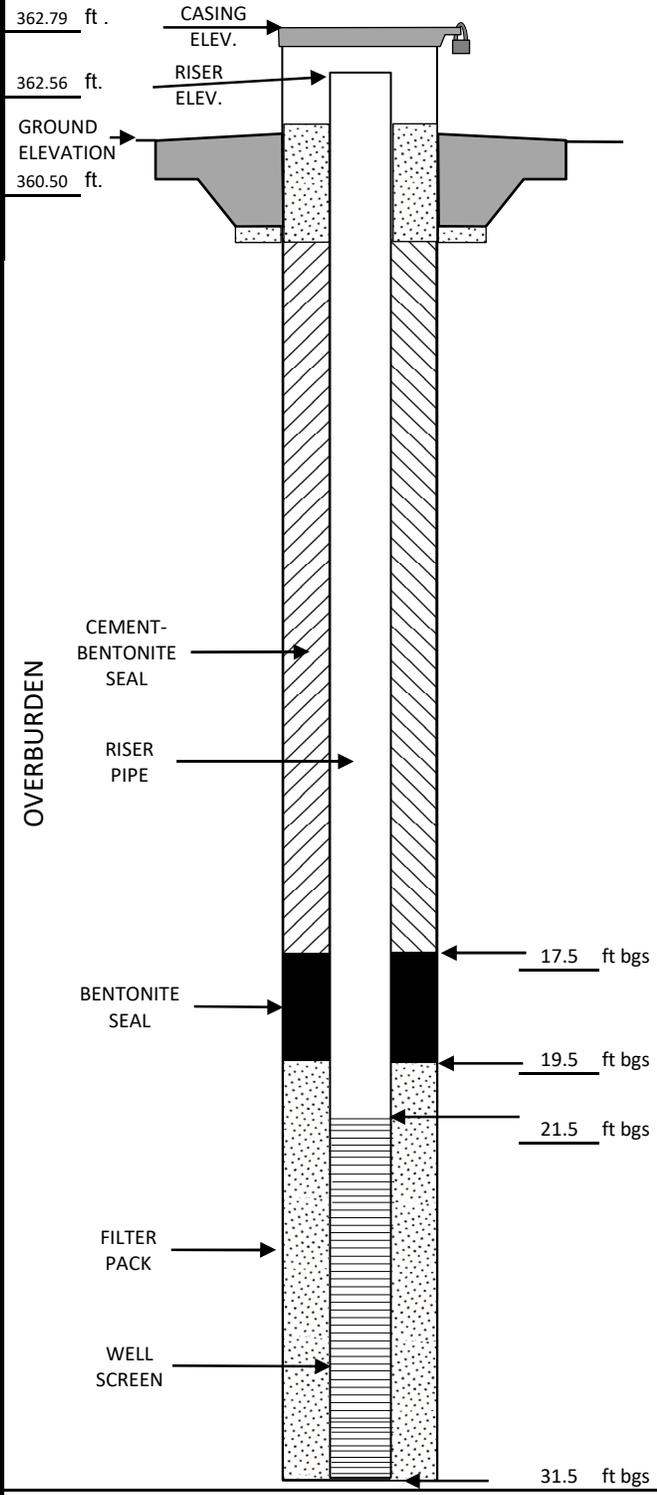
WELL CONSTRUCTION DETAIL (NOT TO SCALE)

Well Type: Monitoring Well
Static Water Level: 9.08 ft bgs
Measurement Point: Ground Surface

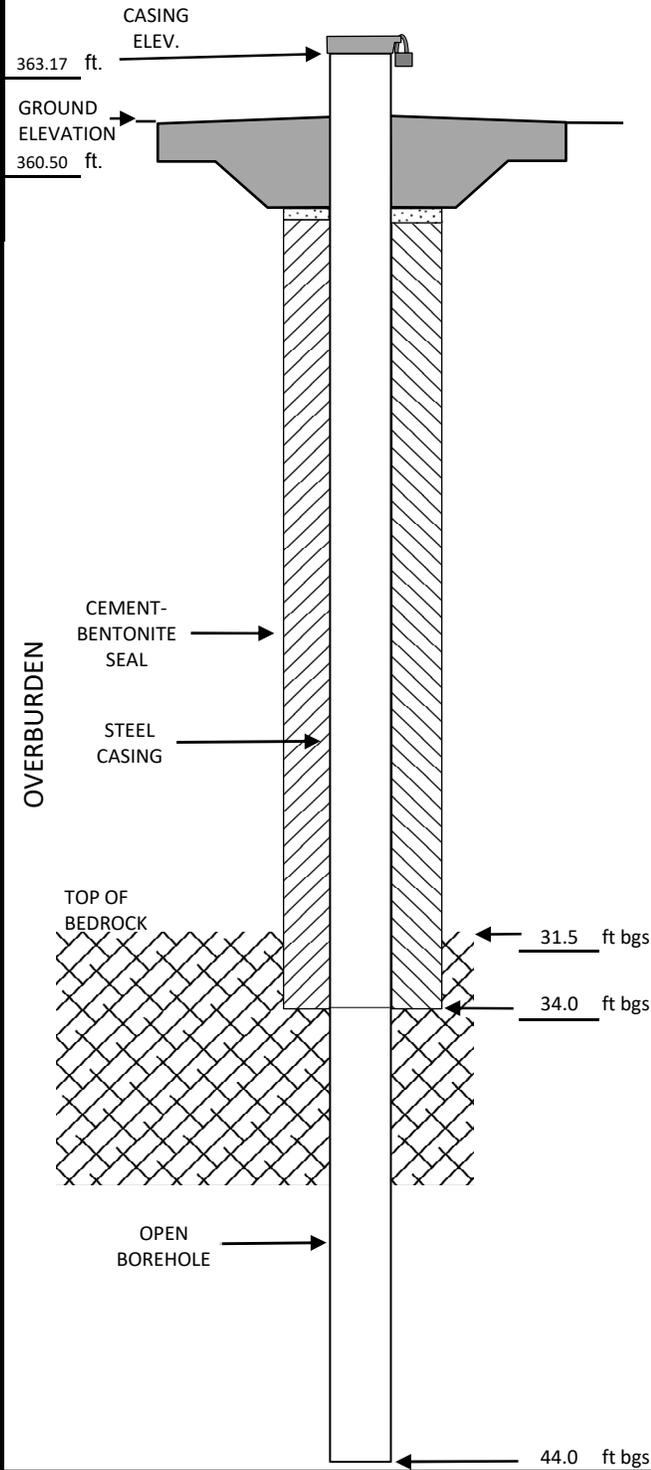
WELL CONSTRUCTION DETAIL (NOT TO SCALE)

Well Type: Monitoring Well
 Static Water Level: 11.60 ft bgs
 Measurement Point: Ground Surface

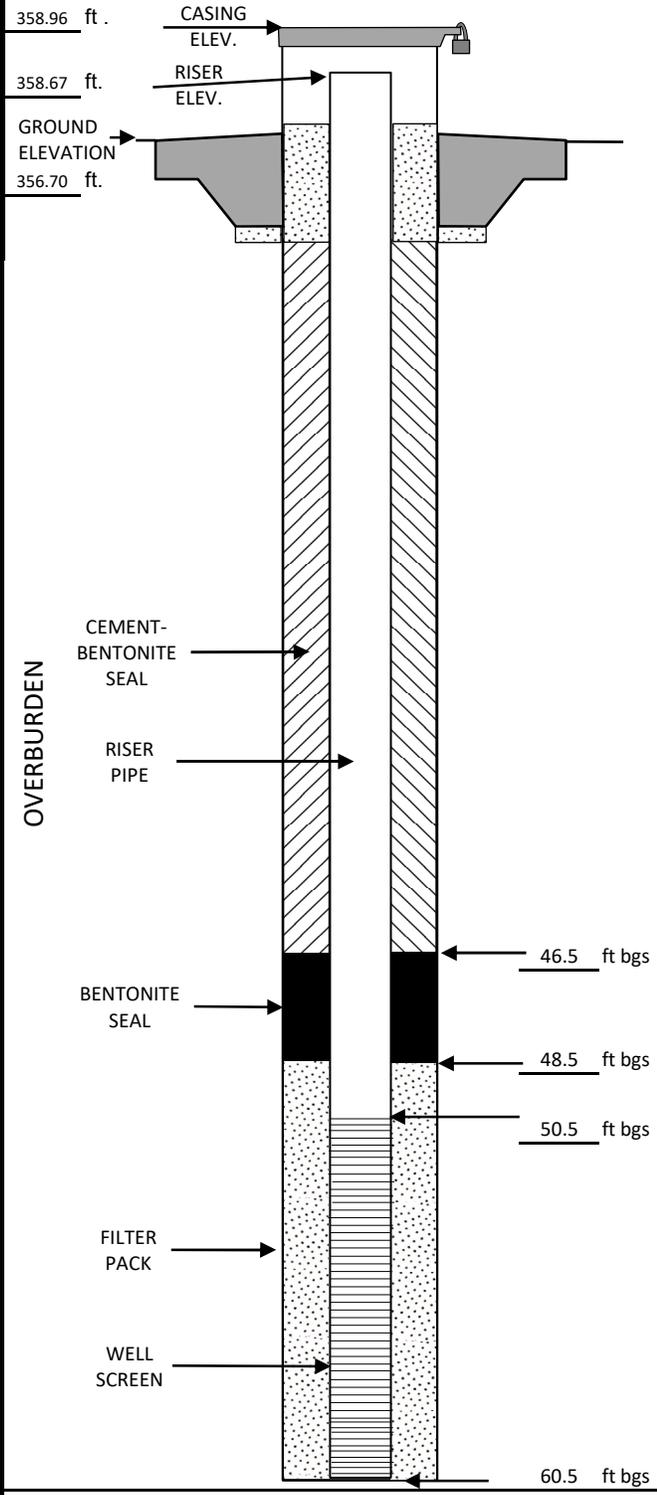
WELL CONSTRUCTION DETAIL (NOT TO SCALE)

Well Type: Monitoring Well

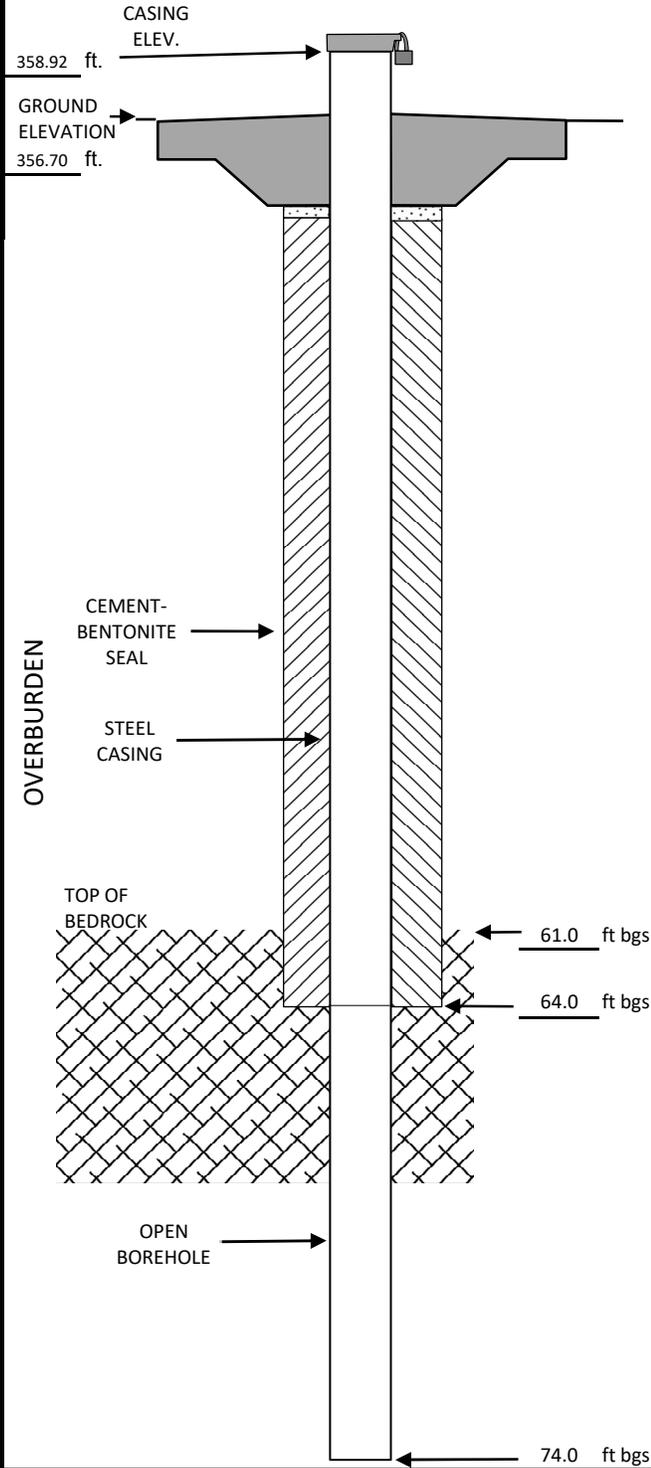
WELL CONSTRUCTION DETAIL (NOT TO SCALE)

Well Type: Monitoring Well
Static Water Level: 8.80 ft bgs
Measurement Point: Ground Surface

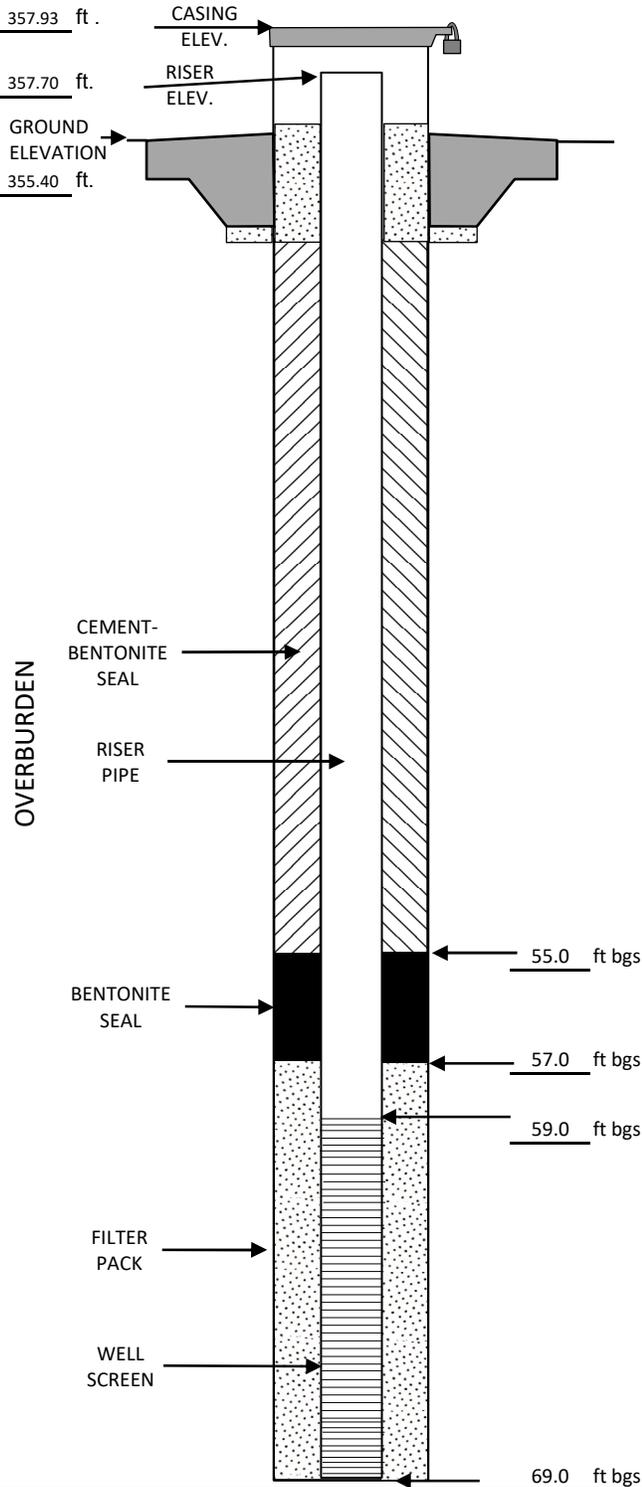
WELL CONSTRUCTION DETAIL (NOT TO SCALE)

Well Type: Monitoring Well
Static Water Level: 5.50 ft bgs
Measurement Point: Ground Surface

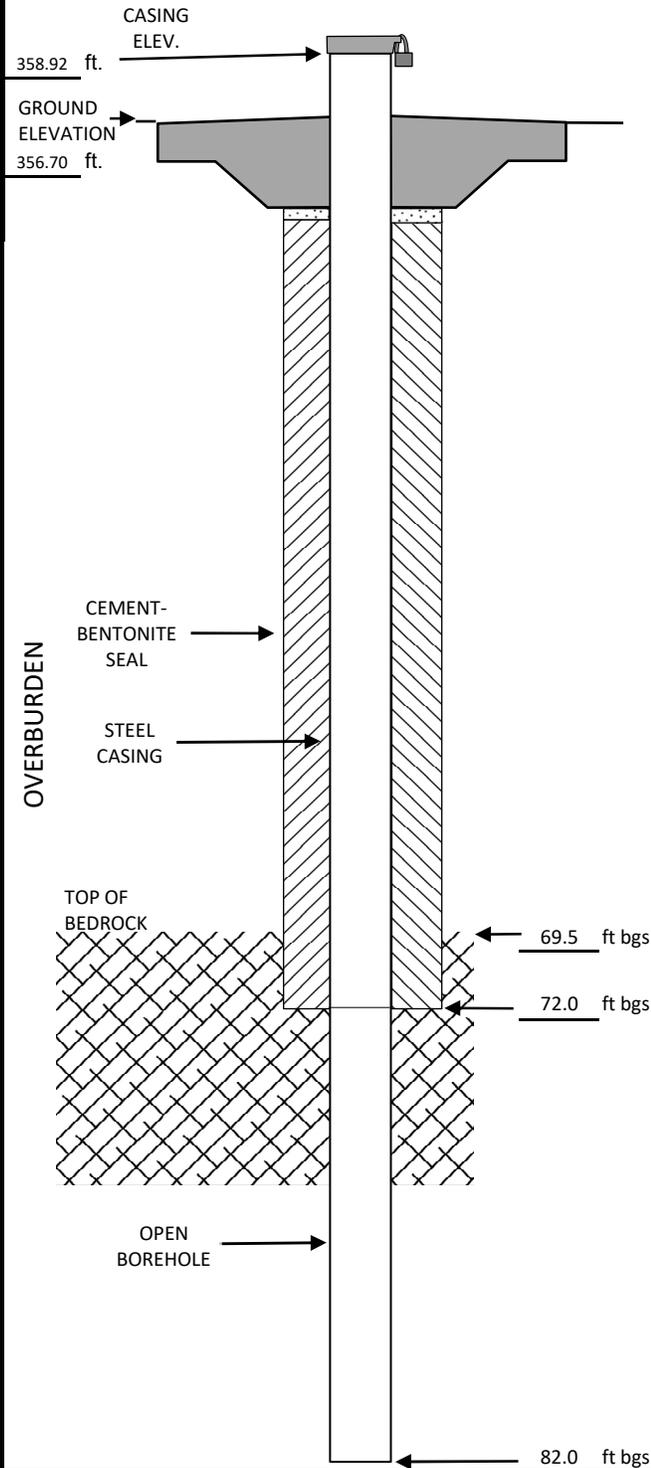
WELL CONSTRUCTION DETAIL (NOT TO SCALE)

Well Type: Monitoring Well
Static Water Level: NM* ft bgs
Measurement Point: Ground Surface
