**No Further Response Action Planned
Decision Document**

Sites ZZ007, TU008, and TU009 at
Schenectady Air National Guard Base
Scotia, New York

National Guard Bureau,
Logistics and Installations Directorate, Operations Division,
Restoration Branch
NGB/A4OR

February 2018

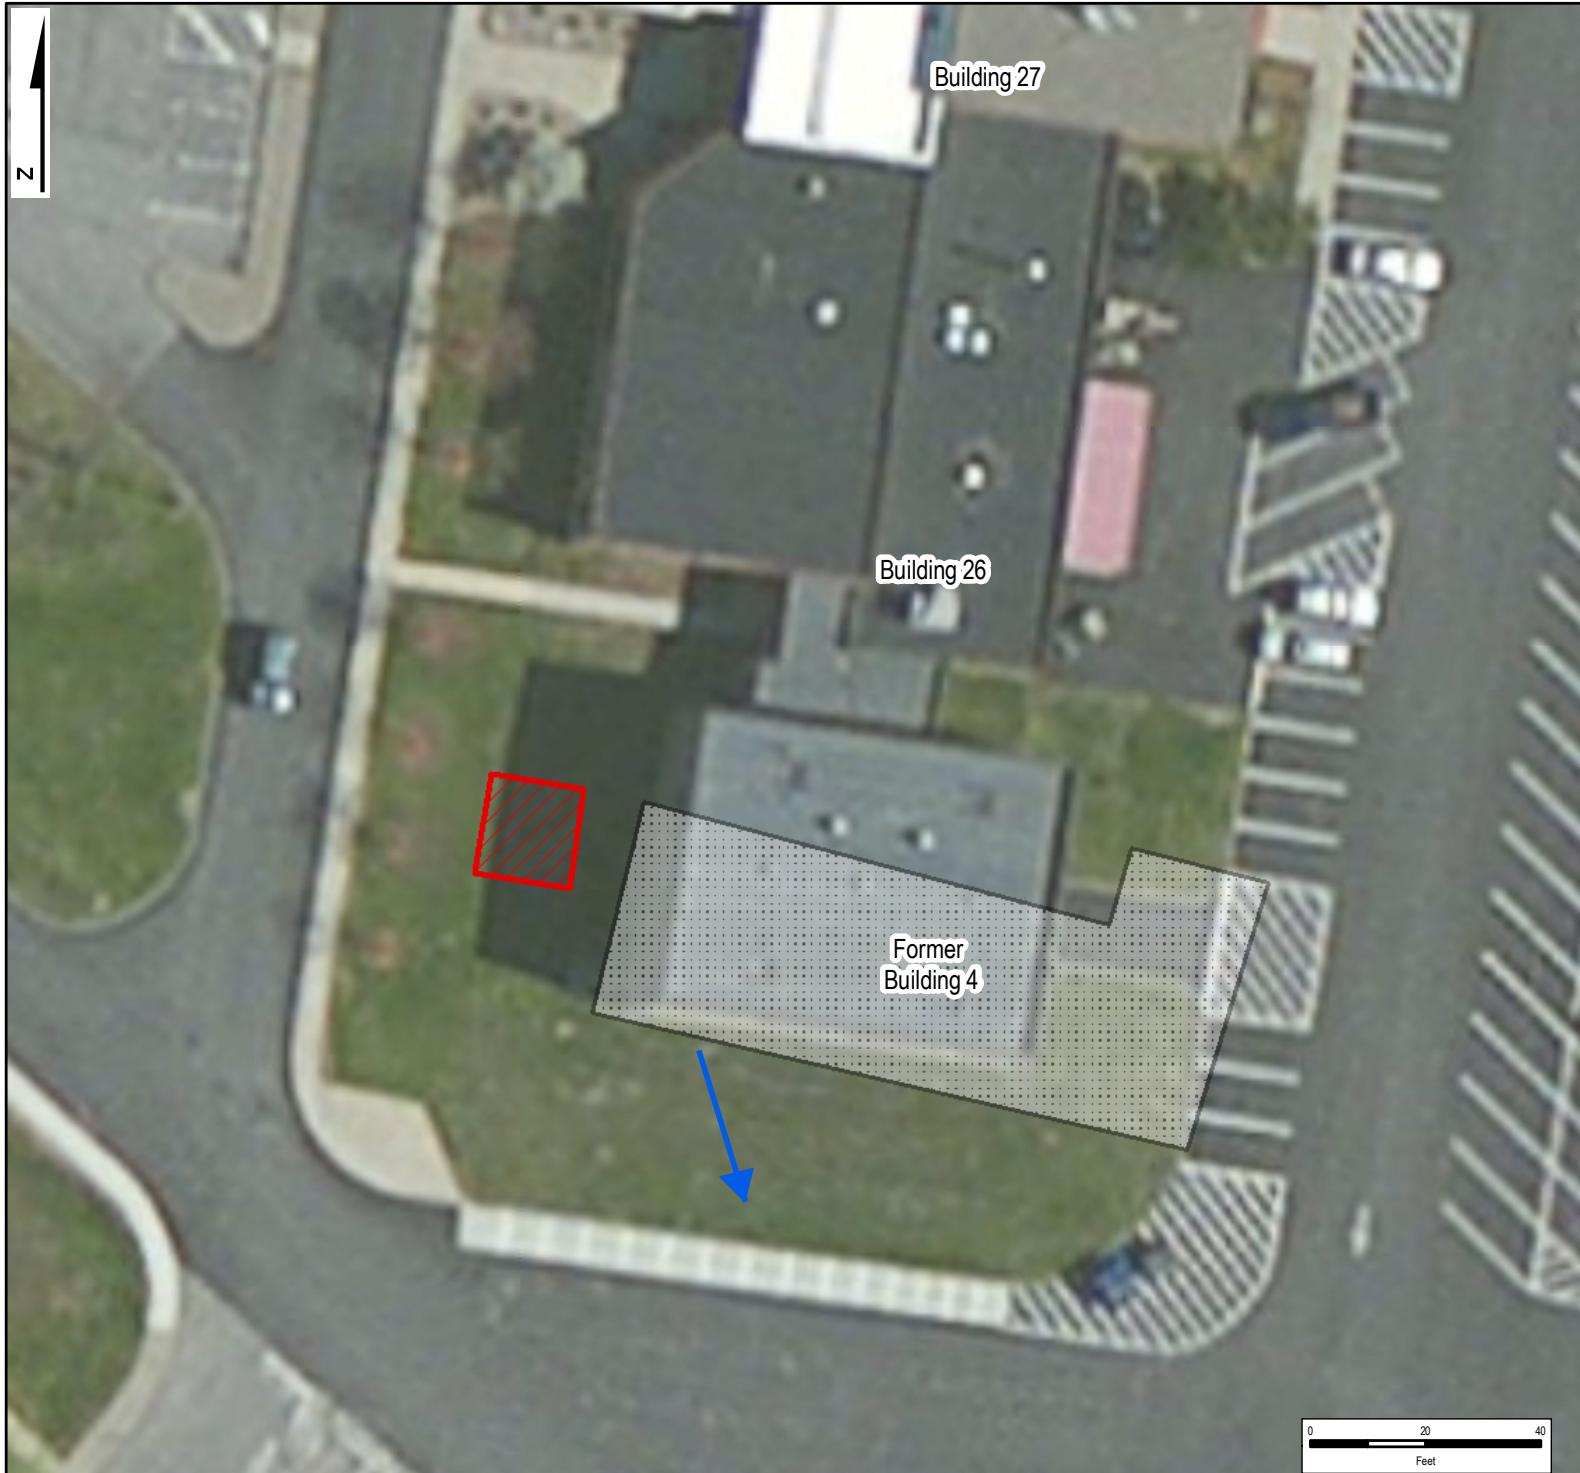
FIGURE 1-3
SITE LAYOUT MAP
SITE TU008 - FORMER HEATING OIL
UST #41 AT FORMER BUILDING 4
SCHENECTADY AIR NATIONAL
GUARD BASE
SCOTIA, NEW YORK

Site TU008 includes Former Building 4, which was a vehicle maintenance facility, and the associated UST #41, which was a 6,000-gallon heating oil tank (**Figure 1-3**). Building 4 was

demolished in 1995. UST #41 was likely removed at the time of building demolition; however, records of removal and/or sampling of the tank pit during removal are not available (AECOM, 2015).

A PA was conducted at Site TU008 by AECOM in November 2013. During the PA, sampling and closure information for Site TU008 was not identified. Former Building 4 was utilized as a vehicle maintenance facility before its removal in early 1995. UST #41 was a 6,000-gallon heating oil tank associated with the building. Records of removal and/or sampling of the tank pit during removal are not available. Soil and groundwater sampling was recommended to assess potential contamination (AECOM, 2015).

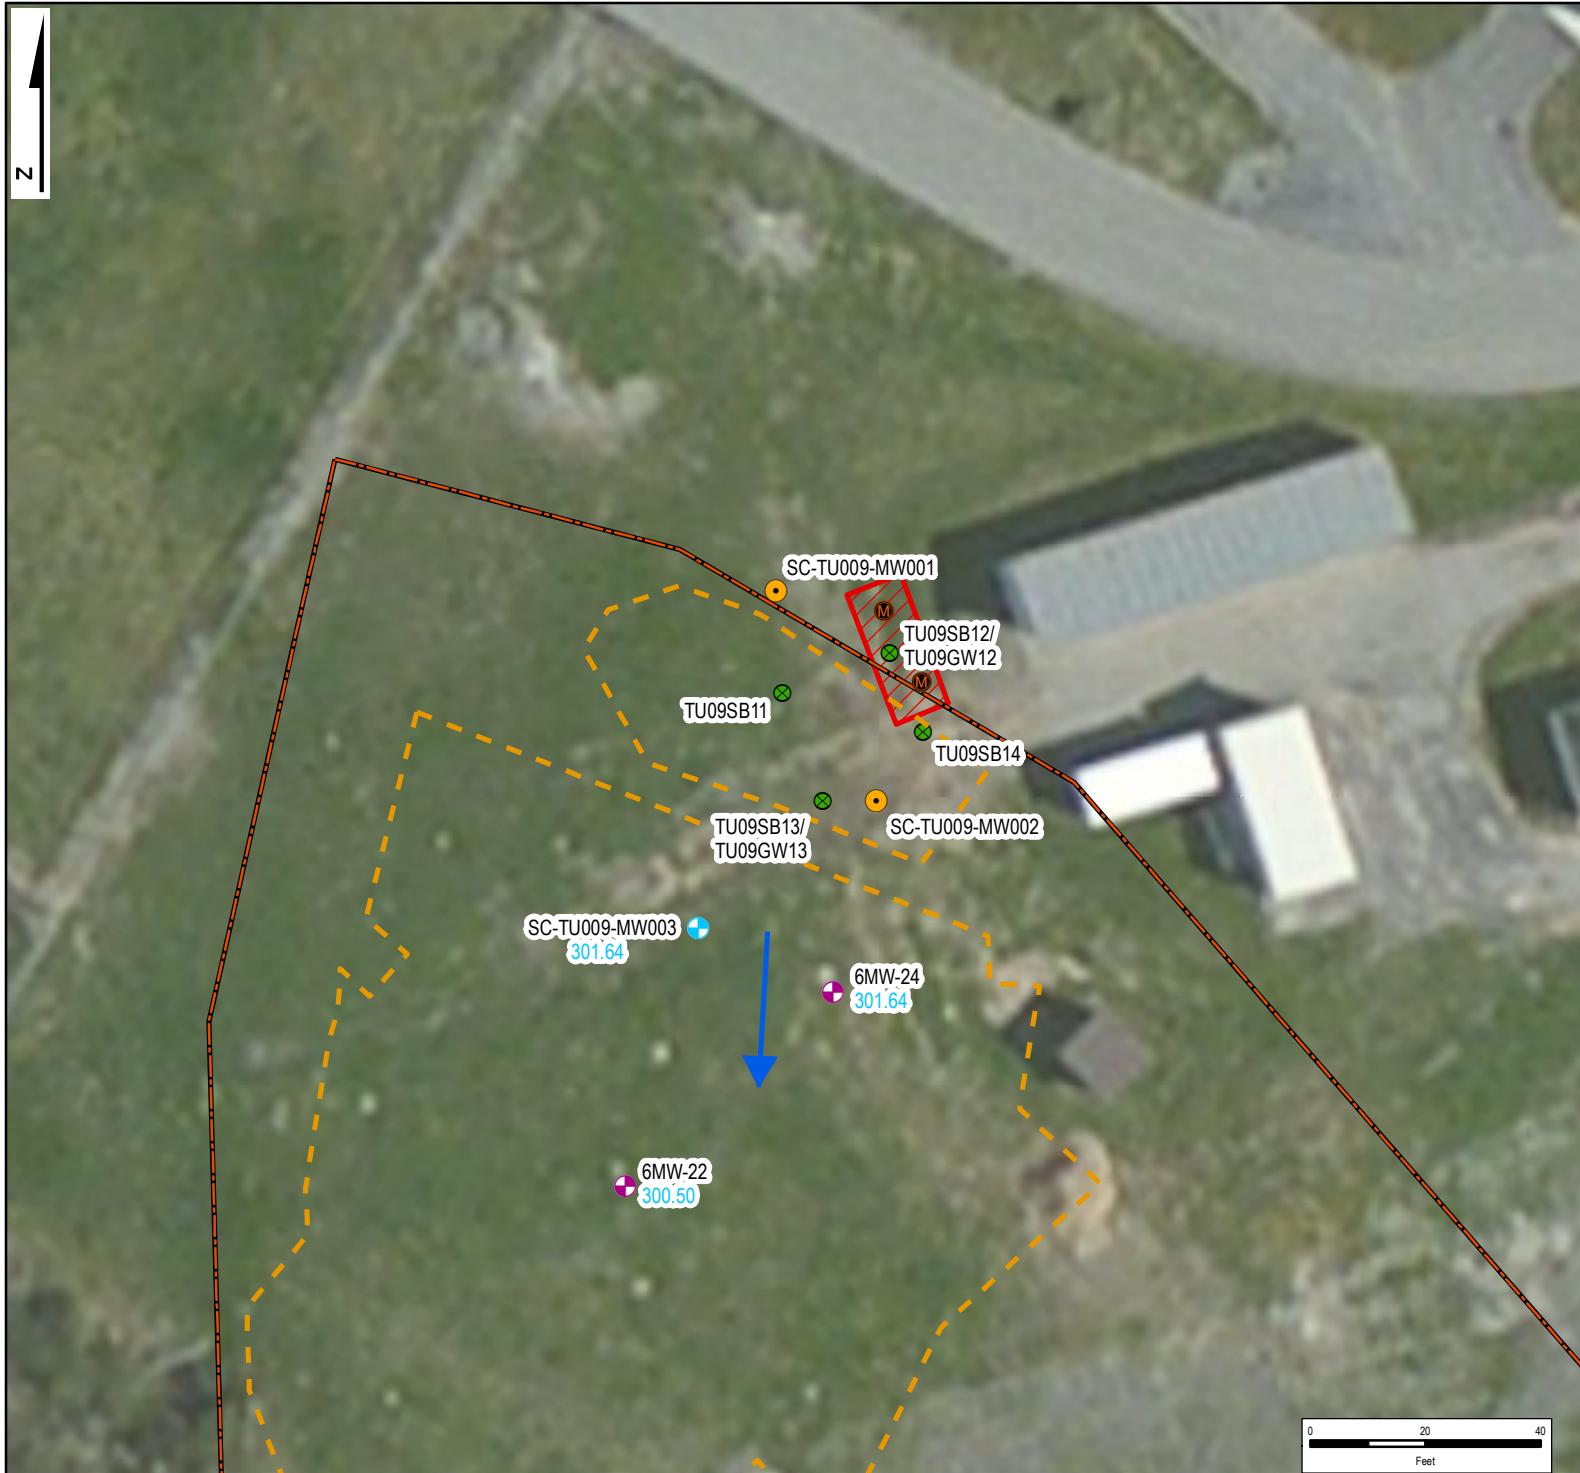
SI and RI sampling locations are presented on **Figure 3-3**. Additionally, an Interim Remedial Action (IRA) was conducted at adjacent IRP Site 6 between May and September 2007 (Earth Tech Northeast, 2007). Soils that were previously identified as being in the chlorinated VOC groundwater plume at IRP Site 6 were excavated. The Site 6 excavation areas are shown on **Figure 3-3**. The excavation areas include the area up to the edge of the WWTP Bypass UST. The soil adjacent to and downgradient of Site TU009 WWTP Bypass UST area has been removed and replaced with soil from the larger excavation area. During the soil removal activities at Site 6, a horizontal infusion gallery was constructed to perform in injections. An enhanced bioremediation pilot test was conducted at Site 6 in 2007 in which Edible Oil Substrate (EOS) and Vitamin B12 supplement were gravity-fed sequentially into the infusion gallery. The overall conclusions were that the injection of EOS and the Vitamin B12 Supplement had a beneficial effect on decreasing the concentration of chlorinated VOCs in the groundwater at Site 6.

An RI was conducted at Site TU009 in June and November 2016 to evaluate the impact of chemicals in soil and groundwater on human health and the environment based on recommendations from the SI. During the RI, seven soil samples were collected from three boreholes (SC-TU009-MW001 through SC-TU009-MW003) and analyzed for SVOCs and metals. In addition, one boring (SC-TU009-MW003) was completed as a permanent groundwater MW. Four groundwater samples were collected from the one new MW (SC-TU009-MW009) and two existing IRP Site 6 MWs (6MW22 and 6MW24) and analyzed for SVOCs during the first sampling event (June 2016). One additional sample was collected from the one new MW during a second sampling event (November 2016) and analyzed for metals.
