# Air National Guard

Schenectady Air National Guard Base

Site 3 and Site 6

Interim Removal Action / Focused Feasibility Study

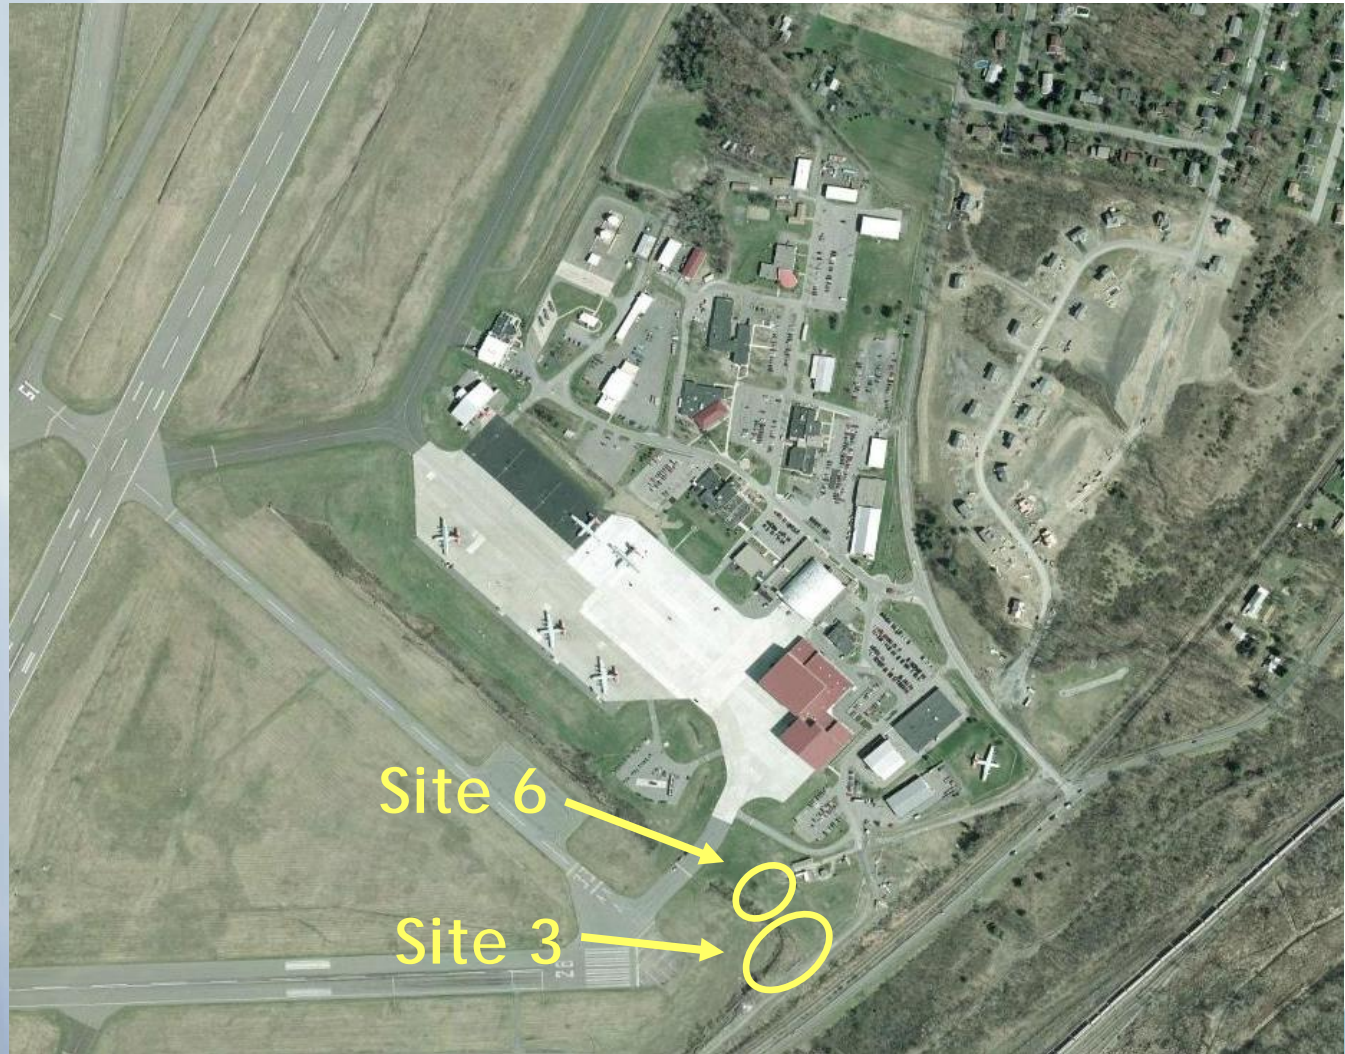
## Site Locations

- ❖ Site 3 - Drum Burial Area
- ❖ Site 6 - Suspected Spill Area

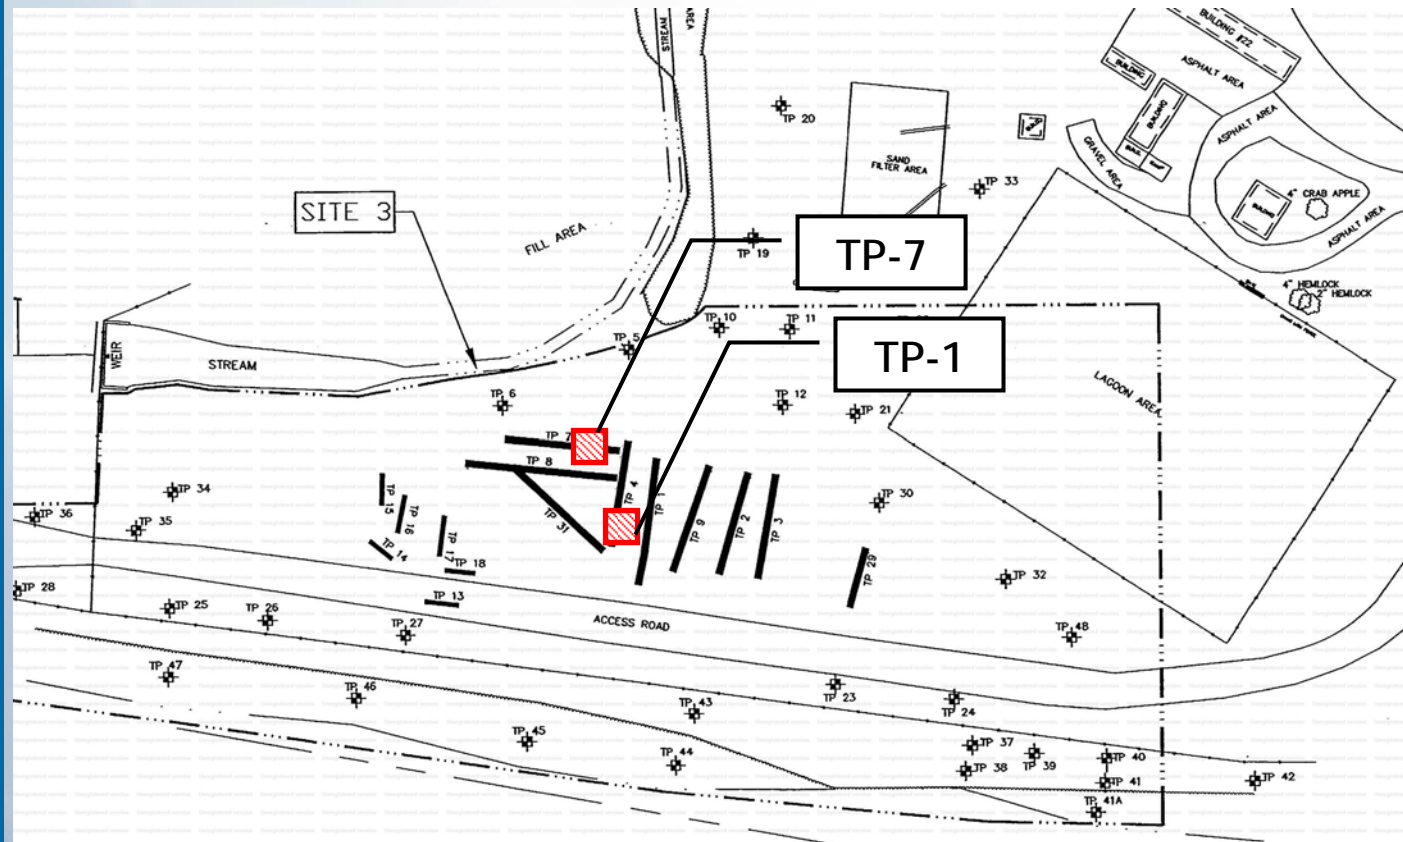
## Site 3 - Background

- ❖ 48 Test Pits
- ❖ 6 Test Pits sampled
- ❖ Two Test Pits had exceedences of NYSDEC TAGM levels:
- ❖ TP-1: BTEX/debris
- ❖ TP-7: SVOCs/debris

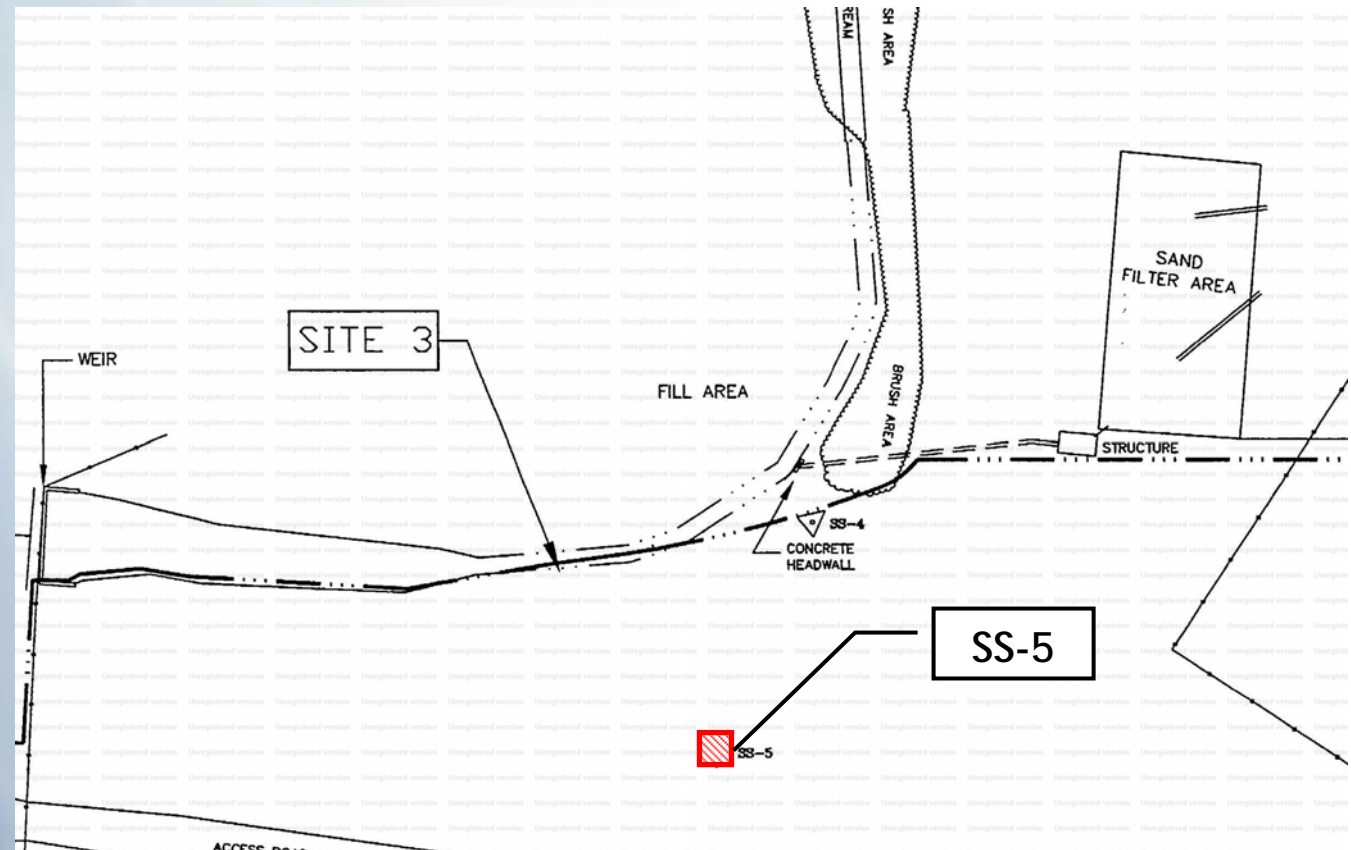
## Site 3 - Background

- ❖ 2 Surface Soils Sampled
- ❖ SS-5: TAGM Exceedences of PAHs

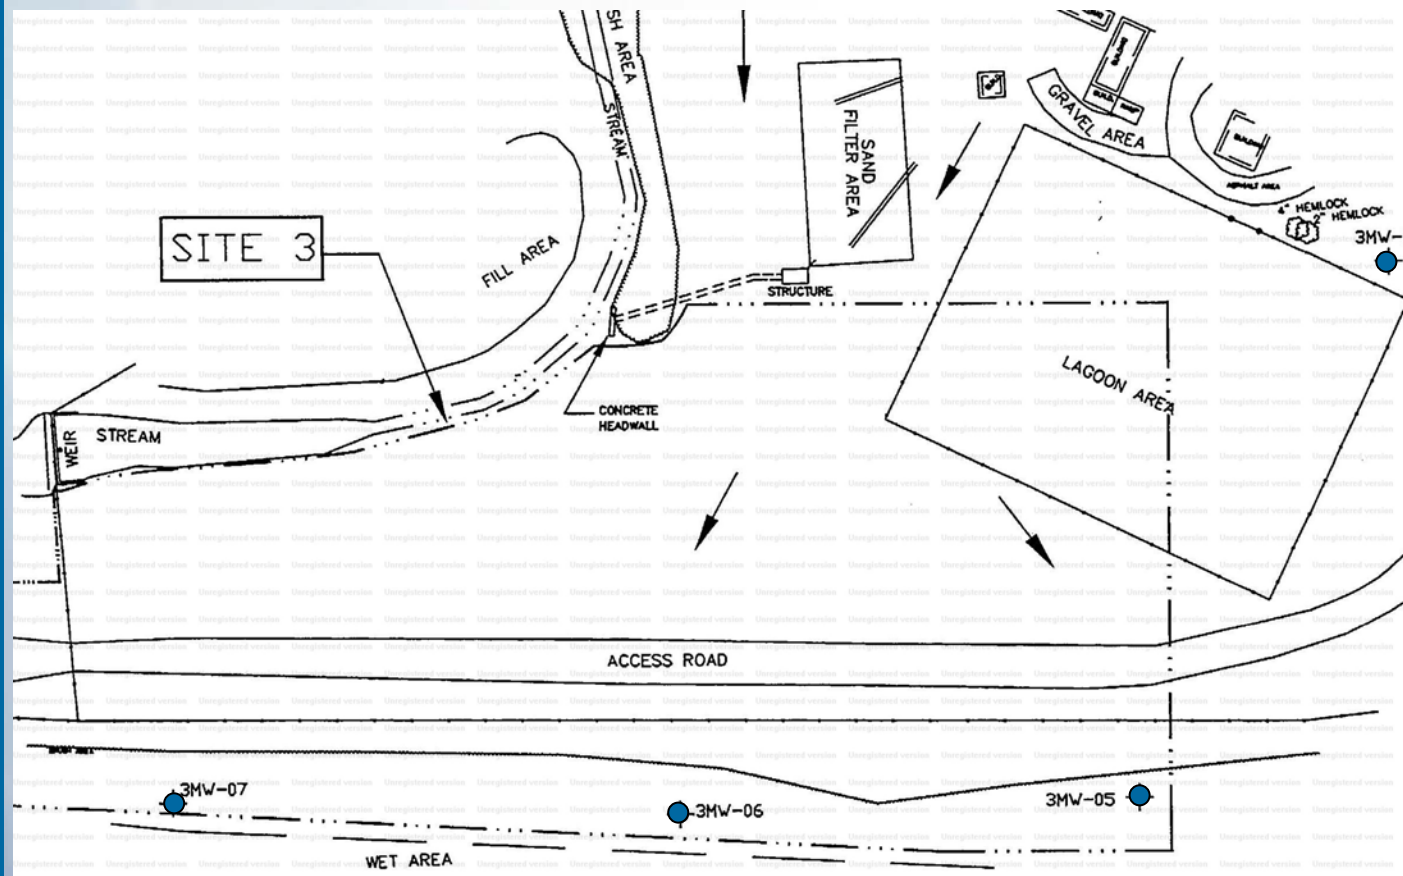
## Site 3 - Background

- ❖ 4 Groundwater Wells Installed
- ❖ Sampled  
Oct 1999  
Dec 1999
- ❖ No site contaminants detected

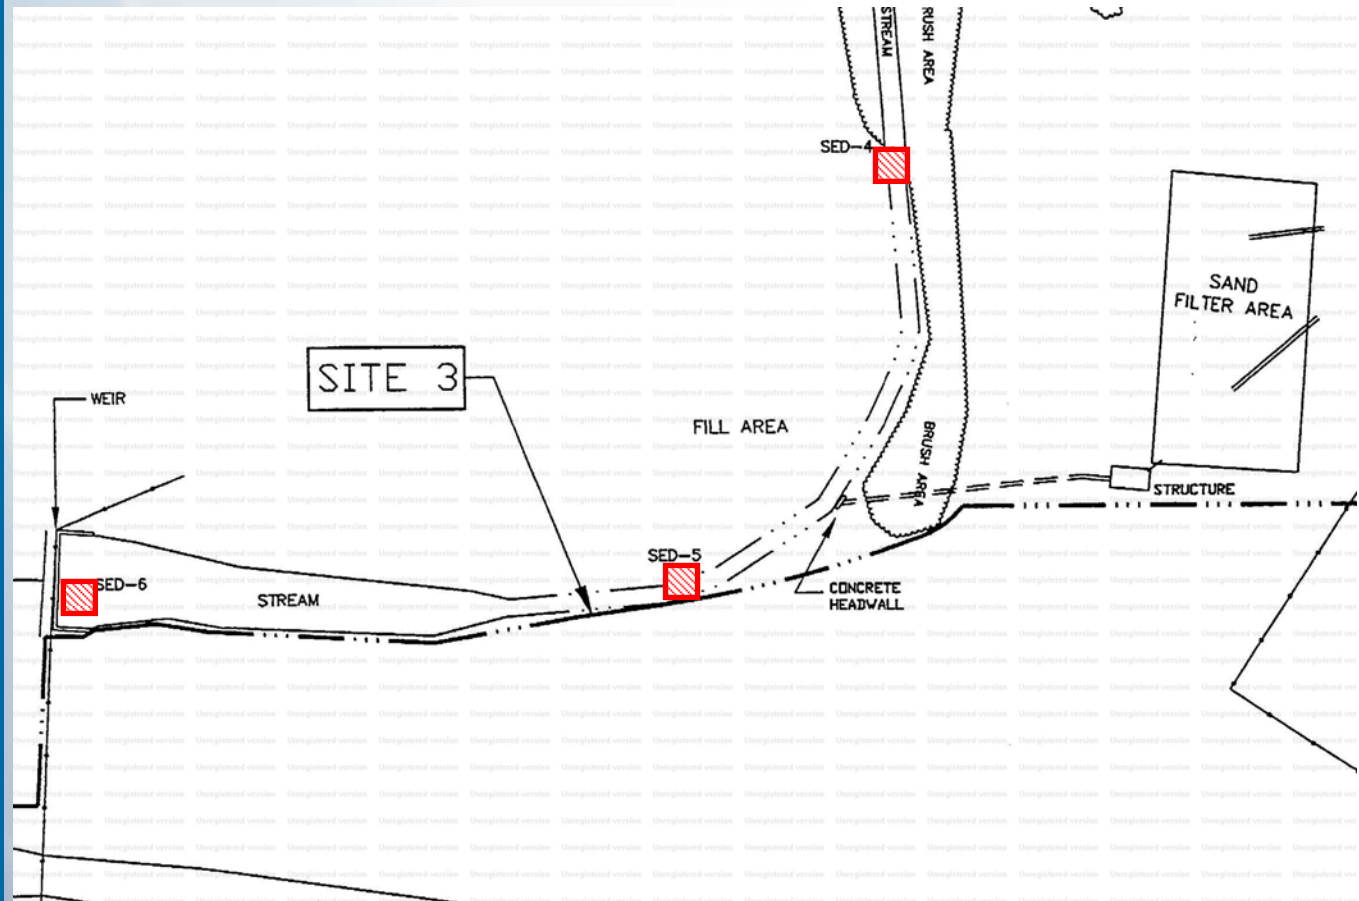
## Site 3 - Background

- ❖ 3 Sediment Samples
- ❖ NYSDEC cleanup standard exceedences of PAHs in each sample

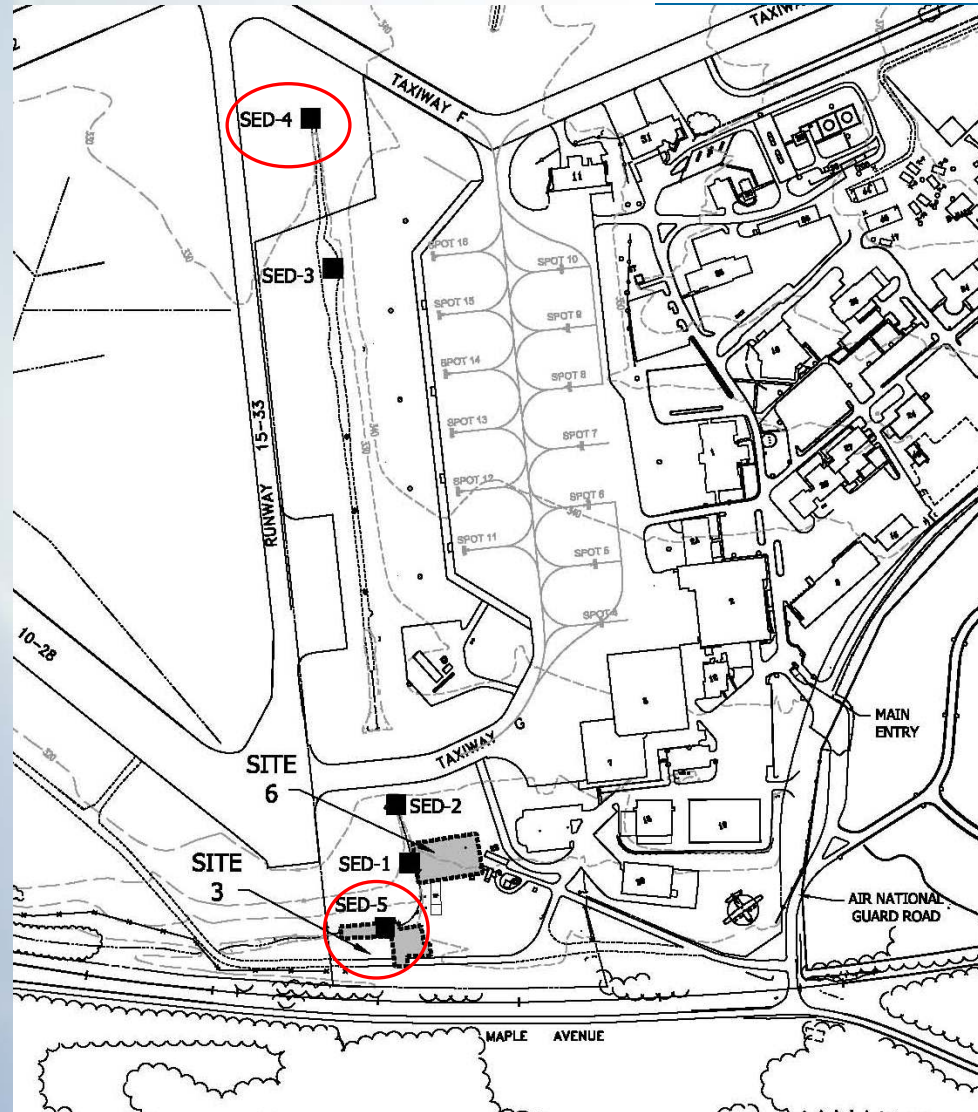
## Site 3 - Background

- ❖ 5 Sediment Samples
- ❖ NYSDEC cleanup standard exceedences of PAHs in
  - SED-5 (44,800 ppb)
  - SED-4 (1,460 ppb)

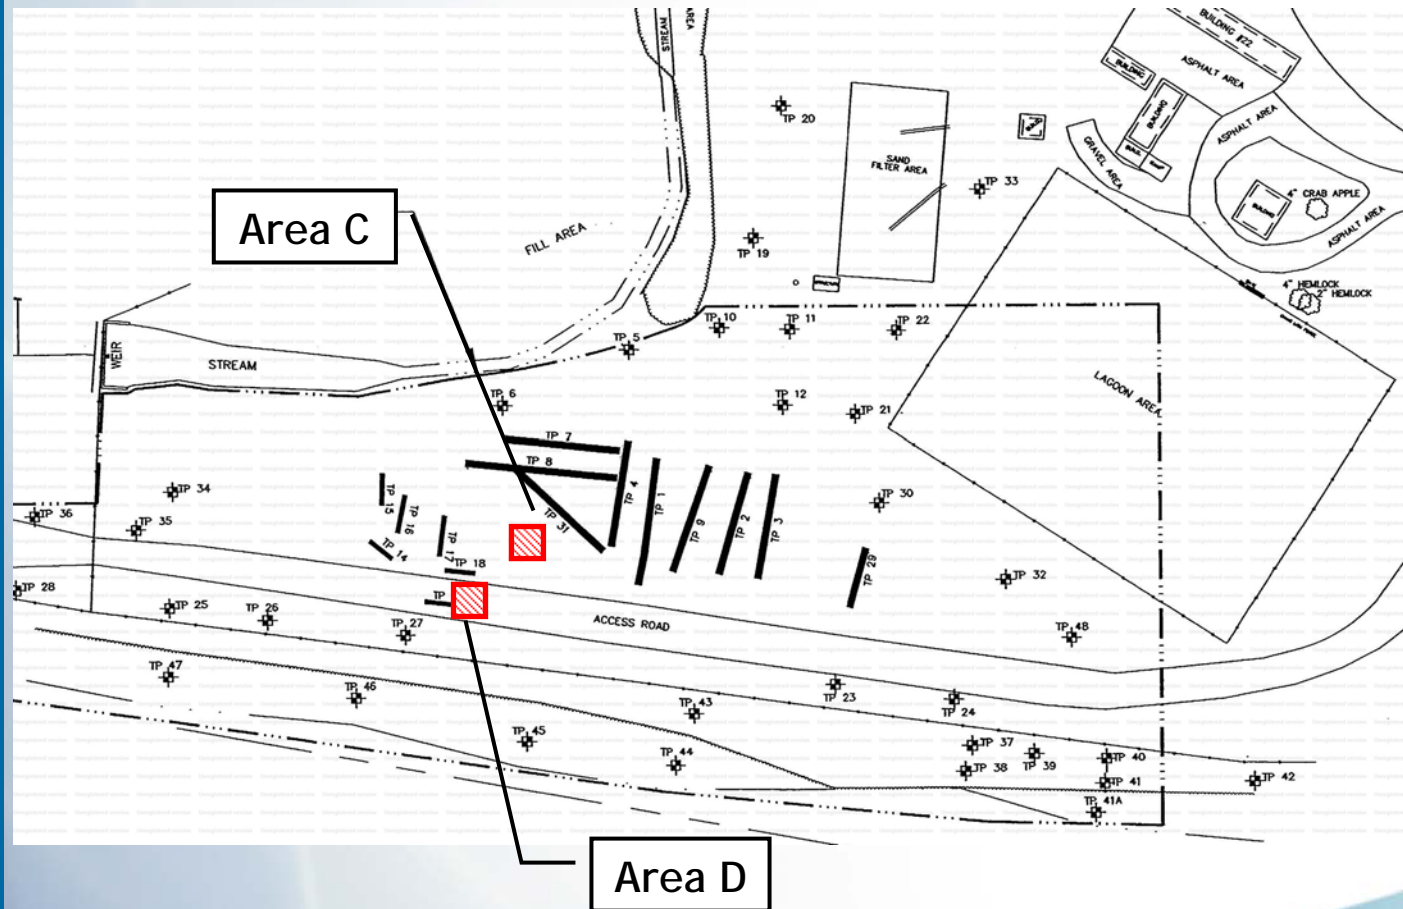
## Site 3 - Geophysical Survey

- ❖ Area C:  
Group of buried  
metallic anomalies  
(unidentified); depth  
unknown
- ❖ Area D:  
Group of buried  
metallic anomalies  
(unidentified); depth  
of 2- to 4-ft

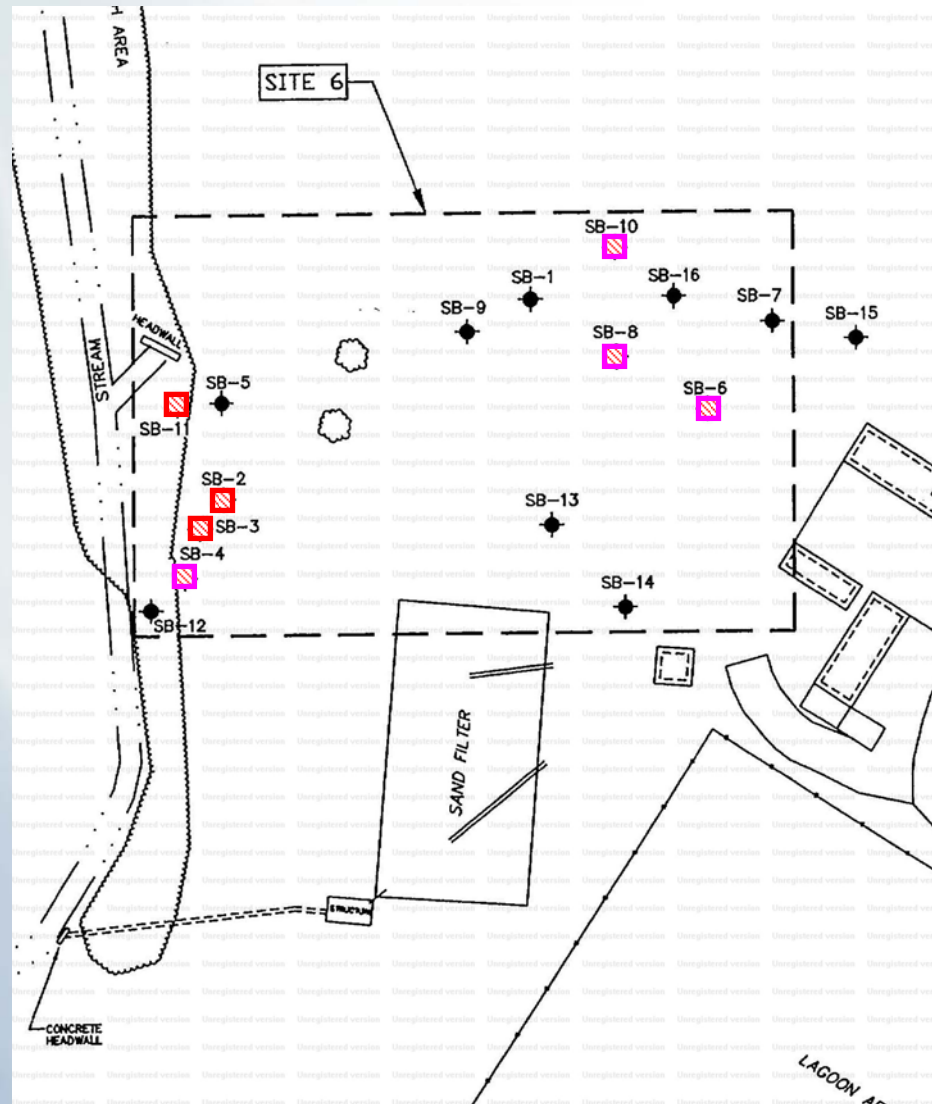
## Site 6 - Background

- ❖ 16 Soil borings advanced
- ❖ Sampled based on PID screening
- ❖ Chlorinated hydrocarbon exceedences: SB-2,-3, and -11
- ❖ High PID readings: SB-4,-6,-8, and -10
- ❖ No exceedences: SB-1,-5,-7,-9,-12,-13,-14,-15, and -16

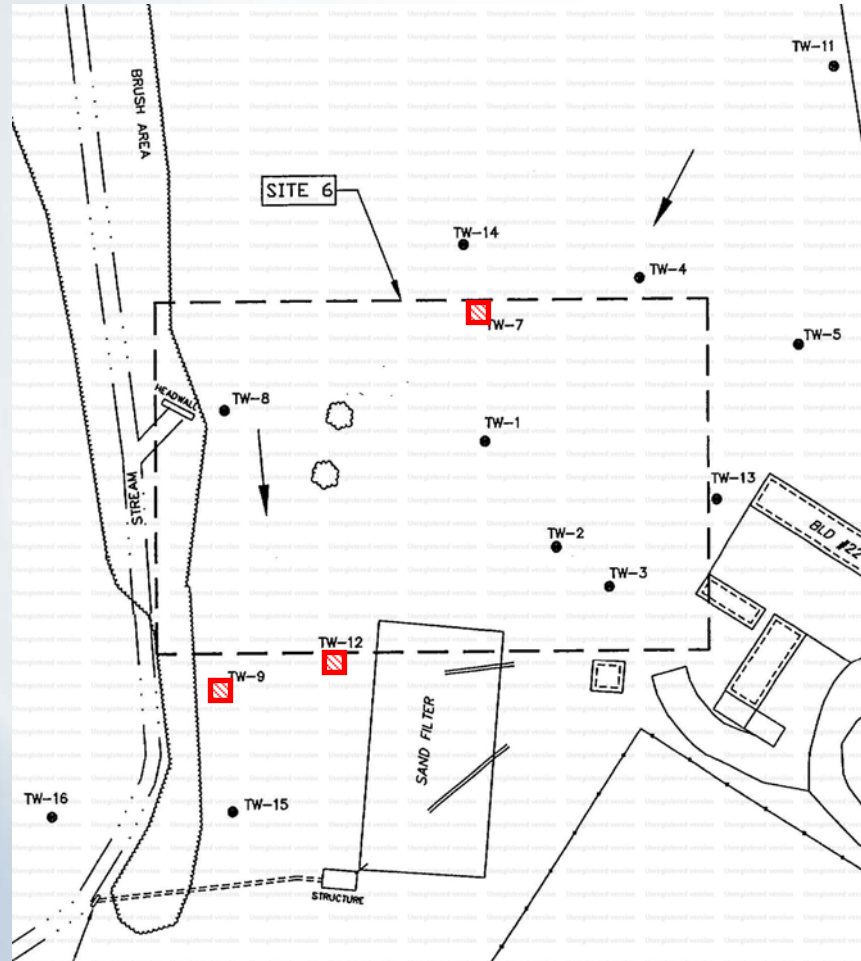
## Site 6 - Background

- ❖ 16 Temporary wells installed
- ❖ Screened for VOCs
- ❖ MCL exceedences of chlorinated hydrocarbons: TW-7, -9, and -12

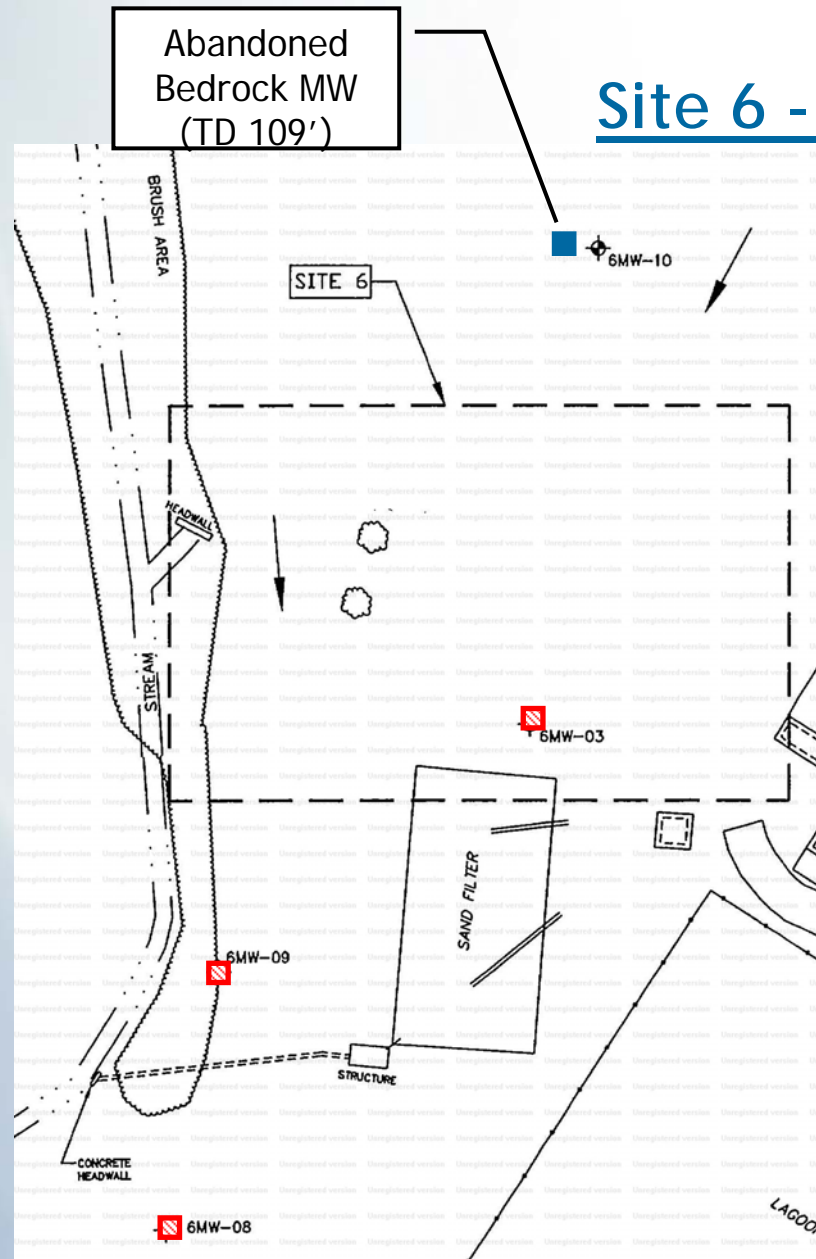
- ❖ 4 Groundwater wells installed; 1 deep bedrock boring
- ❖ Two sampling rounds: Oct & Dec 1999
- ❖ VOC exceedences: 6MW-03, -09, and -08

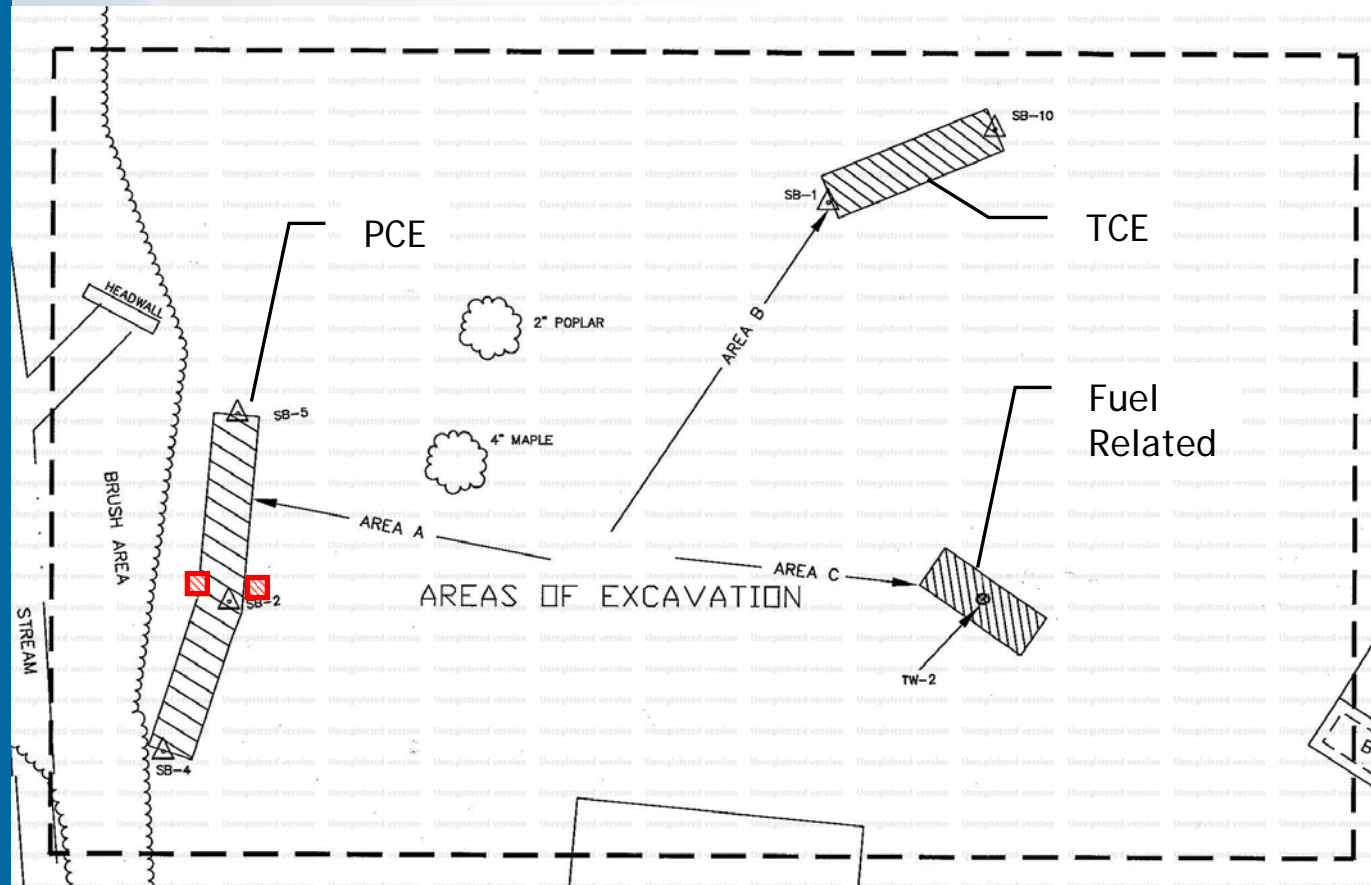
## Site 6 - Background

- ❖ TCRA occurred in April 2002
- ❖ TCRA resulted in excavation of 3 areas: A, B, and C
- ❖ Soil excavated to a depth of 8 ft
- ❖ ~170 CY removed
- ❖ Disposed at ESMI
- ❖ Area A: 2 failed confirmation samples (PCE)
- ❖ Areas B and C: no failed confirmation samples

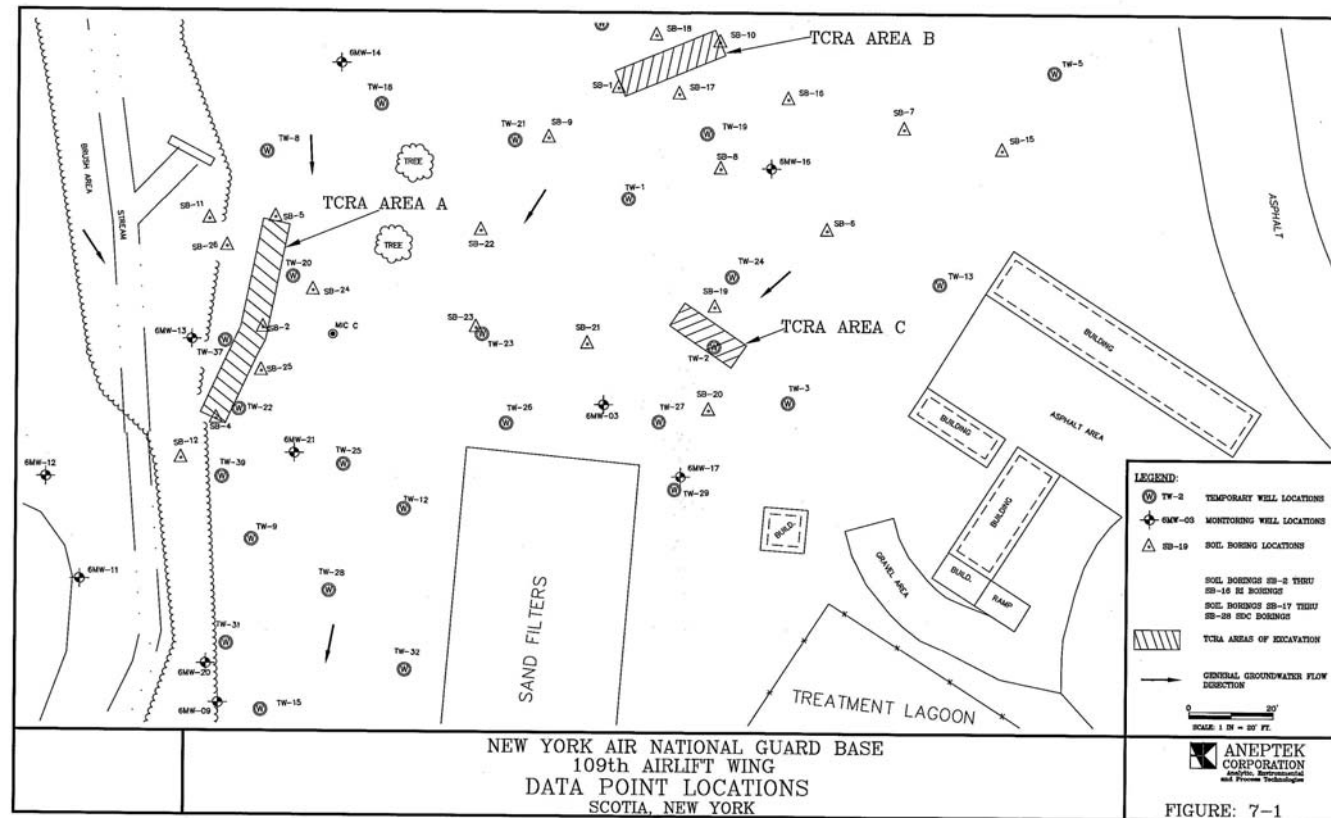
## Site 6 - Background

- ❖ 12 Soil borings: sampled for VOCs, SVOCs, metals based on field screening
- ❖ 23 Temporary wells: GC screening for VOCs
- ❖ 11 Monitoring wells installed & 15 MWs sampled for VOCs, SVOCs, metals in Jun and Aug 2002

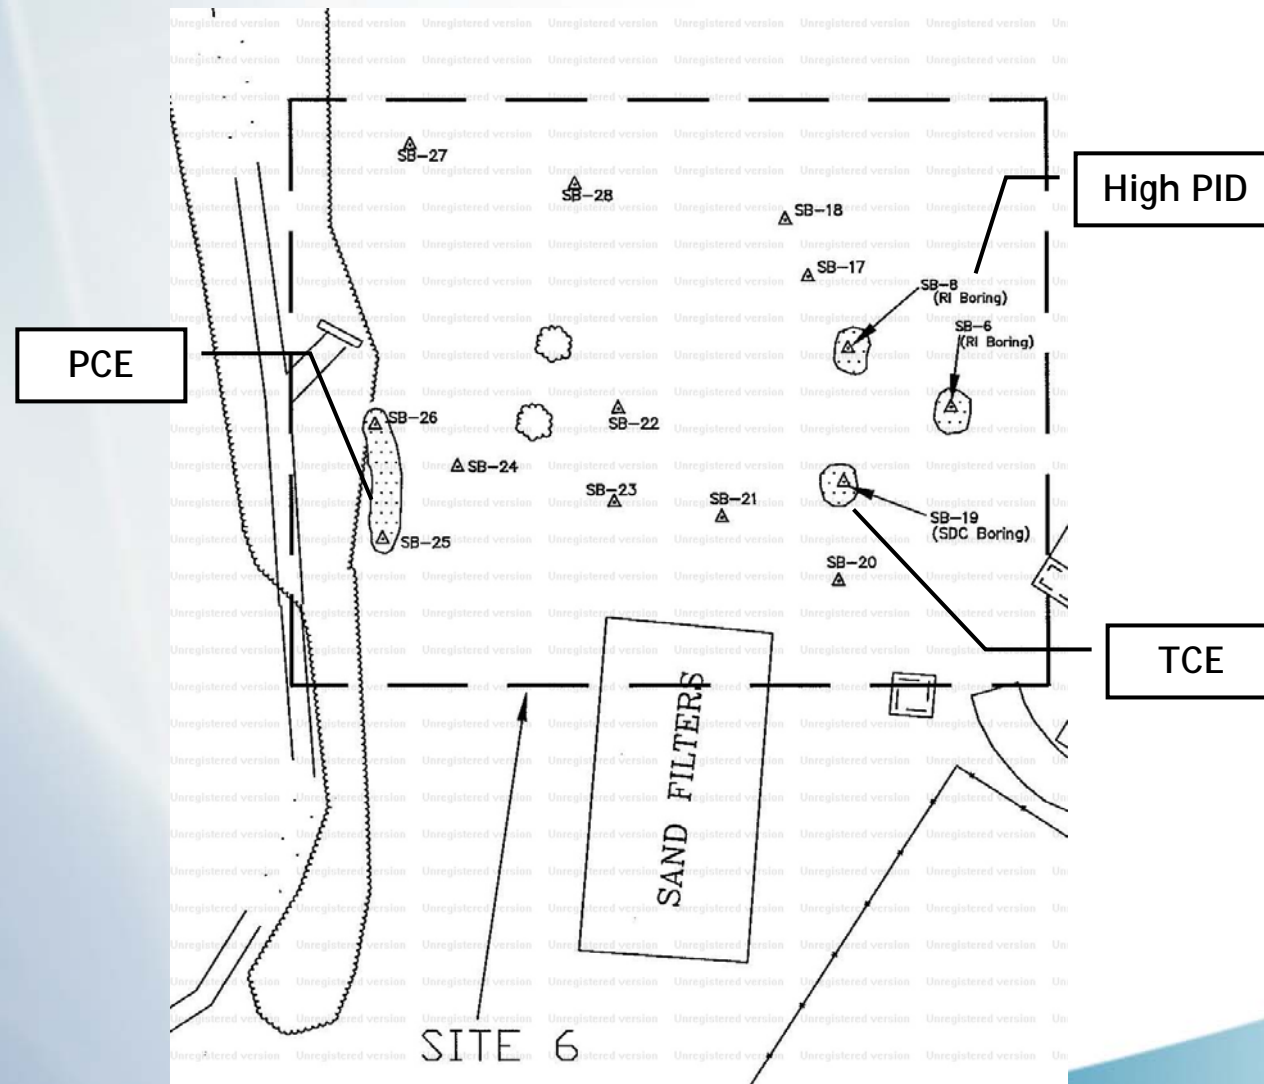
## Site 6 - Background

- ❖ Two new “hot spots” identified; two existing from RI
- ❖ SB-25 and SB-26: PCE
- ❖ SB-19: TCE
- ❖ SB-6 and SB-8: high PID readings (RI)

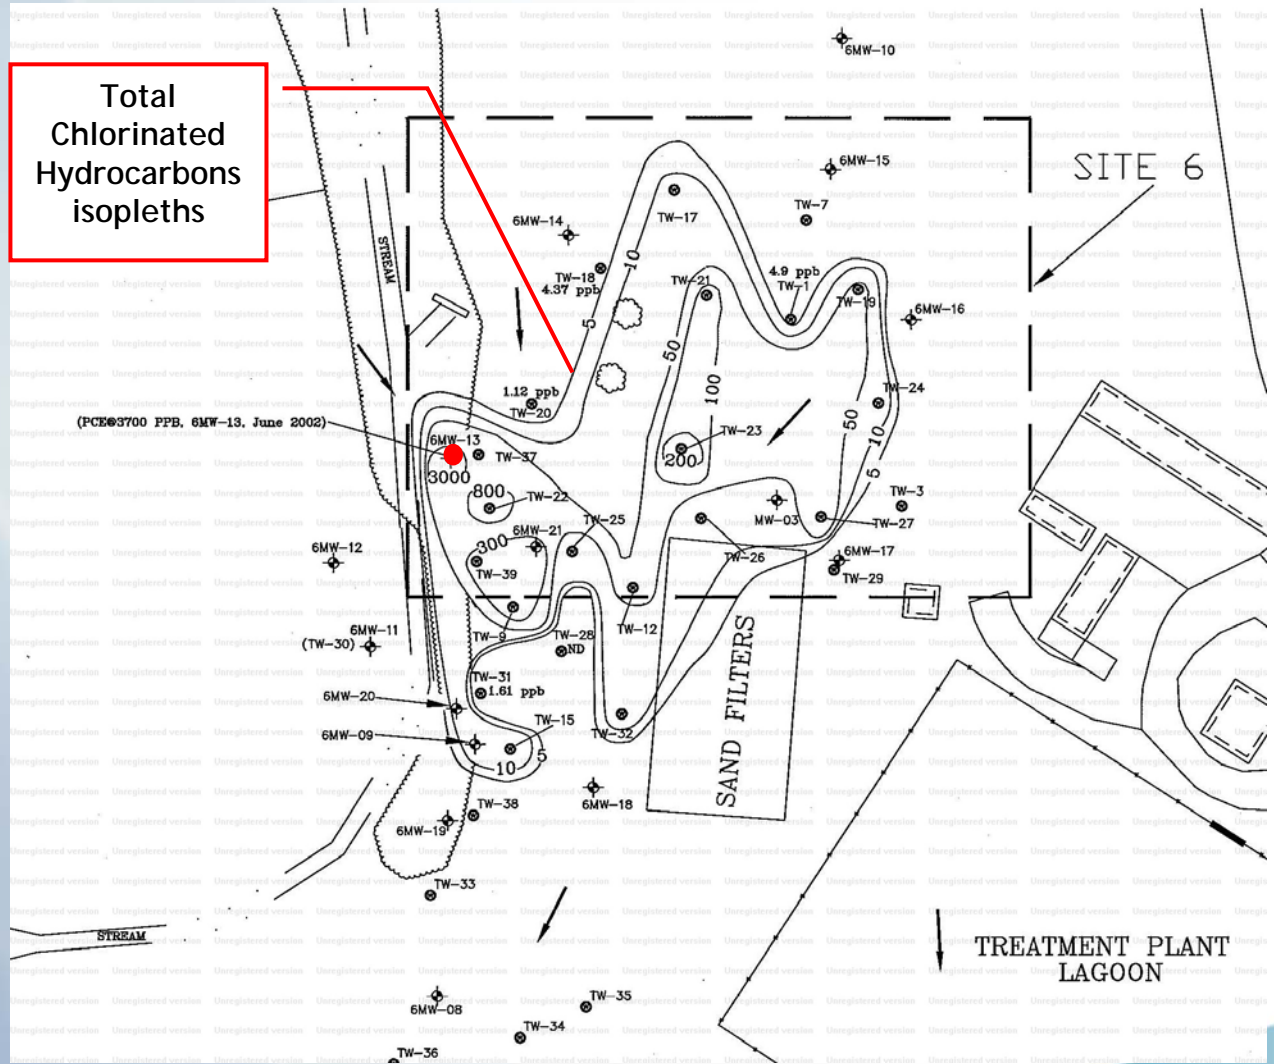
## Site 6 - Background

- ❖ Chlorinated hydrocarbon plume delineated
- ❖ Overburden / weathered bedrock groundwater
- ❖ Max. concentrations ppb (Jun / Aug)  
PCE: 3,700 / 570  
TCE: 18 / 48  
cis-1,2-DCE: 41 / 120  
VC: 2.1 / 6.5

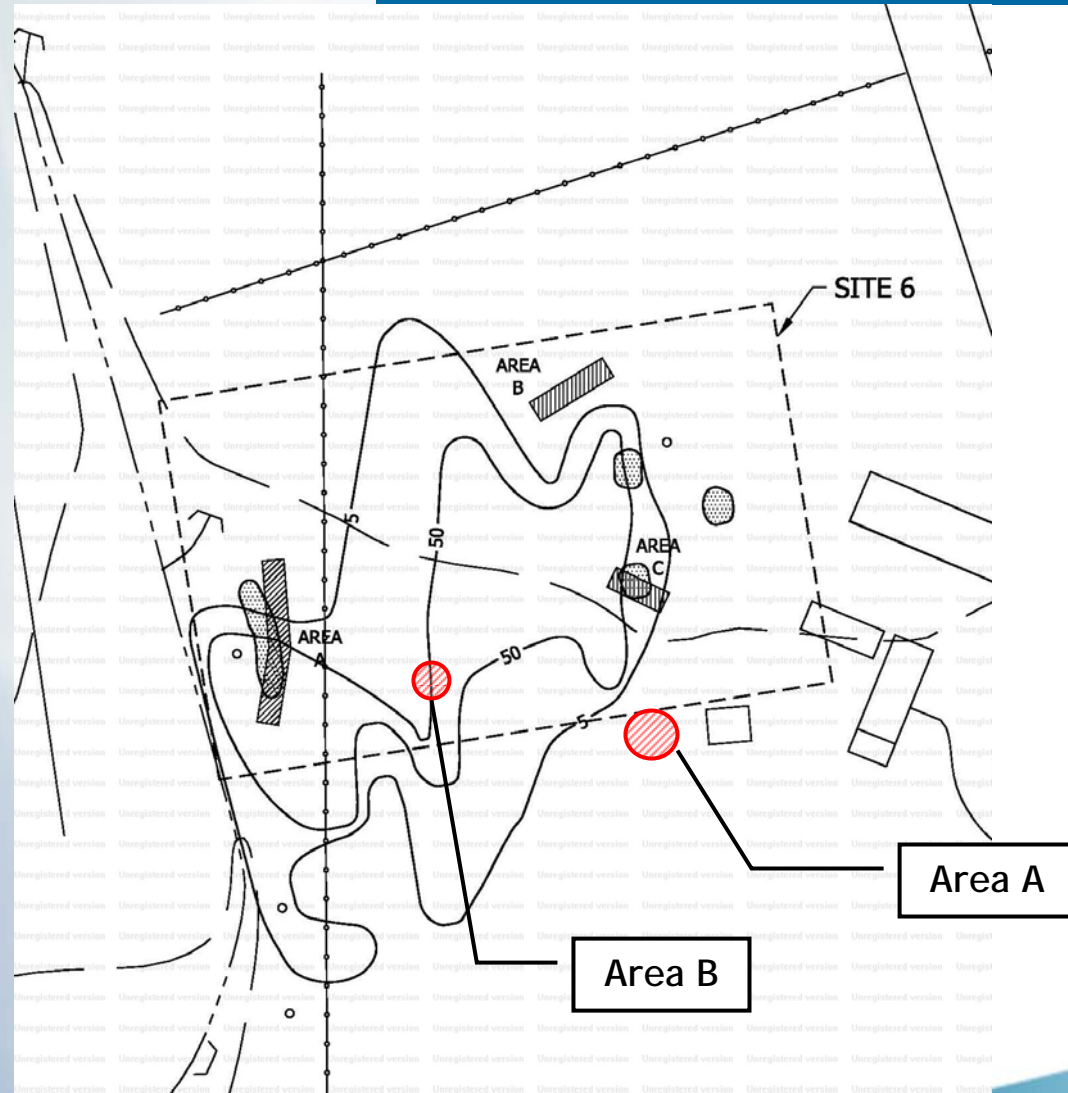
## Site 6 - Geophysical Survey

- ❖ Area A: Buried metallic anomaly (tank?); depth of ~ 2 feet
- ❖ Area B: Buried metallic anomaly (rectangular shape suggest foundation); depth unknown

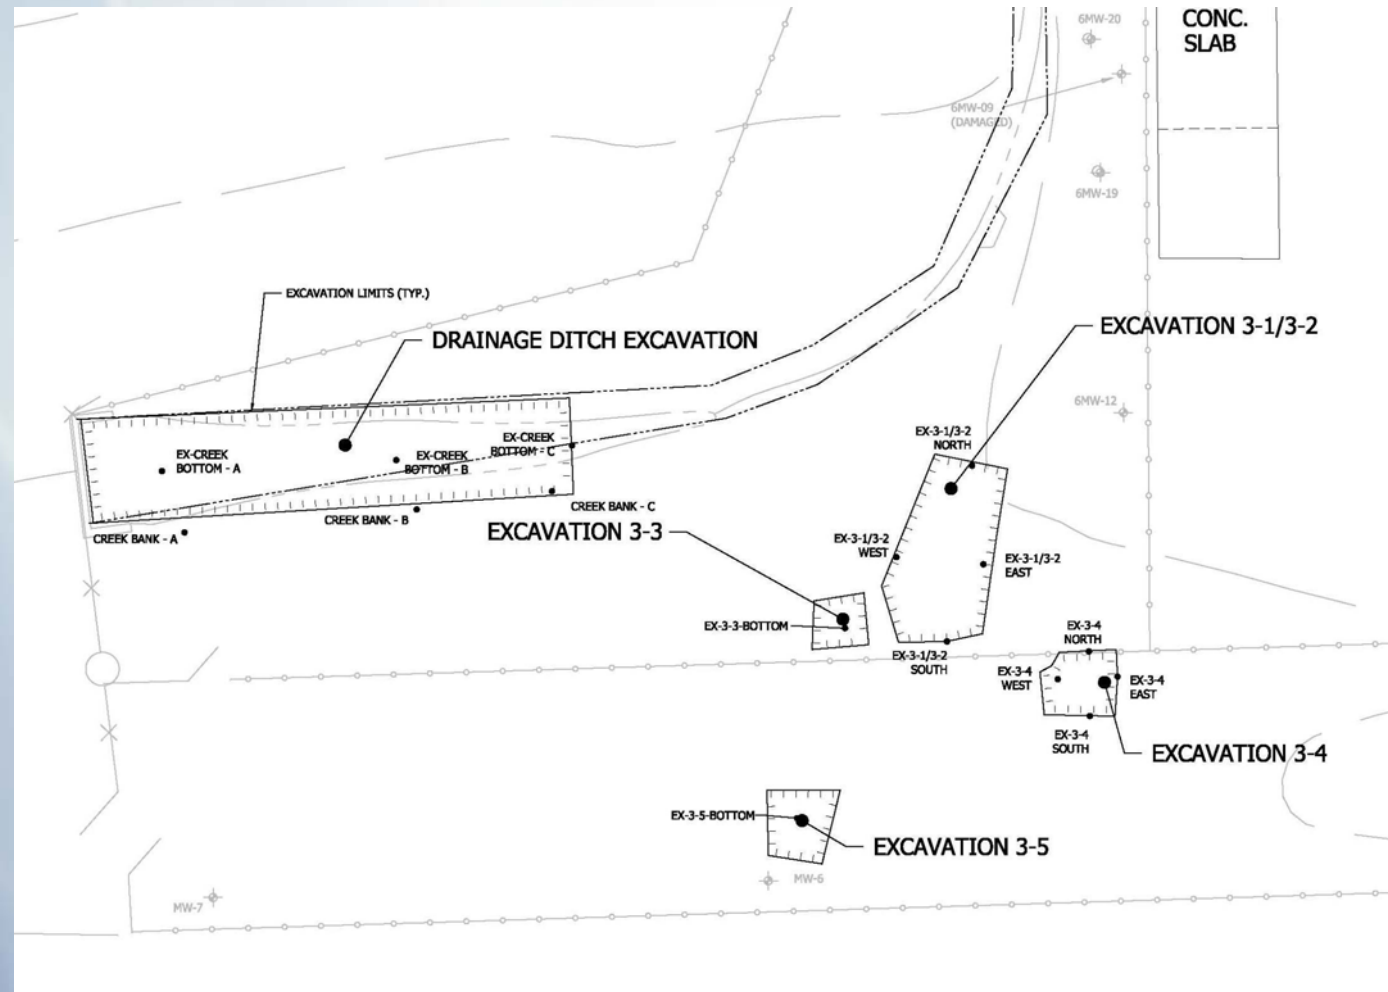
## Site 3 - Interim Removal Actions

- ❖ 5 Excavations
- ❖ EX 3-1/3-2
  - Excavated to Caprock
  - 250 CY Removed
  - 4 Confirm. Samples
- ❖ EX 3-3
  - Excavated 5' in depth
  - 30 CY Removed
  - 1 Confirm. Sample
  - Removed metal debris
- ❖ EX 3-4
  - Excavated to caprock
  - 70 CY Removed
  - 4 Confirm. Samples
  - Removed metal debris
  - Removed 1 drum & 3 paint cans
- ❖ EX 3-5
  - Excavated 5' in depth
  - 40 CY Removed
  - 1 Confirm. Sample
  - Removed metal debris
- ❖ Drainage Ditch
  - All sediment removed
  - 310 CY Removed
  - 3 bank samples taken

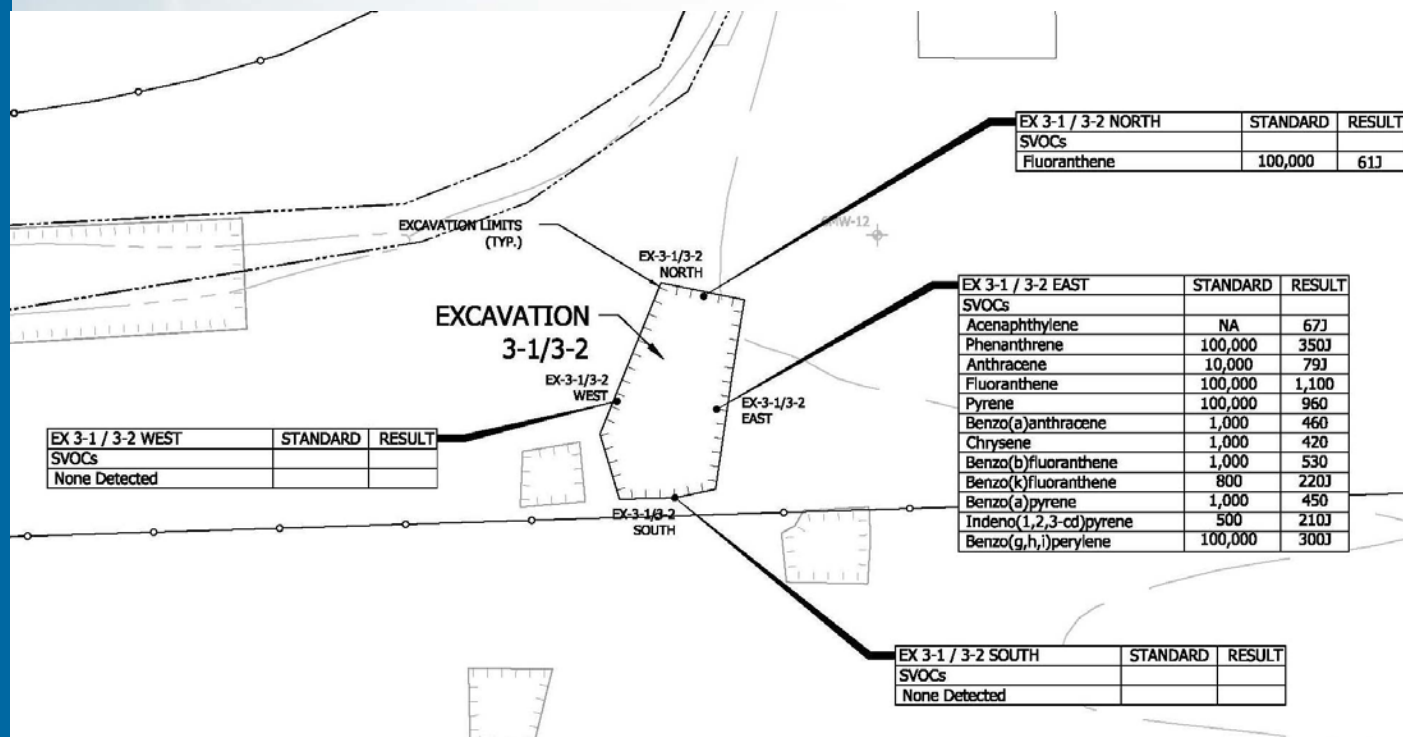
## Site 3 - Interim Removal Actions: EX 3-1/3-2

- ❖ 4 Samples collected along sidewalls
- ❖ Analyzed for SVOCs
- ❖ Several detections, but all less than Part 375 Standard
- ❖ No Further Action

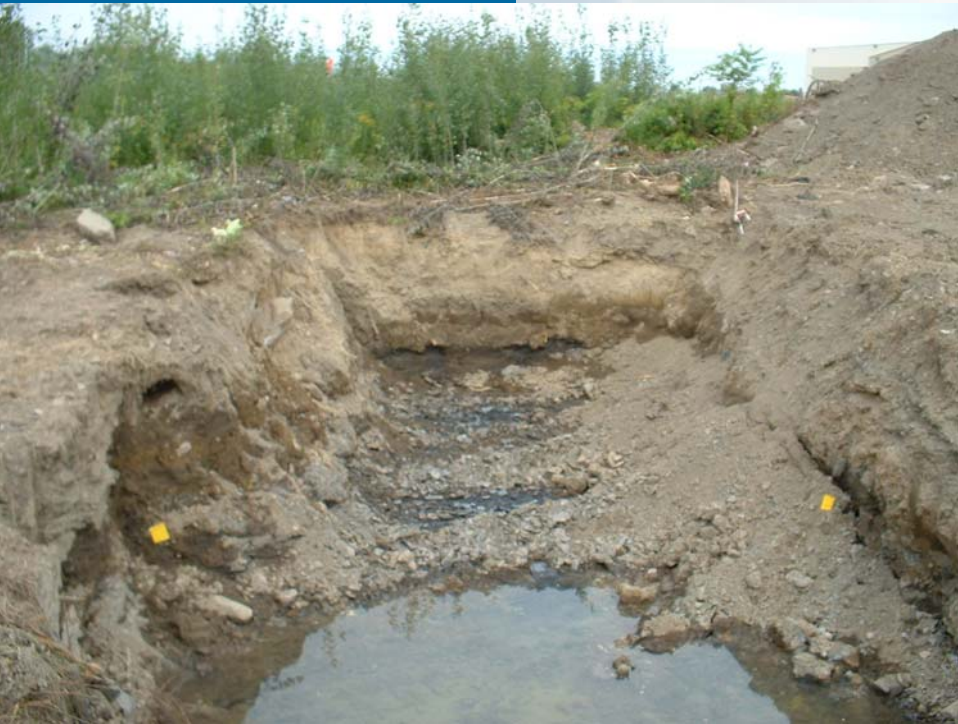
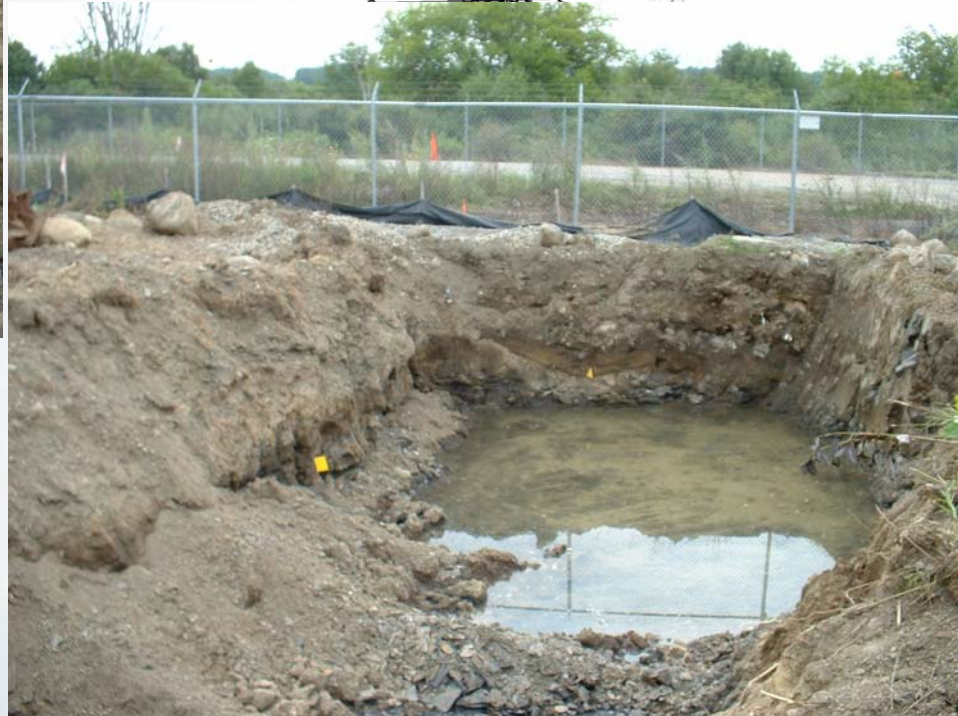
## Site 3 - Interim Removal Actions: EX 3-1/3-2

Looking West

- ❖ 1 Sample collected at base of excavation
- ❖ Analyzed for VOCs, SVOCs, and Metals
- ❖ No Further Action
