# Air National Guard

Schenectady Air National Guard Base

Site 3 and Site 6

Interim Removal Action / Focused Feasibility Study

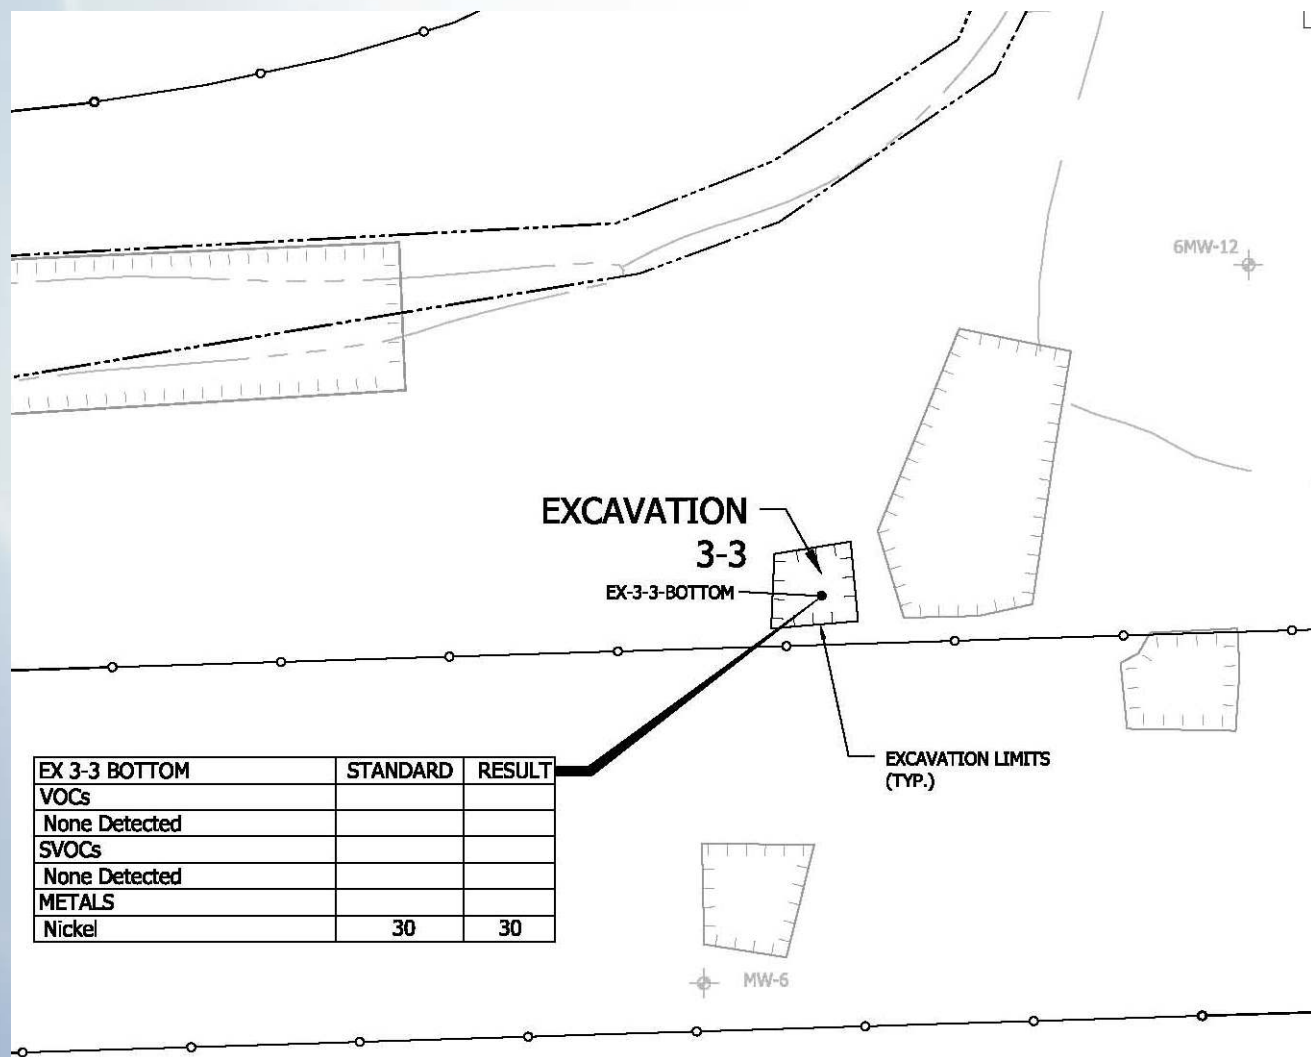
## Site 3 - Interim Removal Actions: EX 3-3

- ❖ 1 Sample collected at base of excavation
- ❖ Analyzed for VOCs, SVOCs, and Metals
- ❖ No Further Action

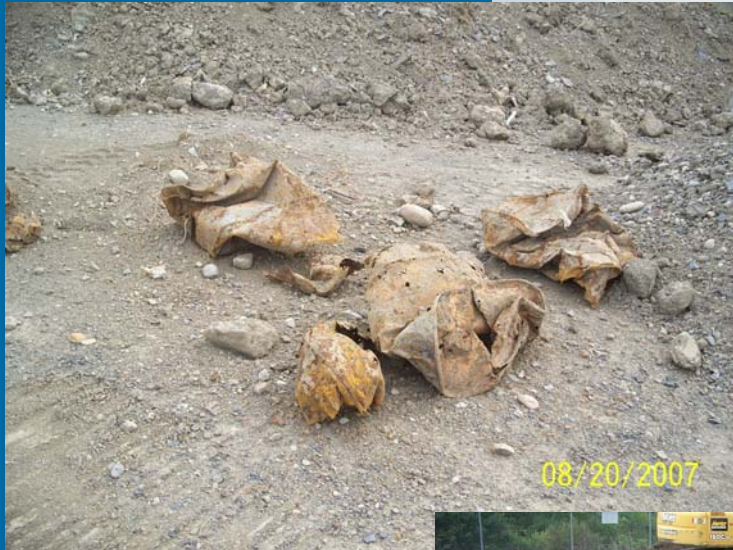
## Site 3 - Interim Removal Actions: EX 3-3

Buried Debris  
Removed from  
Geophysical  
Anomaly

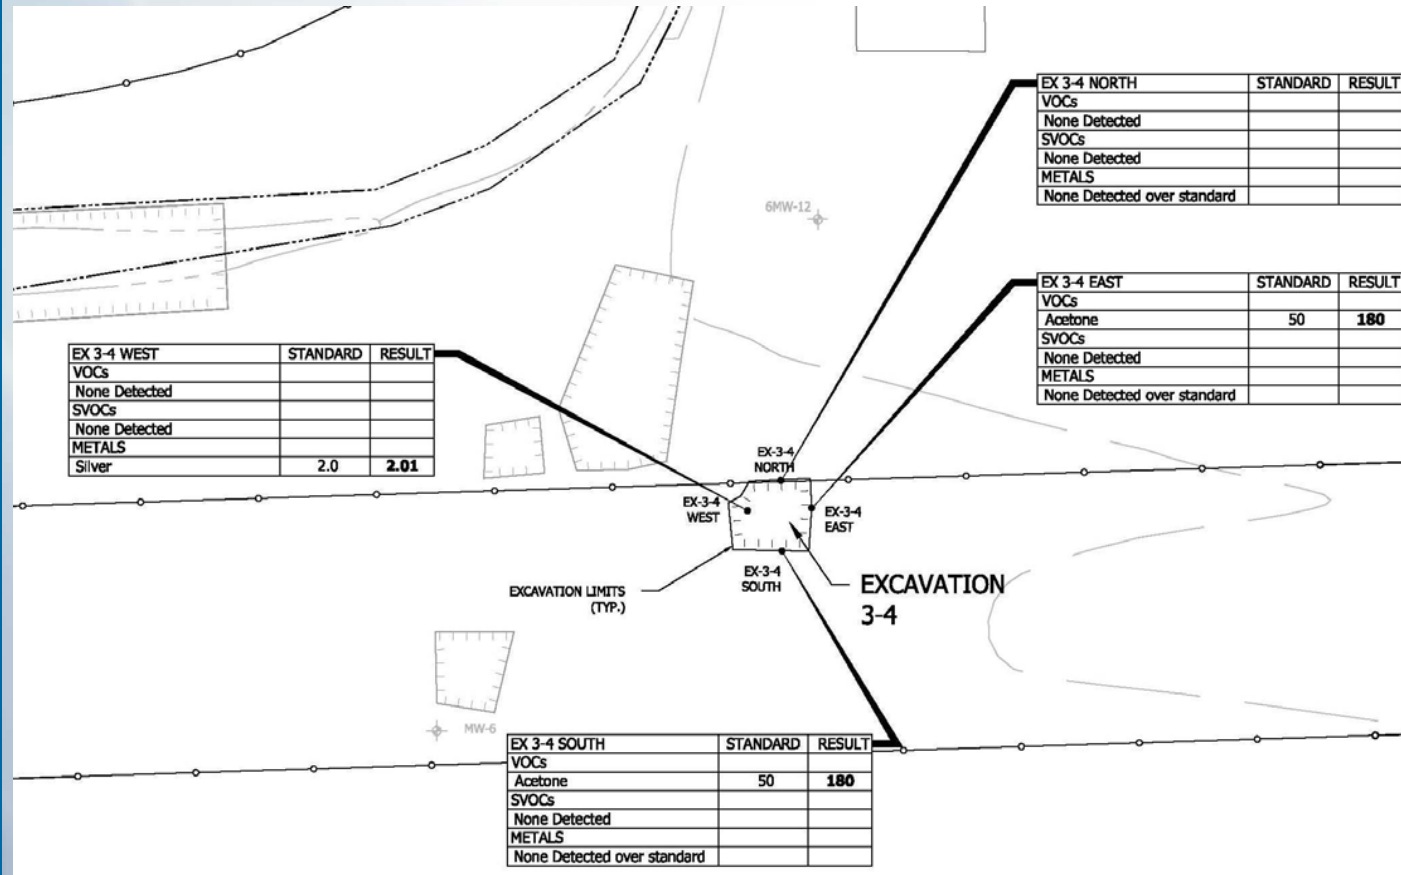
## Site 3 - Interim Removal Actions: EX 3-4

- ❖ 4 Samples collected along sidewalls
- ❖ Uncovered buried drum and 3 paint cans containing dried paint (over packed and disposed off-site)
- ❖ Analyzed for VOCs, SVOCs and Metals
- ❖ Two detections above Part 375 Standard: Acetone (180 ppb / standard 50 ppb)
- ❖ Evaluate with Risk Assessment

- Soil removed to bedrock
- Acetone Exceedence (180 ppb/SCO=50 ppb)
- Silver Exceedence (2.01 ppb/SCO=2.0 ppb)

**Evaluate With Risk Assessment**

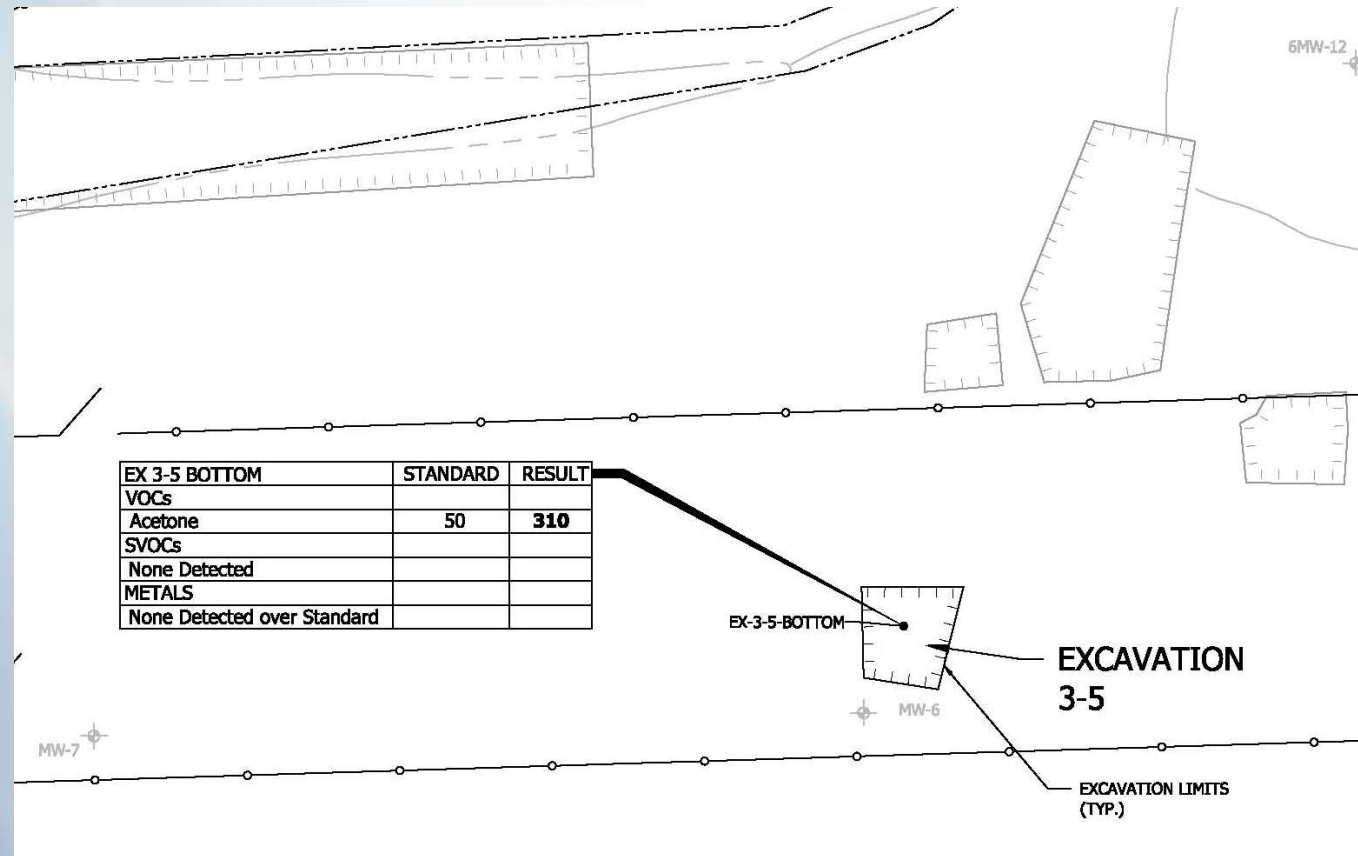
## Site 3 - Interim Removal Actions: EX 3-5

- ❖ 1 Sample collected at base of excavation
- ❖ Analyzed for VOCs, SVOCs, and Metals
- ❖ Only 1 detection above Part 375 Standard
- ❖ Acetone (310 ppb / Standard 50 ppb)
- ❖ Evaluate with Risk Assessment

- Soil removed to 5-ft
- Metal debris removed and recycled
- Acetone Exceedence (310 ppb/SCO=50 ppb)

**Evaluate With Risk Assessment**

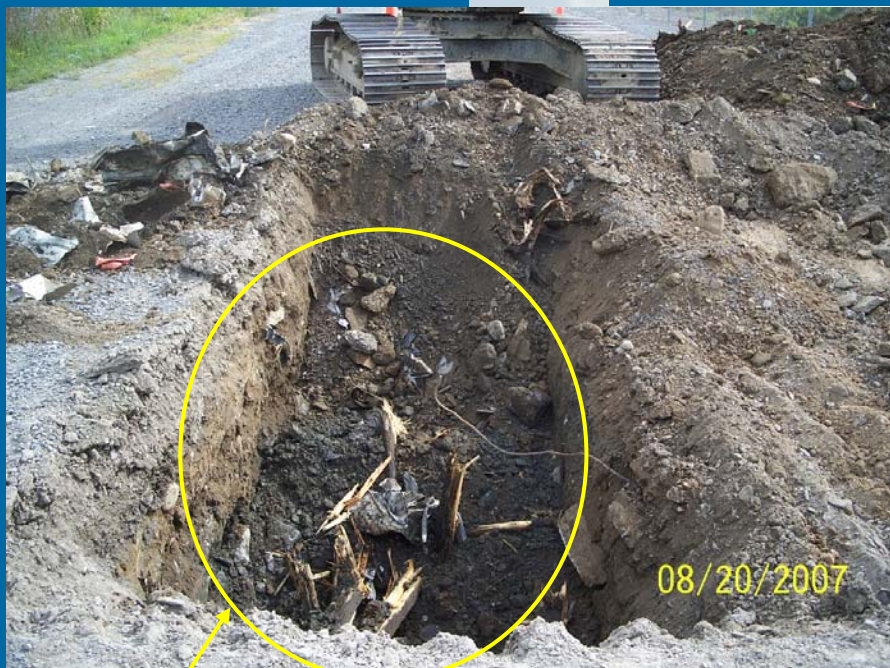
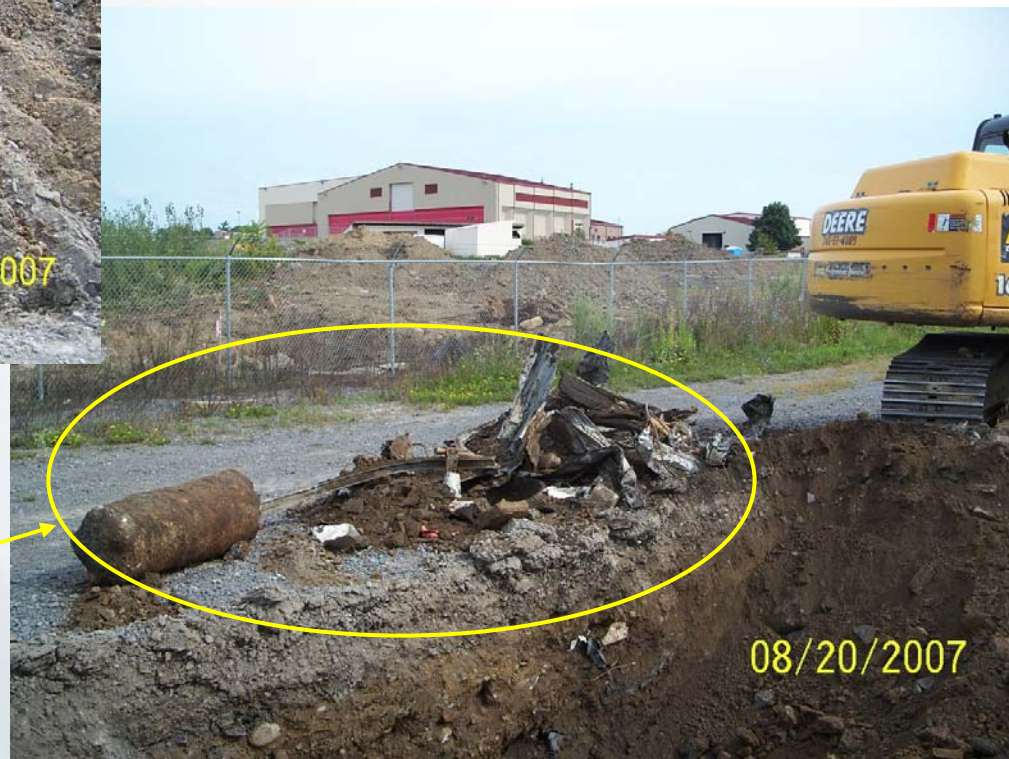
## Site 3 - Interim Removal Actions: EX 3-5

## Buried Debris

Exposed

Removed

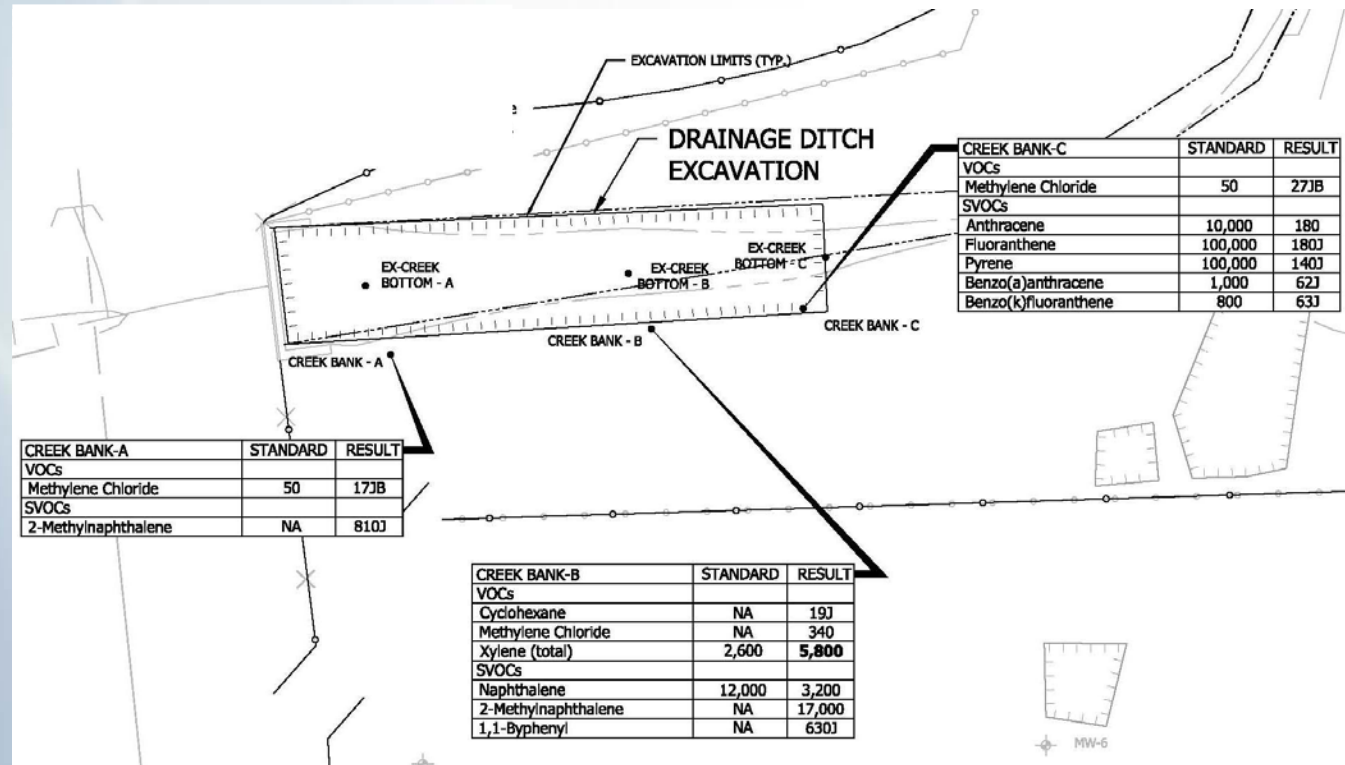
## Site 3 - Interim Removal Actions: Ditch

- ❖ 3 Samples collected along ditch bank
- ❖ Analyzed for VOCs and SVOCs
- ❖ Only 1 detection above Part 375 Standard:  
Xylene (5800 ppb / Standard 260 ppb)
- ❖ Evaluate with Risk Assessment

- All sediment removed
- Xylene exceedence (5800 ppb/SCO=260 ppb) in one creek bank sample (B)

**Evaluate With Risk Assessment**

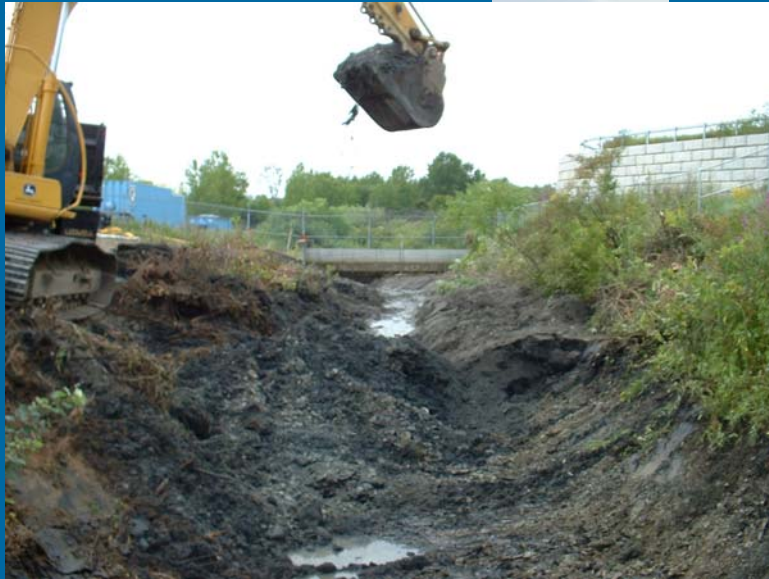
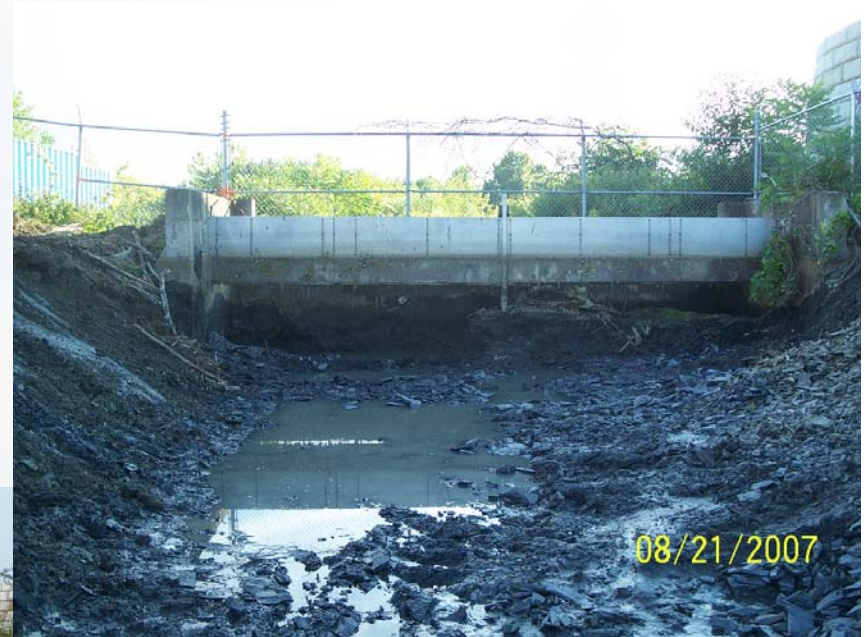
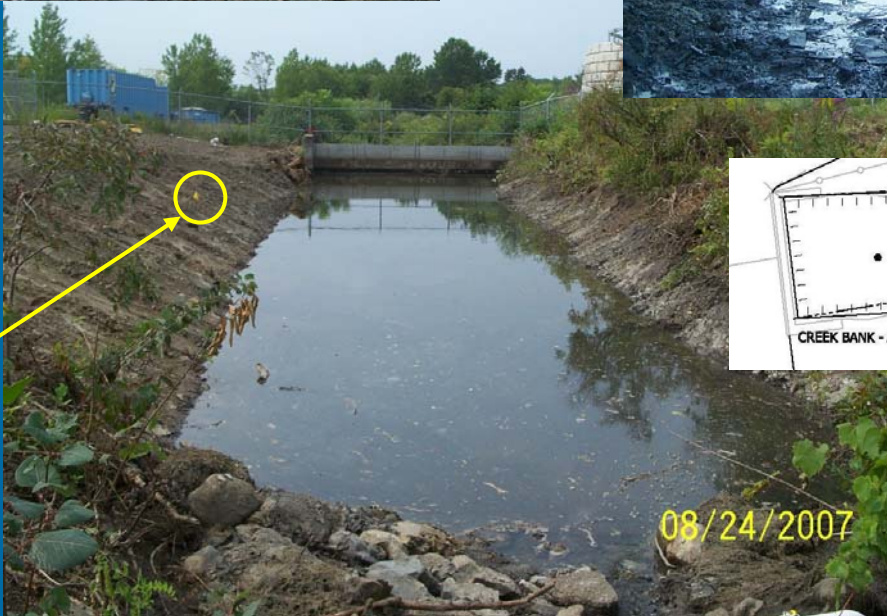
## Site 3 - Interim Removal Actions: Ditch

Bank Sample Location "B"

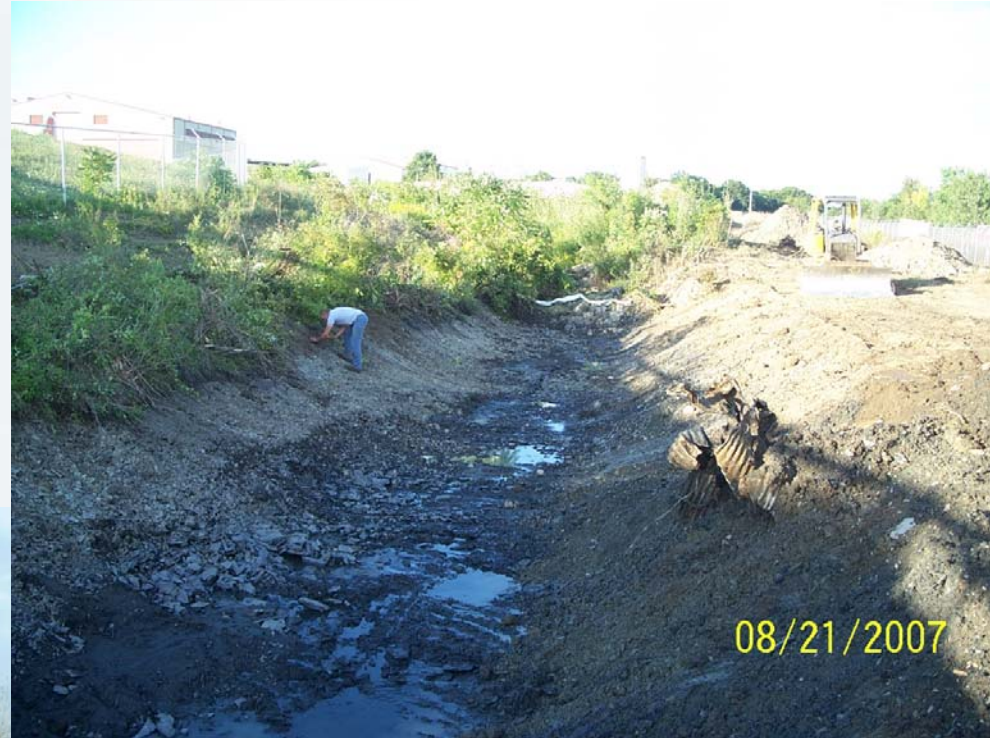
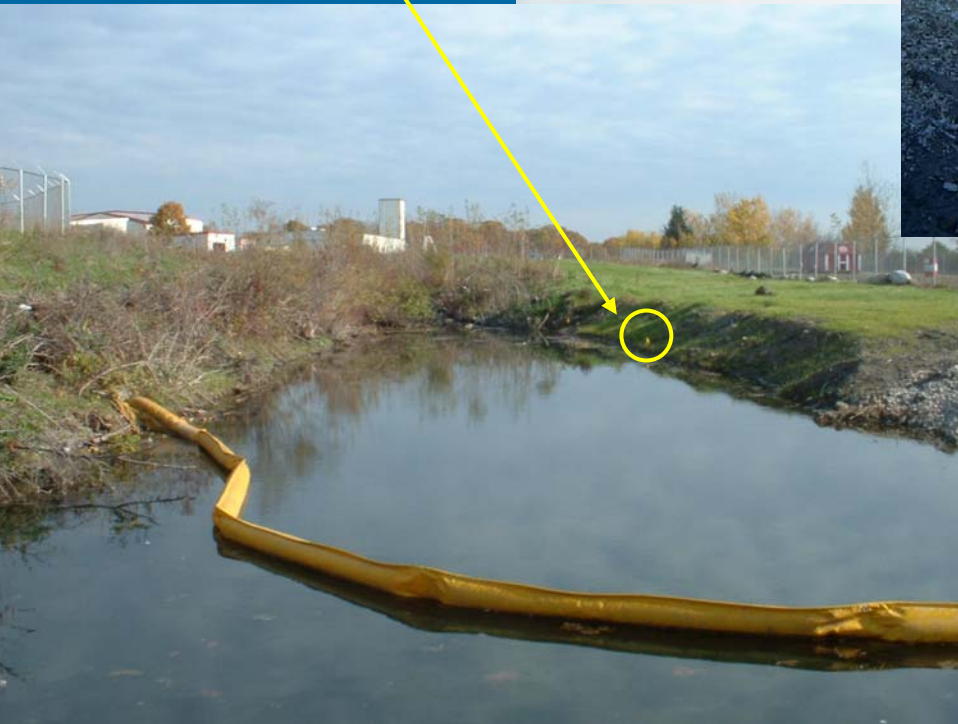
## Site 3 - Interim Removal Actions: Ditch

Bank Sample  
Location "B"

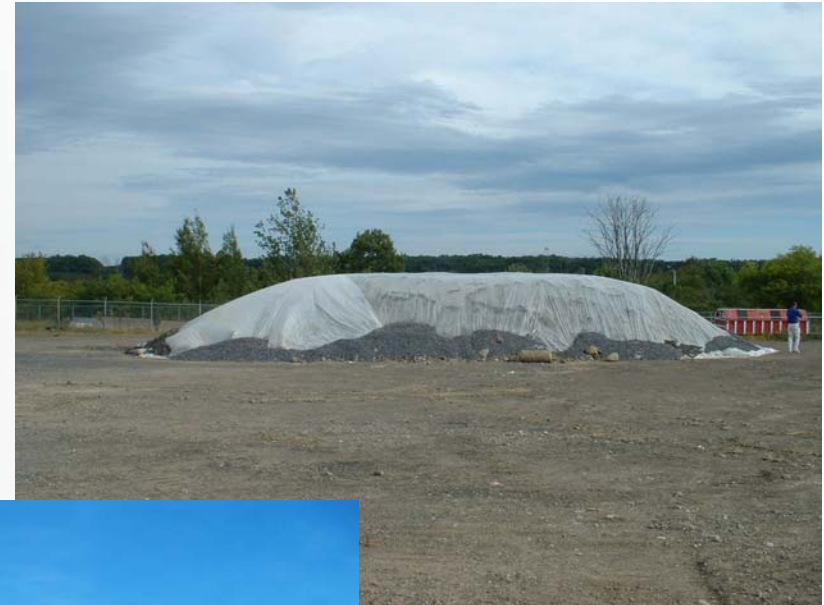
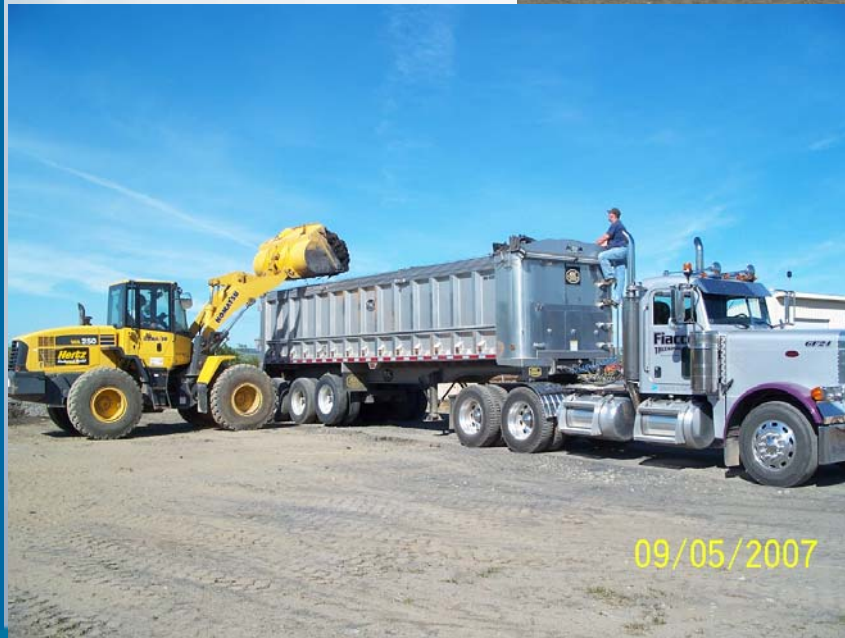
## Site 3 - Interim Removal Actions - Off-Site Disposal

- ❖ 5 Excavations
- ❖ EX 3-1/3-2 (250 CY)
- ❖ EX 3-3 (30 CY)
- ❖ EX 3-4 (70 CY)
- ❖ EX 3-5 (40 CY)
- ❖ Drainage Ditch (310 CY)
- ❖ 807 Tons off site to Town of Colonie Landfill
- ❖ 1 Overpack (drum and paint cans) off site to Chem Cycle, NJ

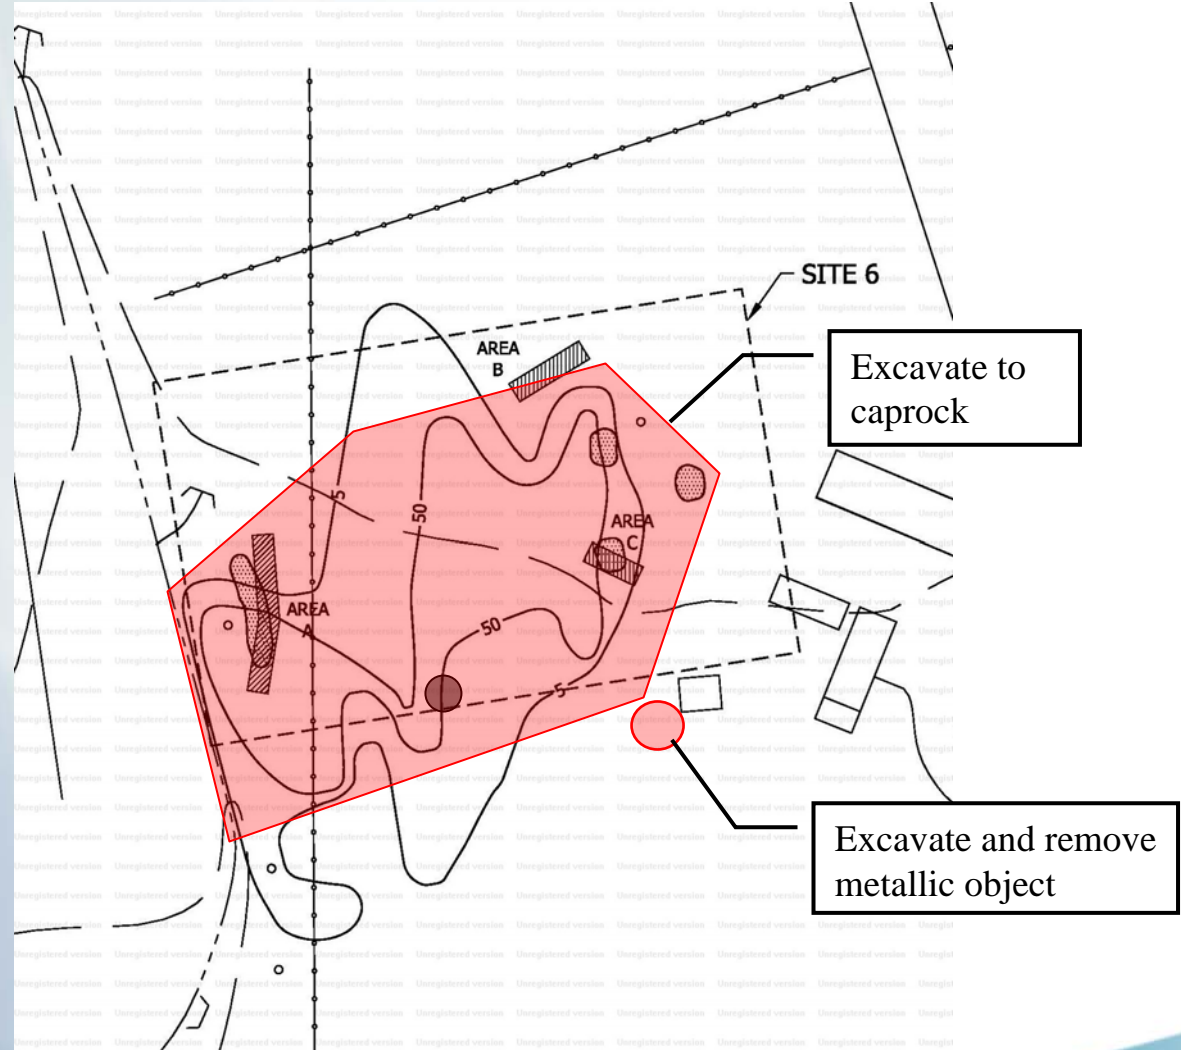
## Site 6 - Interim Removal Action - Proposed

- ❖ Excavate all soil above 50 ppb groundwater plume to caprock
- ❖ Total volume to excavate ~4,500 CY
- ❖ Stockpile excavated soil on site and segregate based on field screening with PID:
  - < 5 ppm
  - < 5 ppm < 50
  - < 50 ppm
- ❖ Stockpiled soil sampled and if results:
  - <Part 375 -> backfill
  - >Part 375 -> off-site
- ❖ Excavate buried metallic object
- ❖ Confirmation sampling

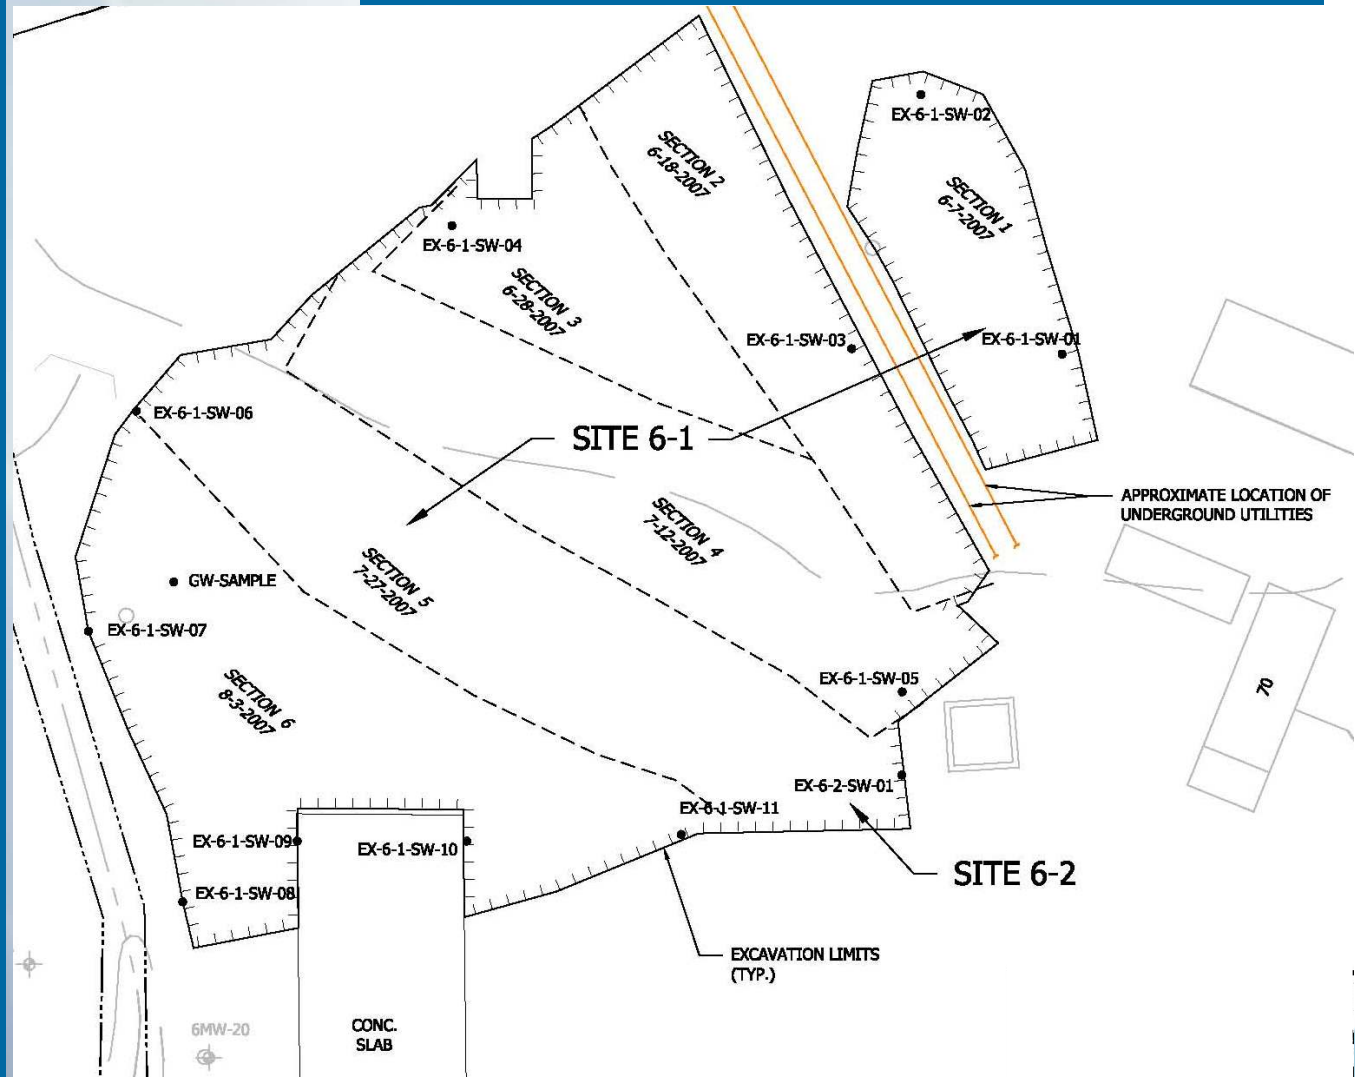
## Site 6 - Interim Removal Actions

- ❖ All soils excavated and segregated with mechanical screener (larger rock used as backfill in bottom 12" to 18" of excavation)
- ❖ EX 6-1/6-2 Combined
  - Excavated to caprock
  - 4790 CY Removed
  - 12 Confirm. Samples
  - piping and concrete blocks were the geophysical anomaly
- ❖ 6 Sections excavated; each section had two stockpiles
  - < 5 ppm
  - 5 ppm to 50 ppm
- ❖ All stockpiled materials used as backfill
- ❖ 10-ft wide area not excavated due to underground utilities

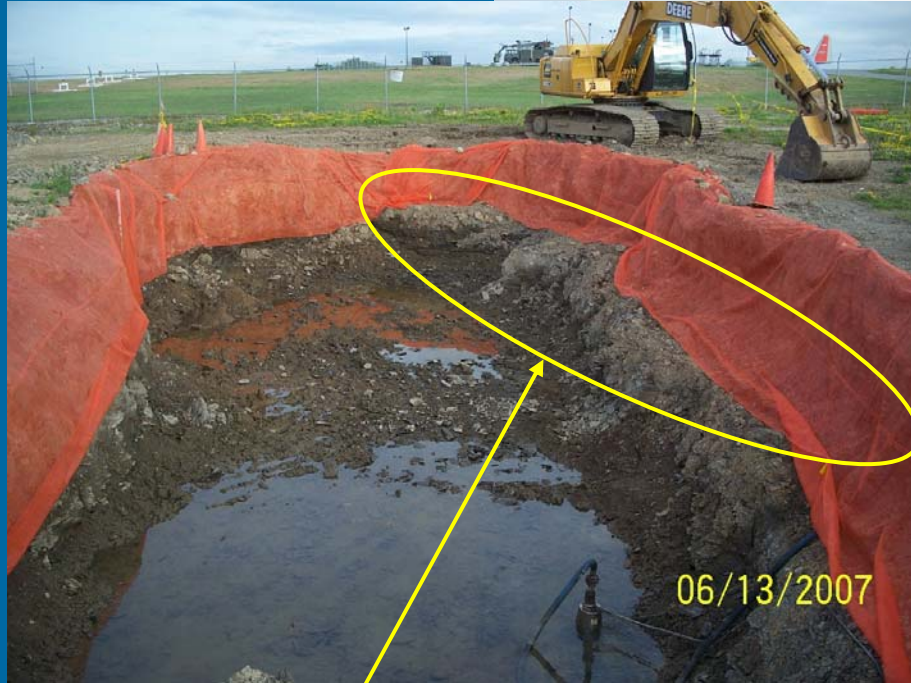
Area of elevated  
PID readings  
(no VOCs detected)

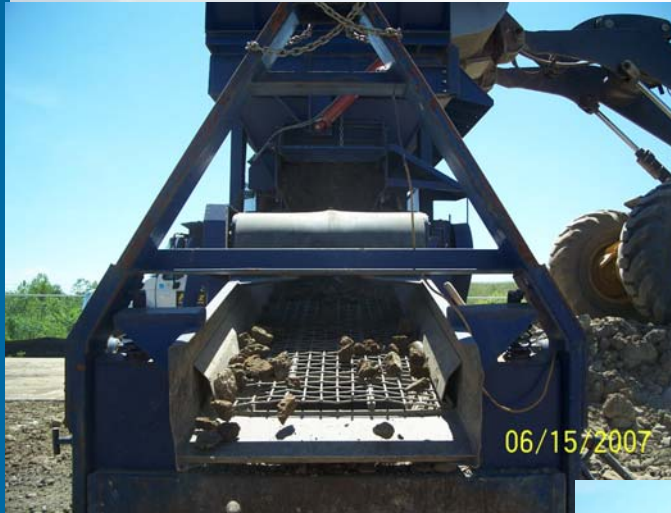
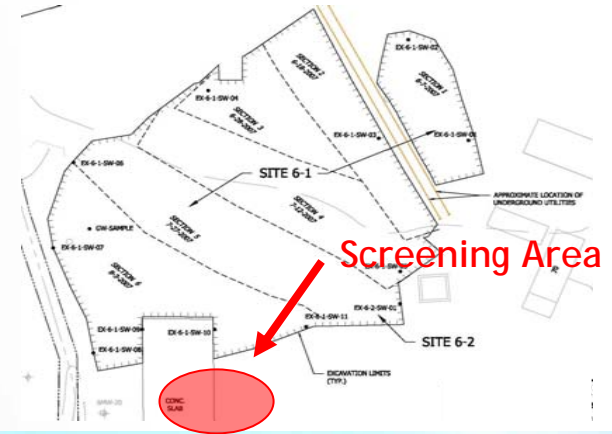
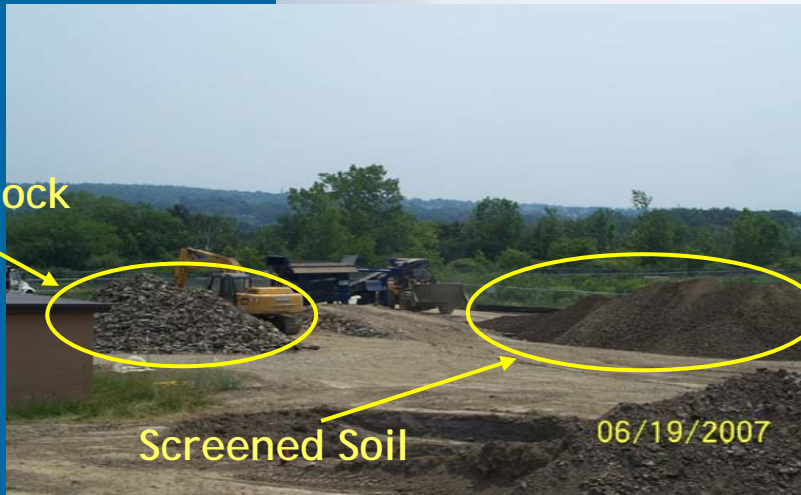
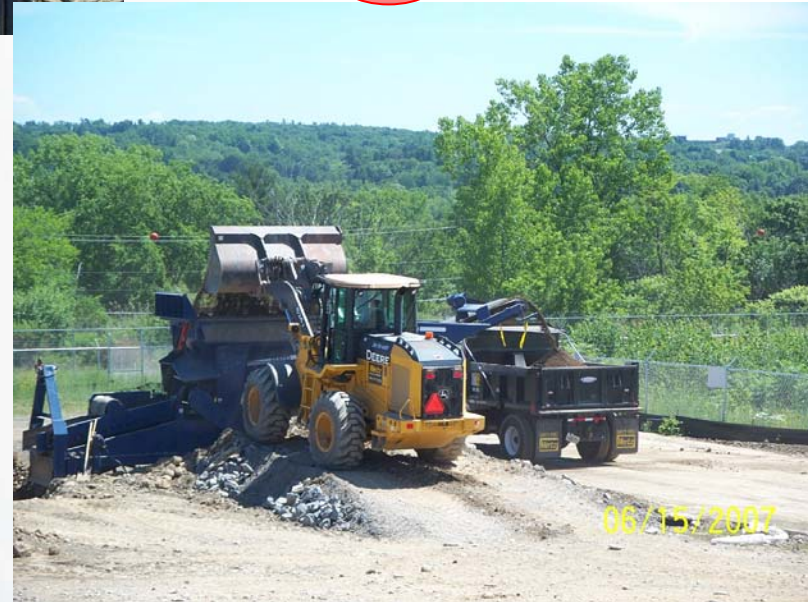
- ❖ 6 Sections excavated
- ❖ Each section had 3 stockpiles:
  - rock (>2")
  - PID<5 ppm
  - 5 ppm<PID<50 ppm
- ❖ Rock stockpile not sampled used as backfill at base of excavation

Screened Rock

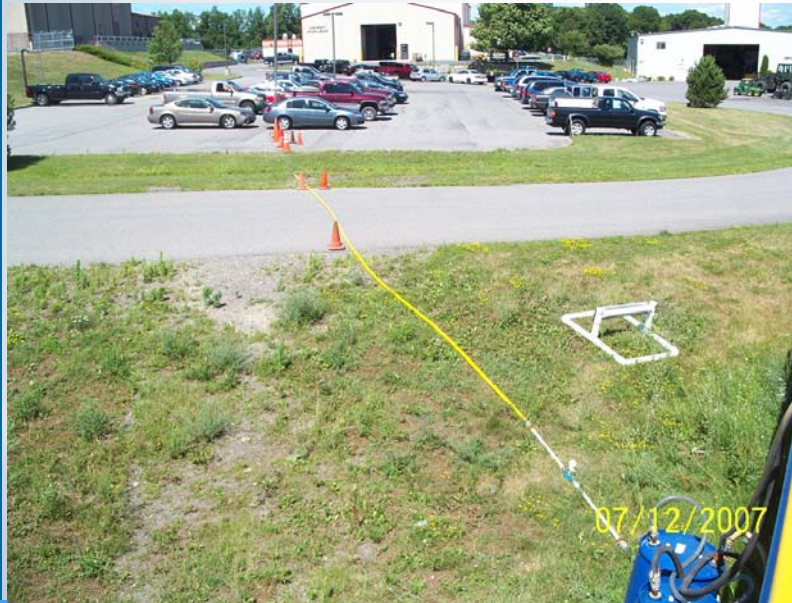
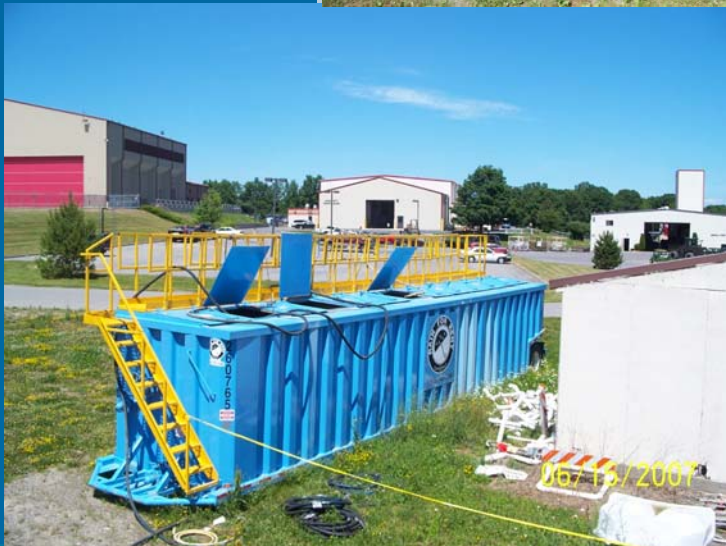
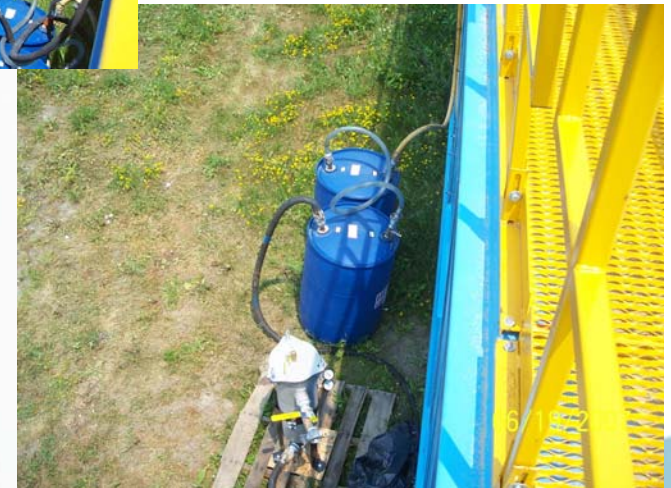
## Site 6 - Interim Removal Actions - Water

- ❖ Water treated with bag filters and carbon
- ❖ Treated water sampled once per 40,000 gallons
- ❖ Treated water discharged to Schenectady POTW
- ❖ A total of 36,522 gallons discharged

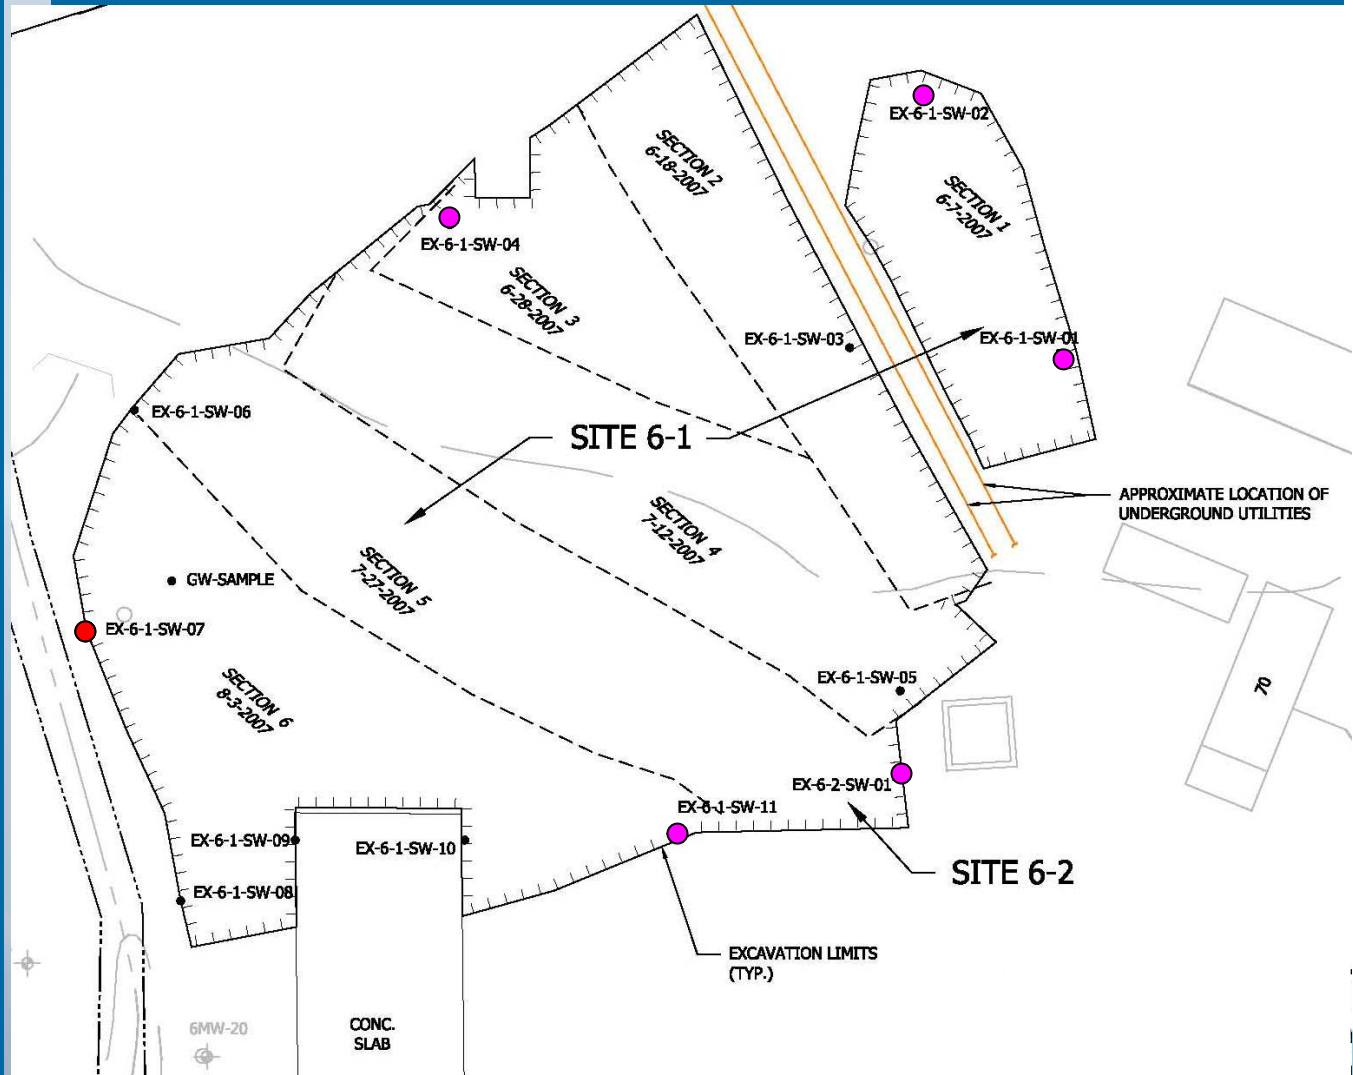
## Site 6 - Interim Removal Actions - Sampling

- ❖ 12 Confirmation samples collected
  - ❖ 11 Analyzed for VOCs
  - ❖ 1 Analyzed for VOCs, SVOCs and Metals (EX6-2)
  - ❖ Exceedences of PCE (1), Acetone (5) and Nickel (1)
- PCE Exceedence  
● Acetone Exceedence

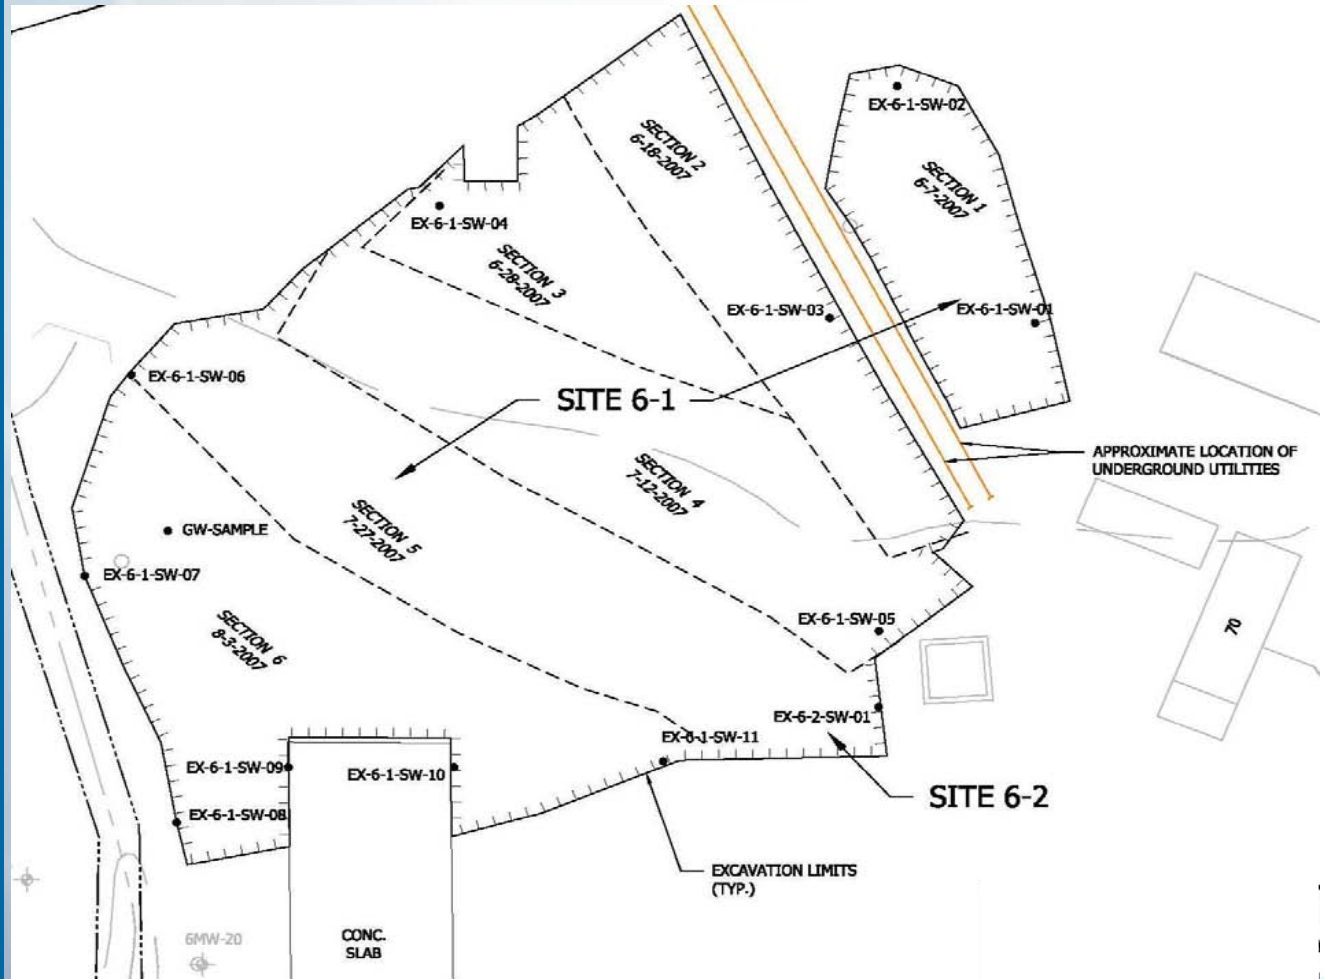
## Site 6 - Interim Removal Actions: Stockpile Samples

- ❖ 6 Sections excavated
- ❖ Each section had 3 stockpiles:
  - rock (>2")
  - < 5 ppm
  - 5 to 50 ppm
- ❖ Soil stockpile analyzed for VOCs
- ❖ Exceedence of methylene chloride in stockpile 3 of 170 CY (60 ppb / Standard 50 ppb)

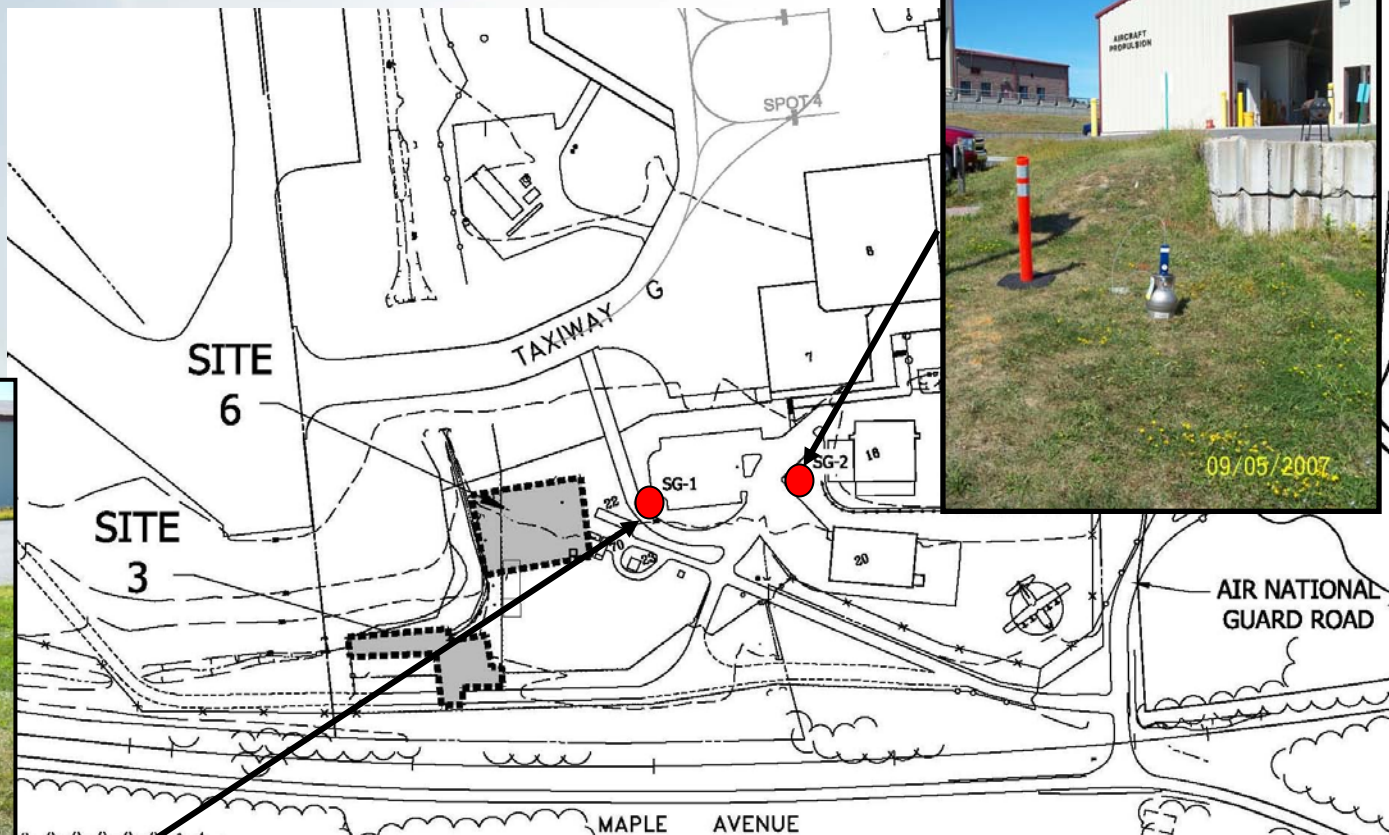
## Site 6 - Interim Removal Actions: Soil Gas

- ❖ 2 Samples collected
- ❖ No chlorinated VOCs detected

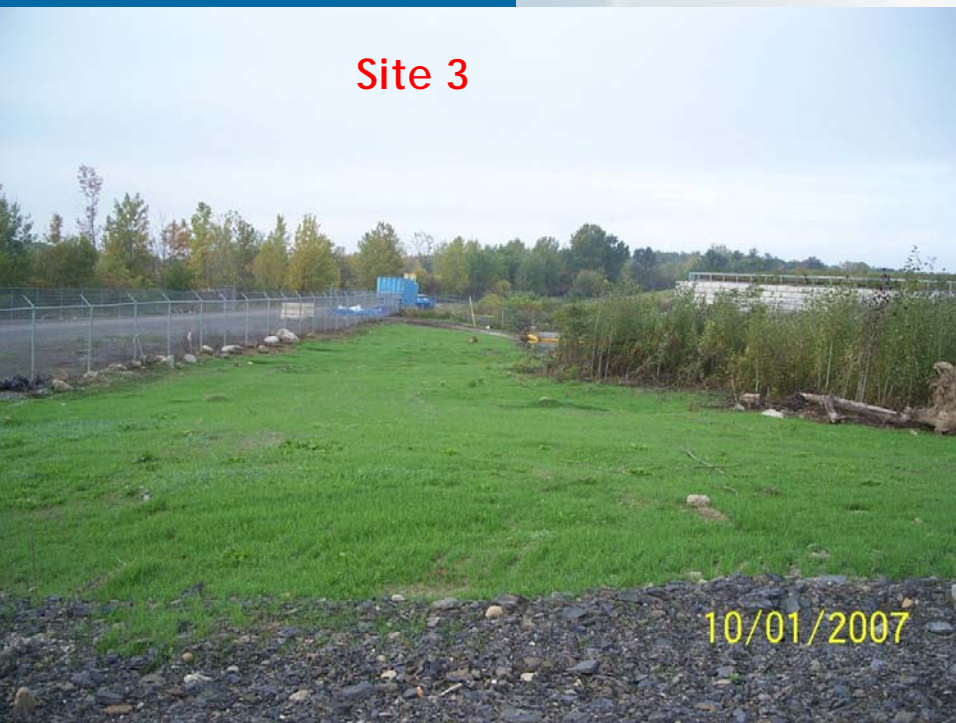
## Site 3 & 6 - Interim Removal Actions - Site Restoration
