# Air National Guard

Schenectady Air National Guard Base

Site 3 and Site 6

Interim Removal Action / Focused Feasibility Study

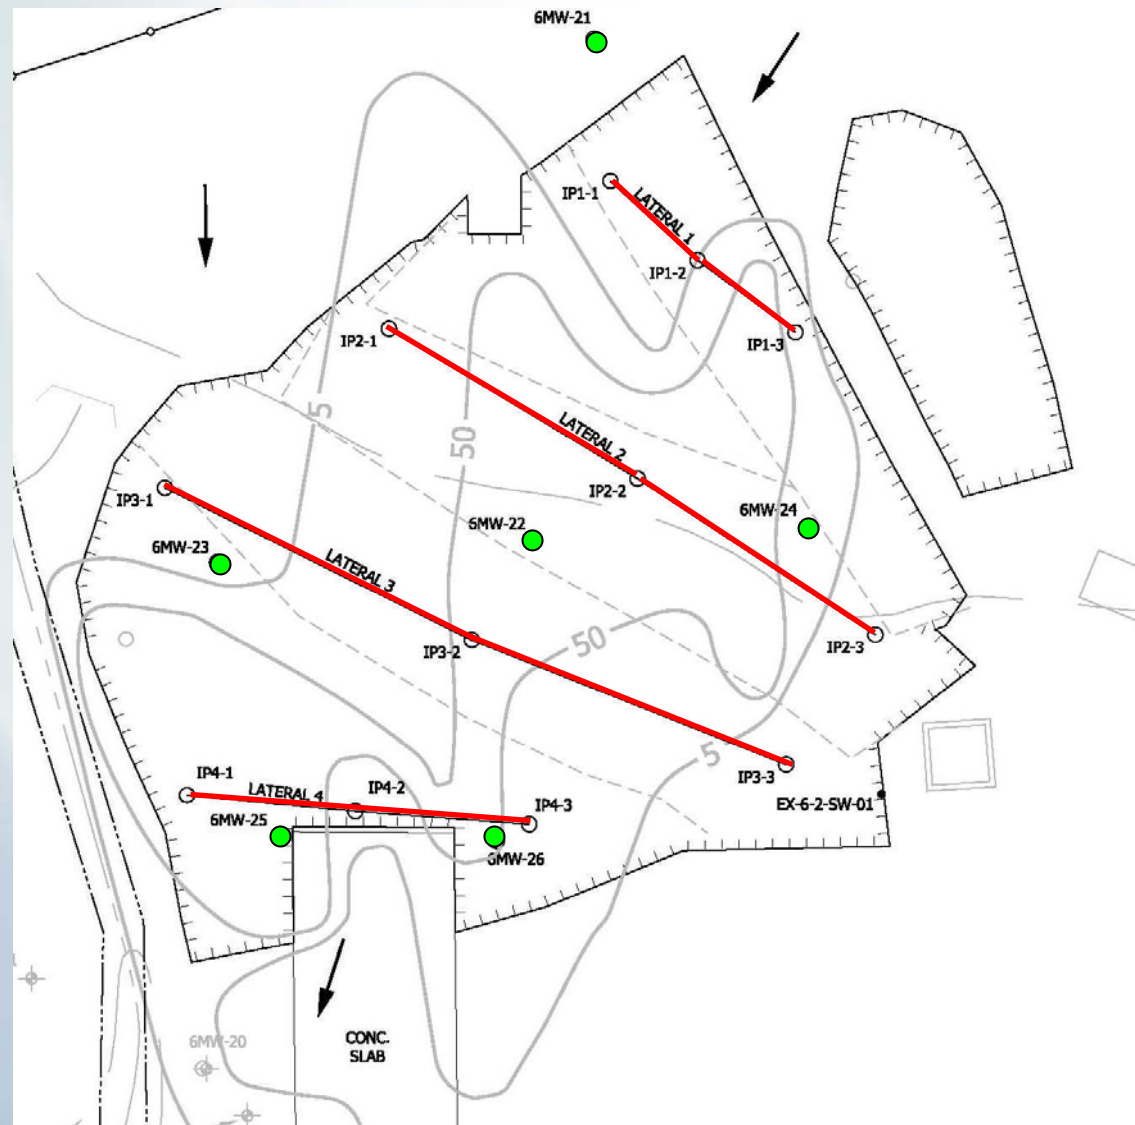
## Site 6 - In Situ Bioremediation Pilot Study

- ❖ Installed 4 horizontal infusion wells
- ❖ Installed 7 overburden / weathered bedrock wells (TD ~ 9' with 5' screen)
- ❖ Installed a single bedrock well (40-ft deep) downgradient of Site 6
- ❖ Infused 10,000 gallons diluted EOS into well network in August 2007
- ❖ Sampling events:
  - Baseline: May 2007
  - 1<sup>st</sup> Round: Sep 2007
  - 2<sup>nd</sup> Round: Nov 2007
  - 3<sup>rd</sup> Round: Jan 2008

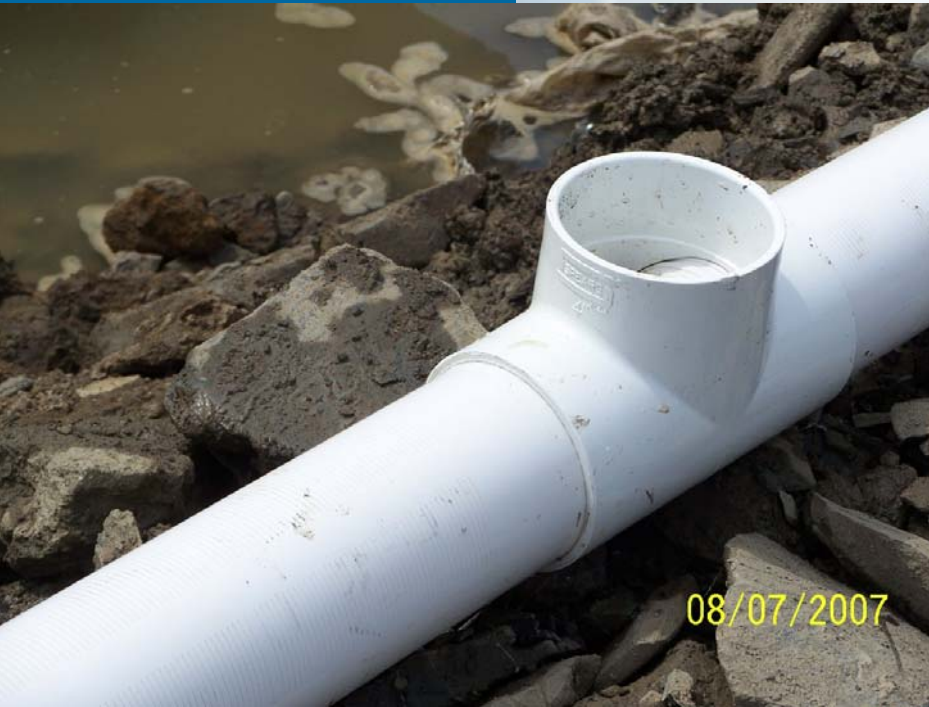
Well screen and Tee connection to riser (not shown)

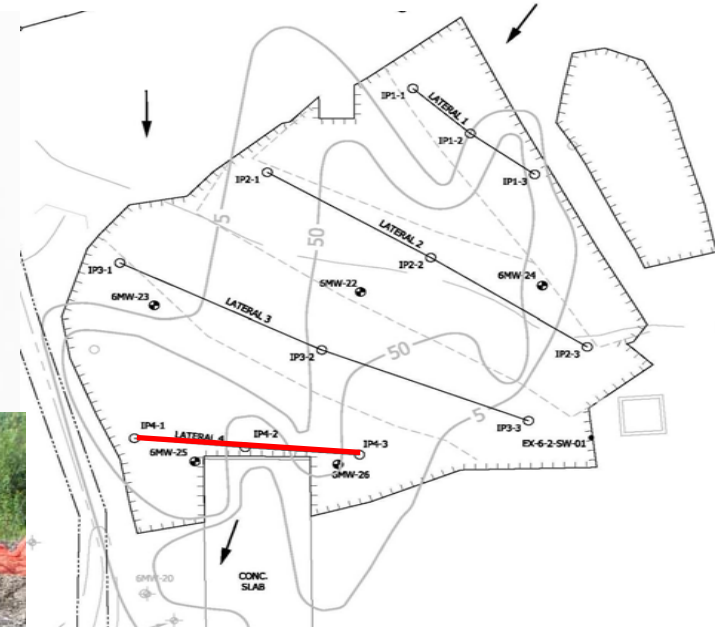
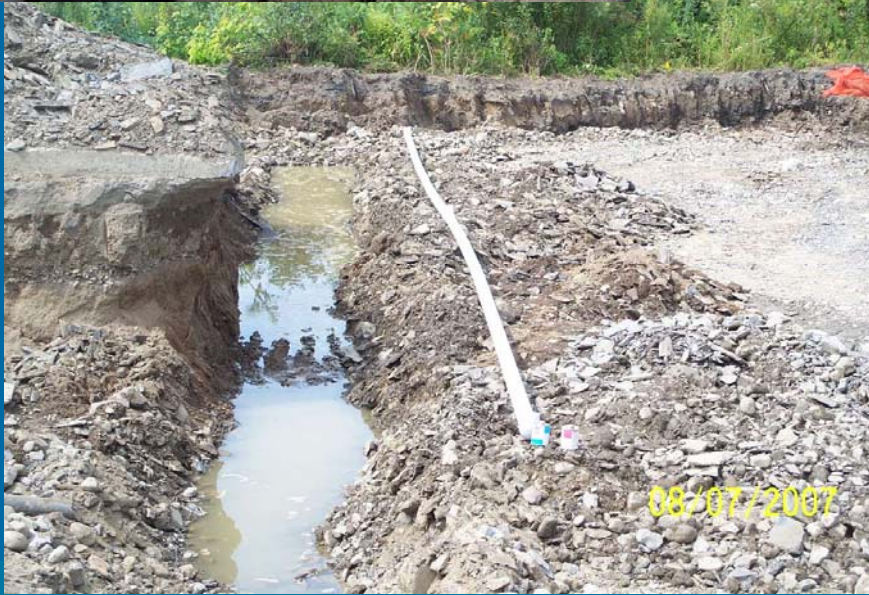
Length of horizontal well ready for placement

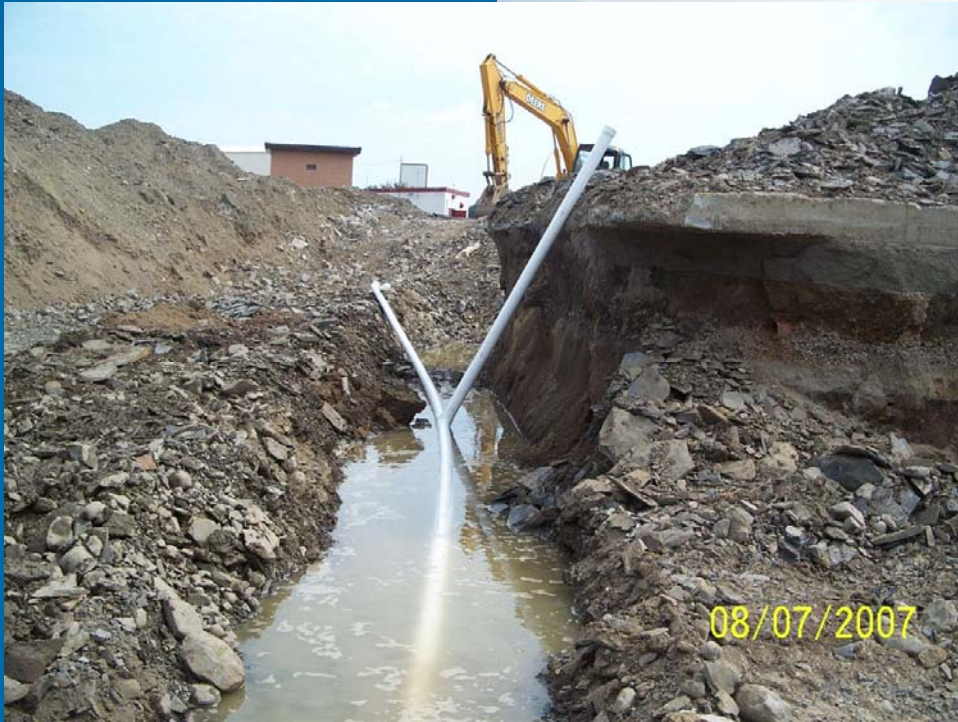
Length of horizontal well being placed

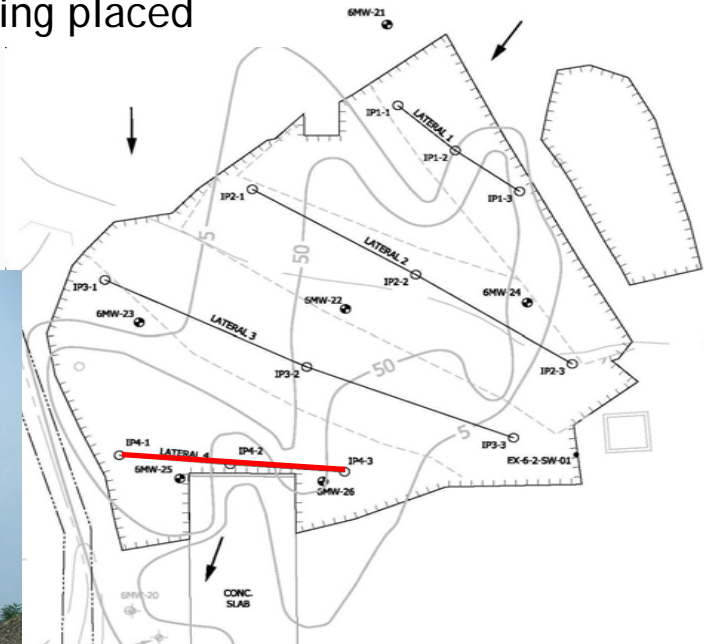
Horizontal well placed and covered with rock and filter fabric

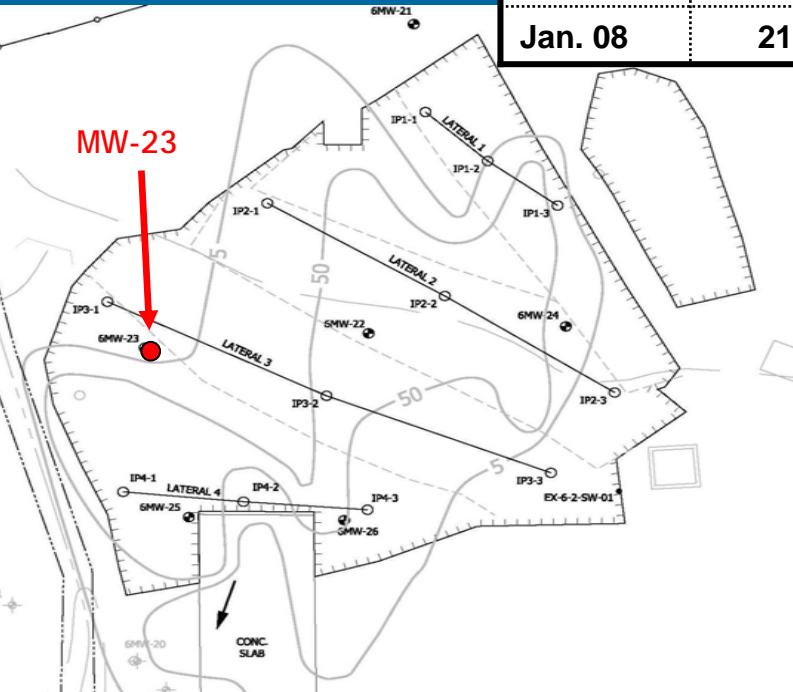
## Site 6 - In Situ Bioremediation: MW-23 Results

PCE	TCE	DCE	VC	TVOCs	TOC	Chloride
Jun 02	3700	48	28	ND	3776		
Aug 02	740	18	120	ND	878		
May 07	310 D	17	190 D	ND	517	1.41	0
Aug 07**	50	44	13	ND	107		
Sept. 07	ND	ND	140	3.1 J	143.1	27	56
Nov. 07	9.8 J	3.7 J	29	3.0 J	45.5	3.66	36
Jan. 08	21	ND	11	ND	32	3.12	14
