**Distribution Holder
Interim Remedial Measure (IRM) Summary Report**

**Schenectady (Seneca Street) Site
Schenectady, New York**

**Niagara Mohawk, A National Grid Company
Syracuse, New York**

**Foster Wheeler Environmental Corporation
Syracuse, New York**

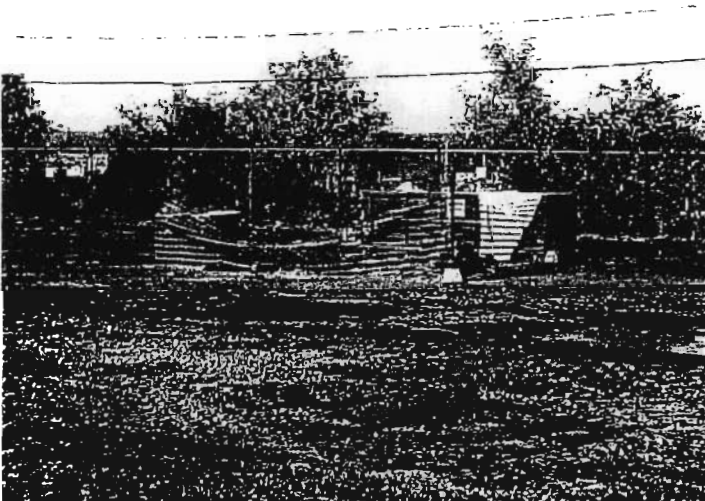
Photograph No.: 1
Date: 10/16/01
Description: Start of test pitting at
northwest end of the Niagara
Mohawk facility's office trailer.
Looking Southwest.

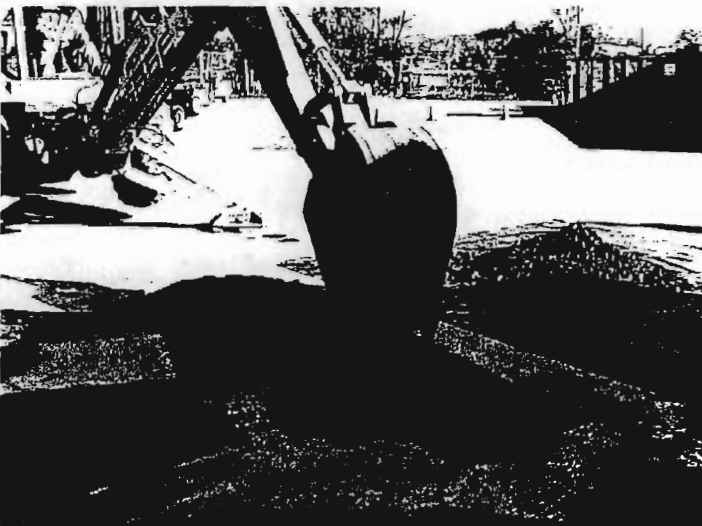
Photograph No.: 2
Date: 10/16/01
Description: View of test pit area
on western margin of former gas
holder location.
Looking West

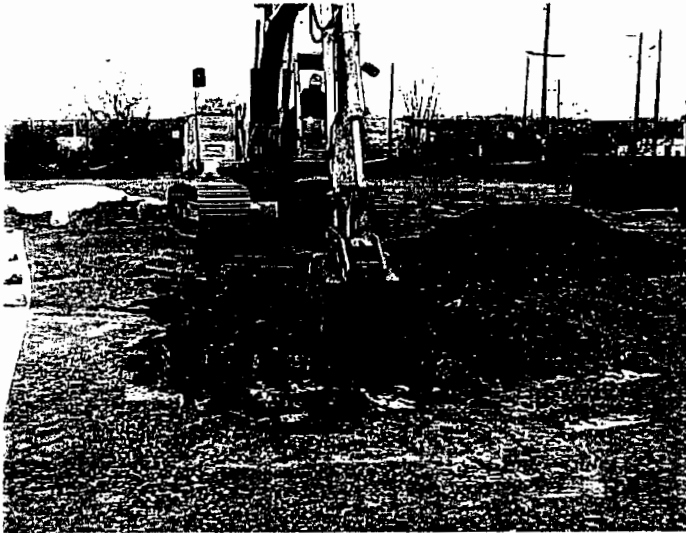
Photograph No.: 6
Date: 10/17/01
Description: Backfilled test pit
location near the north corner of
the Butler building.
Looking Southeast

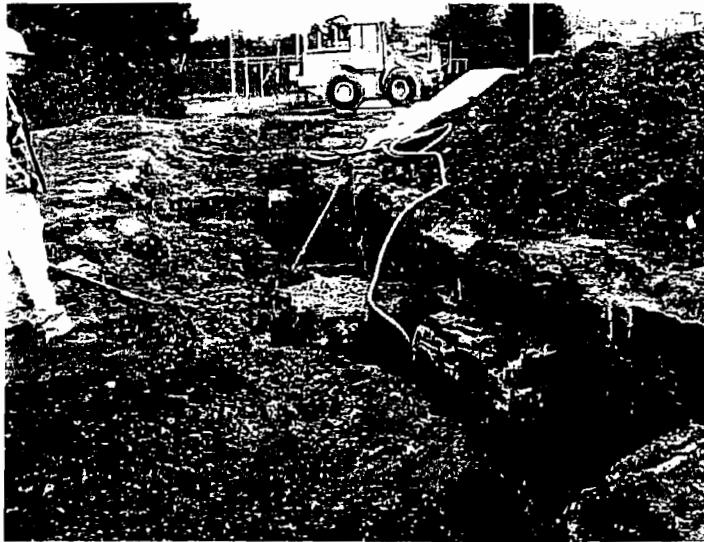
Photograph No.: 9

Description: Dewatering the
excavation with a submersible
pump.

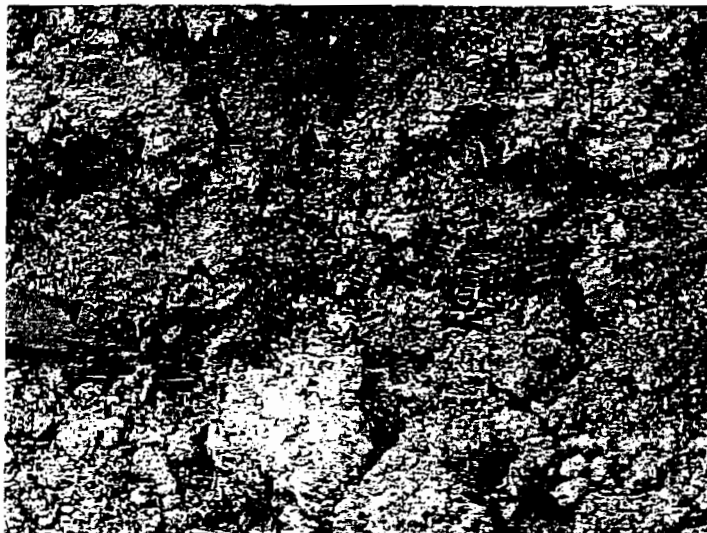
Photograph No.: 11

Description: Pocket of coal tar-type product observed during excavation.

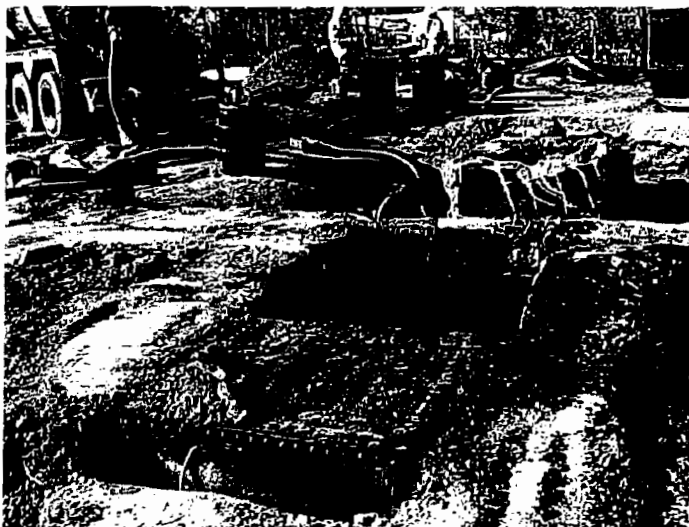
Photograph No.: 15

Description: Preparing to vacuum out the contents of the drip pot located outside the northwest ring wall edge. Vacuum hose from truck attaches to a knock-out moisture separator (55-gallon drum). A hose attached to the drum is placed into the drip pot to evacuate free-liquids. Upon filling, the drum is closed and another drum is placed in-line to accept additional liquids. Looking Southwest

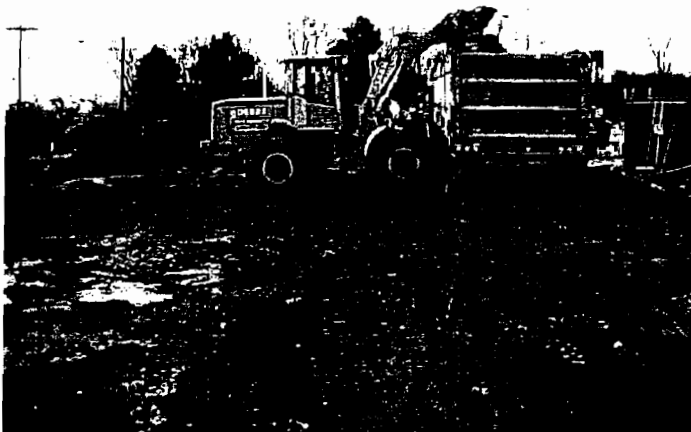
Photograph No.: 21
Date: 11/15/01
Description: Loading excavated
soil into dump trailer for transport
to disposal/destruction facility.
Looking Northeast

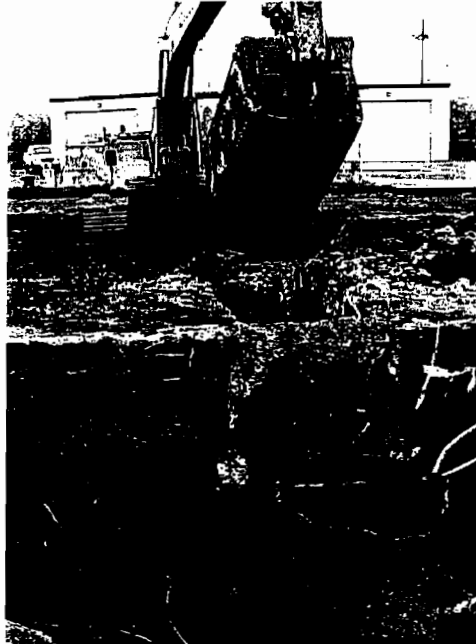
Photograph No.: 22

Description: Using track excavator to remove steel box from concrete vault on west perimeter of ring wall.

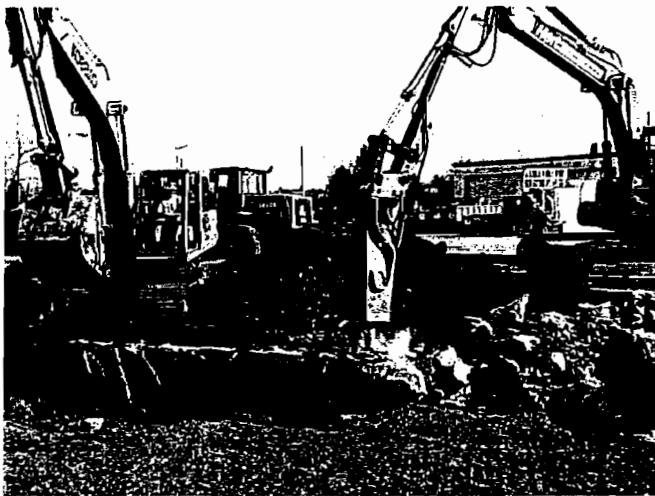
Photograph No.: 23

Description: Using hammer hoe to break up ring wall structure and track excavator to remove broken up debris from the excavation.

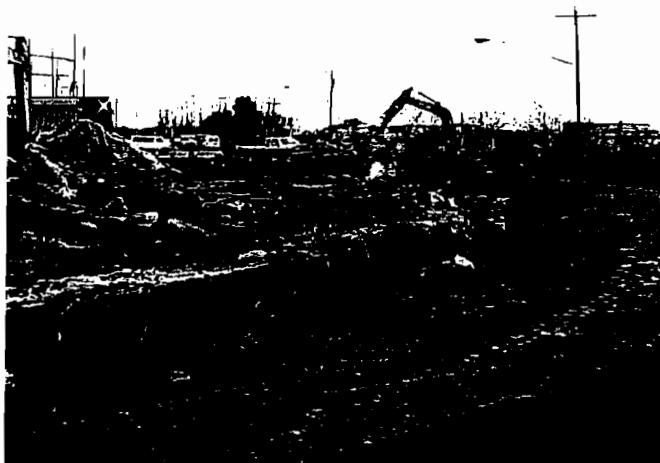
Photograph No.: 24

Description: View of the unearthed, north perimeter of the ring wall during excavation/demolition.

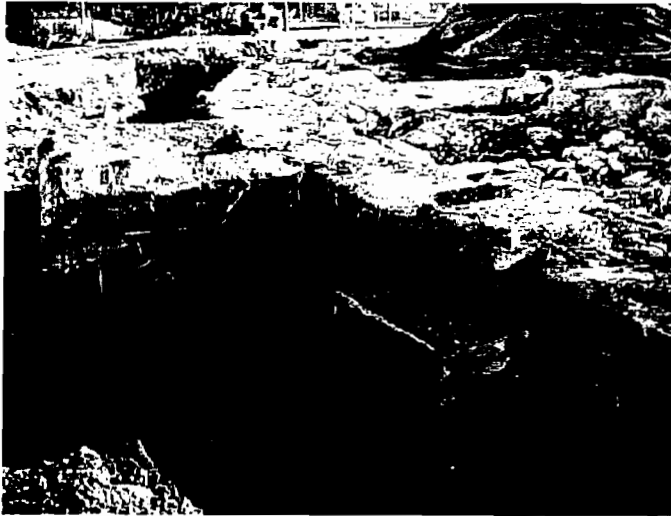
Photograph No.: 25

Description: View of north perimeter of the ring wall prior to demolition. Photograph depicts one of the ring wall structure's piers (foreground right) and a concrete vault housing a steel box (foreground left).

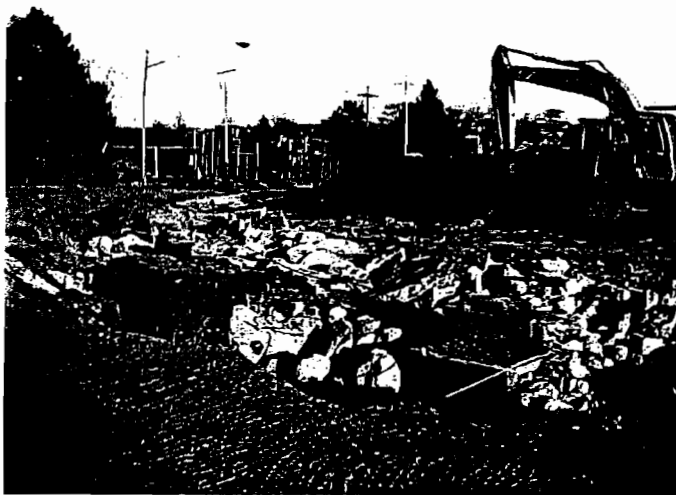
Photograph No.: 26

Description: View of the north perimeter of the ring wall following demolition. Ring wall and concrete vault have been demolished, leaving the pier in place (for future demolition and removal) and exposing the steel box.

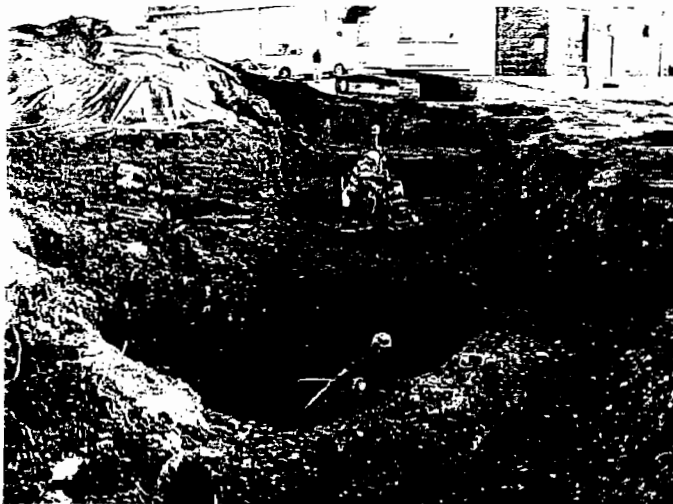
Photograph No.: 27

Description: Compaction of backfill material along the western perimeter of the former ring wall. The steel anchor bolts were left in place after removal of concrete piers. Indication of MGP impact was not observed on the pier directly behind the compactor/operator and the pier was left in place.

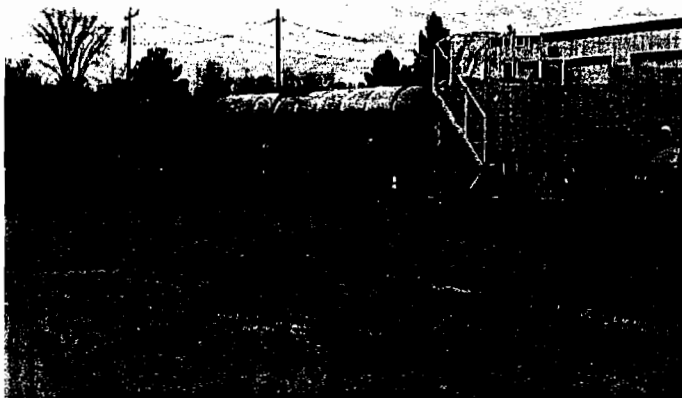
Photograph No.: 28

Description: Transferring the contents of the Frac tank to a tank truck for transportation and proper disposal.

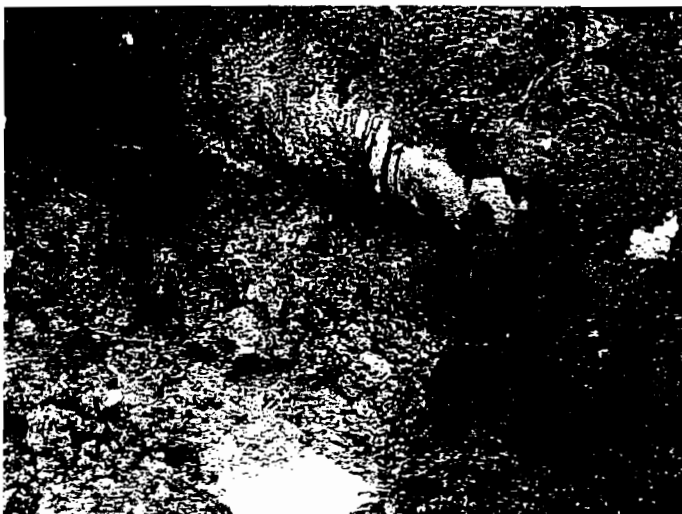
Photograph No.: 29

Description: MGP type product weeping from backfill materials surrounding a 12-inch diameter pipe.

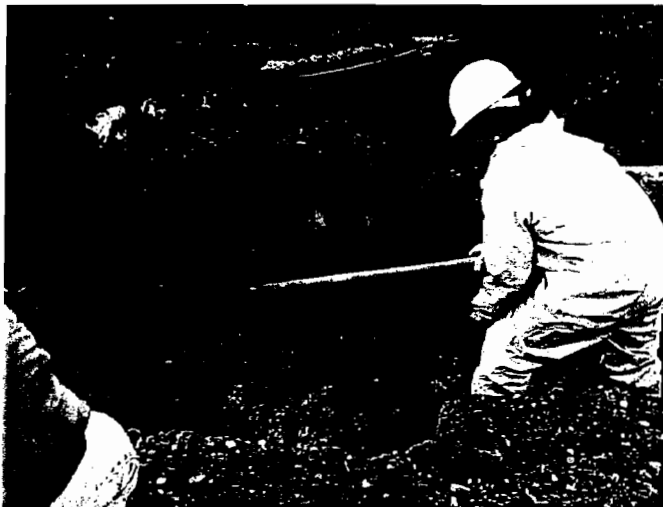
Photograph No.: 31
Date: 11/27/01
Description: Hand excavating
MGP impacted material from the
backfill around the 12-inch
diameter pipe.

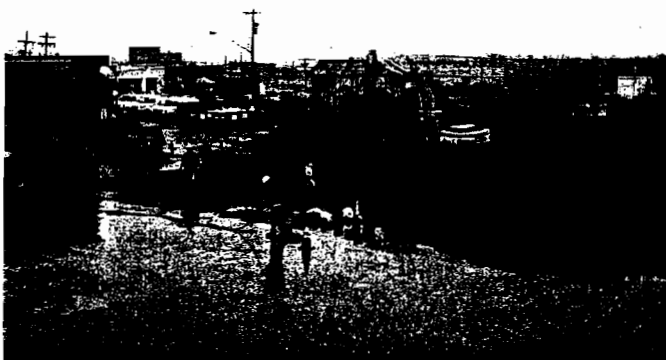
Photograph No.: 32
Date: 12/14/01
Description: View of excavation
activities along the western
margin of the former ring wall
structure.
Looking West

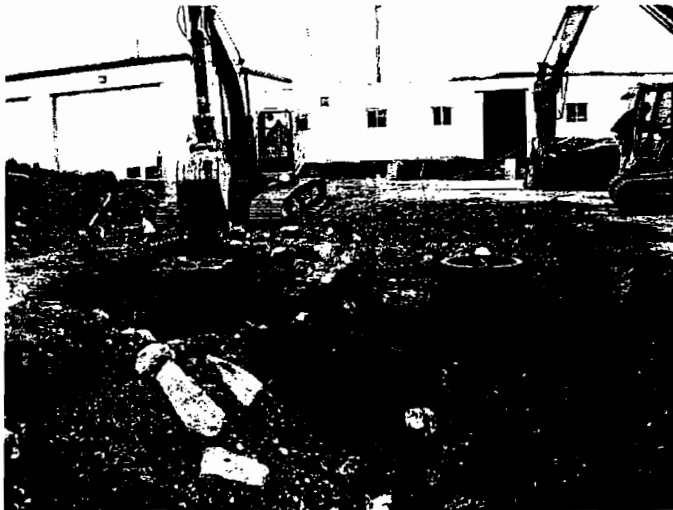
Photograph No.: 35

Description: Unearthed second drip pot and associated steel box located between the garage and the "Butler" building/Niagara Mohawk facility office trailer. Looking Southeast

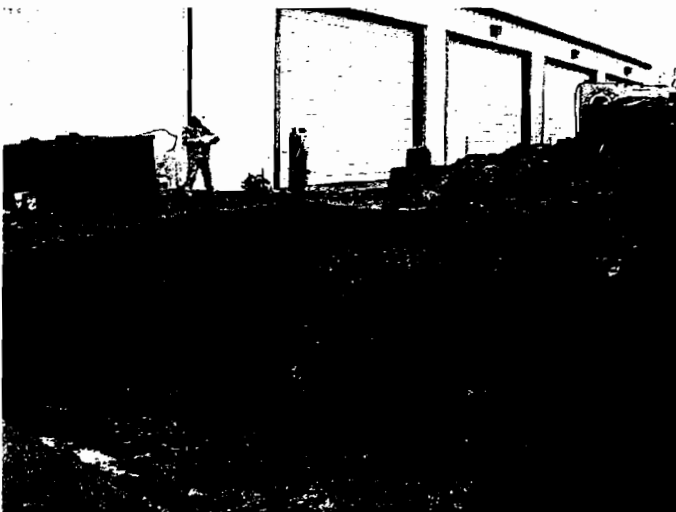
Photograph No.: 36

Description: Excavation around a pier located near north end of "Butler" building. Looking South

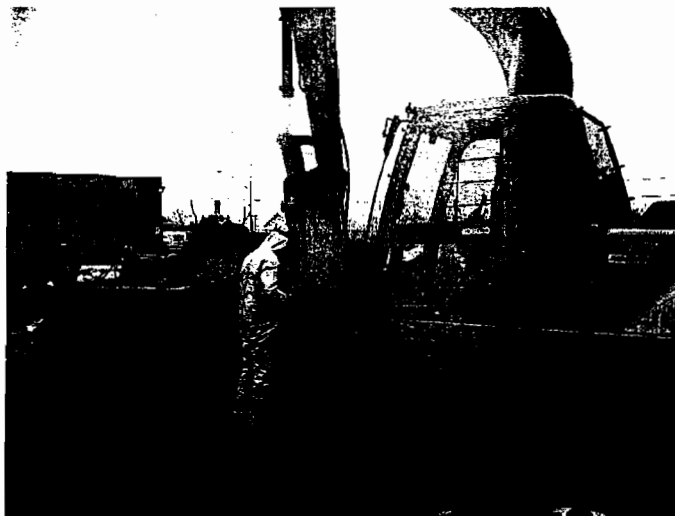
Photograph No.: 39
Date: 01/03/02
Description: Sealed piping and a
thin horizon of MGP impacted
material in the vicinity of the drip
pot located between the "Butler"
building and the garage.

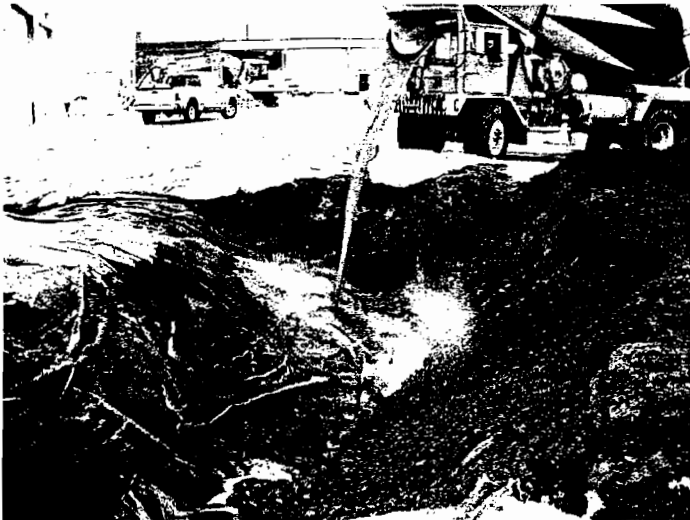
Photograph No.: 43
Date: 01/19/02
Description: Geo-textile fabric capping MGP impacted soils underlying the southwest corner of the "Butler" building.
Looking East

remain in place, under institutional controls that are being established by NM NGrid. These institutional controls will establish a restrictive covenant similar to those typically utilized on other sites whose conditions are similar to those at Seneca Street. To mitigate the possibility of future NAPL impacted material migration, a sprayed on liner system, designed by Foster Wheeler Environmental and approved by the NYSDEC, was installed on the slope of the excavation. The liner system consisted of: 1) a layer of geo-textile fabric placed on the face of the slope from the surface level to the bottom of the excavation; 2) keying of fabric into the till layer with application of an impermeable epoxy material applied on the fabric at a thickness >80 mils; 3) another layer of fabric placed on top of this liner/fabric configuration with application of an additional >80 mil of epoxy liner on the second layer; and 4) approximately 70 cubic yards of flowable fill placed over the liner and against the adjoining backfilled areas, at a mix design to provide a minimum compressive strength of 50 psf and a maximum permeability of 0.00001 cm/sec.

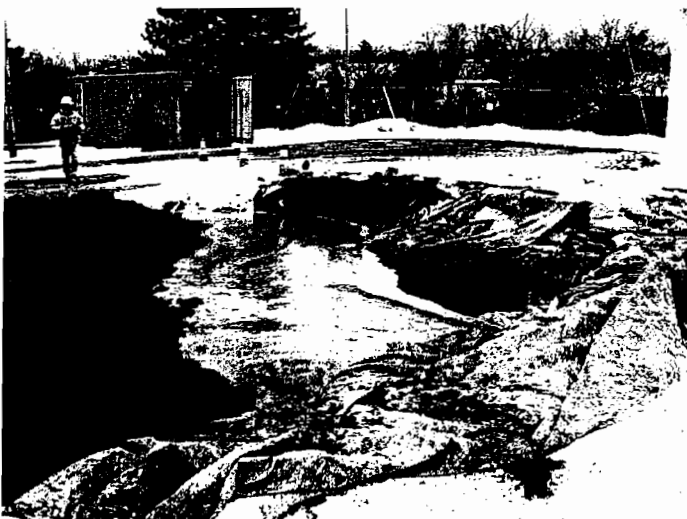
Photograph No.: 44
Date: 01/21/02
Description: Pouring flowable fill into the excavation at the north end of the "Butler" building, covering the geo-textile material capping MGP impacted material underlying the building at this location.
Looking Southwest

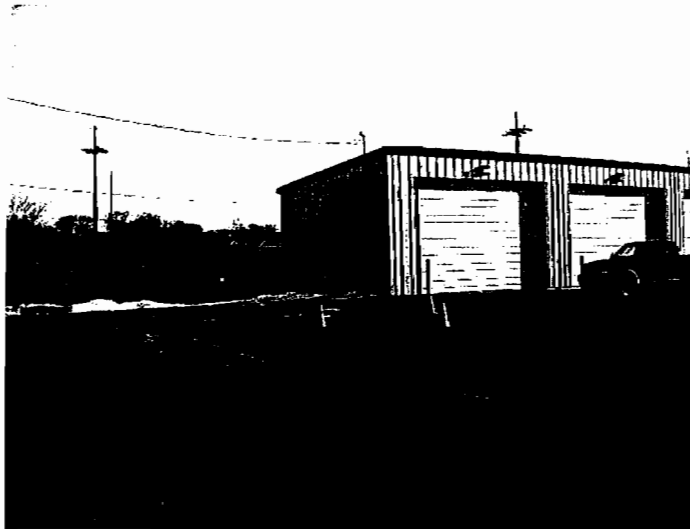
Photograph No.: 45
Date: 01/21/02
Description: Excavation near the north end of the "Butler" building nearly filled with flowable fill.
Looking East

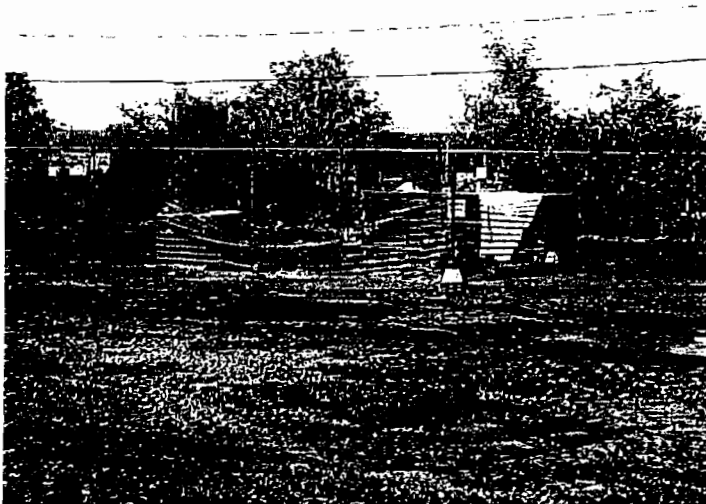
Photograph No.: 2

Description: View of test pit area on western margin of former gas holder location. Looking West

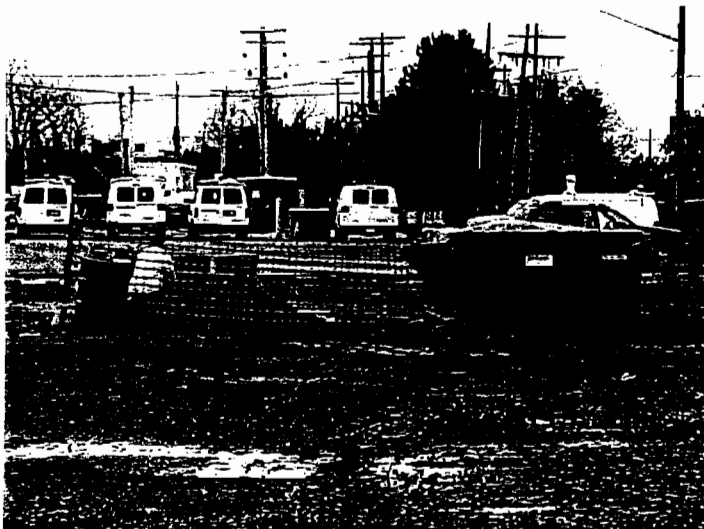
Photograph No.: 5
Date: 10/17/01
Description: View of test pit area
on western margin of former gas
holder location.
Looking Southwest

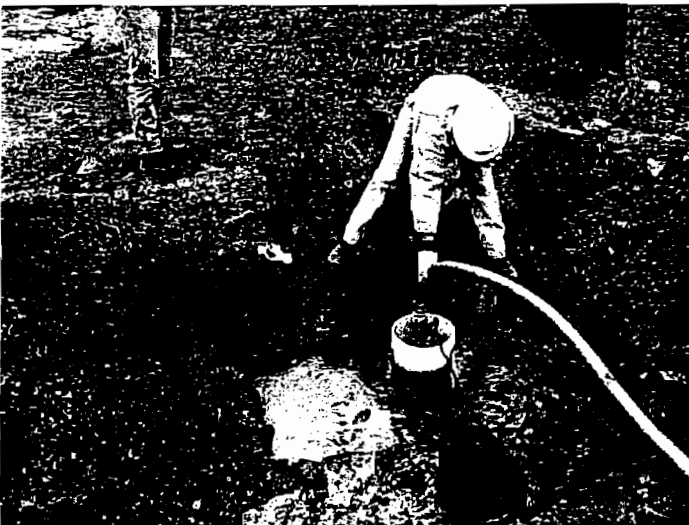
Photograph No.: 9

Description: Dewatering the
excavation with a submersible
pump.

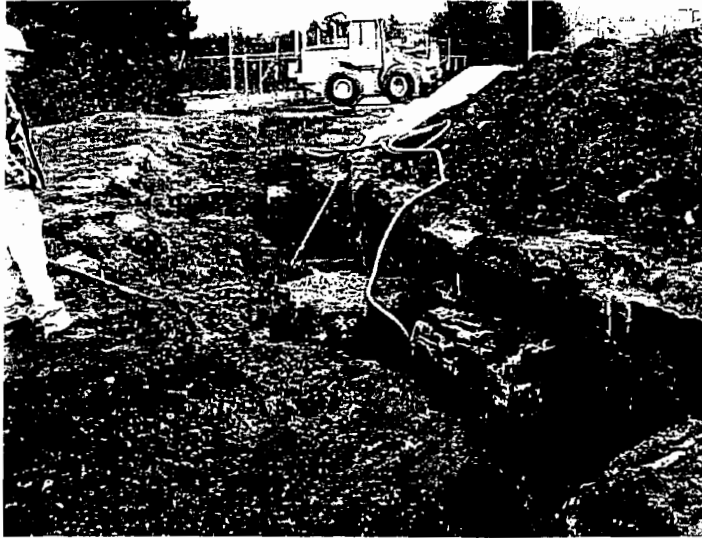
Photograph No.: 10

Description: View of unearthed, northern portion of the former ring wall structure. The tops of concrete piers are observed along the outer perimeter of the ring wall.

Description: View of unearthed, northern portion of the former ring wall structure. The tops of concrete piers are observed along the outer perimeter of the ring wall.

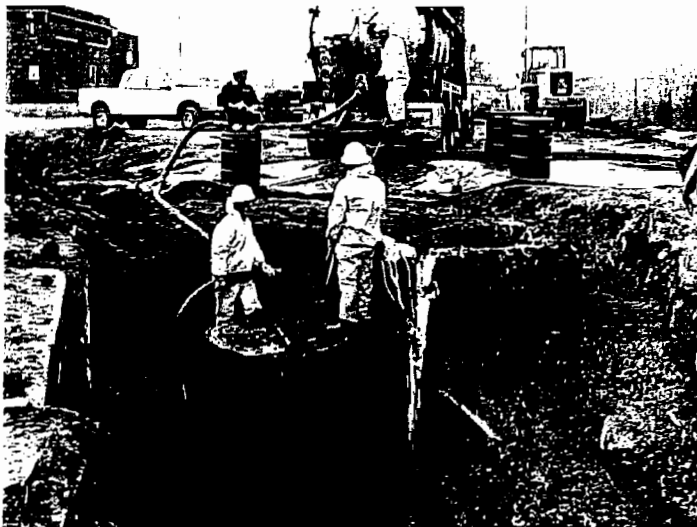
Photograph No.: 15

Description: Preparing to vacuum out the contents of the drip pot located outside the northwest ring wall edge. Vacuum hose from truck attaches to a knock-out moisture separator (55-gallon drum). A hose attached to the drum is placed into the drip pot to evacuate free-liquids. Upon filling, the drum is closed and another drum is placed in-line to accept additional liquids. Looking Southwest

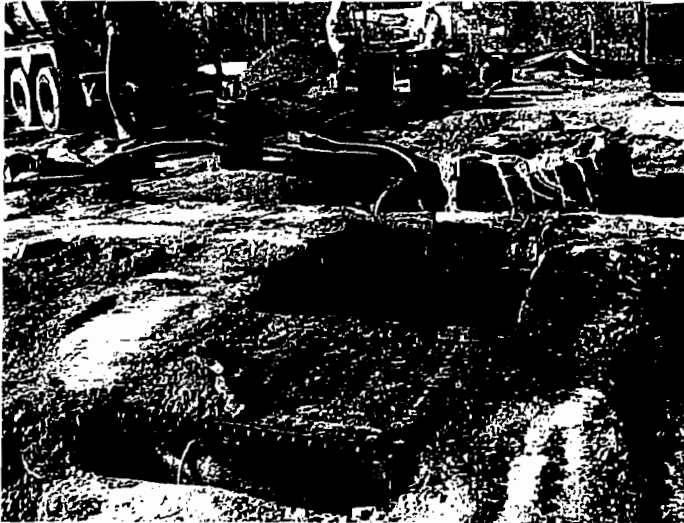
Photograph No.: 16

Description: Rectangular Steel Box located adjacent to drip pot on outside of northwest perimeter of ring wall. Top has been opened with a hammer hoe, exposing the fill materials contained within.

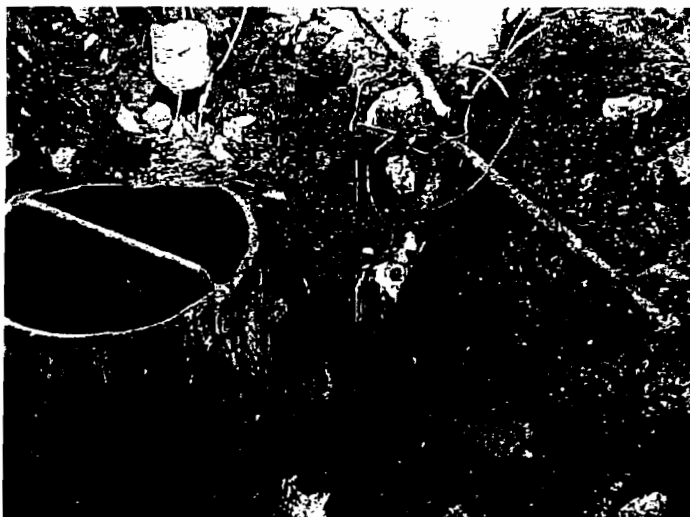
Photograph No.: 18

Description: Drip pot and miscellaneous piping. Free liquid weeping from backfill of 30-inch diameter pipe and from other pipe ends, accumulating at base of drip pot.

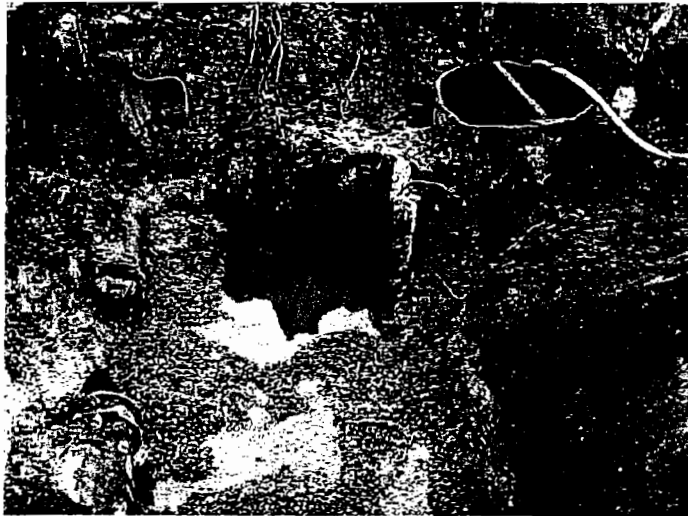
Photograph No.: 20
Date: 11/14/01
Description: Reducing bushing
connecting the 12-inch diameter
piping (left) to the 30-inch
diameter pipe attached to drip pot.

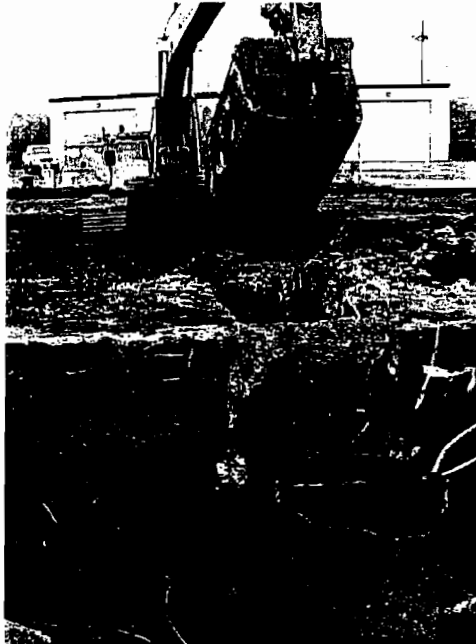
Photograph No.: 22

Description: Using track excavator to remove steel box from concrete vault on west perimeter of ring wall.

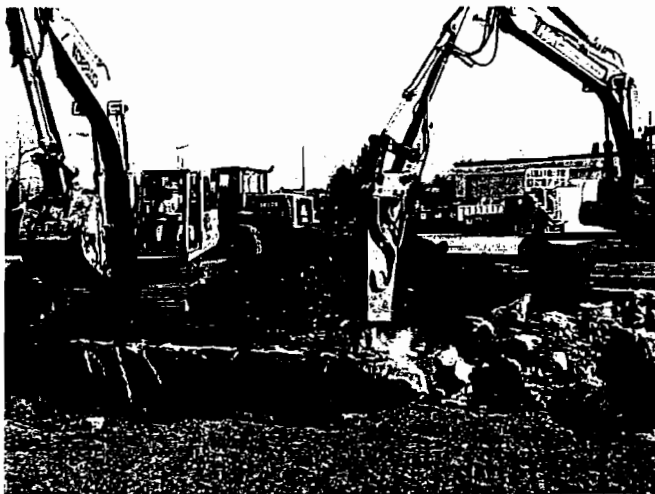
Photograph No.: 23

Description: Using hammer hoe to break up ring wall structure and track excavator to remove broken up debris from the excavation.

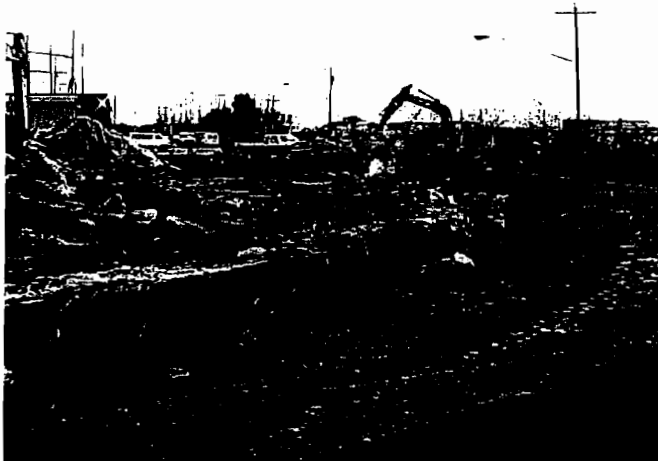
Photograph No.: 24

Description: View of the unearthed, north perimeter of the ring wall during excavation/demolition.

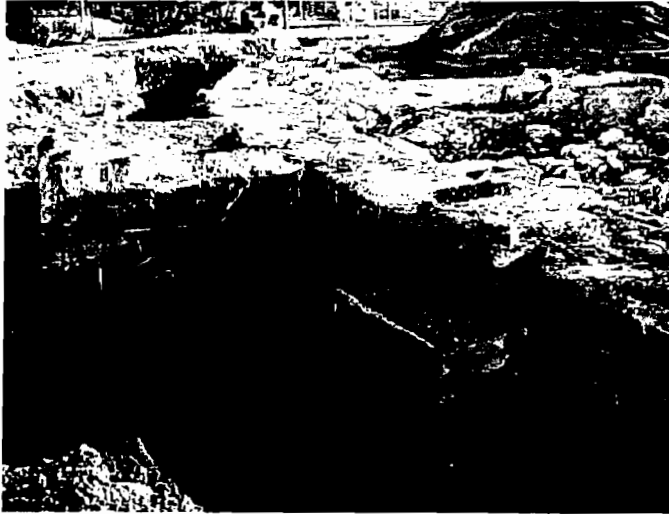
Photograph No.: 25

Description: View of north perimeter of the ring wall prior to demolition. Photograph depicts one of the ring wall structure's piers (foreground right) and a concrete vault housing a steel box (foreground left).

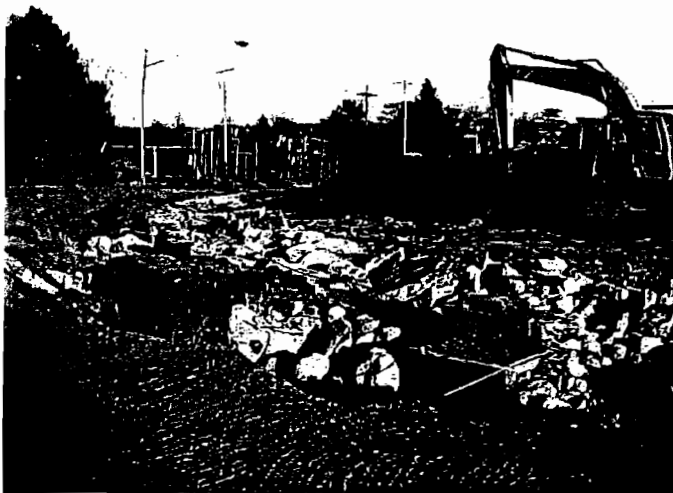
Photograph No.: 26

Description: View of the north perimeter of the ring wall following demolition. Ring wall and concrete vault have been demolished, leaving the pier in place (for future demolition and removal) and exposing the steel box.

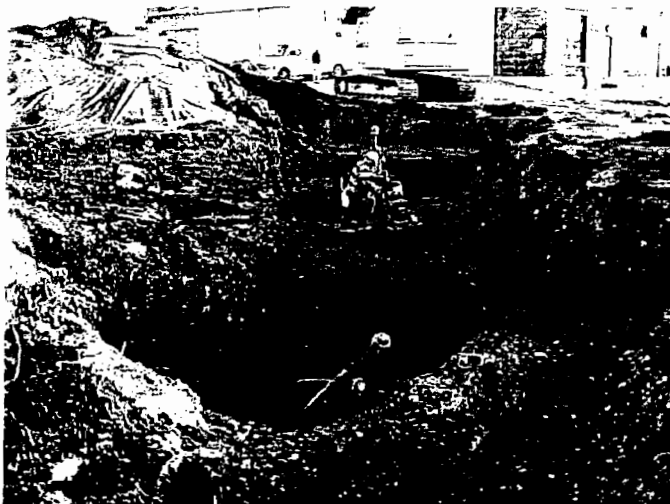
Photograph No.: 27

Description: Compaction of backfill material along the western perimeter of the former ring wall. The steel anchor bolts were left in place after removal of concrete piers. Indication of MGP impact was not observed on the pier directly behind the compactor/operator and the pier was left in place.

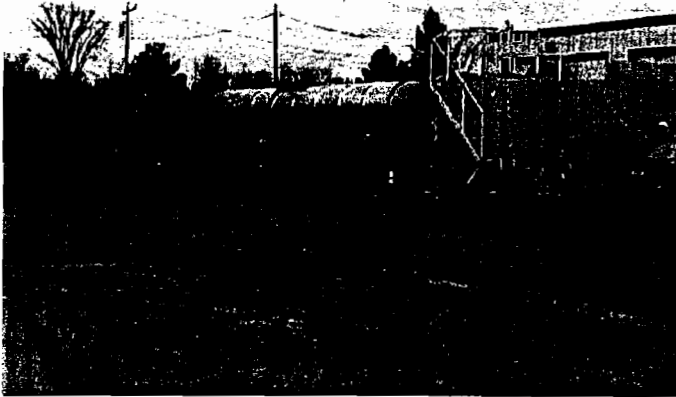
Photograph No.: 28
Date: 11/21/01
Description: Transferring the contents of the Frac tank to a tank truck for transportation and proper disposal.
Looking East

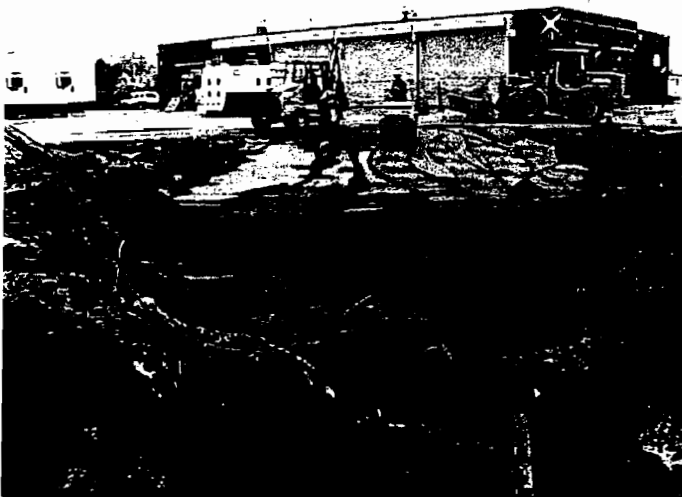
Photograph No.: 30
Date: 11/27/01
Description: Rolling compaction of backfill on western perimeter of former ring wall.
Looking South

Description: Rolling compaction of backfill on western perimeter of former ring wall.

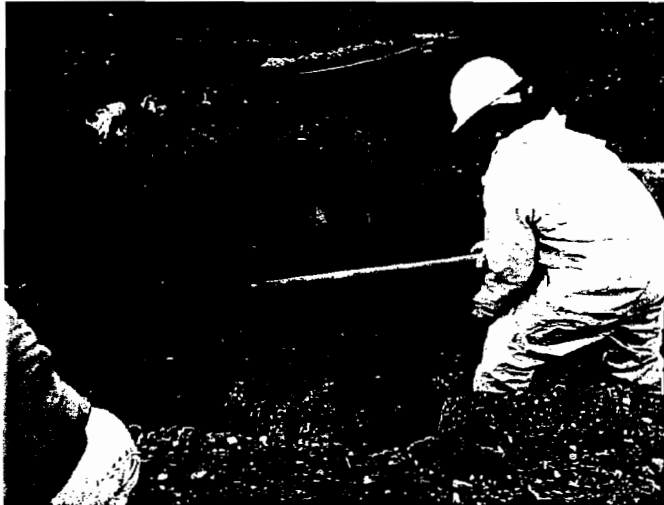
Photograph No.: 31
Date: 11/27/01
Description: Hand excavating
MGP impacted material from the
backfill around the 12-inch
diameter pipe.

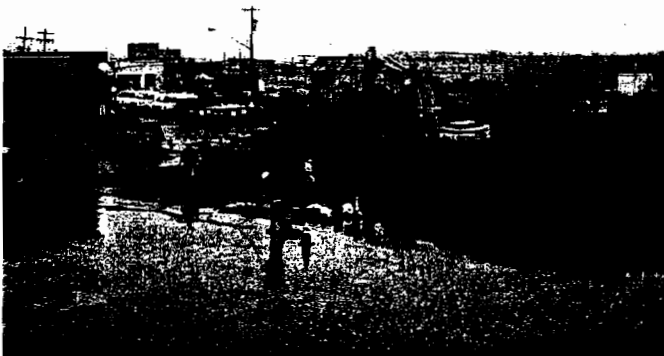
Photograph No.: 32
Date: 12/14/01
Description: View of excavation
activities along the western
margin of the former ring wall
structure.
Looking West

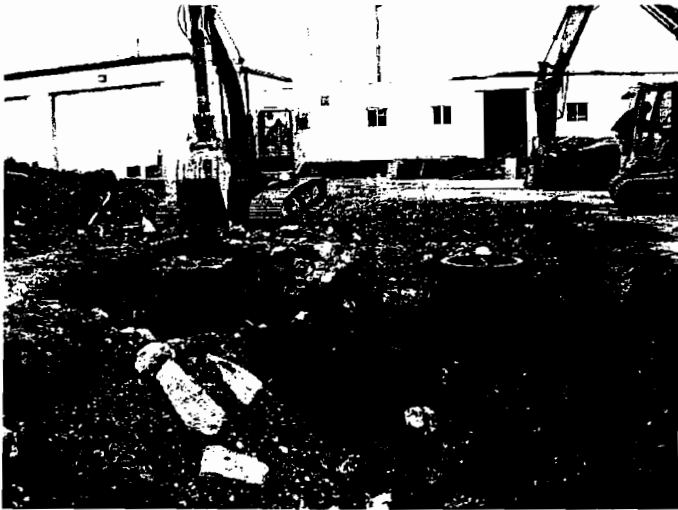
Photograph No.: 35
Date: 01/02/02
Description: Unearthed second drip pot and associated steel box located between the garage and the "Butler" building/Niagara Mohawk facility office trailer. Looking Southeast

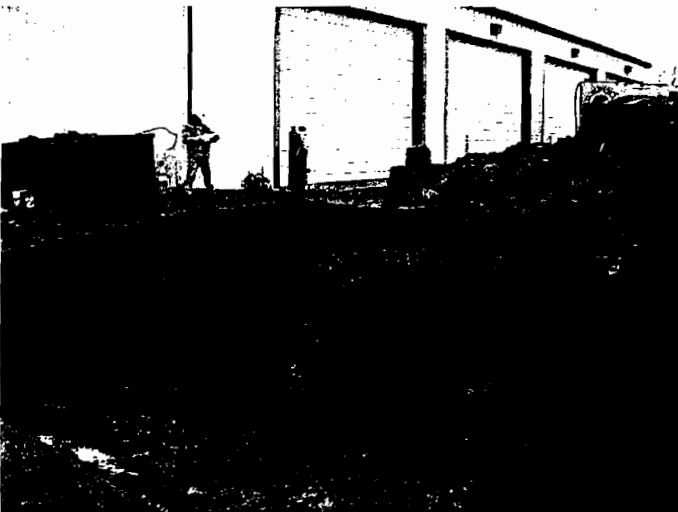
Photograph No.: 36
Date: 12/17/01
Description: Excavation around a pier located near north end of "Butler" building. Looking South

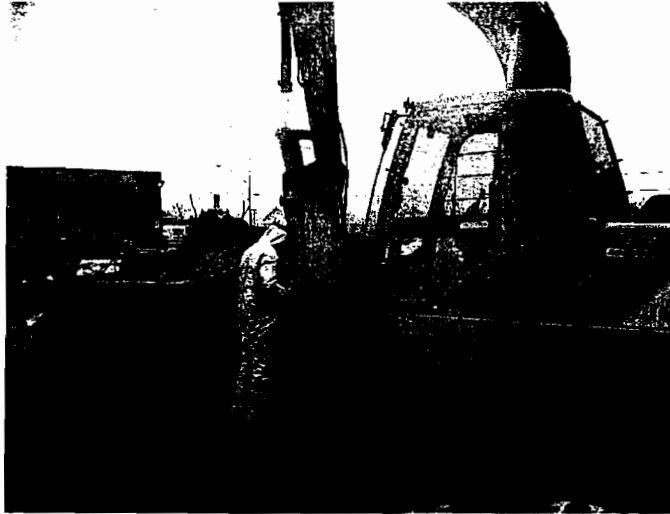
Photograph No.: 40
Date: 01/14/02
Description: Steam cleaning
decontamination of heavy
equipment after remedial action.
Looking West

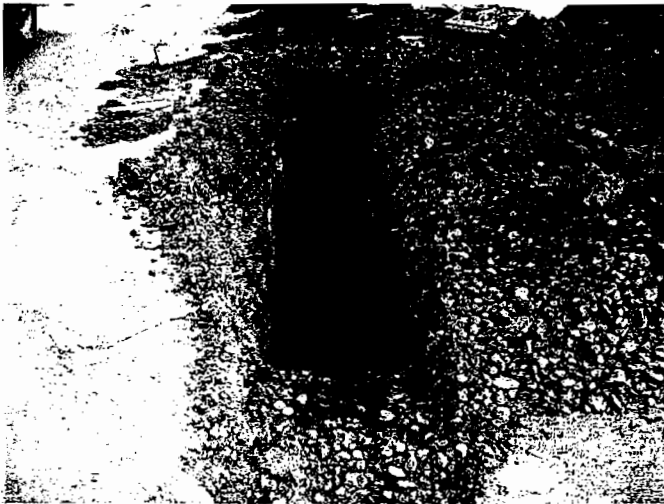
Photograph No.: 41
Date: 01/17/02
Description: Test pit on south side
of main gate, outside of fenced
perimeter of Niagara Mohawk
facility.
Looking Southeast

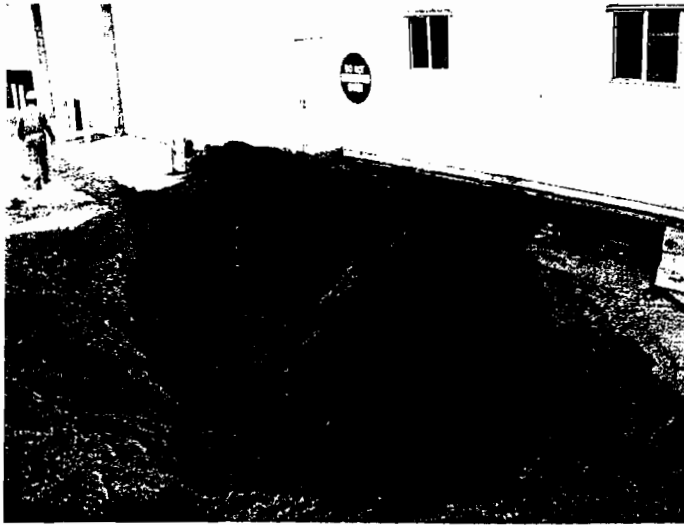
Photograph No.: 43

Description: Geo-textile fabric capping MGP impacted soils underlying the southwest corner of the "Butler" building.

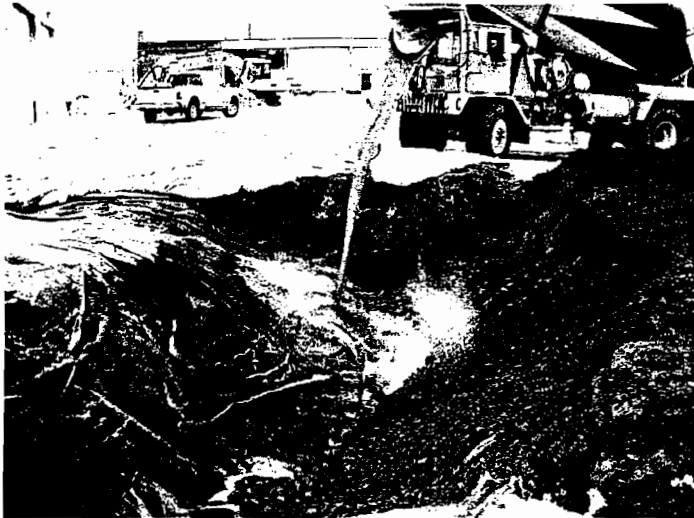
Photograph No.: 44

Description: Pouring flowable fill into the excavation at the north end of the "Butler" building, covering the geo-textile material capping MGP impacted material underlying the building at this location.

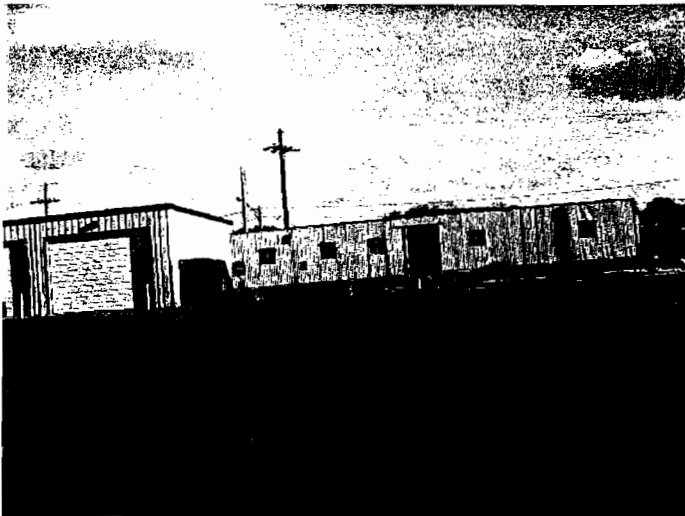
Photograph No.: 47
Date: 01/22/02
Description: Post remediation
view of the area between the
Niagara Mohawk facility office
trailer and the garage.
Looking Southeast

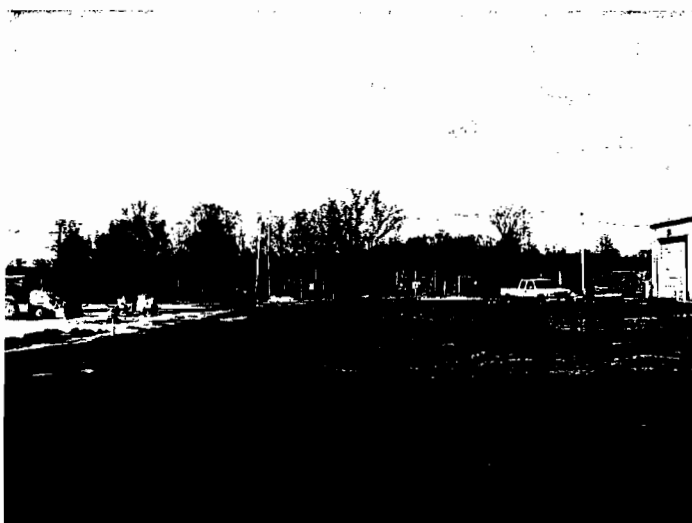
Photograph No.: 48
Date: 01/22/02
Description: Post remediation
view from the garage toward the
front gate of the facility.
Looking Northeast

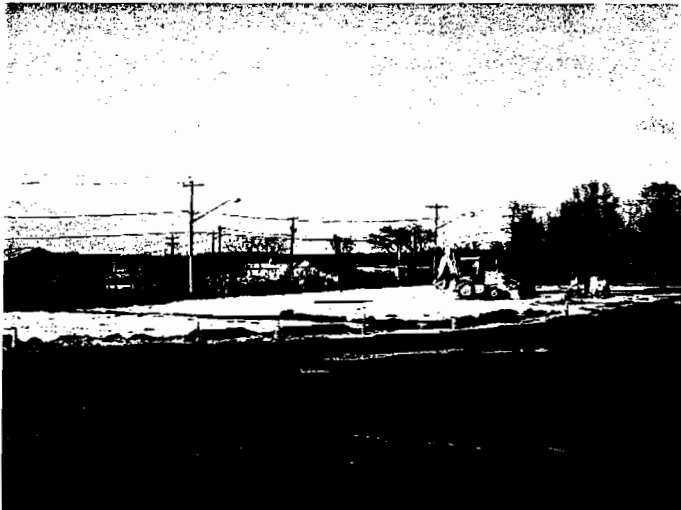
Photograph No.: 50
Date: 01/22/02
Description: Post remediation
view from the garage toward the
north corner of the facility.
Looking North

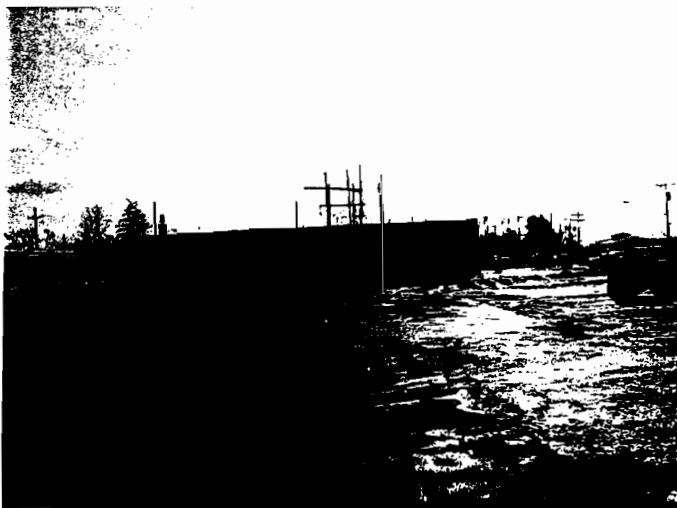
Photograph No.: 51
Date: 01/22/02
Description: Post remediation
view from near the front gate
toward the garage building.
Looking Southwest

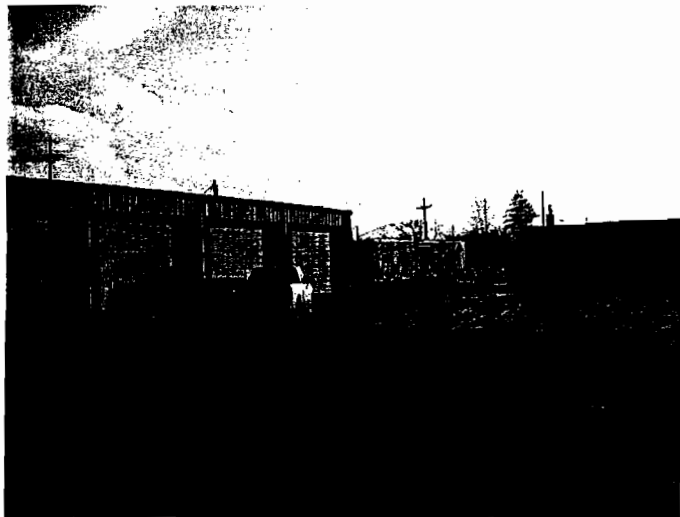
Photograph No.: 52
Date: 01/22/02
Description: Post remediation
view from near the front gate
toward the Niagara Mohawk
facility office trailer.
Looking South

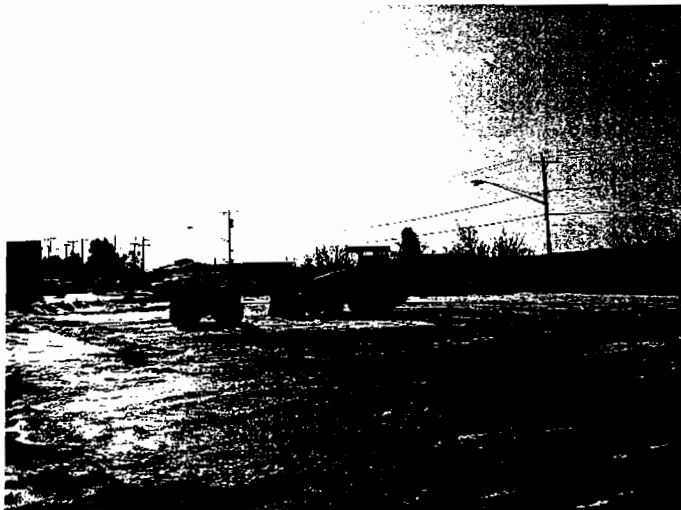
Photograph No.: 53
Date: 01/22/02
Description: Post remediation
view to the west across the Site.
Looking West

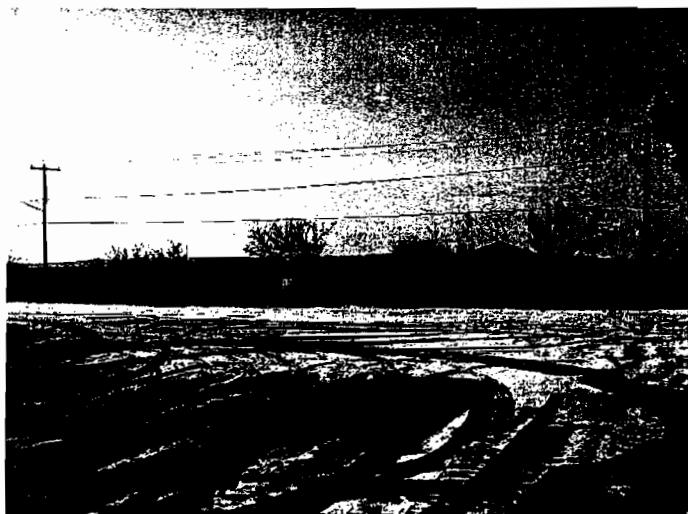
Photograph No.: 54
Date: 01/22/02
Description: Post remediation
view to the northwest across the
Site.
Looking Northwest
