Re: National Grid NM Seneca St. – Schenectady MGP (447025)  
Periodic Review Report [Reporting Period – September 1, 2010 – September 3, 2013]

**Periodic Review Report – NM Seneca St. Schenectady MGP (447025)**

**Reporting Period – September 1, 2010 to September 3, 2013**

## NG Seneca Street Site - Photolog

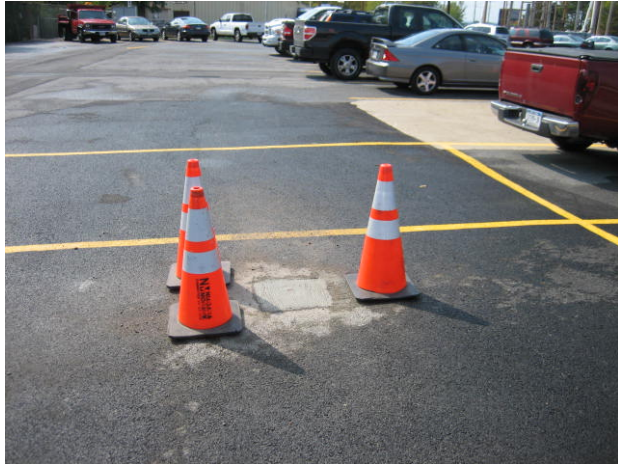
Reinstalled Monument #3 on 9/22/10

- In September 2010, National Grid Facilities added an asphalt parking area near Monument #3 and inadvertently covered the monument. The monument was re-established and resurveyed.
- In December 2010, NG Facilities relocated the existing main security gate 10-15 feet further south to allow vehicles entering the facilities to temporarily park safely away from Seneca Street while the gate opens.
- In September 2011, asphalt cap cracks were repaired/sealed.
- In March 2013, it was noted that Monument #2 was damaged by a snow plow but is still intact and functional.

Keeping an eye on the asphalt cracks at the seams of the excavation.  
 Located and replaced monument #3 on 9/22/2010 with C.T. Male.

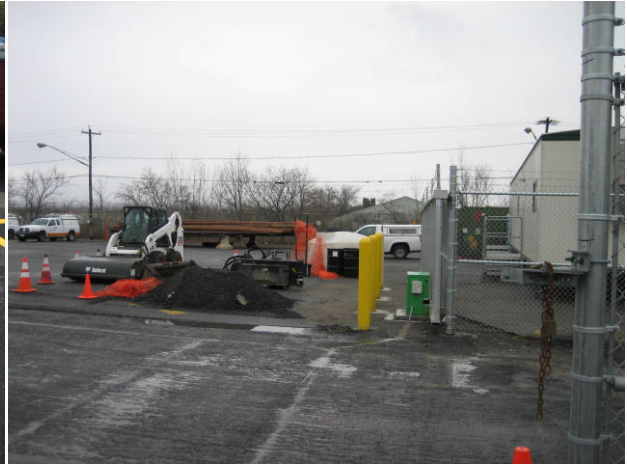
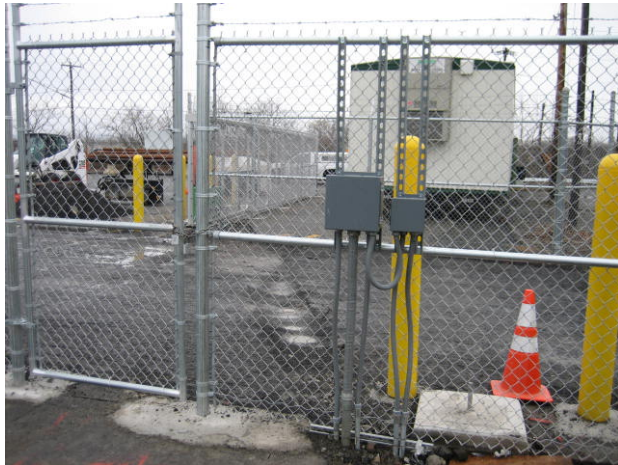
Relocated Main Security Gate 12/1-5/10

Keeping an eye on the asphalt cracks at the seams of the excavation.  
 EPS has completed the gate relocation project.

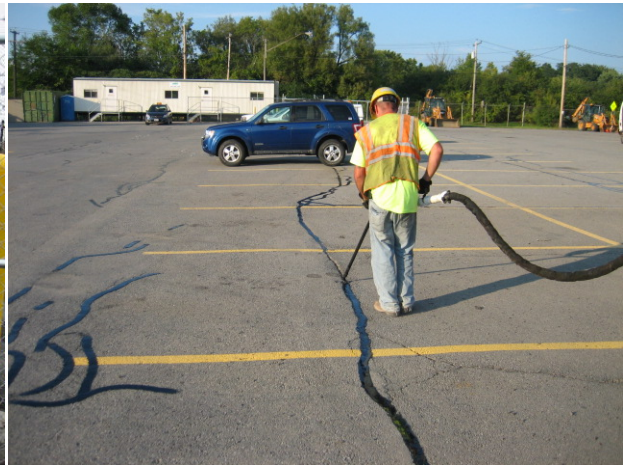
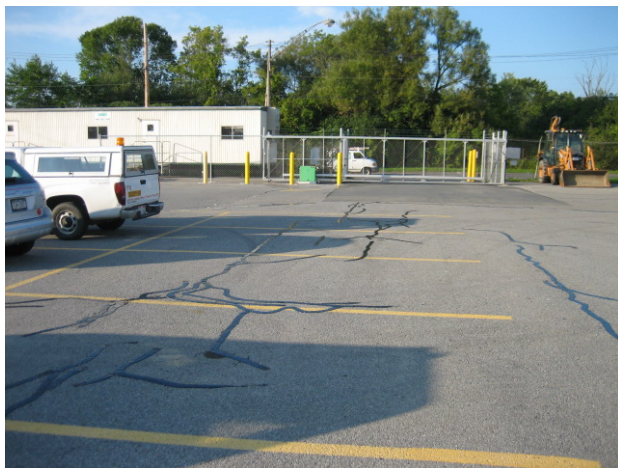
Keeping an eye on the asphalt cracks at the seams of the excavation.  
 These will need to be sealed sometime in the next 12 months.

Asphalt Cap Repair on 9/12/11

Donnelly Construction completed the hot asphalt sealing of cracks in the pavement area of the holder.

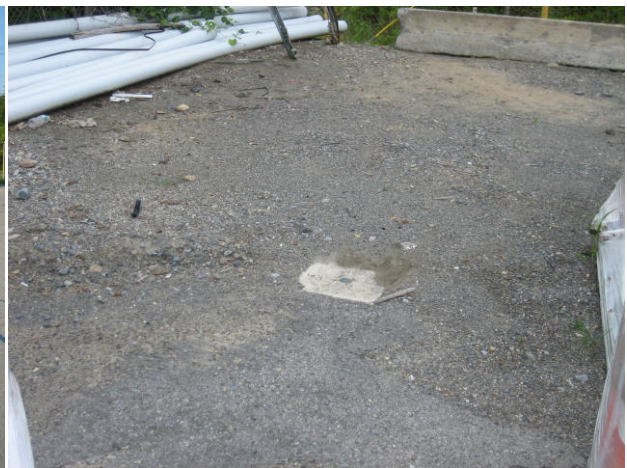
| <b>Area Boundary Controls</b> | | | | |
|---|---|---|---|---|
| Monument - 2 | PRESENT | | MISSING | COMMENTS: Monument has been hit by snowplowing.<br>The concrete base is loose. |

| <b>Area Boundary Controls</b> | | | | |
|---|---|---|---|---|
| Monument - 2 | PRESENT | | MISSING | COMMENTS: Monument had been hit by snowplow. The concrete base is loose. But Secure. |

Monument #2 Intact But Damaged (Taken 9/2/13)
