Dambrose Cleaners
SCHENECTADY COUNTY, NEW YORK
Final Engineering Report

NYSDEC Site Number: 447030

JANUARY 2012

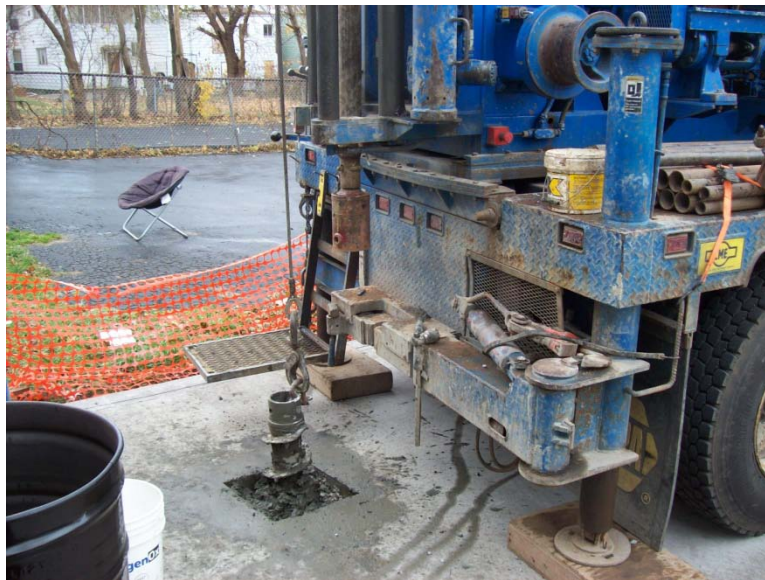
Pulling augers after completion of MW-1R

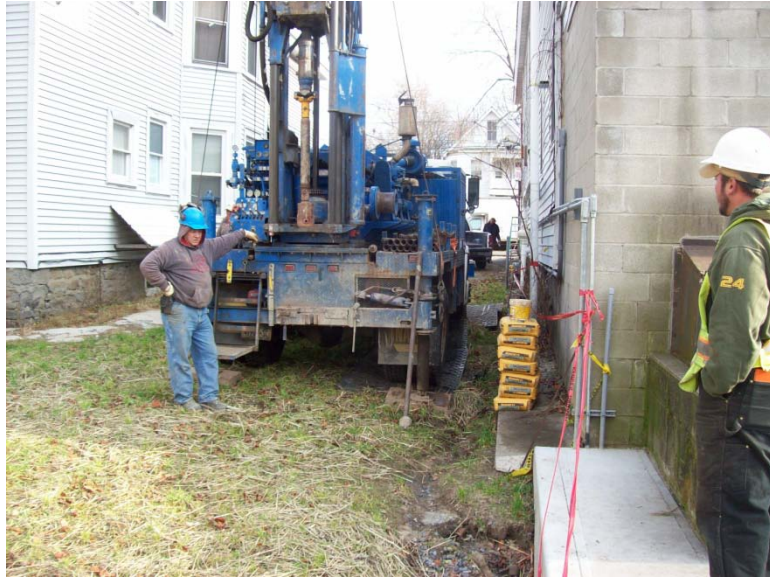
MW-2R drilling location

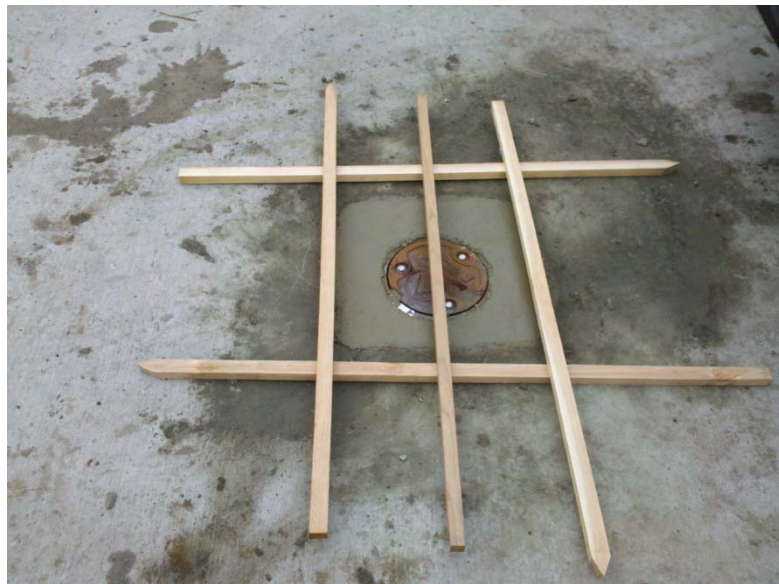
MW-1R

Description of Tests/Inspections Performed: Split spoon soil samples were collected during the drilling of both wells. The soils were classified by Precision Environmental and screened for VOC vapors with a Thermo Environmental Instruments Model 580OB OVM. No VOC vapors were detected in the soils screened with this instrument.

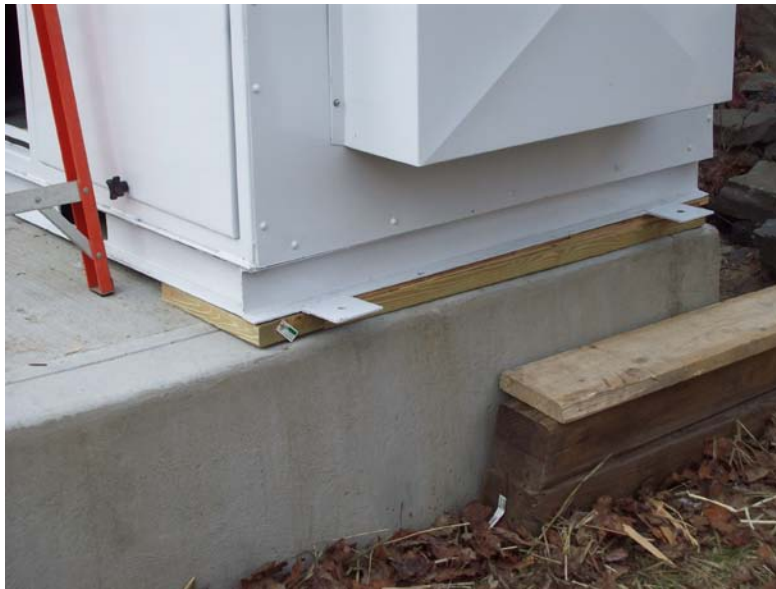
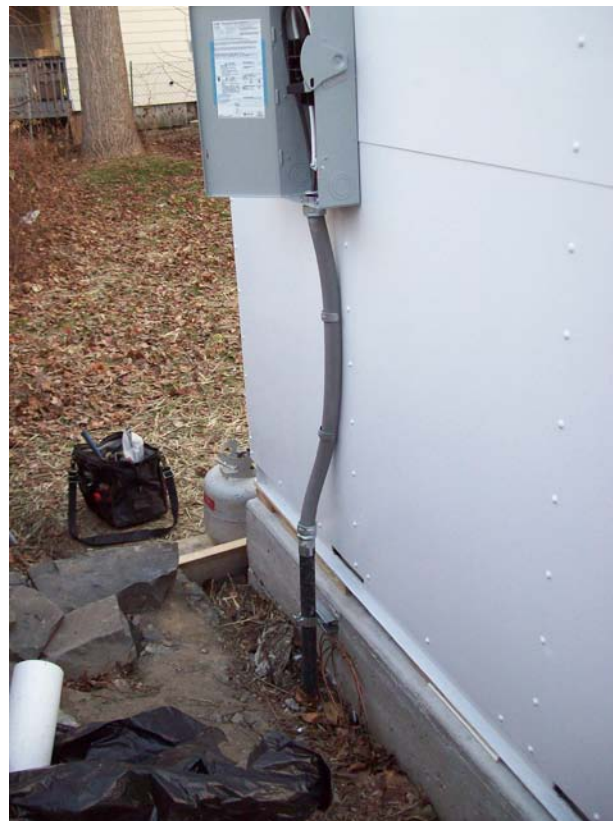
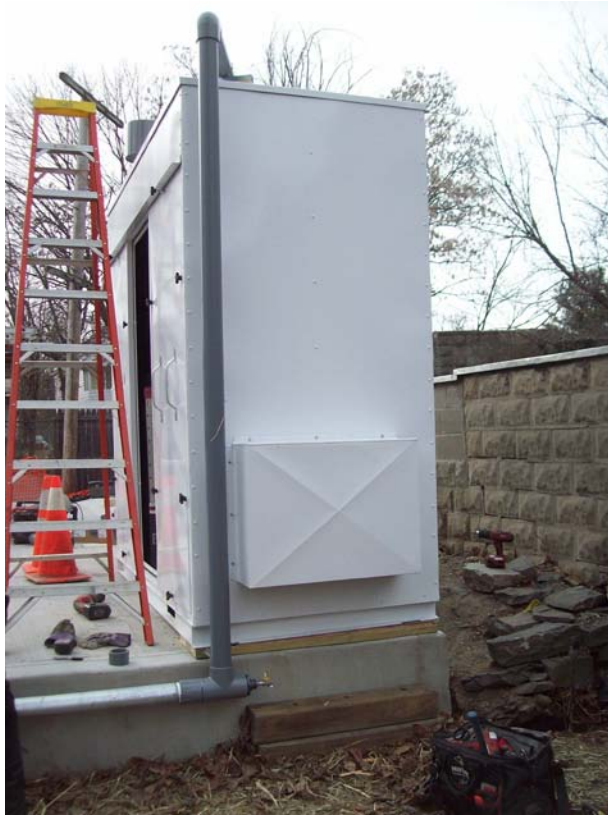
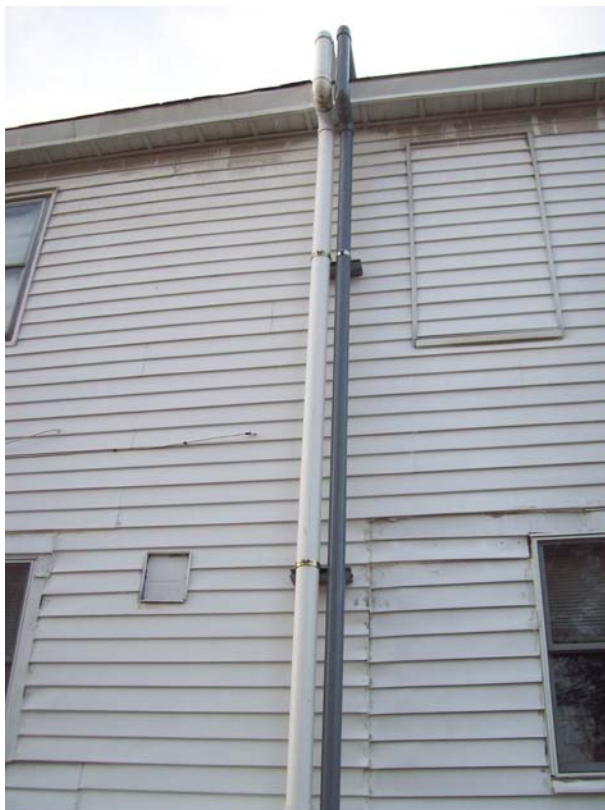
Daily Inspection Report\12-7-2010

General Description of Work Performed: Precision Environmental Services completed tying in the SVE system to the exposed ends of the trench lines, began securing the enclosure to the concrete slab, and erected safety bollards around the system. Additionally, the final wiring and connections to the SVE system were completed pending the meter's connection to the utility. It was noted that, due to the position of the system, angle iron is needed to secure the enclosure to the side of the slab. Materials will be obtained in the future to accomplish this task.

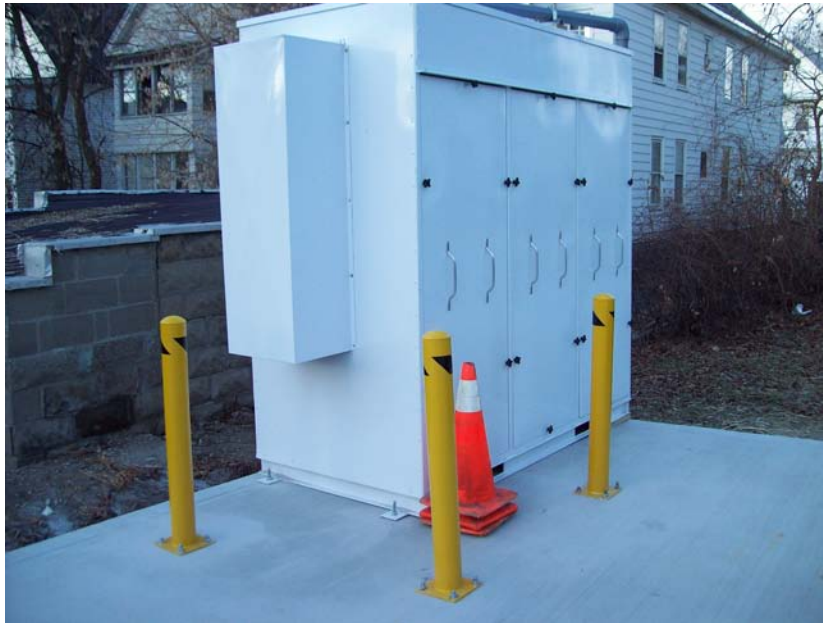
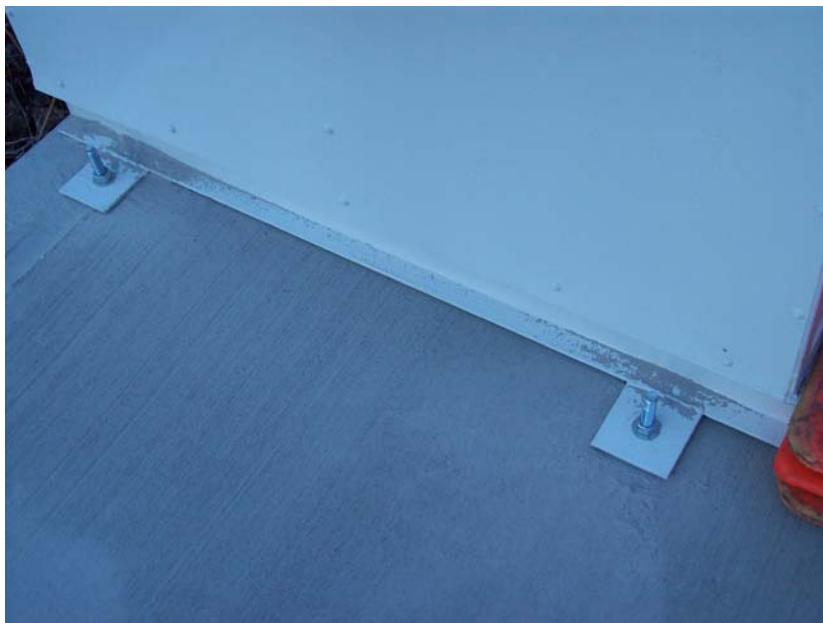
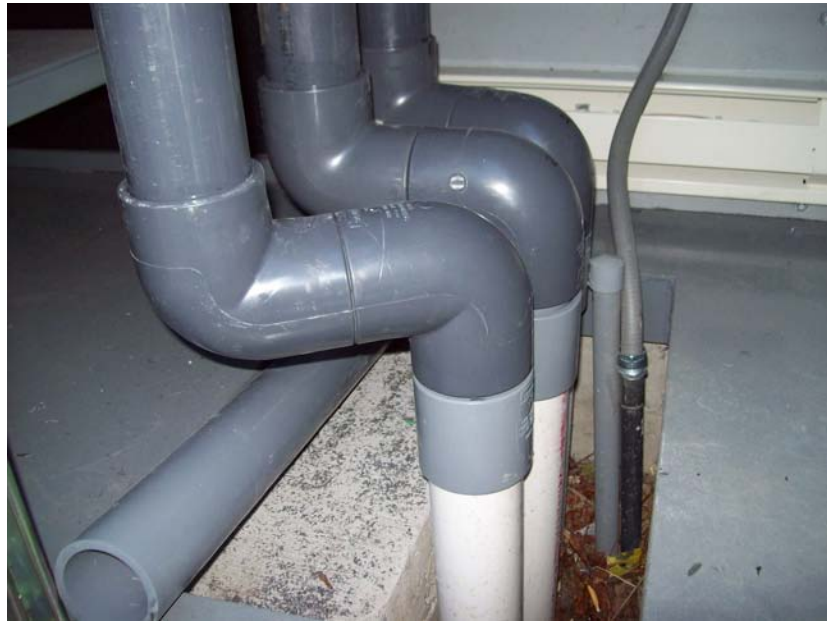
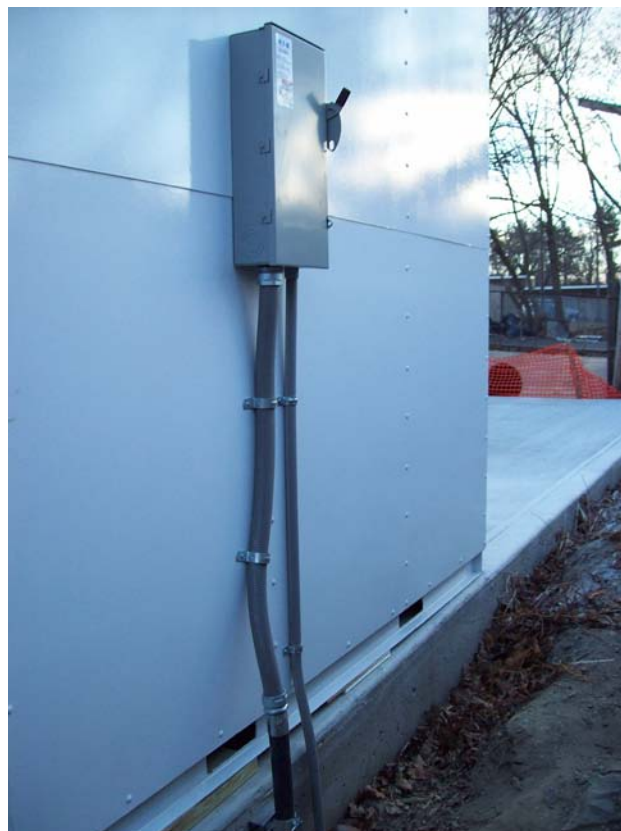
Daily Inspection Report\12-8-2010

General Description of Work Performed: Precision Environmental Services sealed the opening in the concrete where the vent lines and conduit enter the system, and finished securing the enclosure to the concrete slab using sections of angle iron. Additionally, a Verizon representative was on-site to run phone line for the system. It was noted that more sealing will be required to protect the system from the elements and infestation. Materials will be obtained in the future to accomplish this task.
