PERIODIC REVIEW REPORT

PERIOD: July 1, 2013 to June 30, 2016

**DAMBROSE CLEANERS SITE
1517-1519 Van Vranken Avenue
Schenectady, NY**

NYSDEC SITE NO.: 447030

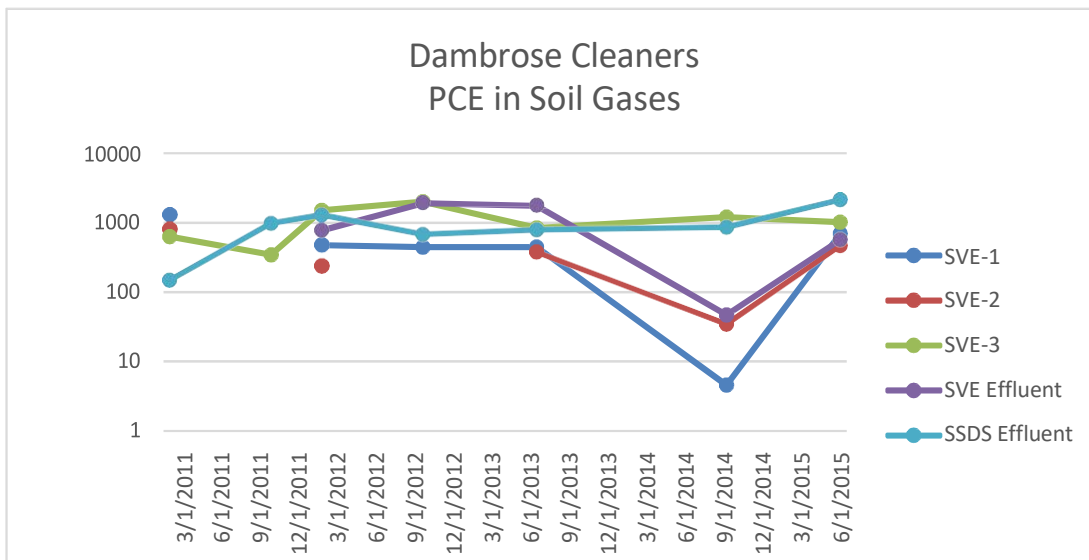
Data over the last three years indicates PCE concentrations in soil vapor and groundwater samples continue to fluctuate, however, an upward trend existed due to 2015 data. As described below in Section 4.0, this may be due to low levels of precipitation which exposes greater surface area of the SVE wells to the smear zone and adsorbed contaminant mass in soil. This may have led to increased soil vapor extraction.

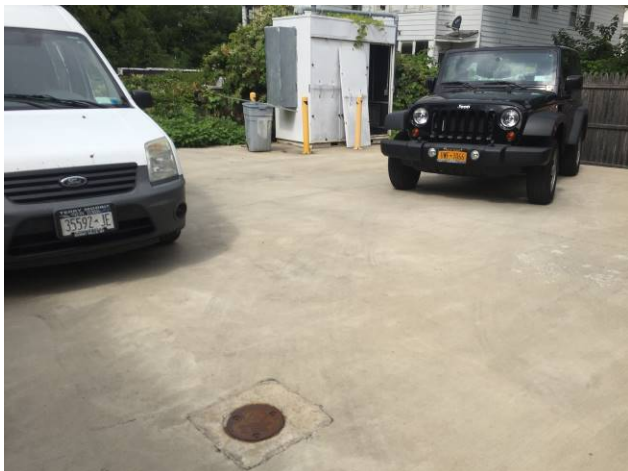
Visual inspection of the soil cap and concrete occur on a monthly basis and during annual evaluation to monitor performance of this control. Both are significantly intact as originally constructed with no obvious wear. Photo documentation of the Cap is presented in Appendix A.

Soil cover and concrete cap

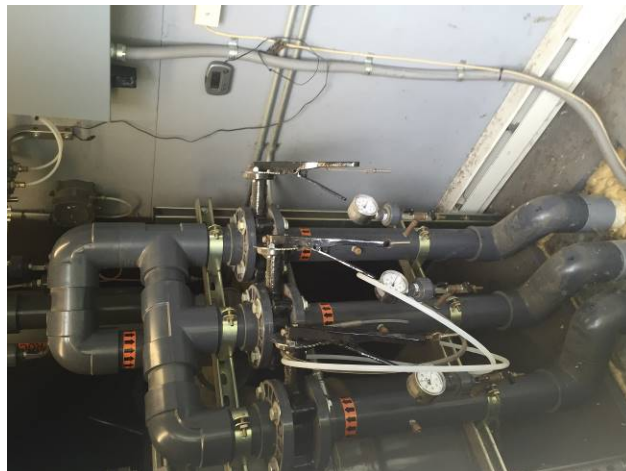
SVES

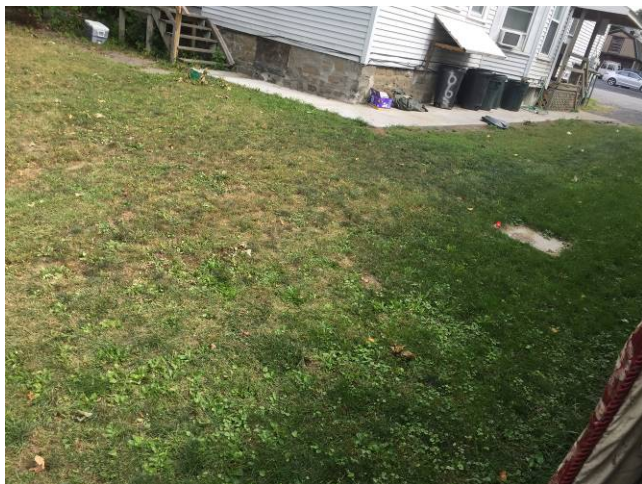
No significant wear on the soil cover and concrete cap was observed. This control appears to be maintained in satisfactory condition.

Soil cover and concrete cap

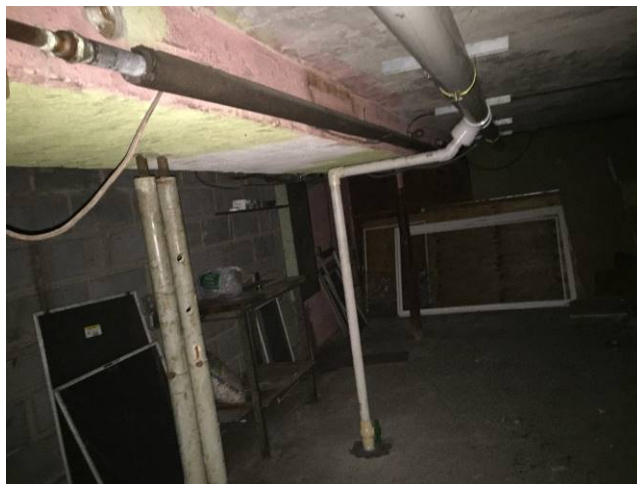
SSDS Piping

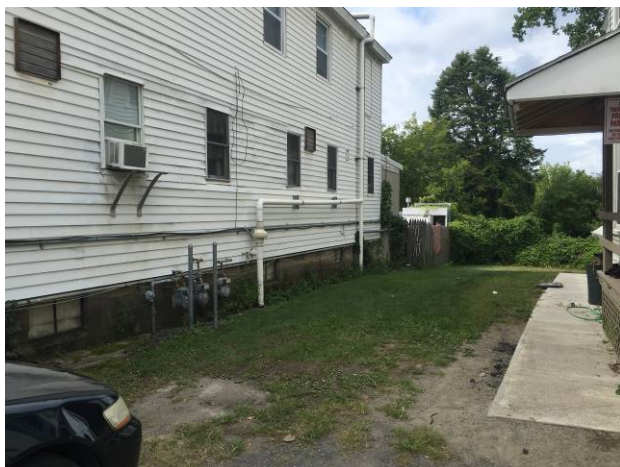
SSDS Blower and Piping
