CONSTRUCTION COMPLETION REPORT

222 Ferry Street Site NYSDEC Site No. 447047

222 South Ferry Street
Schenectady, New York

Issued On: March 1, 2022

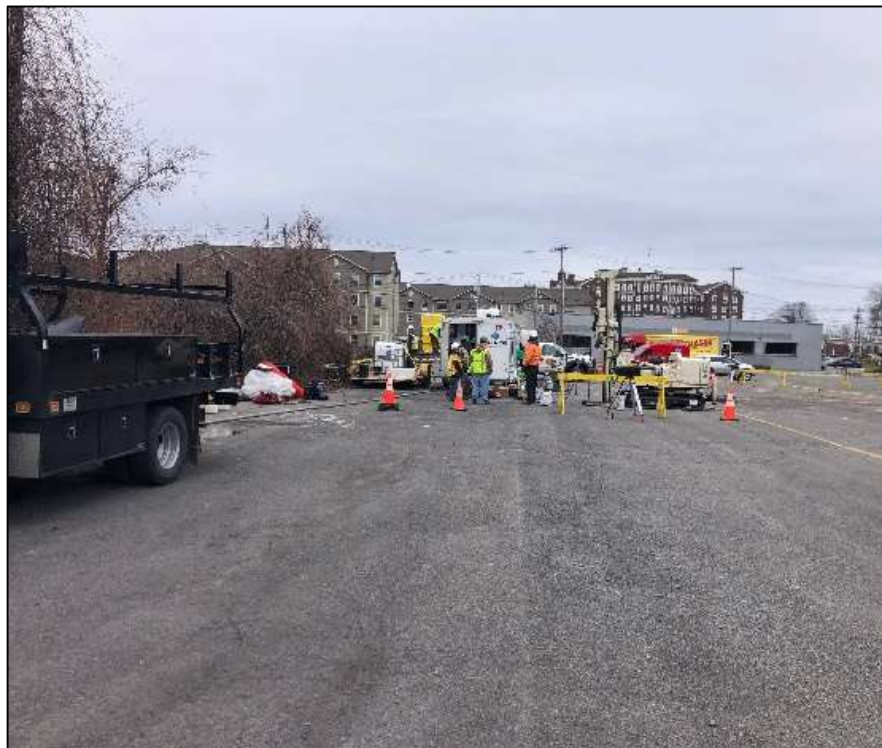
Photo 1: Injection area with Geoprobe and RRS trailer. Looking West.

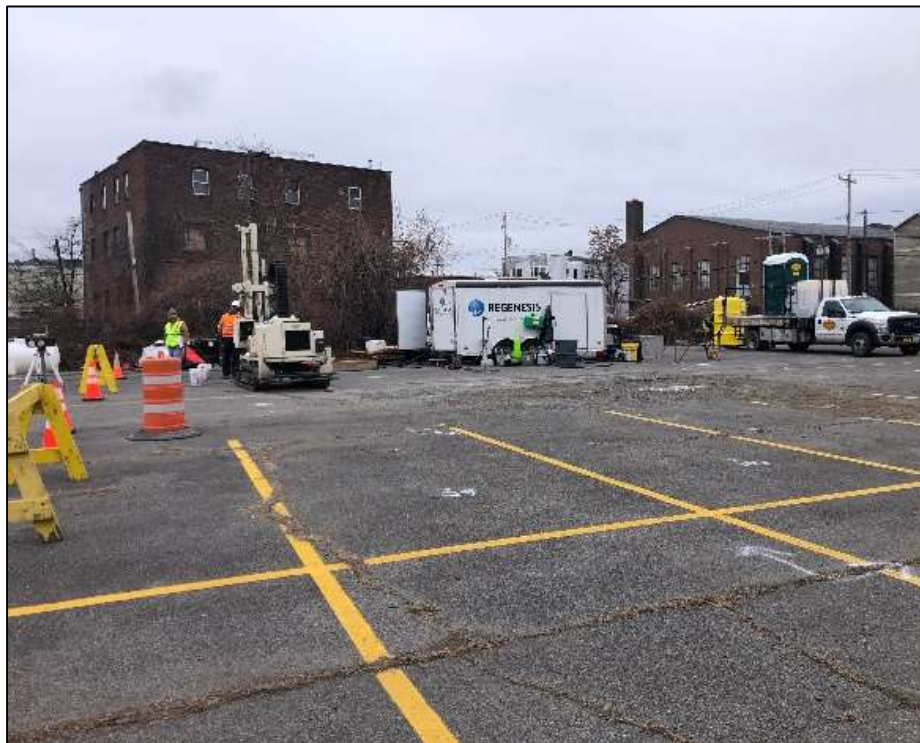
Photo 2: Injection area. Looking South.

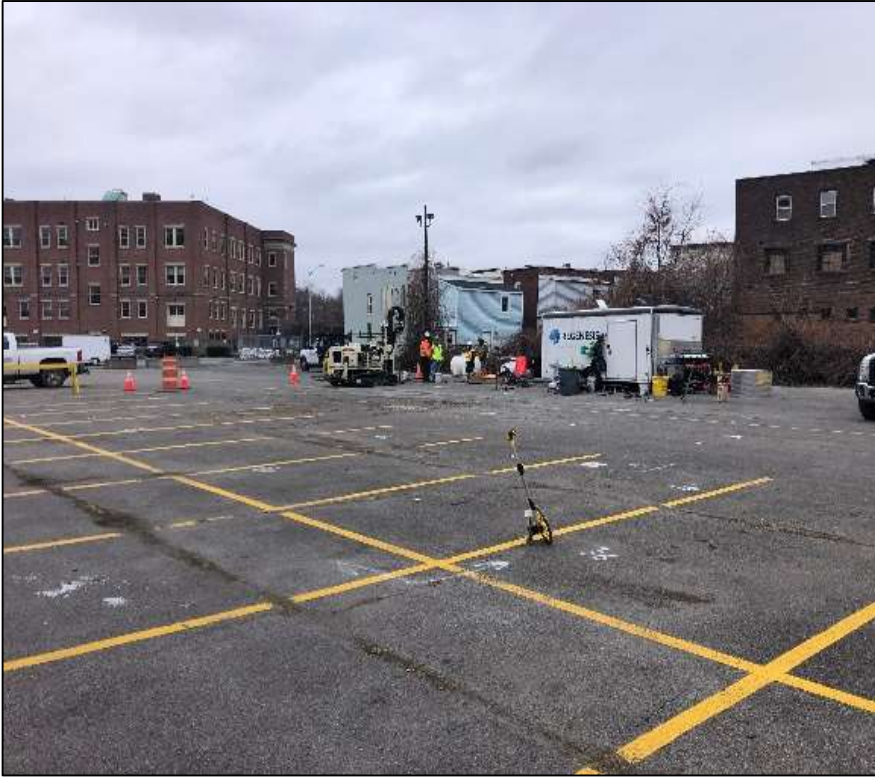
Photo 3: Injection area. Looking SE.

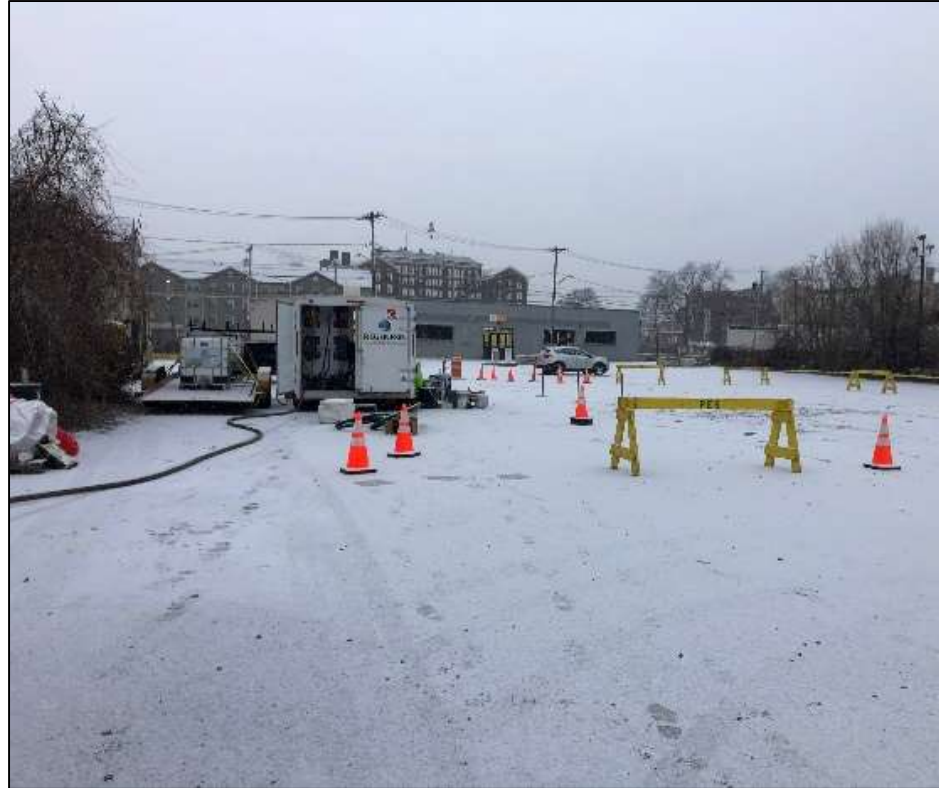
Photo 4: Injection area covered in snow. Looking West.

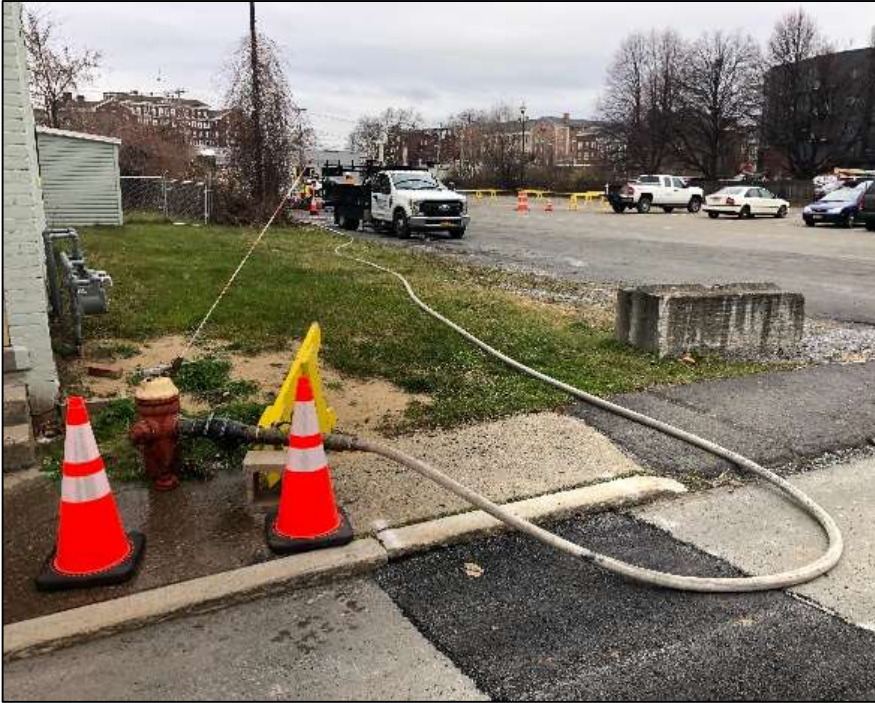
Photo 5: Water hydrant on S Ferry Street.

The three components were stored in separate containers onsite. 3DME and S-MZVI were mixed with water to prepare a 6% solution. Water was supplied by hydrants located on South Ferry Street and South Church Street. Mixing was conducted onsite using a proprietary system housed in a trailer. BDI was added to the mixture using nitrogen gas to prevent aeration of the anaerobic culture. The reagent solution, containing all three components, was pumped from the trailer into three injection points simultaneously, using a manifold system. Each injection point was equipped with a flow meter and pressure gauge to record volume in gallons, and injection pressure in pounds per square inch (psi). Flow into the injection points ranged from 1.54 to 6.45 gallons per minute (gpm) and injection pressure ranged from 0 to 30 psi during the two events.

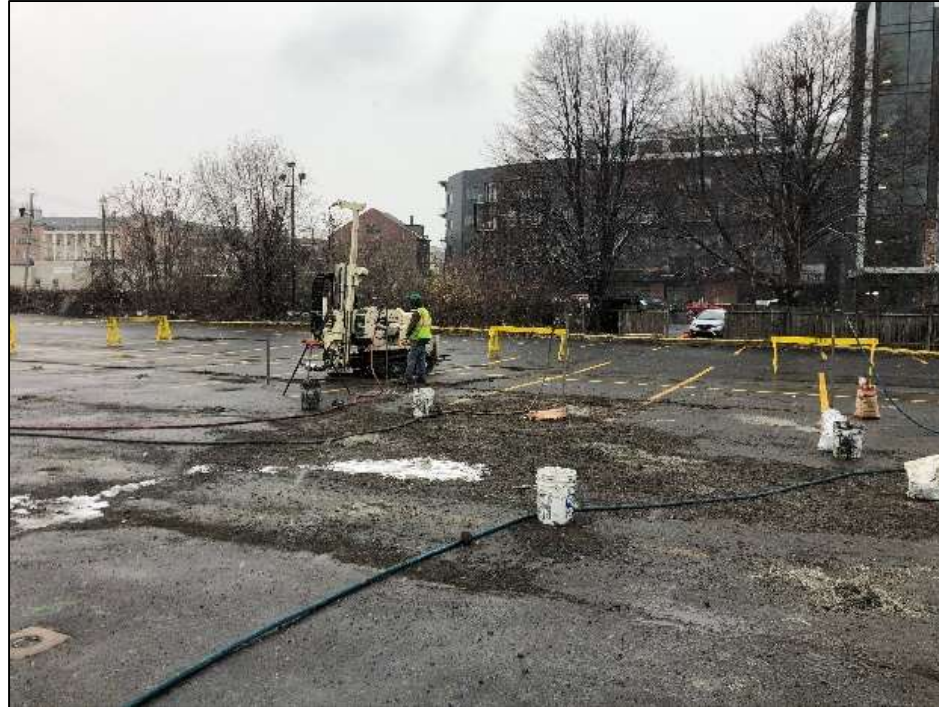
Photo 6: Injections around previous excavation.
Looking North.

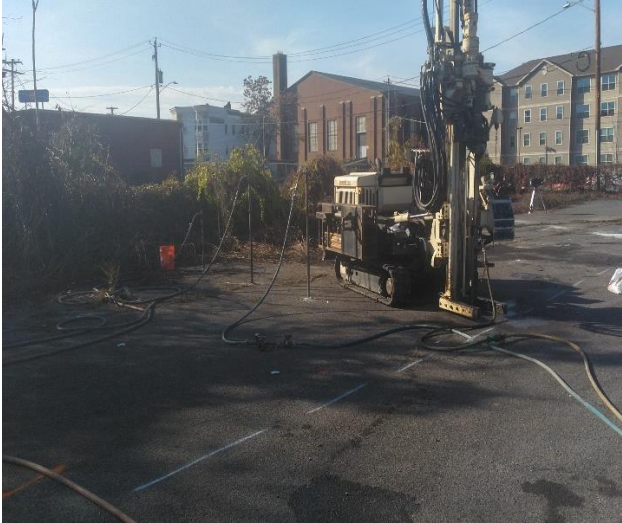
Photo 1: Direct Push Rig and injections ongoing on parking lot. Looking SW.

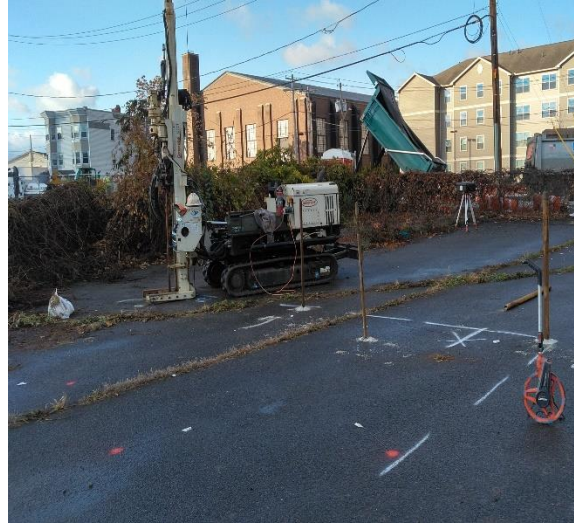
Photo 2: Points marked out on the ground. Looking SW.

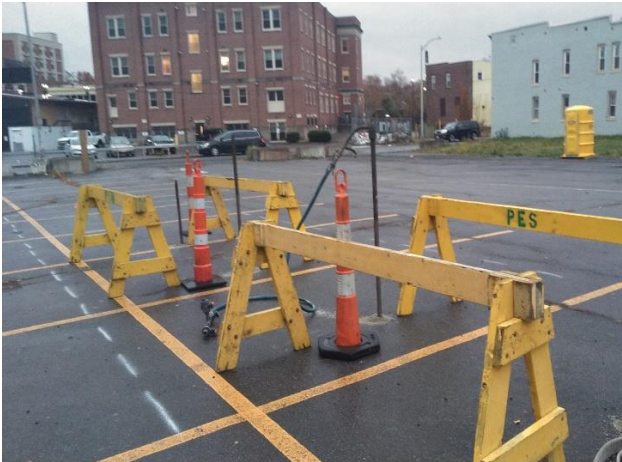
Photo 3: Signaling of injection points on site. Looking SE.

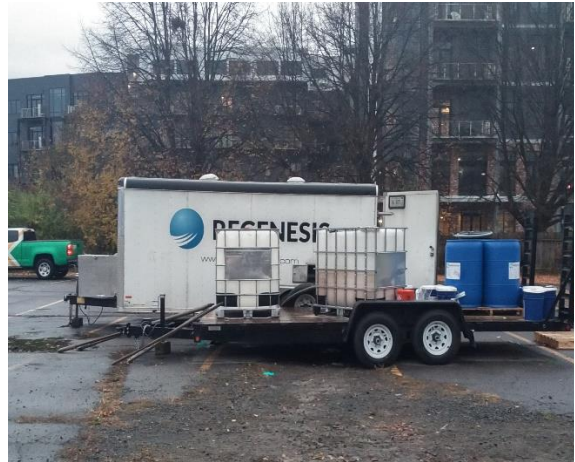
Photo 4: RRS trailer staged and products displayed.

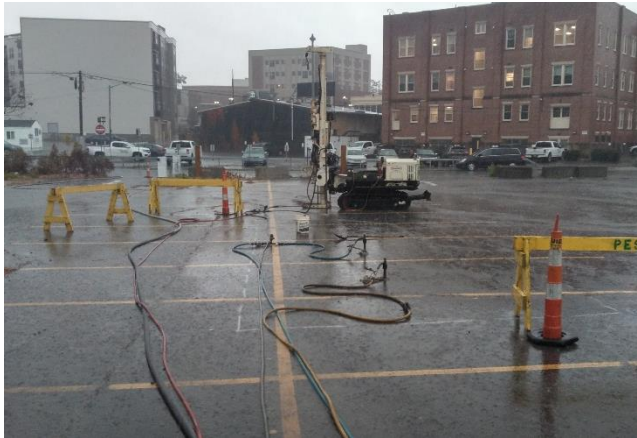
Photo 5: Signaling of points and injections on site. Looking E.

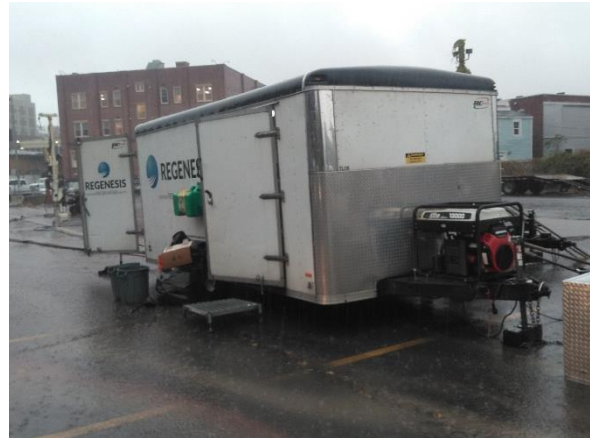
Photo 6: RRS trailer staged and equipment.
