Re: Wallace and Son Scrapyard Site (# 4-48-003), Cobleskill, New York  
2008 Annual OM&M Report

**M. Wallace and Son, Inc. Scrapyard Site  
Cobleskill, New York  
Site No. 4-48-003**

*2008 OM&M Report*

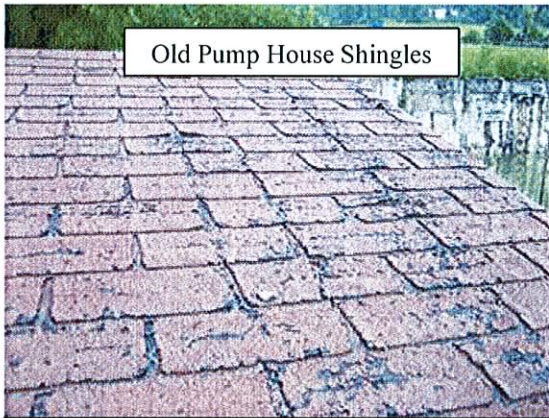
- Stripped the old roofing materials off the pump house and installed new asphalt shingles and underlayment.

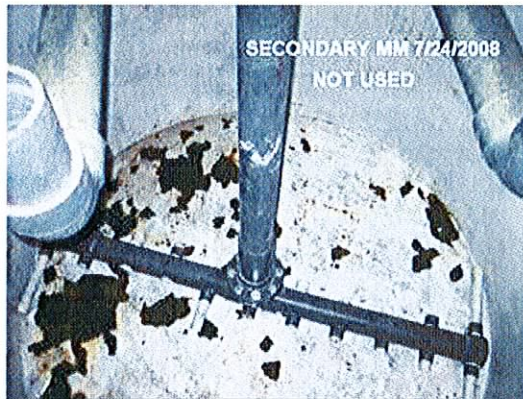
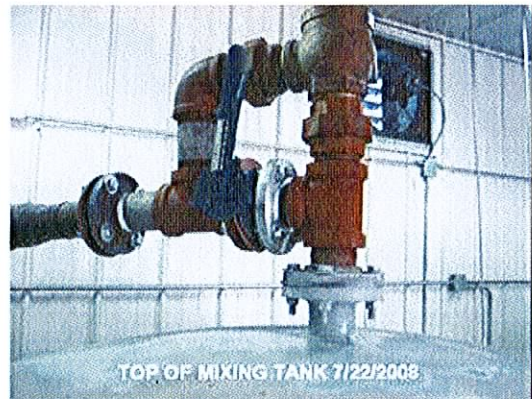
- Calgon performed the carbon and multi media removal of the secondary system. All the vessels were completely emptied and the interiors were power washed. Detailed Summary of Work is included in Appendix D.
- The secondary system is officially out of commission.

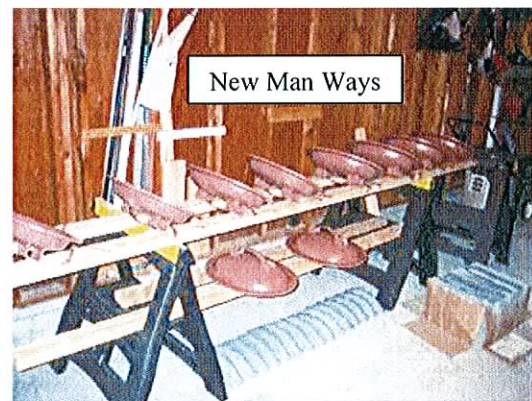
- CDM had Calgon use the existing carbon and anthracite that was left on site from the previous change out.
- Due to heavy oxidation on several of the man ways, eight new man ways were ordered, primed, painted and installed on the carbon and multi media vessels with new gaskets.

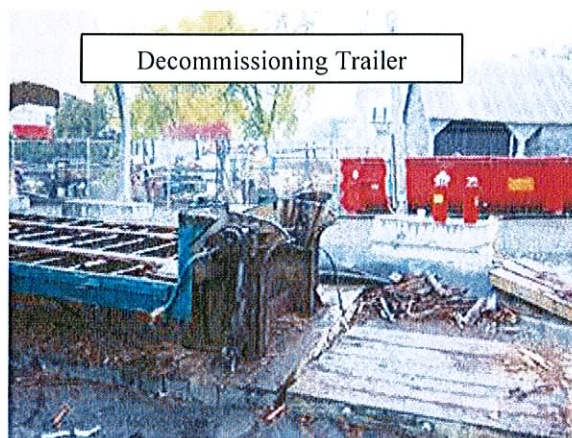
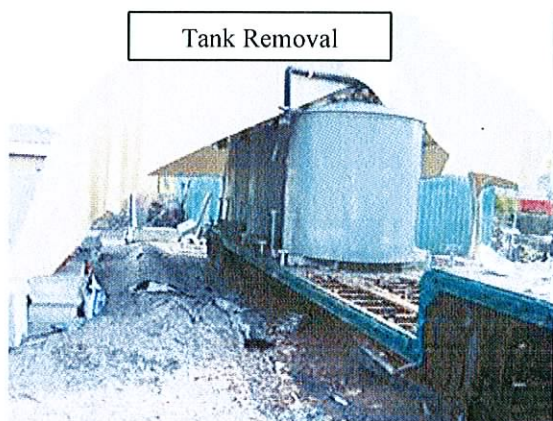
- Removal of the electrical service and pole from the former secondary system area.
  - Removal of the electrical system from inside the building.
  - Removed pump P3 and took to Gardner Equipment for complete annual maintenance. Pump P2 is being used during this time.

- After decommissioning activities were complete, the area was rough graded and sloped for storm drainage.

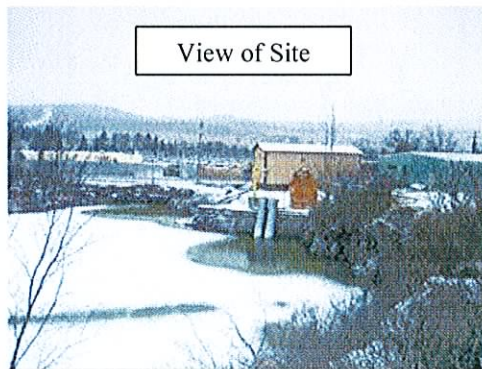
- Received monthly effluent water sample analysis from previous month. No detections of PCBs were reported.
- Completed monthly LNAPL Recovery Systems OM&M.
- Completed the monthly system PCB sampling/analysis.
- Conducted and documented the monthly site inspection.
- Ordered two new Grundfos submersible pumps. The 5hp pump will be connected to a VFD and have an operating range of 30-100gpm. A 15hp pump with a VFD will have an operating range of 100-275gpm. These pumps were determined as good replacements after meeting with Bruce Ruggles of Gartner Equipment at the site on November 19, 2008.
- On December 13, 2008 a 10hp rental submersible pump was installed at the site to help lower the rising quarry level due to several storm related events.
