Re: 2024 Restoration Monitoring Report  
NYSEG - Plattsburgh Saranac St. MGP, Operable Unit No. 1  
Saranac Street, Plattsburgh  
Clinton County  
Site No.: 510007

Subject: **2024 Restoration Monitoring Report**

Plattsburgh (Saranac Street) Former Manufactured Gas Plant Site, Operable Unit No. 1  
NYSDEC Site No. 5-10-007

NYSEG  
PLATTSBURGH (SARANAC STREET) FORMER MGP SITE  
PLATTSBURGH, NEW YORK  
2024 POST-CONSTRUCTION MONITORING REPORT

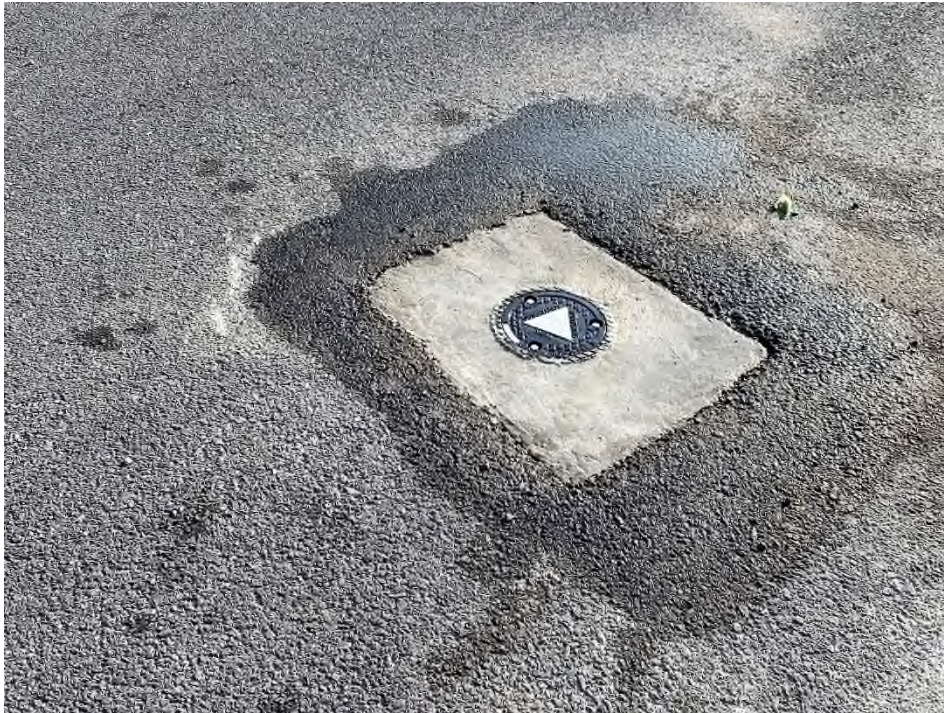
**Photograph: 1**

As noted in the 2023 Post-Construction Monitoring Report, well surface completions for monitoring wells MW-99-12S and MW-99-12D, located in the Durkee Street parking lot were scheduled for repairs due to damage from vehicle traffic and snow plowing.

**Description:**  
MW-99-12S repaired  
surface completion

**Location:** Durkee  
Street Parking Lot

Monitoring well repairs were performed on July 24, 2024, and included replacing the flush-mount curb boxes and pouring new concrete pads for each well. Well repairs were completed by Arcadis staff from Syracuse, New York (New York State Drilling Registration # NYRD11023), and were supervised by a National Ground Water Association Certified Well Driller (CWD #3111452). Photos of the completed monitoring well repairs are included in Attachment 1.

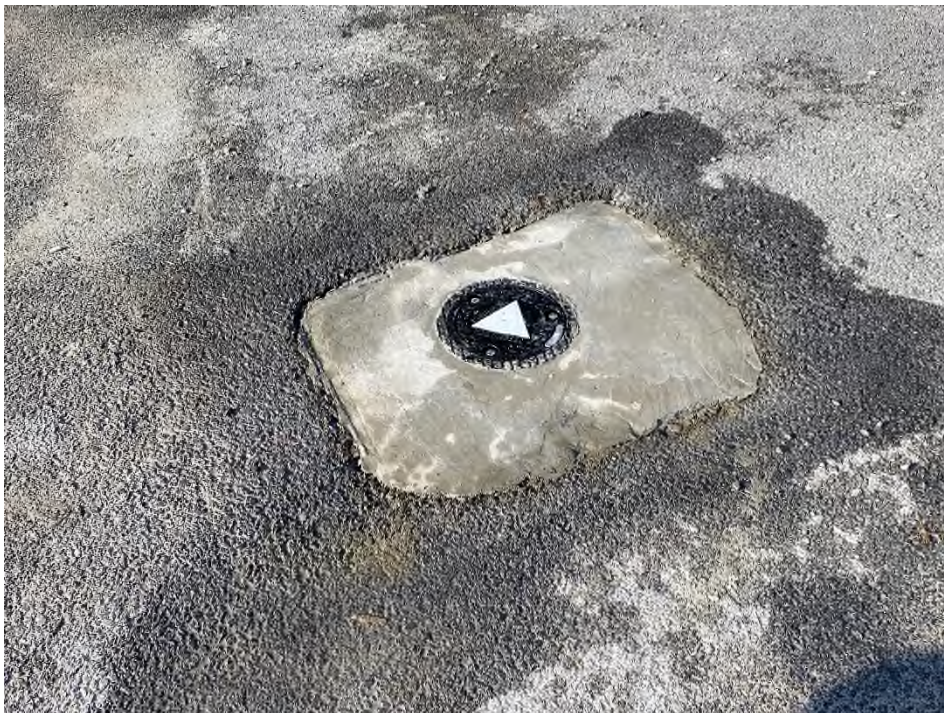
**Photograph: 2**

**Description:** MW-99-  
12D repaired surface  
completion
