SITE CLOSURE REPORT

DECEMBER 2020

Atlas S-6
641 Dry Bridge Road
Black Brook, New York
FUDS Property # C02NY0211

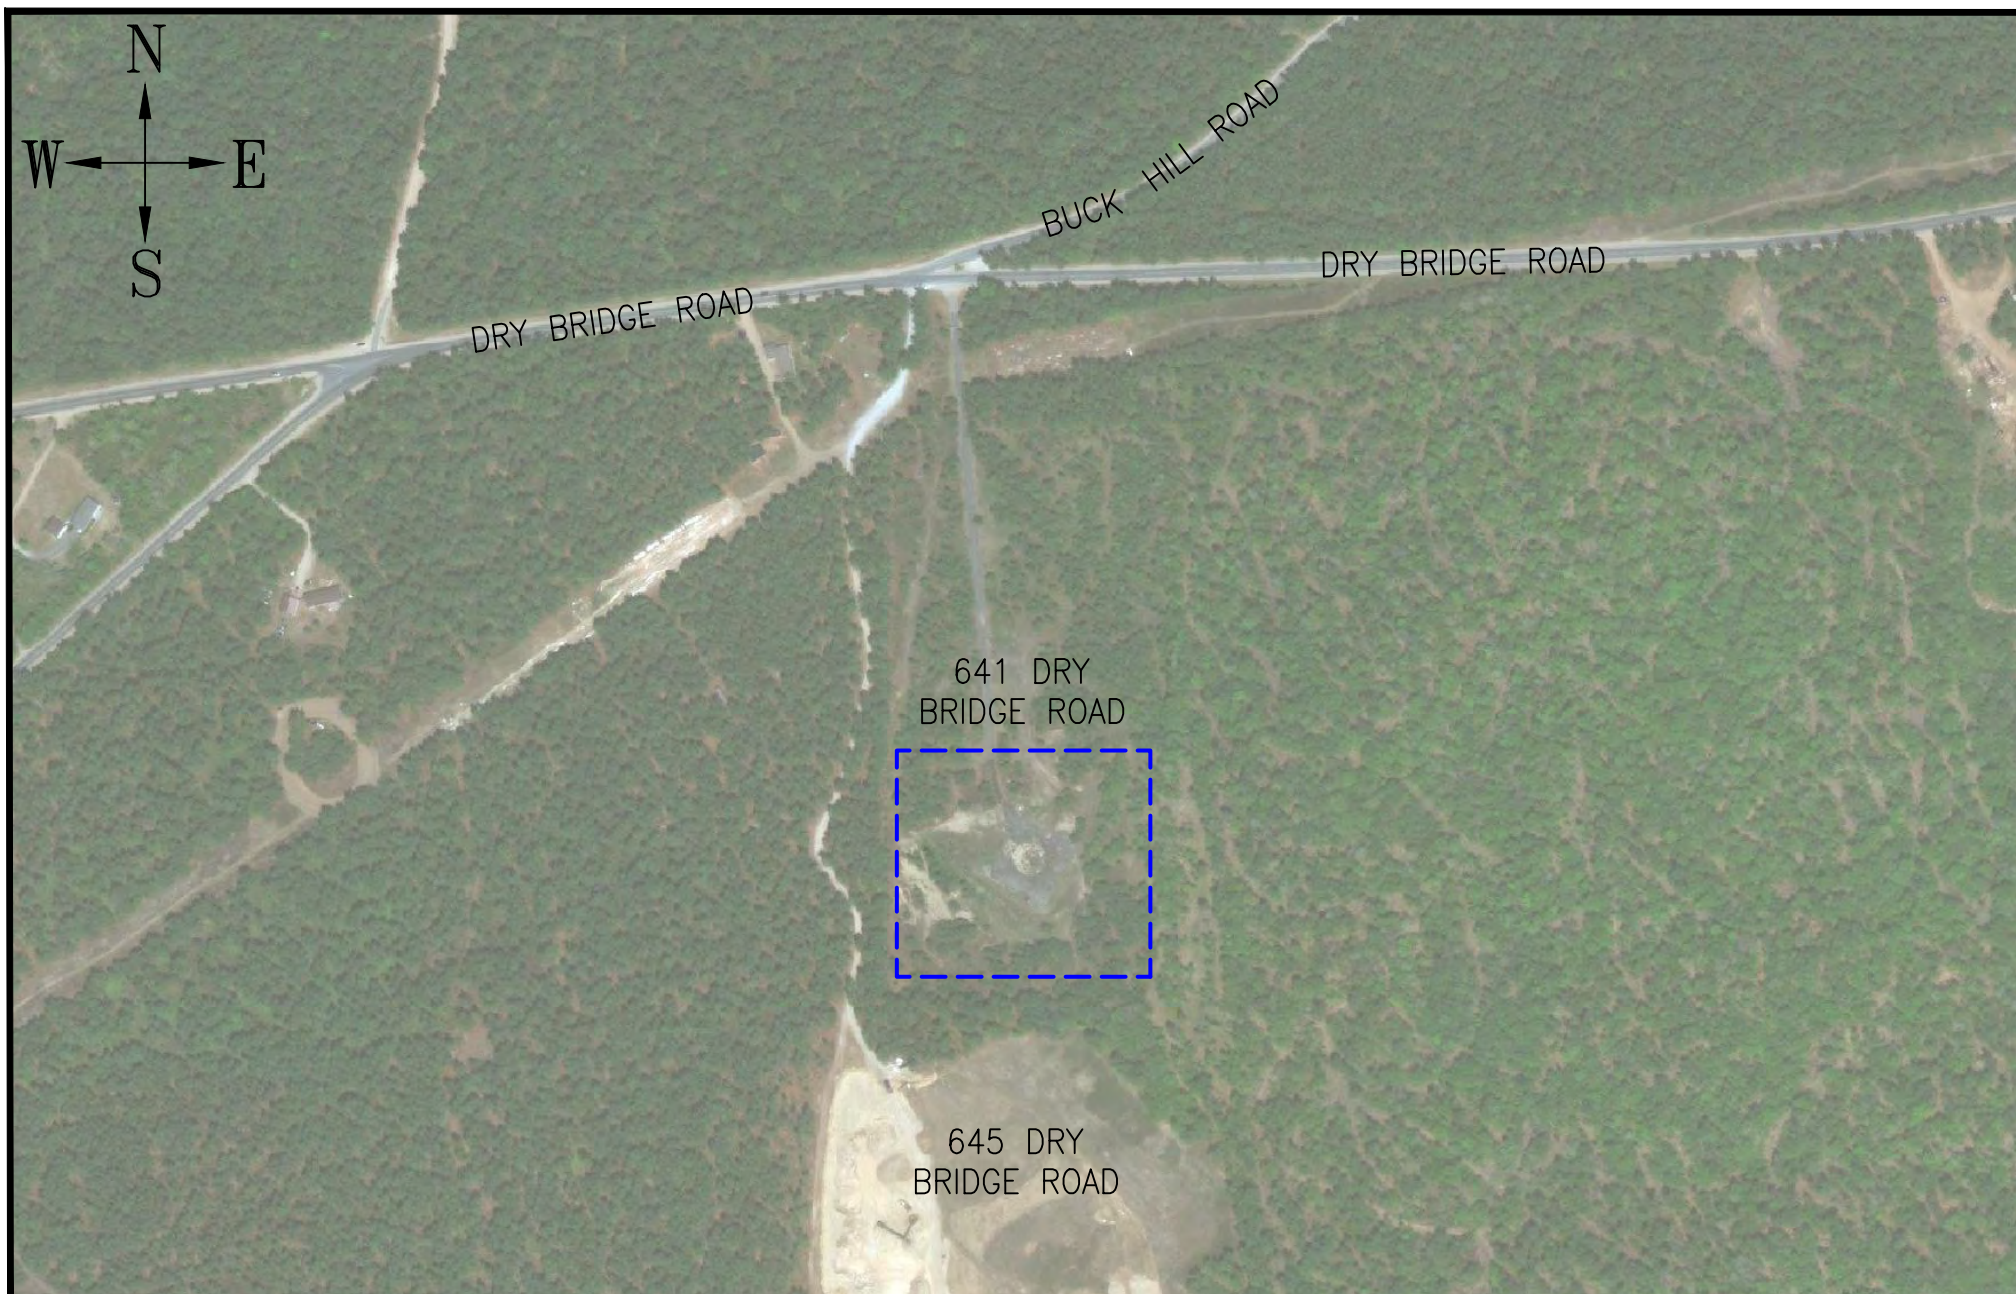
FIGURE 1

ATLAS S-6: BLACK BROOK, NY
SITE OVERVIEW

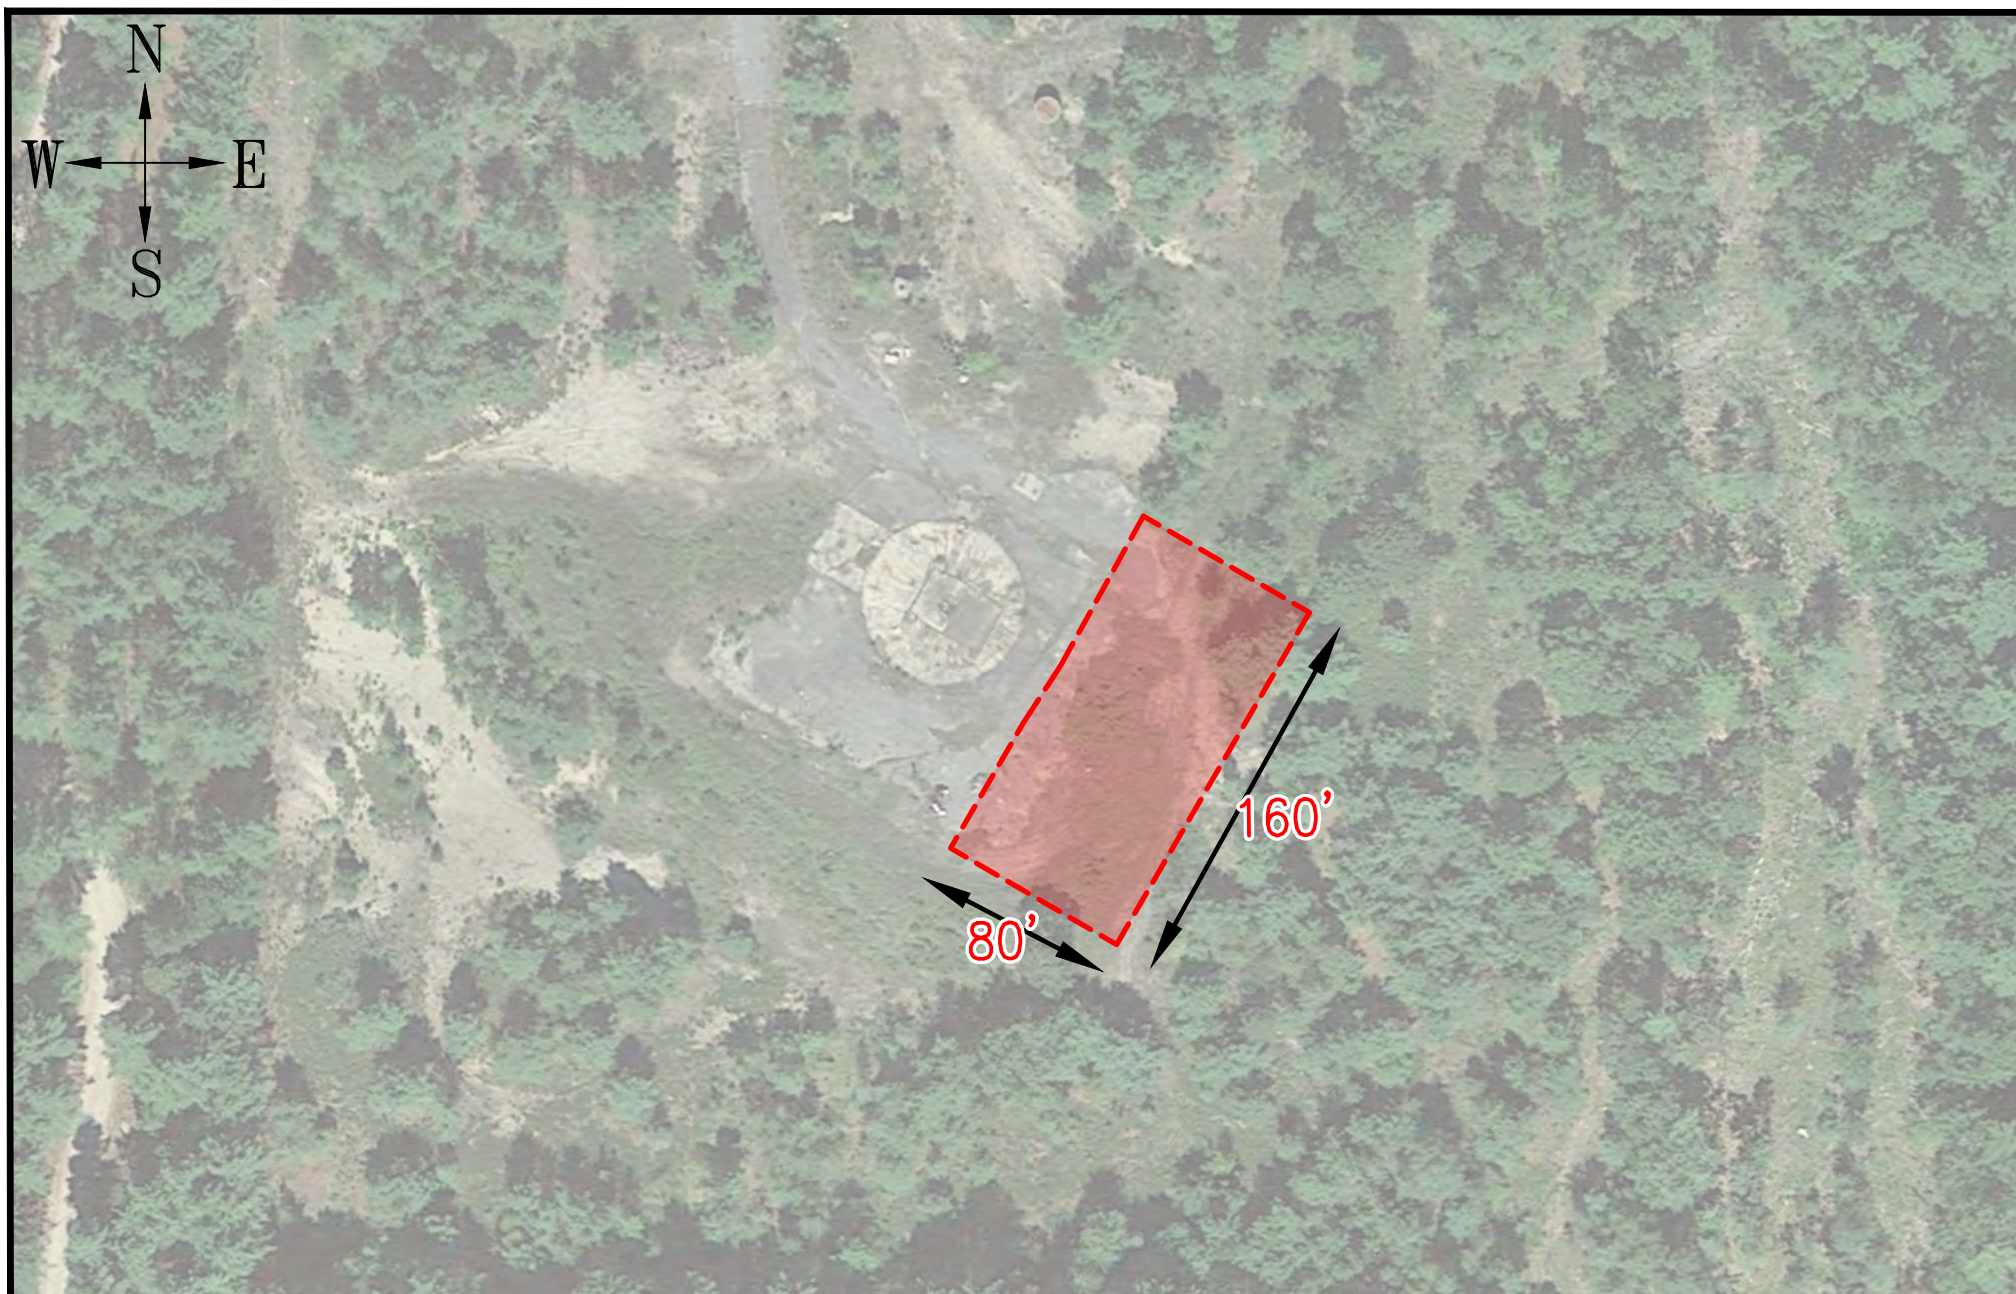
Renova mobilized to the Site with a geophysicist from GPRS, Inc. (GPRS) on 27 October 2020 to perform a geophysical investigation at the location of the suspected UST, identified on **Figure 2**. The investigation made use of an Underground Scanning Ground Penetrating Radar (GPR) Antenna, Electromagnetic Pipe and Cable Locator, Magnetometer, and a Split-Box. Mr. Harry Hendler from USACE was onsite for the duration of the site work.

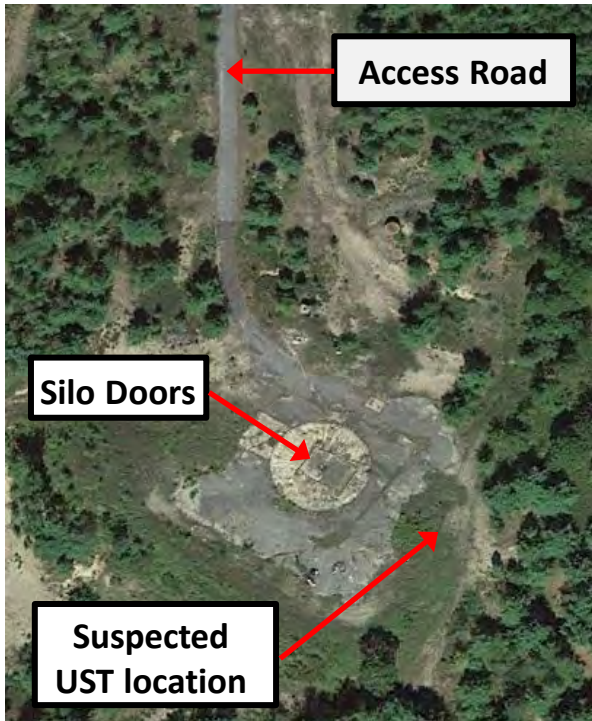
Perform Geophysics Investigation at possible UST location. Contractor shall work around abandoned monitoring well.

View of Investigation Area

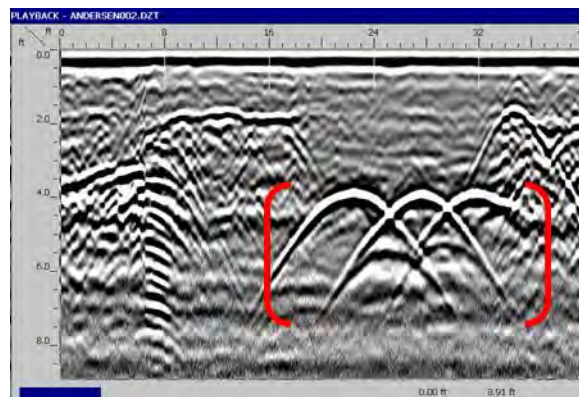
Sample GPR data screenshot showing three reactions from probable USTs. The diameters cannot be determined from these hyperbolas but they can be seen to be larger than a reaction from a typical utility.

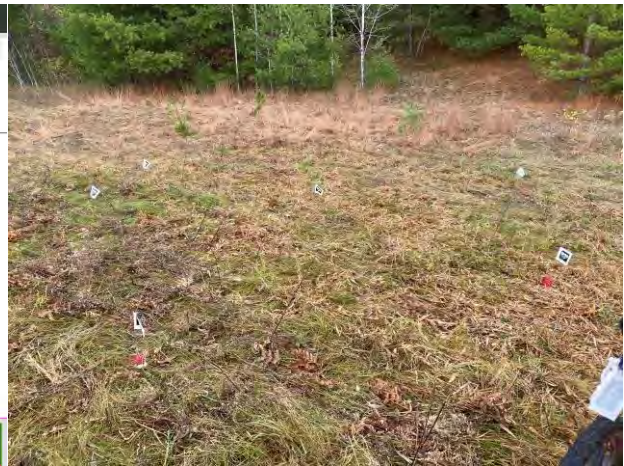
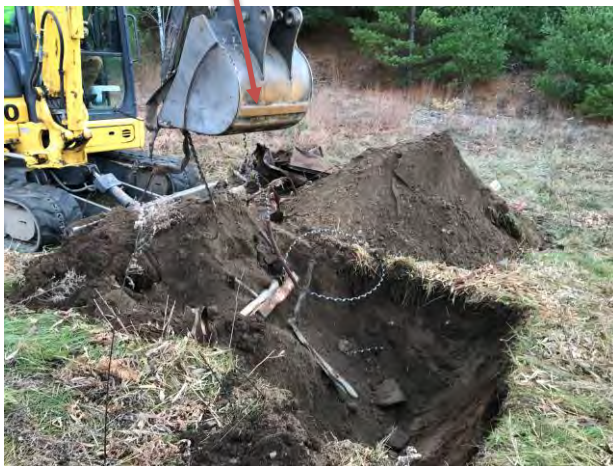
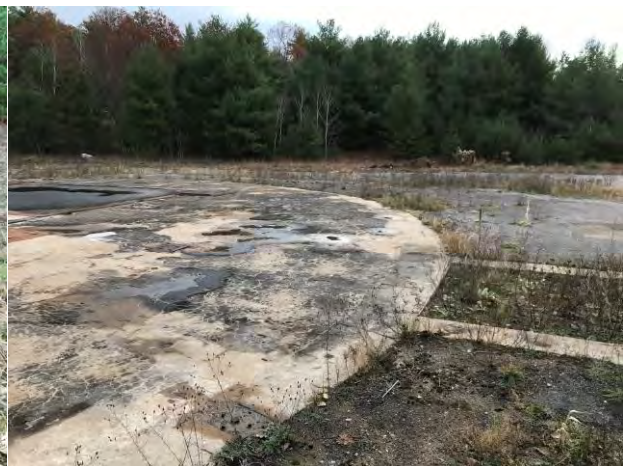
GPR Data Screenshots and Photos

Test pit concluding in scrap metal found in location of suspected UST.

GPR scans not indicative of UST. Rather, conductive to numerous metal reactions below surface.

Client directed Project Manager to scan in location of suspected underground storage tank. Numerous scans within the area did not indicate typical UST data readings. Upon scanning, Project Manager found areas indicative of metal reactions below the surface. While digging a test pit, it was found that scrap metal was located within scanned area in which UST was suspected. Government official on-site informed that previous owner of property claimed that UST was removed. However, no documentation of this claim was acquired.

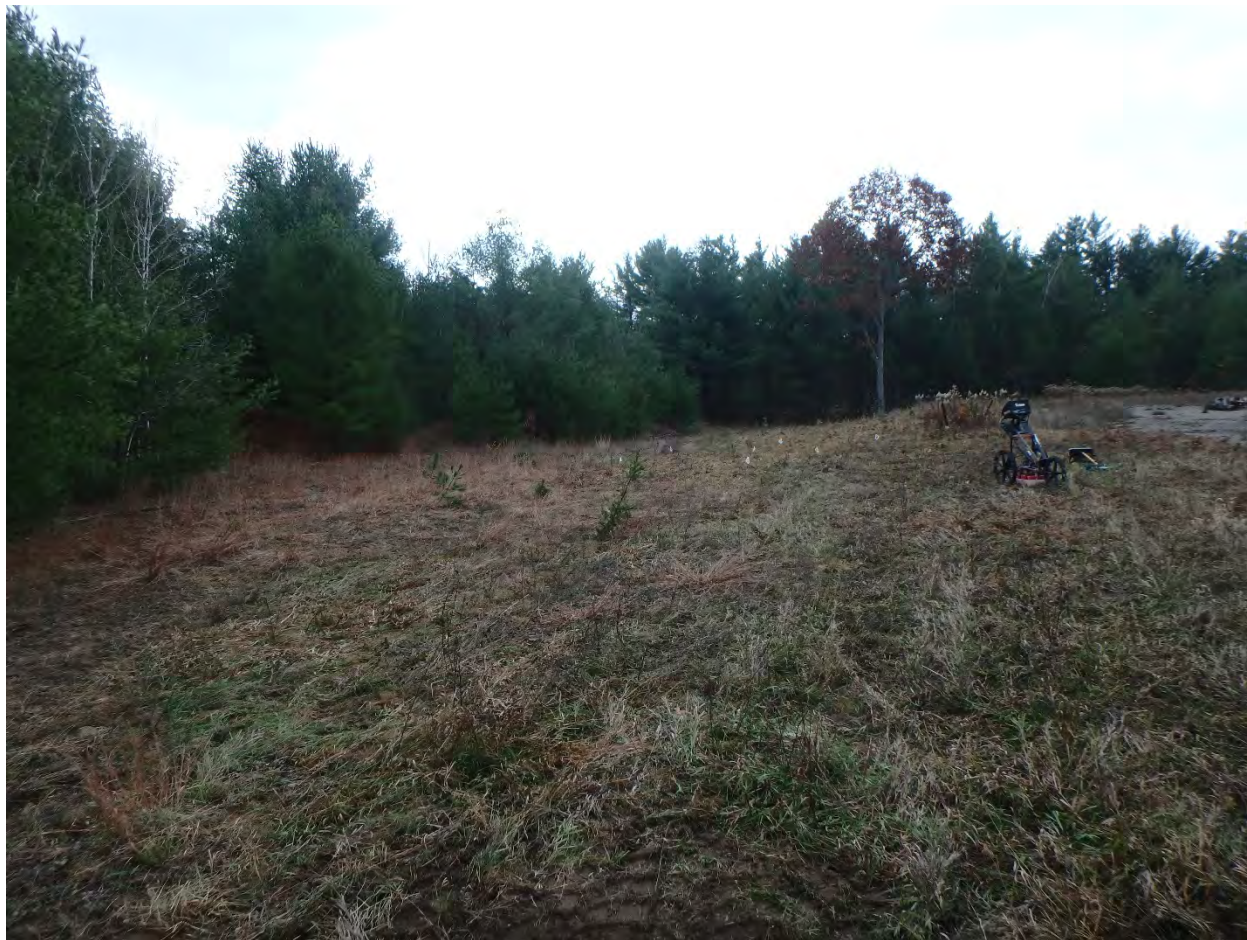
Photo 1 – Area of tank investigation

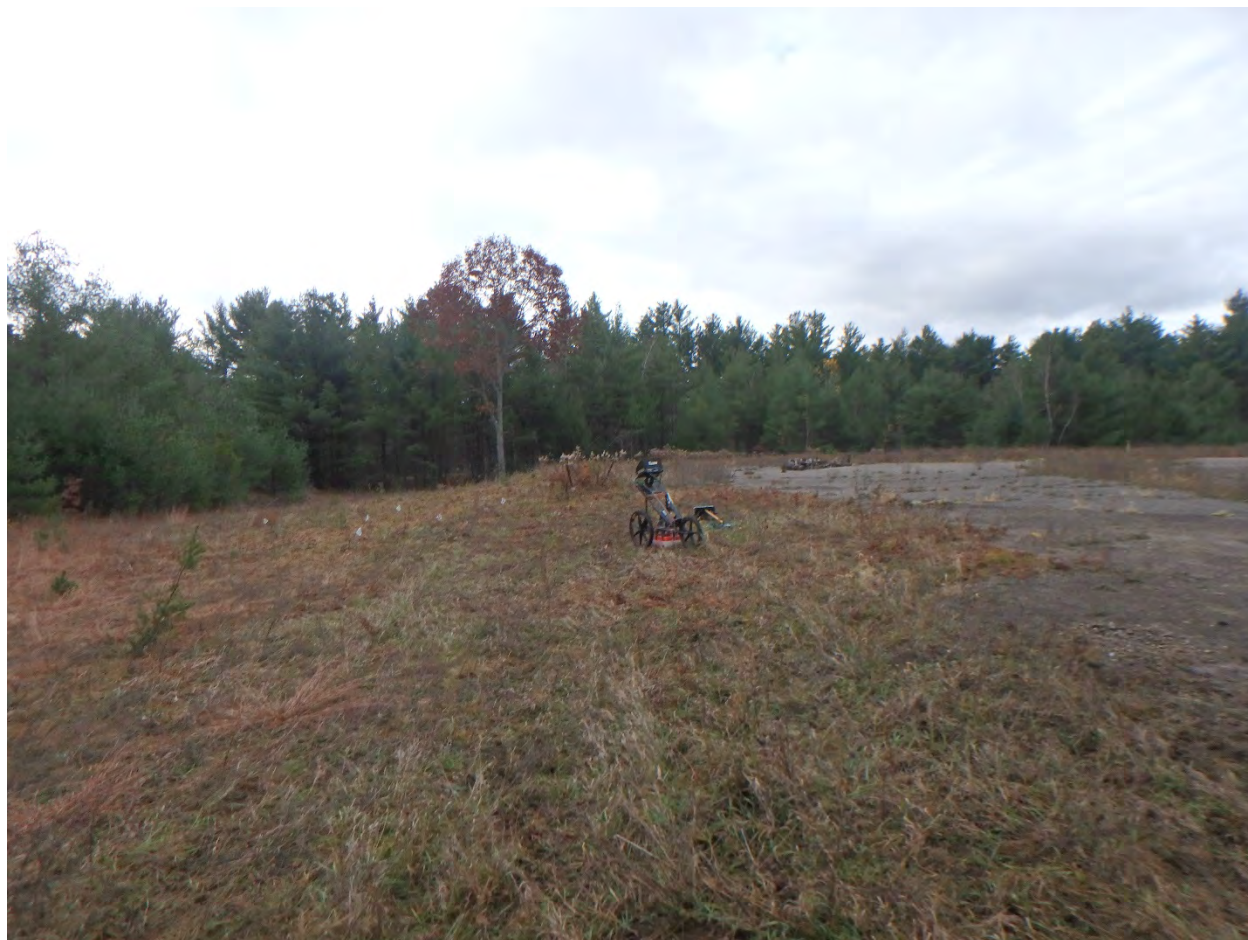
Photo 2 – Area of tank investigation

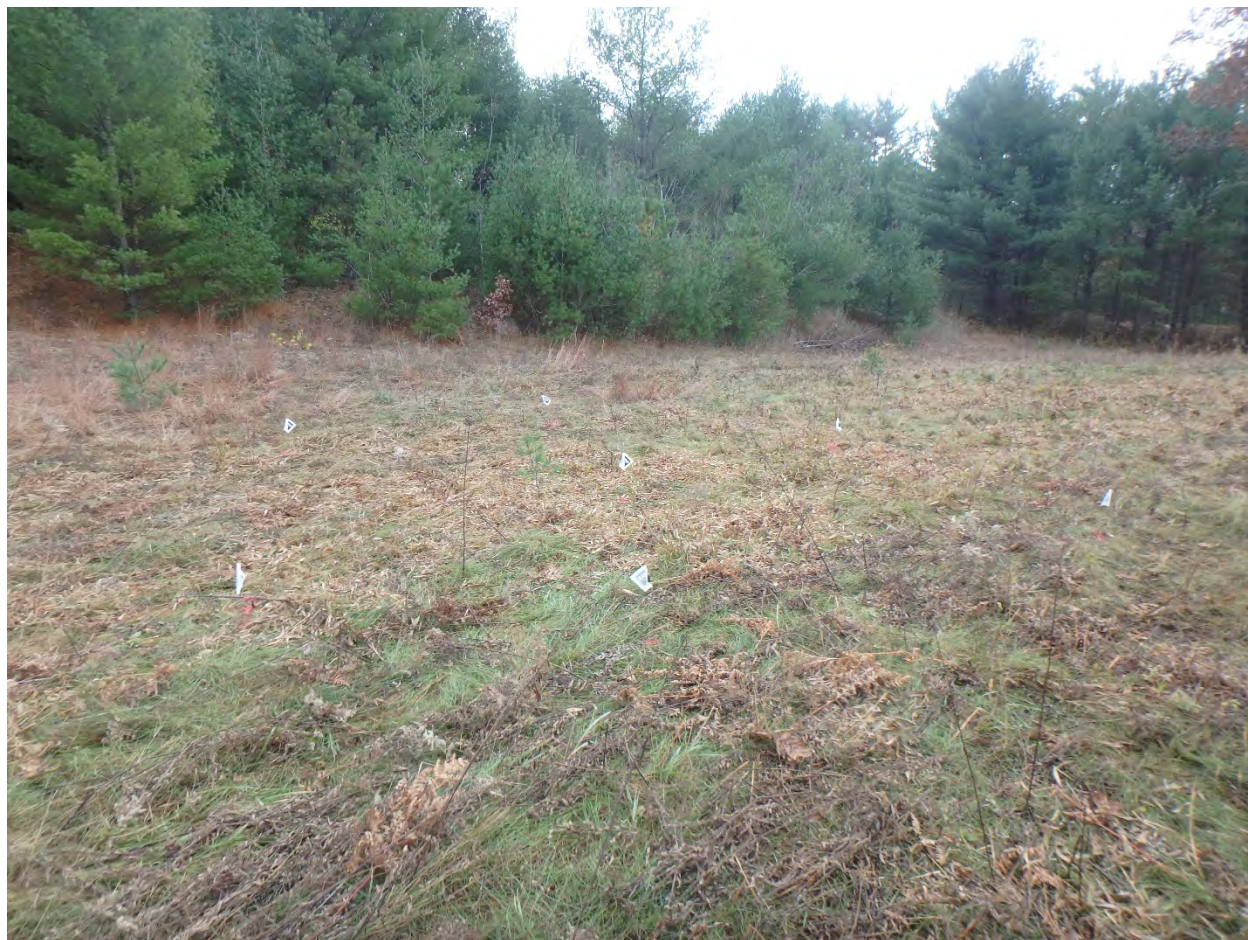
Photo 3 – Flags marking areas to investigate further with test pits

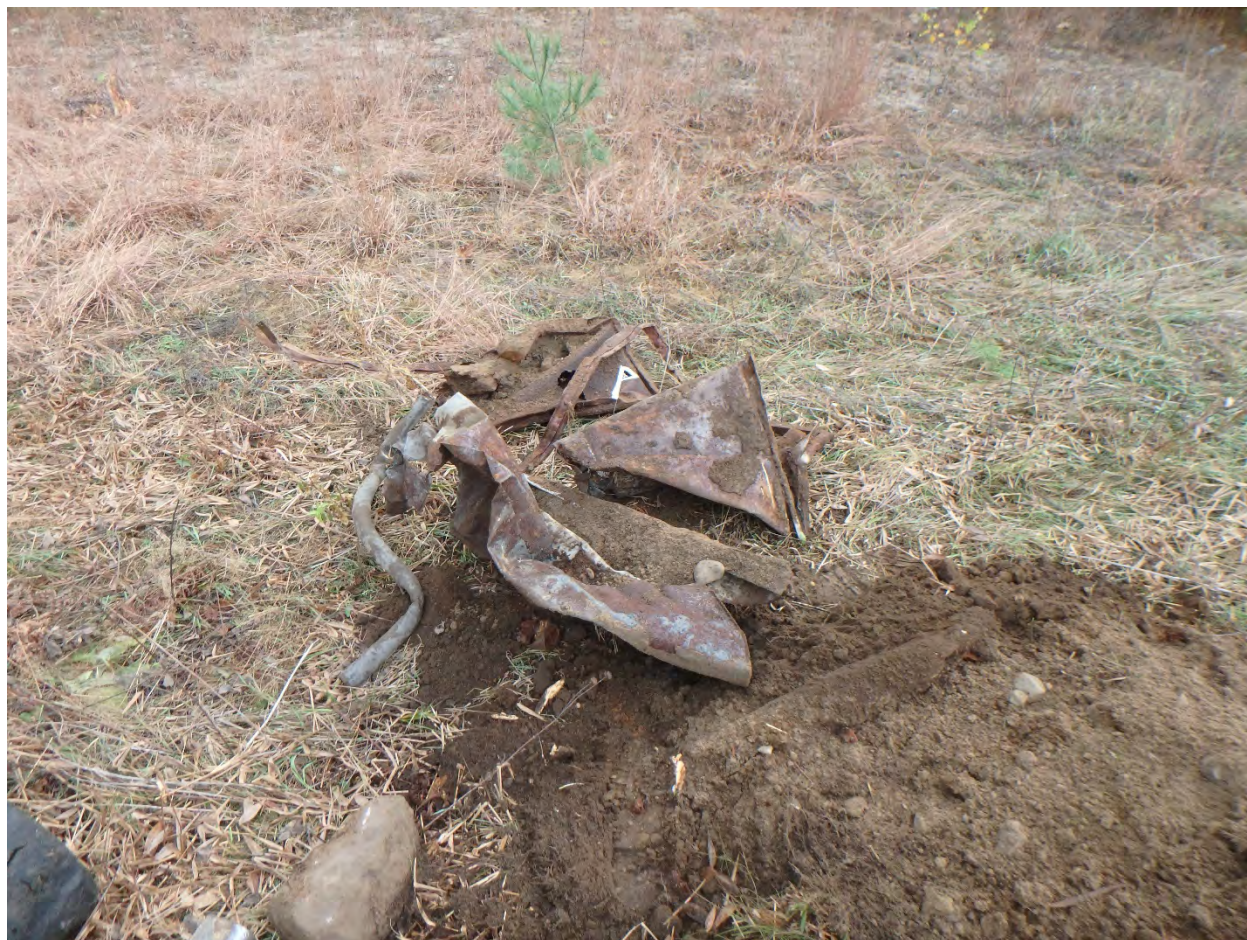
Photo 4 – Scrap metal uncovered from test pit

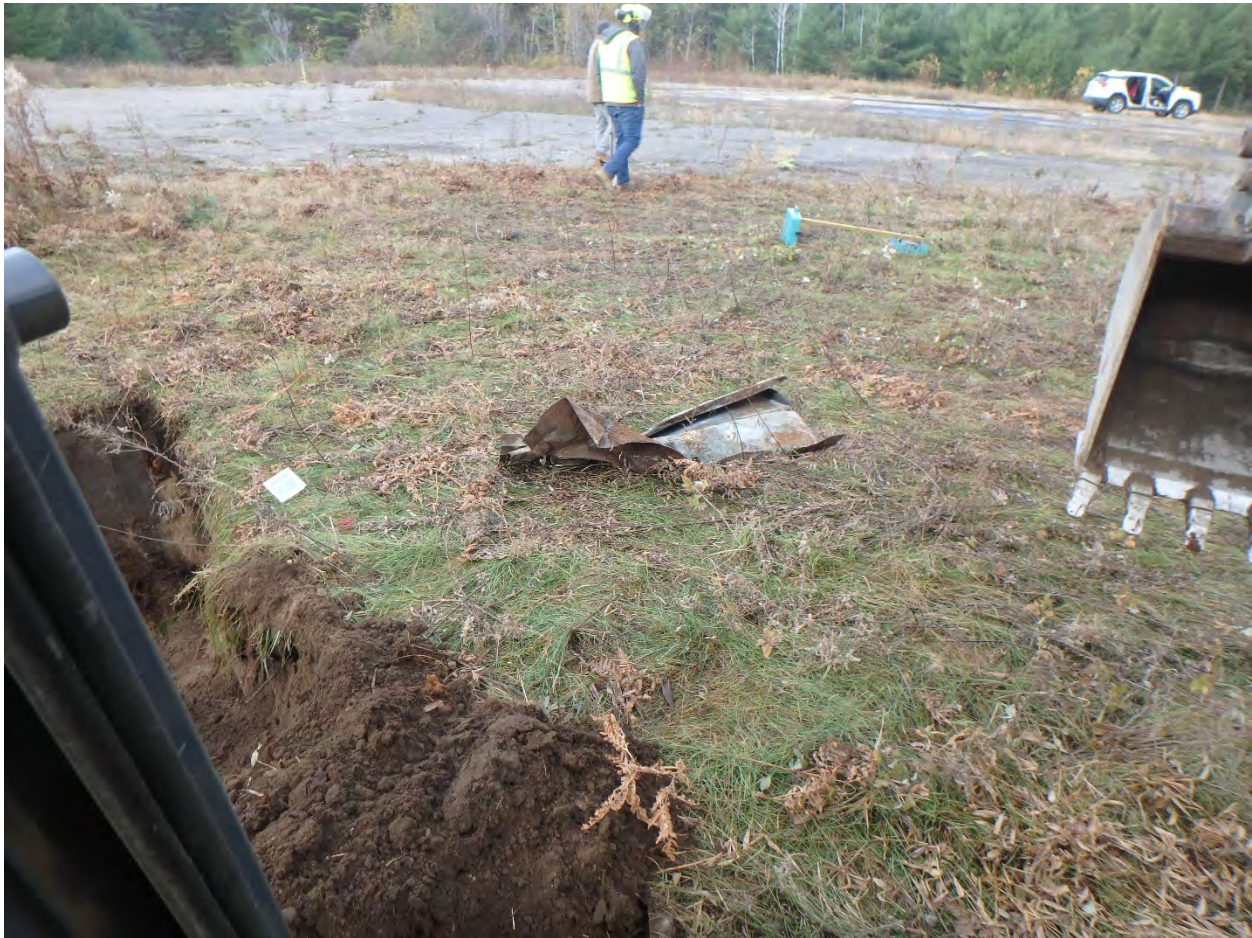
Photo 5 – Scrap metal uncovered from test pit

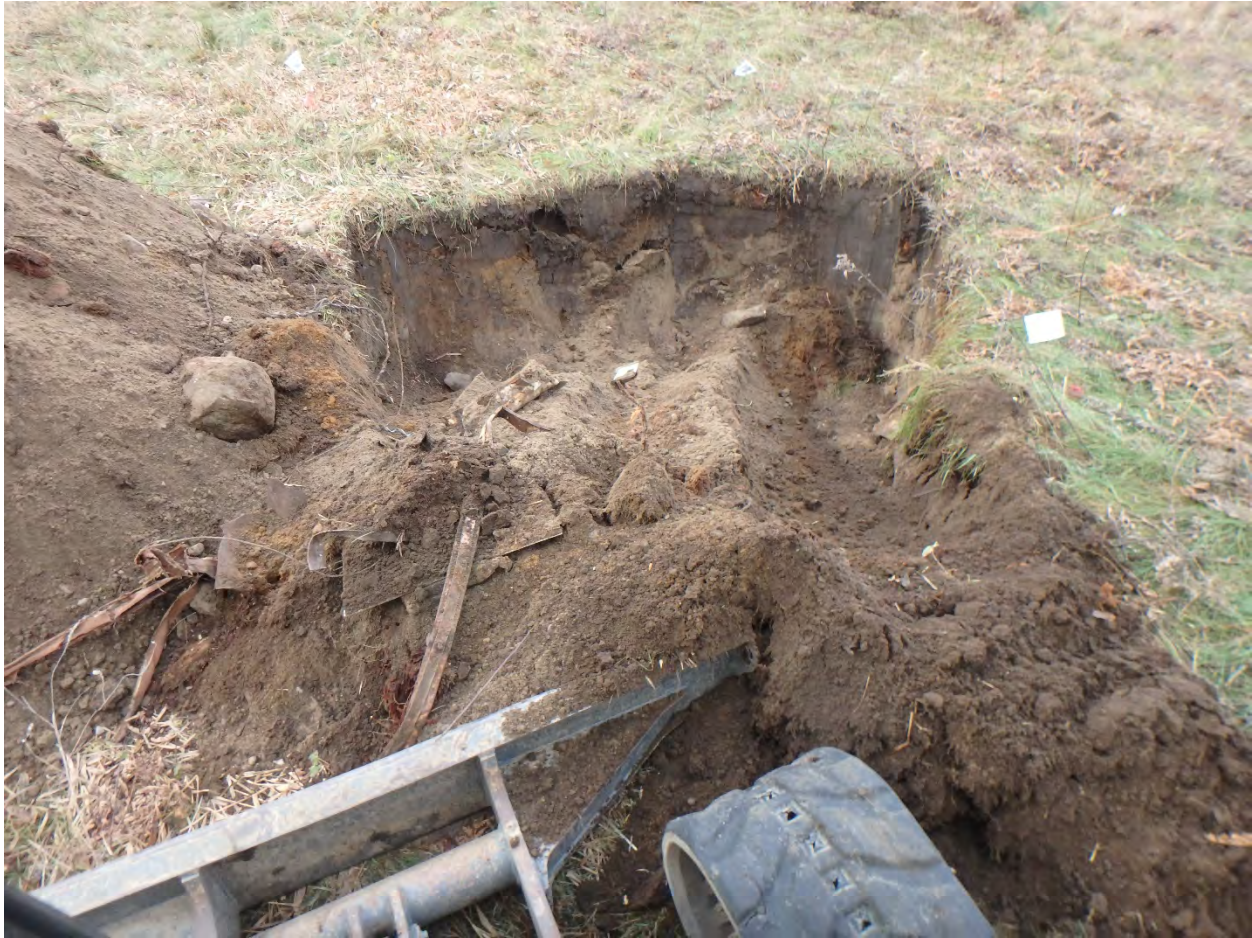
Photo 6 – Scrap metal / trash uncovered from test pit

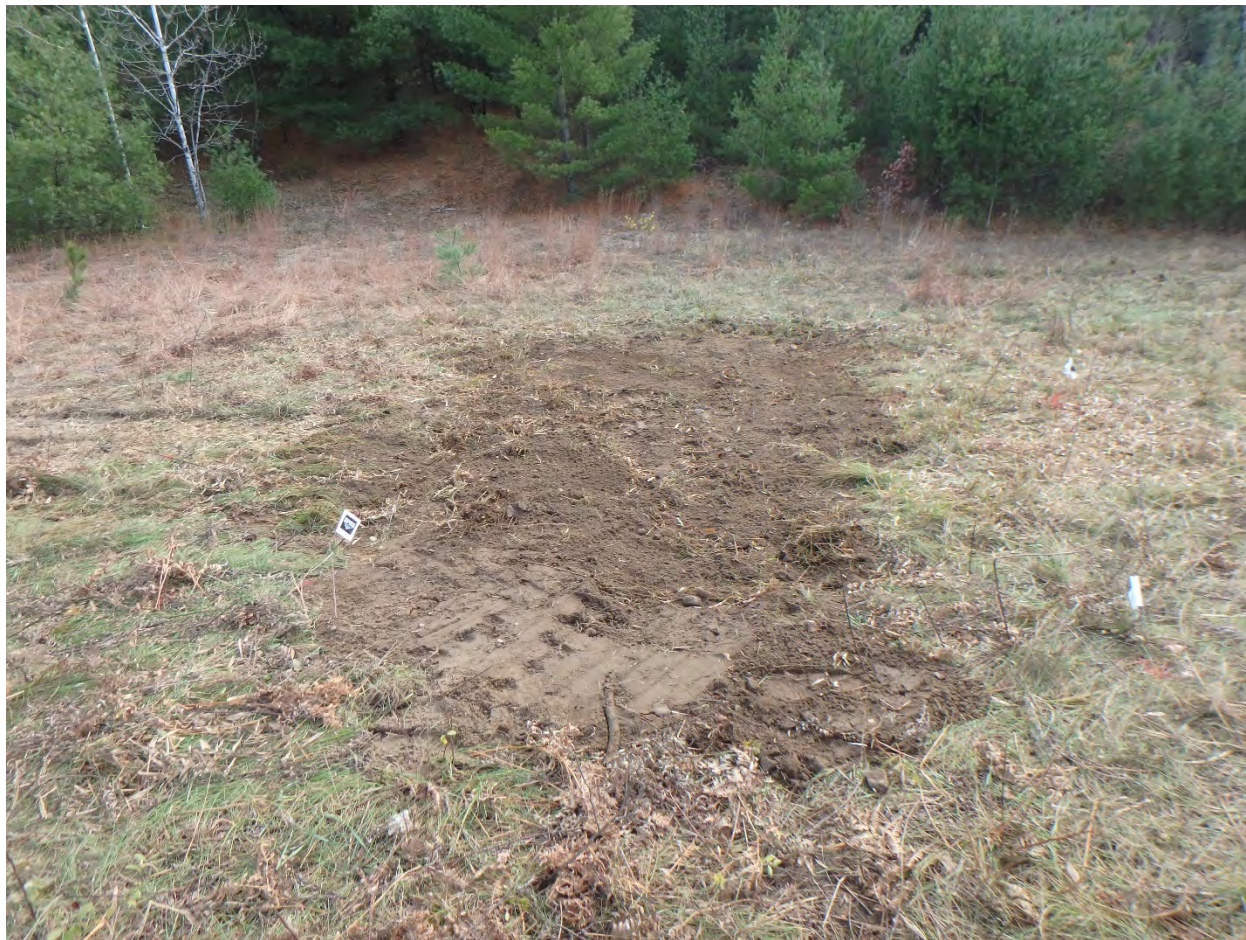
Photo 7 – Test pits backfilled upon conclusion of investigation
