Bridge Street Former Manufactured Gas Plant Plattsburgh, New York

REMEDIAL INVESTIGATION REPORT

JANUARY 15, 2004

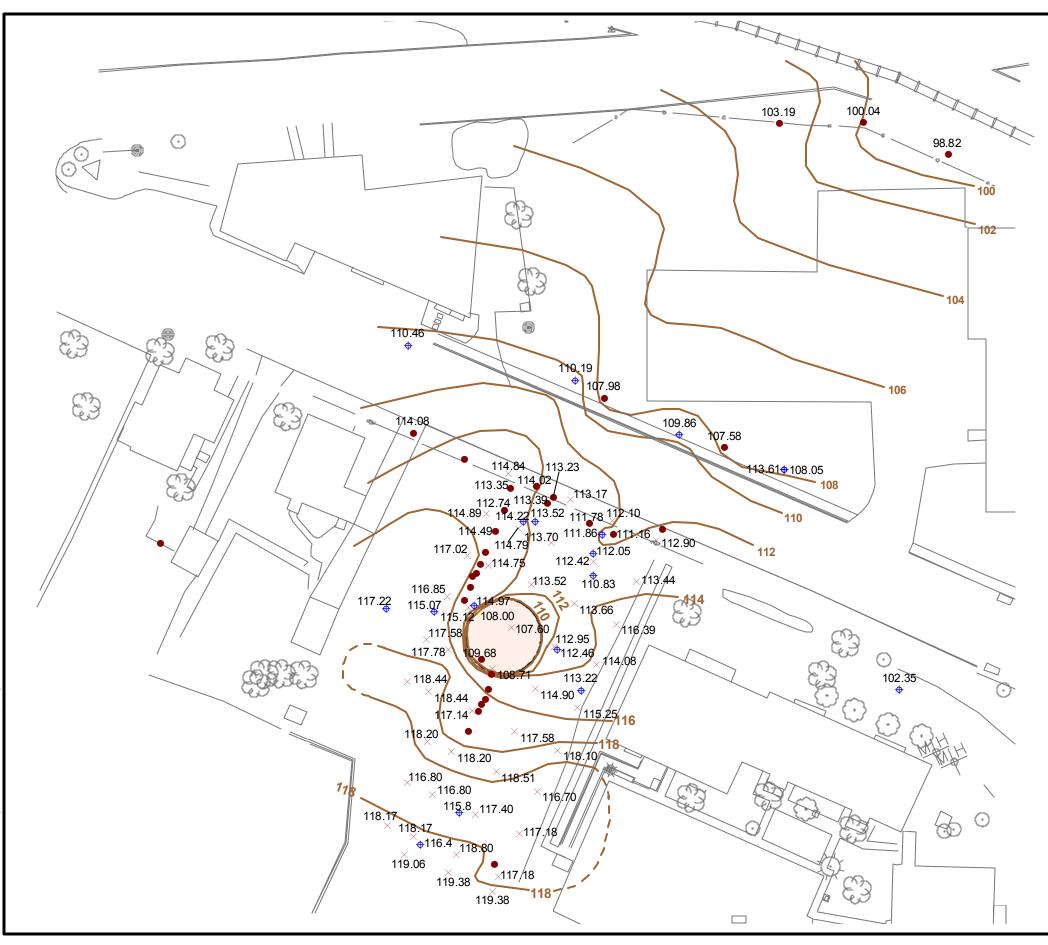
database/NYSEG/bridge st/arcview/bedrock.apr/Fig. 5-Top of Bedroc

Based on the core, the bedrock beneath the site was found to be very competent, with the exception of a weathered zone at the surface and some vertical and horizontal fractures. A near horizontal bedding plane fracture zone that generally slopes to the northeast was found beneath the site at a depth of about 35 feet beneath the holder. This fracture and the weathered bedrock surface are the primary pathway for MGP-related NAPL and dissolved contaminants to migrate in the bedrock beneath the site. Benzene, PAHs, phenols, and cyanide were detected at concentrations that exceed the NYSDEC's groundwater standards in bedrock groundwater samples collected on-site. Benzene, phenol, and cyanide were detected at concentrations that exceed the NYSDEC's groundwater samples from at least one off-site bedrock monitoring well. Traces of NAPL were found in on-site bedrock zone. The area in which NAPL was observed was limited to the east and northeast of the former gas holder. None of the wells have recoverable amounts of NAPL.

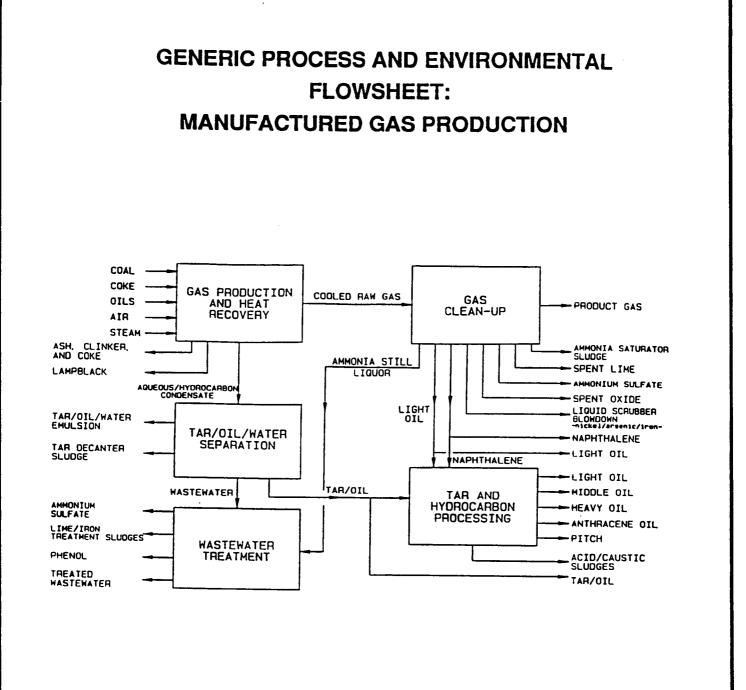
MANAGEMENT OF MANUFACTURED GAS PLANT SITES.-VOLUME 1, WASTES AND CHEMICALS OF INTEREST, GAS RESEARCH INSTITUTE OCTOBER, 1987

In the coal carbonization process, only coal was used in gas production. Solid end products from coal carbonization, depending on the extent of gas production, could consist of coal, coke, or ash. Coal ash may have been high in metals including iron, copper, lead, zinc, and others. In the CWG process, the coal or coke used to produce gas was reduced to ash, and petroleum products (which were subsequently "cracked") and steam were added to increase the heat yield of the gas. Various petroleum products, without coal or coke, were used in the oil gasification process.

After being produced, the gas was passed through heat recovery cooling and condensation for the removal of condensible impurities. By-products of the quench process included solid residue carry-over from the gas production, condensed

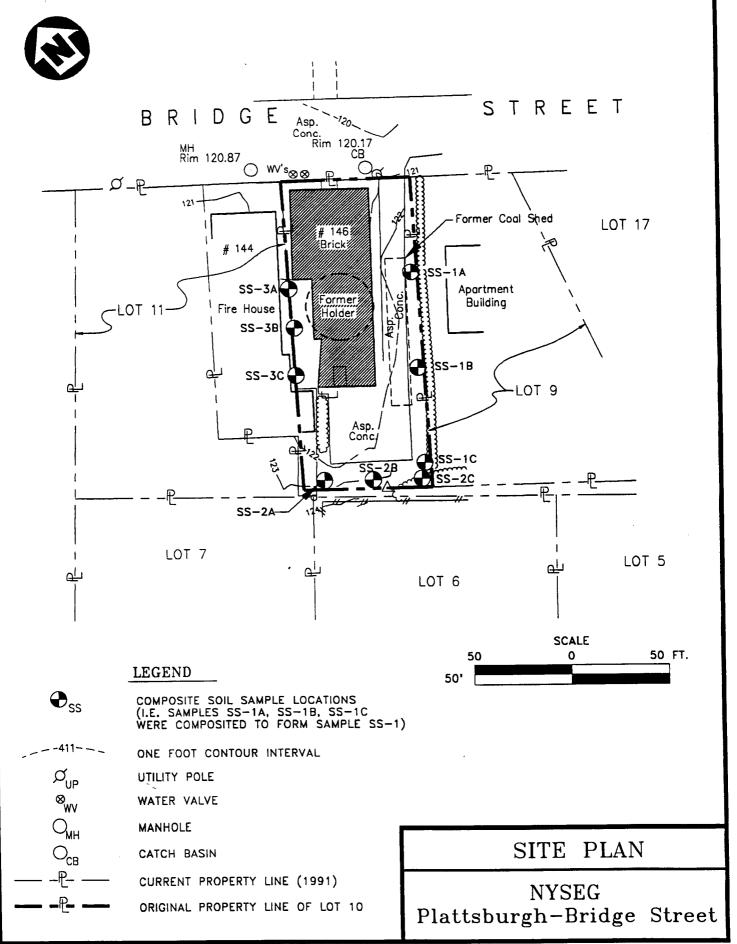
FIGURE 3.1

Three composite samples were collected to characterize the surface soils at the site (Tables 3.2 and 3.3). The sample locations are shown on Figure 3.1. The sampling methodology, equipment decontamination procedures, and analytical protocols for Part 4 are described in detail in the project QAPP. Dedicated sampling apparatus was used for each site and no sample equipment decontamination occurred on the site. The analytical methods utilized are presented on Table 3.2.

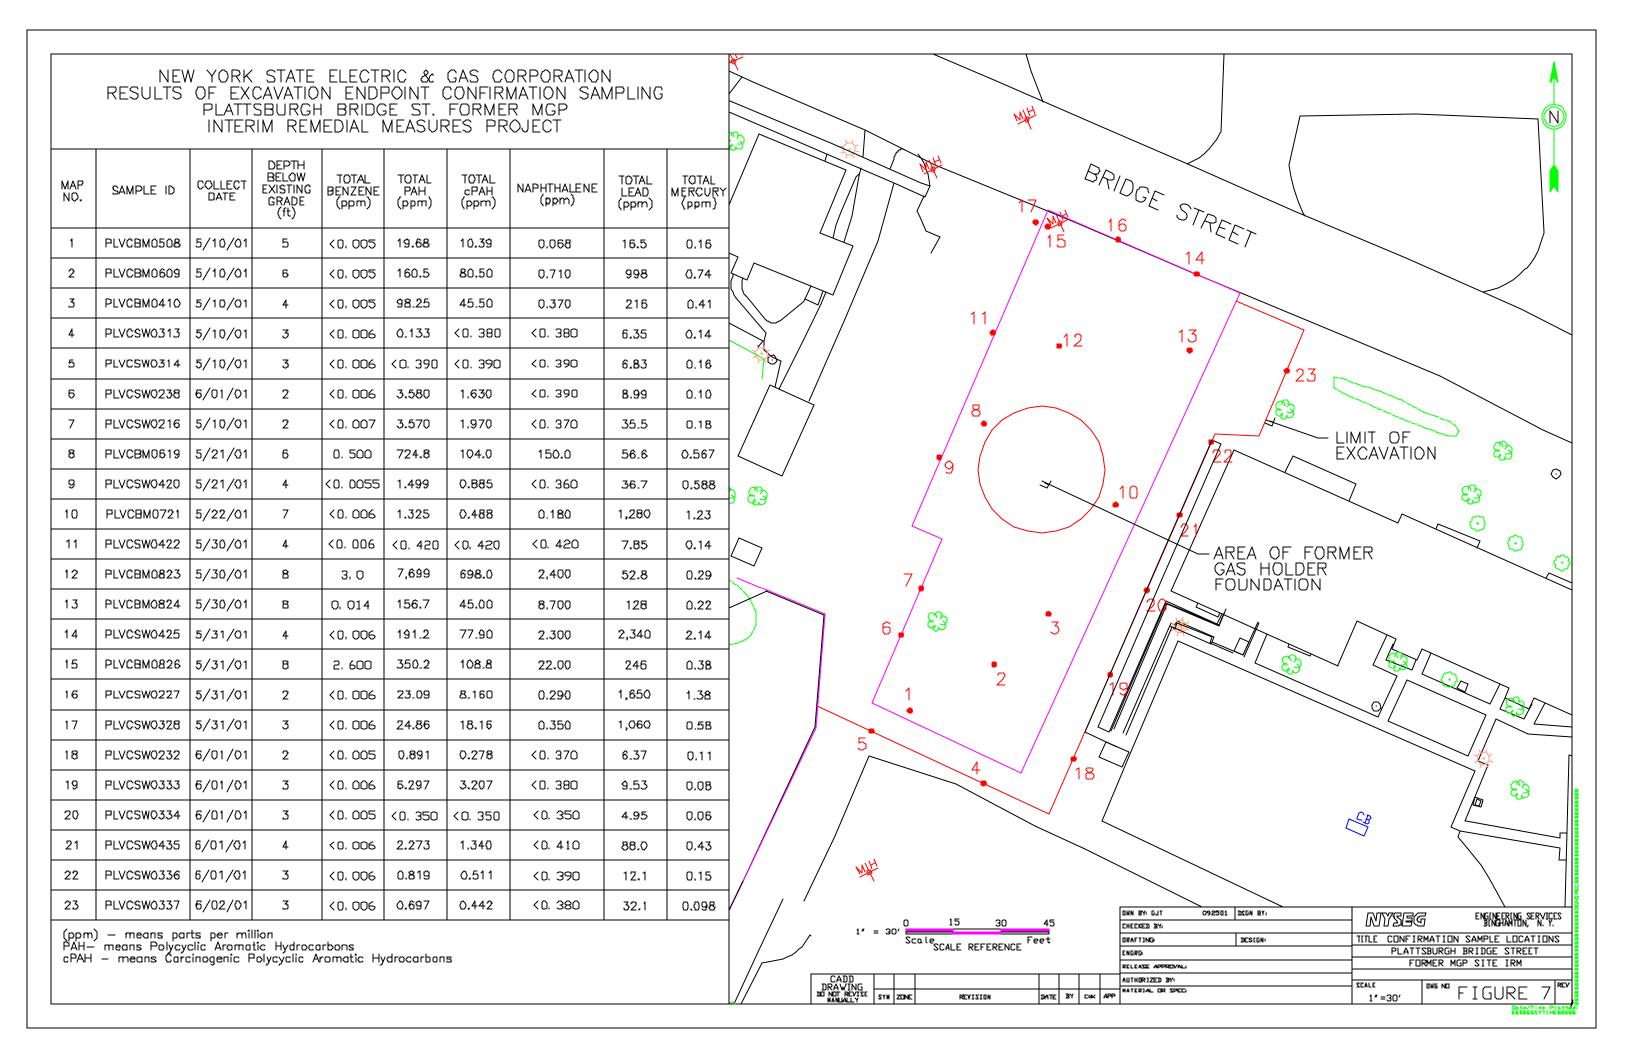
2001 INTERIM REMEDIAL MEASURE POST-EXCAVATION SAMPLING LOCATIONS

The former gas holder, its contents, and site soils were removed during the 2001 IRM. Postexcavation sampling indicated that the majority of the soils that remain at the site meet the sitespecific cleanup objectives, which were based on total benzene and PAH concentrations. The primary exception was at the north side of the site along Bridge Street where further soil removal was not possible because of the proximity of the excavation to Bridge Street and the associated subsurface infrastructure. Post-excavation samples of the material on the bedrock surface and within fractures showed that residual MGP-related material was in the upper weathered portion of the bedrock. Based on these findings, NYSEG and the NYSDEC agreed that investigation of the bedrock beneath the site was warranted.
