Prepared by:  
AECOM  
Latham, NY  
60273289  
September 2017

# Periodic Review Report

## June 15, 2016 through June 15, 2017

**Korkay, Inc.**  
**Site No. 5-18-014**

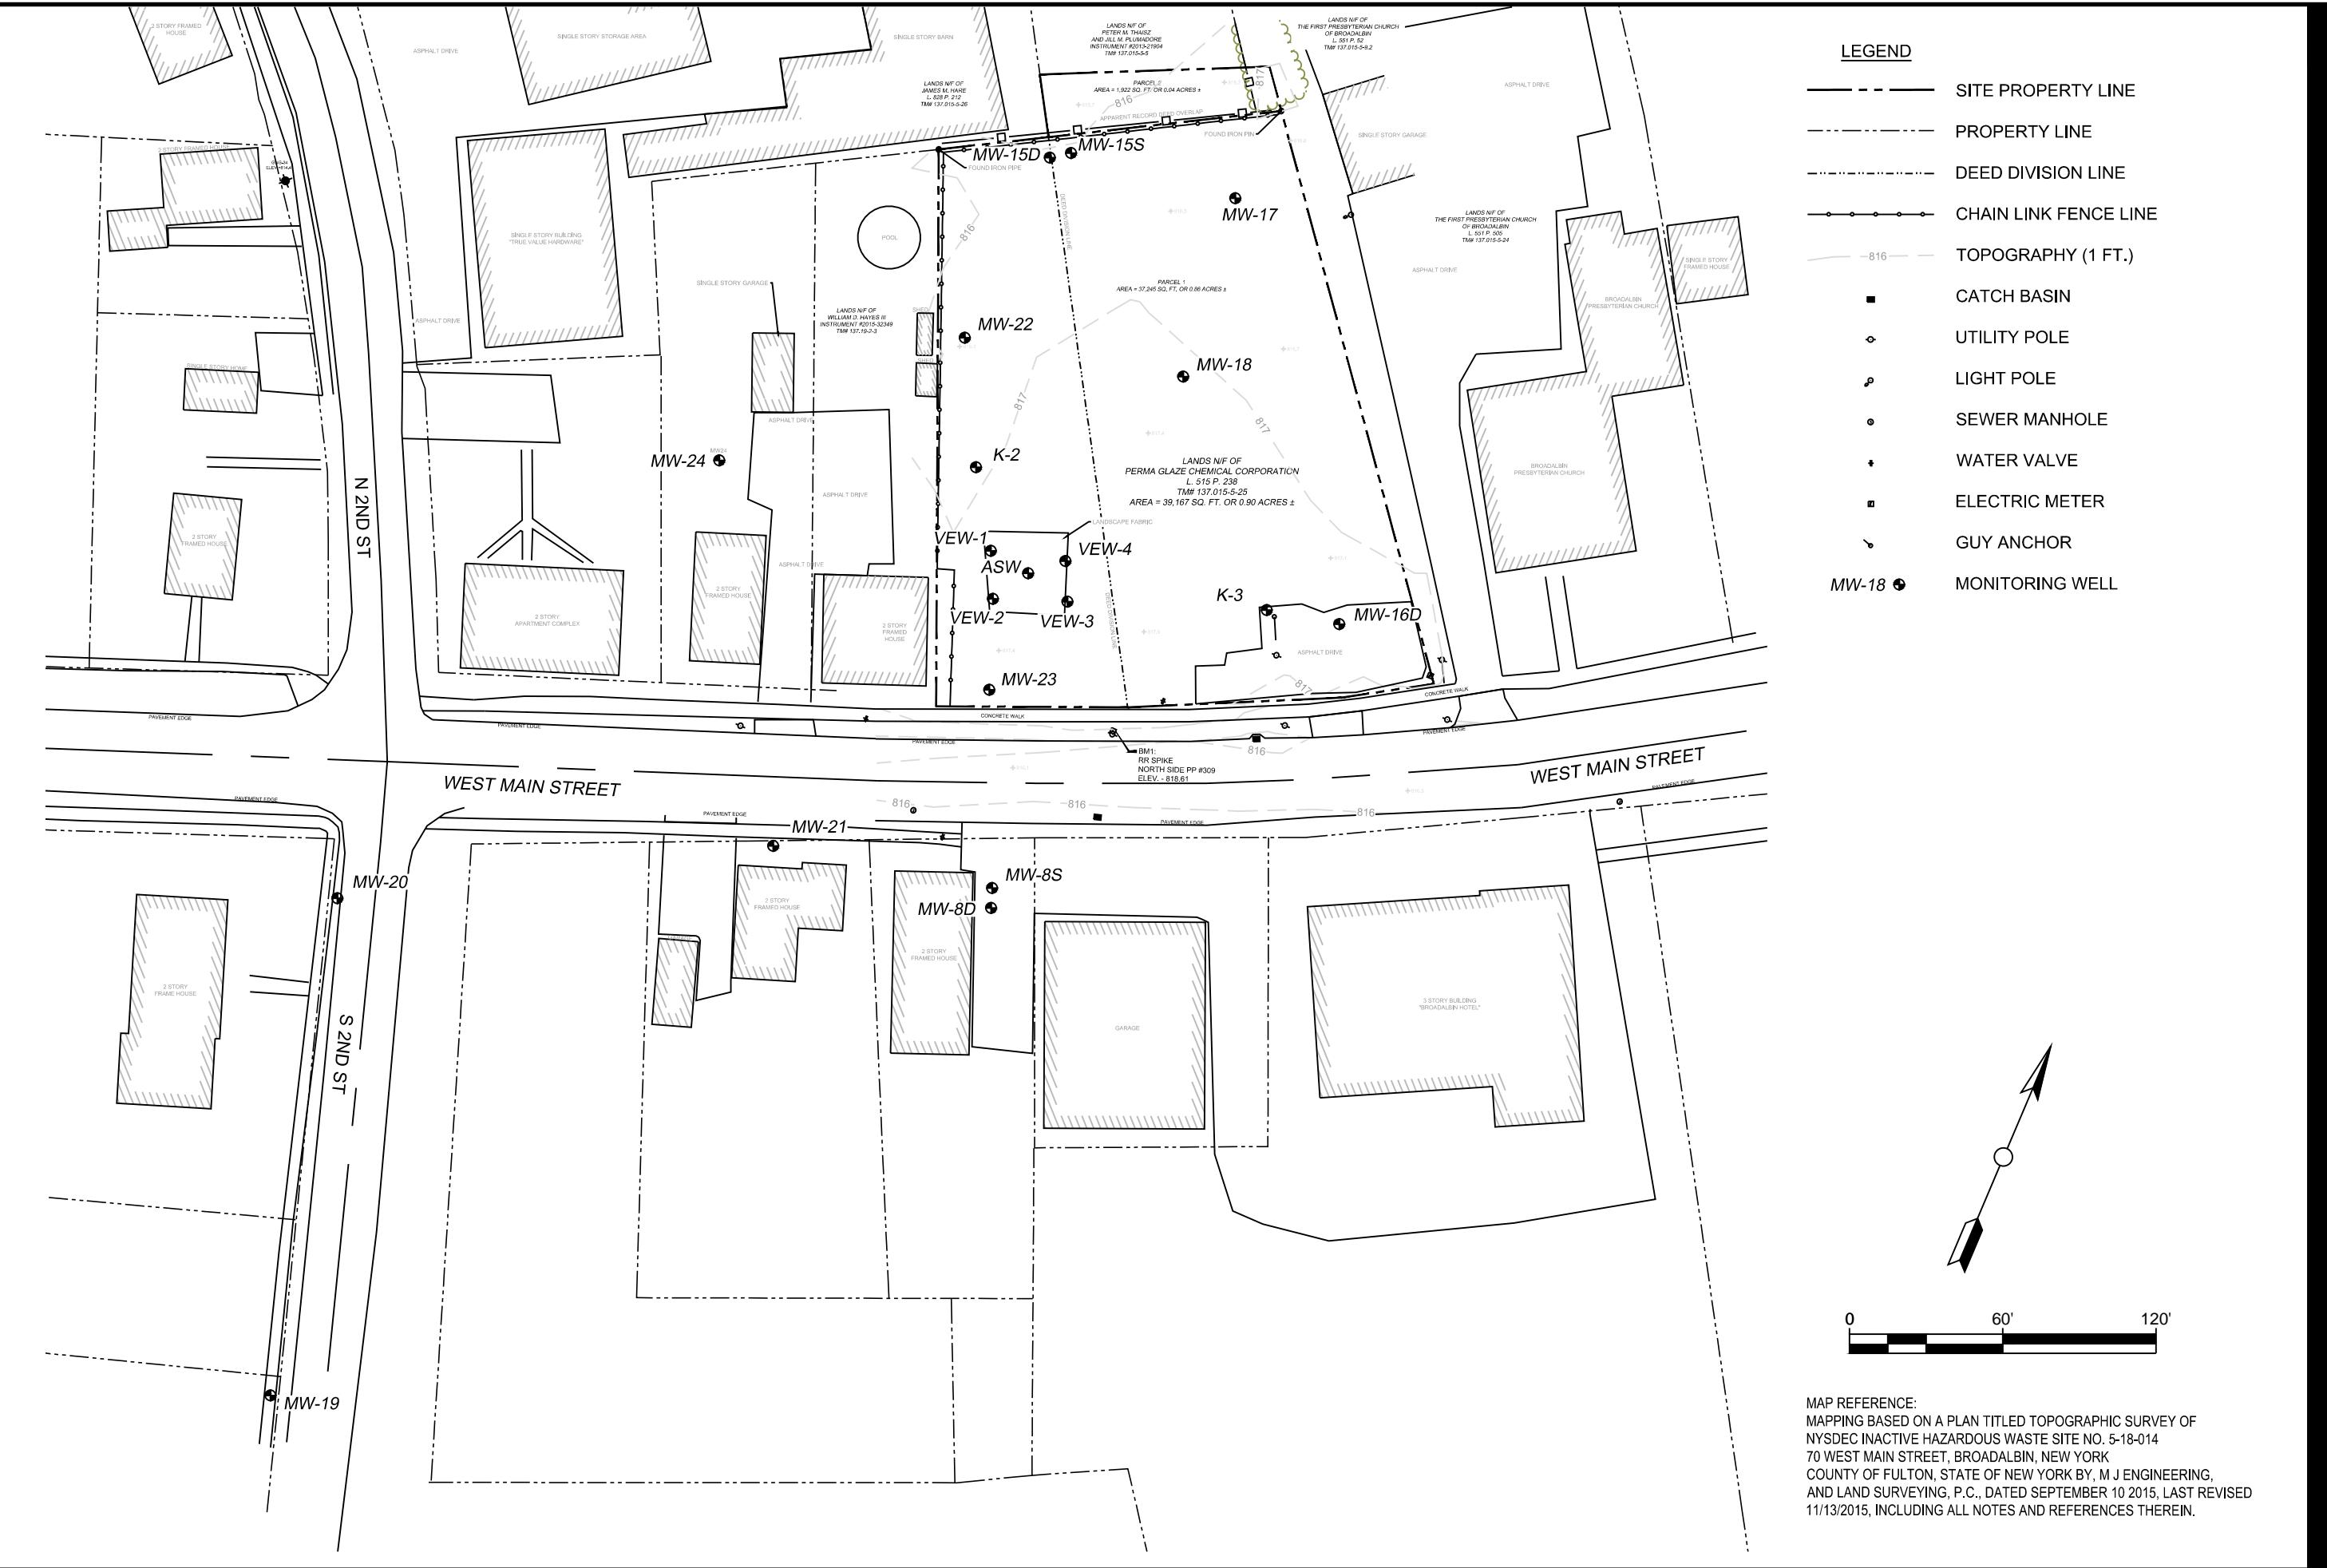
**EXISTING CONDITIONS**

Annual (5-quarter) groundwater sampling events are performed as required in the SMP to provide data from all Site monitoring wells (Figure 2) to evaluate trends in groundwater quality at the Site through the Site management phase. The 5-quarter events performed in January 2012 and June 2013 demonstrated that groundwater contamination persisted in some of the same areas as discussed in the 1988 RI report, primarily beneath the southwest quadrant of the Site, in the former source area; groundwater results from the deep wells at the Site continued to be below relevant SCGs.

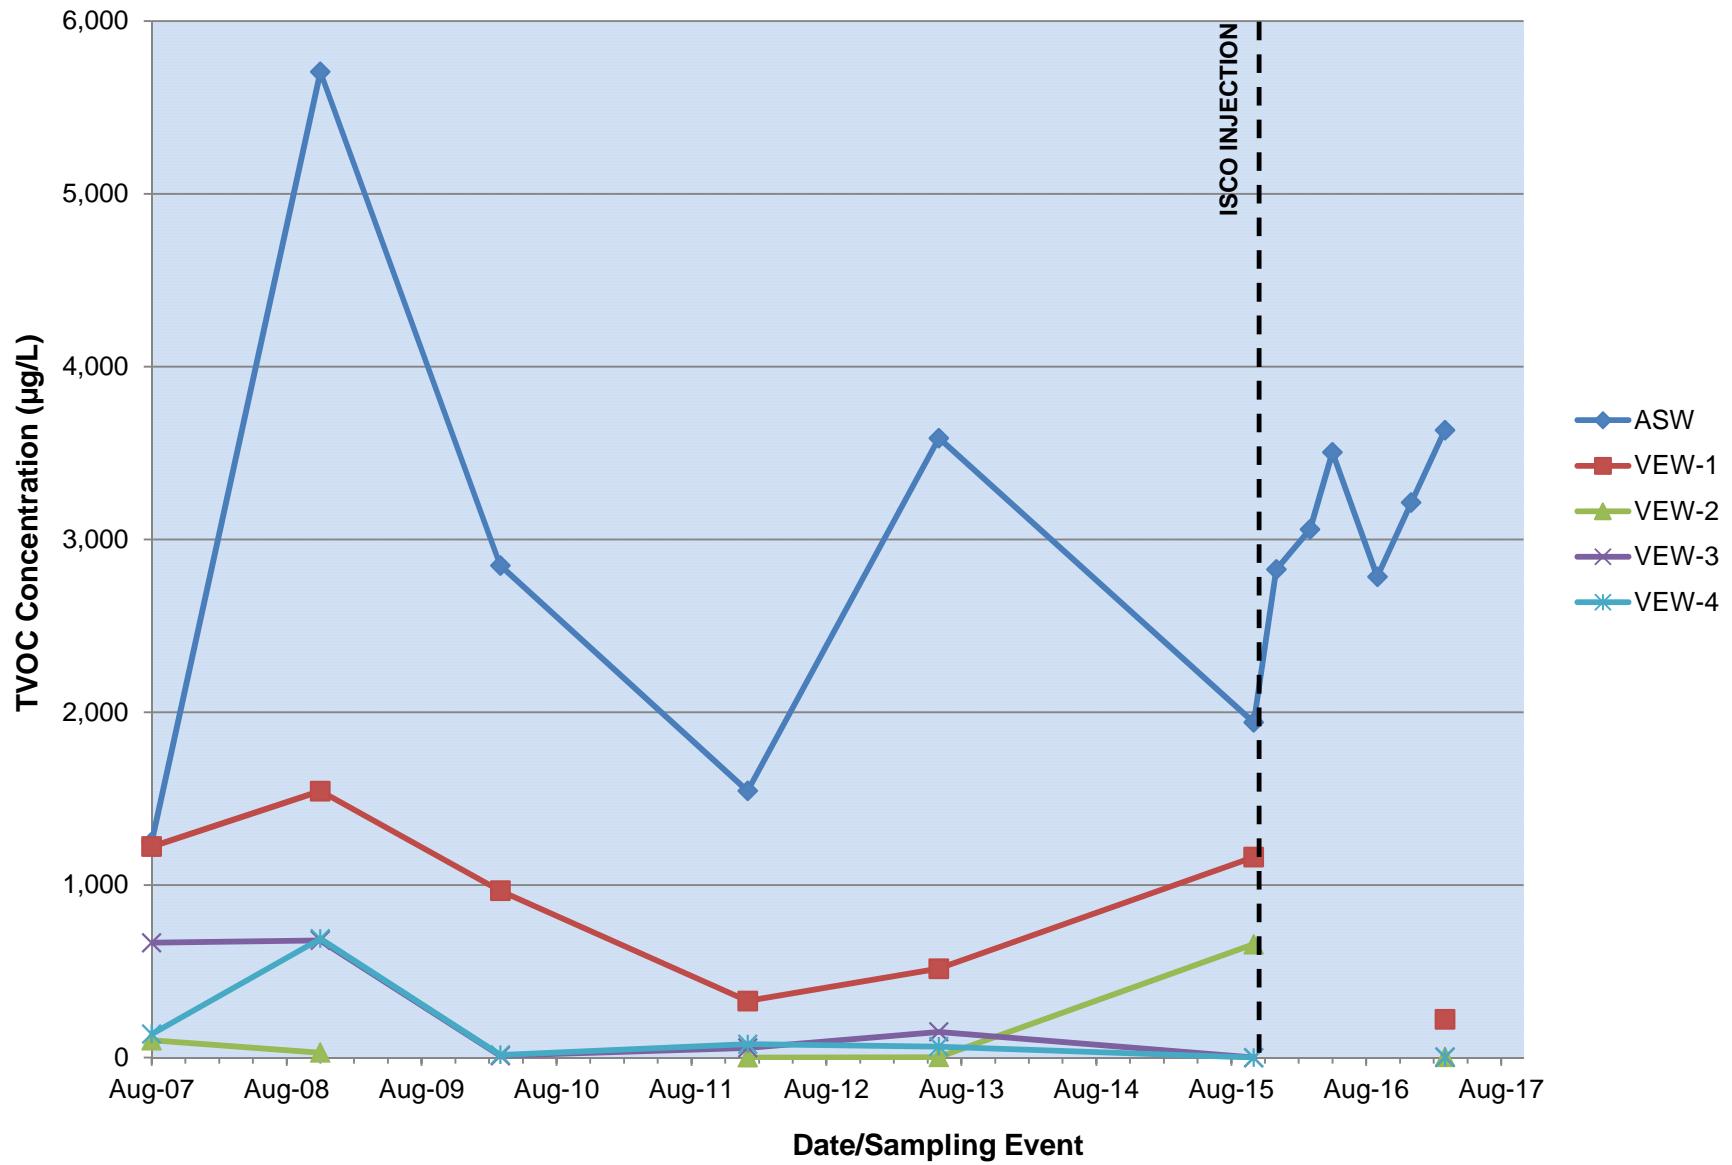
**Chart 1**  
**Historical Groundwater Total VOC Concentration Trends - Source Area Wells**  
**Korkay Inc.**

Chart 1 depicts TVOC concentration trends to date in five wells located in the former source area (ASW, VEW-1, VEW-2, VEW-3 and VEW-4). The chart shows that TVOC concentrations in well ASW have remained fairly consistent with levels that were observed prior to the ISCO injection and there has been no upward or downward trend in concentrations since the injection work. The graphs indicate that TVOC concentrations have decreased appreciably in the four VEW wells since the ISCO injection, although this is based on only one (March 2017) post-ISCO event.
