**TANK INSPECTION REPORT  
WRIGHT-MALTA CORPORATION PROPERTY  
MALTA ROCKET FUEL AREA  
SUPERFUND SITE  
TOWNS OF MALTA AND STILLWATER  
SARATOGA COUNTY, NEW YORK**

**May 1991**

**Geraghty & Miller, Inc.  
125 East Bethpage Road  
Plainview, New York 11803  
(516) 249-7600**

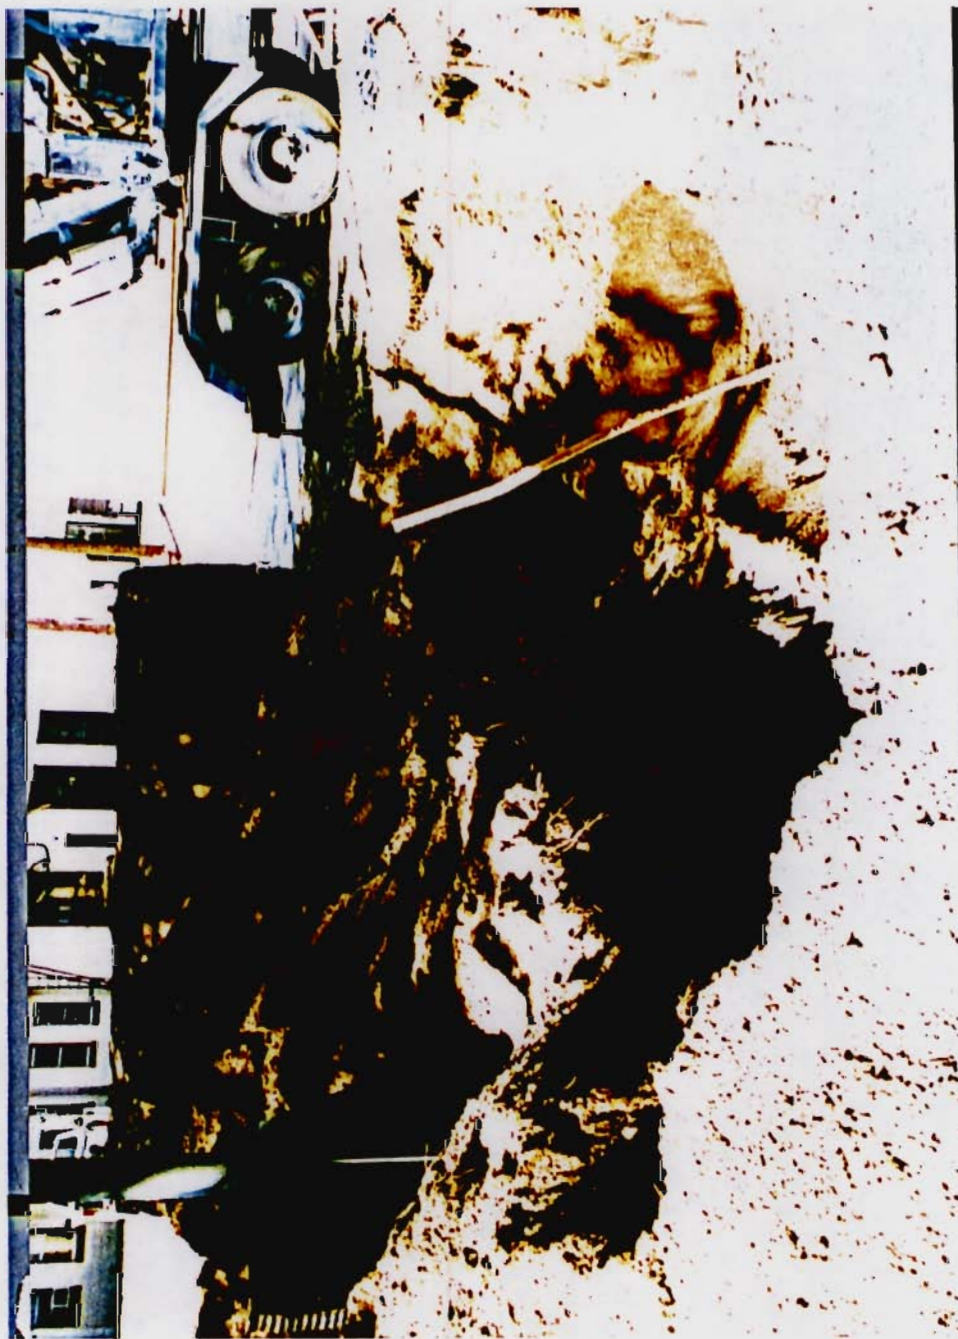
Photograph 2: Building 15, Gasoline Tank Excavation Pit (Tank 1).

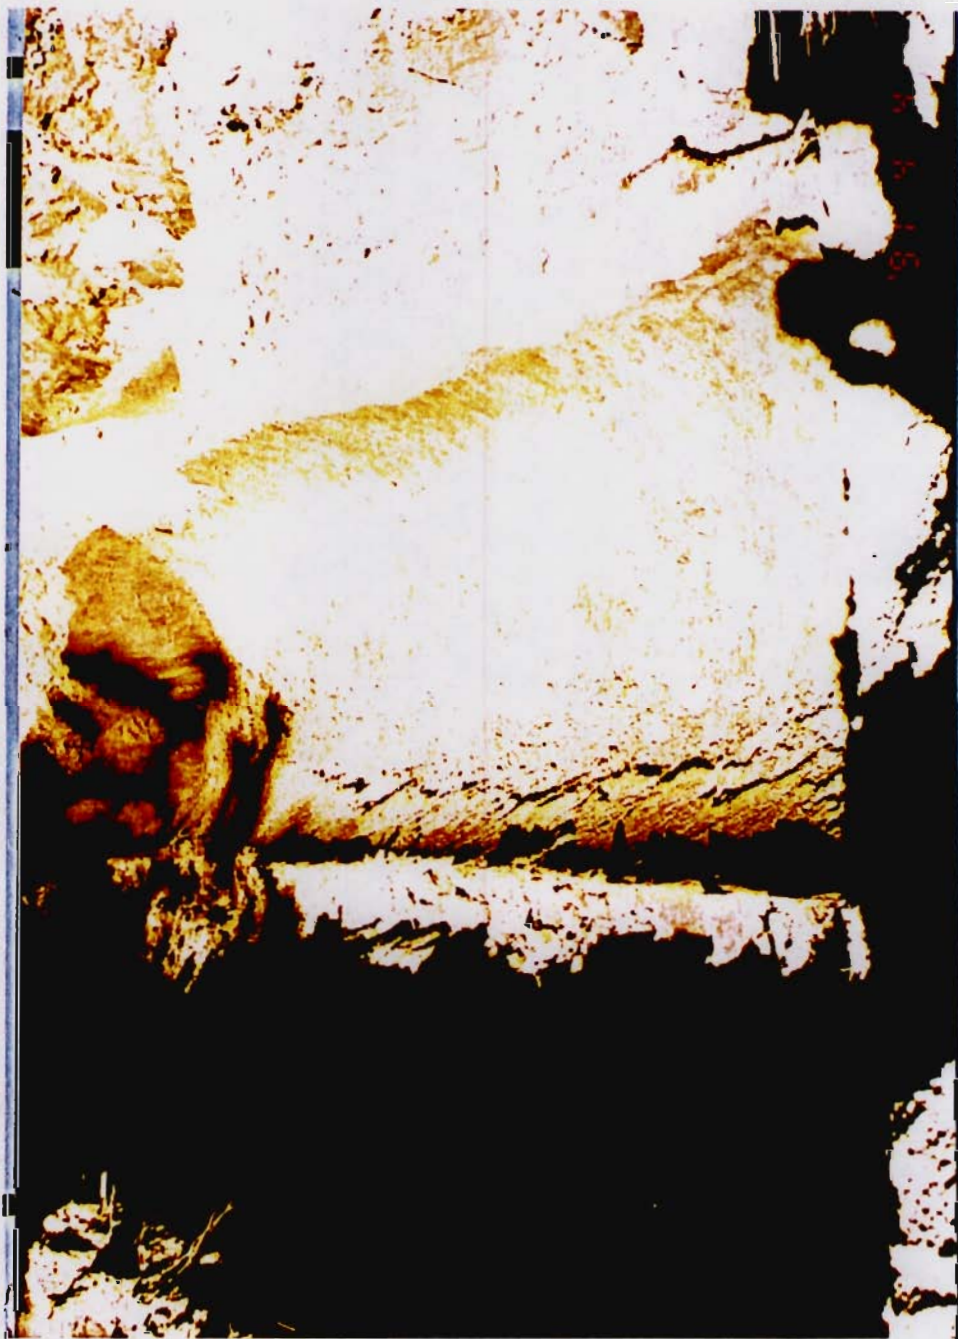
Photograph 3: Building 15, Gasoline Tank Excavation Pit (Tank 1).

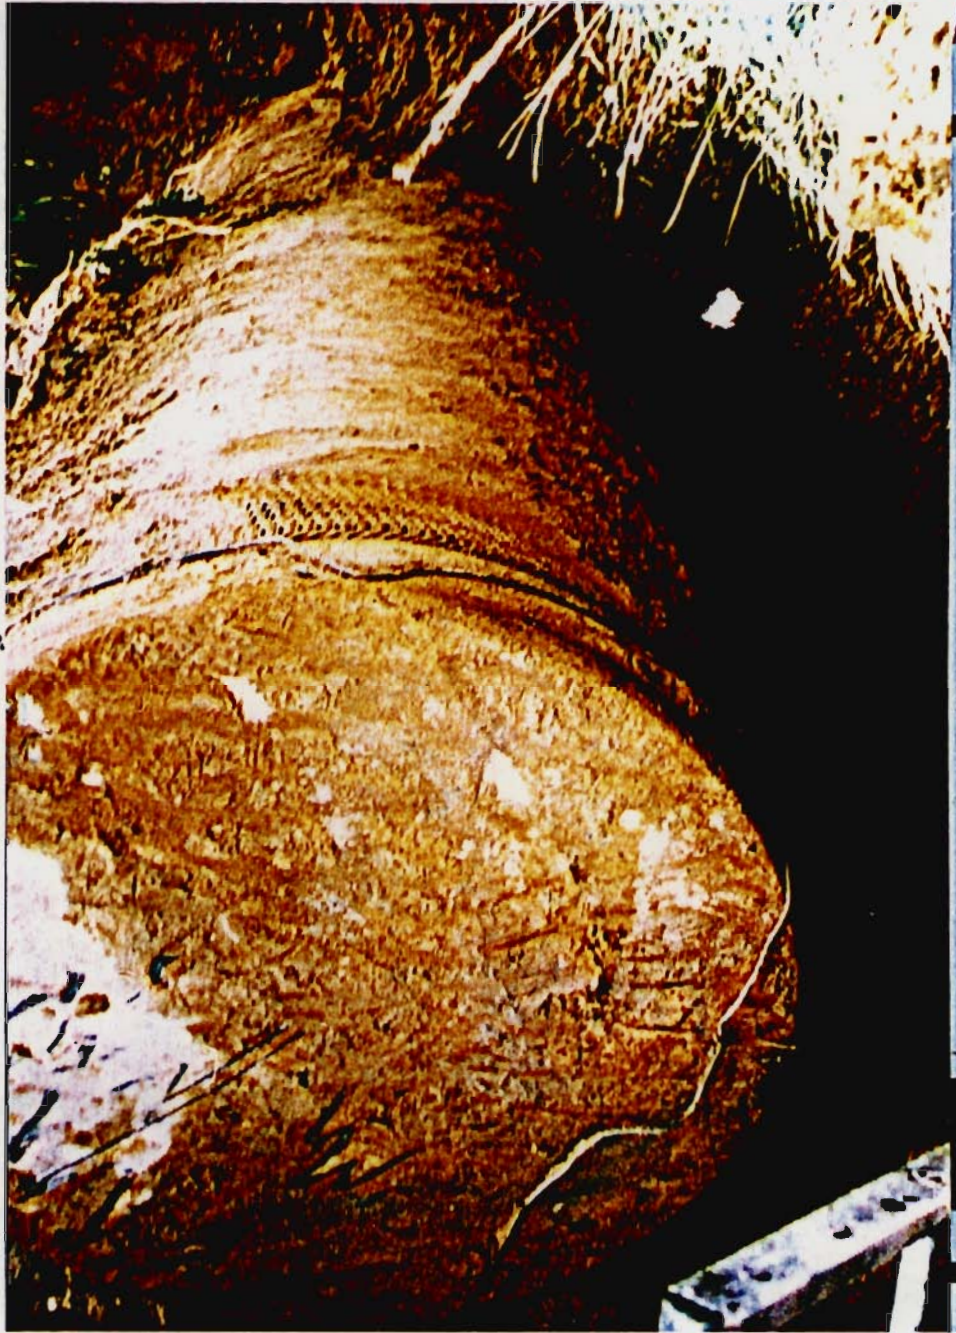
Photograph 4: Building 28, Fuel Oil UST (6,000 gallon) - Tank 5.

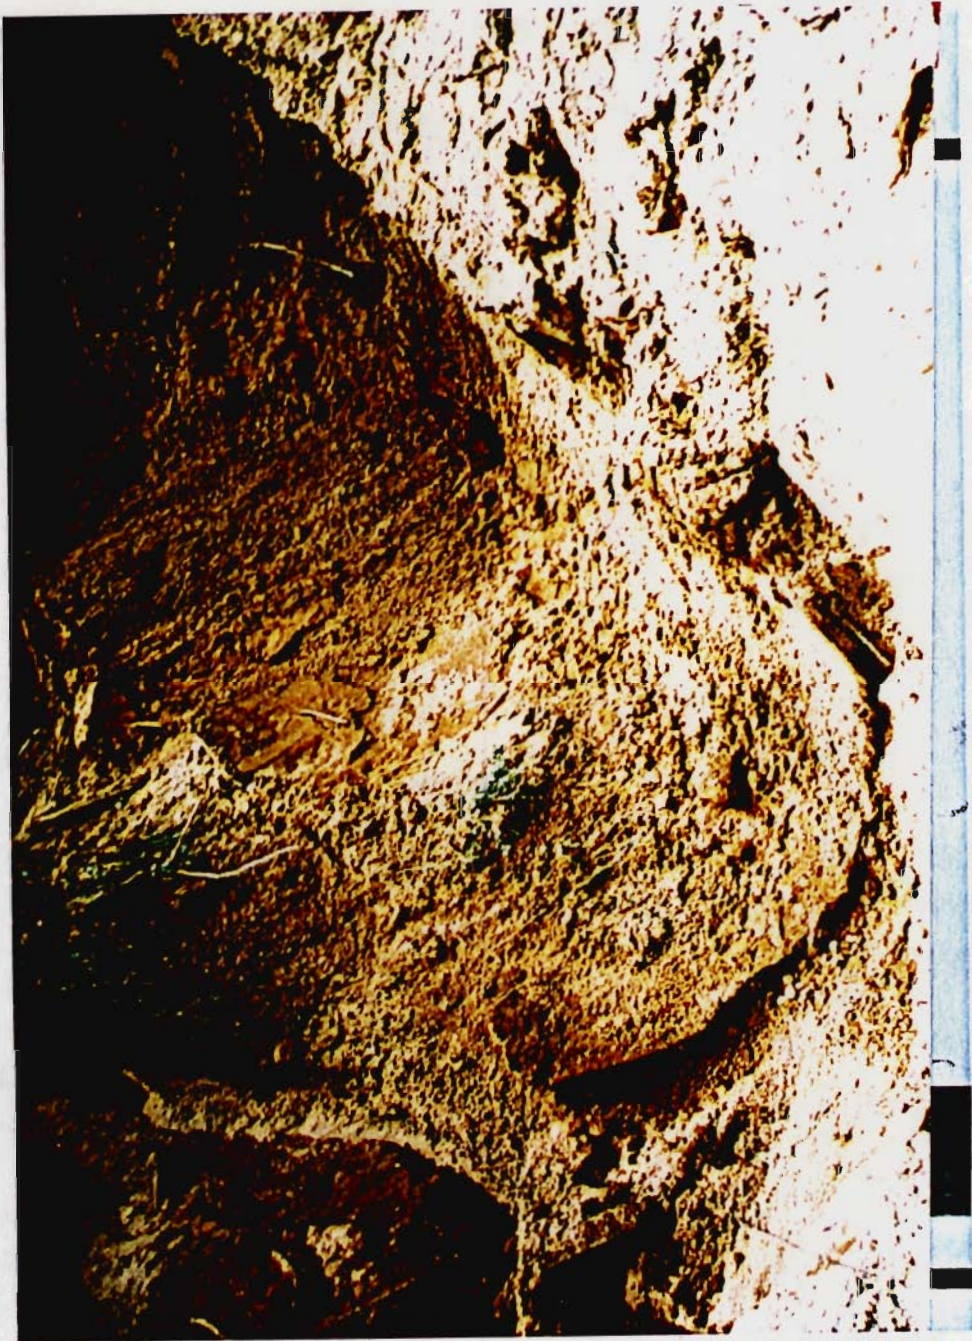
Photograph 5: Building 28, Fuel Oil Tank Excavation Pit (Tank 5).

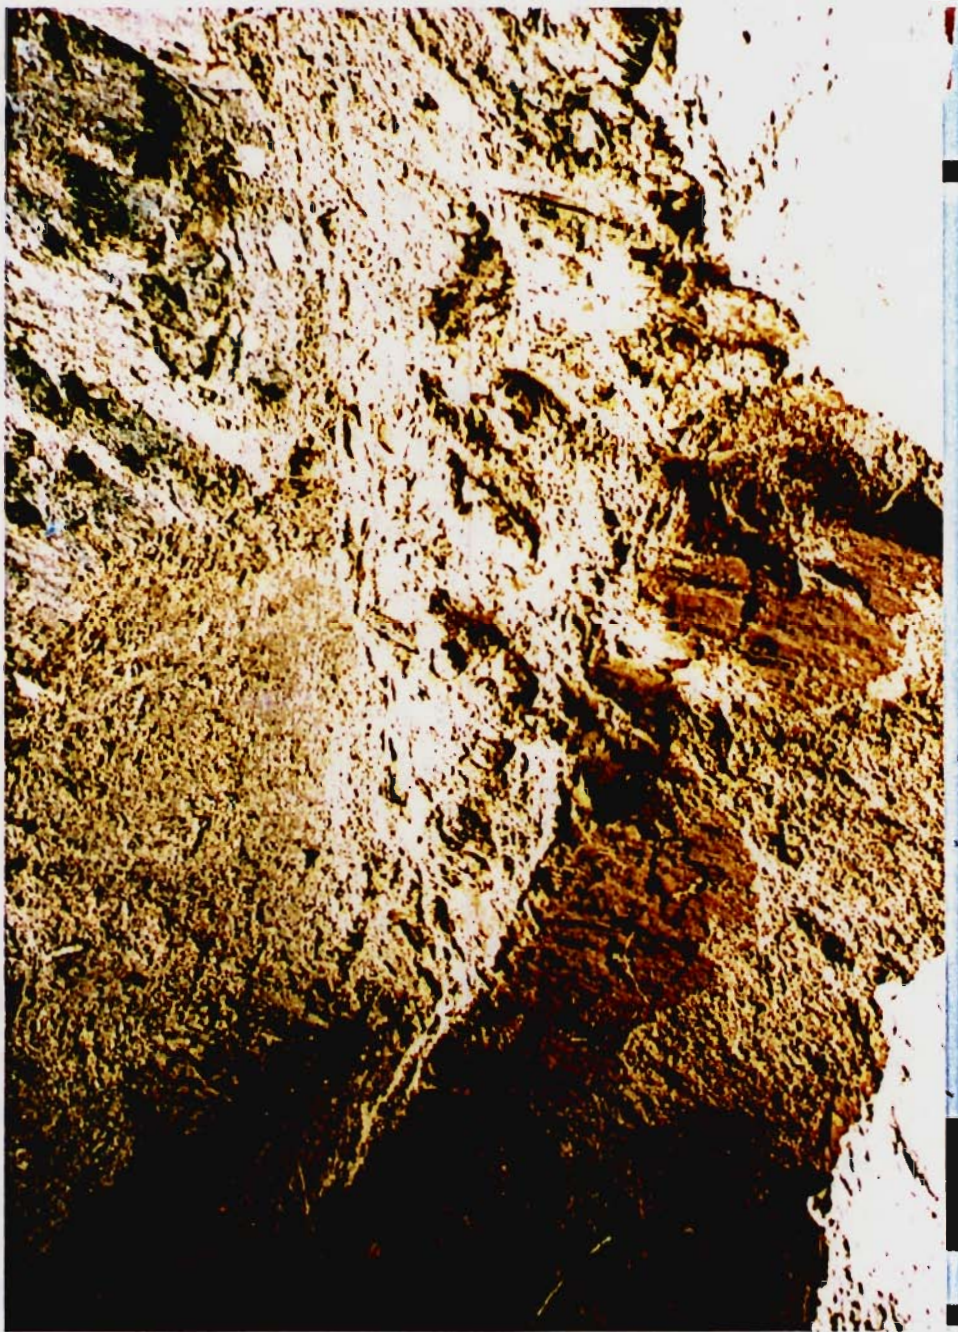
Photograph 6: Building 28, Fuel Oil Tank Excavation Pit (Tank 5).

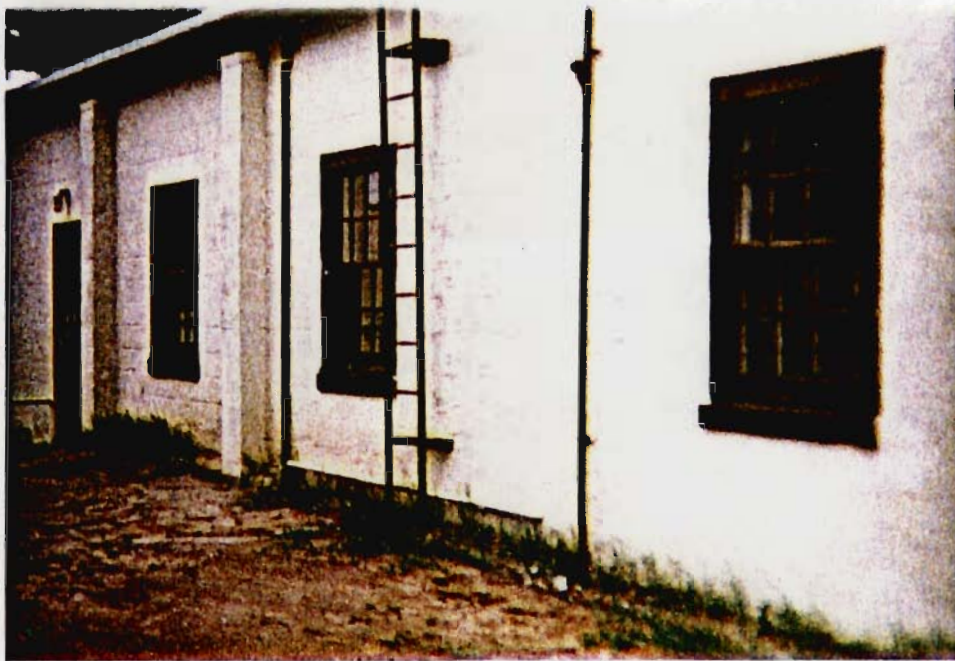
Photograph 7: Northwest wall of Building 15. Vent pipes for gasoline tanks (Tanks 1 and 2). Piping entered building below ground surface and through floor.

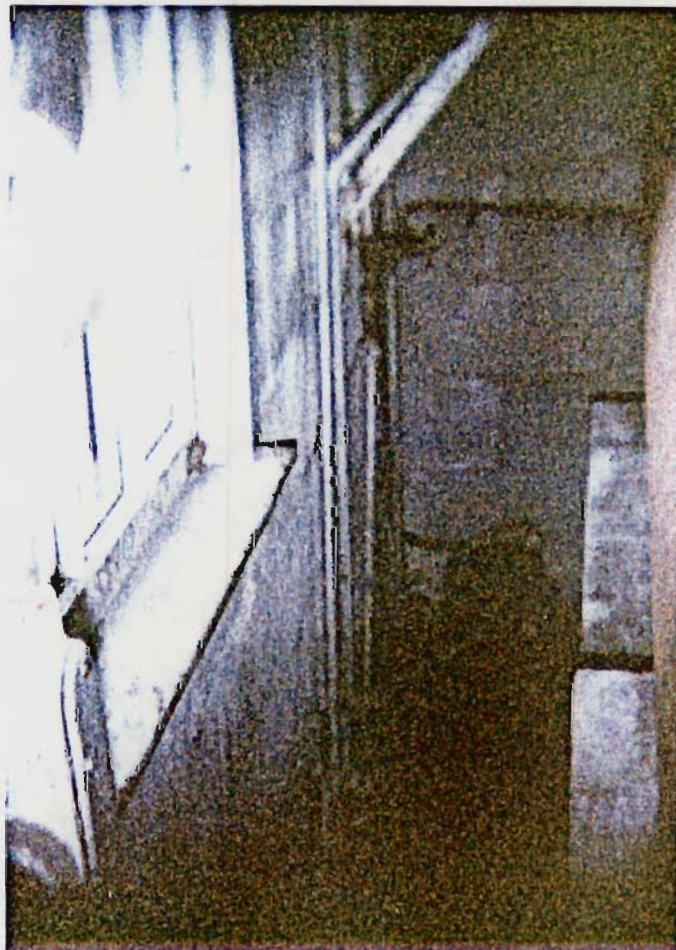
Photograph 8: Northwest interior wall of Building 15. Pipes leading from the two gasoline tanks.

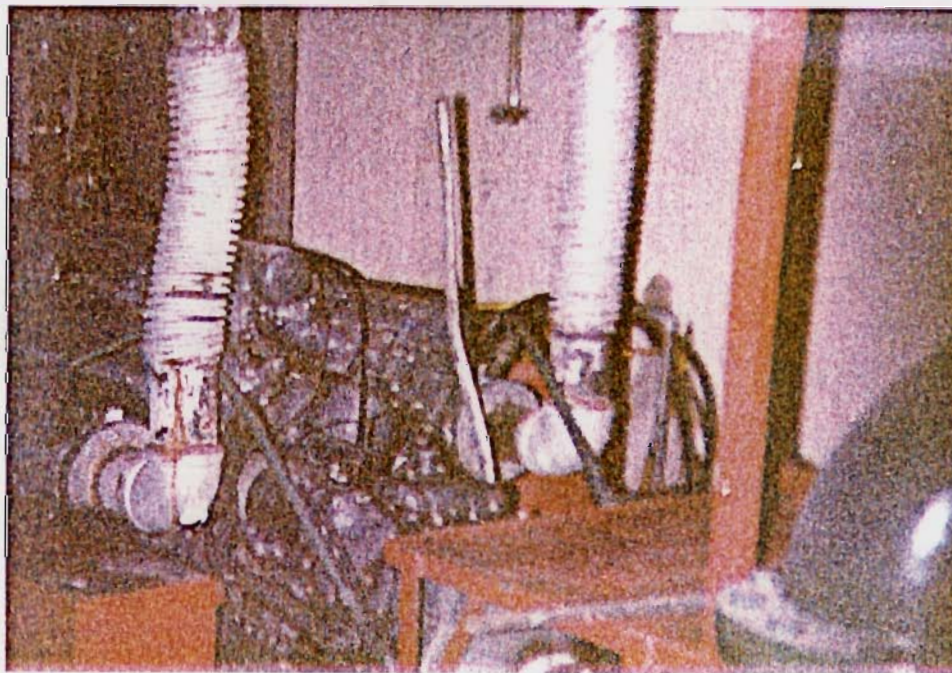
Photograph 10: Backroom of Pneumatic Laboratory, Building 15. Gasoline driven engines used in the laboratory and connected to Tanks 1 and 2.

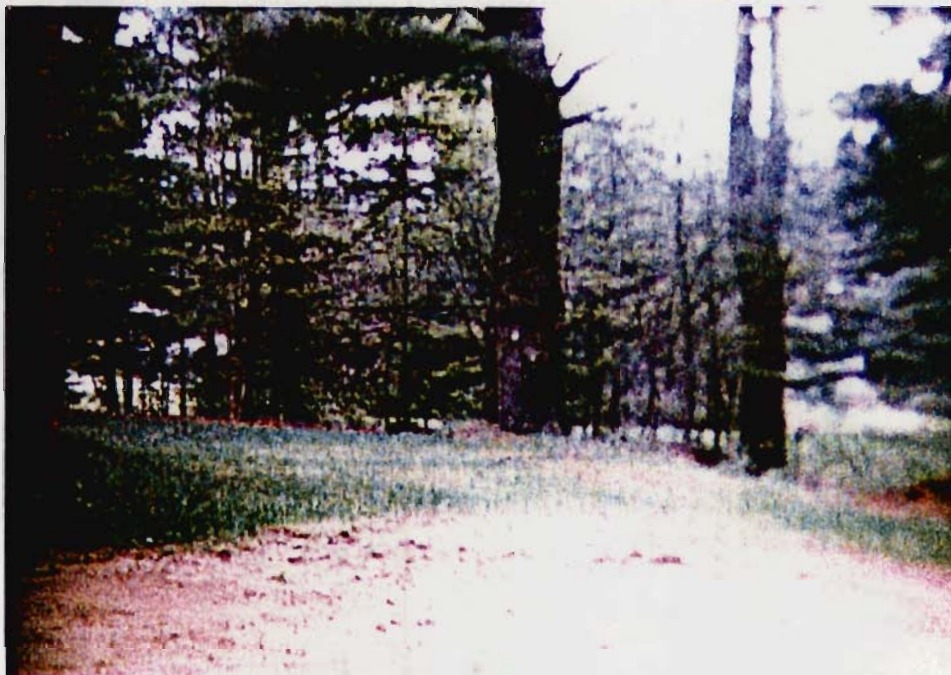
Photograph 11: Southwest side of Building 15 with brick chimney. Disturbed soil from fuel oil tank (Tank 3) excavation.

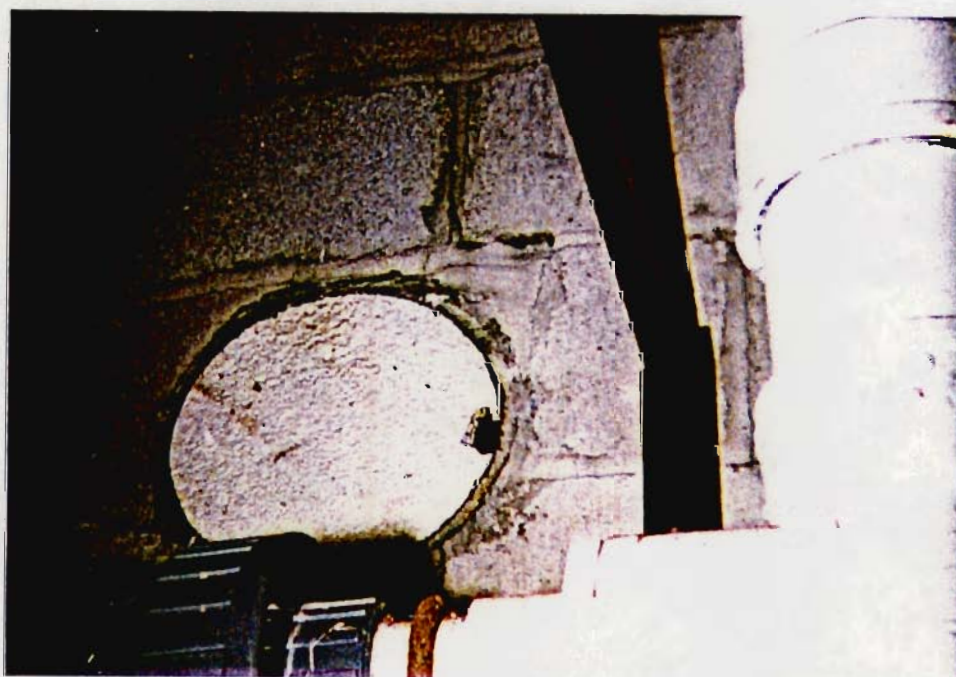
Photograph 12: Southwest interior wall of Building 15. This is an exhaust port for the heating furnace. The port enters the brick chimney. The furnace, now removed, was located below the port. Fuel feed lines entered the building below ground surface and through floor.

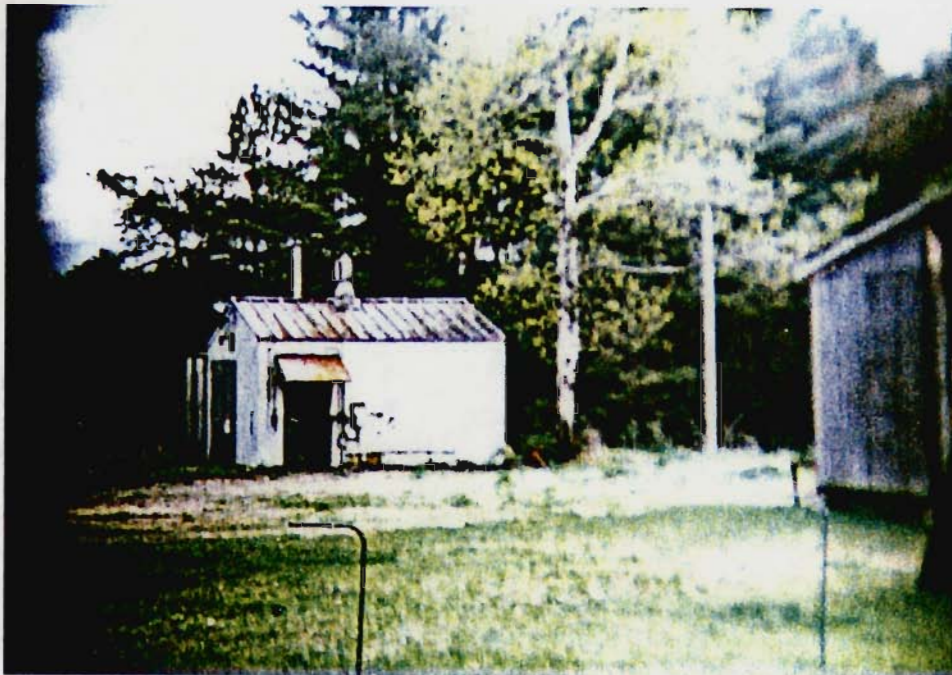
Photograph 13: Building 28 and 28H (center) and northeast wall of Building 10 (right edge of photo). This was the site of the two 6,000-gallon, fuel oil tanks (Tanks 4 and 5).

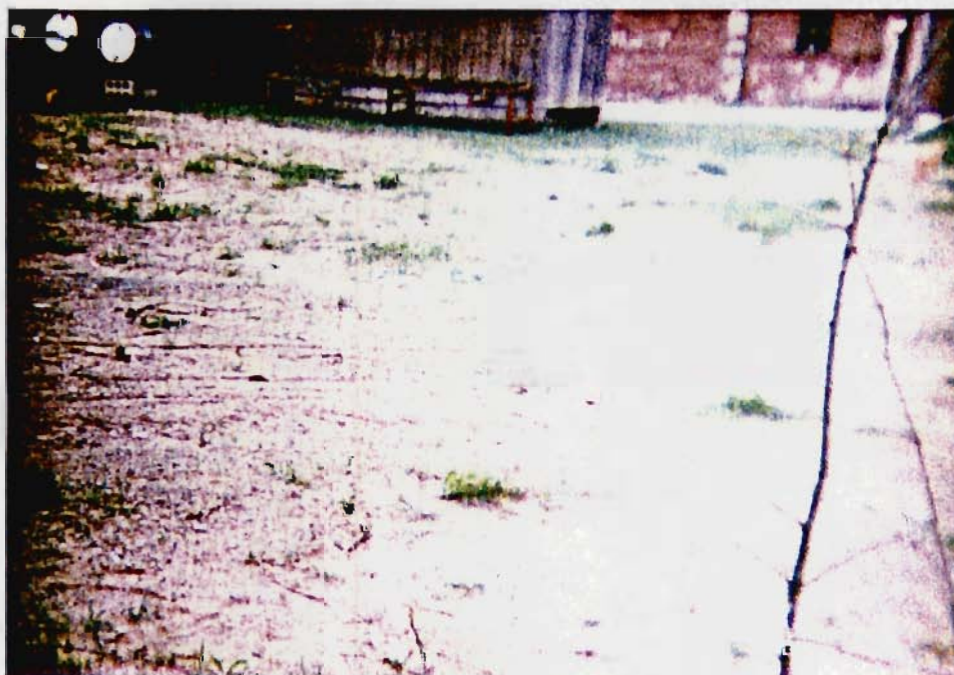
Photograph 14: Building 28 area. This is the disturbed soil in the Tank 4 and 5 excavation area. The southwest side of Building 10 is visible in the upper portion of the photograph.

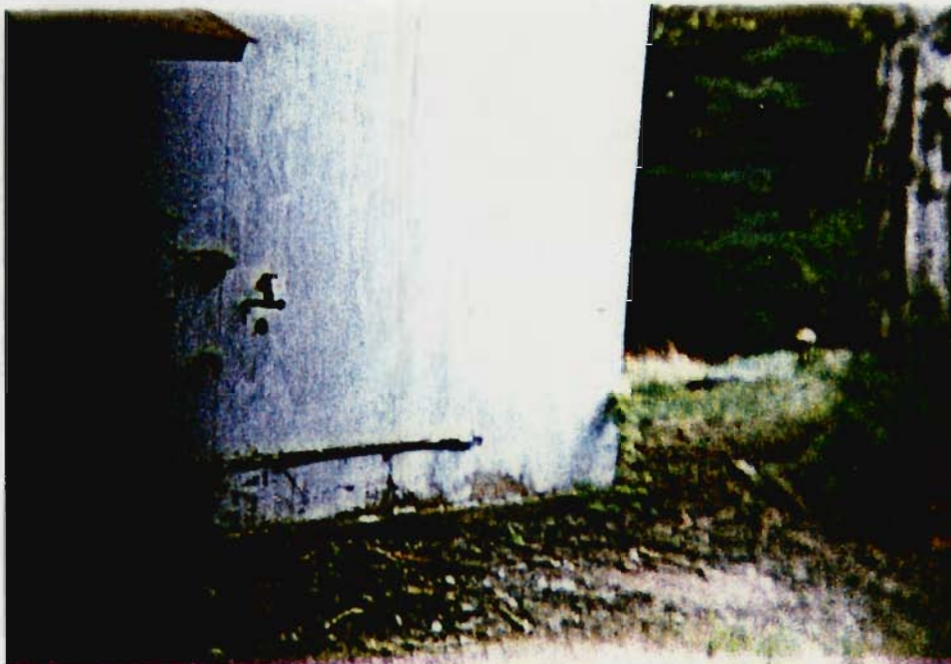
Photograph 15: Northwest wall of Building 28. Fuel oil pipes from Tanks 4 and 5 entered the building through the holes at the base of the wall.

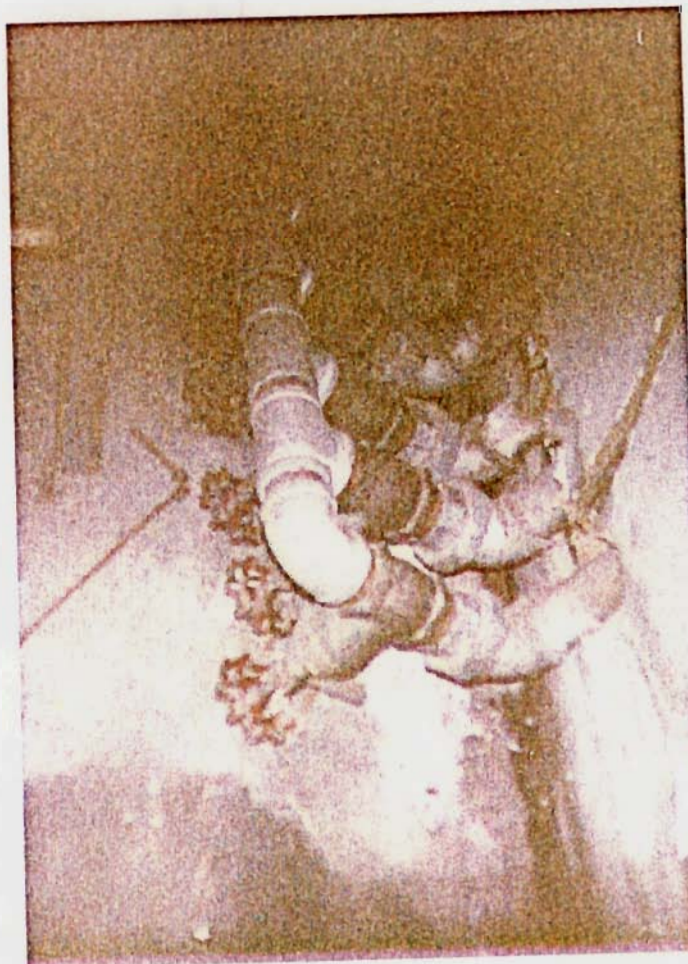
Photograph 16: Northwest interior wall of Building 28. Fuel oil pipes from Tanks 4 and 5 connected to one line leading to a furnace in Building 28H.

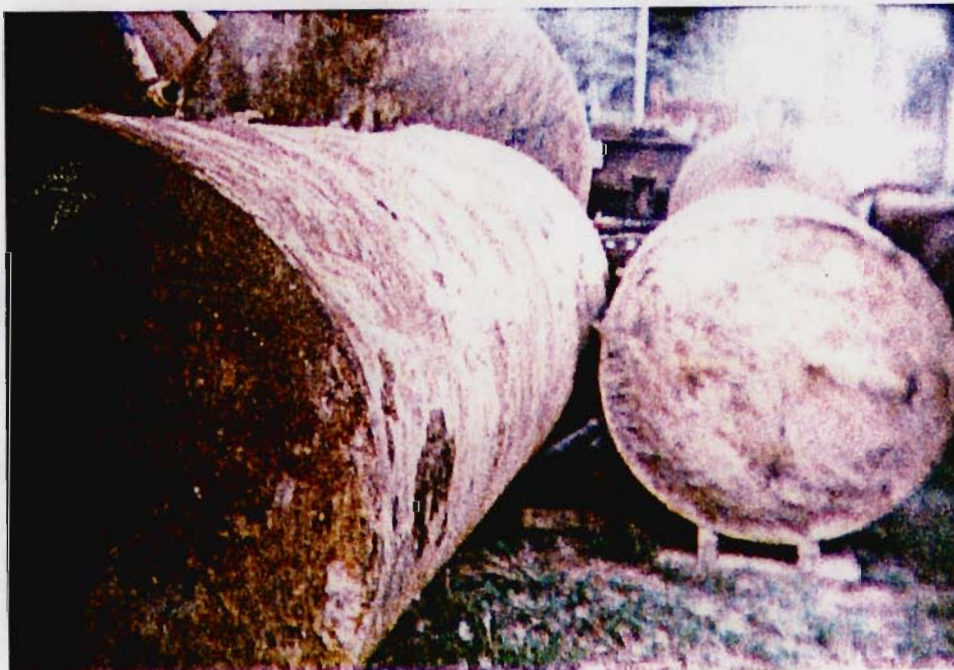
Photograph 18: Storage area 1D-4. Gasoline tanks in foreground (Tank 1 on left, Tank 2 on right) and fuel oil tanks in background.

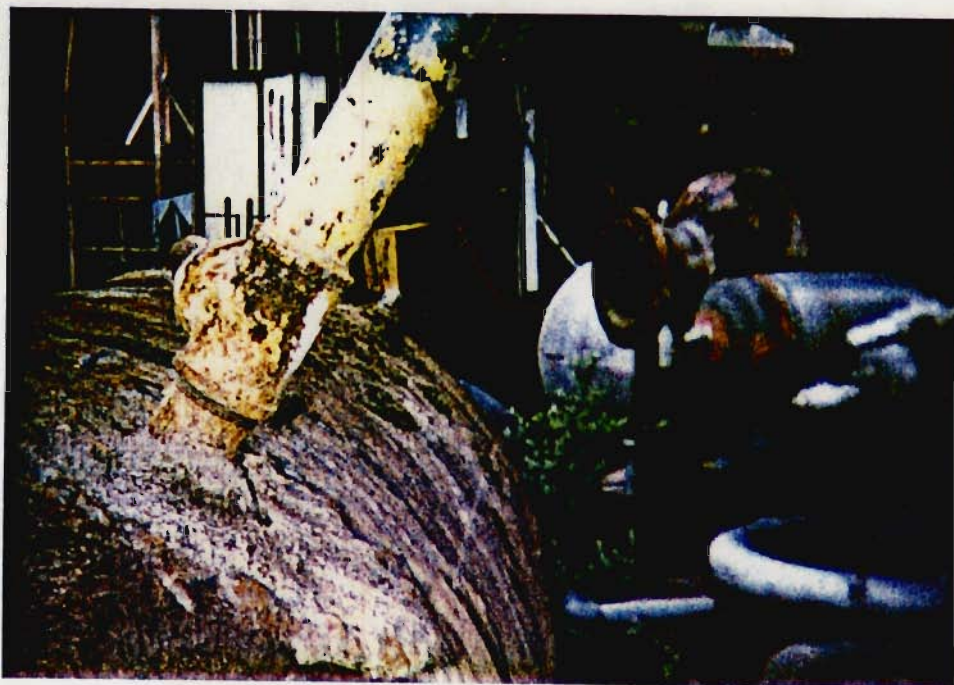
The tank was superficially rusted. It had minor pitting but no holes. The seams were intact. There was no product staining or evidence of leakage. The bottom of the tank was also intact. It had remnants of asphalt coating.

Photograph 19: Top of Tank 1 (3,000 gallon gasoline tank).

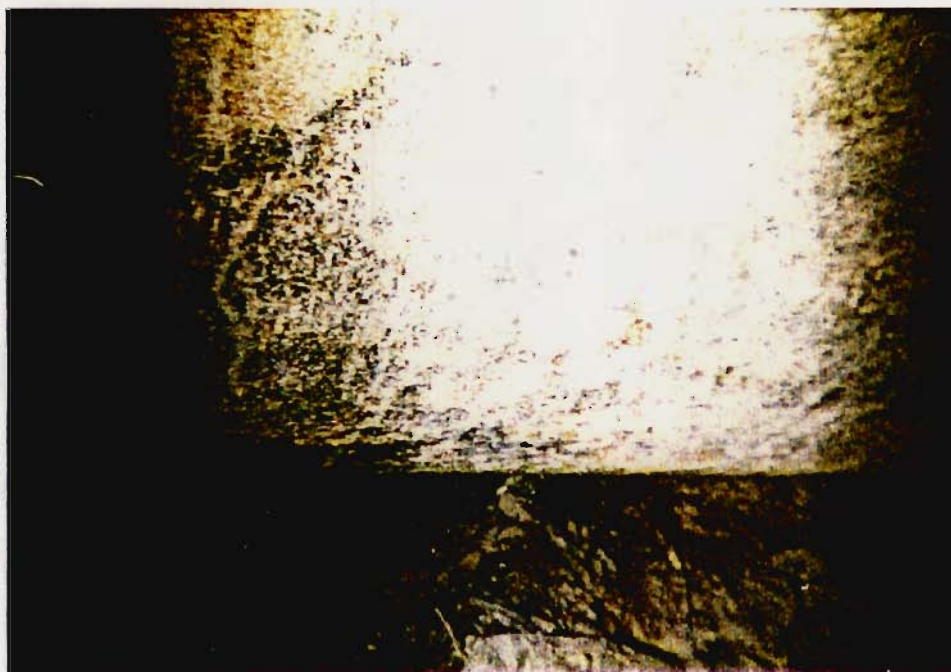
Photograph 20: Bottom of Tank 1 (3,000 gallon gasoline tank).

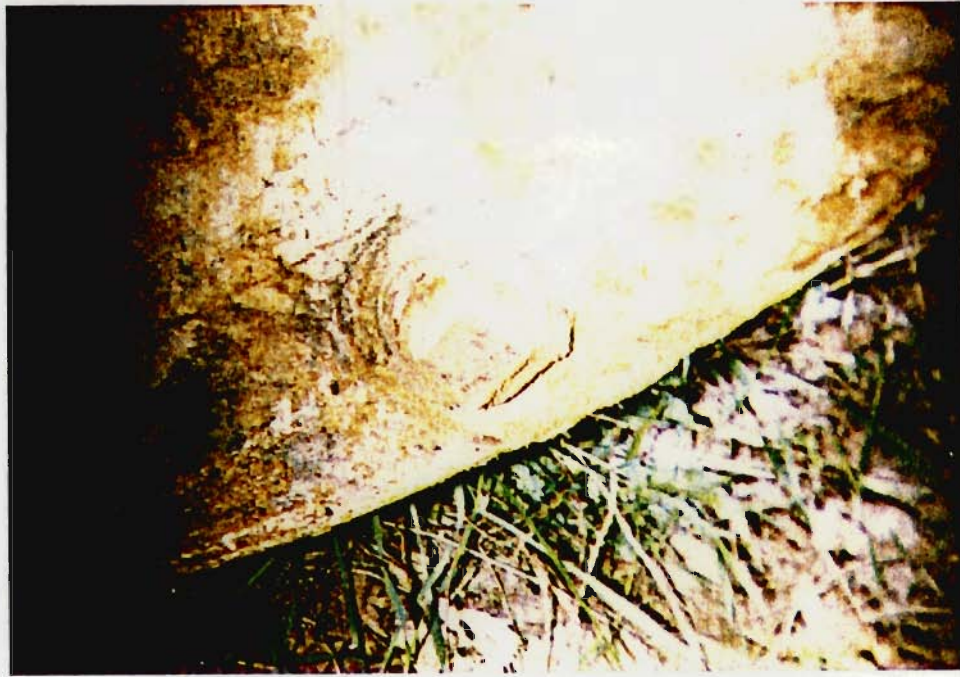
Photograph 21: Bong at bottom of Tank 1.

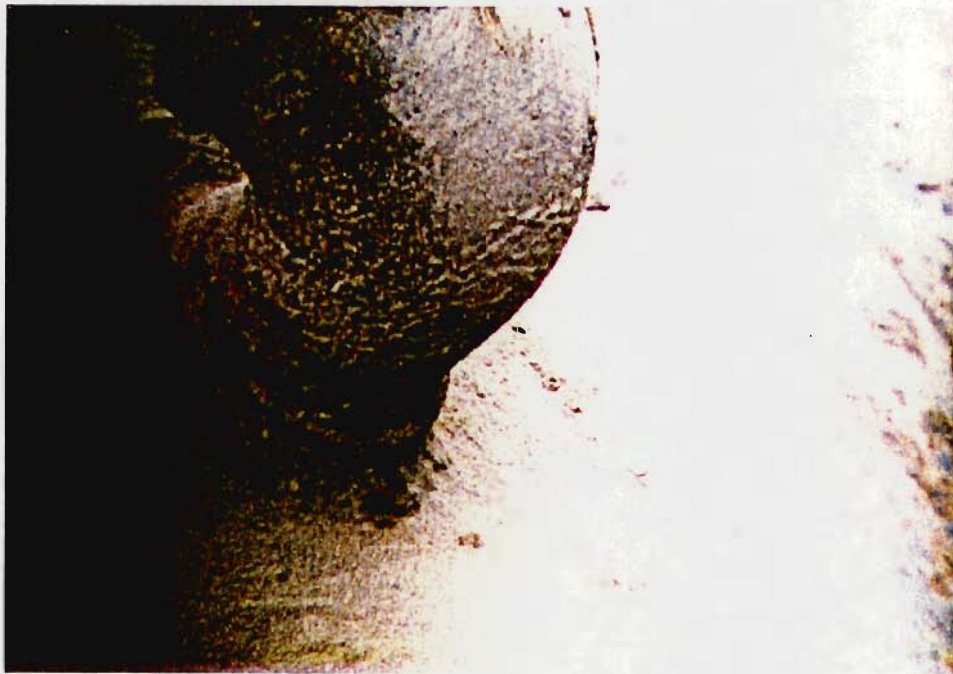
The fill-pipe and bong areas were free of any product staining. The pipe was cut, exposing a 1/4-inch thick steel wall. The piping was superficially rusted and slightly pitted.

Photograph 22: Fill pipe at top of Tank 1.

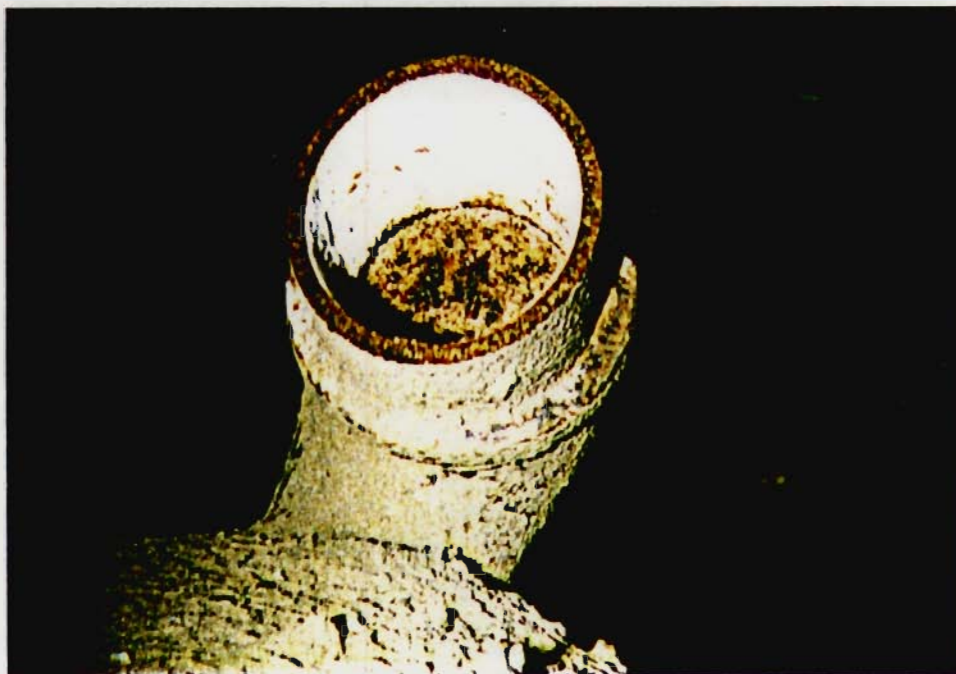
Photograph 23: Fill pipe at top of Tank 1.

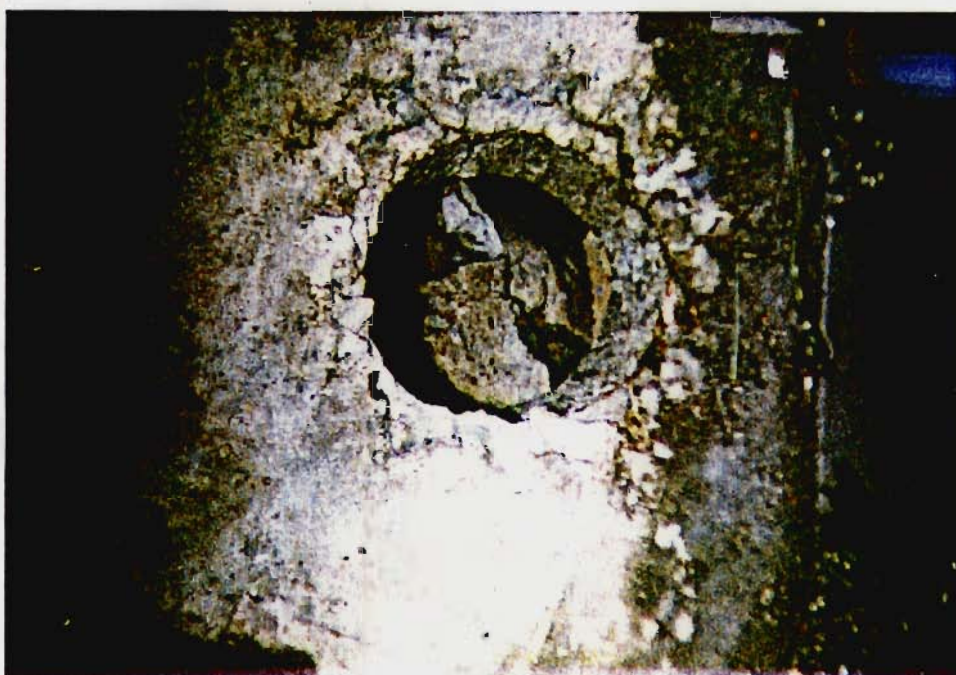
| | years. I observed the fuel mixing tanks (aboveground tanks) and former hydrogen peroxide pressure bottles. R. Kazzaka showed me the concrete cover above the 3,000 gal. gasoline tank removed from Building 15. This square concrete cover was intact and protected the bong area of the gasoline tank. It was not stained. |

Photograph 24: Interior of concrete housing which covered the fill pipe for Tank 1.

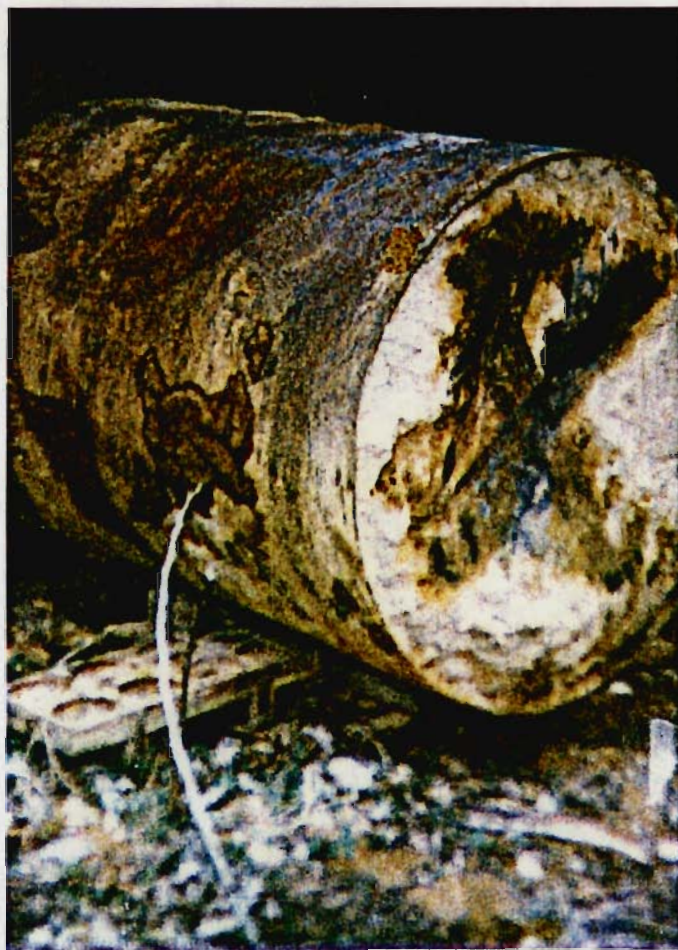
The tank was surficially rusted. It had minor pitting but no holes. The seams were intact. There was no product staining or evidence of leakage. The bottom of the tank was also intact. It had remnants of asphalt coating.

Photograph 25: Tank 2 (5,000 gallon gasoline tank).

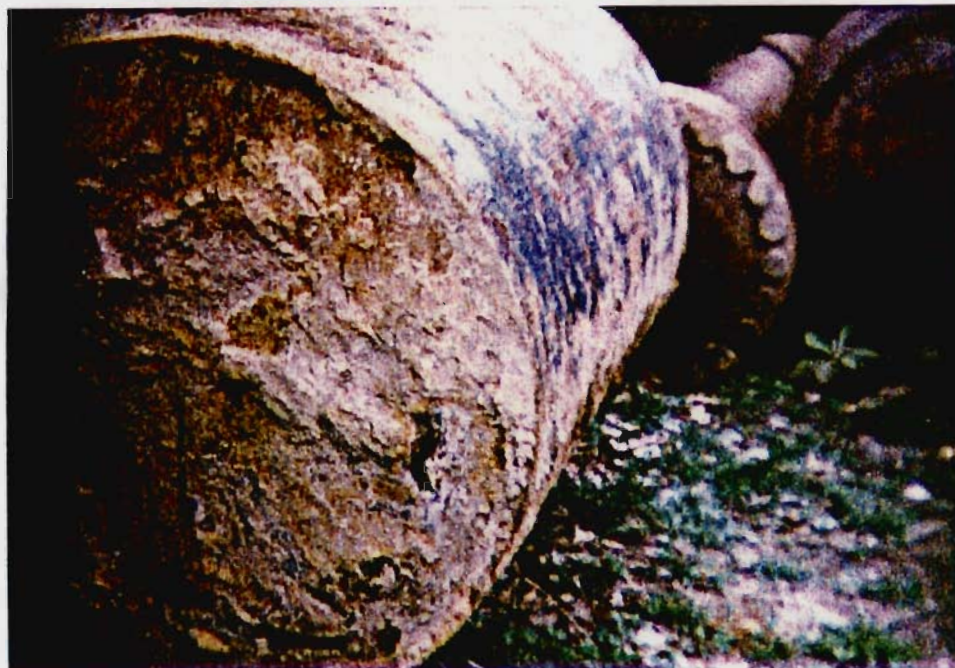
The tank was surficially rusted. It had minor pitting but no holes. The seams were intact. There was no product staining or evidence of leakage. The bottom of the tank was also intact. It had remnants of asphalt coating.

Photograph 26: Tank 3 (550 gallon fuel oil tank).

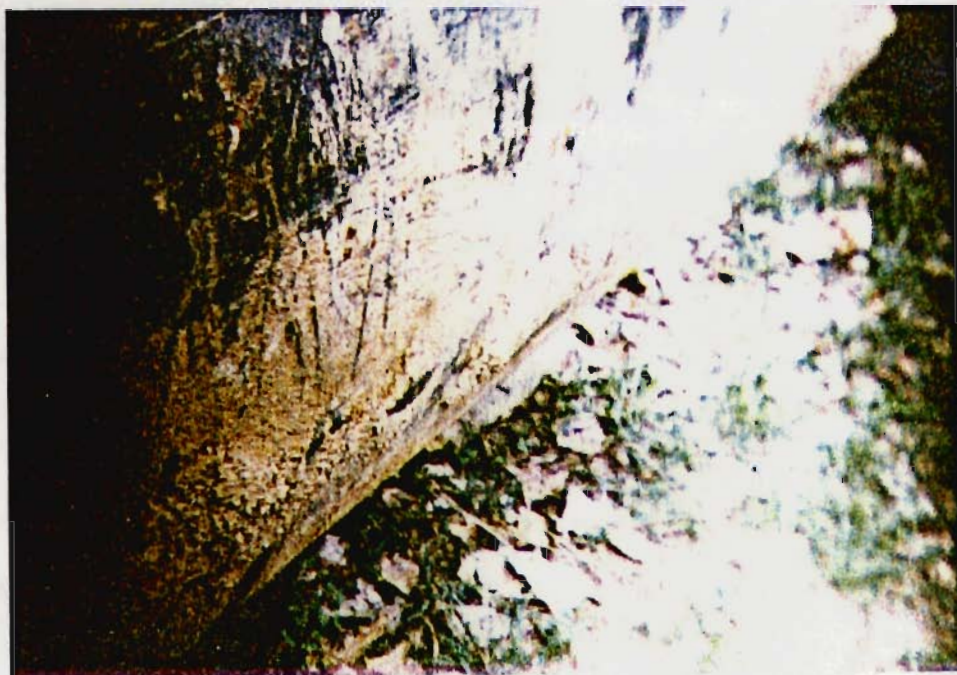
Photograph 27: Bottom of Tank 3, asphalt coating still visible.

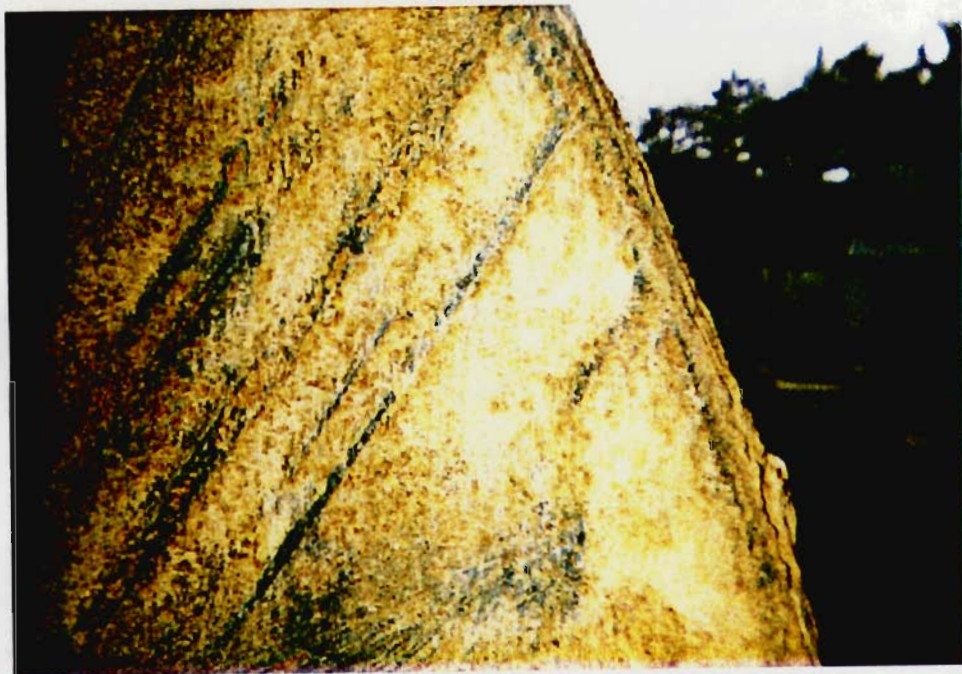
The tank was surficially rusted. It had minor pitting but no holes. The seams were intact. There was no product staining or evidence of leakage. The tank had remnants of asphalt coating. Because of the manner in which it was stored and its close proximity to other tanks, the bottom of the Tank 5 was inaccessible and could not be inspected in detail.

Photograph 28: Tank 5 (6,000 gallon fuel oil tank) seams with crane shovel gashes and surficial pitting visible.

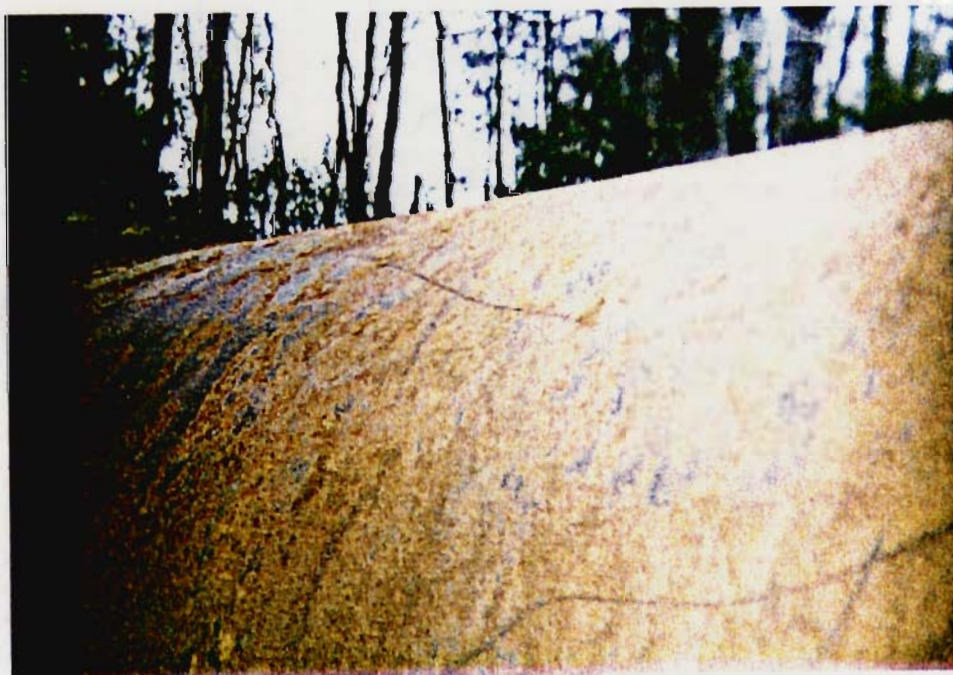
The tank was surficially rusted. It had minor pitting but no holes. The seams were intact. There was no product staining or evidence of leakage. The tank had remnants of

Photograph 30: Top of Tank 4 (6,000 gallon full oil tank).

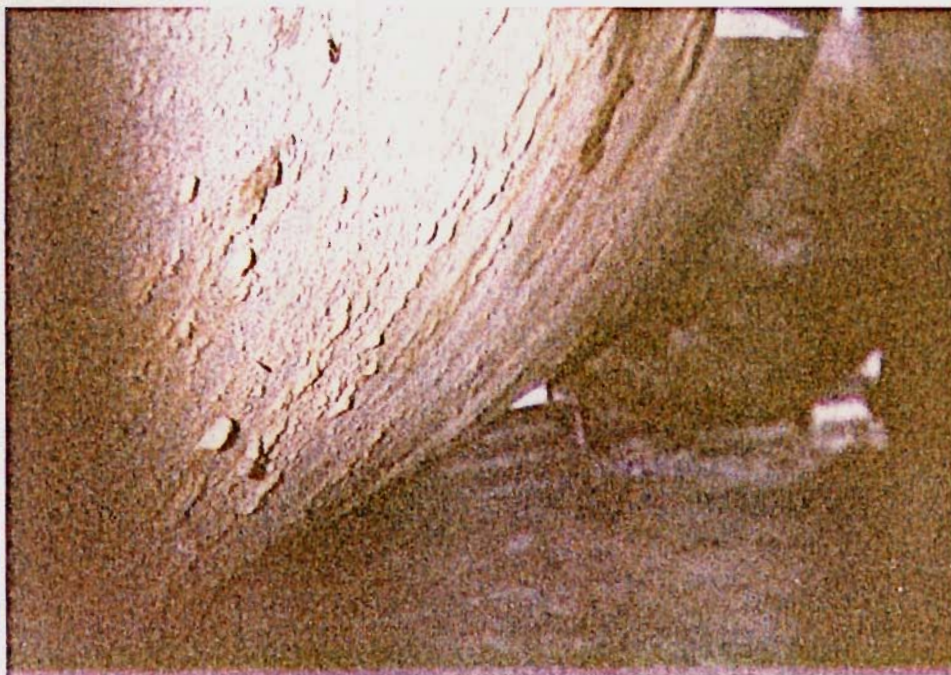
asphalt coating. Because of the manner in which it was stored and its close proximity to other tanks, the bottom of Tank 4 was inaccessible and could not be inspected in detail.

Photograph 31: Bottom section of Tank 4. The area was poorly accessible due to the proximity of Tanks 4 and 5.

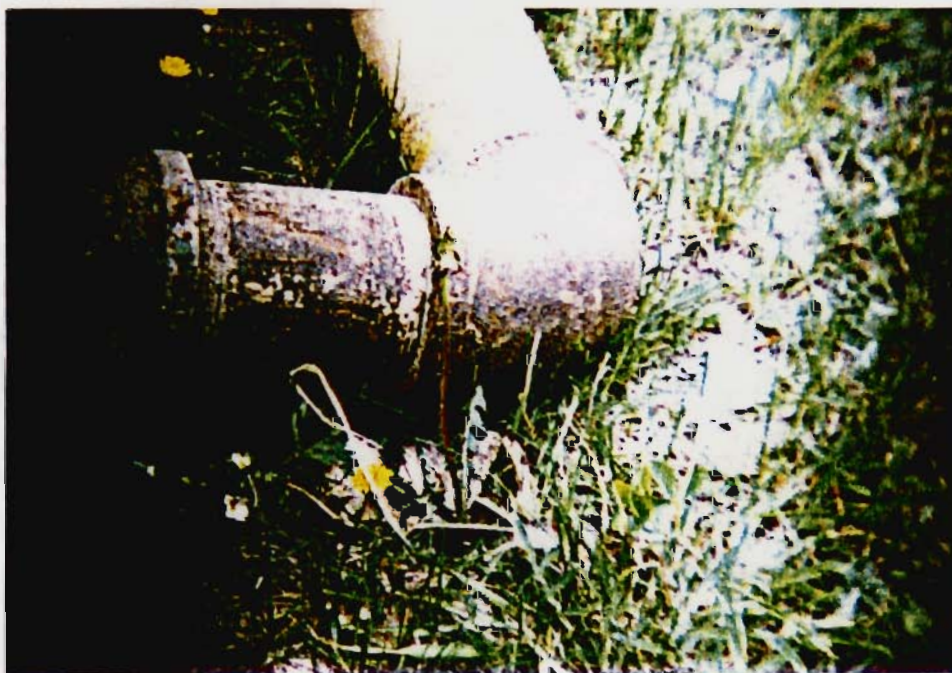
The fill-pipe and bong areas were free of any product staining. The piping was cut, exposing a 1/4-inch thick steel wall. The piping was surficially rusted and slightly pitted.

Photograph 32: Piping from Tank 4 and 5.
