**TANK INSPECTION REPORT  
WRIGHT-MALTA CORPORATION PROPERTY  
MALTA ROCKET FUEL AREA  
SUPERFUND SITE  
TOWNS OF MALTA AND STILLWATER  
SARATOGA COUNTY, NEW YORK**

**May 1991**

**Geraghty & Miller, Inc.  
125 East Bethpage Road  
Plainview, New York 11803  
(516) 249-7600**

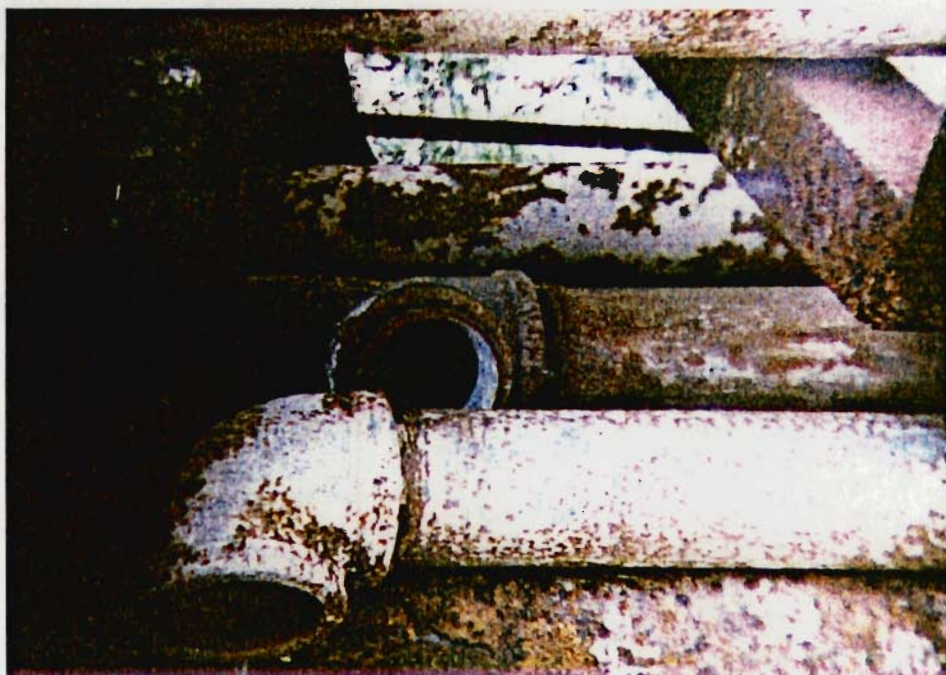
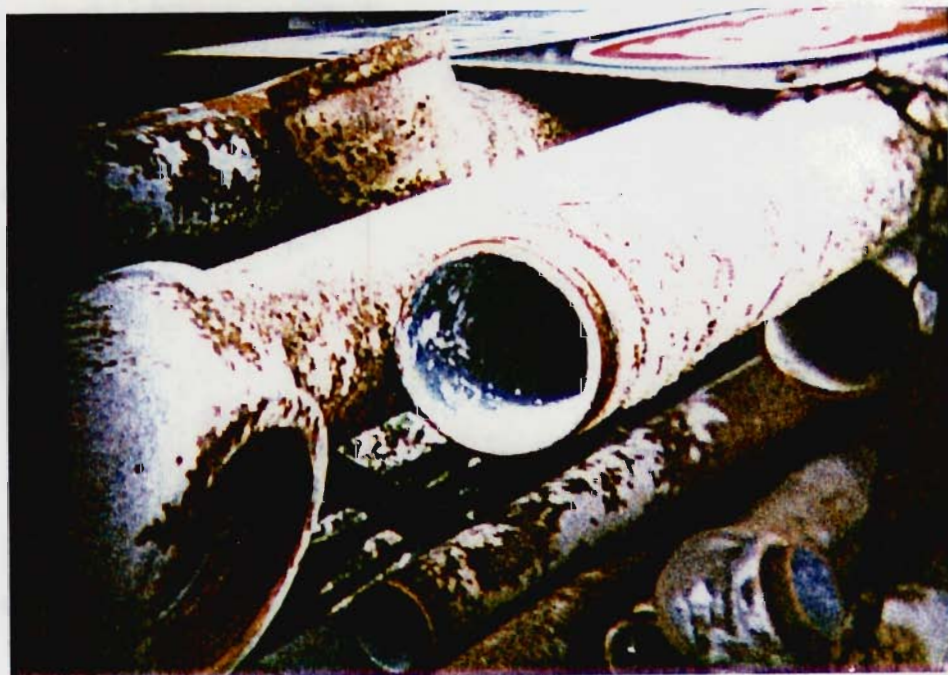
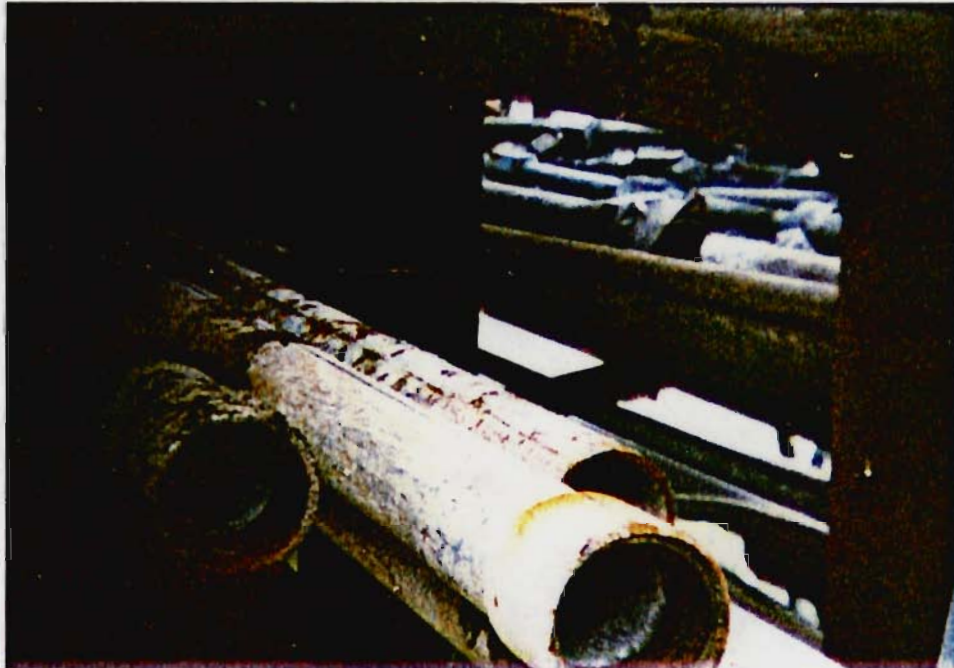
Photograph 33: Tank piping stored in racks.

Photograph 34: Tank piping stored in racks.

Photograph 35: Tank piping stored in racks.
