REMEDIAL INVESTIGATION REPORT

TEE BIRD COUNTRY CLUB – NORTH COURSE
MOREAU, NEW YORK

NYSDEC Site #546028

June 9, 2011

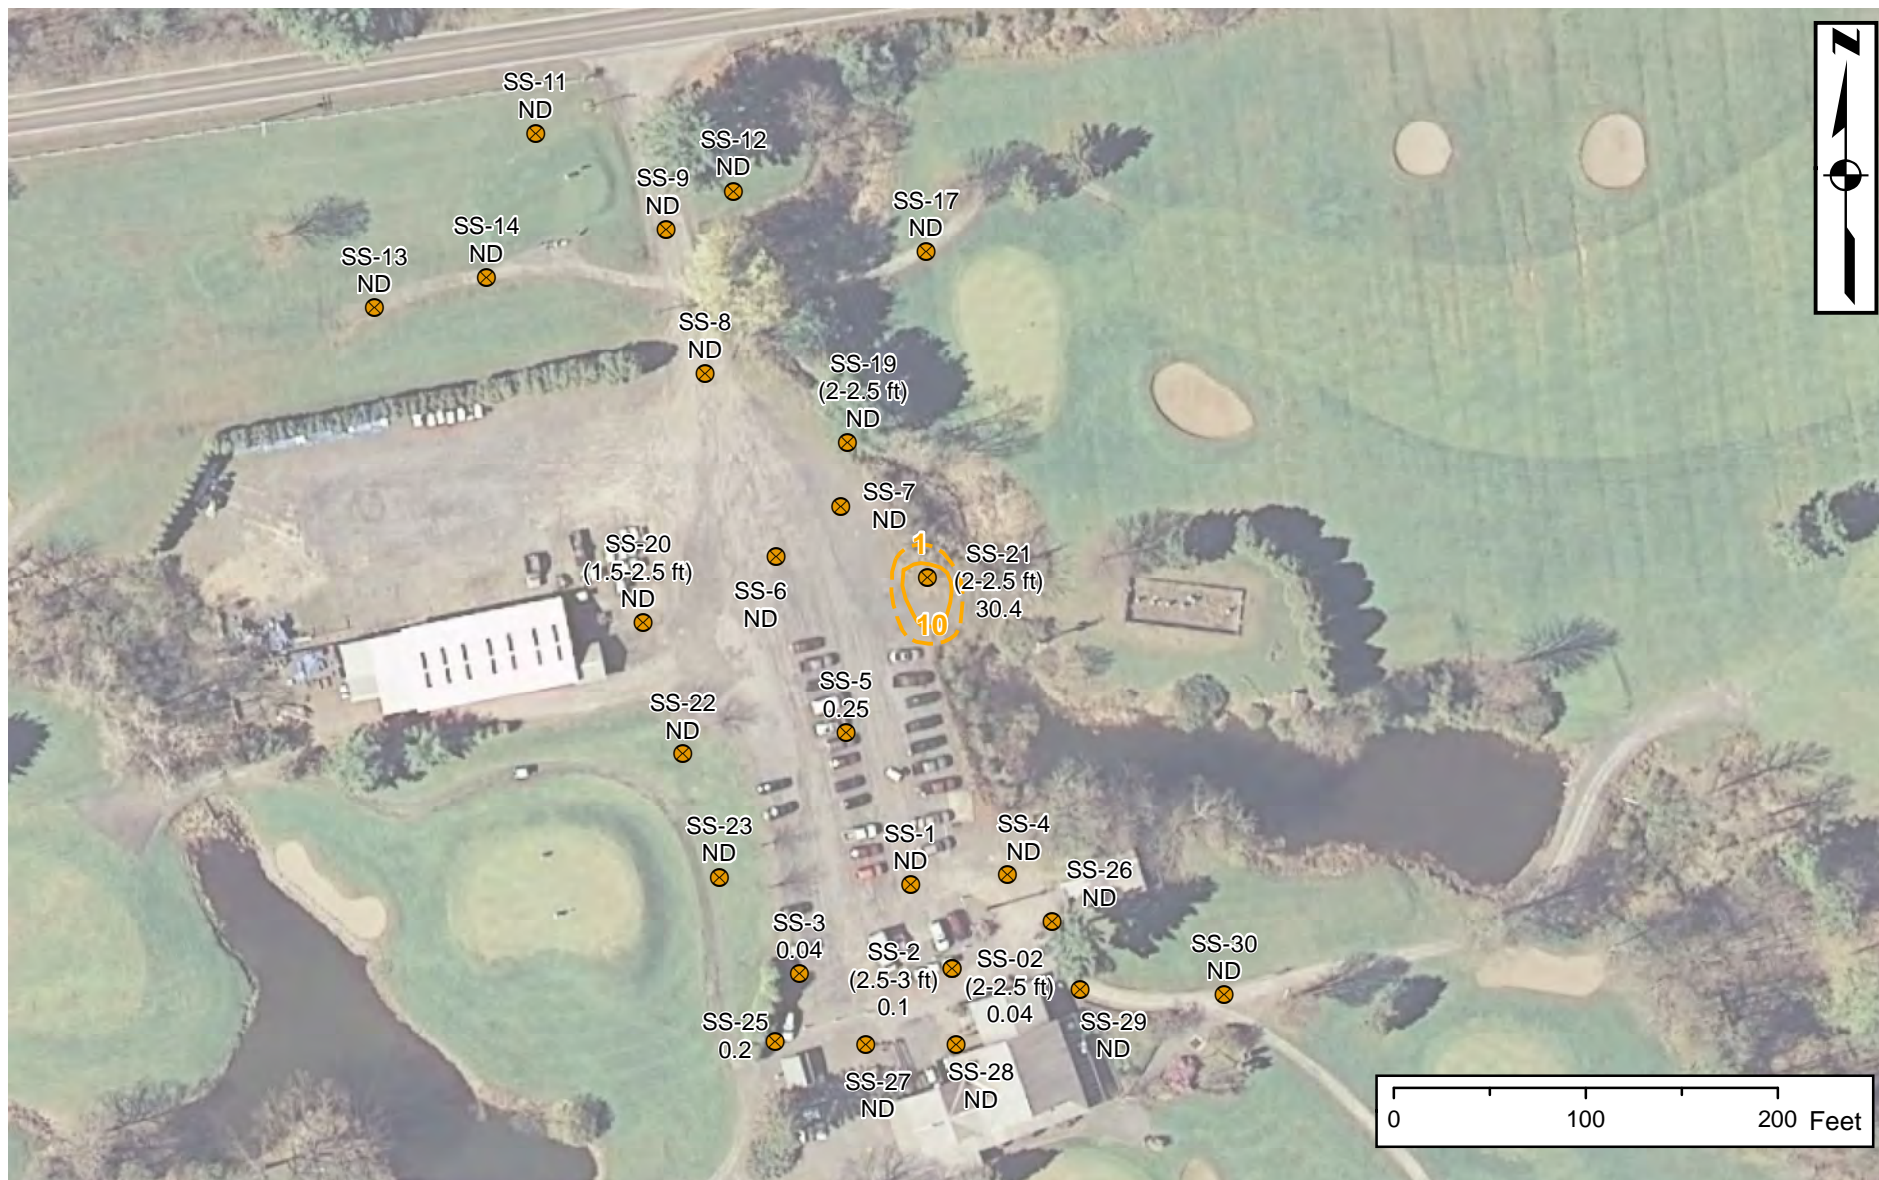
- SS-13 ND Total PCBs in Soil (mg/kg)
- Total PCB Concentration Contour

- Basemap: Saratoga County 12-inch Resolution Natural Color Orthoimagery (April 2007), NYS Office of Cyber Security & Critical Infrastructure Coordination.
- Concentrations are reported in milligrams per kilogram (mg/kg).
- ND indicates PCBs were not detected.
- Sample depth is 2 to 3 feet below pavement or vegetative cover, unless noted.

- beneath the south central portion of the parking lot, where concentrations range up to 3.07 mg/kg in the 2-3 ft interval, and
- along the edge of the asphalt on the driveway to the former trailer foundation area, where PCBs were found at 30.4 mg/kg in the 2-3 ft interval.
