**Pre-Design Site Assessment Report  
Old Moreau and Special Area 13  
Dredge Spoil Disposal Area Sites  
Moreau, New York**

**Site Numbers 546040 & 546041**

**December 2021**

**ECOLOGY AND ENVIRONMENT ENGINEERING AND GEOLOGY, P.C.  
368 Pleasant View Drive  
Lancaster, New York 14086**

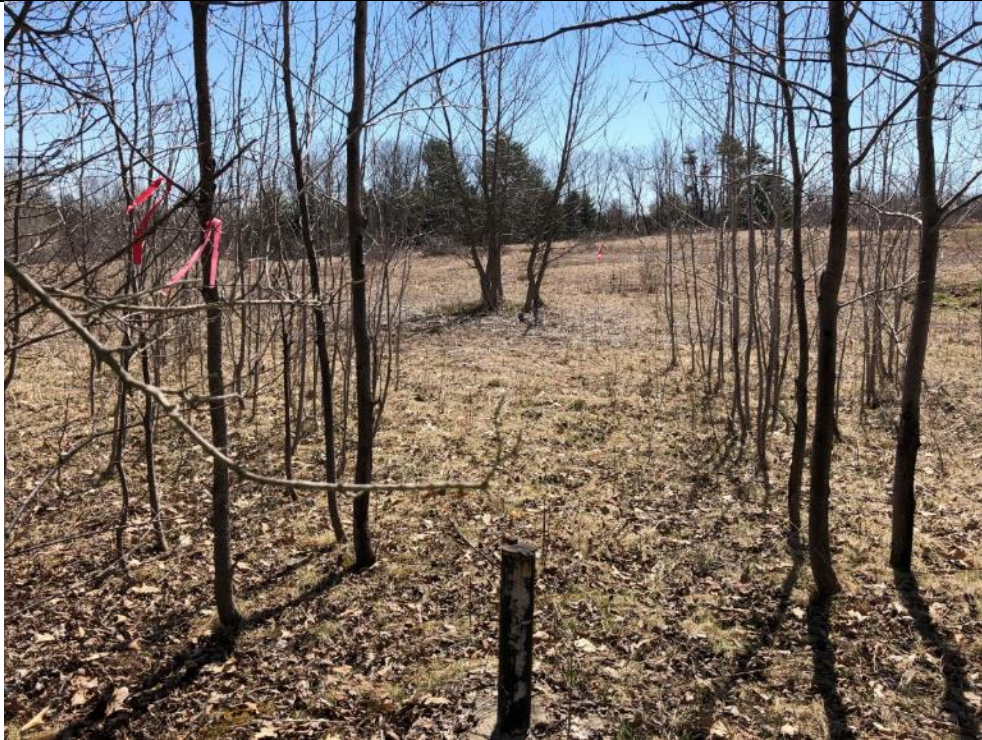
| <b>Photo No.:</b> | 01 | <b>Direction of View:</b> | South |

| <b>Date:</b> | 04/08/2021 | <b>Subject:</b> MW-08 with New Moreau landfill in background. | |

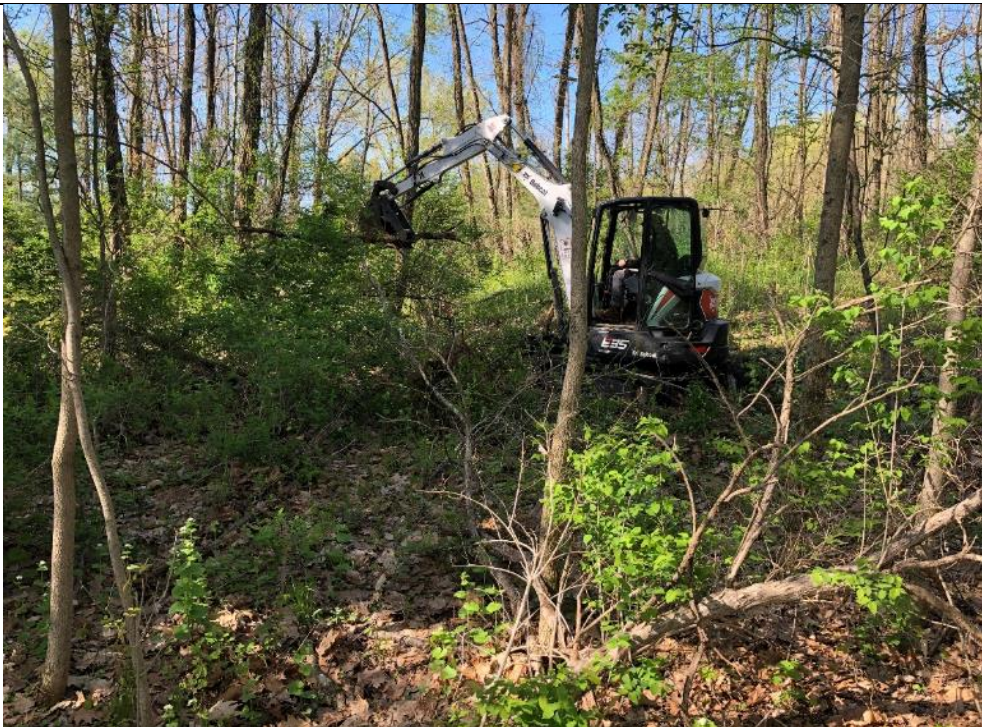
| <b>Photo No.:</b> | 02 | <b>Direction of View:</b> | East-southeast |

| <b>Date:</b> | 03/01/2021 05/13/2021 | <b>Subject:</b> Clearing of trees and brush from Old Moreau white plastic-like area. | |

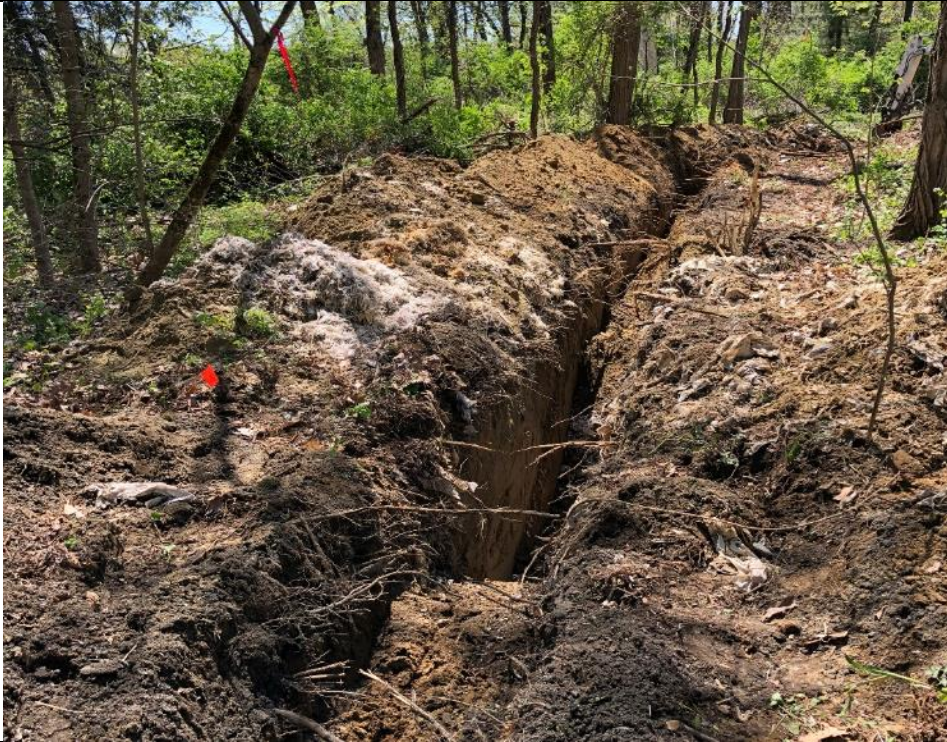
| <b>Photo No.:</b> | 03 | <b>Direction of View:</b> | Southwest |

| <b>Date:</b> | 05/13/2021 | <b>Subject:</b> Test Pit A in Old Moreau white plastic-like area. | |

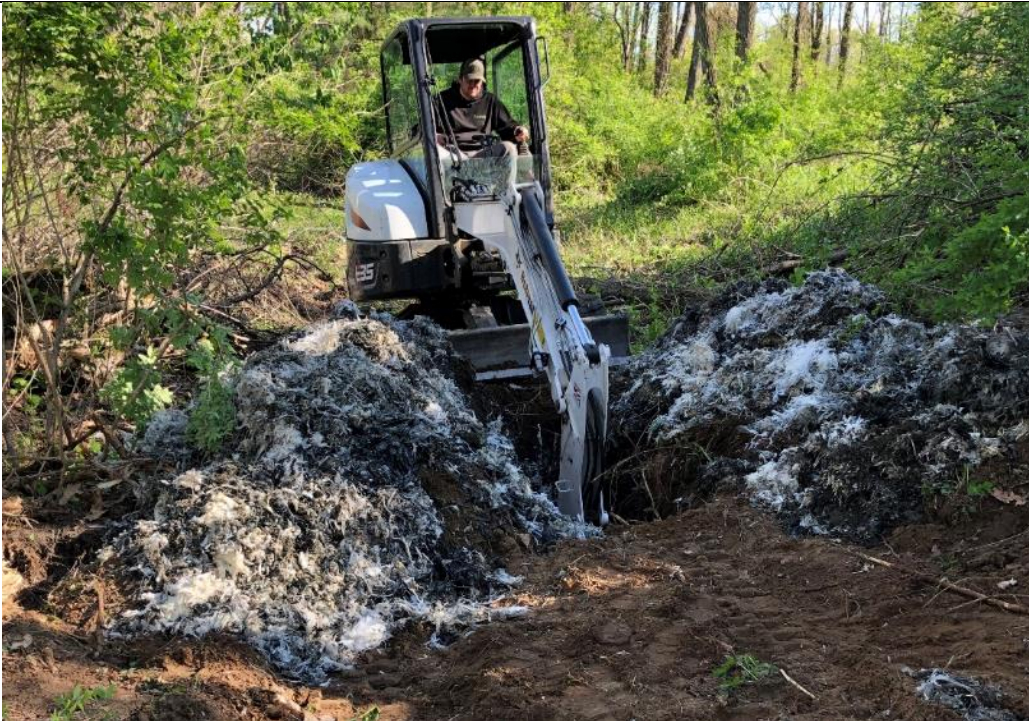
| <b>Photo No.:</b> | 04 | <b>Direction of View:</b> | South |

| <b>Date:</b> | 05/13/2021 | <b>Subject:</b> Test Pit I in Old Moreau white plastic-like area. | |

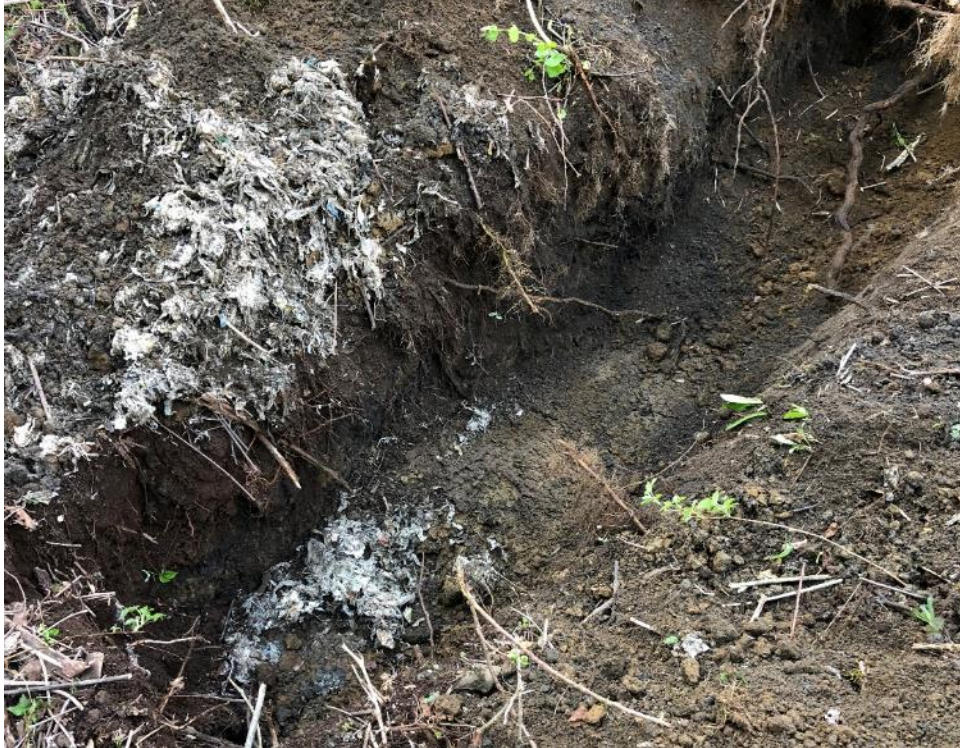
| <b>Photo No.:</b> | 05 | <b>Direction of View:</b> | NA |

| <b>Date:</b> | 05/13/2021 | <b>Subject:</b> Test Pit J through Moreau Drainage Ditch.<br>Plastic-like material 1.5 feet below ground surface. | |

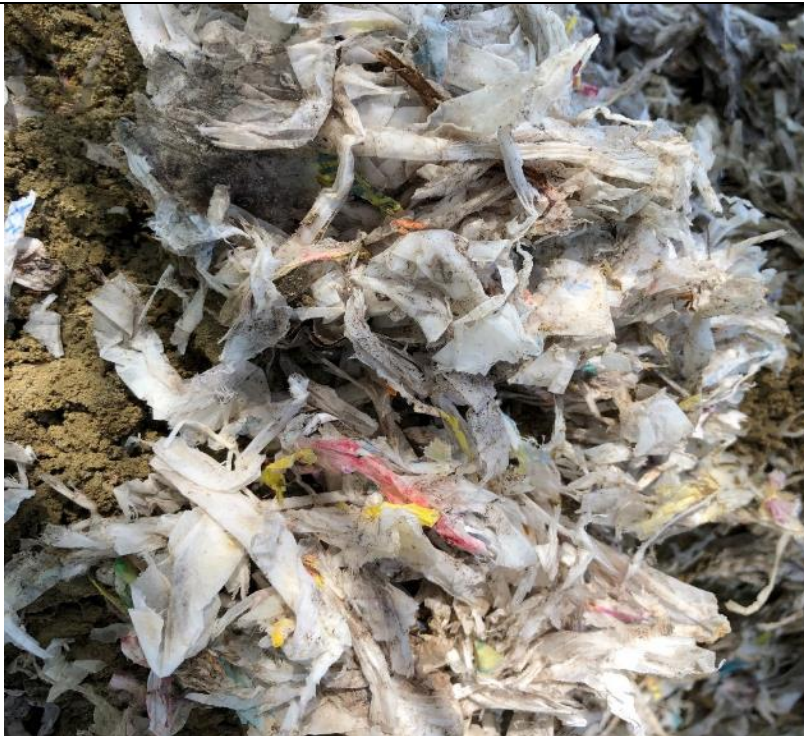
| <b>Photo No.:</b> | 06 | <b>Direction of View:</b> | NA |

| <b>Date:</b> | 05/13/2021 | <b>Subject:</b> Up close photo of white plastic-like material. | |

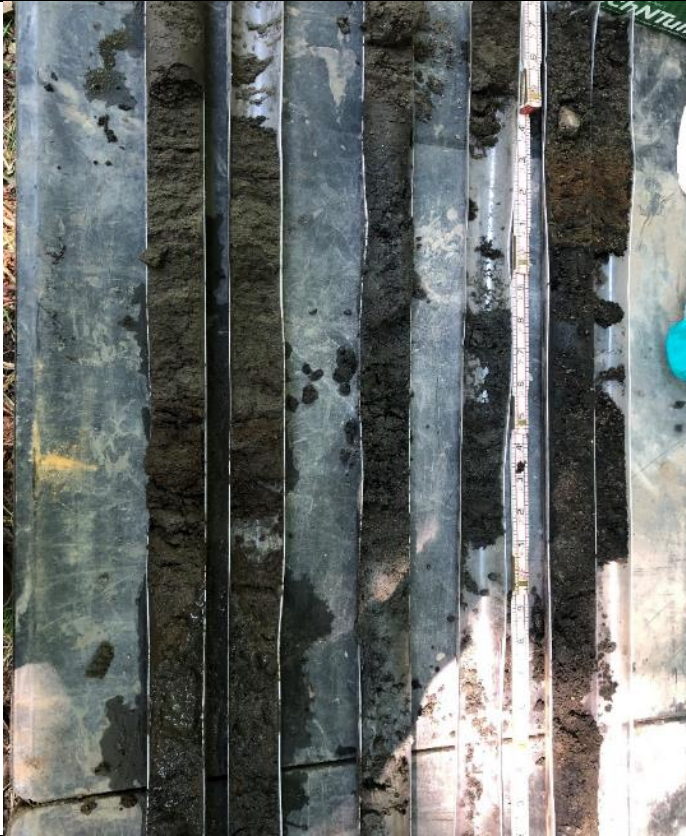
| <b>Photo No.:</b> | 07 | <b>Direction of View:</b> | NA |

| <b>Date:</b> | 07/23/2021 | <b>Subject:</b> Direct-push subsurface soil collected from SA-GP01. | |

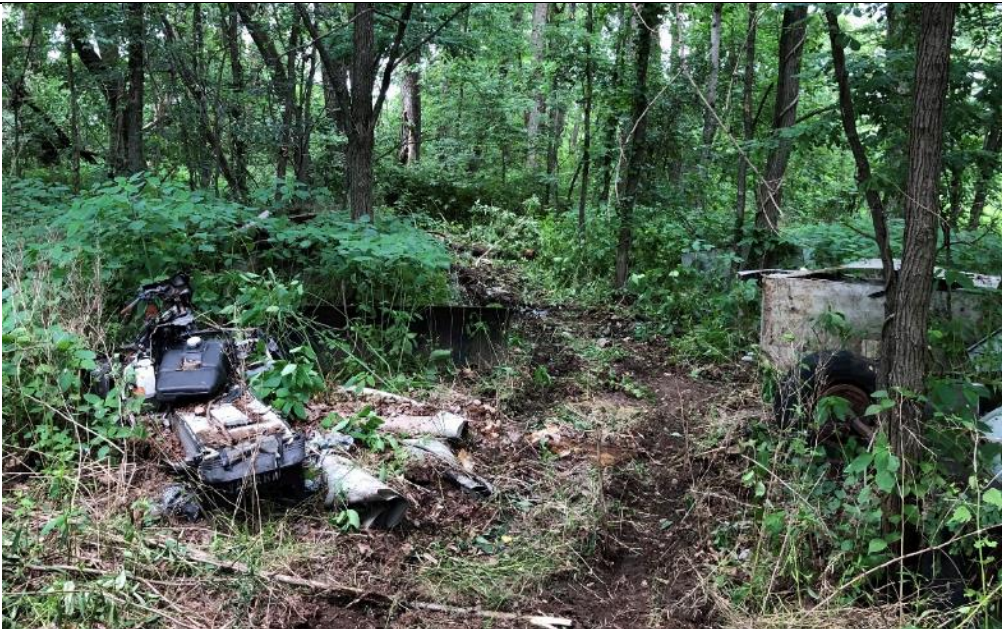
| <b>Photo No.:</b> | 08 | <b>Direction of View:</b> | Northwest |

| <b>Date:</b> | 07/23/2021 | <b>Subject:</b> Fill area 3 with SA-GP03 (straight ahead) and SA-GP04 (ahead and left). | |

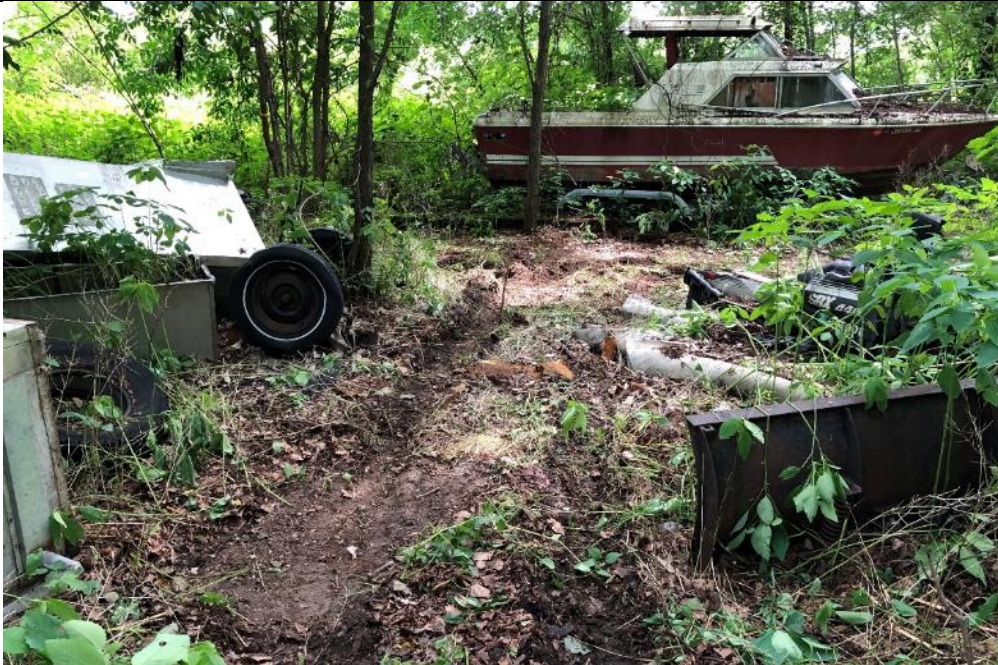
| <b>Photo No.:</b> | 09 | <b>Direction of View:</b> | East-Southeast |

| <b>Date:</b> | 07/23/2021 | <b>Subject:</b> | Fill area 3 with SA-GP02 located next to tree in front of boat. |

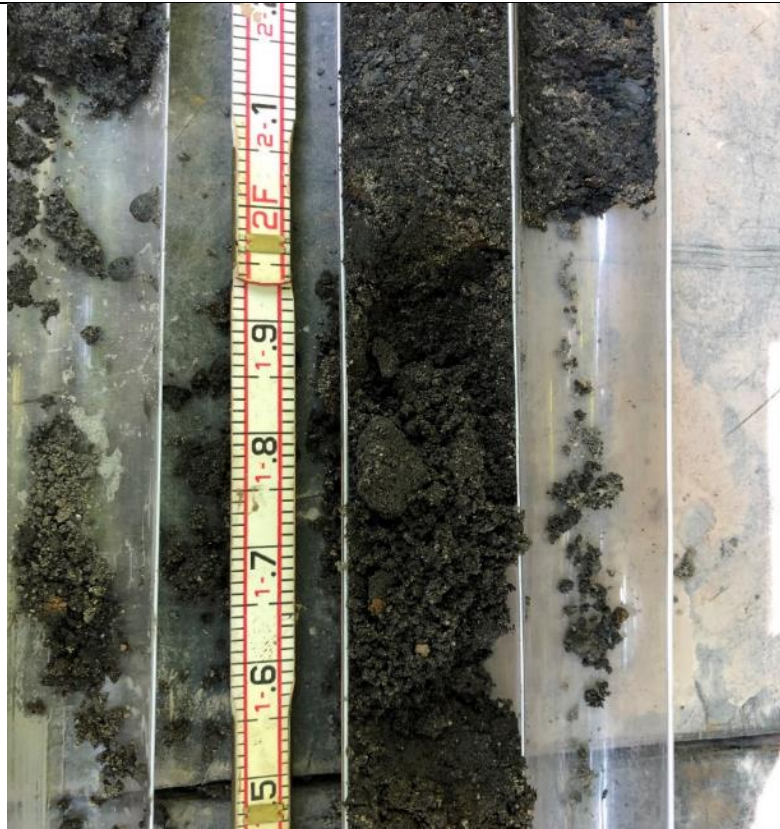
| <b>Photo No.:</b> | 10 | <b>Direction of View:</b> | NA |

| <b>Date:</b> | 07/23/2021 | <b>Subject:</b> | Direct-push subsurface soil collected from SA-GP01. |
