PRELIMINARY SITE ASSESSMENT REPORT

CAMAROTA CLEANERS SITE

325 - 327 Park Avenue
Mechanicville, New York
Site No. 5-46-044

Work Assignment No. D002676-45

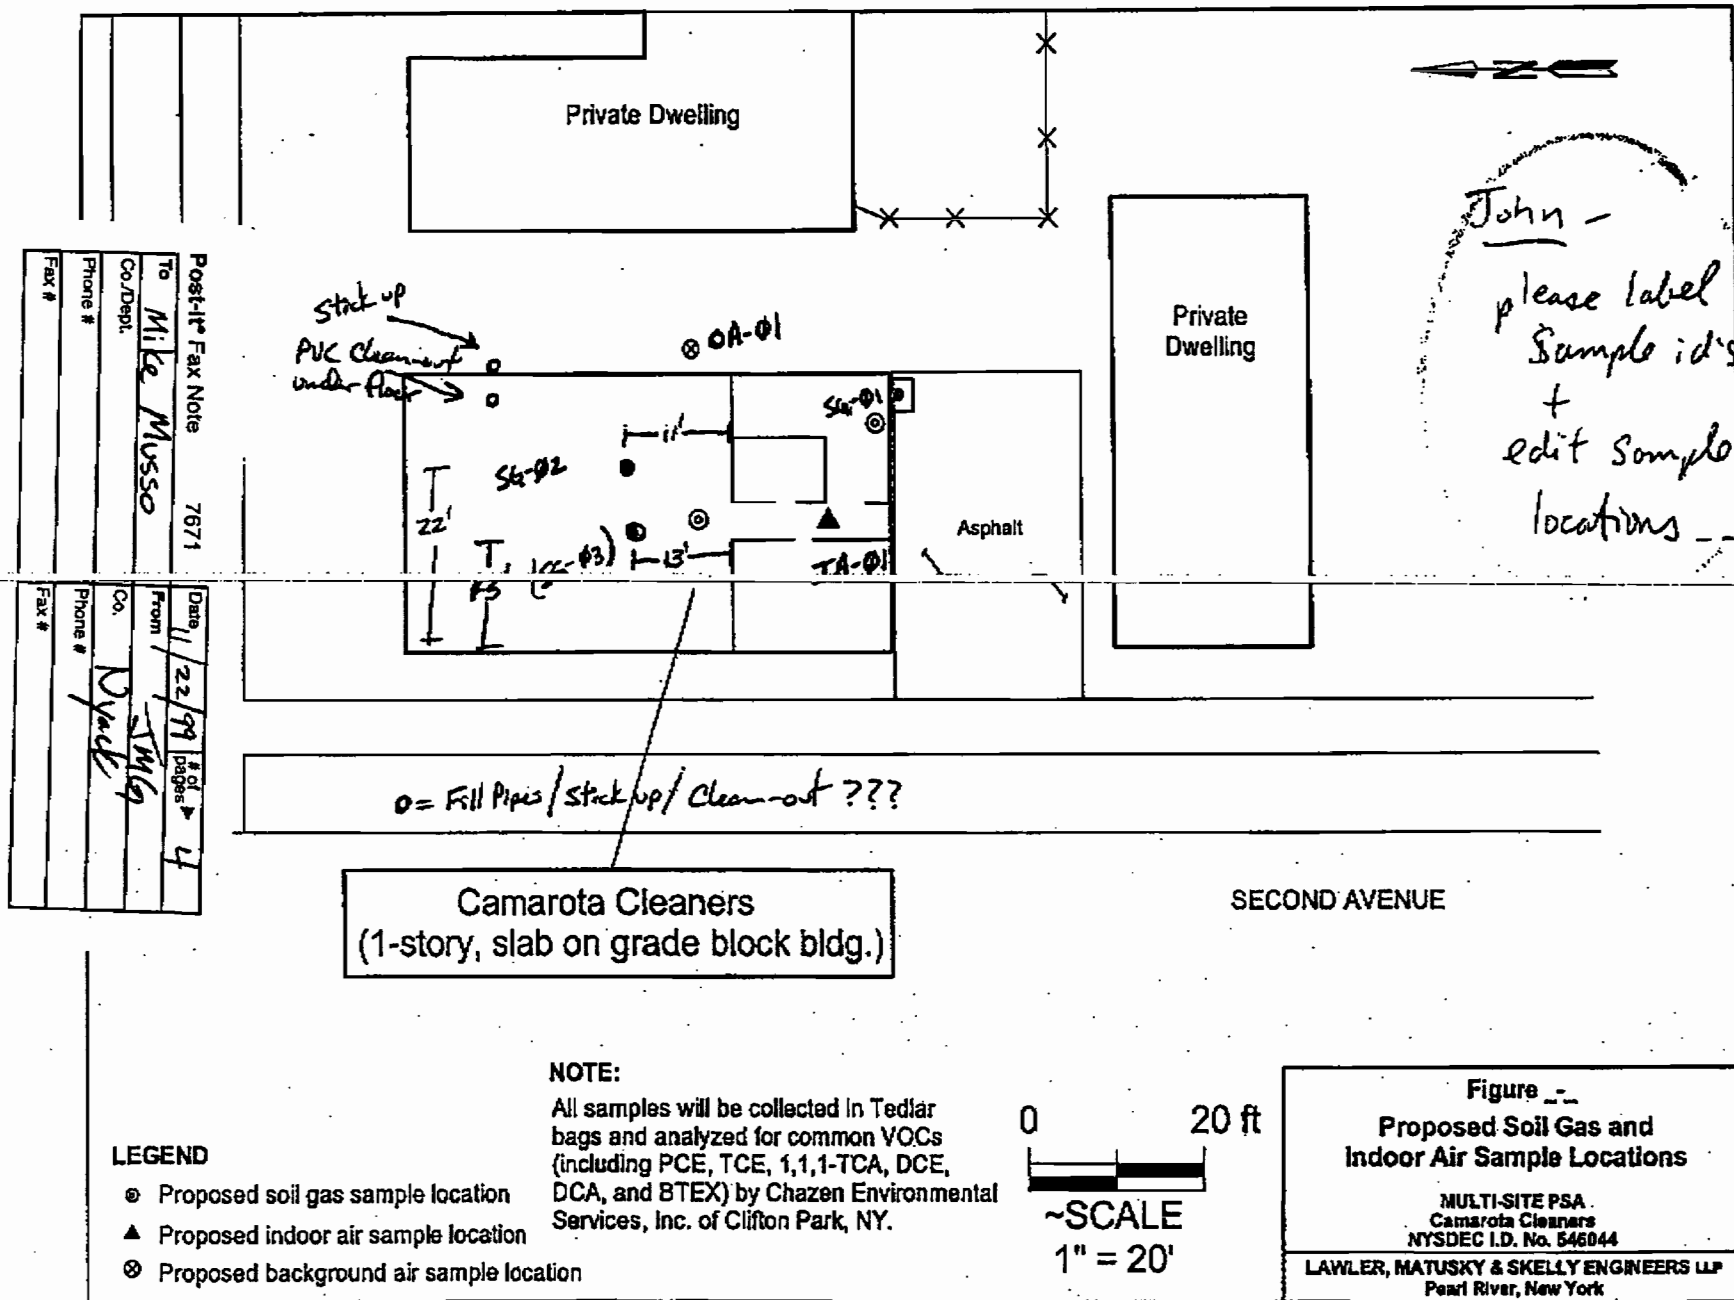
The indoor air sample was collected with a small diaphragm pump and a short piece of dedicated tubing. The pump was allowed to pump ^{ambient} air through the tubing for approximately 2 minutes. The tubing was ^{then} attached to the Tedlar bag to allow it to fill. The area was scanned with a HNU systems DH-101 photoionization detector with a 10.2 eV lamp during this process. This sample was collected in the hallway between the office & bathrooms.
