**SUBJECT: 2019 Groundwater Monitoring and Periodic Review**

**Site Name:** Camarota Cleaners

**Site Code:** 546044

**DATE:** September 30, 2019

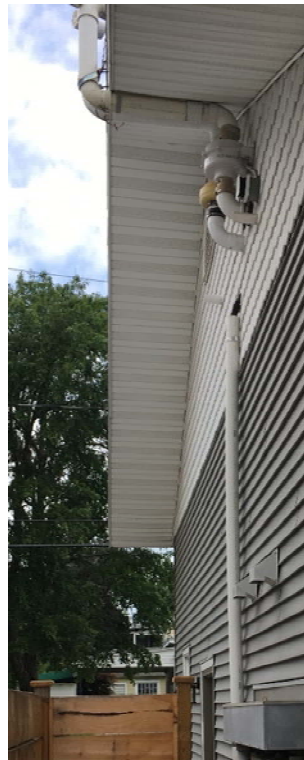
SSDS Fans

On July 12, 2019, NYSDEC assessed the site by completing the Site-Wide Inspection List and Periodic Operations Visit Form, Appendix A. Field staff entered the building during the inspection and recorded monometer vacuum values of 2.1" and 1.8" of water for the two sub-slab depressurization fans. These readings indicate that the system is working and maintaining a negative vacuum beneath the building. There were no potable wells identified on the site and the monitoring wells were in good condition. The site building was divided into two apartment units. Photographs of the site can be found in Appendix A. Certifications by the property owner regarding compliance with the SMP are included in Appendix C. Based on this information, the site is in compliance with the SMP.

Continued operation of the sub-slab depressurization system is necessary as the site is occupied. Future certifications by the property owner are necessary to verify compliance with the SMP.
