Report No.: 8003-144
Work Assignment No.: 019-2JZZ
Contract No.: 68-W9-0051
February 26, 1993
Volume 1 of 3

RE: Warrensburg Board & Paper Company Site Inspection Prioritization Evaluation

The following is a summary of the Site Inspection Prioritization evaluation of the Warrensburg Board & Paper Company site (CERCLIS ID No. NYD013348438) (Ref. No. 1).

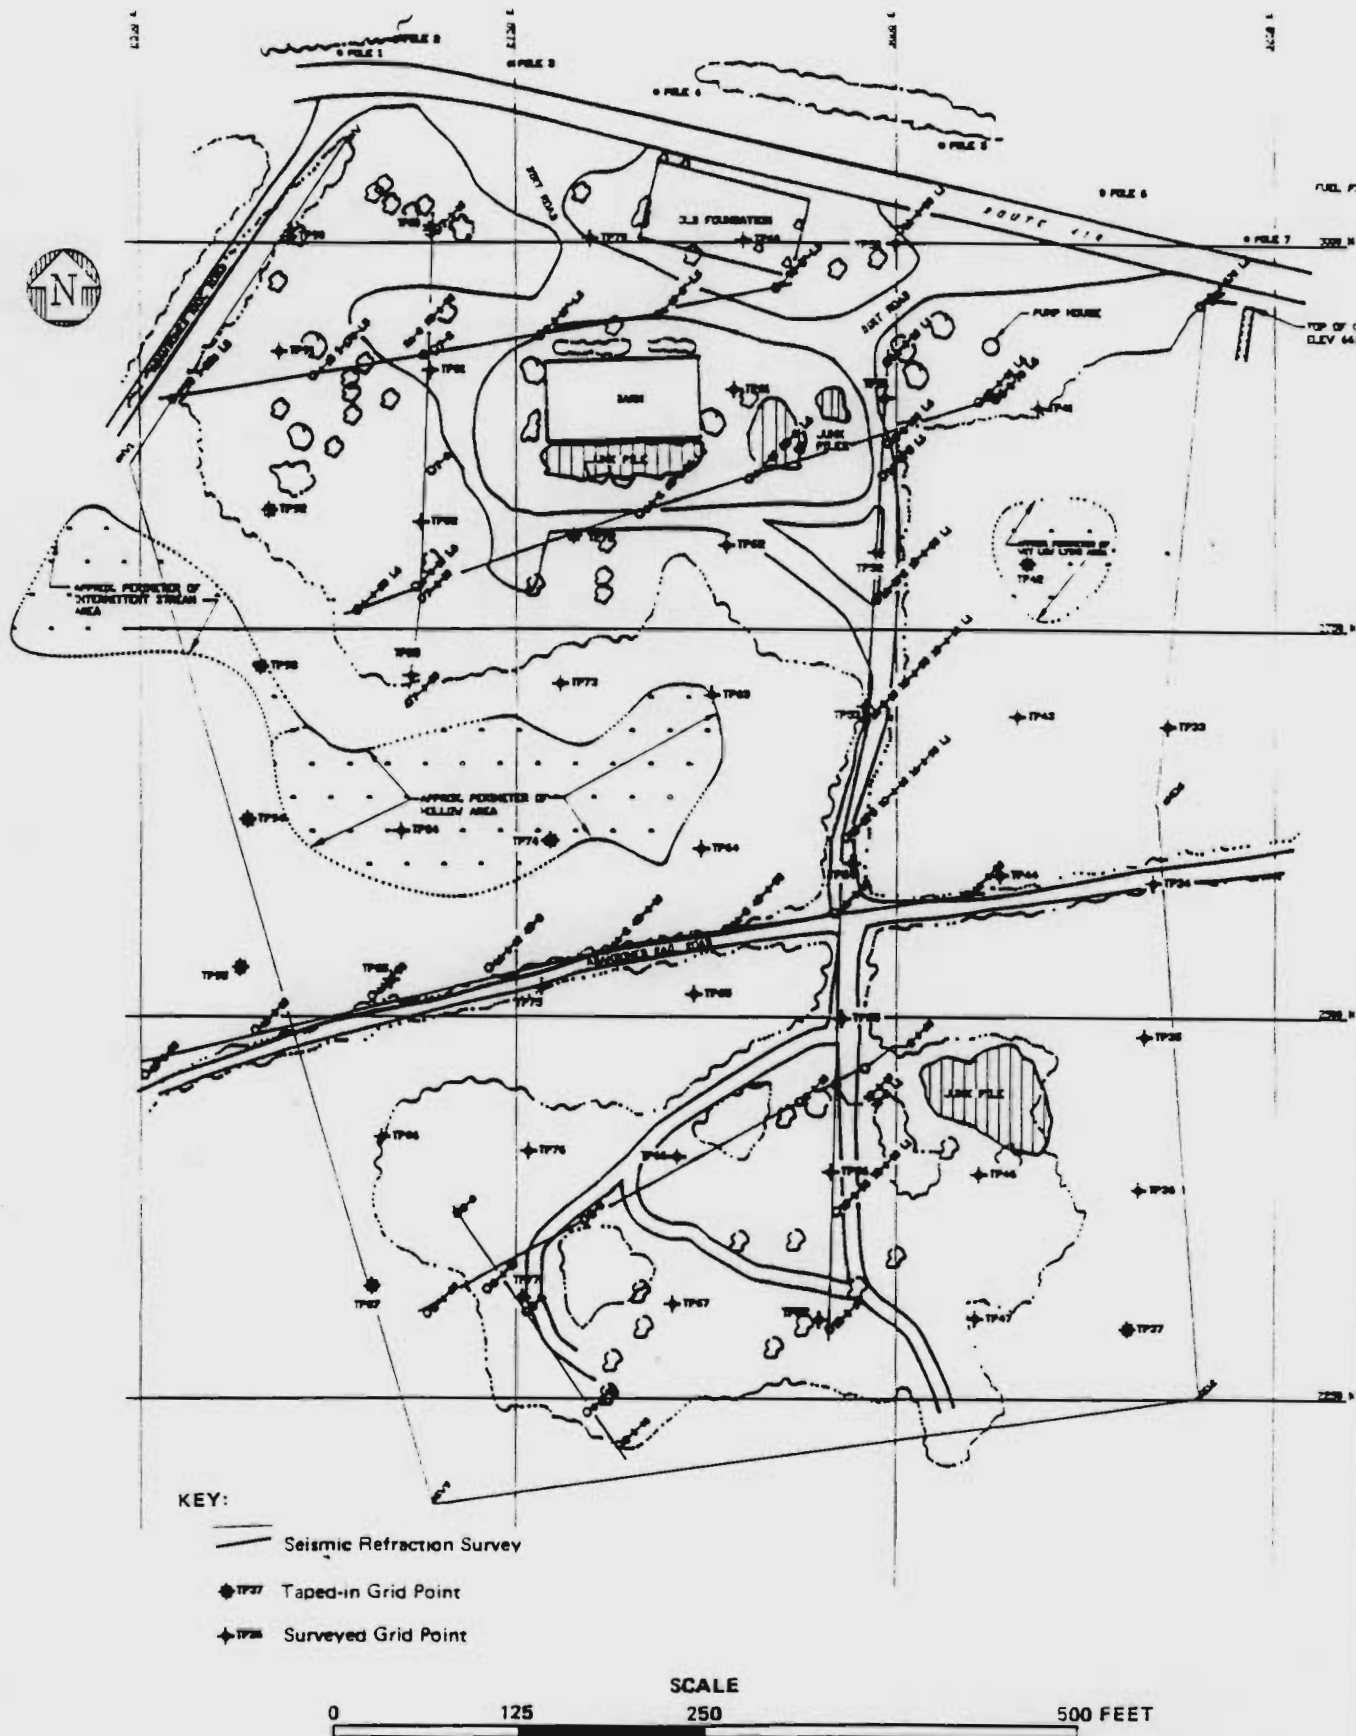
Figure 2-1 WARRENSBURG GEOPHYSICAL SURVEY

The soil and vadose zone investigation was conducted in areas of suspected contamination, i.e., the area of alleged illegal dumping in the southwest corner of the south landfill area; the area of potential

contamination behind the barn; and the perimeter of the leachate pond in the hollow directly north of the railroad. In addition, areas where anomalies were identified by the geophysical investigation were also investigated in order to identify the source of the anomaly. Eleven test trench areas were excavated using a backhoe for site investigation purposes. The backhoe was operated by Clean Harbors, Inc., of Albany, New York. Examination of the trenches also provided for description of surface geology (see Section 3.4.1). A total of 12 onsite surface and subsurface soil and material samples also were collected as described in Table 2-1. Samples collected during the excavation with the backhoe are identified as "Cataug" samples. Samples collected using a hand auger are identified as "Auger" samples. In addition, a sample was collected from an undisturbed offsite area to characterize background surface soil conditions, as discussed in Section 4, and for comparison purposes an offsite sample of liquid material was collected from the WB&P mill's fuel storage building in accordance with the request of NYSDEC. All fourteen soil and solid material samples were analyzed for priority pollutant metals and iron, VOCs (including xylene), base/neutral and acid extractables, pesticide/PCBs, and cyanide.

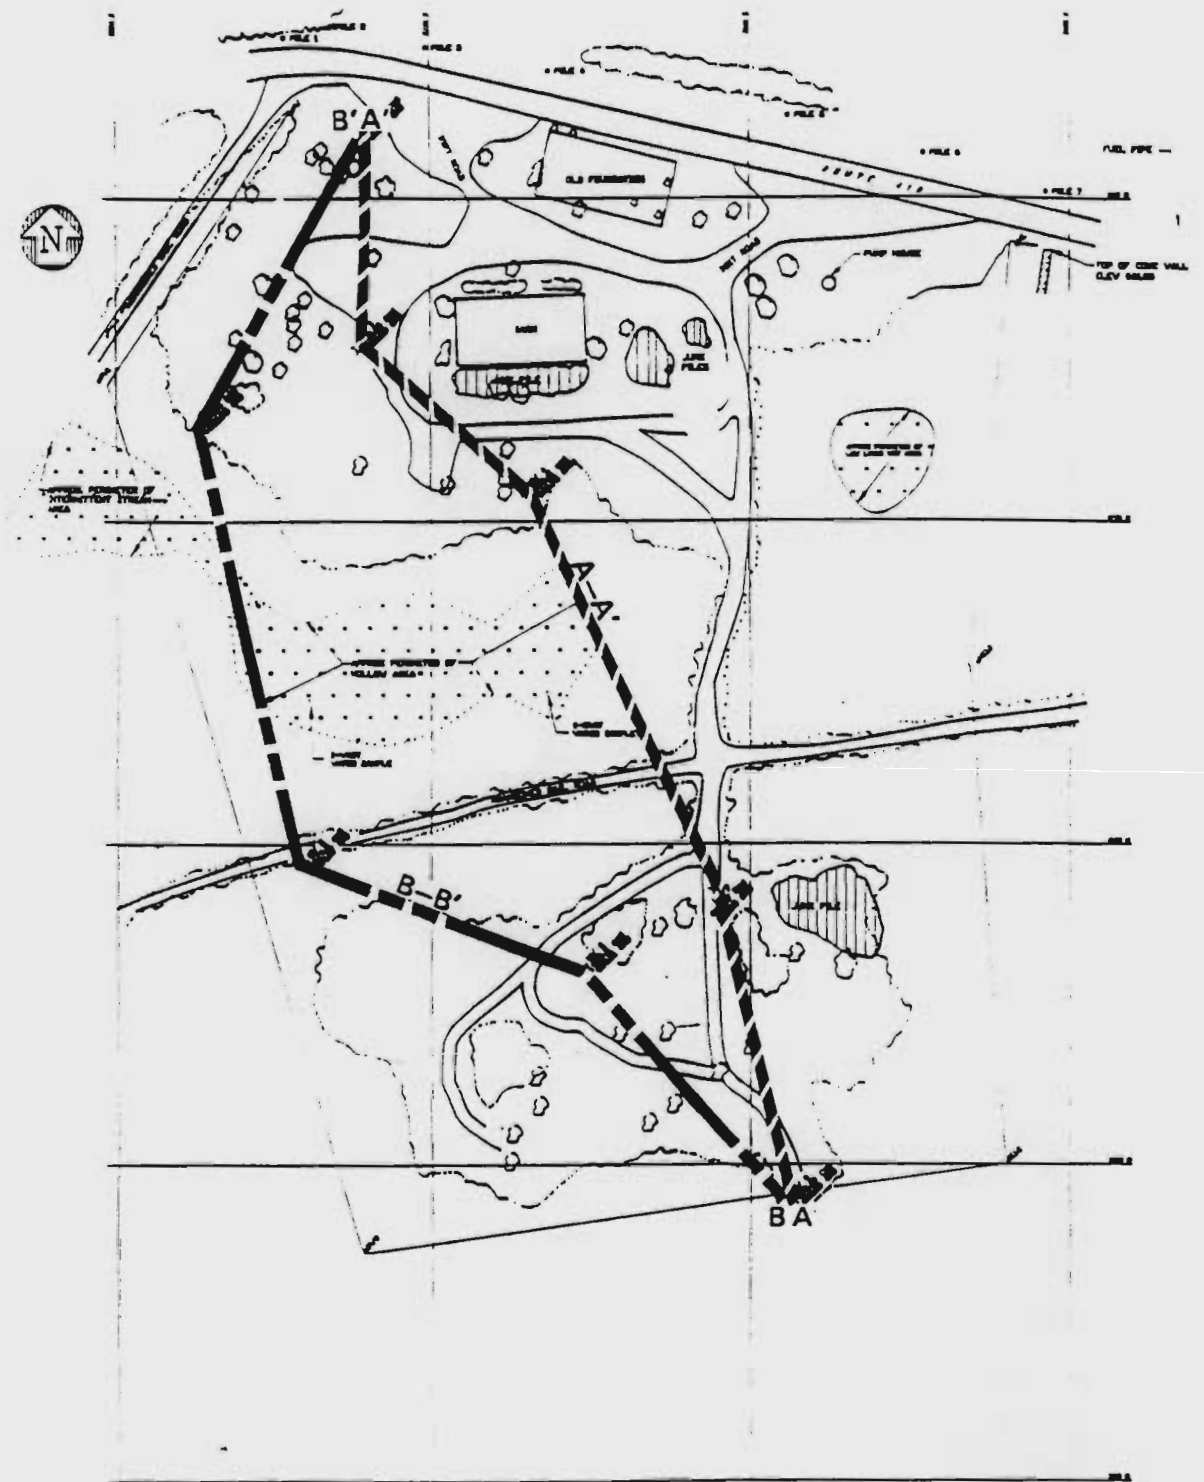
Figure 3-2 GEOLOGIC CROSS SECTION ORIENTATION

Cross sections were constructed through the site (see Figure 3-2), running from MW8 at the southeast corner of the site to MW3 at the northwest corner. Figure 3-3 shows the cross section (A-A') through MW8 and MW7, the spring in the hollow, MW4, MW1, and MW3. Figure 3-4 shows the cross section (B-B') through MW8, MW6, MW5, the hollow, MW2, and MW3. An indication of bedrock elevations illustrated in Figures 3-3 and 3-4 is given, based on the seismic data (see Appendix B). It is very clear that there are two different geologic settings on site, essentially corresponding to the south landfill/railroad embankment area and the north landfill, with the hollow marking the boundary between the two.

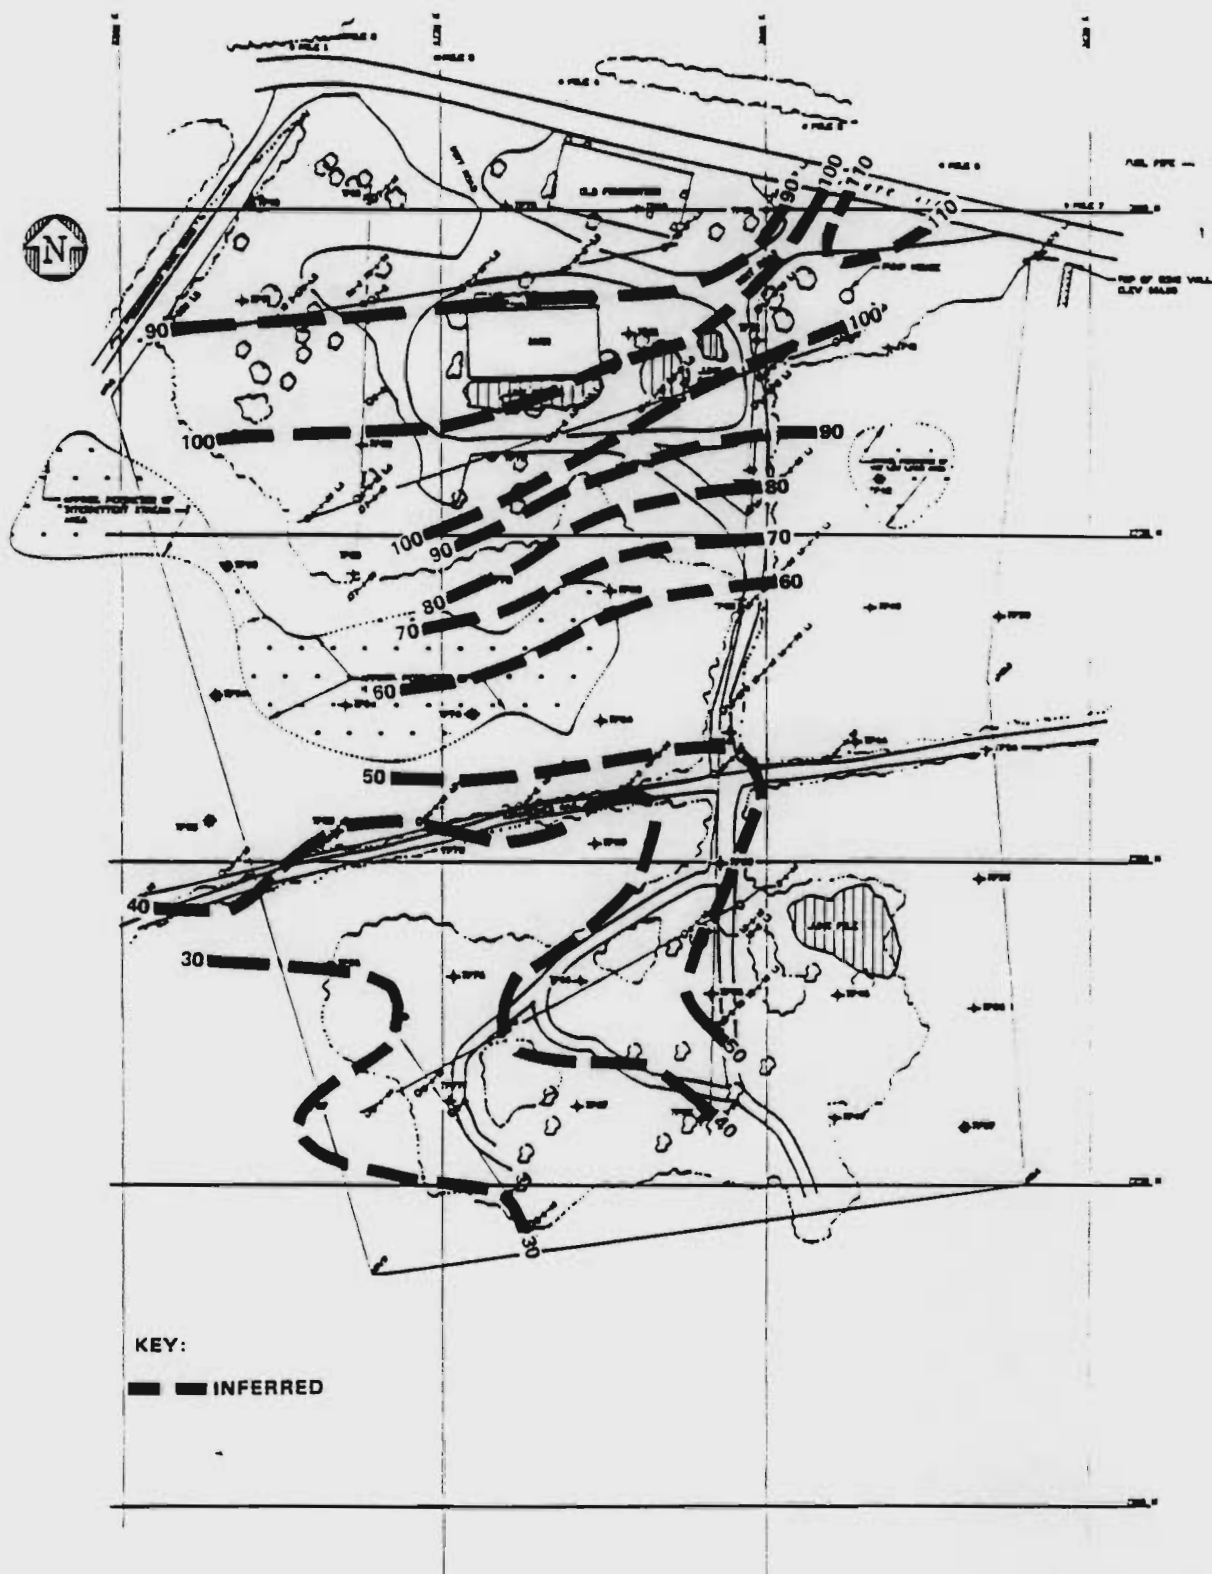
Figure 3-5 ISOPACH MAP OF OVERBURDEN THICKNESS FROM SEISMIC SURVEY

Beginning under the area of the hollow, the bedrock drops off approximately 50 feet and there is apparently a depression in the bedrock running approximately east-northeast/west-southwest just south of the barn, with some indication of a subsequent slope upward to the north toward the road (see Figure 3-5) and Section 3.4.2. This results in thicknesses of sediment above the bedrock under the north landfill ranging up to 110 feet. As seen in MW1 and MW2, sediments under the north landfill showed silt or organic-rich muck layers probably of low permeability. Both wells were completed in what is obviously a perched water table. But if either well encountered the layer of relatively low permeability which must support this localized perched water table, they penetrated it (see Section 3.6). With only two wells completed into this water table, the direction of flow is impossible to define. Neither of the remaining wells, MW3 and MW4, encountered either a silt layer or a perched water table. Both were drilled entirely in sand, gravel, and boulders; MW3 to 35 feet and MW4 to 93 feet (the latter reaching close to bedrock, as defined by the seismic survey).

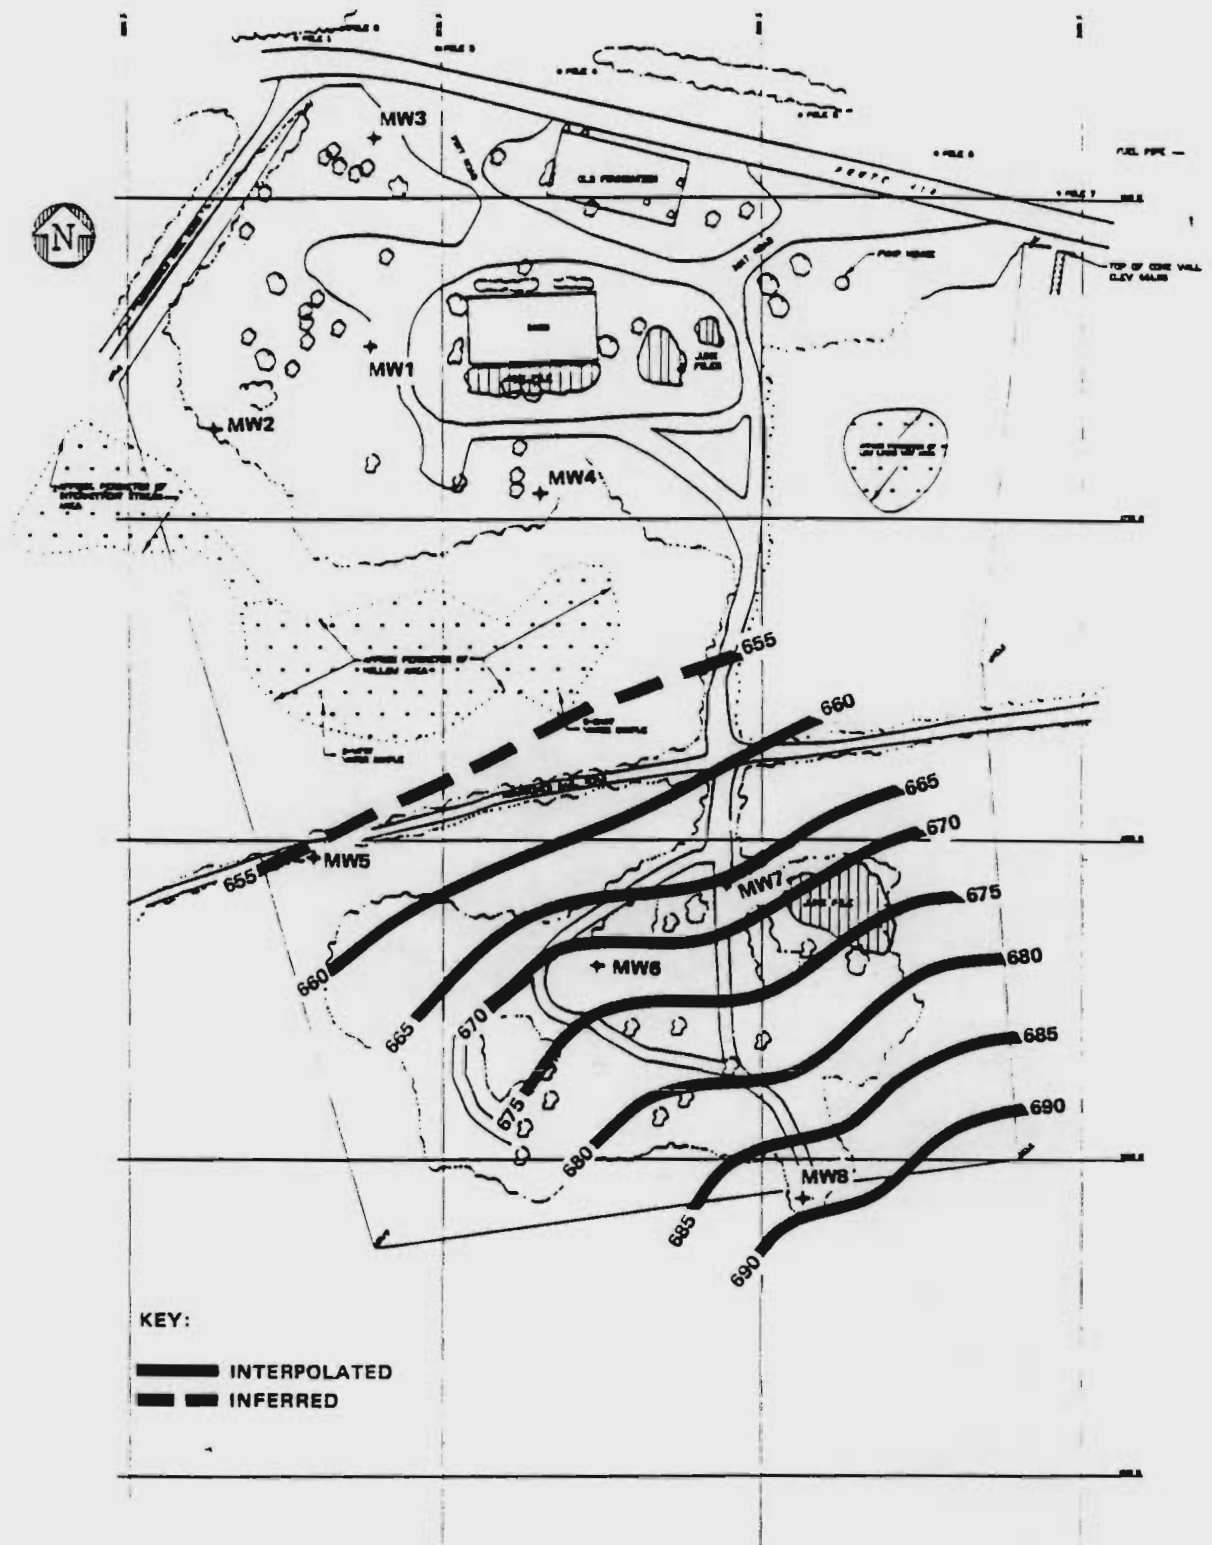
Figure 3-9 UPPER LANDFILL PERCHED WATER TABLE

The hollow appears to be, as noted above, an area in which the perched water table crops out as surface water. The well adjoining the hollow, MW2, has a water level at, or very close to, the surface water level in the hollow, and this perched water table in which both MW2 and MW1 are completed may well be an extension of the surface water in the hollow. This is consistent with the possibility that the landfilled area in which these two wells are located may have been created by filling in a former extension of the hollow which was occupied by the previously existing pond (see Figure 3-4). Although both MW1 and MW2 are completed with the bottom of the screens against permeable sediments (boulders in MW1 and sand in MW2), it could be that a silt layer that was not encountered in these two wells underlies them. What is known is that the water table in these wells cannot be the main water table because the coarse sediments encountered in all four wells (MW1, 2, 3 and 4) could not possibly sustain the steep gradients which would

have to be postulated between MW1 and 2 and MW3 and 4. (Compare cross sections A-A' and B-B' in Figures 3-3 and 3-4, respectively.) As there are only two wells completed in this perched water table, no flow direction can be inferred. It is possible that the water levels in either or both MW1 and MW2 do not accurately represent the perched water table in the fill. Instead they may represent a level resulting from an equilibrium between water from the perched water table entering the well screen near the top and water draining out of the well screen into an underlying unsaturated zone at the base of the screen. In such a case, the well penetrates the layer on which the water table is perched but is screened both above and below it. Typically such a well would be expected to show larger fluctuations in water elevations from dry to wet periods than adjoining wells, and, in fact, both MW1 and well MW8 do fluctuate in this way (see Table 3-1 and below).
