MEMO

To: Brian Jankauskas, New York Department of Environment and Conservation
From: Arlene Lillie, John Bartos, Nigel Goulding
CC: Jim Vondracek – Ashland
Stephen Havlik, BASF
Date: October 21, 2015
Re: Hudson River Hydrology and Geomorphology Review

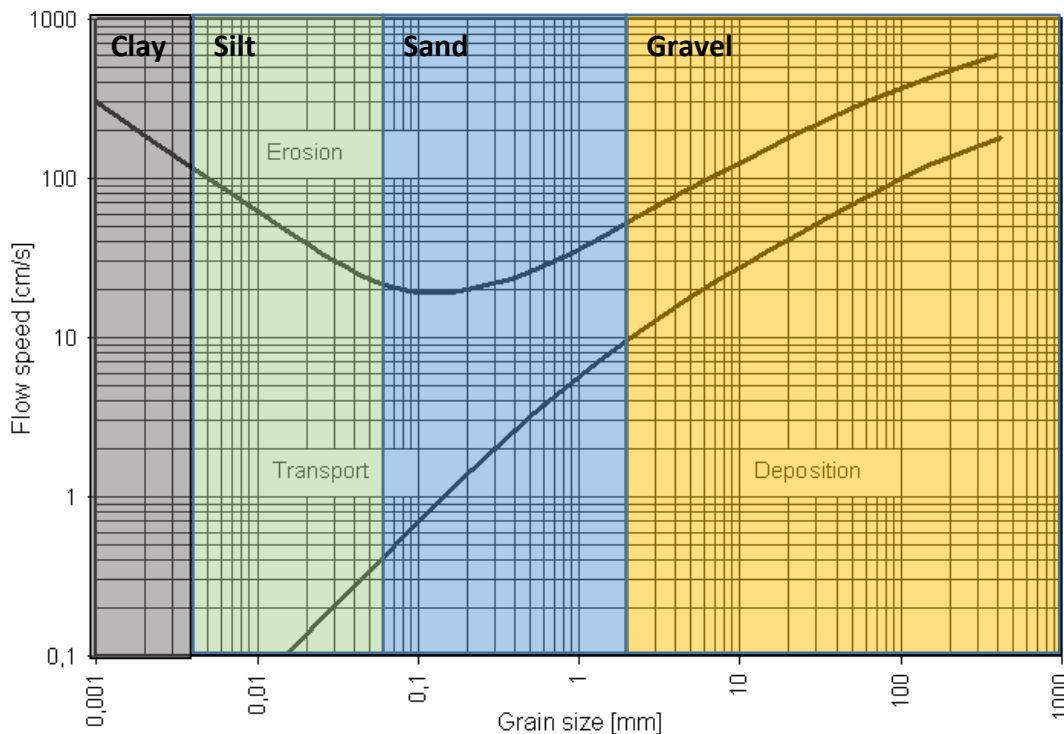
Exhibit A - Hjulstrom-Sundborg Diagram (annotated with silt, clay and gravel grain size ranges)

These relationships between stream flow velocity and mean grain size are illustrated by the Hjulstrom-Sundborg Diagram summarized by Sundborg (1956). This graph (Exhibit A) shows the empirical relationship in three sediment transport phases. At very high stream flow velocities, the grains are fully suspended and there is a net loss of sediment from the stream bed, called erosion; in this phase particles are eroded and transported in the water column and there is no net deposition. The second phase, at a lower velocity, is transport which has the grain being moved by two different mechanisms. The first mechanism is entrainment which is the bulk movement of grains in suspension without net loss of the sediments (i.e., no erosion). The second mechanism that occurs at lower stream velocities is bedload transport. Bedload transport is when grains move by rolling or saltating which forms plane beds under conditions of limited transport. The last phase, occurring at even lower velocity, is deposition where the grain “settles” from the water column onto the sediment bed.

The “U-shaped” curve, the critical erosion velocity, marking the transition between the transport and erosion phases reflects the resistance of clays to erosion and the geometric progression of grain mass with increasing diameter. The reverse is also true for the bottom curve, the mean settling velocity, from erosion to transport to sedimentation with decreasing velocity is relatively abrupt for coarse-grained grains because of the mass relationship. Finer grained sediments like silts and clays can remain in transport for a much larger range of velocity conditions. Once a particle settles in the “deposition” phase of the Hjulstrom-Sundborg Diagram, the velocity has to be greater than the mean settling velocity for the finer sediment to become resuspended.

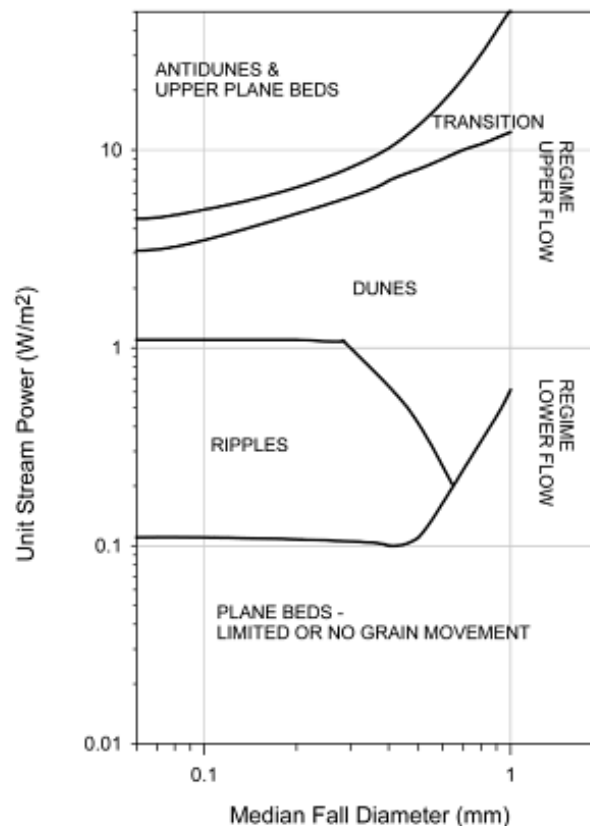
Exhibit B - Simons and Richardson (1966) relationship between grain diameter and stream power in the fluvial sedimentation process and the bedforms that are developed

The type of beds that form (bedforms) in the river bed sediment is dependent on the relationship between stream power and fluvial sedimentation process. Simmons and Richardson (1966) illustrated an empirical relationship between the stream power and the median grain diameter and the types of bedforms that develop like plane beds, and ripples as illustrated on Exhibit B.

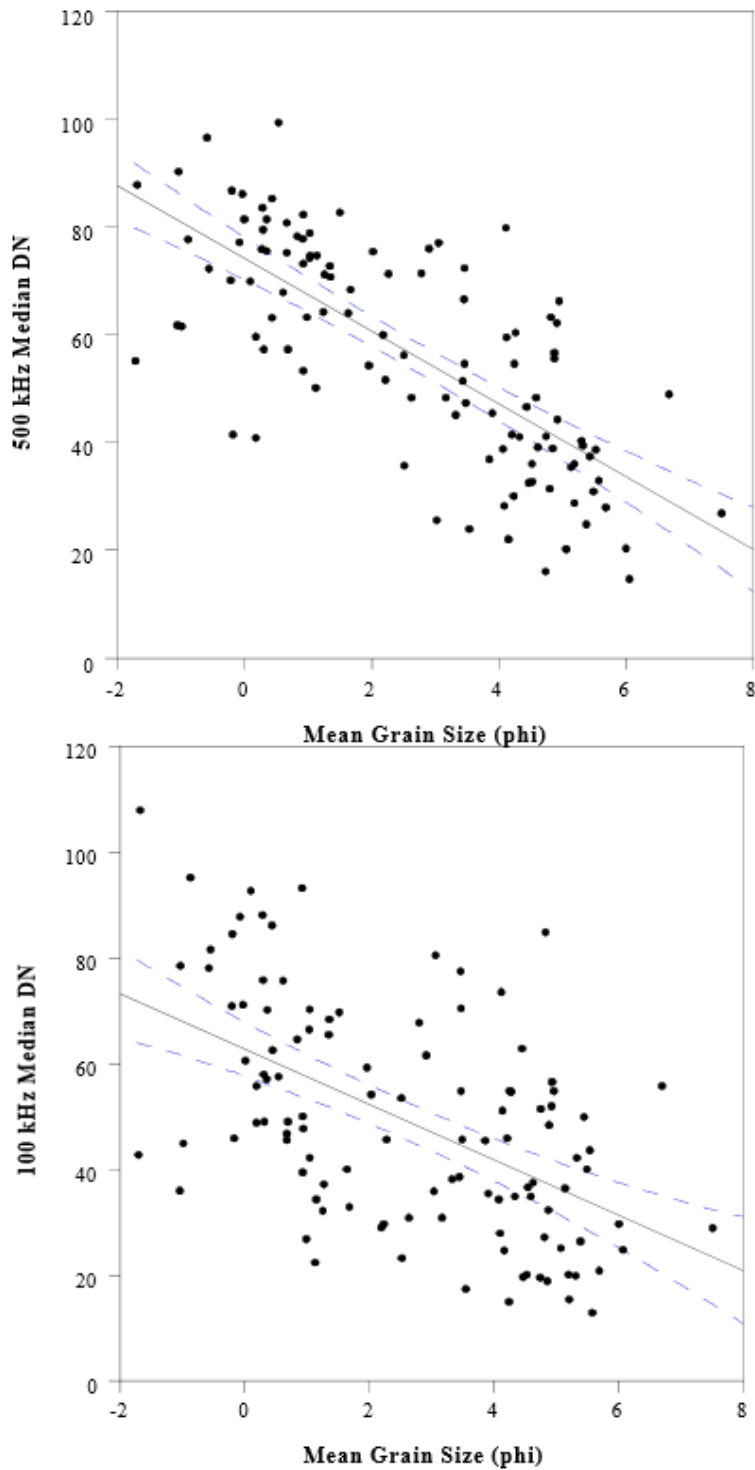
Figure 4-4
Calibration Plots of DN vs. Grain-Size
Exhibit G – Figures 4-4 and 4-5 from USEPA 1997

Note:
 $\phi = \text{phi} = \frac{\log[\text{grain-size}(\text{mm})]}{\log 2}$

It was noted by USEPA that there were possible reasons for the scatter observed in the correlation plots on Figure 4-4 (Exhibit G) including: (1) the effects of bottom slope on image value as the bottom is not horizontal at all sample locations; (2) the sonar correction technique results in a different "calibration" for different water depths or slant ranges (3) there is variability in the sediments at a scale smaller than sonar can resolve, and not enough sediment samples have been recovered to adequately characterize the bottom at the scale of the sonar record; (4) standard grain size parameters may not be appropriate measures of bottom roughness to use for comparison to the sonar values; (5) small bubbles of gas attached to sediment particles could affect sonar reflectivity; (6) biota, e.g., shells or marsh grass, also affects sonar reflectivity in some areas; (7) in some areas a fine sediment veneer may overlie coarser sediments. In addition to the above validation, USEPA also completed a comparison of the SSS interpretation with historical (1976 to 1978) sediment classification data collected by NYSDEC. This comparison was presented as an Appendix to the 1997 USEPA report and was titled a "Comparison of 1976-1978 Sediment Classifications and the Side-Scan Sonar Interpretation." From the NYSDEC database, sediment classification data was available for 493 locations throughout the area of SSS coverage. These locations were obtained for both the Thompson Island Pool and for areas below the Thompson Island Dam.

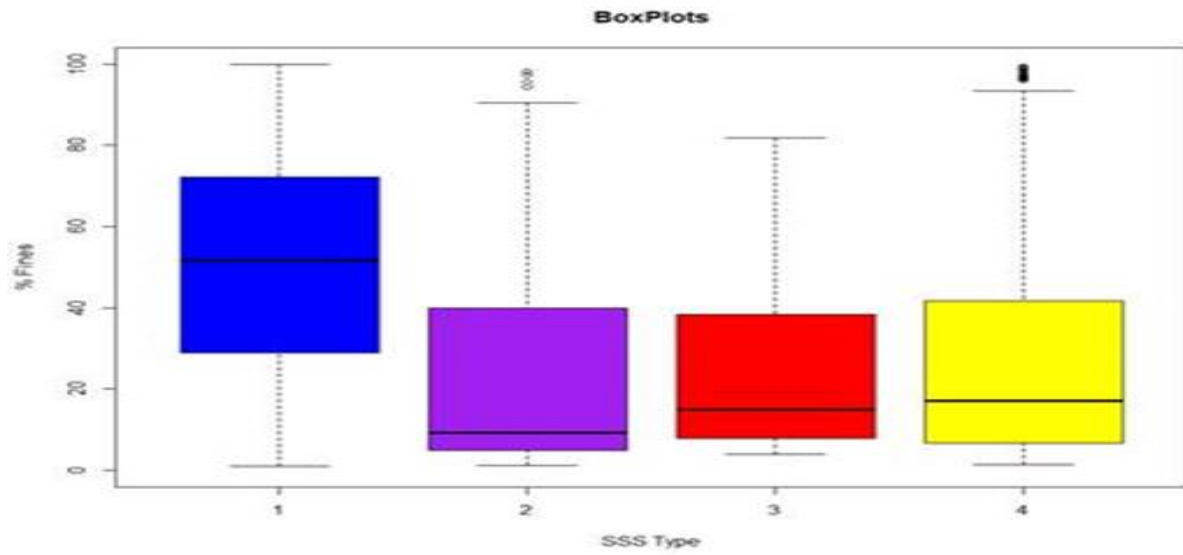
Exhibit O - Percent Fines in SSS Sediment Types

As demonstrated in the box and whisker plots the Type I (clay, silt and fine sands) exhibit the highest mean (bold line) and highest lower quartile value (bottom of box) for fine percentage, clay percentage and organic carbon content compared to all other sediment types. The Type I sediments also exhibit the highest upper quartile values for fraction of organic carbon.

These results indicate that the SSS reliably identifies the areas of highest silt, clay and organic carbon content where organics and inorganics are likely to be preferentially distributed. Further the box and whisker plots present a clear indication of the correlations between fines content and clay and organic carbon fractions.

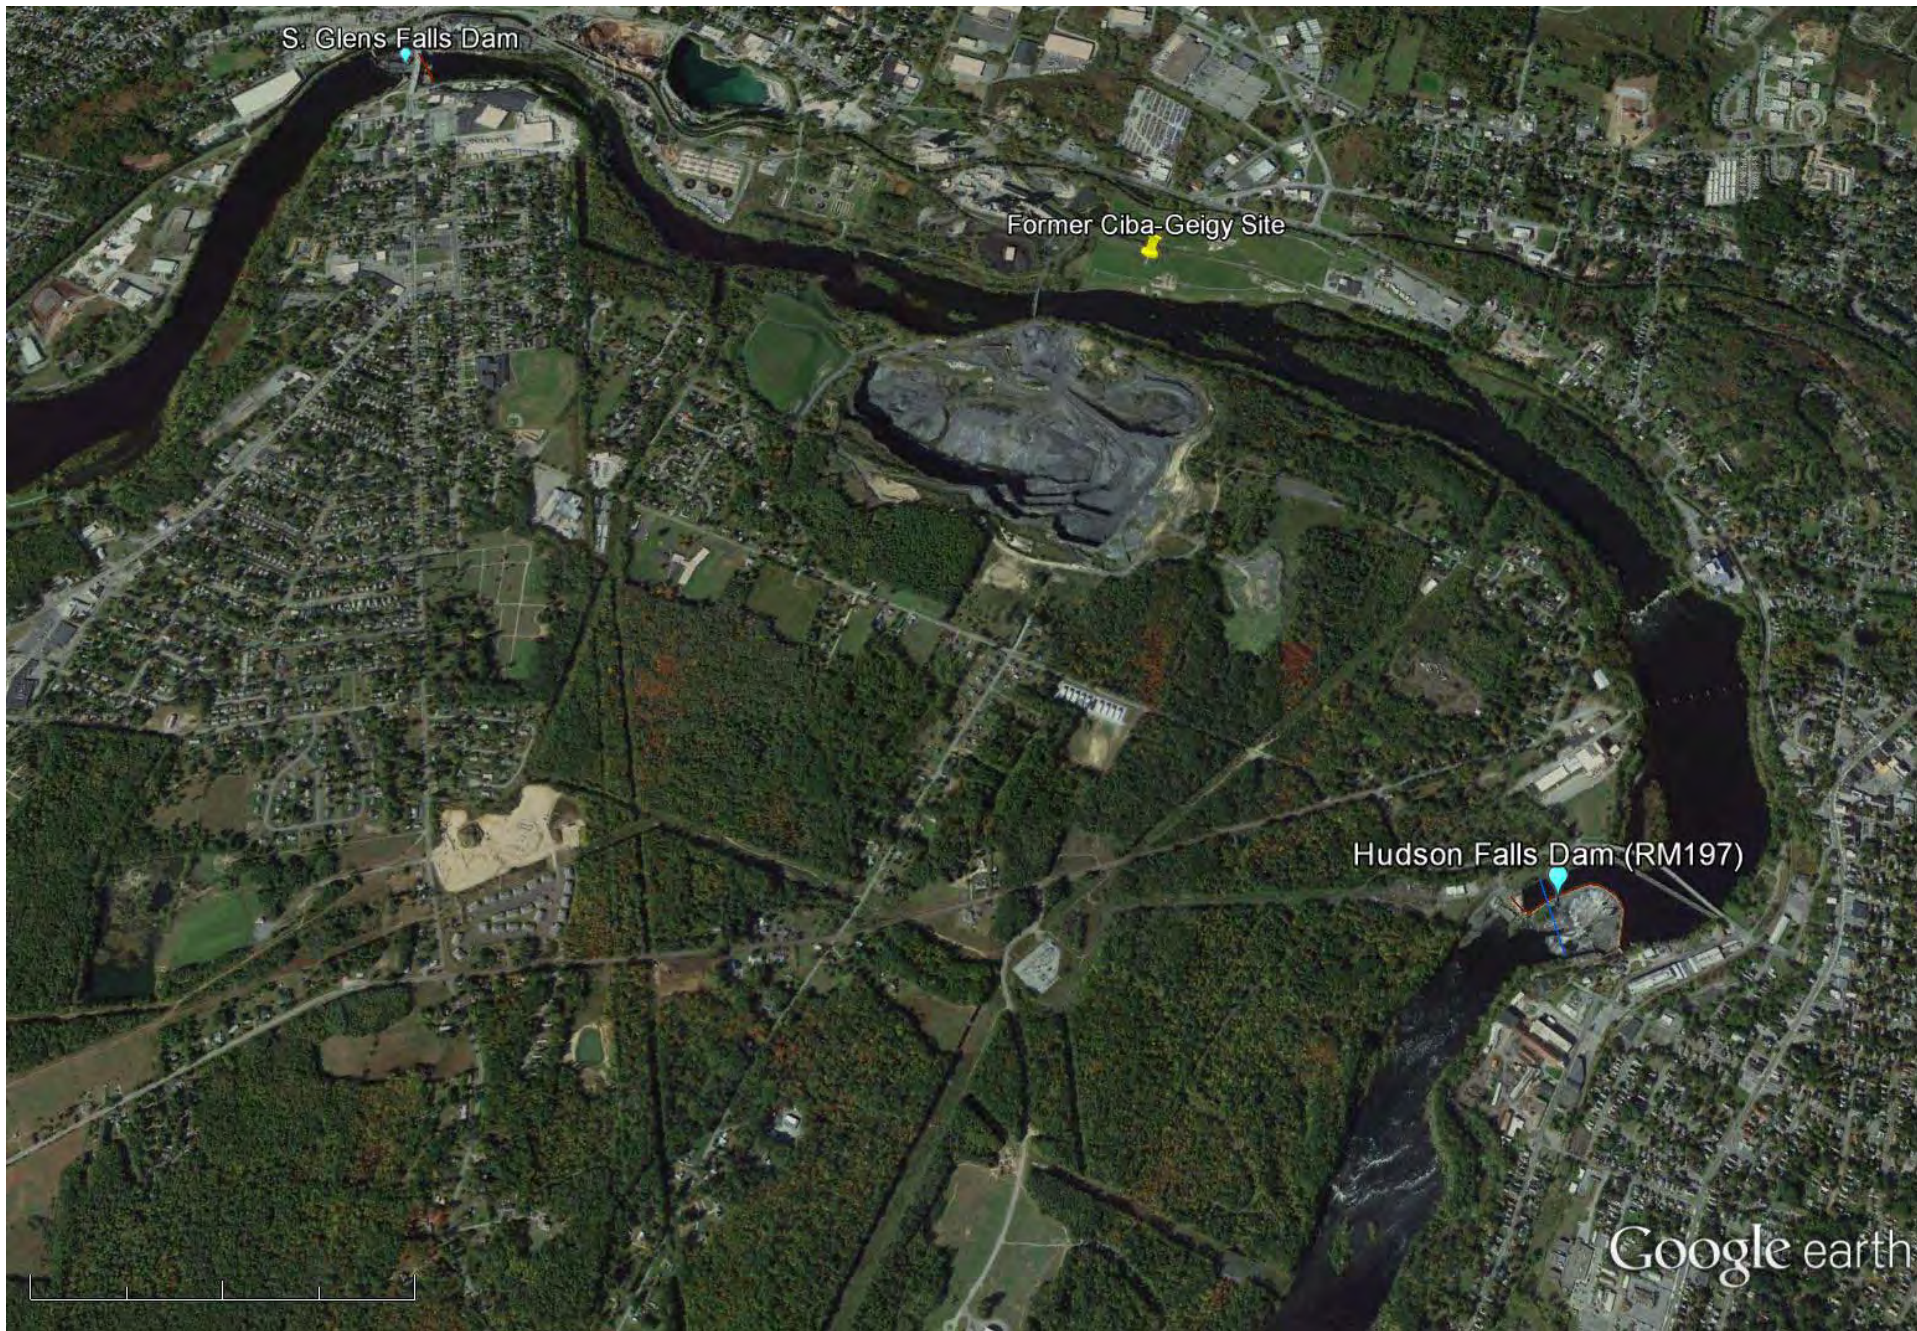
FIGURE 1 - HUDSON RIVER FEATURES

The remaining areas of the Hudson River are dominated by a meandering system of the river and back pools of the dams that extends throughout the study area (Figures 1 through 7).

The Hudson River Superfund Site is split into the three sections: River Section 1 (from the former location of the Fort Edward Dam to Thompson Island Dam); River Section 2 (from Thompson Island Dam to Northumberland Dam); and River Section 3 (from Northumberland Dam to the Federal Dam at Troy). Key river features are illustrated on Figure 1.
