**2005 ANNUAL OPERATION,  
MAINTENANCE AND  
MONITORING REPORT**

**2200 BLEECKER STREET  
UTICA, NEW YORK 13501  
NYSDEC SITE NO. 622003**

Synapse Risk Management, LLC.  
400 University Building  
120 East Washington Street  
Syracuse, New York 13202

April 2005

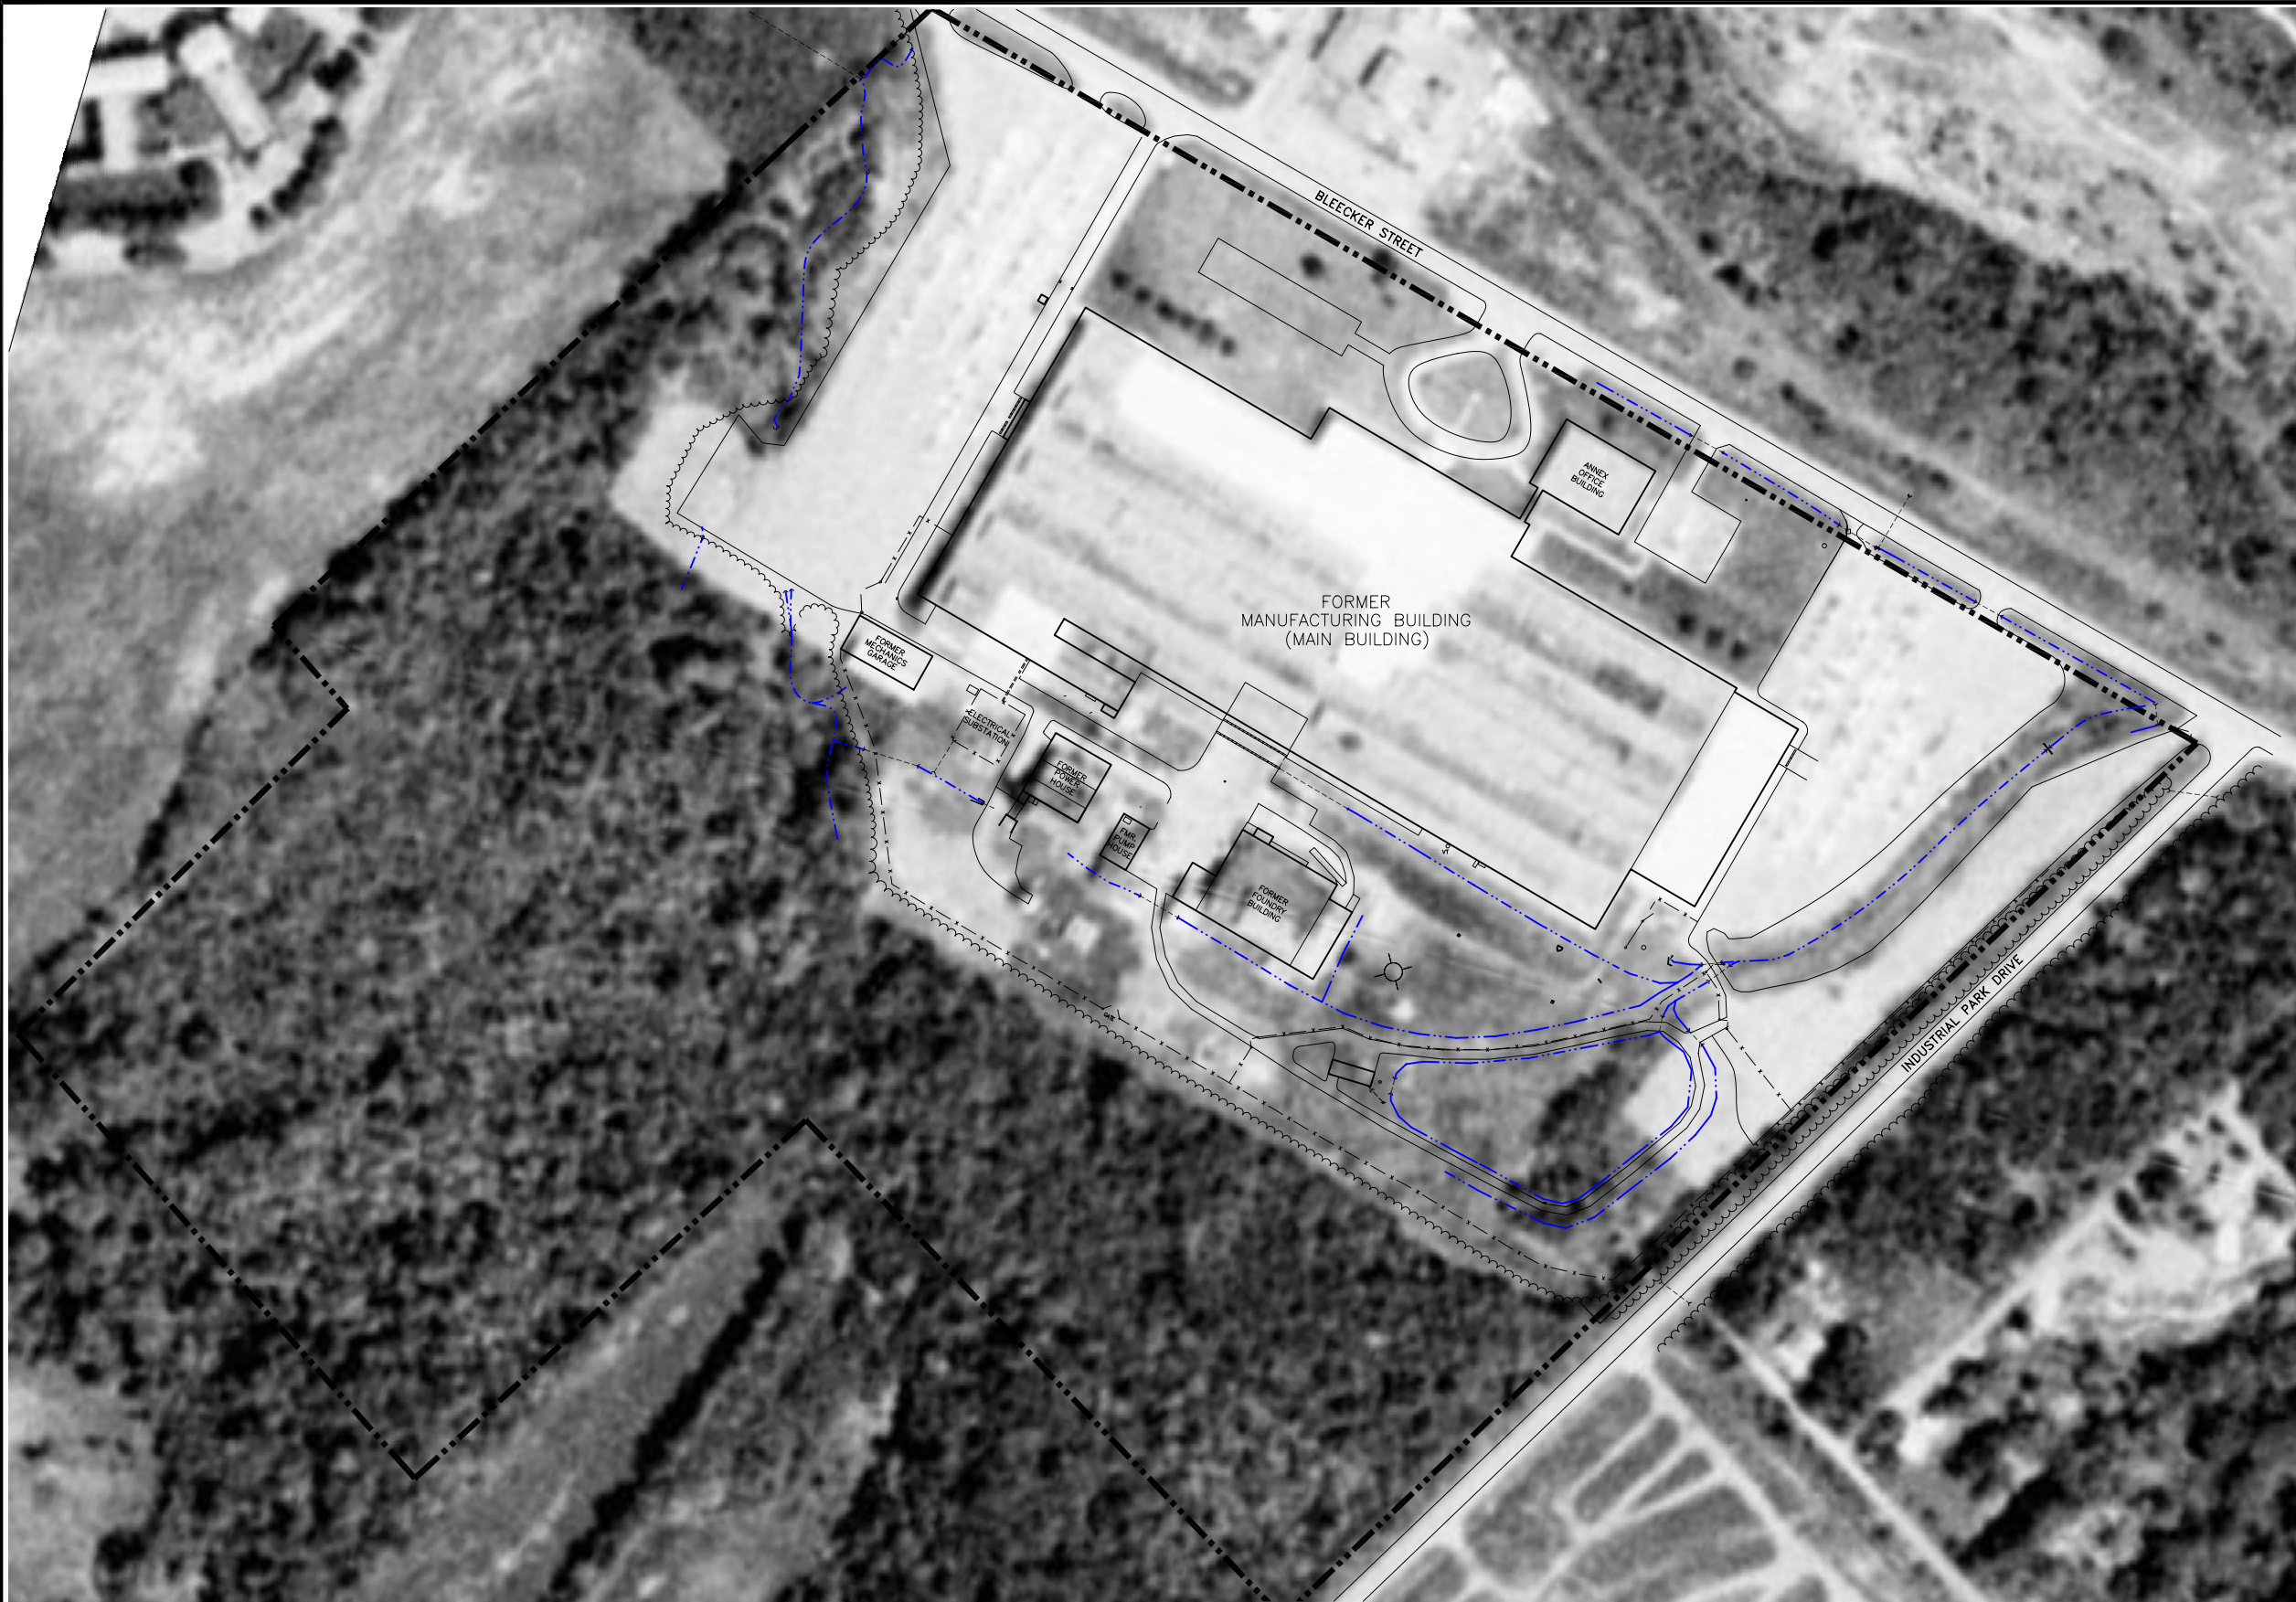
PROJECT NO.:  
DANA 01-04  
DATE:  
APRIL 2006  
FIGURE NO.:  
**2-1**

**AERIAL PROPERTY MAP**
