**2008 ANNUAL OPERATION,
MAINTENANCE AND
MONITORING REPORT**

**2200 BLEECKER STREET
UTICA, NEW YORK 13501
NYSDEC SITE NO. 622003**

April 2009

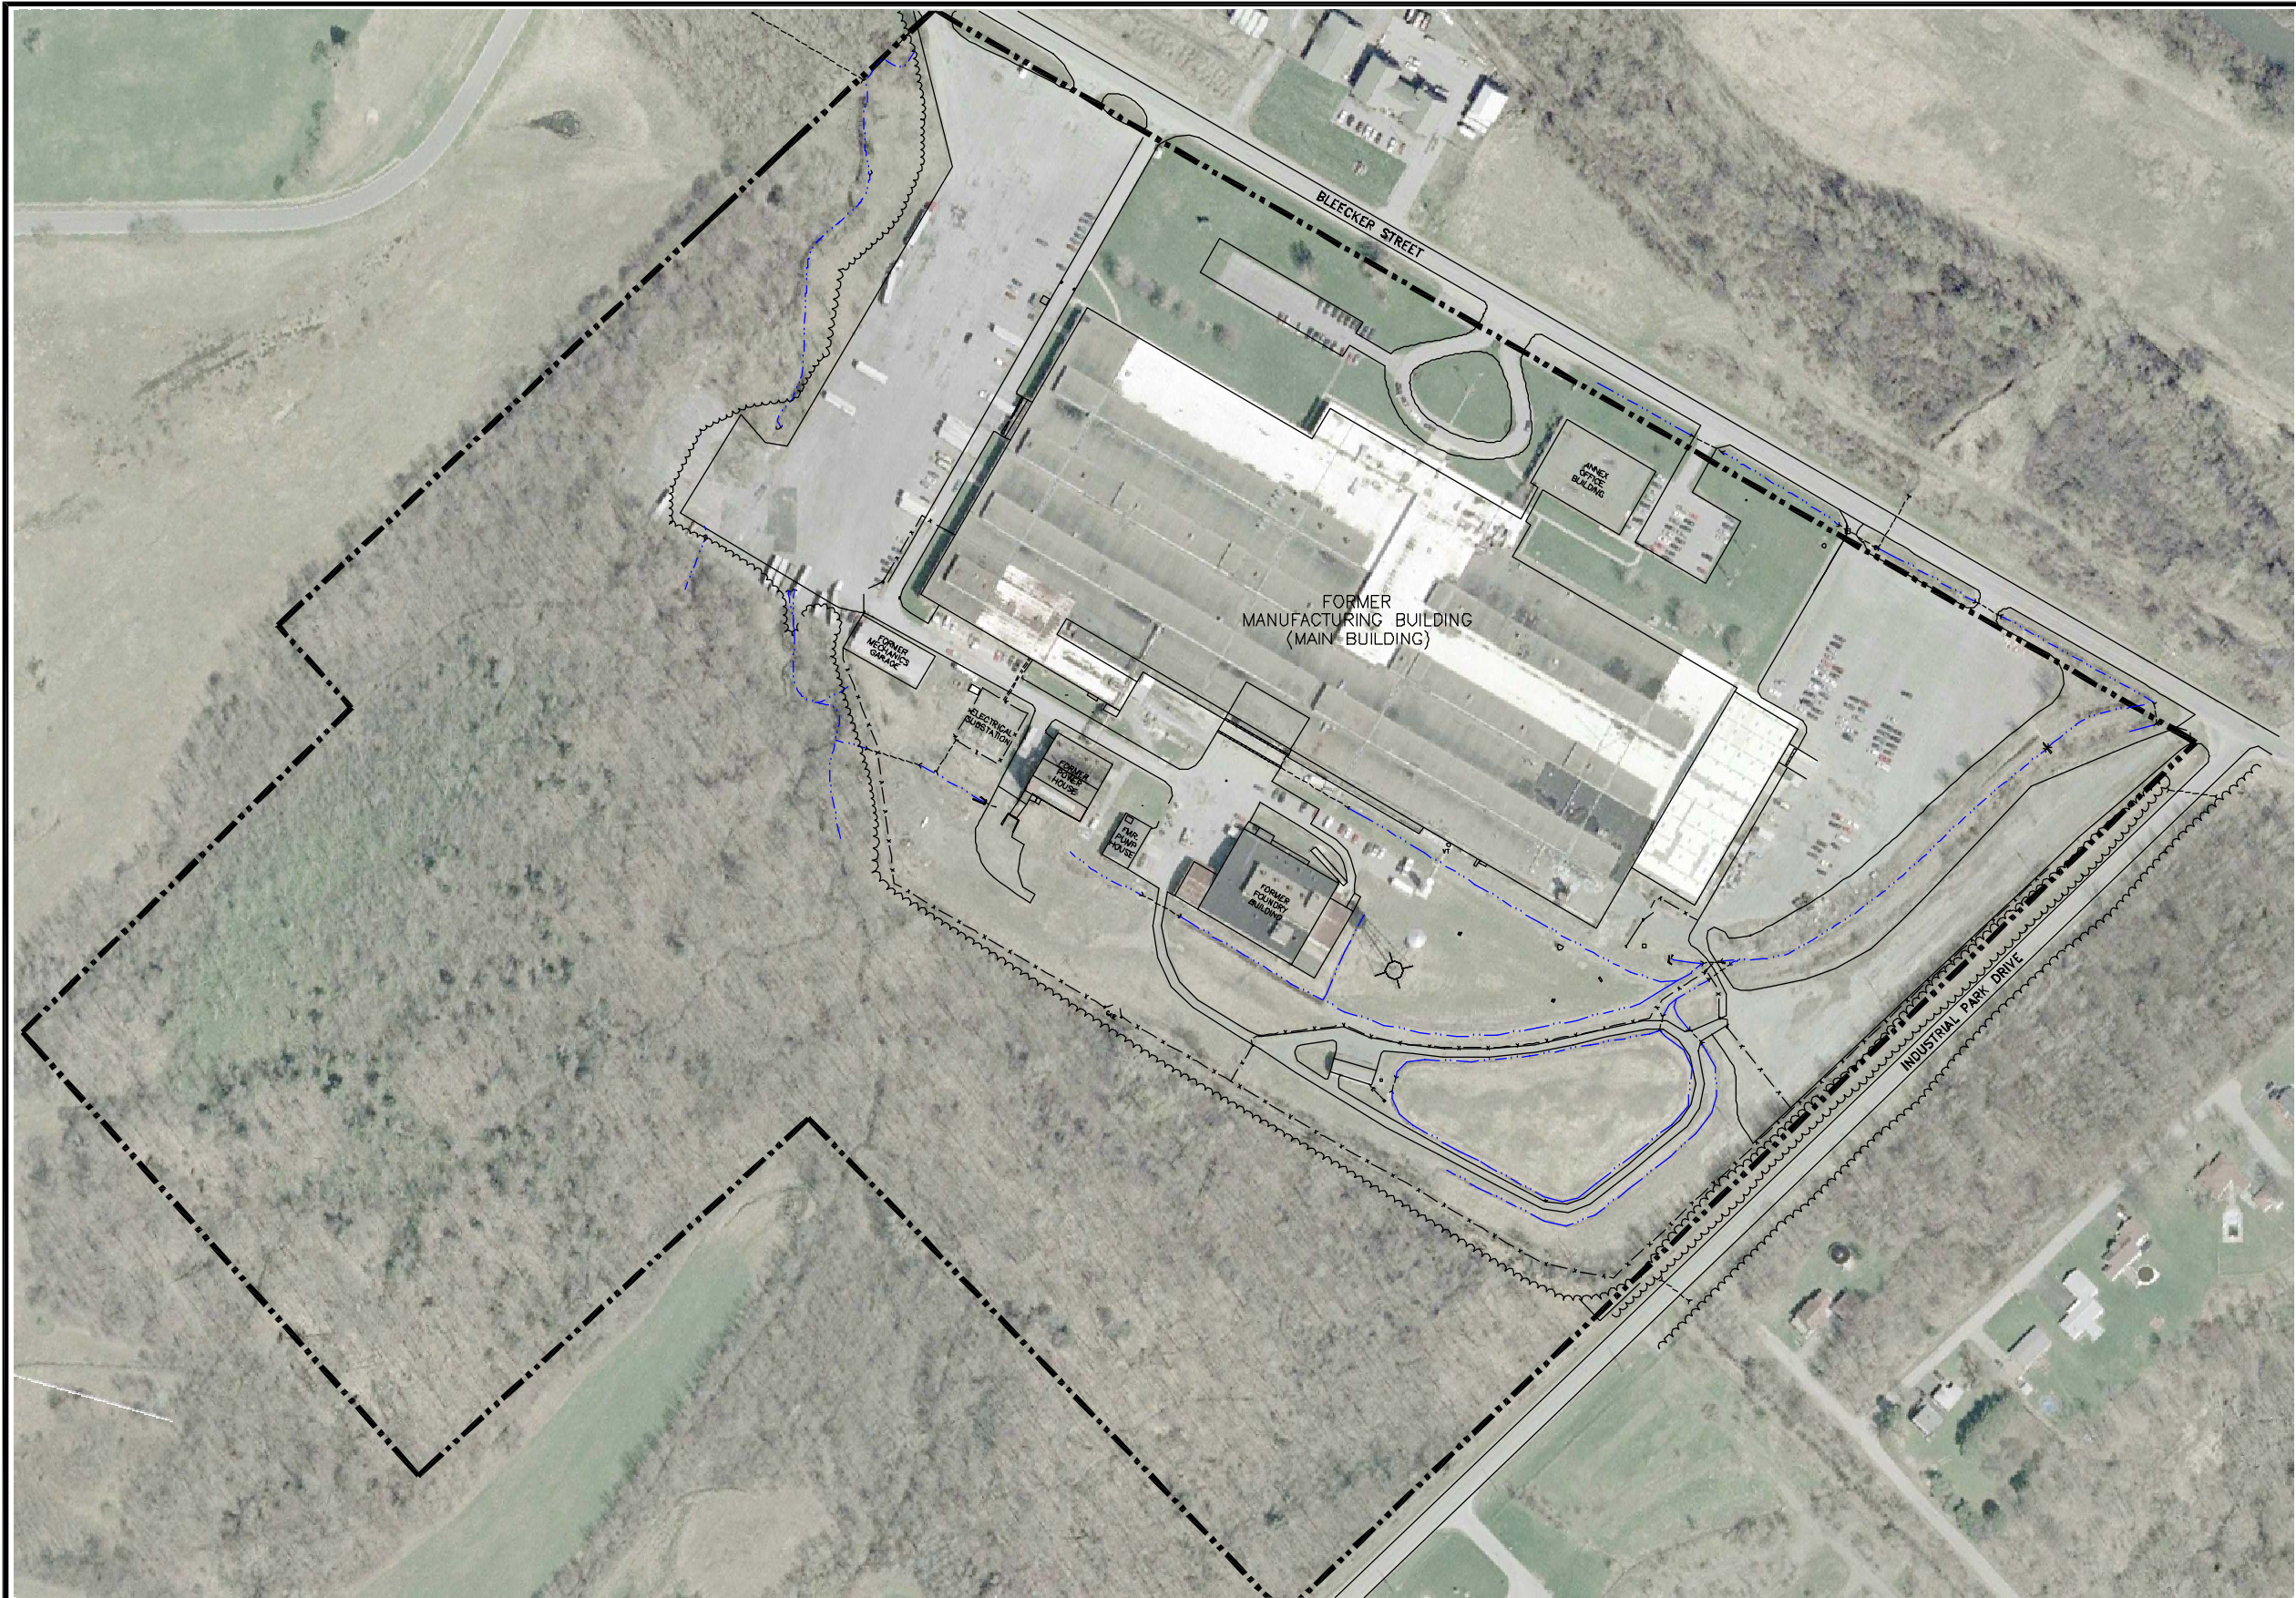
PROJECT NO.:
DANA 01-04
DATE:
MARCH 2009
FIGURE NO.:
2-1

AERIAL PROPERTY MAP

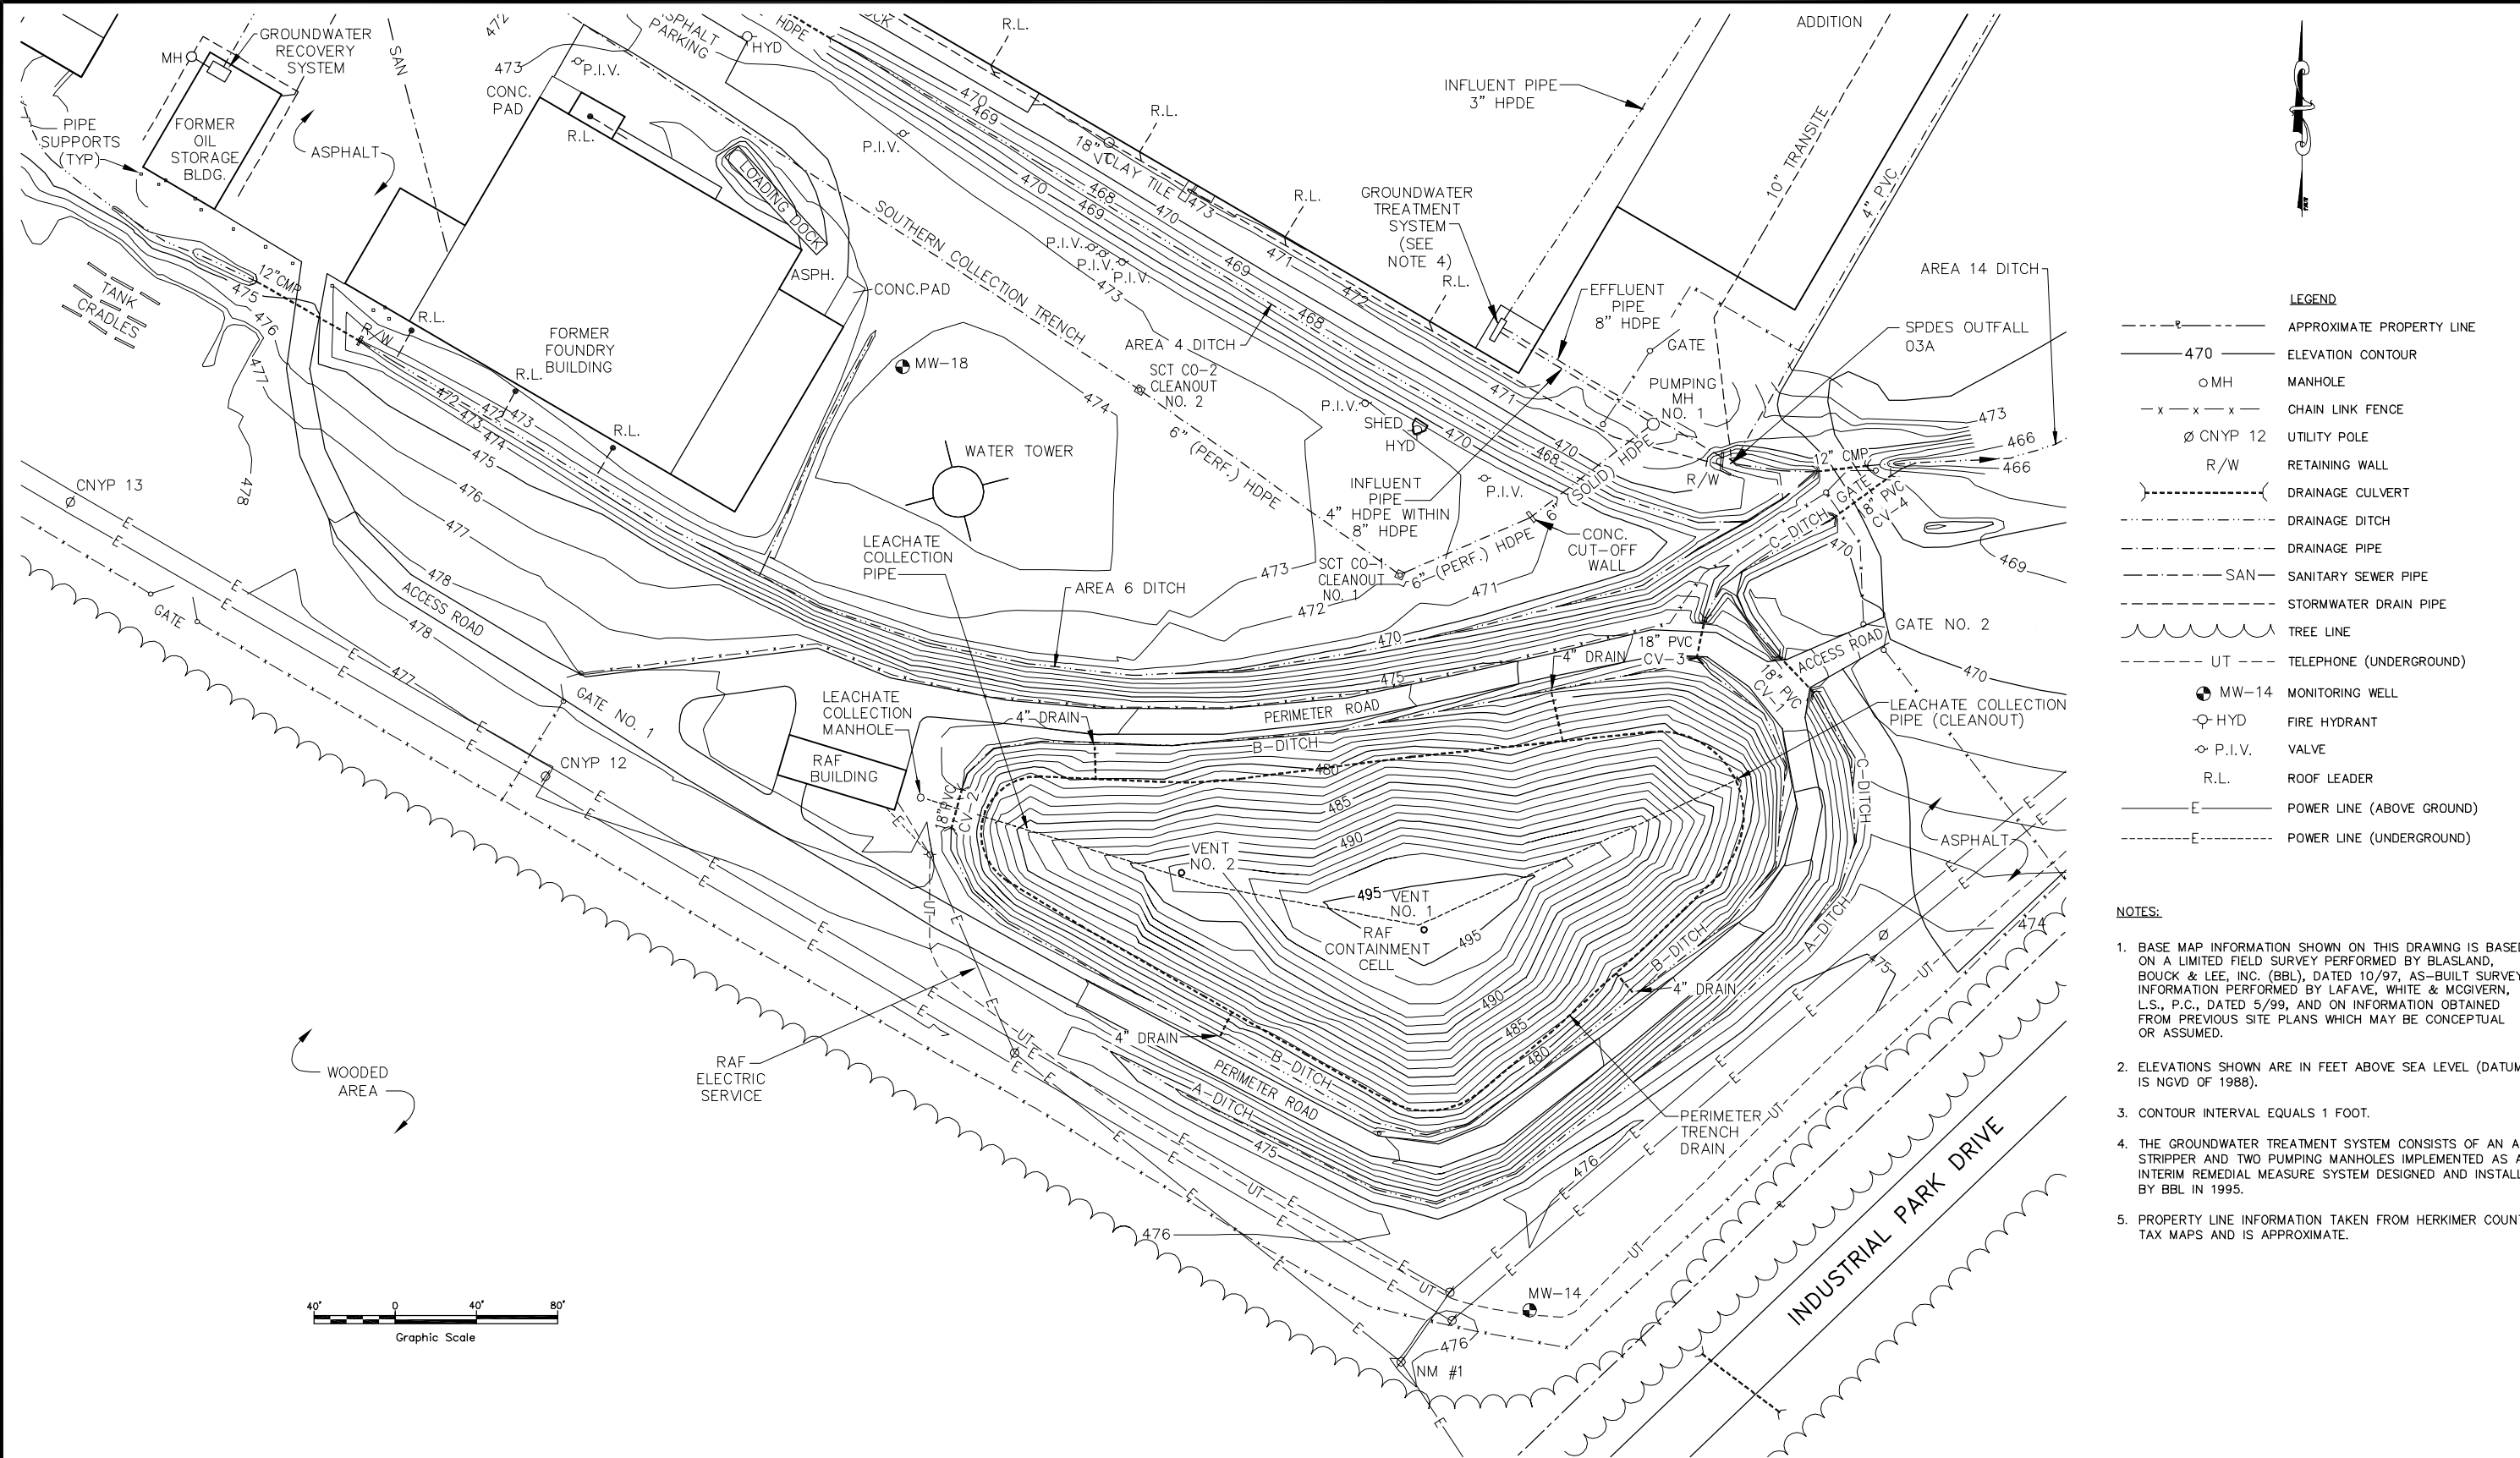
The RAF is situated in the mid-eastern portion of the Property, within a fenced area encompassing approximately 3.8 acres, as presented on Figure 3-1 – Remedial Action Facility Plan. The OM&M of the RAF was conducted by Synapse, in accordance with the guidelines set forth in the NYSDEC-approved OM&M Manual dated April 2001. Field reports provide monthly documentation of the site inspection events and any adjustments made to components associated with the RAF. The results of these inspections generally sets forth any maintenance activities, if required.

- *Leachate Collection System* - A leachate collection system, comprised of a collection pipe that extends the length of the containment cell and is connected to the collection manhole, which is installed adjacent to the western side of the containment cell. The collection manhole is equipped with two pumps to transfer leachate to a storage tank prior to disposal. All components of the leachate collection system are double contained with fail safe monitoring systems. The collection pipe surfaces at the east end of the containment cell providing access for cleaning, as needed. The leachate collection system components are noted on Figure 3-1.

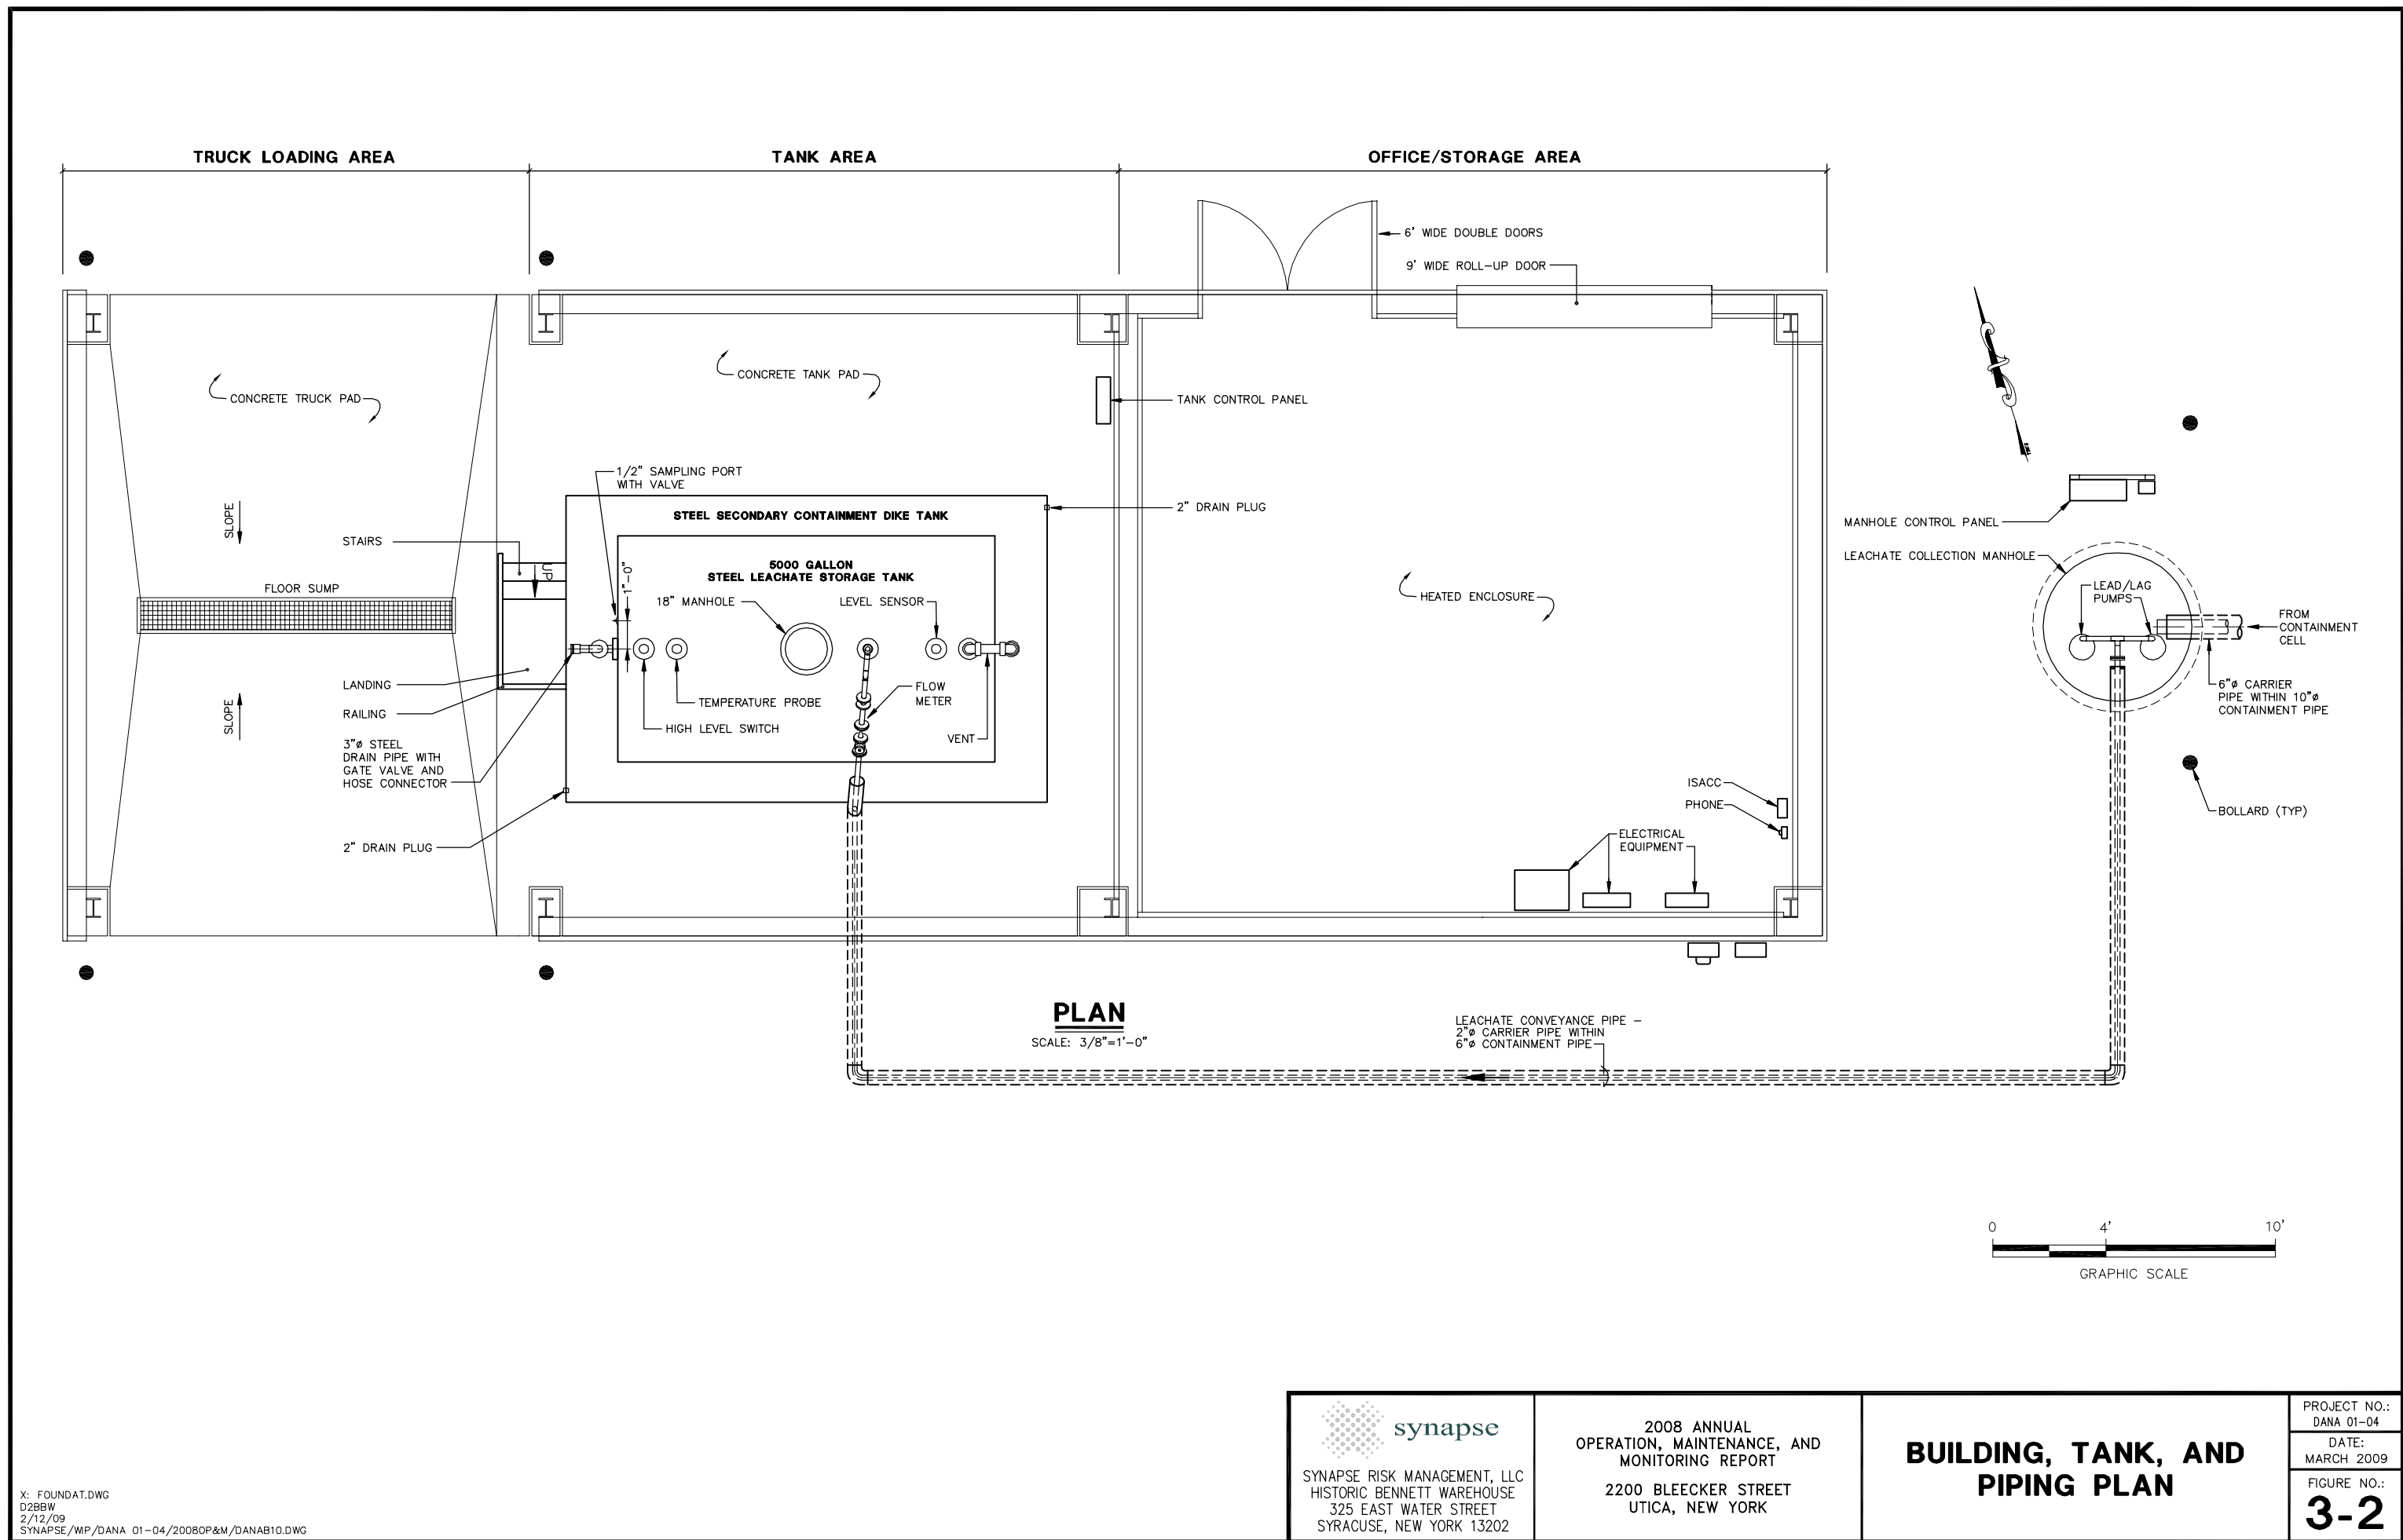
- *Leachate Storage System* - Leachate pumped from the collection manhole is stored in an aboveground 5,000-gallon steel storage tank within a steel secondary containment structure as shown on Figure 3-2 – Building, Tank, and Piping Plan. A flow totalizer is used to track the quantity of leachate pumped to the tank from the collection manhole, and a level sensor installed in the tank is used to determine the instantaneous quantity of leachate in the tank. The level sensor is also electronically connected to an auto dialer system to notify personnel of alarm conditions via telephone and facsimile. The tank is also equipped with a sampling port, drain fitting, electric heating elements, and insulation, utilized to prevent freezing of the tank and piping during winter months. In addition, a concrete truck pad, with a grated sump is located adjacent to the tank to provide containment during pumping of leachate from the tank to a tanker truck, prior to disposal.

- *RAF Building* - A 1,278-square foot building constructed of a steel frame and siding on a concrete slab foundation is used to house the leachate collection tank (tank area), and truck pad (truck loading area), noted above. Additionally, the building enclosure has an office area for maintaining

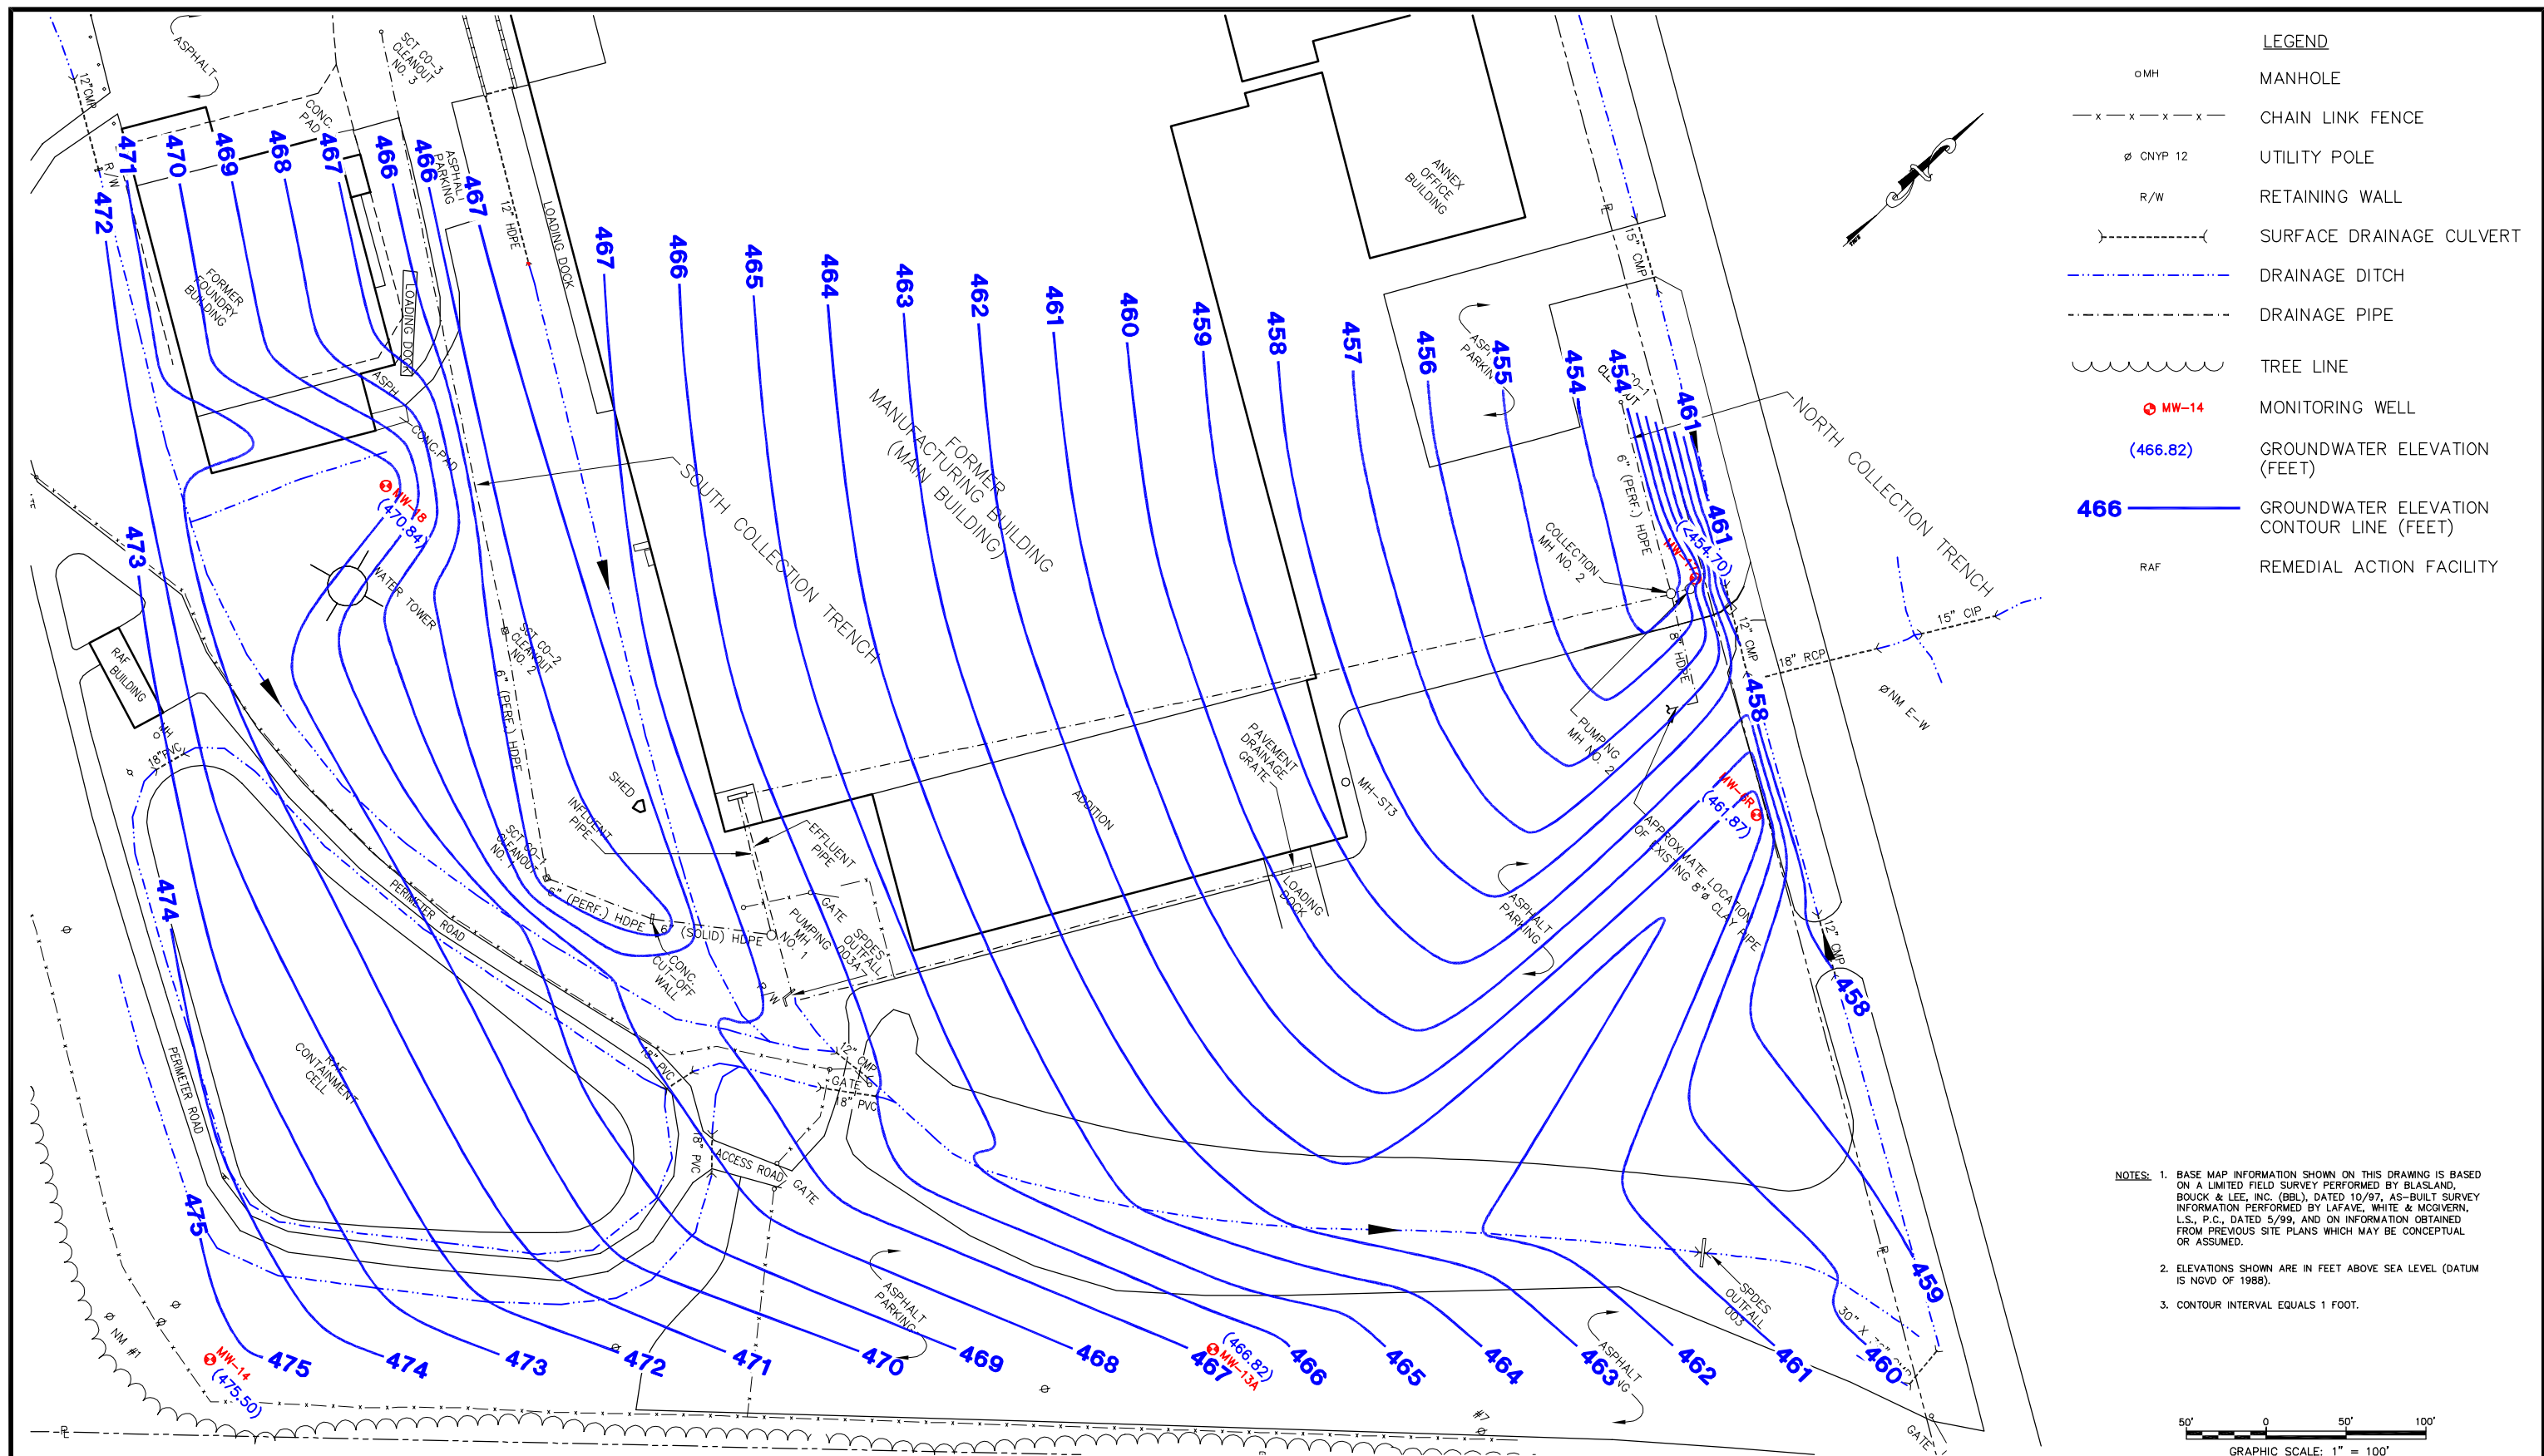
PROJECT NO.:
DANA 01-04
DATE:
MARCH 2009
FIGURE NO.:
4-1

**OVERBURDEN GROUNDWATER
ELEVATION CONTOUR MAP
APRIL 29, 2008**

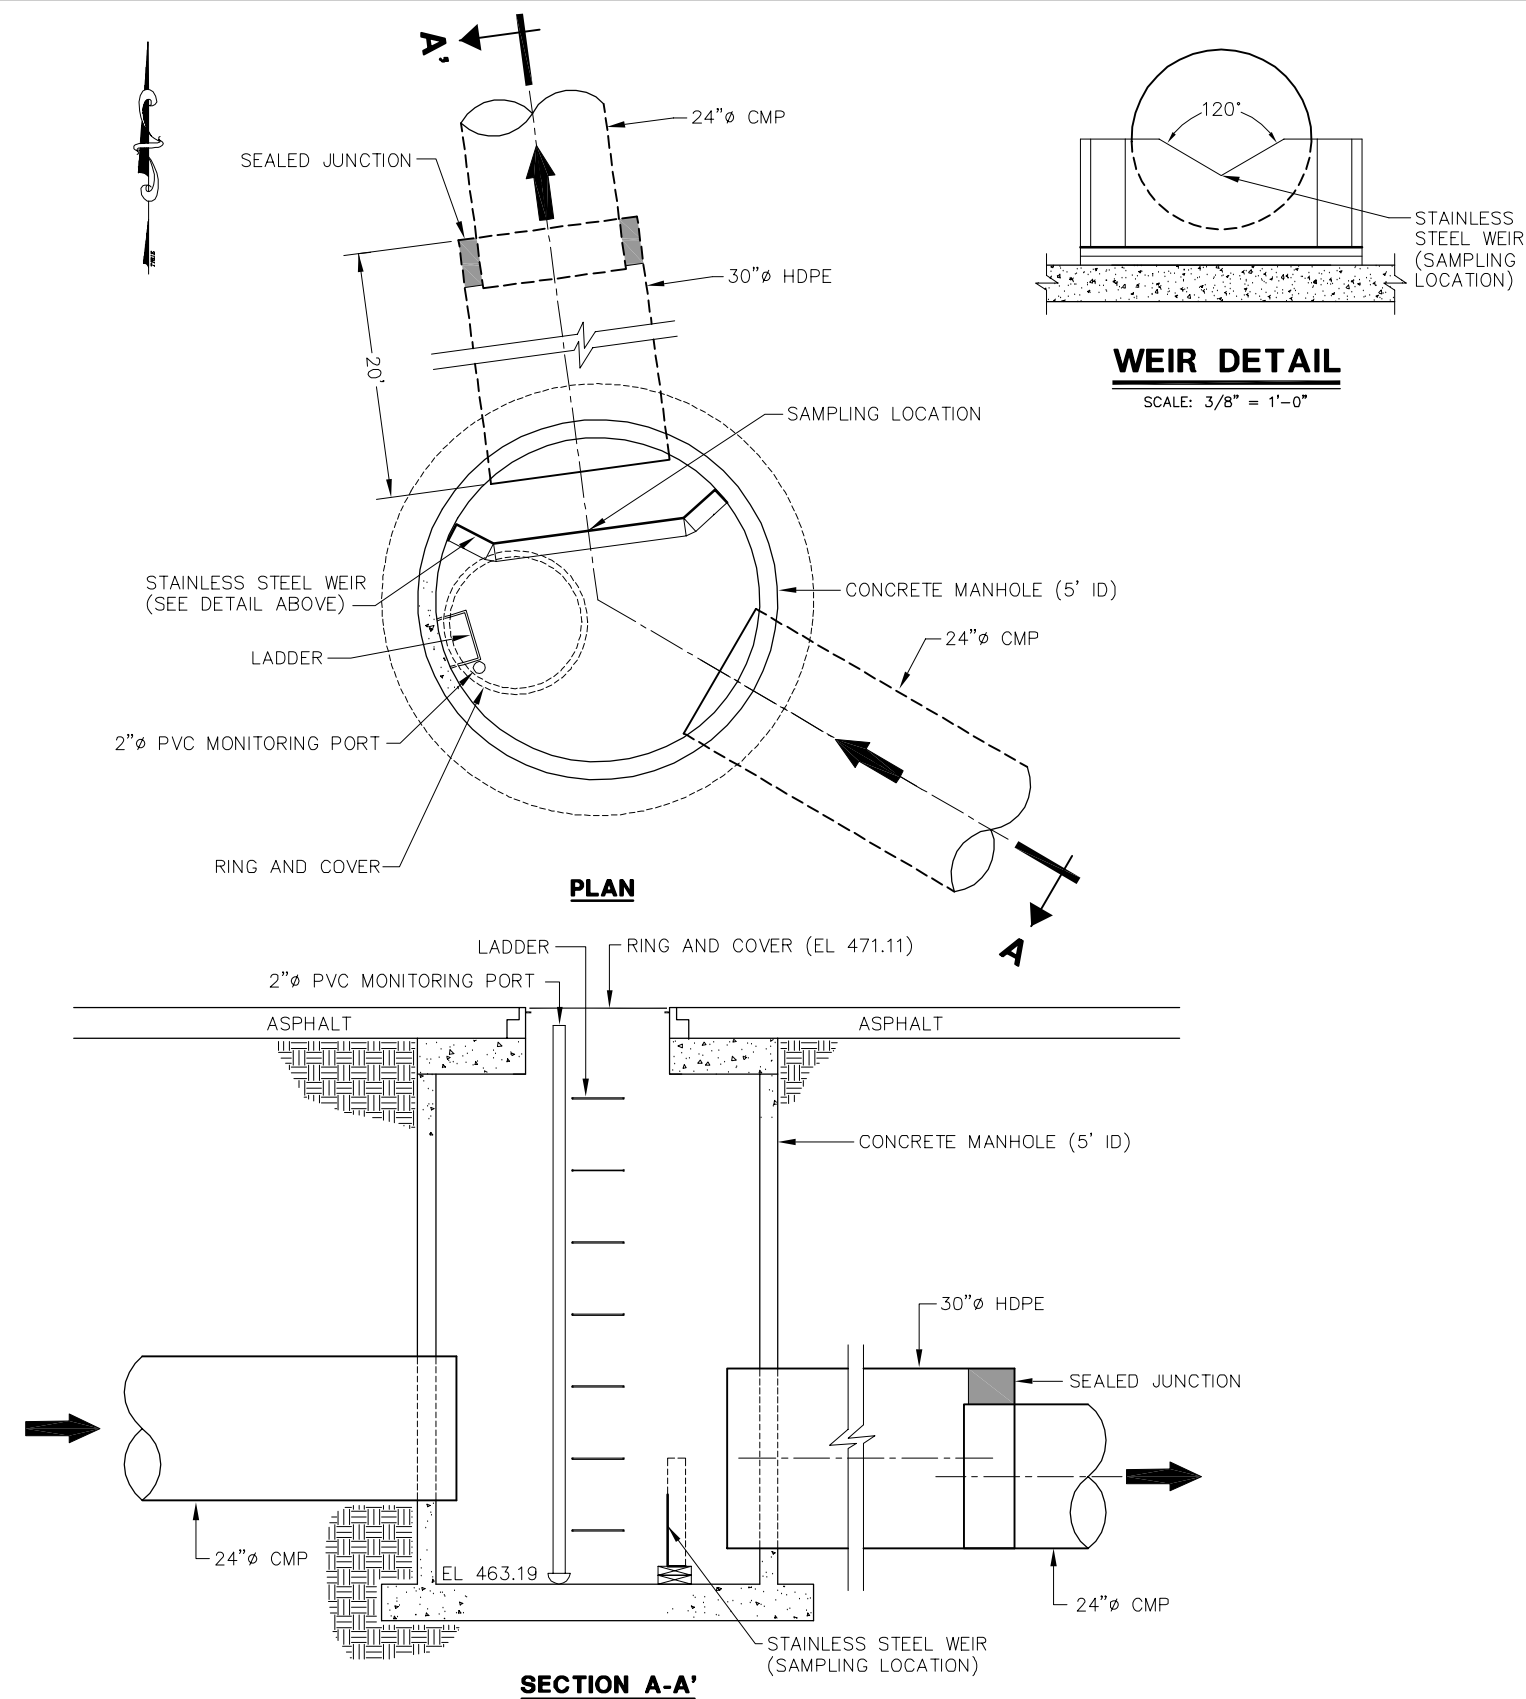
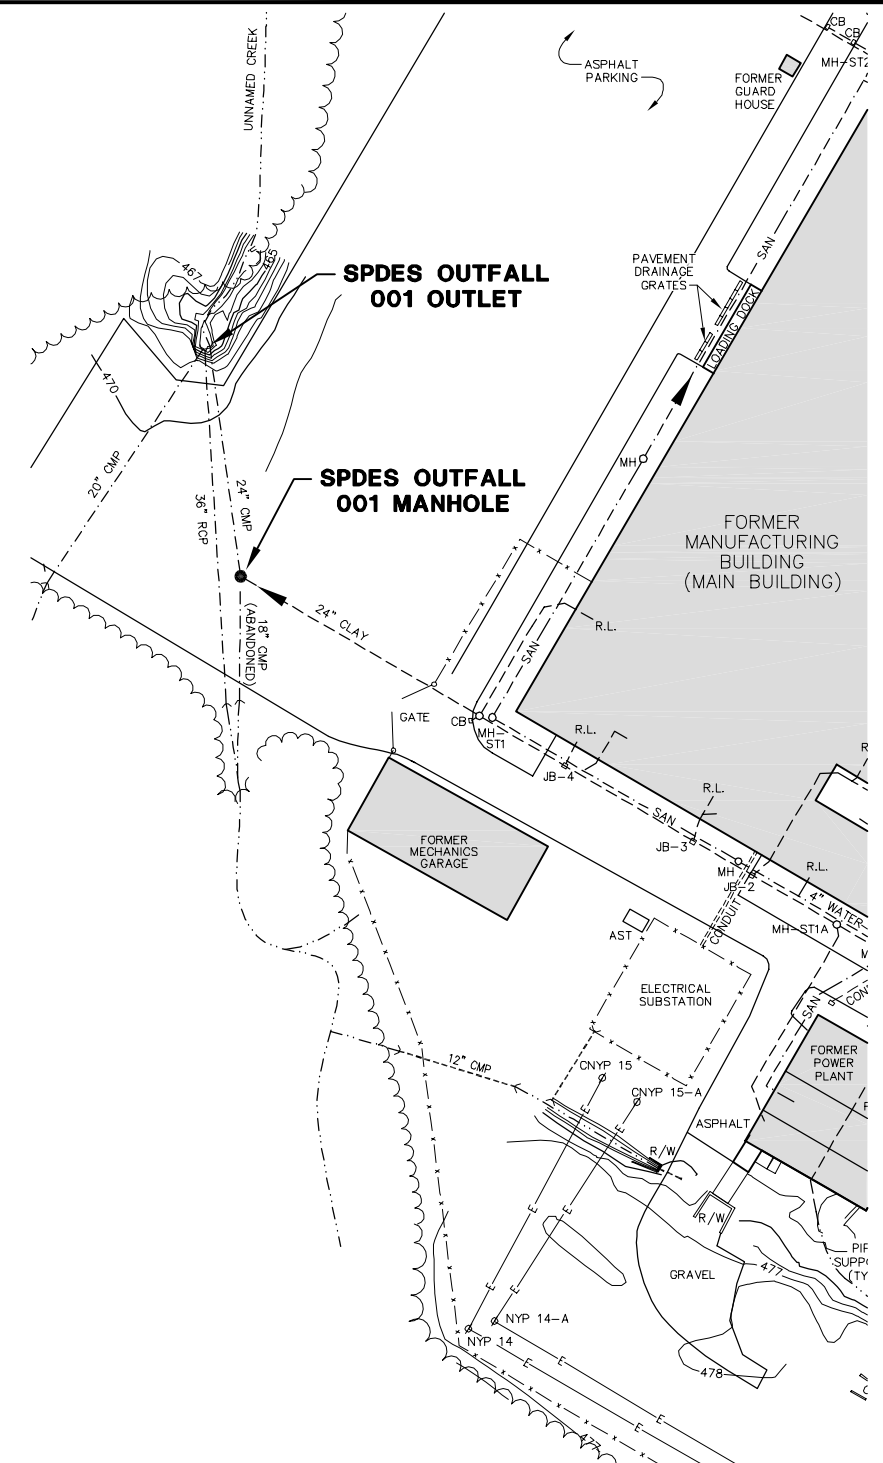
PROJECT NO.:
 DANA 01-04
 DATE:
 MARCH 2009
 FIGURE NO.:
5-1

- A stainless steel, sharp edged, 120-degree, V-notch weir was installed at the effluent side of the manhole. The weir was fastened to the floor and sidewalls of the manhole utilizing concrete fasteners and sealed with grout;

SPDES OUTFALL 001 MANHOLE PLAN AND SECTION

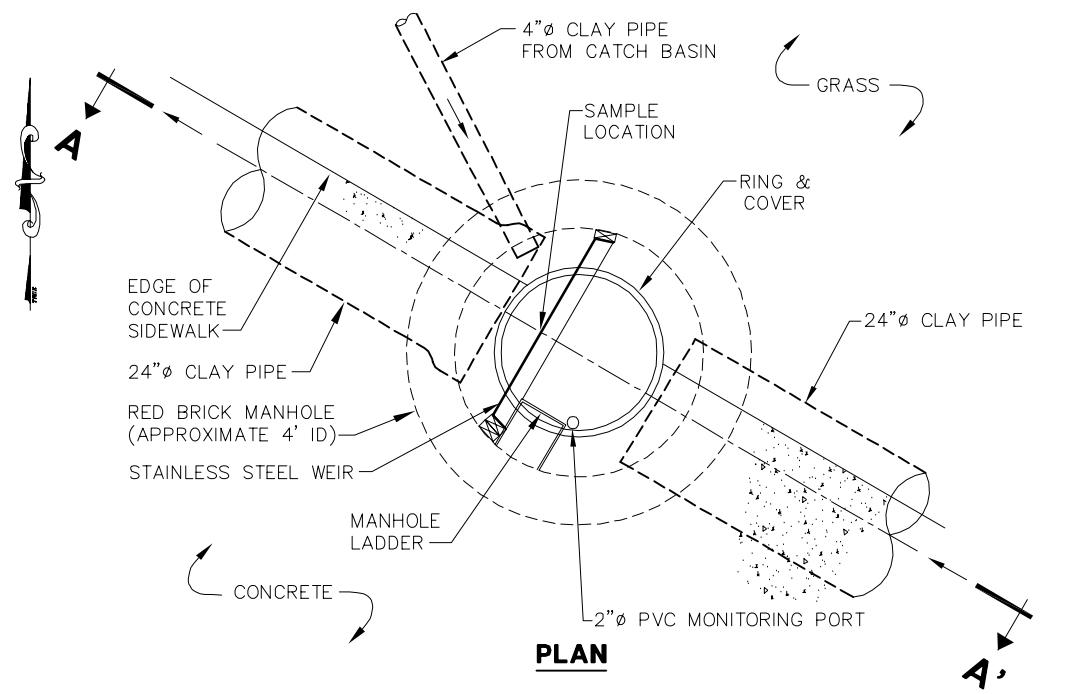
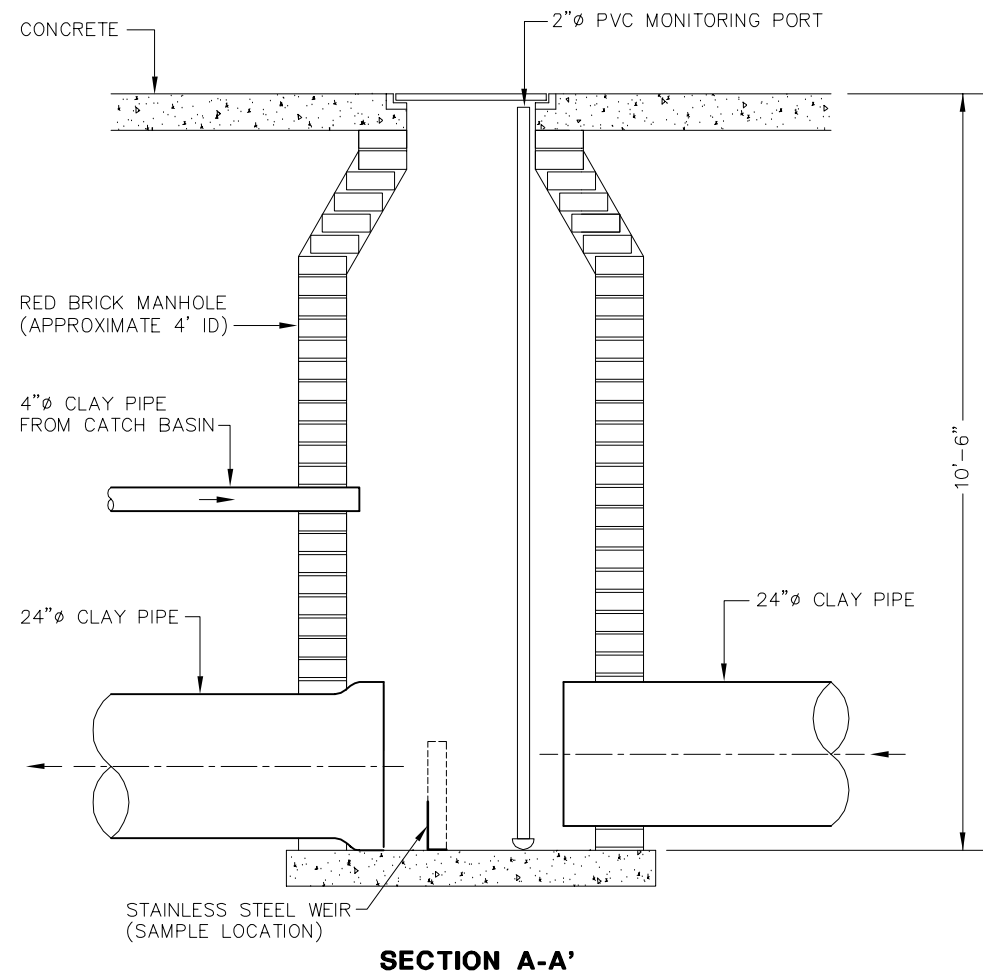
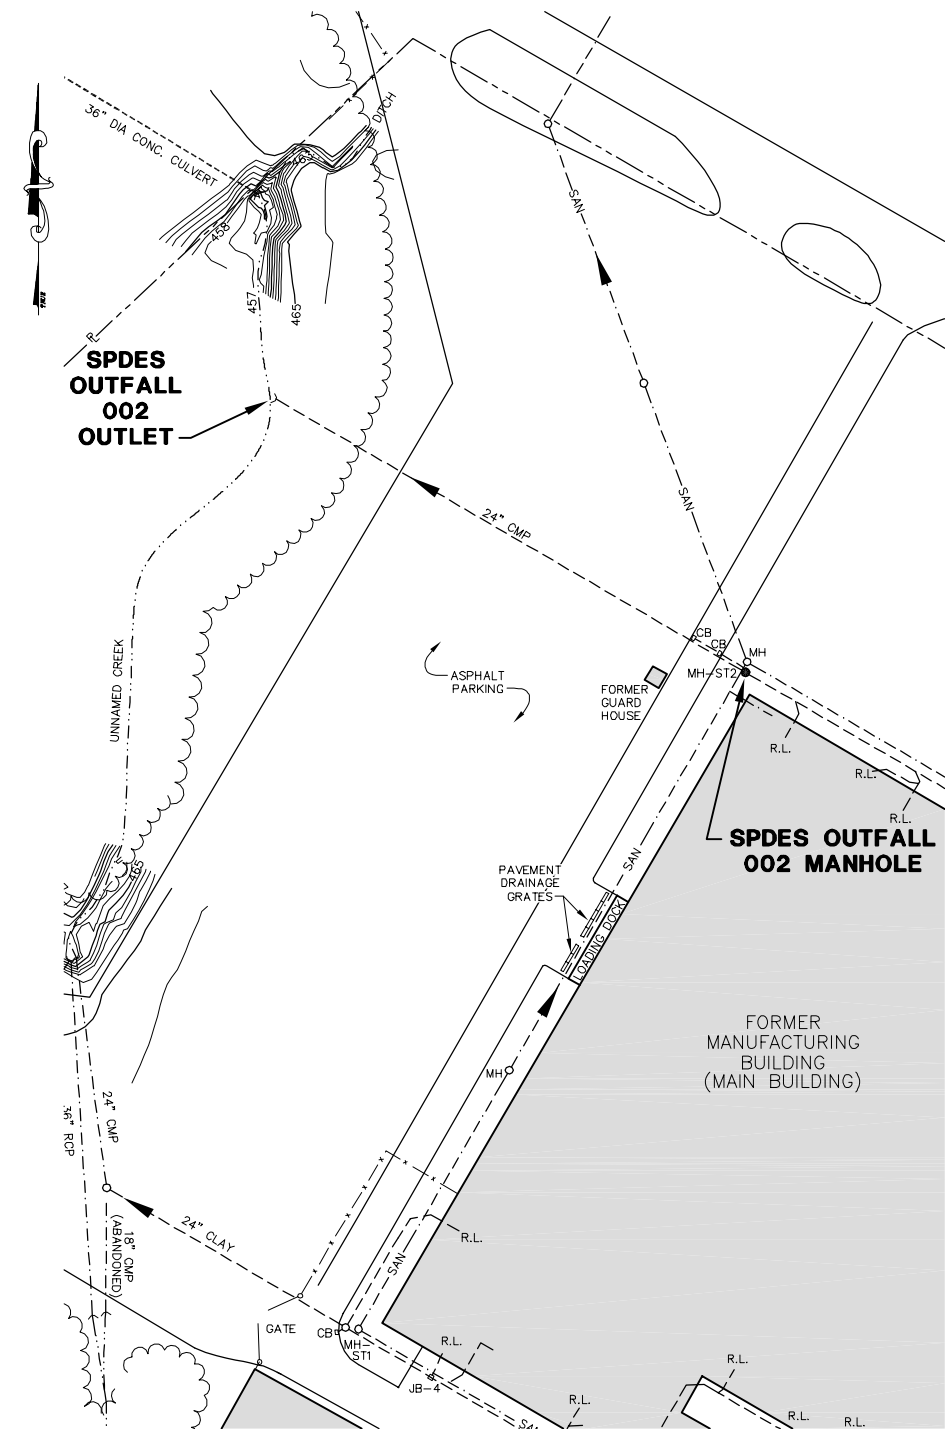
PROJECT NO.:
DANA 01-04
DATE:
MARCH 2009
FIGURE NO.:
5-2

- A stainless steel sharp edge, 120-degree, V-notch weir was installed adjacent to the effluent 24-inch VCP, at the bottom of the manhole. The weir was fastened to the floor and sidewalls of the manhole utilizing concrete fasteners and sealed with grout;
- A 2-inch diameter, schedule 80, PVC flow measurement port was affixed adjacent to the weir, and effluent flow rates were calibrated based on the water level flowing over the weir; and
- A NYSDEC-approved sign was posted on the bank, adjacent to the outfall outlet.

SPDES OUTFALL 002 MANHOLE PLAN AND SECTION
