**2008 ANNUAL OPERATION,
MAINTENANCE AND
MONITORING REPORT**

**2200 BLEECKER STREET
UTICA, NEW YORK 13501
NYSDEC SITE NO. 622003**

April 2009

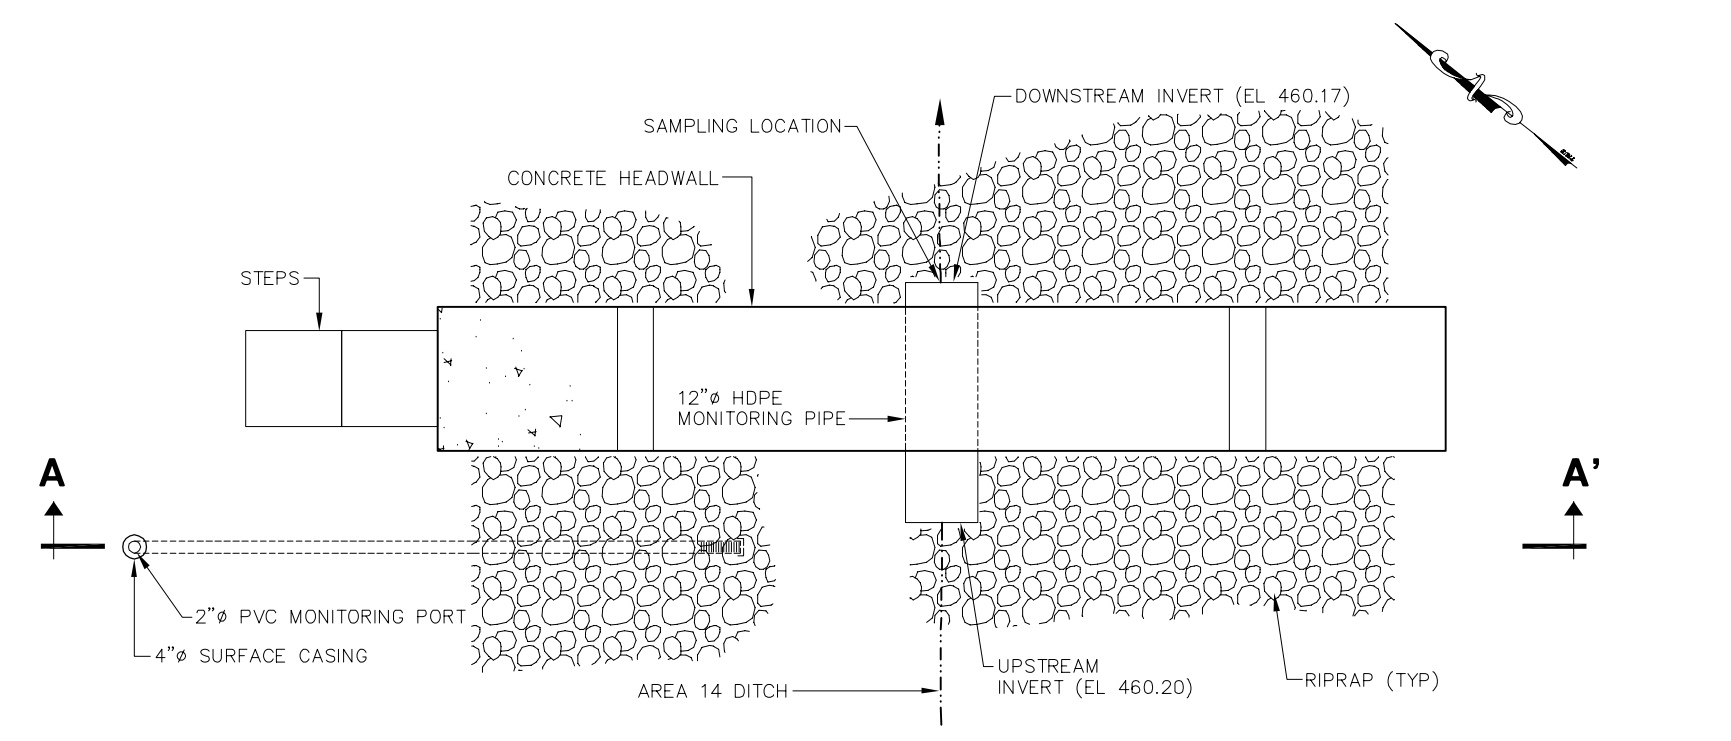
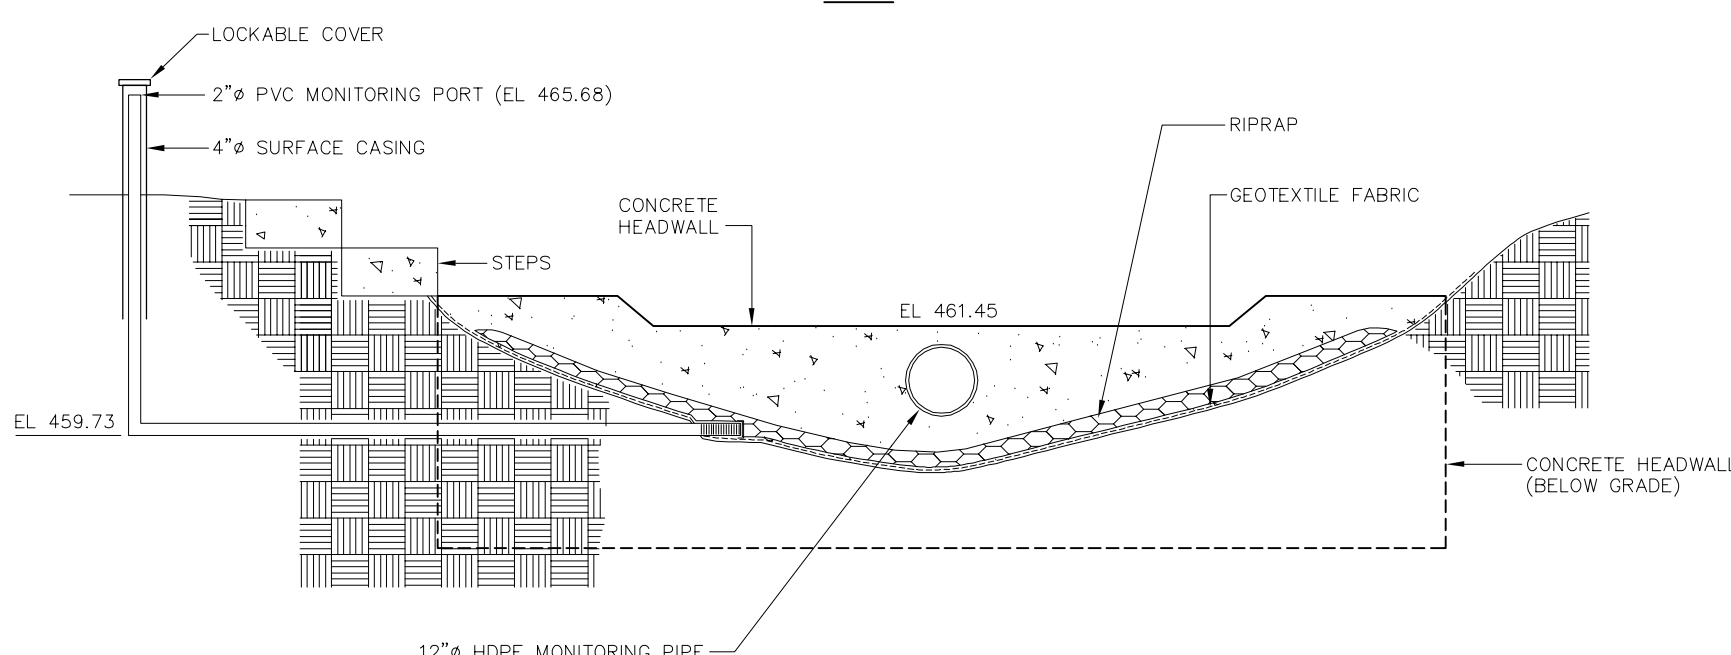
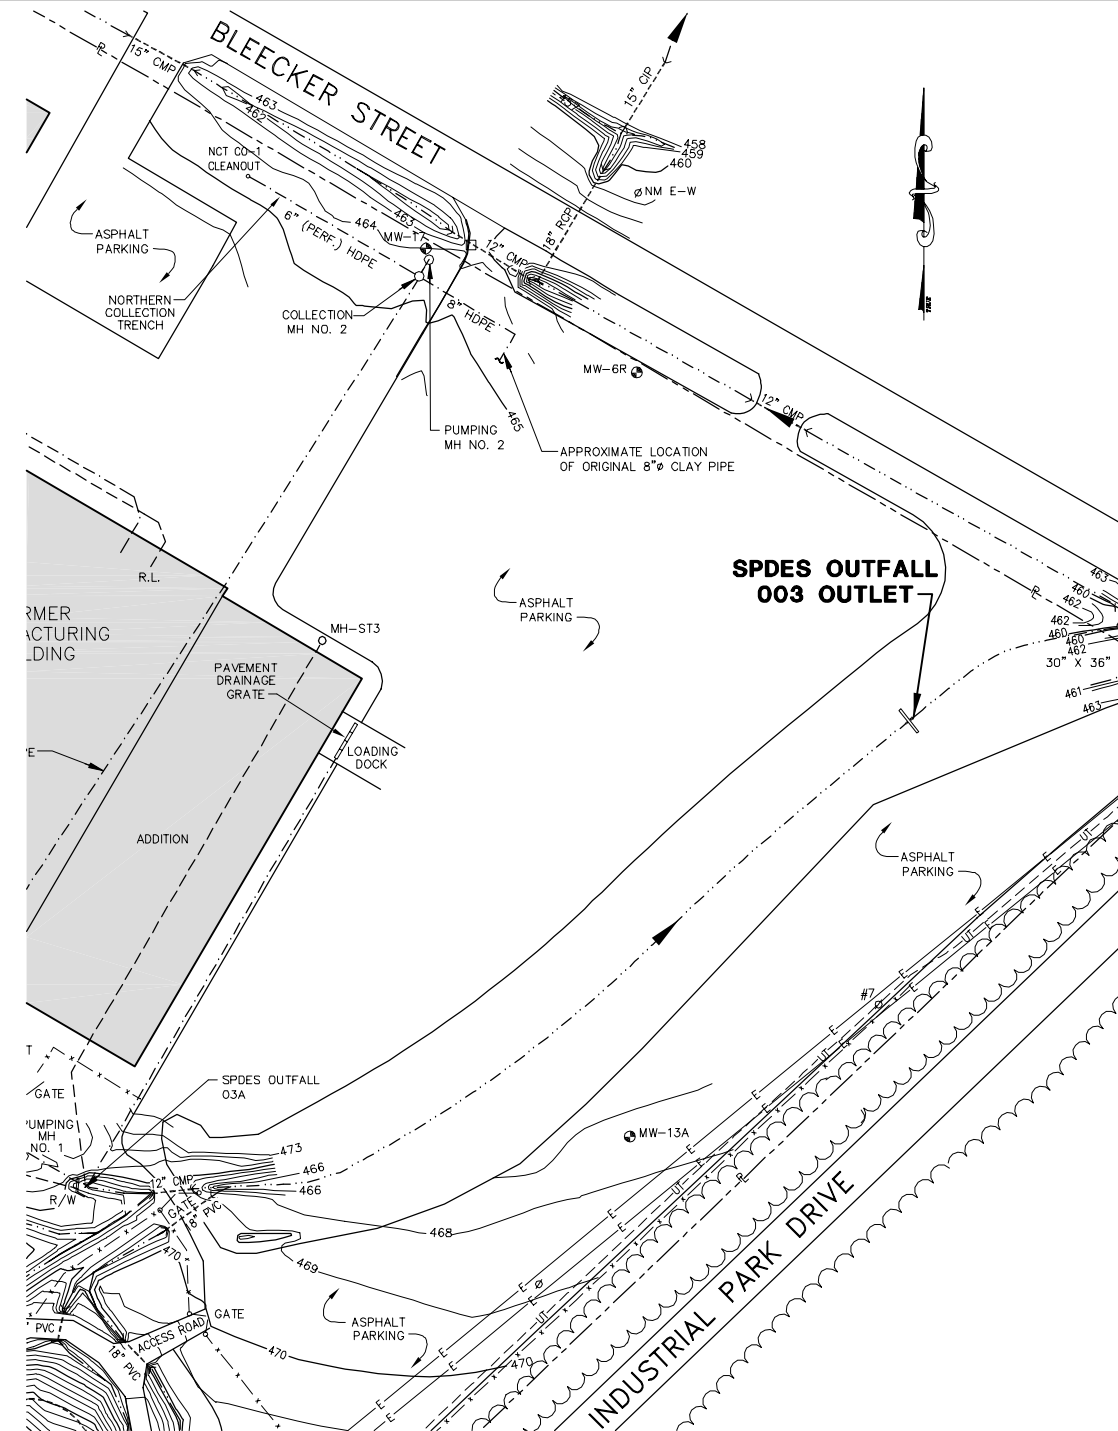
PROJECT NO.:
DANA 01-04
DATE:
MARCH 2009
FIGURE NO.:
5-3

- A 12-inch HDPE pipe was installed within a concrete headwall spanning the width of the tributary allowing surface water to flow through the pipe. Samples are collected and parameters measured directly from the effluent end of the 12-inch HDPE pipe;
- A monitoring port was installed adjacent to the concrete headwall to facilitate flow measurement data collection representative of actual discharge conditions. The monitoring port was constructed by installing a horizontal 2-inch PVC pipe at a measured elevation adjacent to the influent side of the headwall. This horizontal pipe connects (via a 90 degree elbow) to a vertical riser extending several feet above grade adjacent to the tributary. The water level of the tributary, and thus the flow rate, can be measured from this monitoring port; and
- A NYSDEC-approved sign was posted on the bank adjacent to the outfall outlet.

SPDES OUTFALL 003 OUTLET PLAN AND SECTION

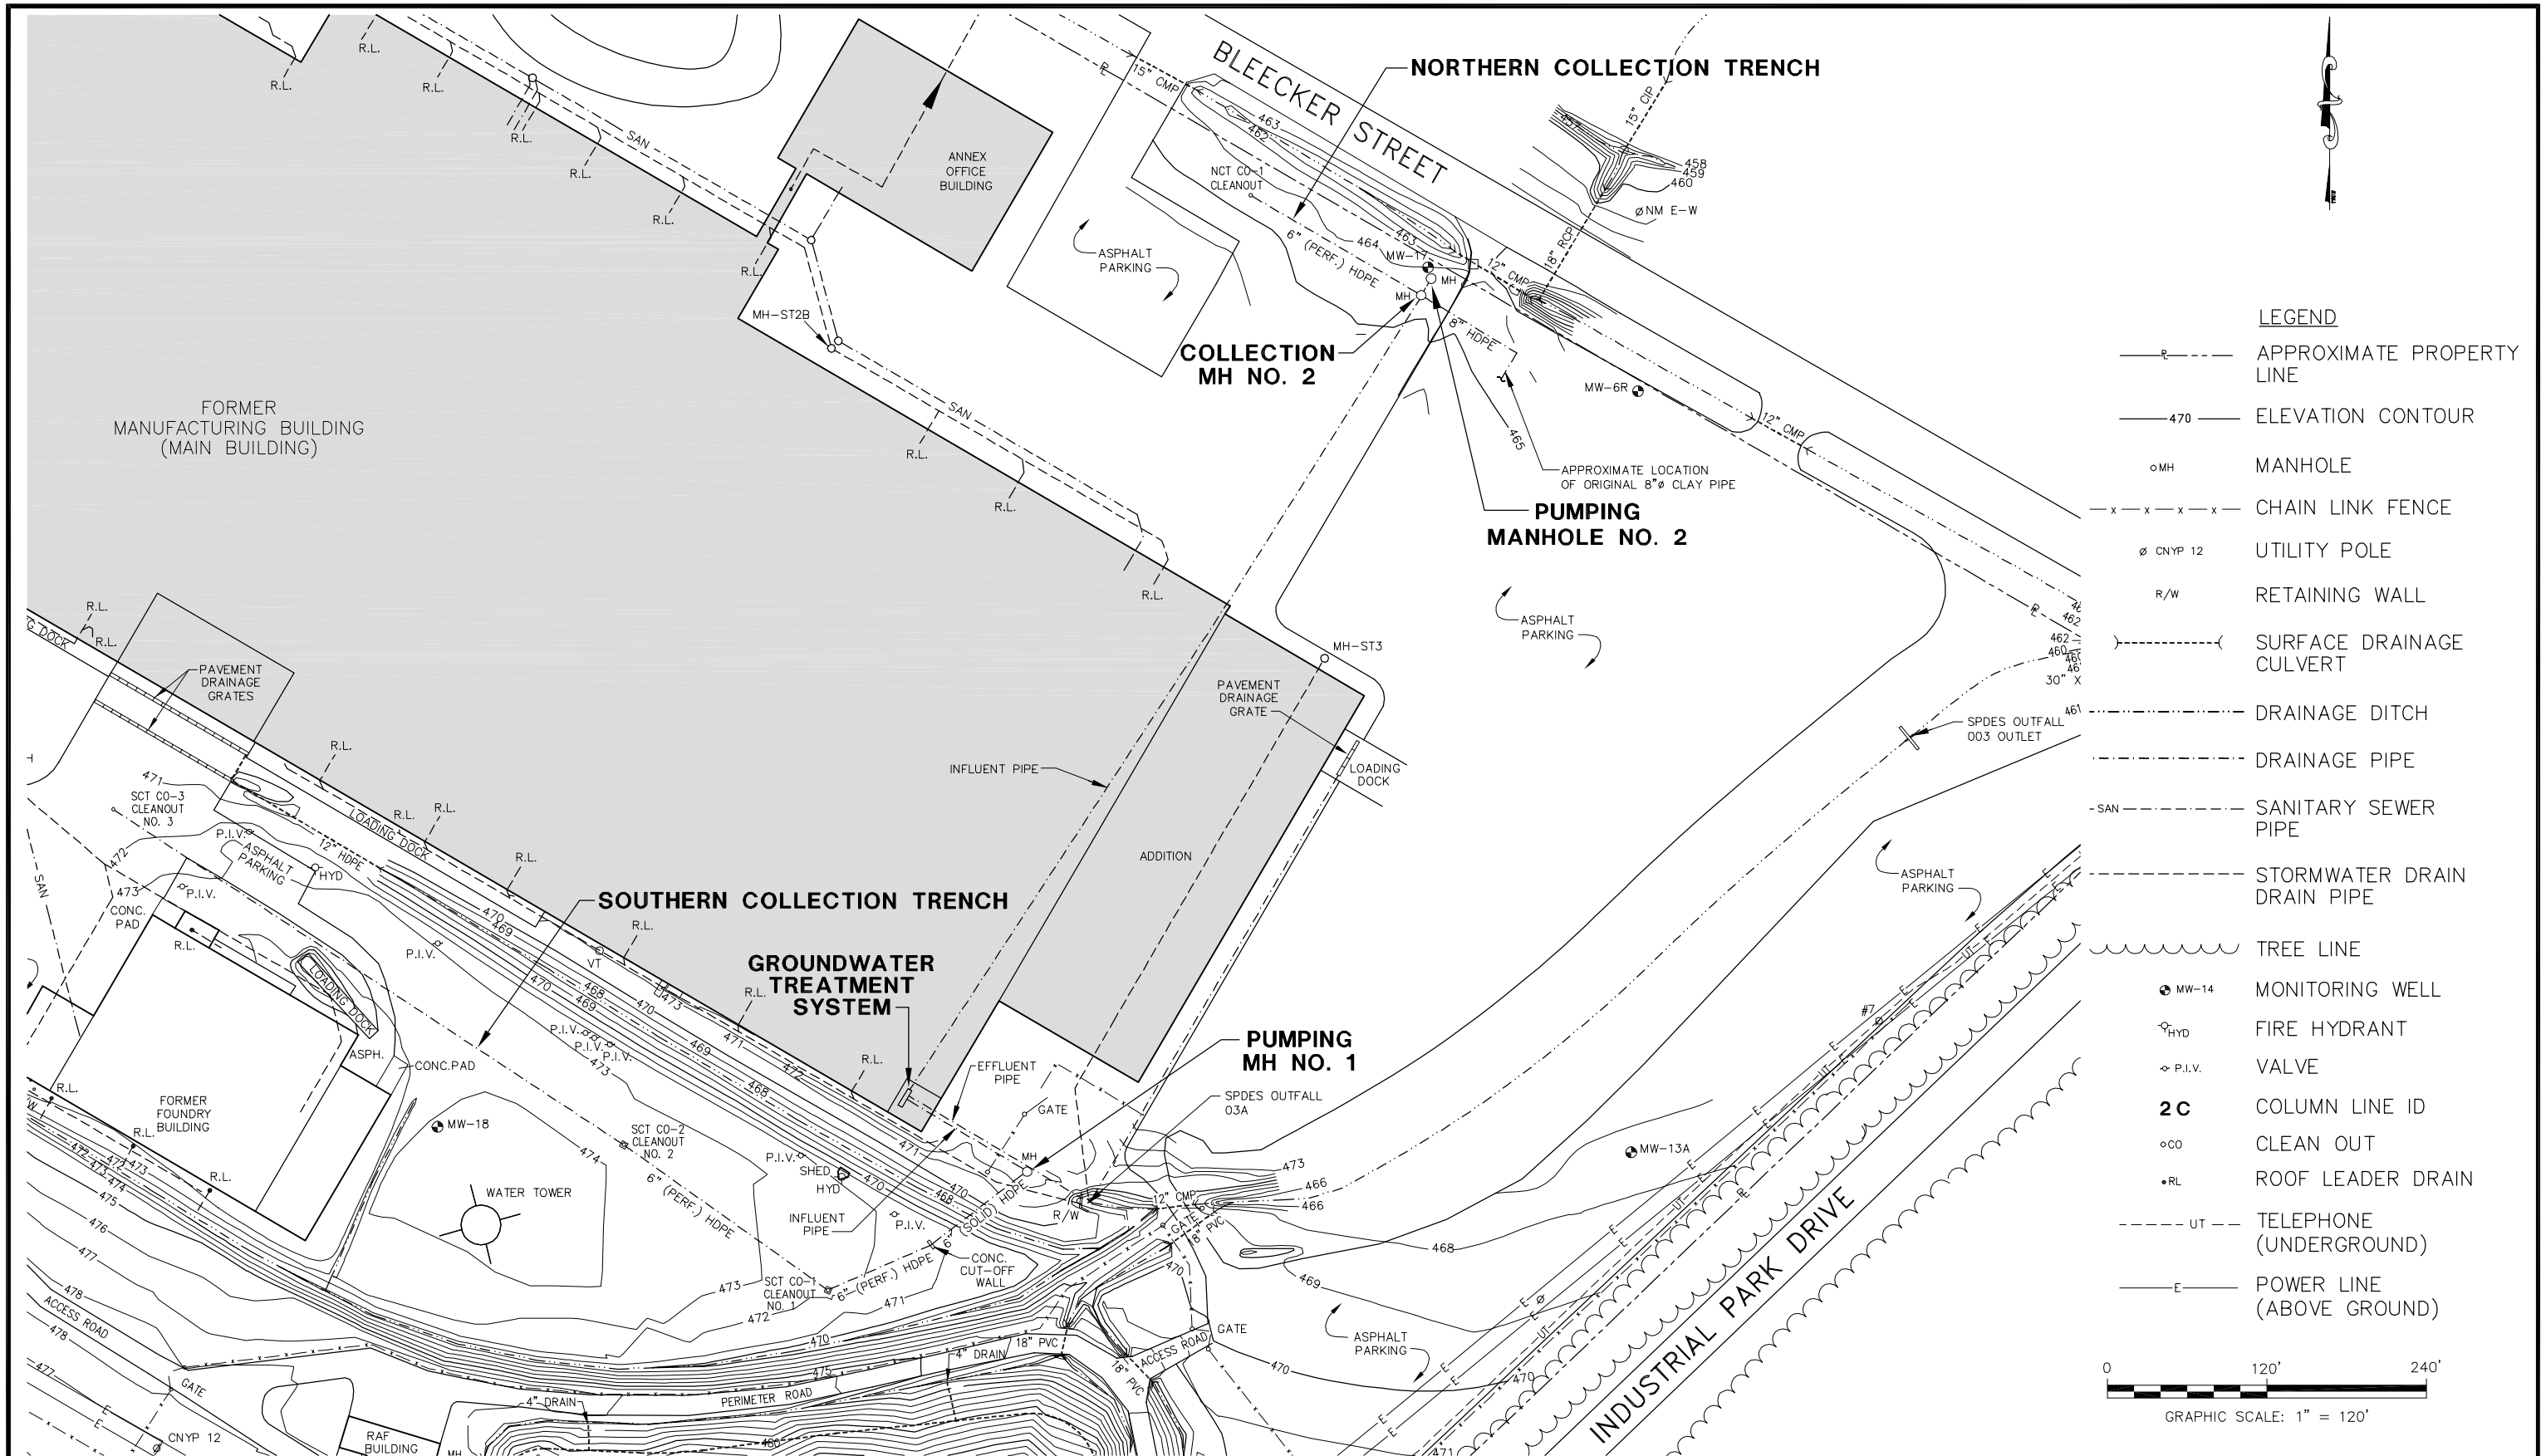
PROJECT NO.:
DANA 01-04
DATE:
MARCH 2009
FIGURE NO.:
6-1

GROUNDWATER
TREATMENT SYSTEM
PLAN

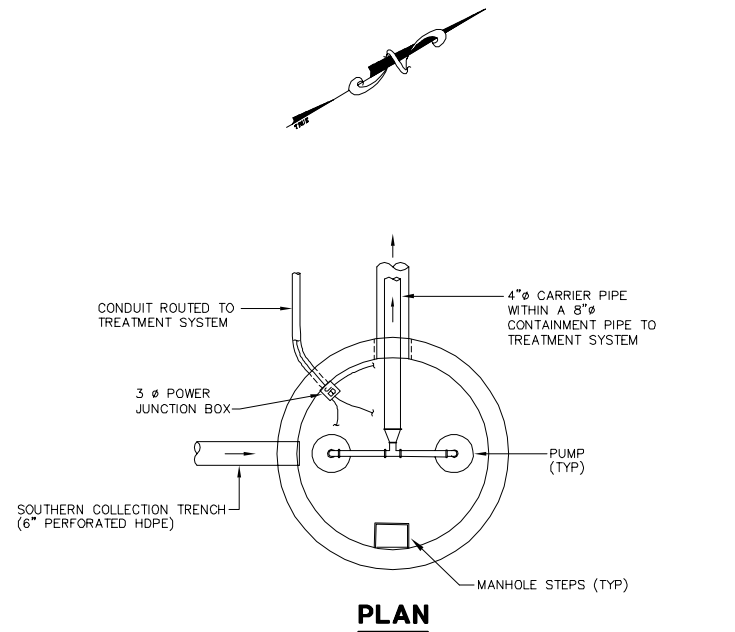
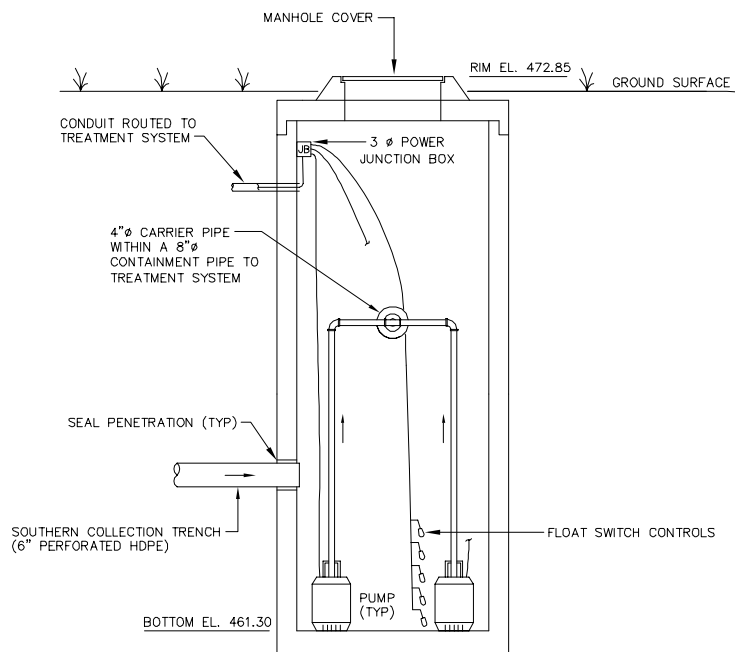
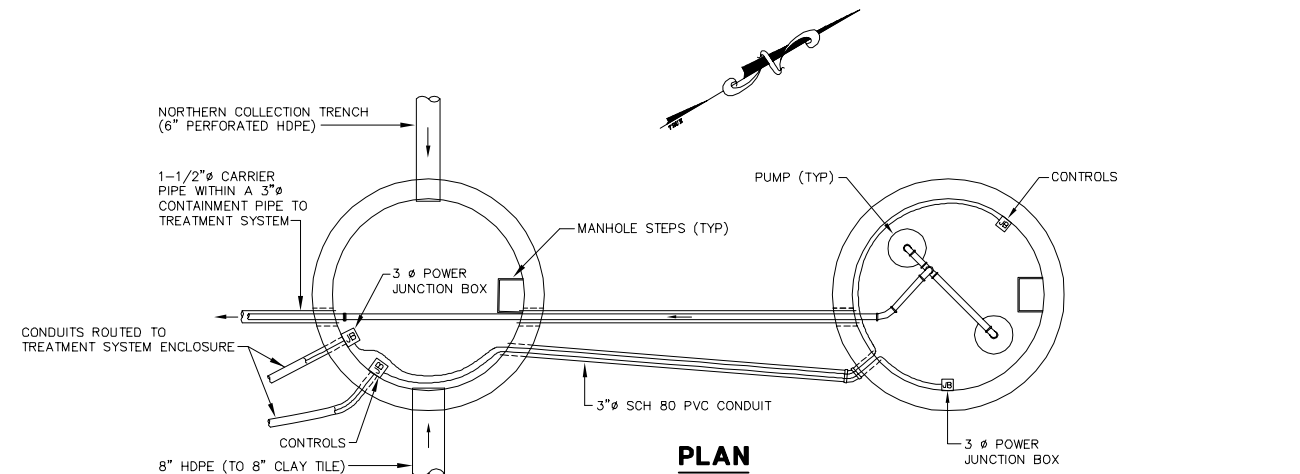
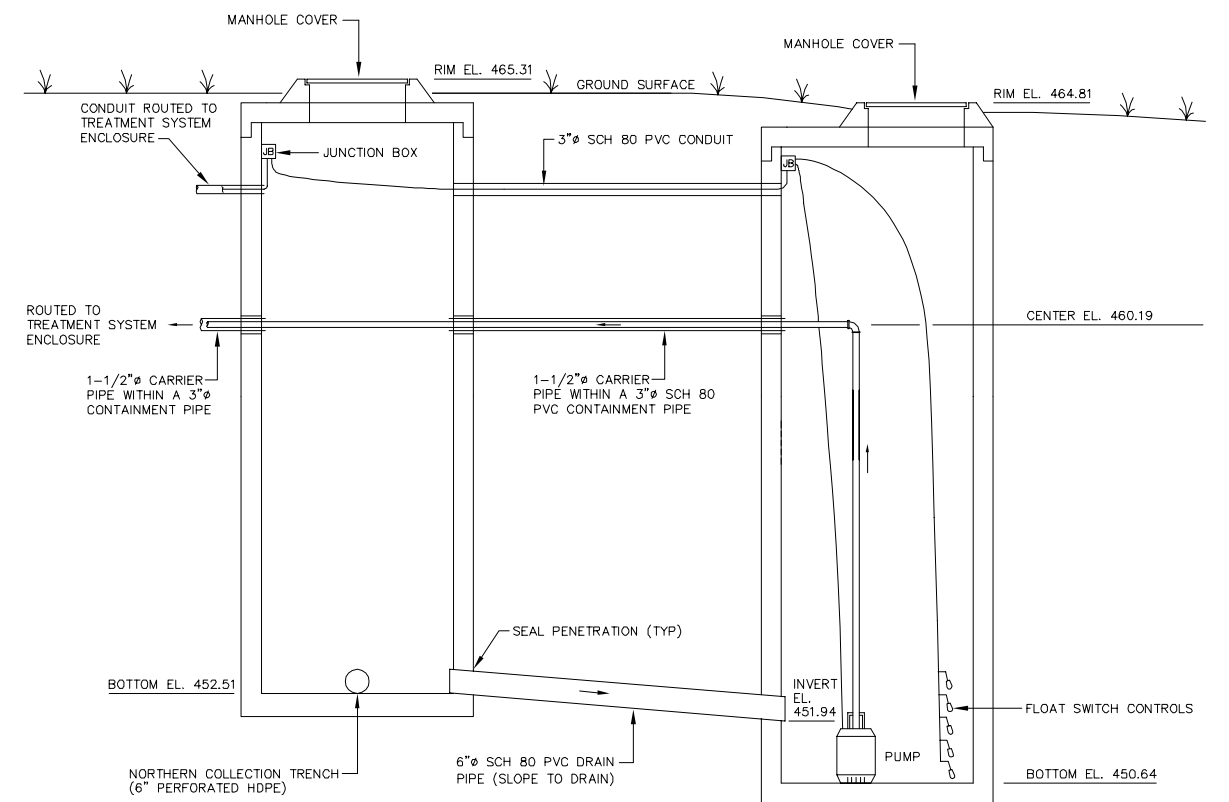
6-3

PUMPING MANHOLE NO. 1 PLAN AND SECTION

COLLECTION MANHOLE

PUMPING MANHOLE

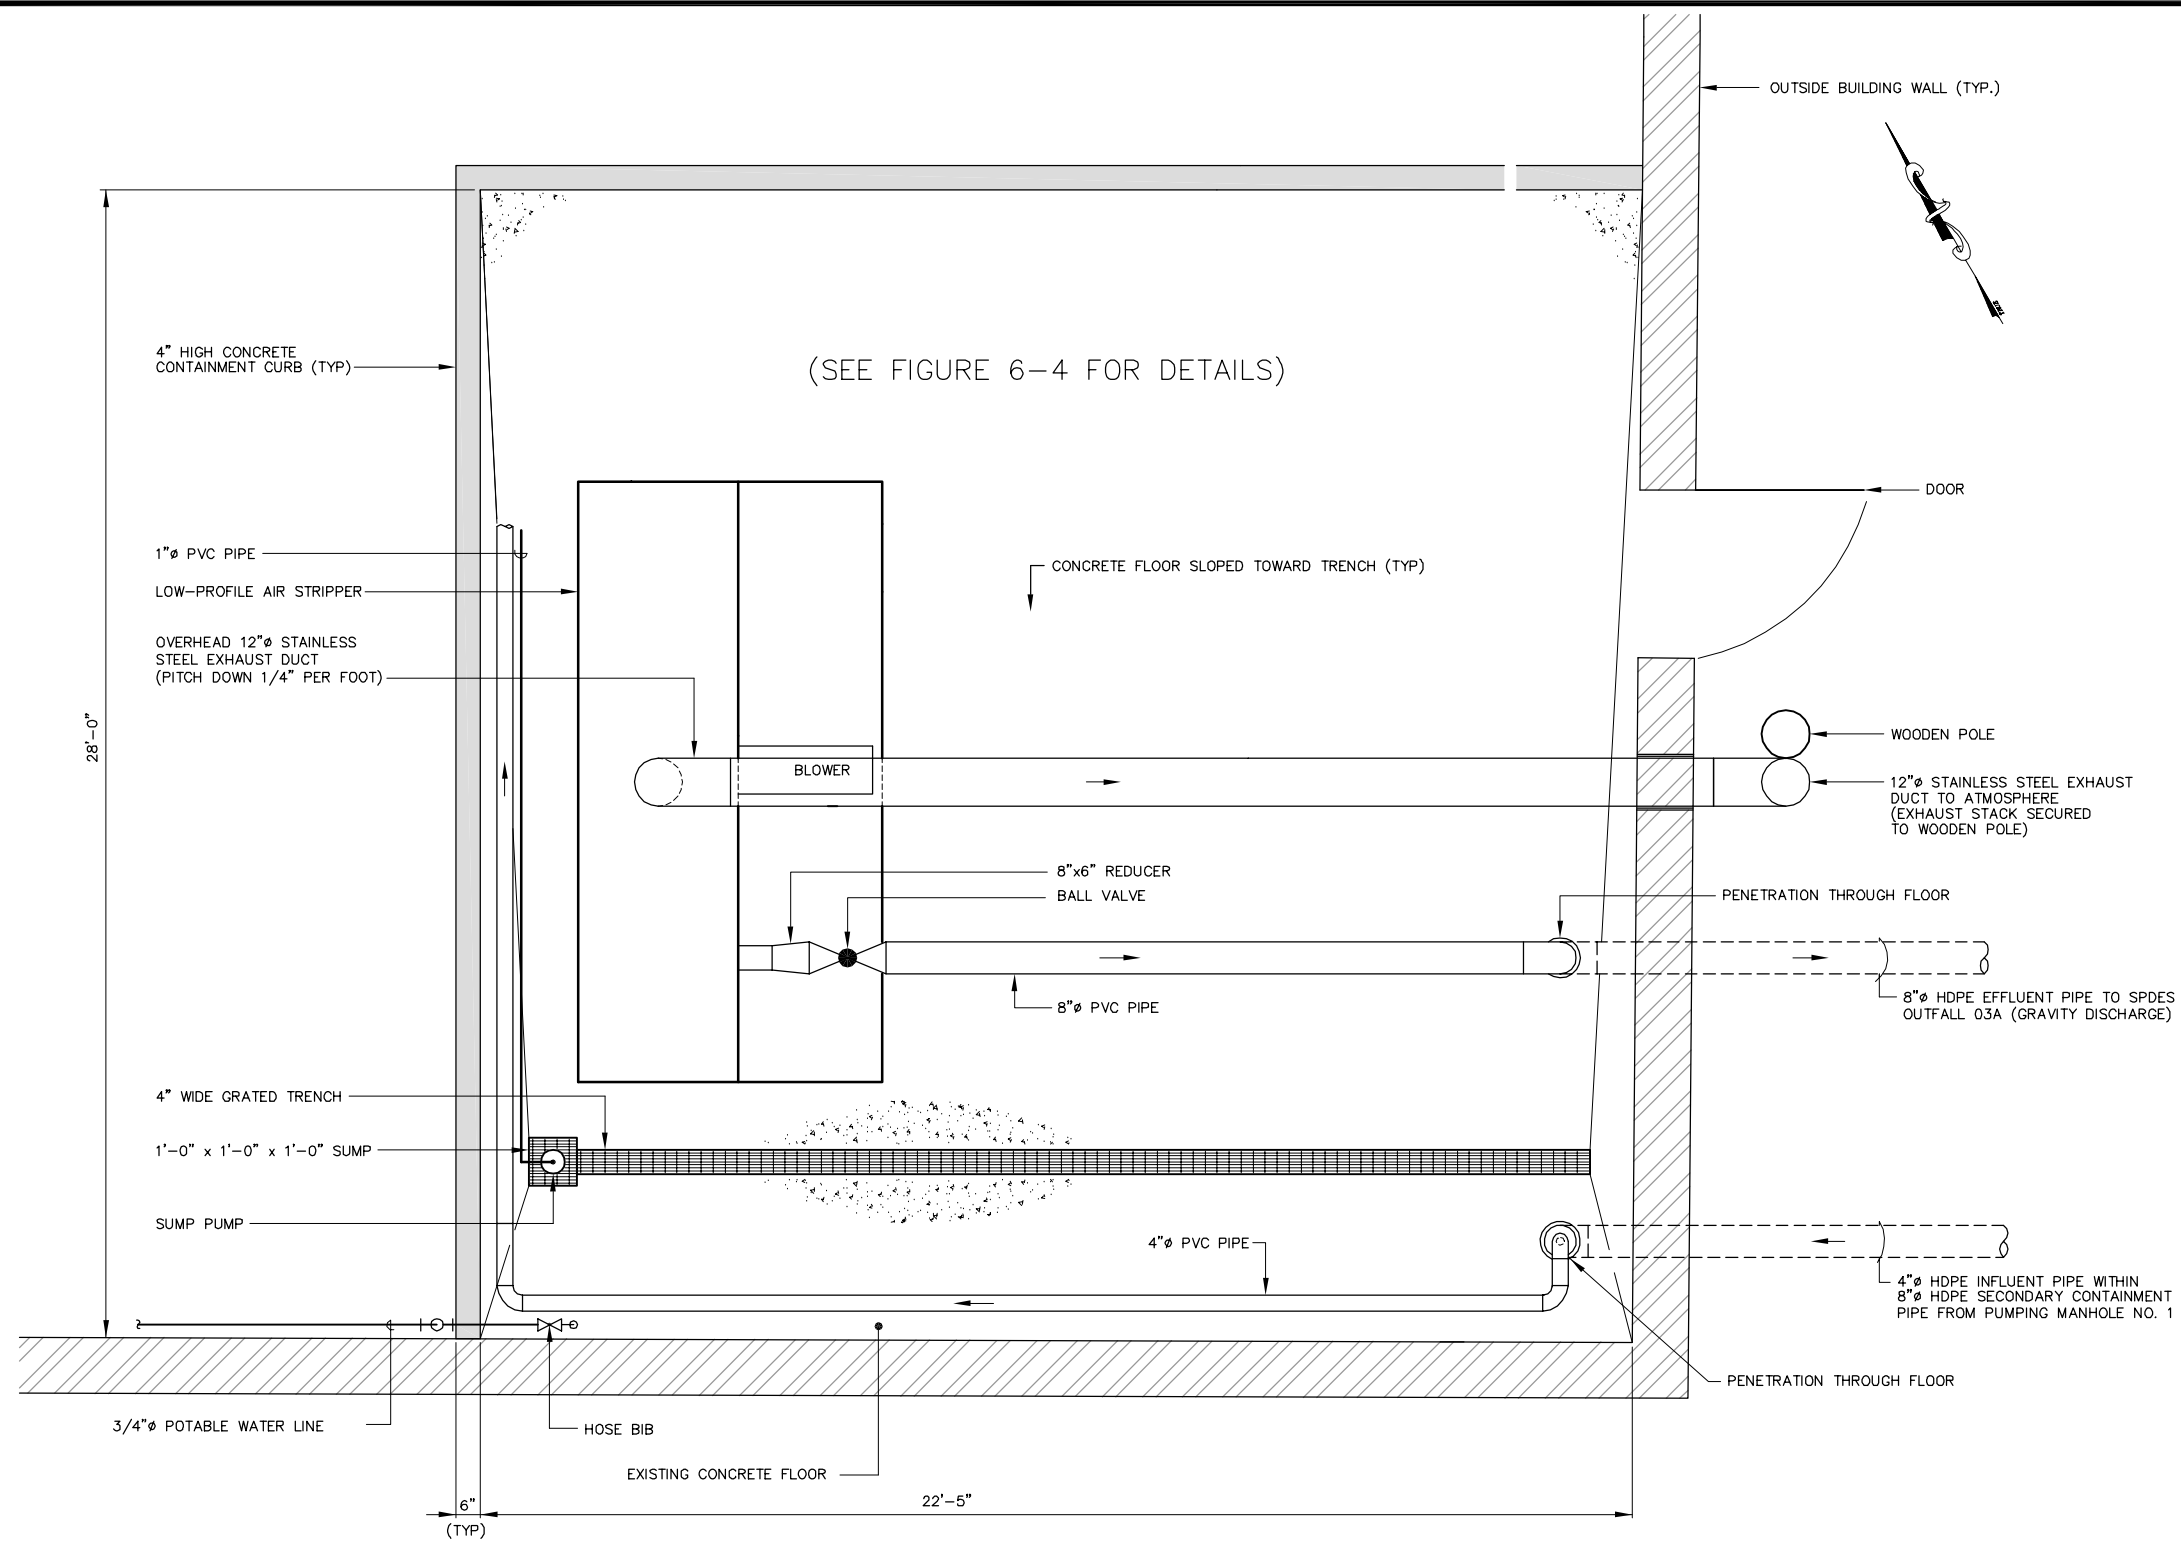
PROJECT NO.:
DANA 01-04
DATE:
MARCH 2009
FIGURE NO.:
6-2

FLOOR PLAN
1/4" = 1'-0"
