**2009 ANNUAL OPERATION,  
MAINTENANCE AND  
MONITORING REPORT**

**2200 BLEECKER STREET  
UTICA, NEW YORK 13501  
NYSDEC SITE NO. 622003**

July 2010

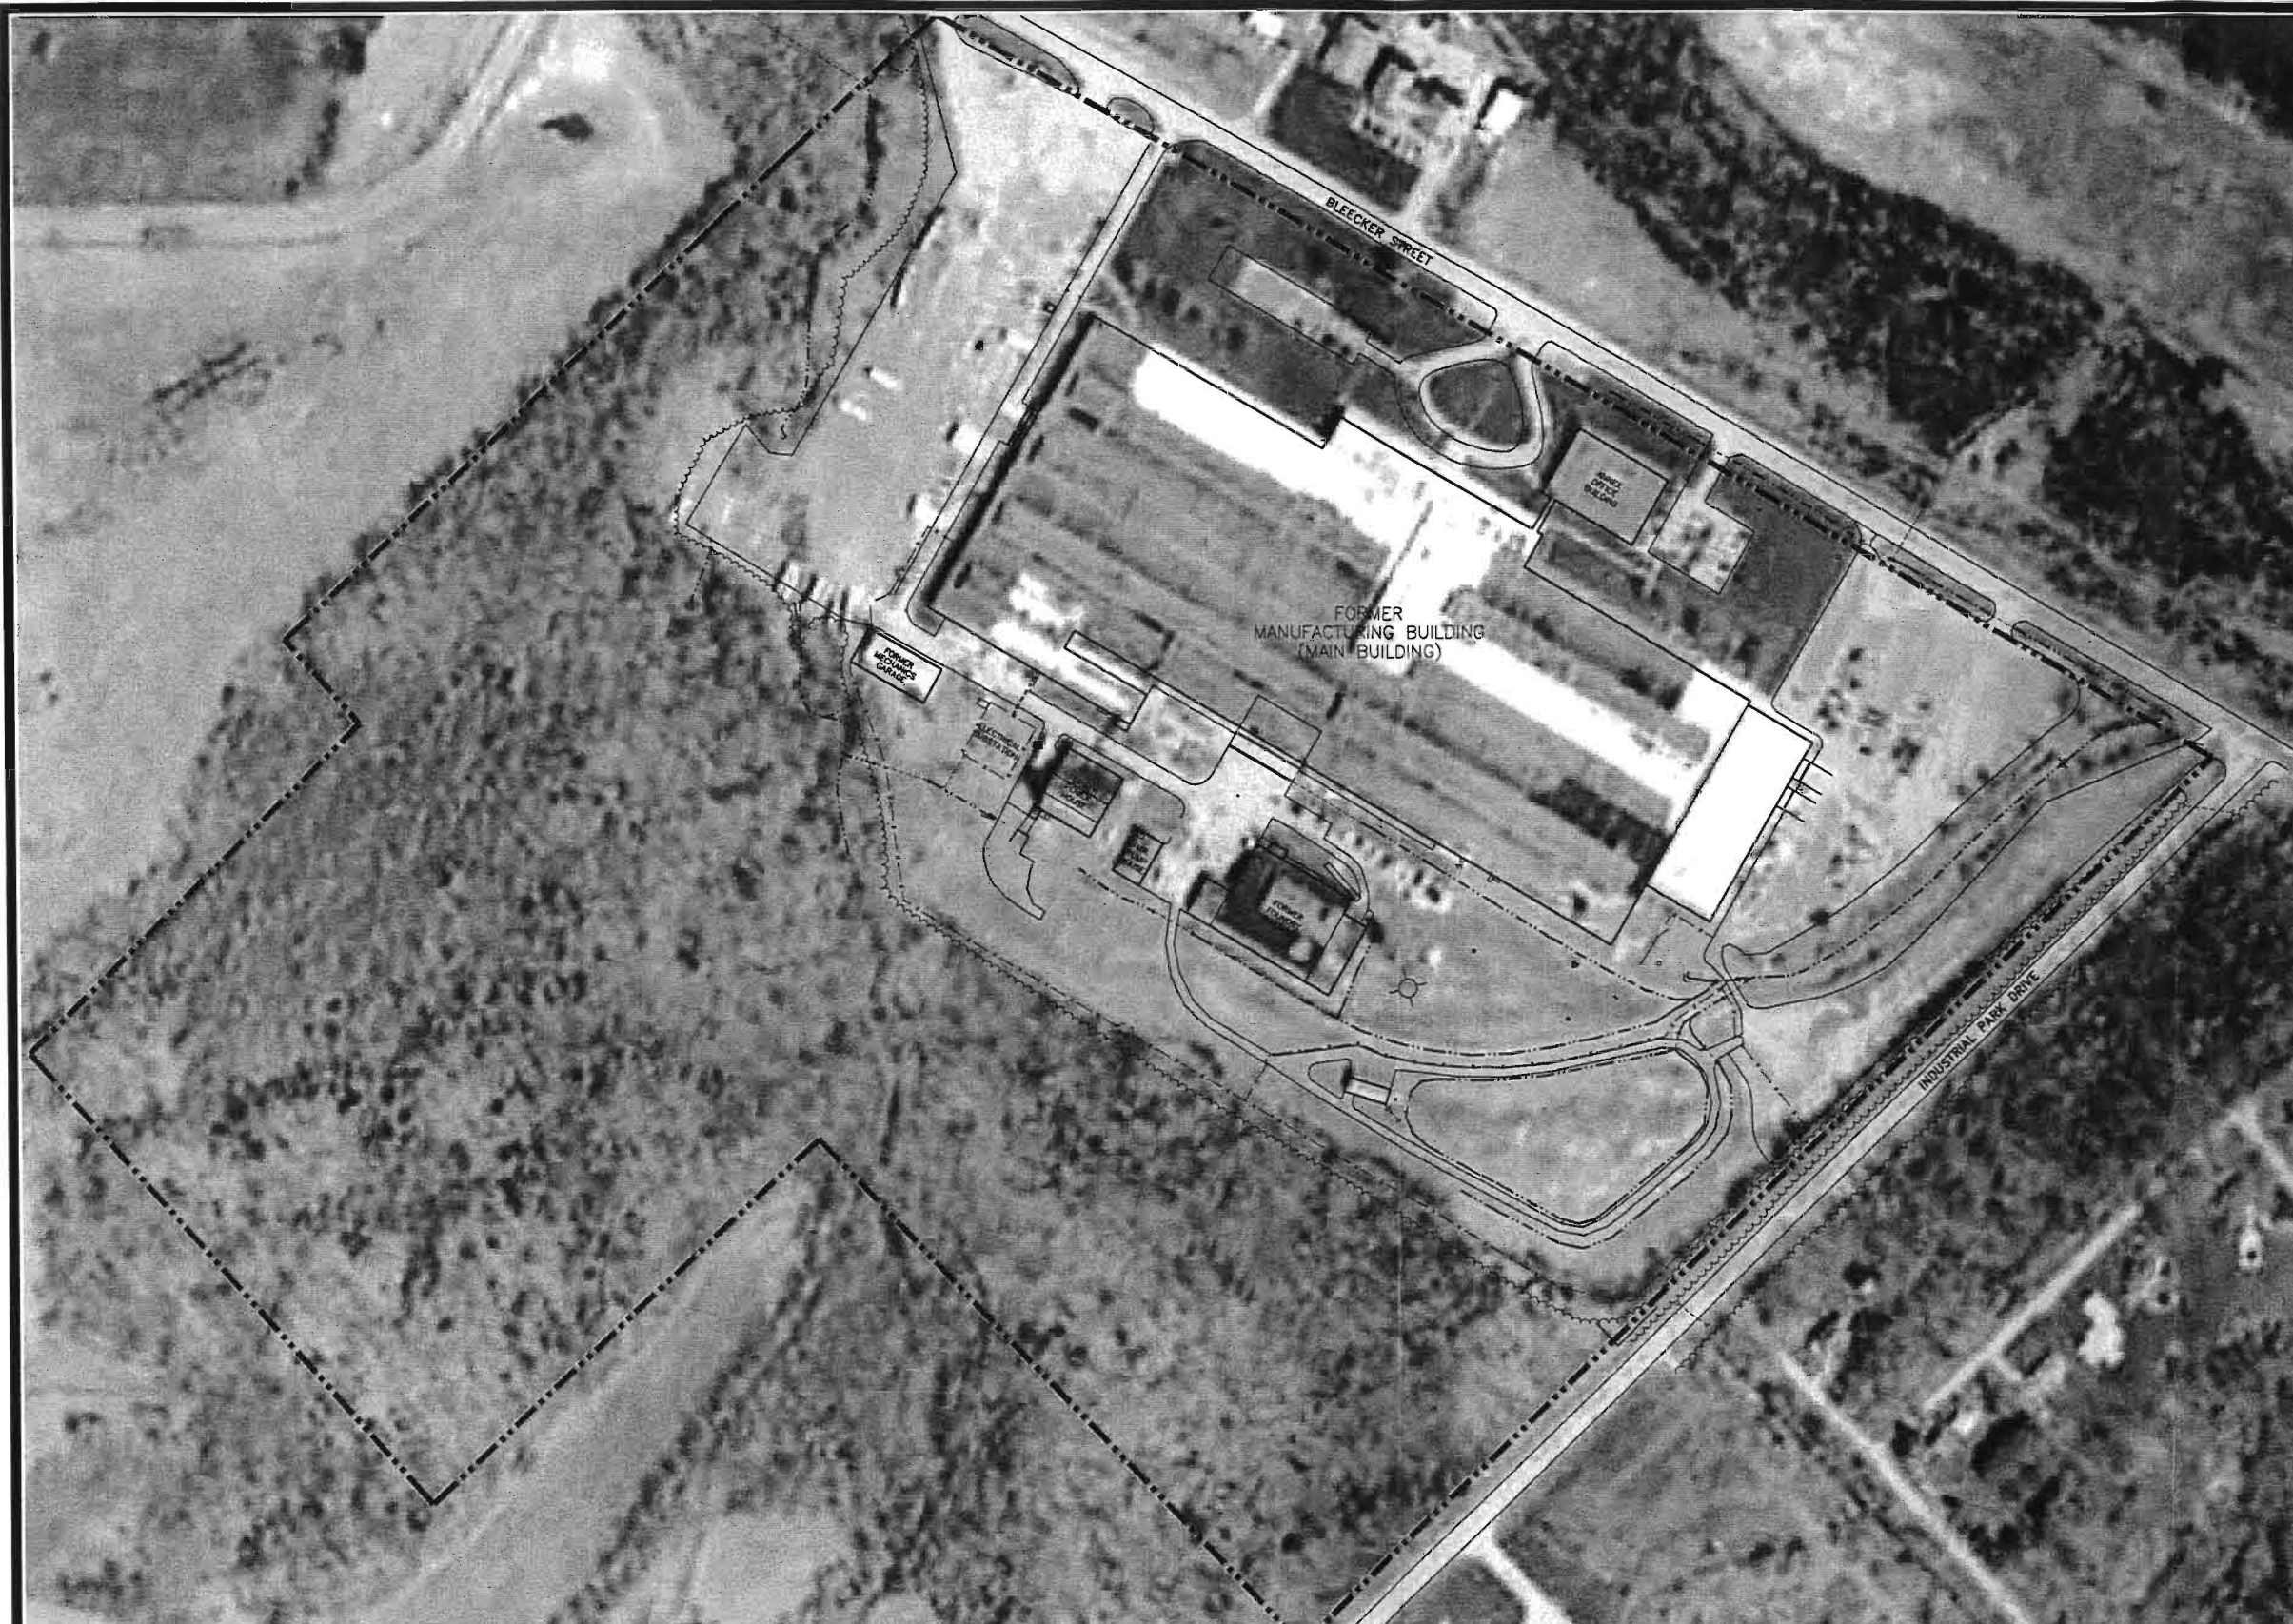
- 2-1 Aerial Property Map
- 2-2 Facility Plan
- 2-3 Historical Remedial Action Areas
