2015 PERIODIC REVIEW REPORT

**2200 BLEECKER STREET
UTICA, NEW YORK 13501
NYSDEC SITE NO. 622003**

February 2016

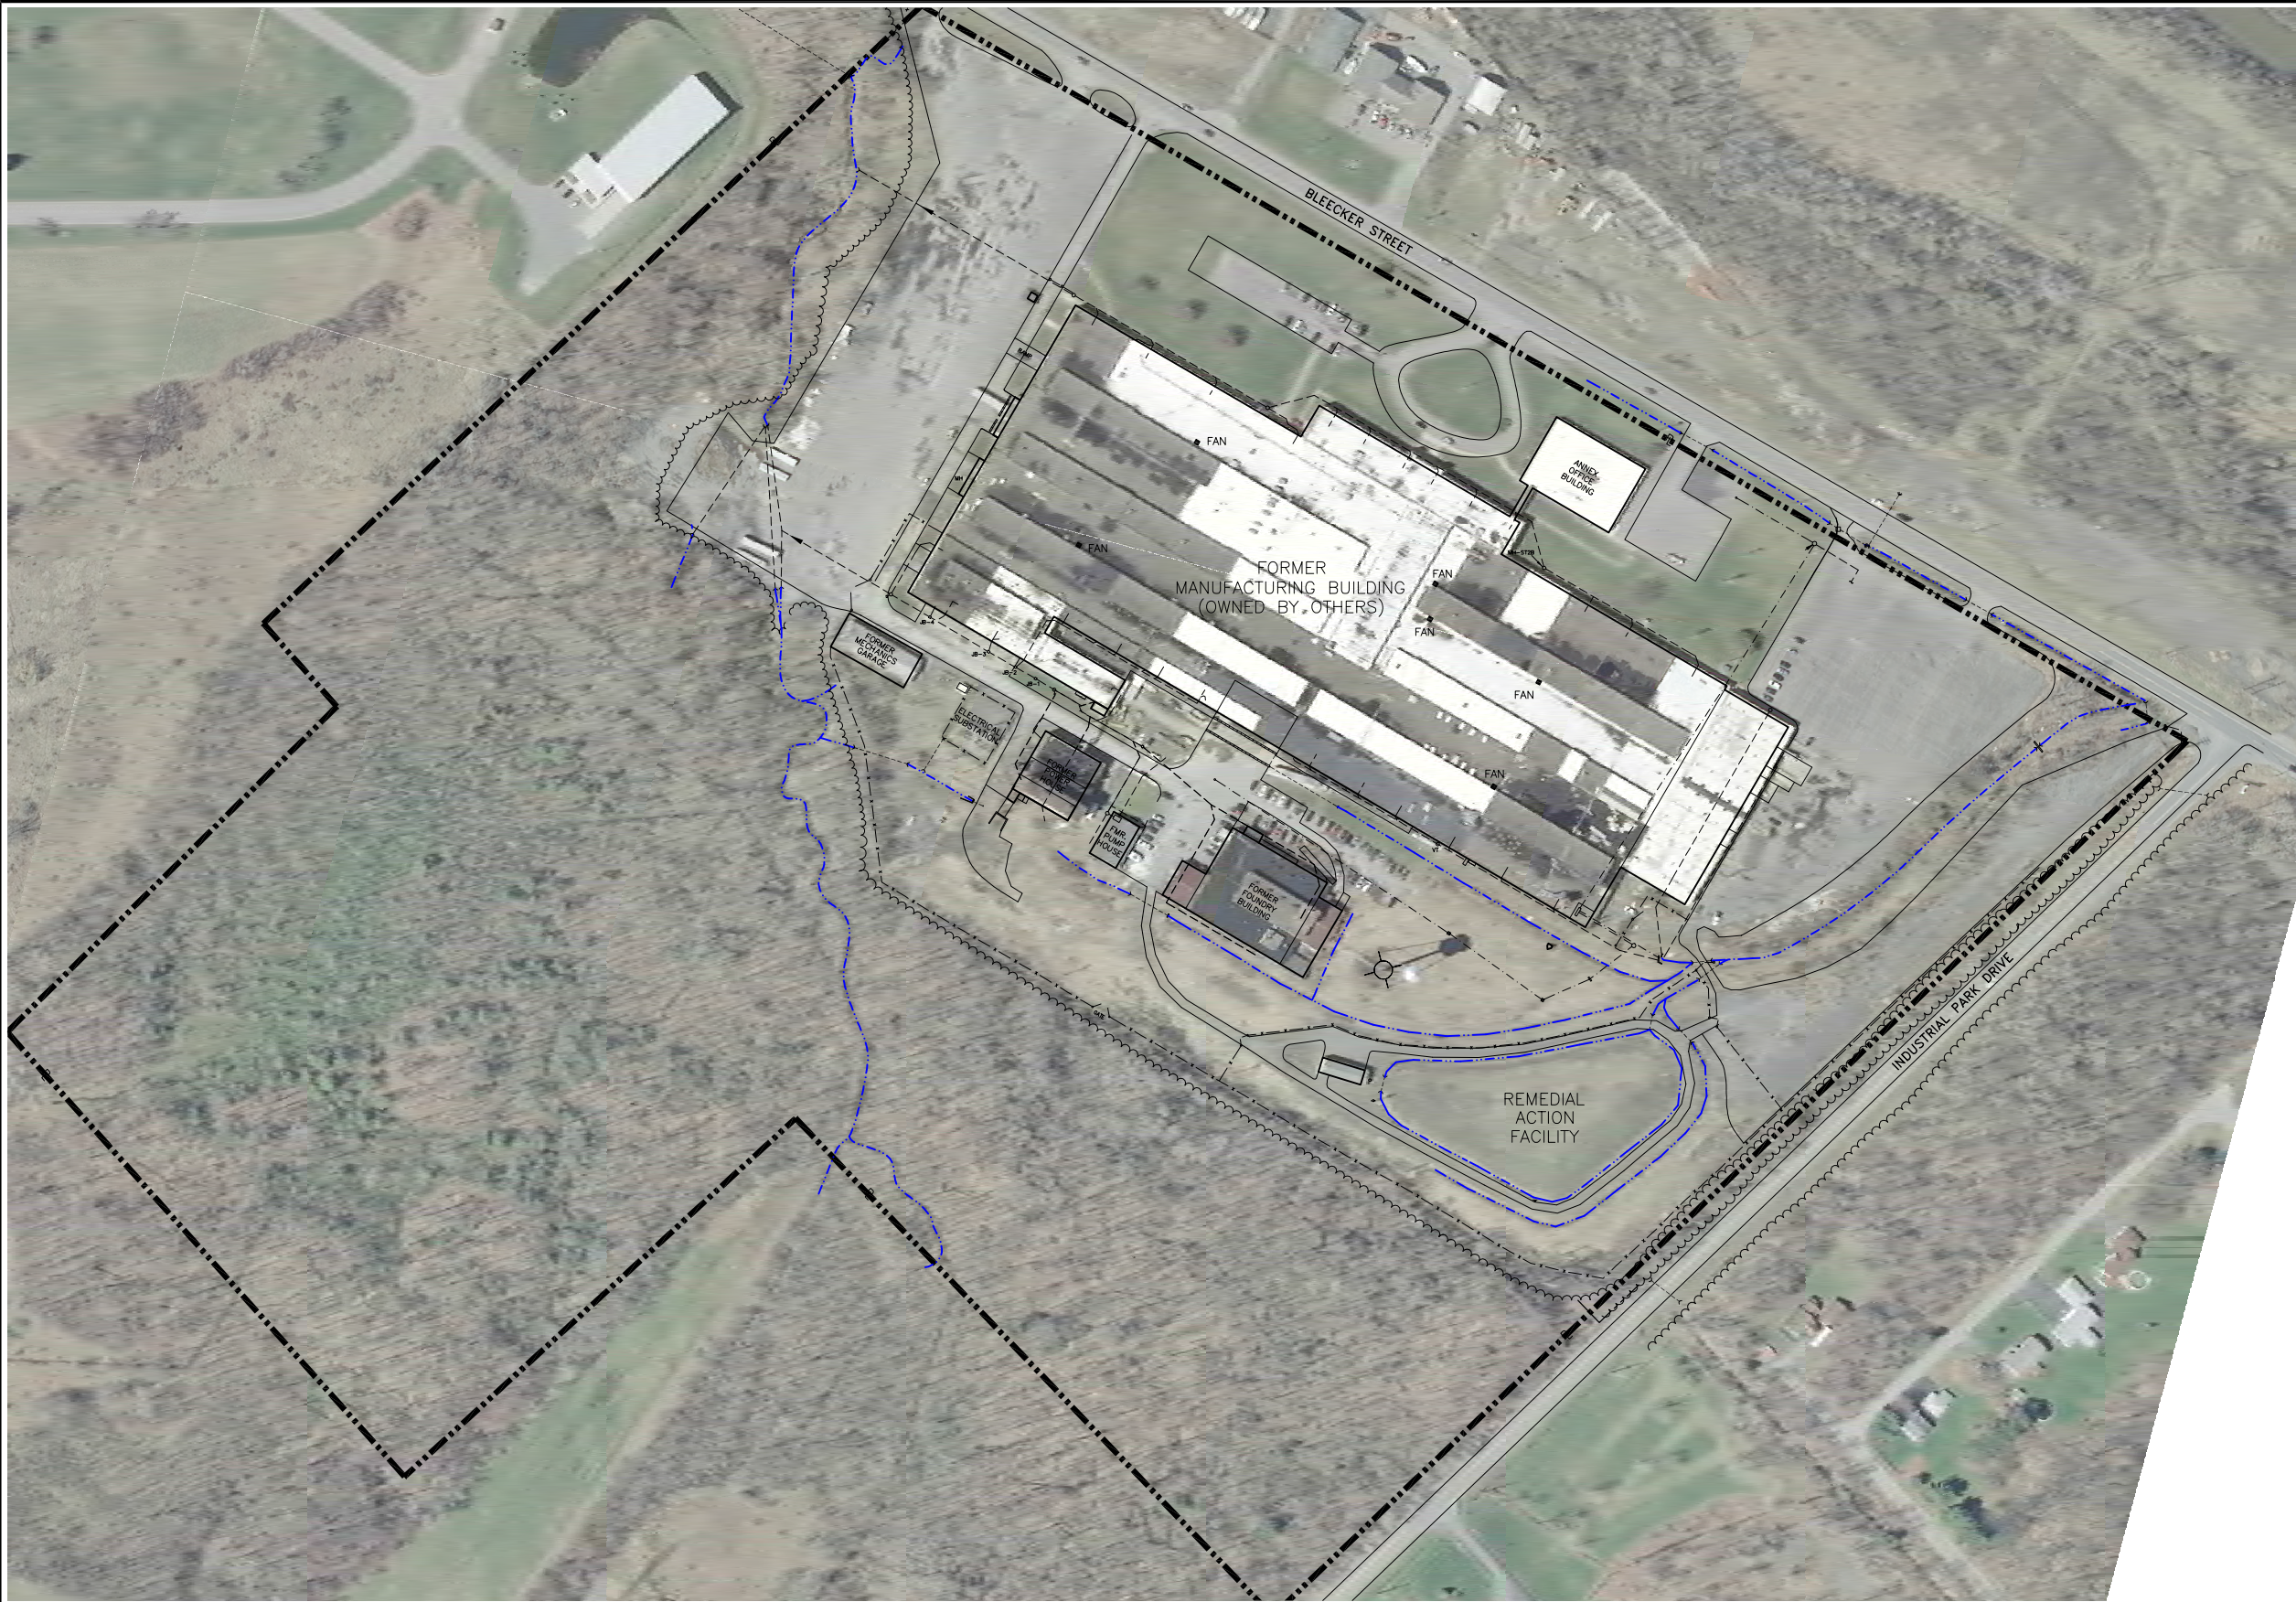
PROJECT NO.:
DANA 01-15
DATE:
FEBRUARY 2016
FIGURE NO.:
2-1

AERIAL PROPERTY MAP

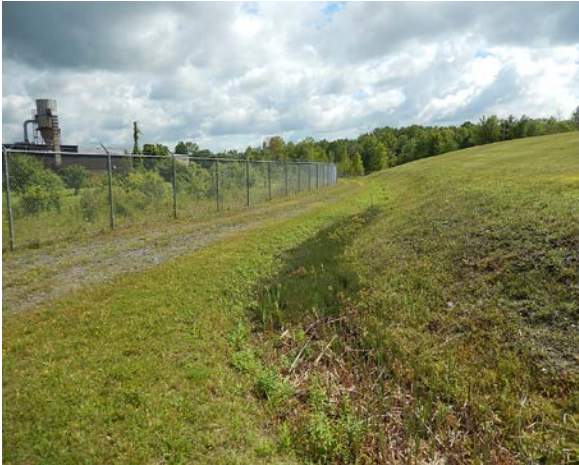
View of the containment cell from the west.

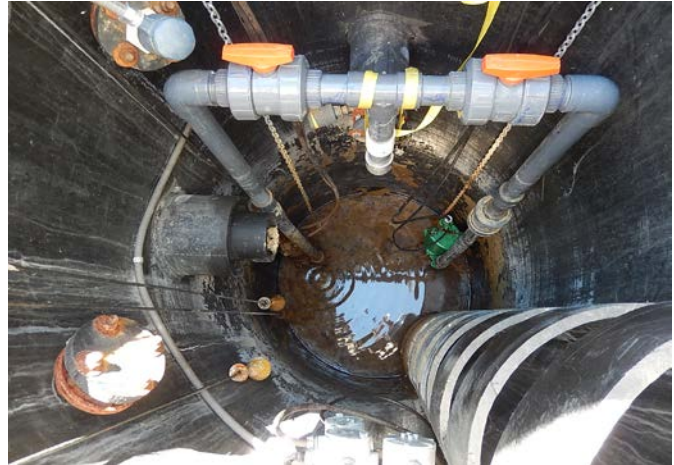
View of the leachate collection manhole with new lead pump installed.

- Replaced the lead pump in the leachate collection manhole;
- Replaced the flow totalizer register and installed a new remote reader for the totalizer;
- Elimination of persistent and damaging vectors from the containment cell;
- Placement and grading of top soil followed by seeding and mulch;
- Spot restoration of vegetative cover on the containment cell;
- Removal of woody vegetation; and
- General cleaning of the building.

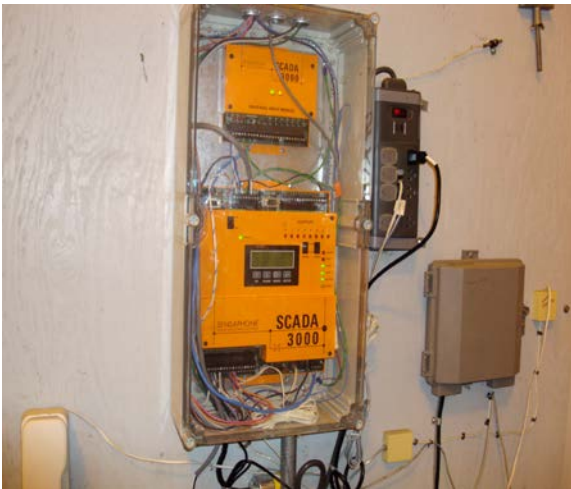
View of the SCADA 3000 auto-dialer from inside the RAF building.

The RAF building was viewed during the inspection for inconsistencies in the structural, security, electrical, and telephone systems, as well as assessing the condition of the heat and vent systems. The SCADA 3000 is located in the RAF building and provides continuous monitoring information of the leachate collection manhole (i.e., High Manhole Level, Manhole Leak and Pipe Leak) and the leachate storage tank (Tank Level, Tank High Level, Tank Leak Tank 90% Full and Tank Low Temperature). This system is generally accessed remotely via modem semi-monthly for data collection and management. In the event of an alarm condition, the auto dialer system alerts designated Synapse personnel based on the guidelines set forth in the OM&M Manual and the auto dialer program logic. The Auto Dialer Alarm Incident and Testing Report, Form F-1, included in Appendix C, provides documentation of alarm conditions received, if any, and testing during the 2015 calendar year. An annual total system check was performed on December 2, 2015, as required, and documented on Form F-1. Two RAF alarms were triggered during the 2015 monitoring period, associated with Channel No. 5, triggered by surface water collecting in the manhole interstitial space; this condition was contributed to the manhole cover leak and a malfunctioning interstitial space probe.

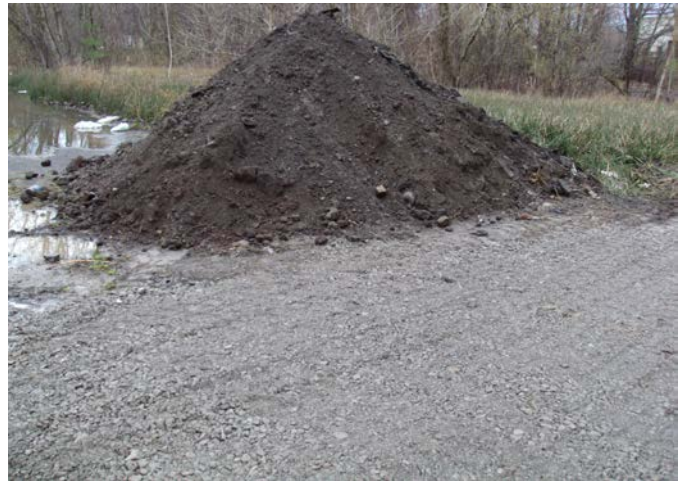
View soil pile in the west parking lot from the 4/2015 unauthorized excavations conducted by 2200 BSP.

NYSDEC issued a letter in October 2015 to both 2200 BSP and UHC requiring the off-site disposal of two of the three soil piles generated by 2200 BSP's unauthorized excavation activities. NYSDEC's letter did not specify the party responsible for soil disposal. UHC undertook the characterization and disposal of the two soil piles at its own expenses, resulting in the disposal of approximately 398 tons of soil at Seneca Meadows landfill in Waterloo, New York in December 2015. Weight tickets and non-hazardous manifests are provided in Appendix A. The third soil pile, located in the southeast parking lot, remains and NYSDEC has requested this pile be spread-out and seeded to prevent erosion.

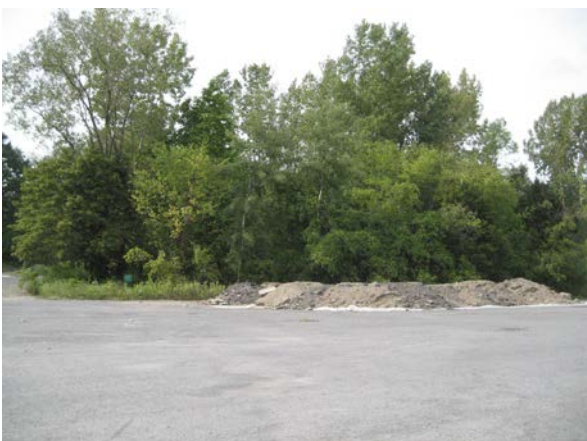
View soil piles in the west parking lot from the 9/2012 unauthorized excavations conducted by 2200 BSP (October 2014).

In a letter dated March 6, 2014, NYSDEC directed 2200 BSP to develop and implement a Workplan to characterize the two soil piles located at the southwest and southeast parking lots. 2200 BSP issued a revised Workplan in December 2014 at the request of NYSDEC to address the third soil pile that was generated during the repair of the sink hole for which UHC was not notified.

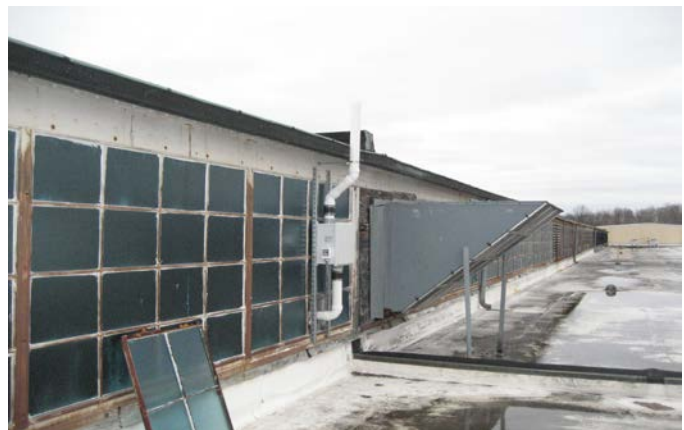
Typical SSDS fan mounted to the upper monitor windows of the 2200 Bleecker Street building.

The above referenced alarms, requiring a Property visit to restart the fans are attributed to a power failures or power surges associated with the Main Buildings' electrical system, which the SSDS is powered.
