2023 SAMPLING REPORT

**HITEMAN LEATHER SITE
NY Route 51
West Winfield, NY 13481**

NYSDEC SITE NO.: 622007

December, 2023

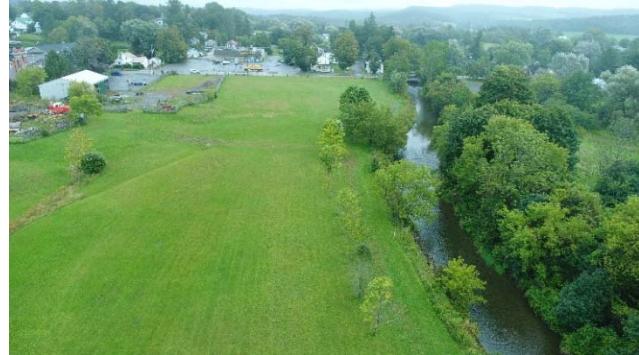
Main Site

Due to historic leather tannery operations, metals contamination was documented at levels requiring interim remedial measures. After site planning, investigation and design, soil was excavated and much was placed in a consolidation area on the site. Polyethylene liners and soil cover were installed to help protect the area.

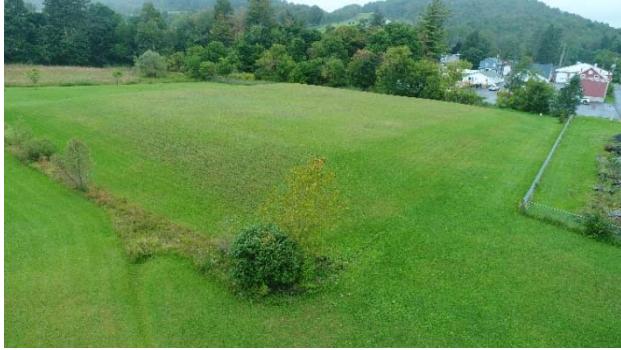
The Lined Consolidation Area as well as the Soil Cover System exhibited little to no erosion. Our September 19, 2023 site inspection, as well as August 29, 2023 water sampling activities, revealed no significant changes at the Site.

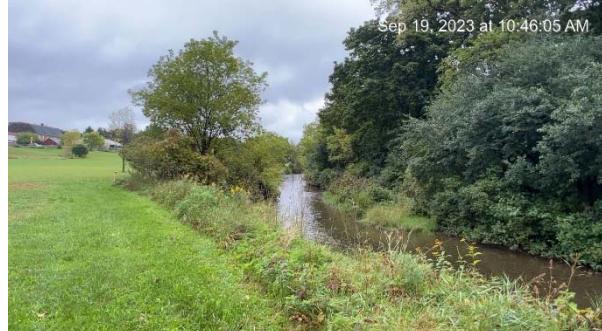
- Subsurface soil demarcation areas appeared undisturbed.
- Site Drainage and designated swales were in good condition
- no evidence of intrusive activities was observed
- North and east perimeter fence was satisfactory.
- Minor displacement of rip-rap was observed at the Unadilla River streambank along the West End. While not significant it should be replaced. The remaining stream bank appeared satisfactory.
- At Crumb Trailer Park, the west end of the chain-link fence fence-line should be re-set or replaced.

- Continue groundwater monitoring to document effectiveness of the remedy,
 - Continue site inspection to verify site conditions;
 - Retain a certified herbicide applicator to develop plan to eradicate Japanese Knotweed discovered on site.
 - Monitoring of the stands of Phragmites yearly to determine if they are expanding
 - Replace minor rip-rap dislodged from Unadilla River streambank along the West End.
 - At Crumb Trailer Park, the west end of the chain-link fence fence-line should be re-set or replaced.
-

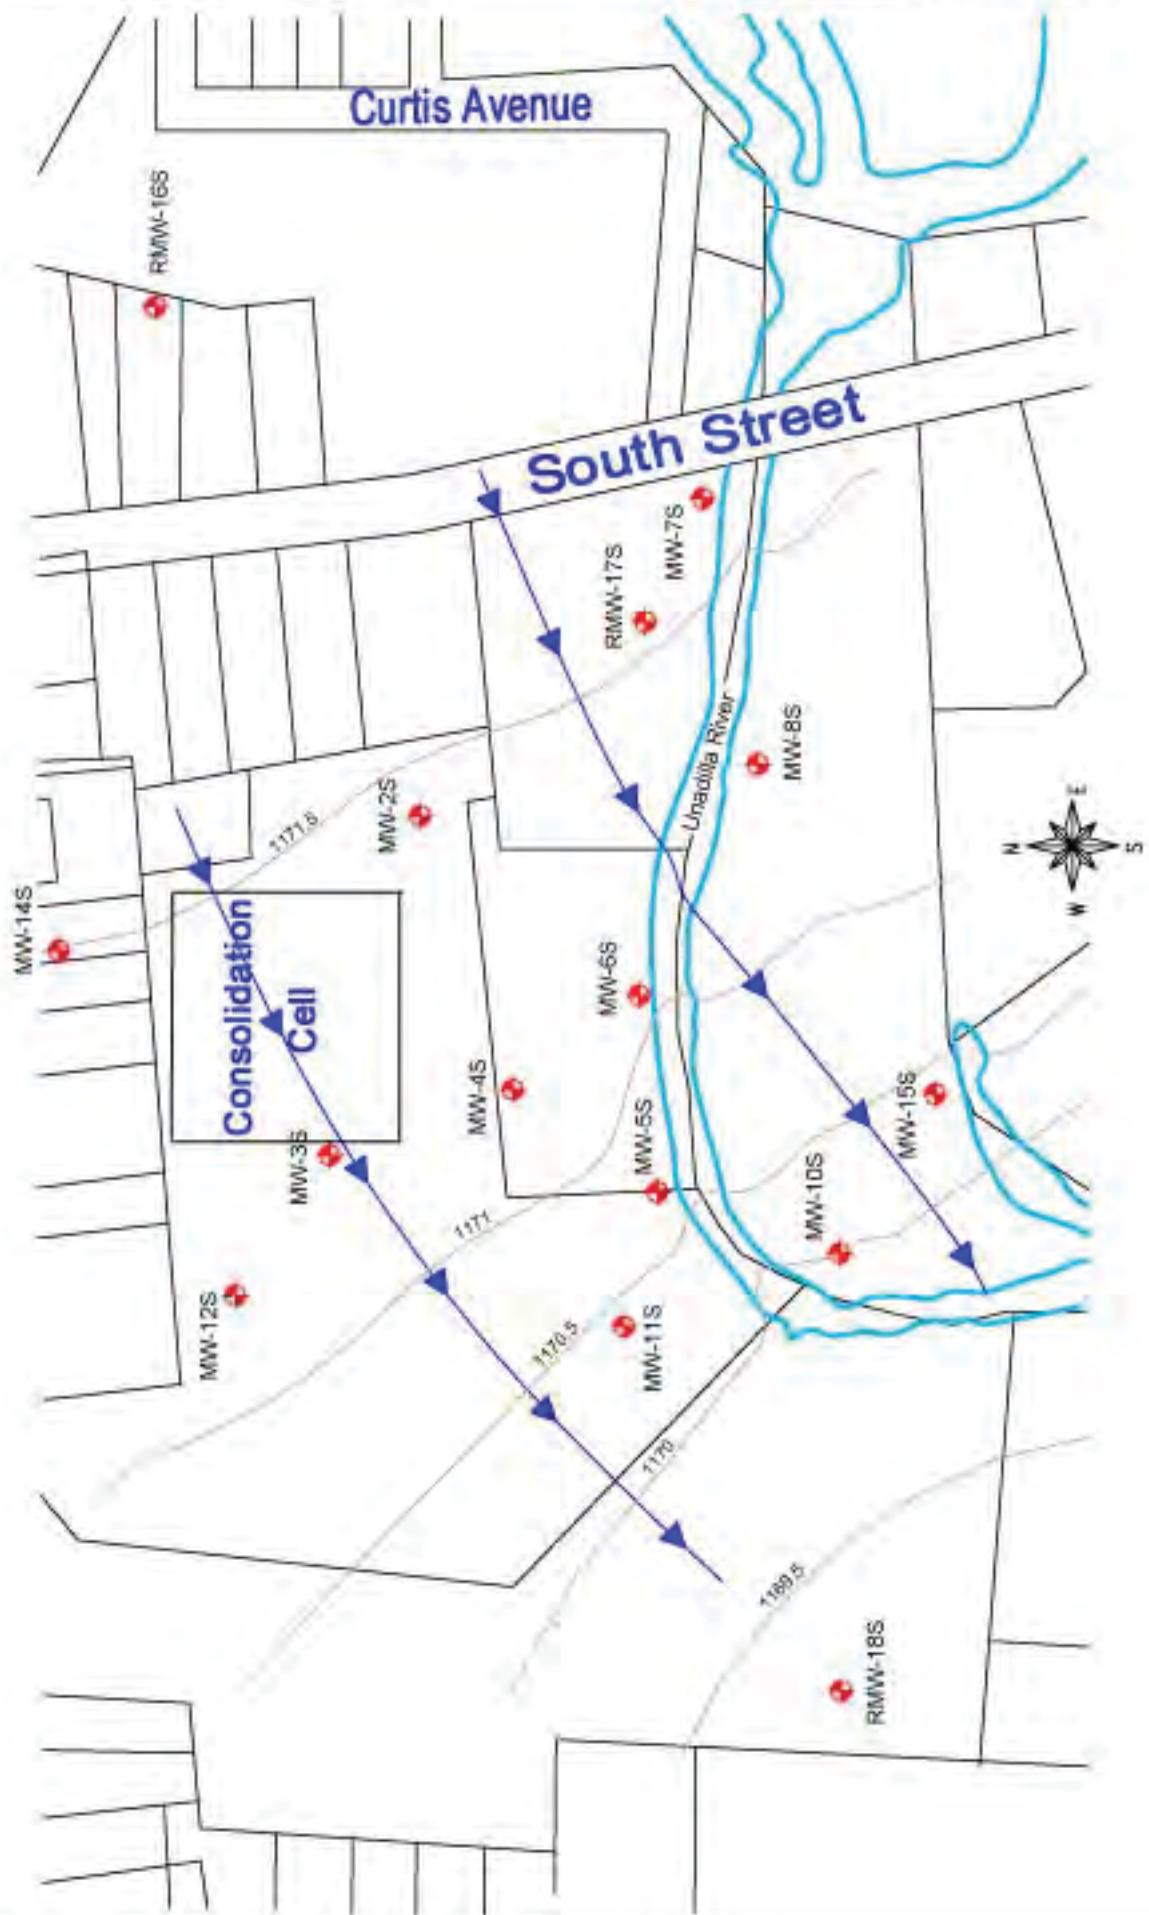
Figure 4
Groundwater Flow Map
Site Manager Plan
Hieman Leather
West Winfield, New York

- MW-11S SHALLOW MONITORING WELL LOCATION
- APPROXIMATE GROUNDWATER FLOW DIRECTION

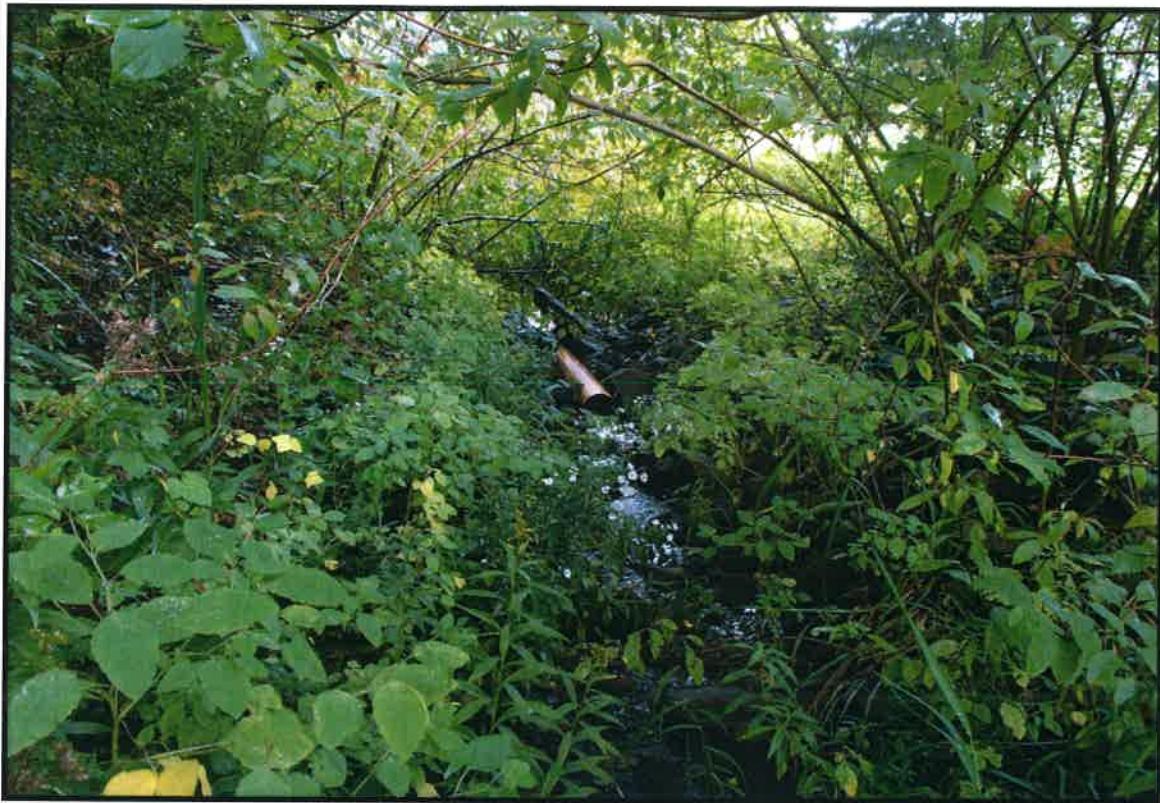
The wetland in the western portion of the property remains dominated by cattail (*Typha latifolia*), Joe-pye-weed (*Eupatorium maculatum*), late goldenrod (*Solidago gigantea*), and other Palustrine emergent wetland species of Forbes and grasses. The wetland has not changed its hydrologic character, species composition, or structure in the past five (5) years. The wetland also appears stable in its functions and benefits. The wetland outfall to the Unadilla River was noted as intact and functioning. The 6" PVC pipe and rip-rap area of the outfall were clear of debris and obstructions. It was evident that water flows through the pipe and rip-rap during periods of high water, as intended.

Photograph 1) View of the wetland outfall pipe and rip-rap area at the confluence of the wetland drainage and the Unadilla River.

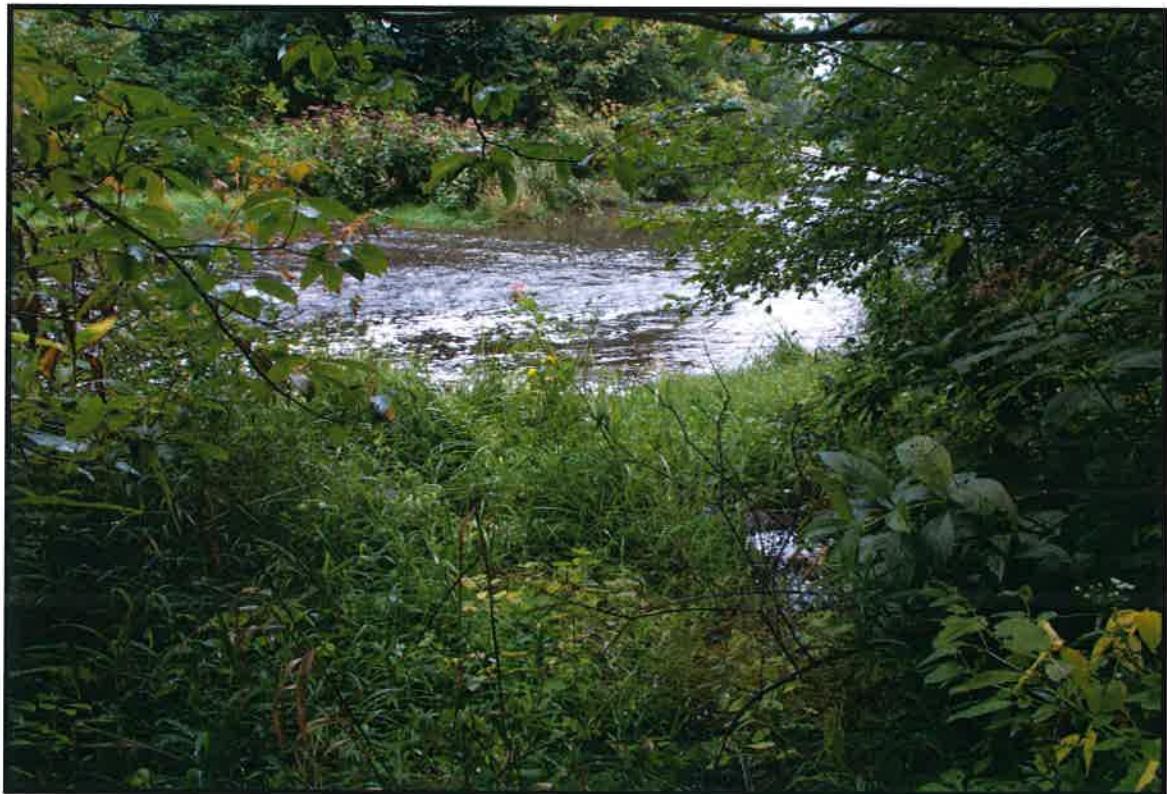
Photograph 2) View of the confluence of the wetland outfall and Unadilla River.

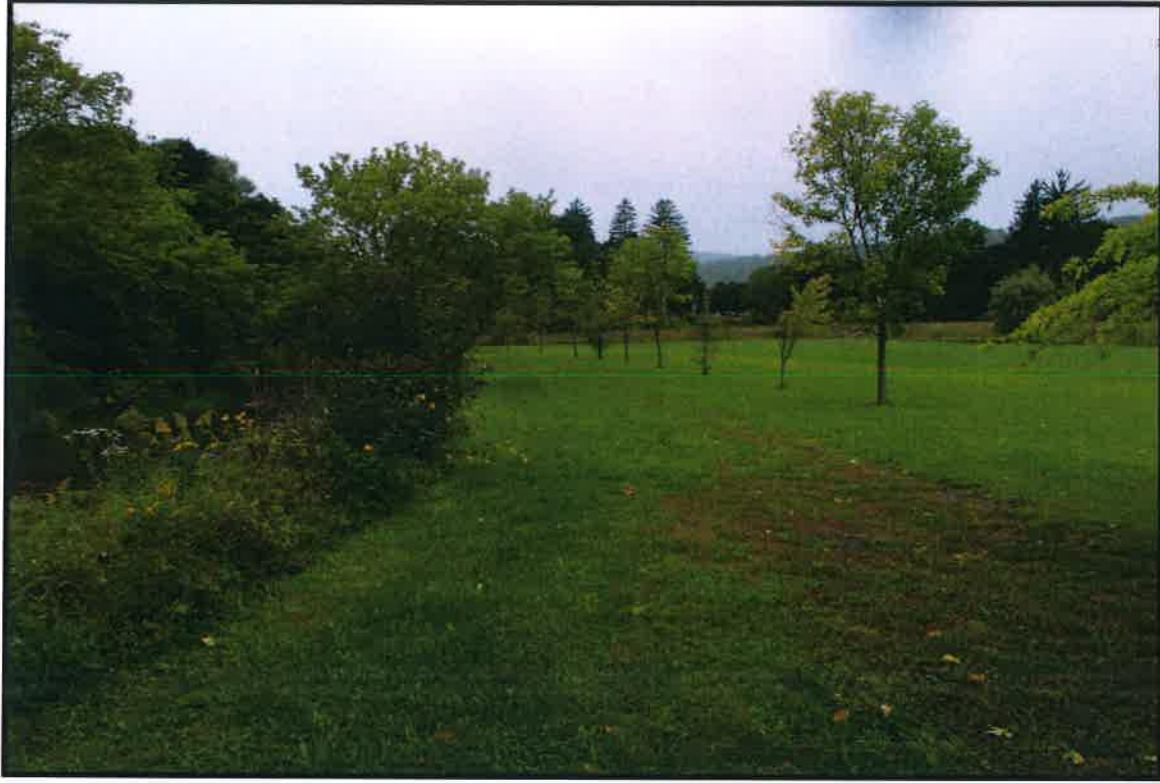
The banks of the Unadilla River were fully vegetated with grasses, Forbes, shrubs, and trees. The vegetation and their roots maintain the stability soils of the bank of the river. The banks appeared stable and intact and no erosion or slumping of the bank was observed.

Photograph 3) View of the bank of the Unadilla River upgradient of the wetland outfall.

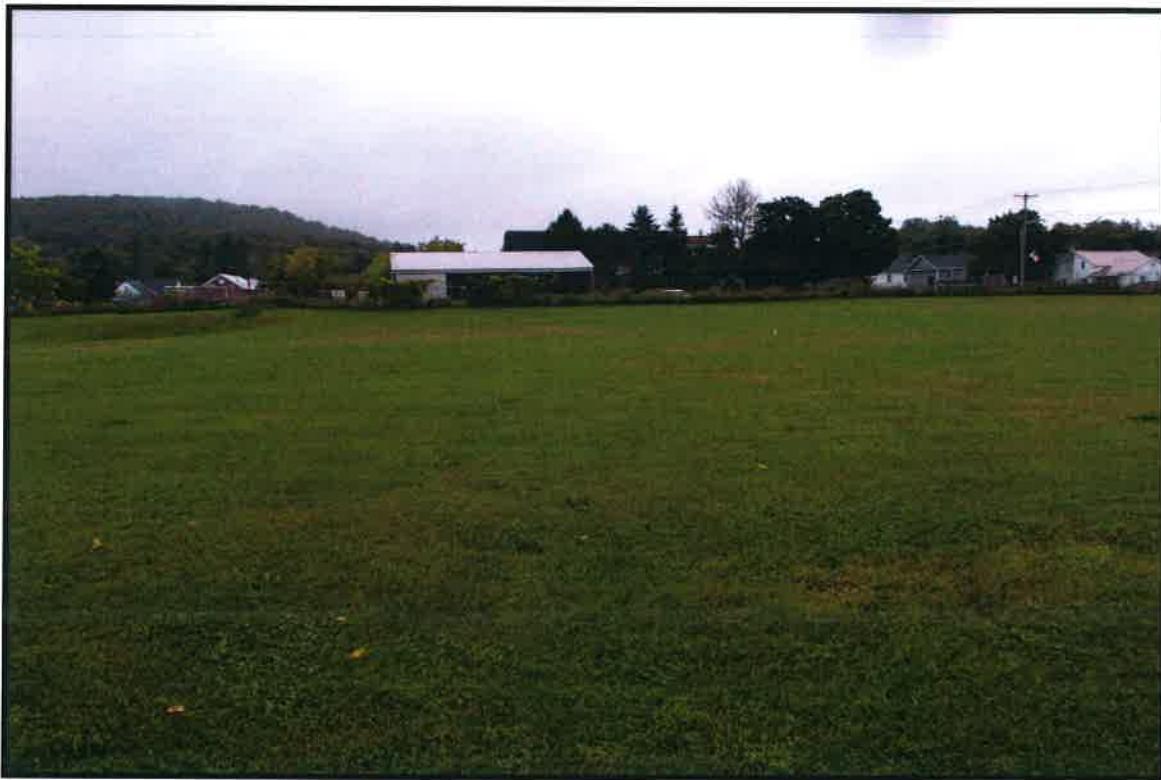
Photograph 4) View of the interior of the Site.

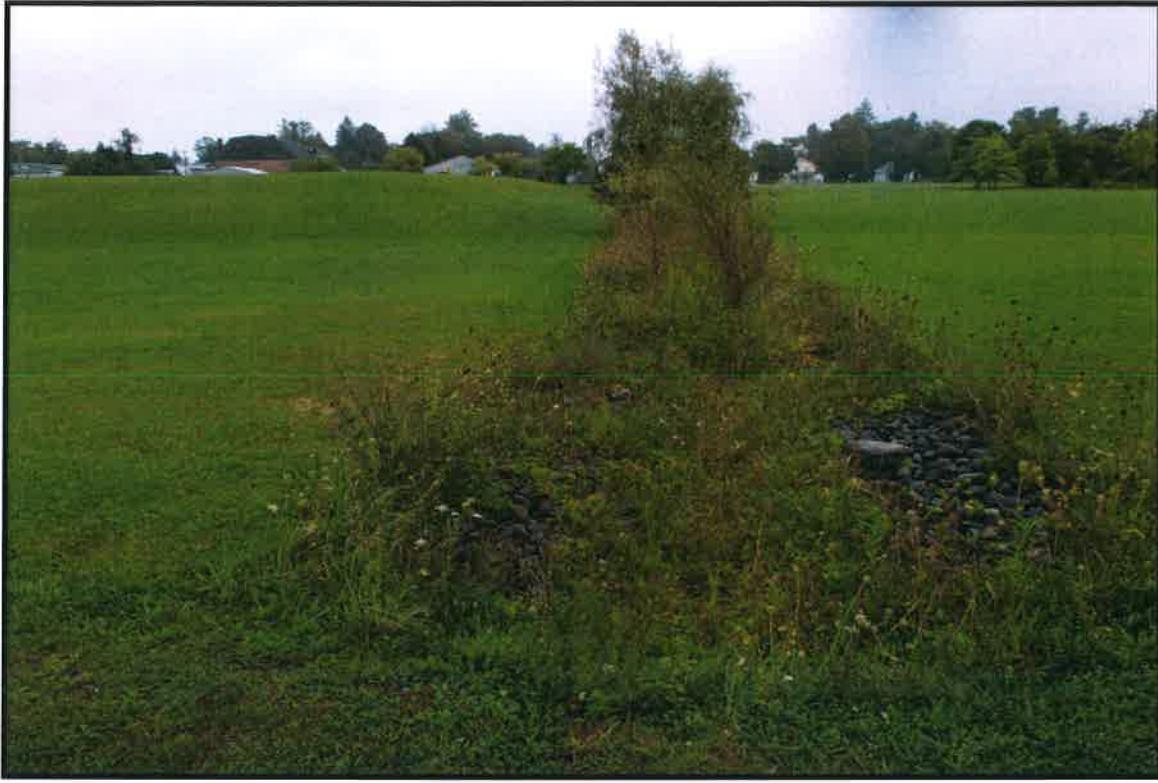
The central linear drainage was collecting and transferring water to the culvert pipe under the access path. The vegetation along the drainage had been cut as per NCES's recommendation in 2019 ("to increase flow and improve drainage, the swale could be cleared of vegetation in the future"). The vegetation has regrown, but allows for the unrestricted flow of water

through the ditch. The culvert under the access path was found to be in good condition and water was flowing freely through the pipe to the emergent wetland to the west.

Photograph 5) View of the central linear wetland ditch in the center of the Site.

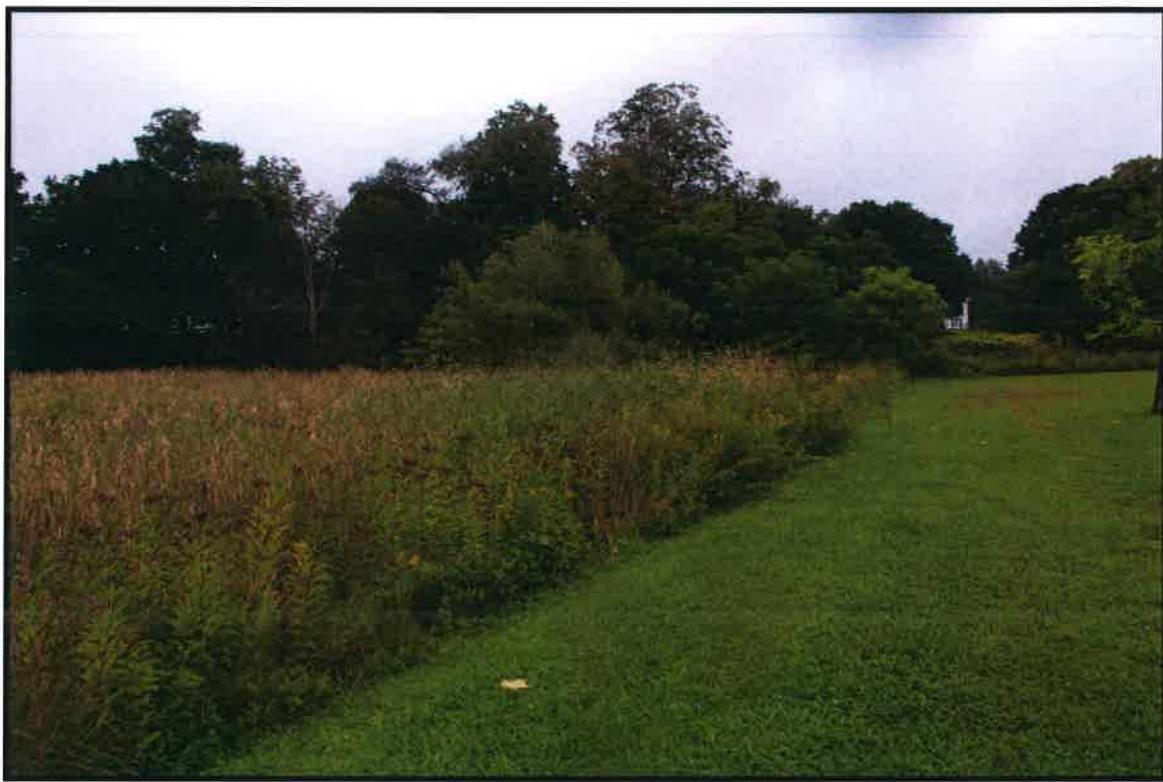
Photograph 6) View of the edge of the lawn and large wetland complex.

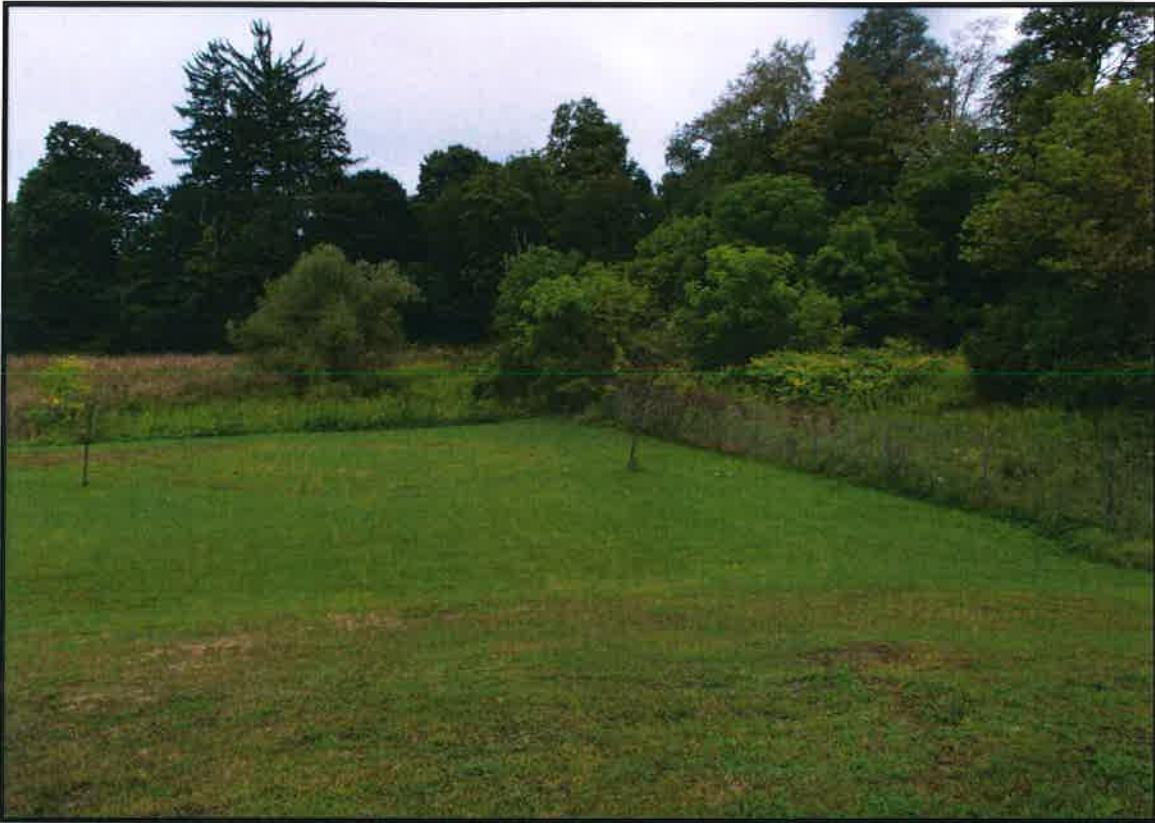
During the field inspection, the Japanese Knotweed (*Fallopia japonica*) that is located within the inside of the chain link fence in the northwest corner of the site, had been cut. It appears the knotweed was cut as part of the routine mowing of the property. The presence of the plant is a result of an established stand of Japanese Knotweed found adjacent to the site, and abutting the fence at this location. Based on previous reports for the site, the plants have not spread significantly from 2012 to 2021. NCES recommends, as was recommended in 2019, leaving the area surrounding the Japanese Knotweed un-mowed and fallow. As stated in the 2019 report, one method Japanese Knotweed spreads is through fragmentation by the mowing/cutting of the plant's stem. The mowing of the stand only promotes its potential spread to other areas of the property. It appears that the native vegetation surrounding the Japanese Knotweed is keeping it from spreading into the Site, and also on the adjacent property.

Photograph 7) View of the Japanese Knotweed that is located in the northwest corner of the Site.

To combat the spread of both Japanese Knotweed and Phragmites, NCES recommends that consultation with a certified herbicide applicator be conducted to develop a plan for the eradication of the on-site plants. The method to manage these species includes applying herbicide to the cut stalks in September, prior to the plant going dormant for the winter. The cut portion of the plants are bagged and disposed of in a landfill.

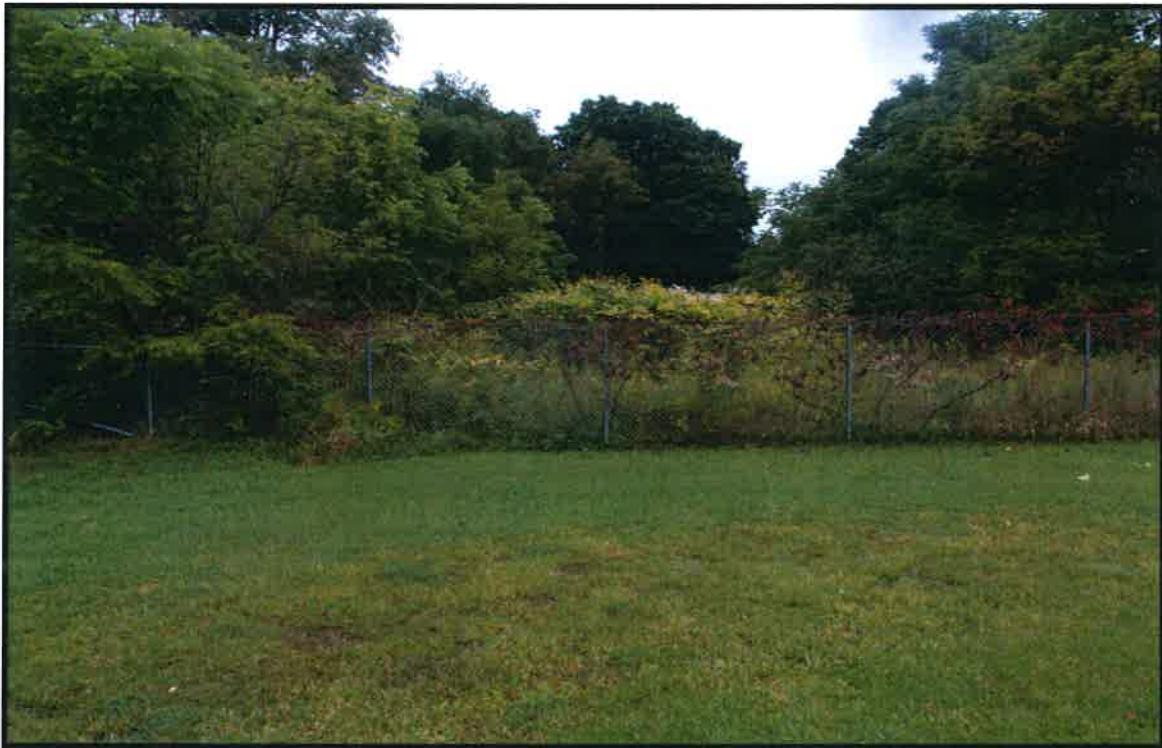
Photograph 8) View of the Japanese Knotweed at the fence, and just beyond the property boundary.

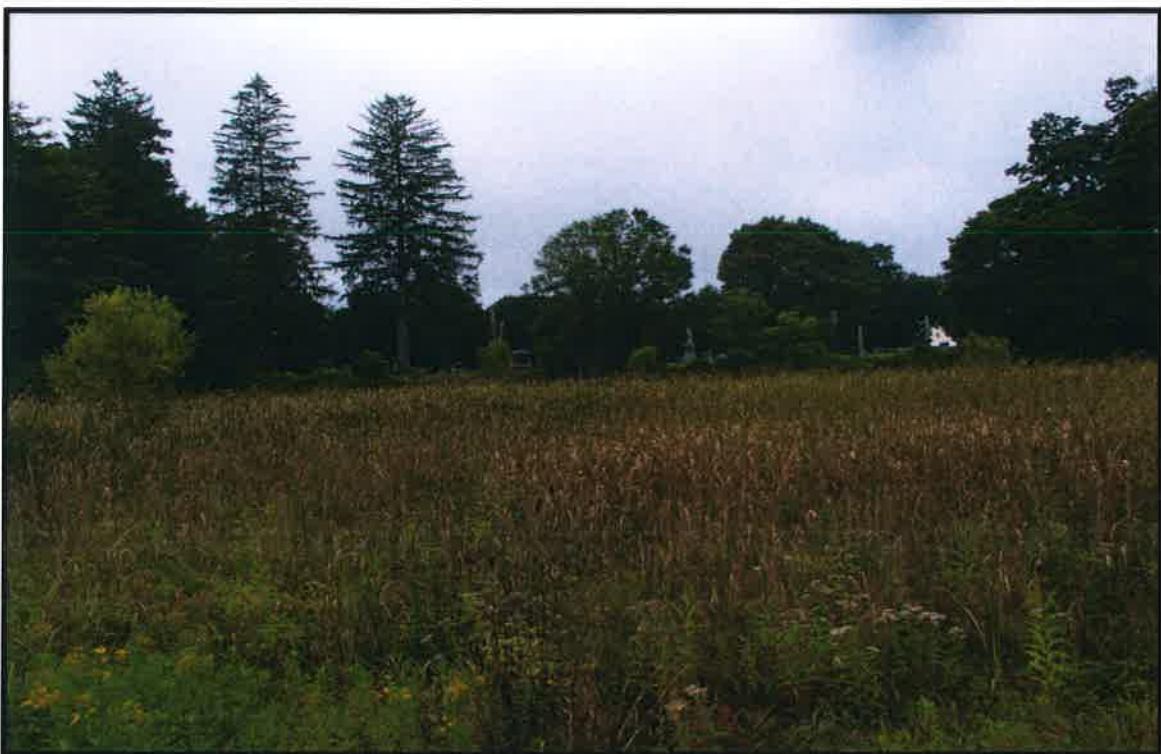
Photograph 9) View of the main wetland complex.

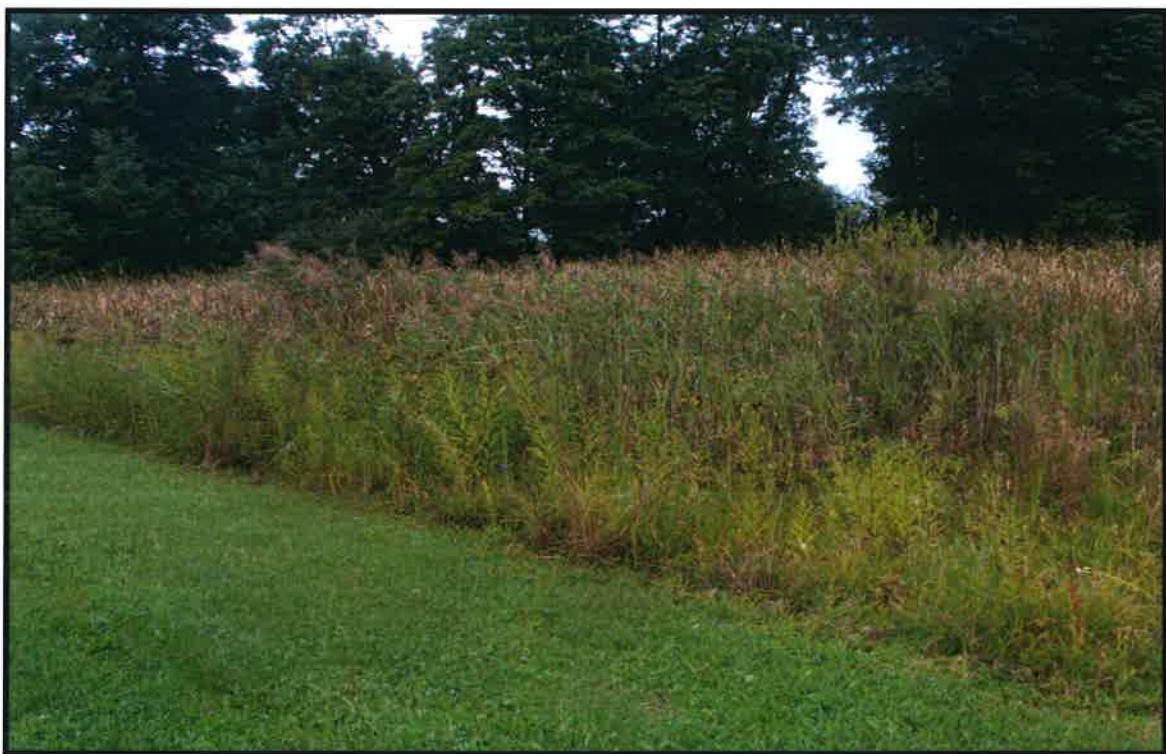
During the field inspection, Common Reed (*Phragmites australis*) was again noted within the wetland, primarily along the eastern edge of the wetland. Phragmites is a common invasive species within wetlands and can spread by seed dispersal or by rhizomes spreading from established plants. There are now three (3) distinct patches that cover an area of 20' x 30' each. The stands of Phragmites within the wetland do not appear to have enlarged since reported in 2019. The Phragmites, while still present are not spreading and are occupying their current location.

Photograph 10) View of the Phragmites within the main wetland complex.

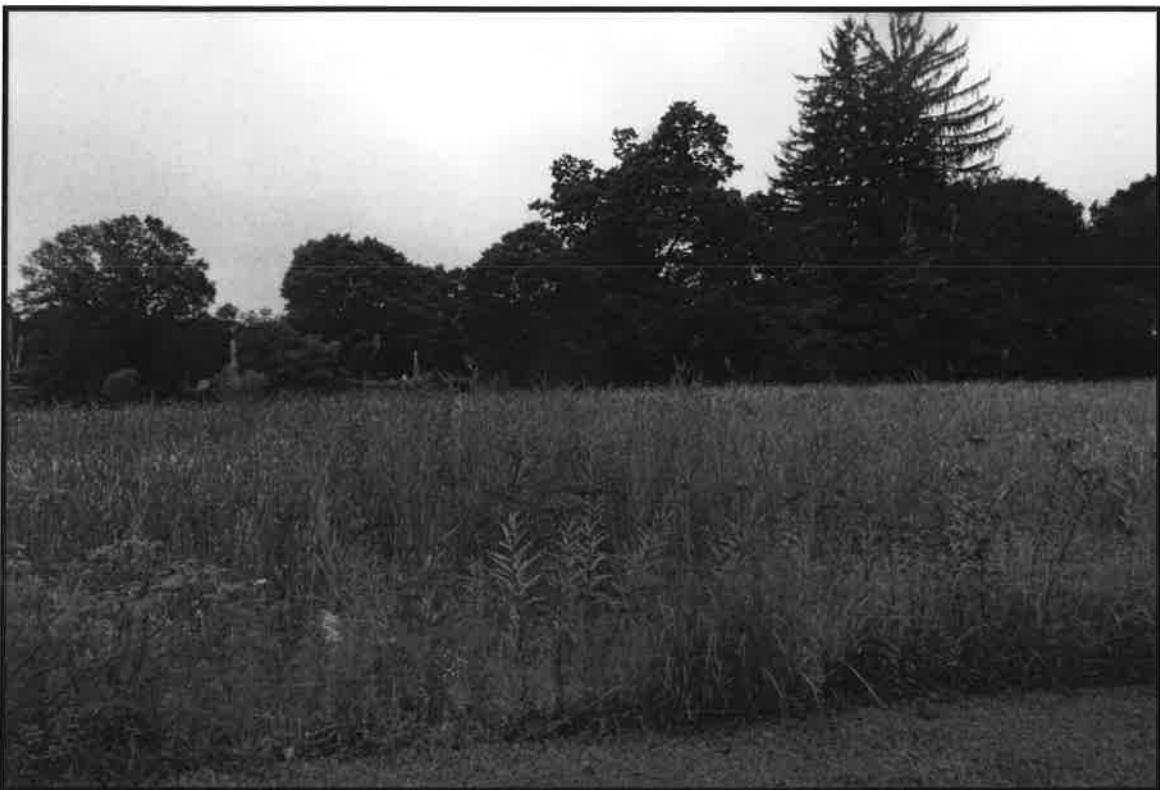
Photograph 11) View of one of the three Phragmite patches in the wetland.
