**Union Fork & Hoe Site  
HERKIMER COUNTY, NEW YORK**

**Final Engineering Report**

**NYSDEC Site Number: 622011**

**Prepared by:**  
Tetra Tech  
3136 S. Winton Drive  
Rochester, NY

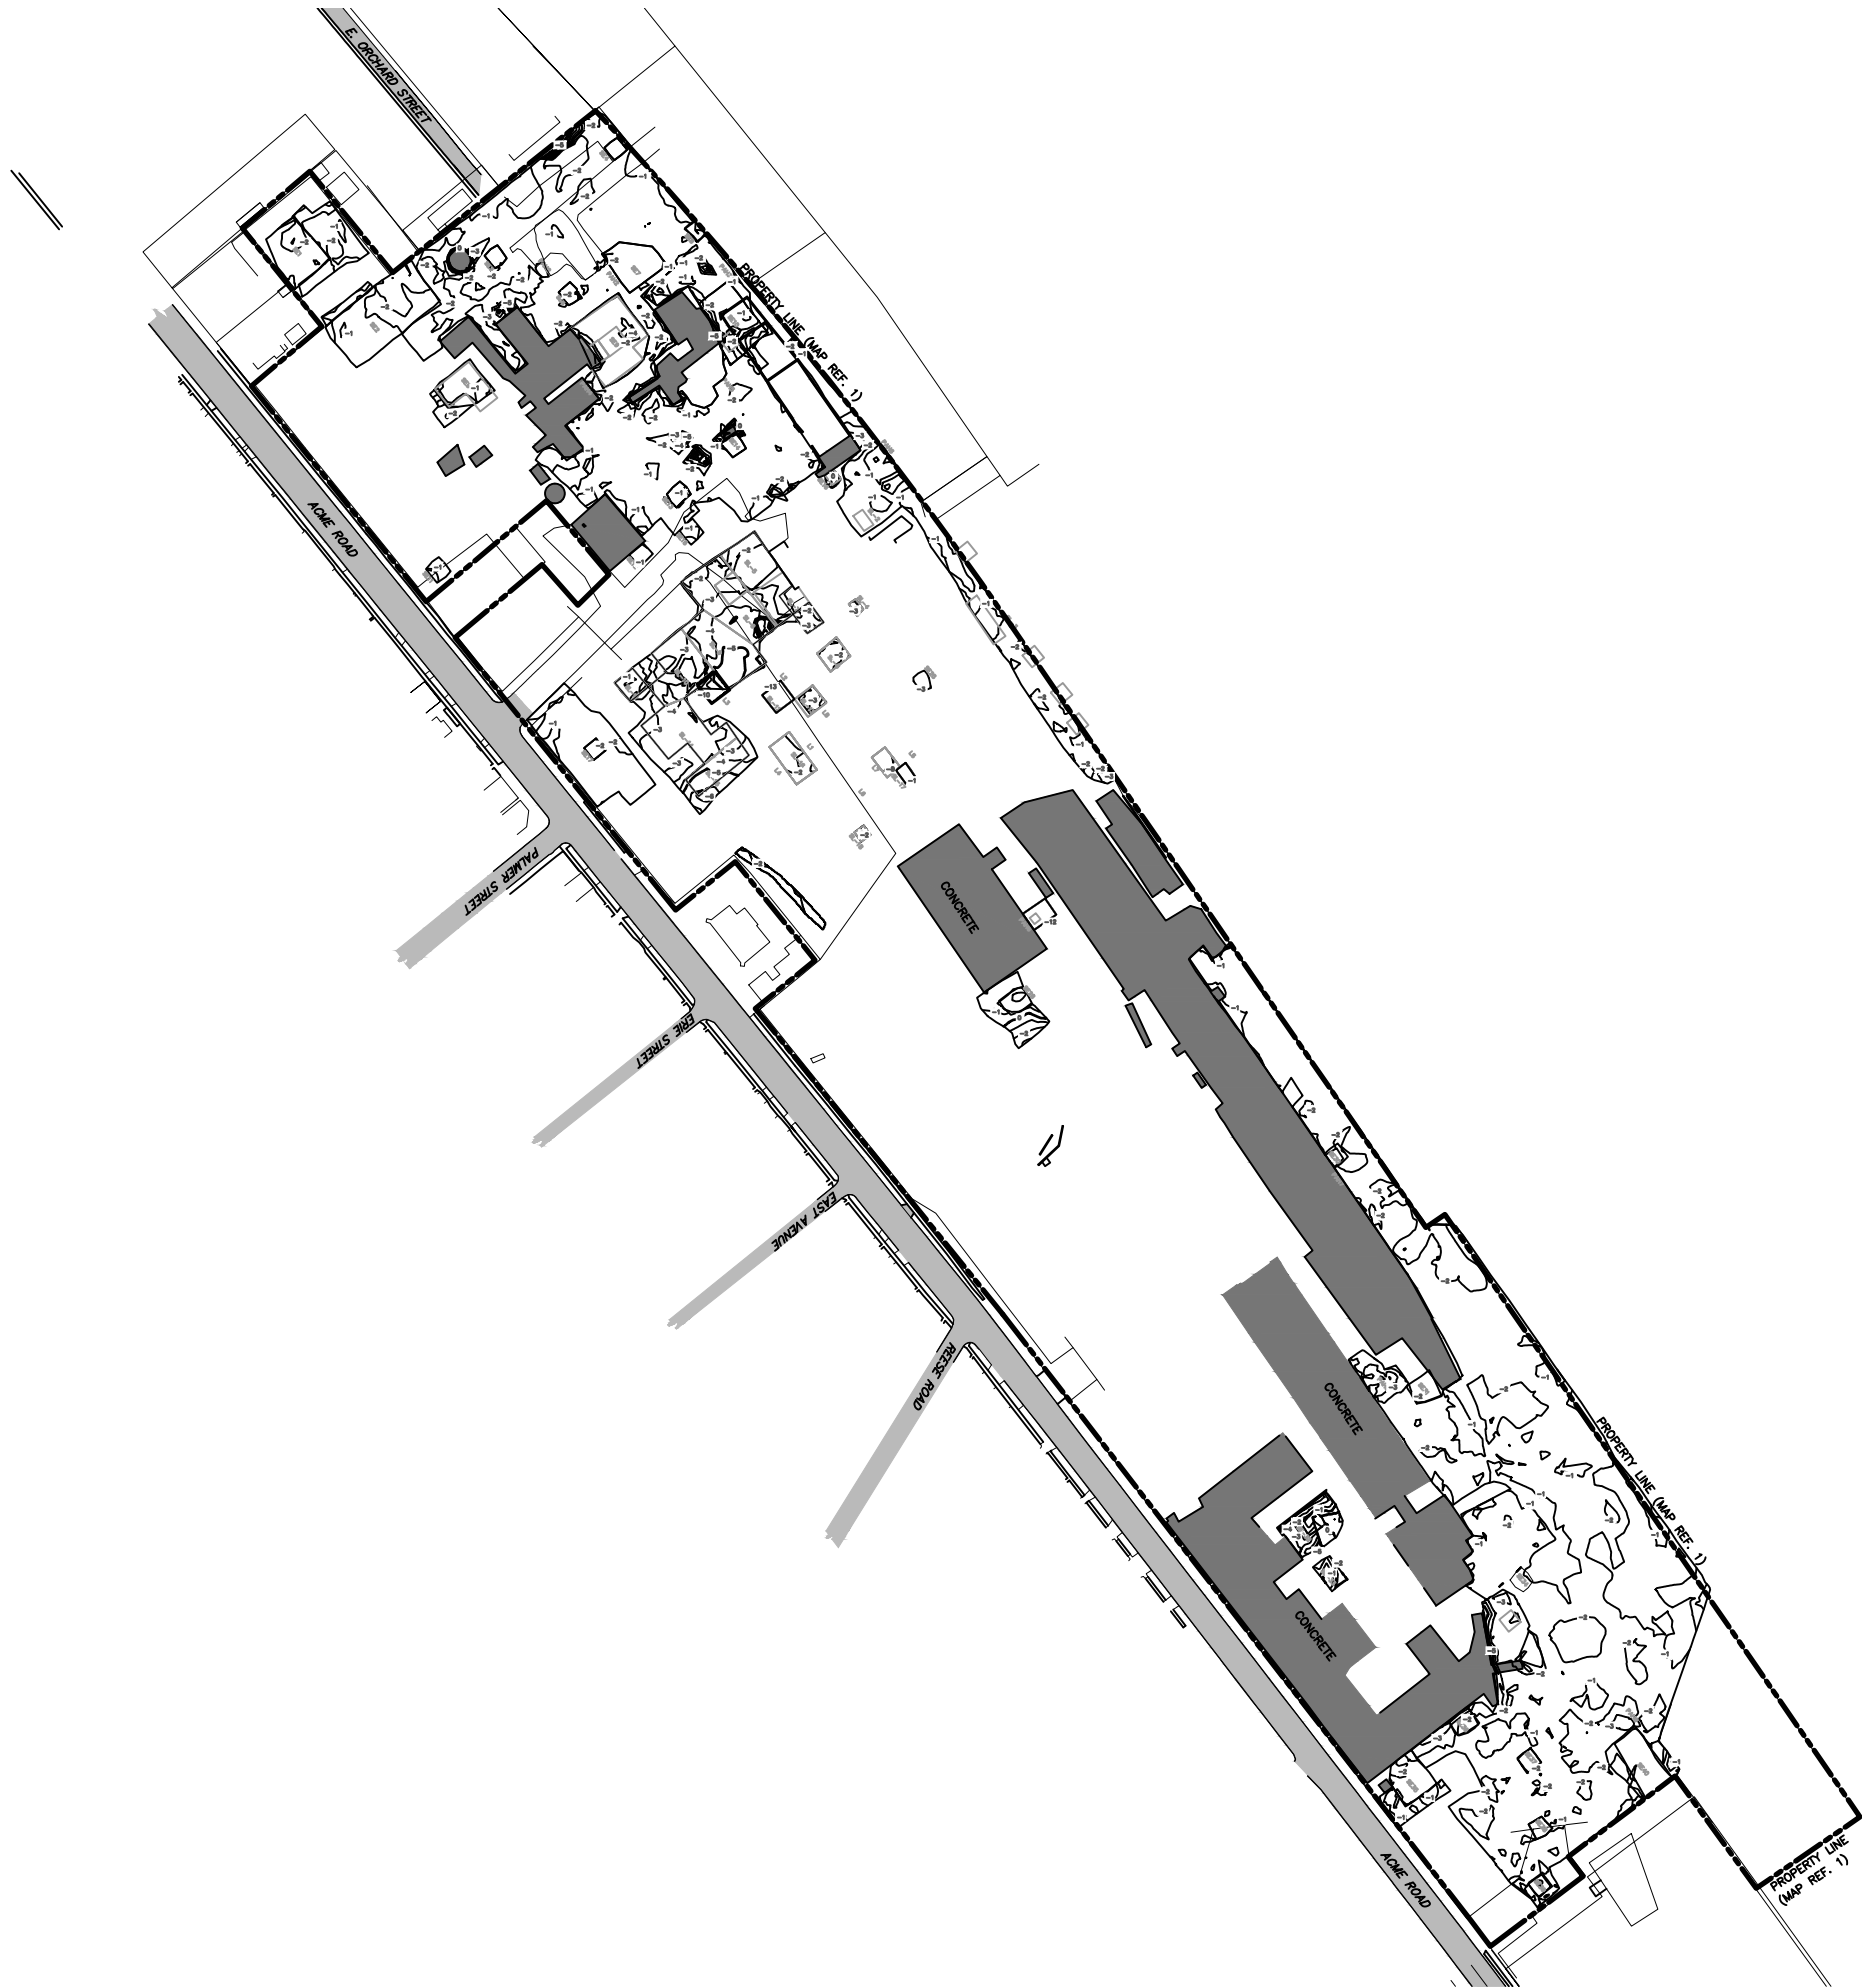
- 1--- EXCAVATION BELOW GROUND SURFACE
- PROPERTY LINES
- ORIGINAL EXCAVATION EXTENTS
- CONCRETE
- ASPHALT
