SITE MANAGEMENT

ANNUAL REPORT 2012 CALENDAR YEAR

ROSE VALLEY LANDFILL
RUSSIA (T)

SITE NO. 622017
HERKIMER (C), NY

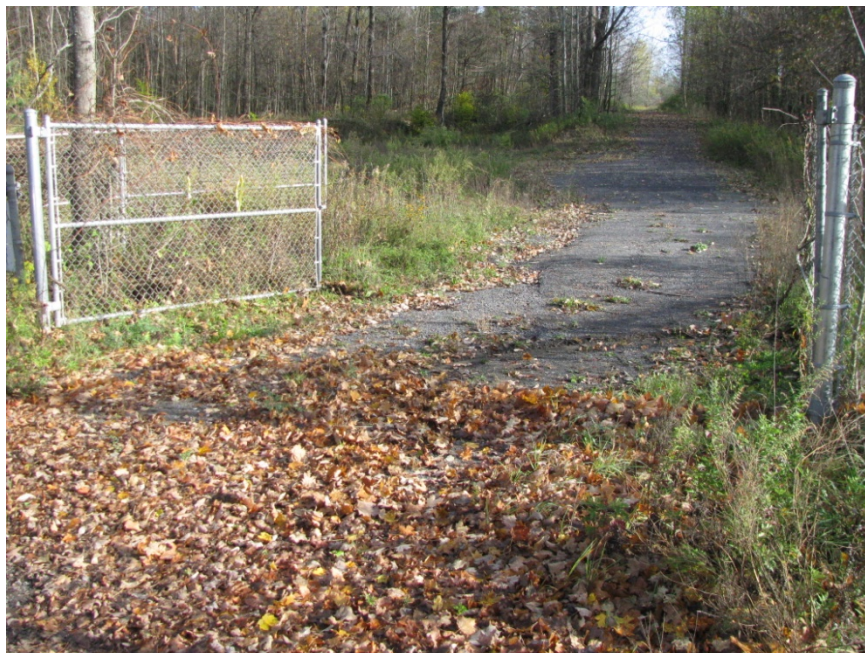
Photo 3: 10/17/12 Erosion/rilling in access road. Conditions are similar to those documented in July 2011 site inspection.

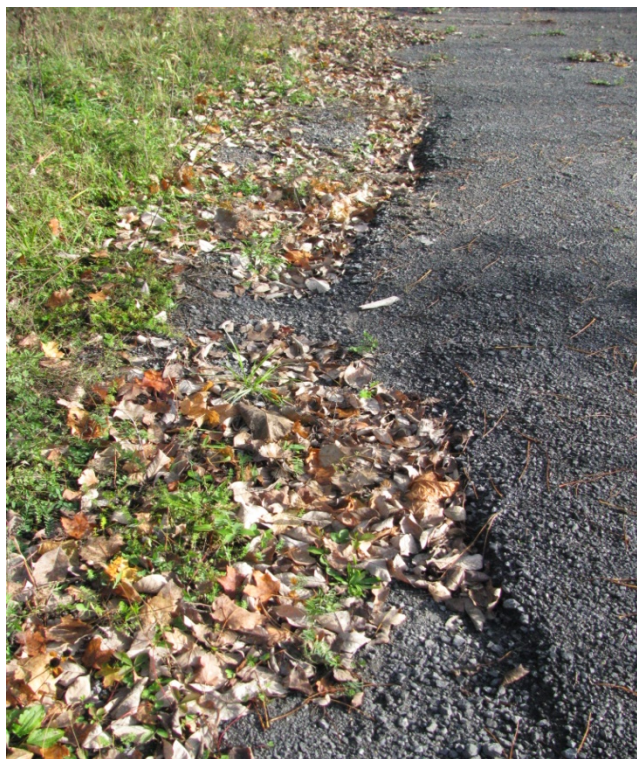
Photo 4: 10/17/12 Close-up of erosion/rilling in access road shown in Photo 3.

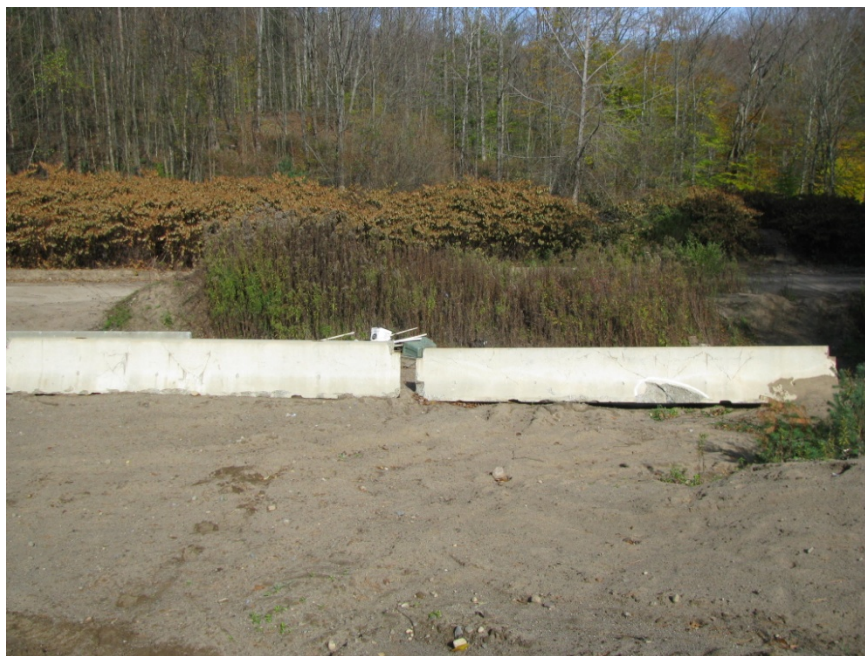
Photo 5: 10/17/12 Jersey barrier installed near Military Road to limit site access and trash disposal.

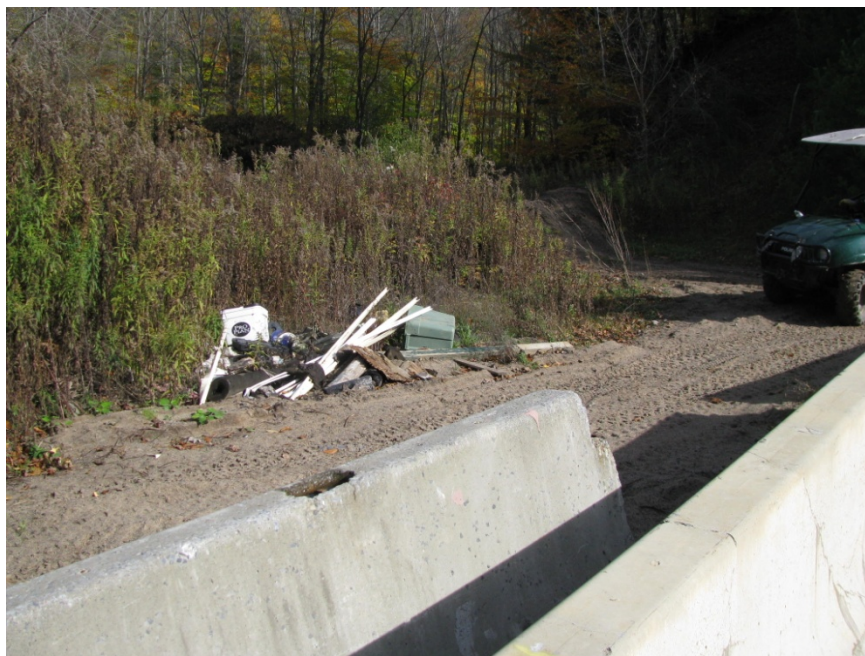
Photo 6: 10/17/12 Trash dumped on the northern side of the Jersey barrier between the barrier and Military Road.

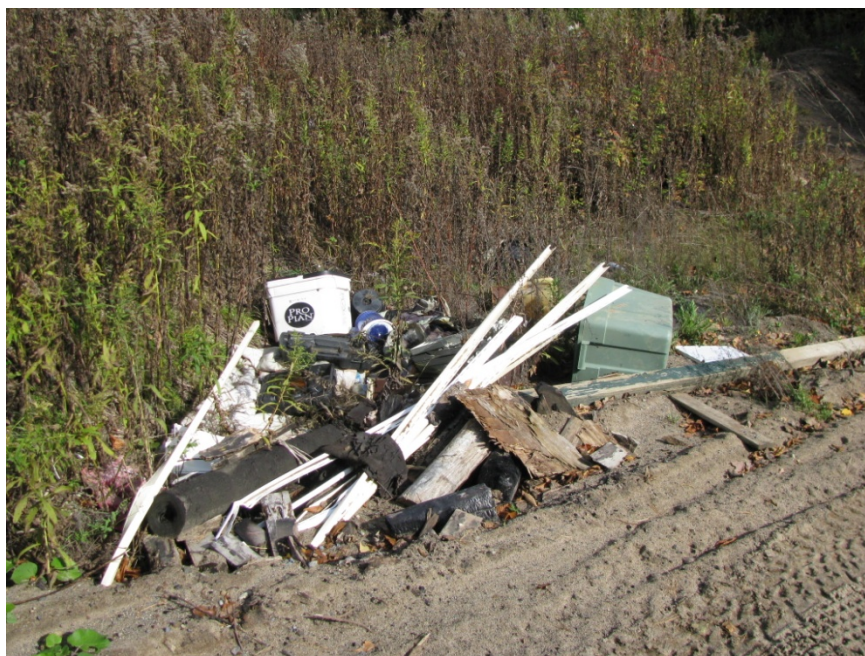
Photo 7: 10/17/12 Close up of the trash/debris that has been dumped.

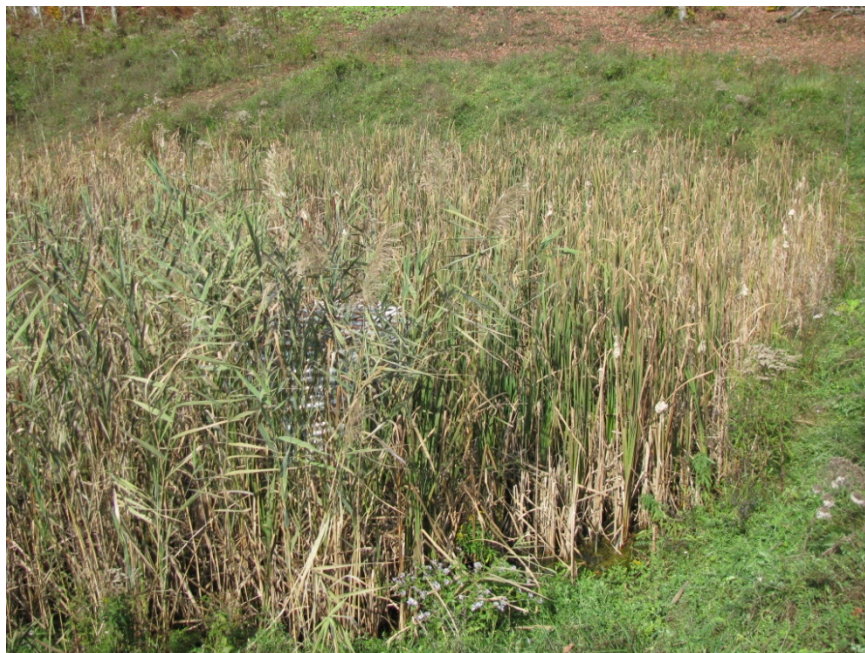
Photo 11: 10/17/12 Corrugated metal standpipe in North Detention Pond, barely visible due to vegetative growth.

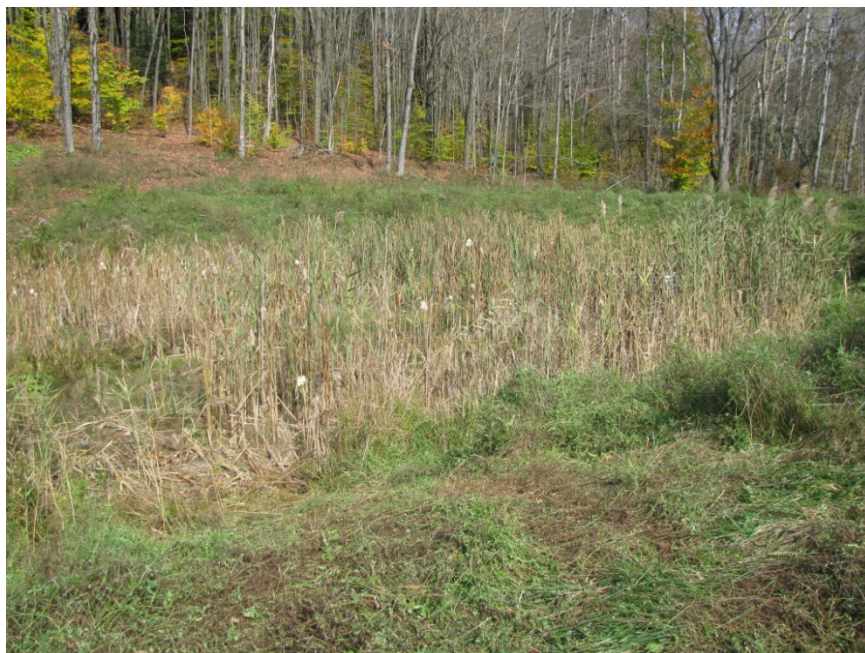
Photo 12: 10/17/12 North Detention Pond. Sediment accumulation is evident.

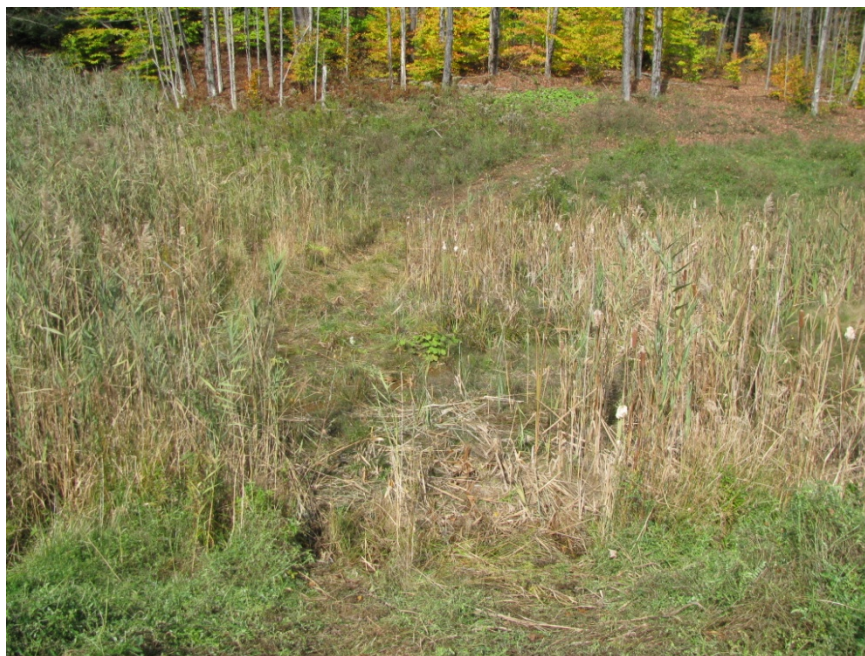
Photo 13: 10/17/12 North Detention Pond. Some four-wheeler/all-terrain vehicles have driven directly through the North Detention Pond.

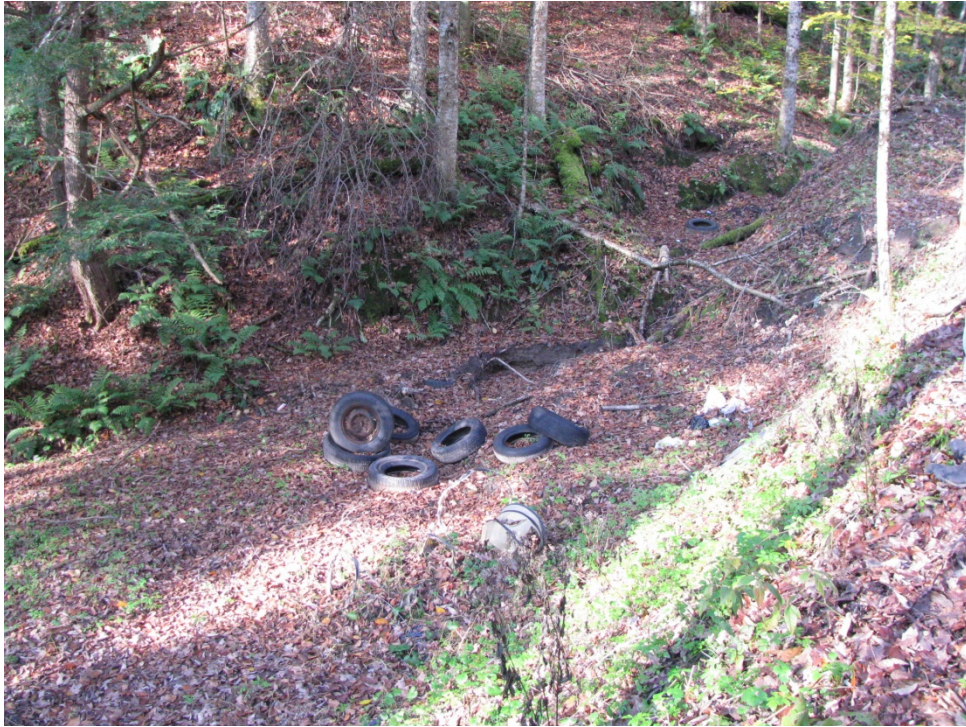
Photo 15: 10/18/12 Tires continue to be discarded in ravine along Military Road. The NYSDEC had removed and disposed of several hundred discarded tires from this location.

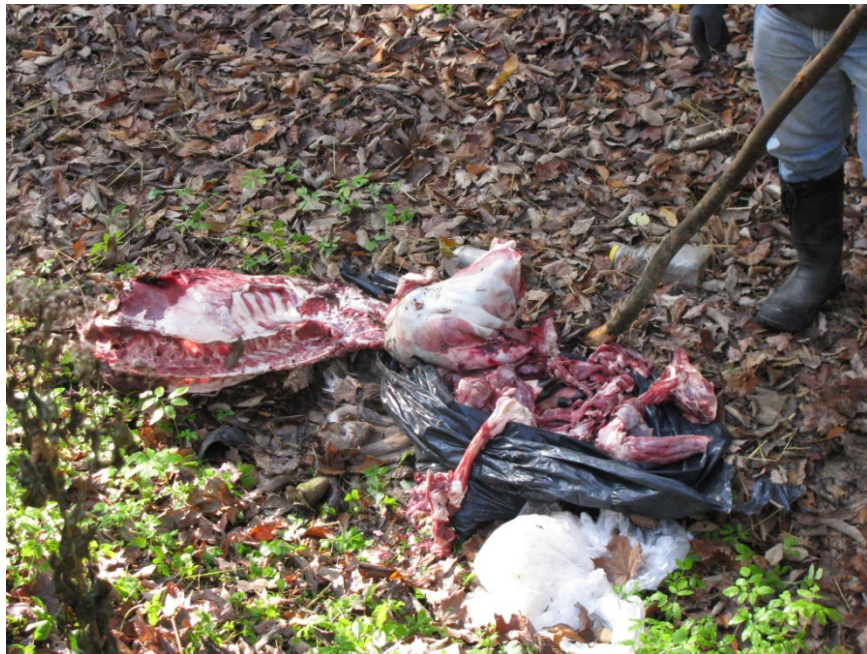
Photo 16: 10/18/12 Dumped deer carcasses in ravine along Military Road.

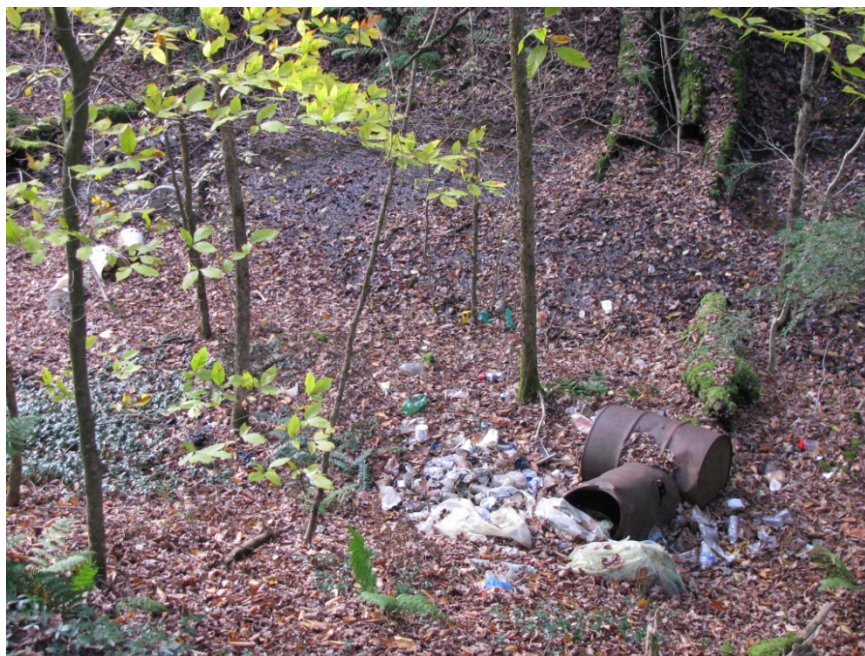
Photo 17: 10/18/12 Trash and empty barrels in ravine along Military Road, southeast of the location where tires have been discarded.

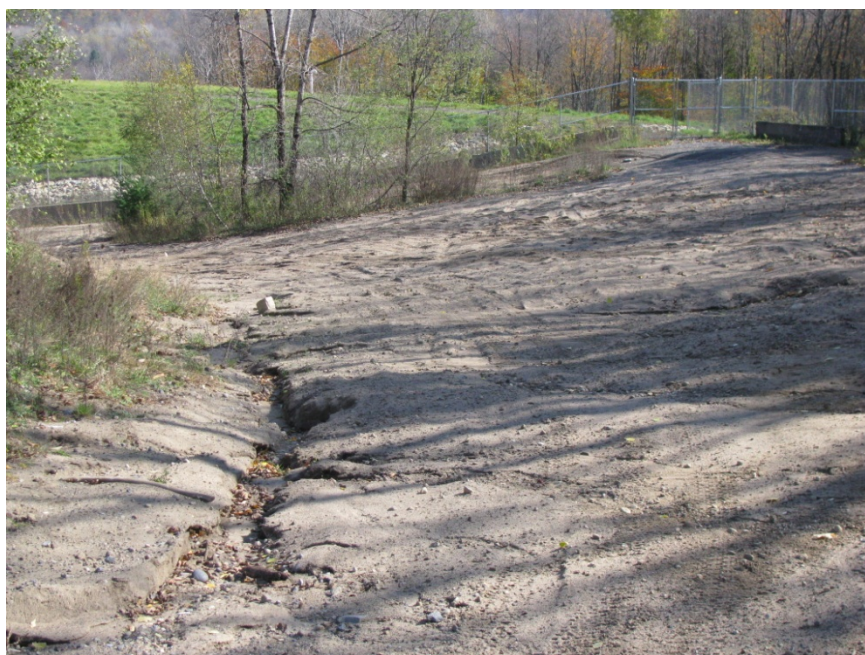
Photo 18: 10/18/12 Looking east at landfill. The rilling/erosion in this area is starting to re-occur. Erosion is up to 1 foot across and 1 foot deep.

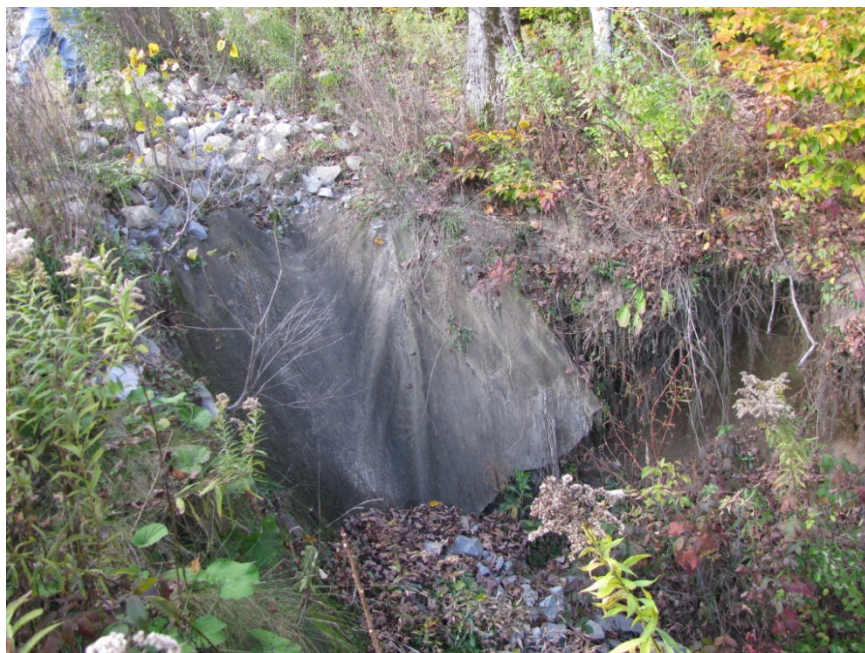
Photo 24: 10/18/12 Erosion occurring north of landfill, exposing fabric. Continued monitoring is advised.

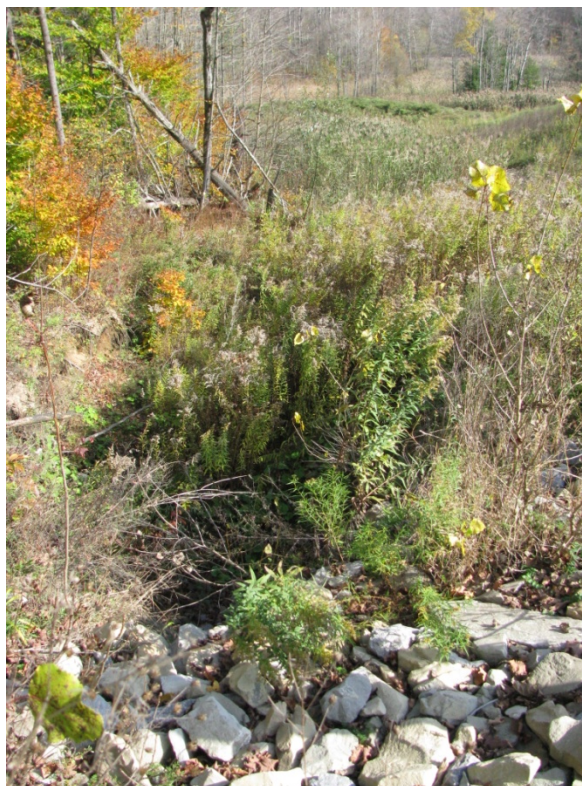
Photo 25: 10/18/12 Erosion occurring at area where rip-rap terminates. Looking east towards North Detention Pond.

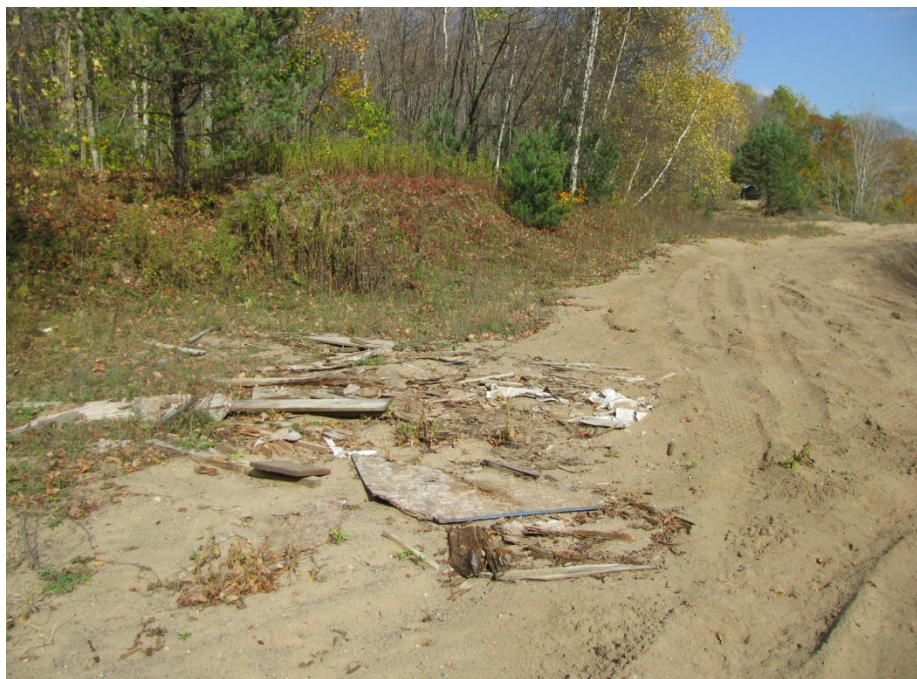
Photo 27: 10/18/12 Construction and demolition debris being discarded west of landfill/site.

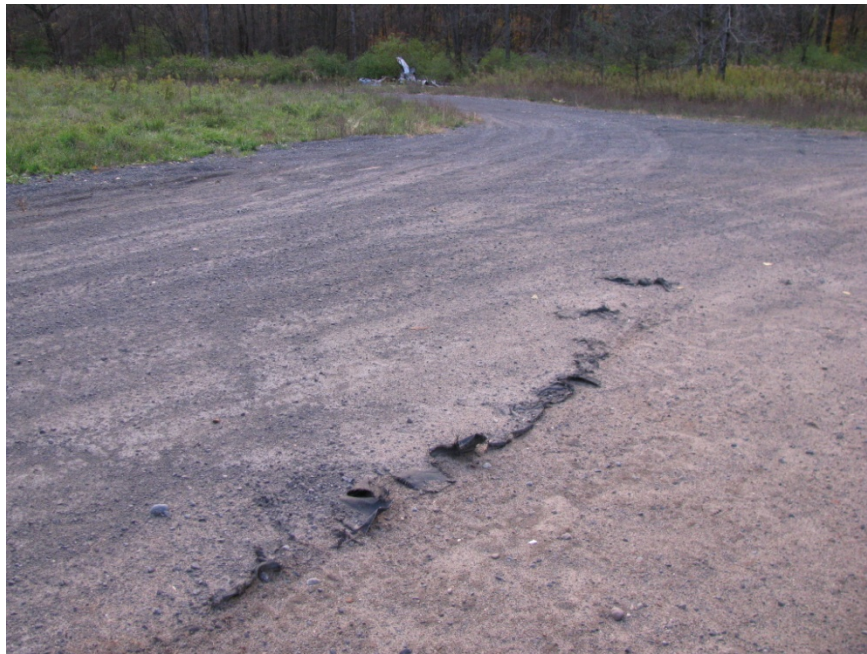
Photo 34: 10/18/12 Erosion exposing geotextile fabric at along site access road, approximately half way between front gate and actual landfill.

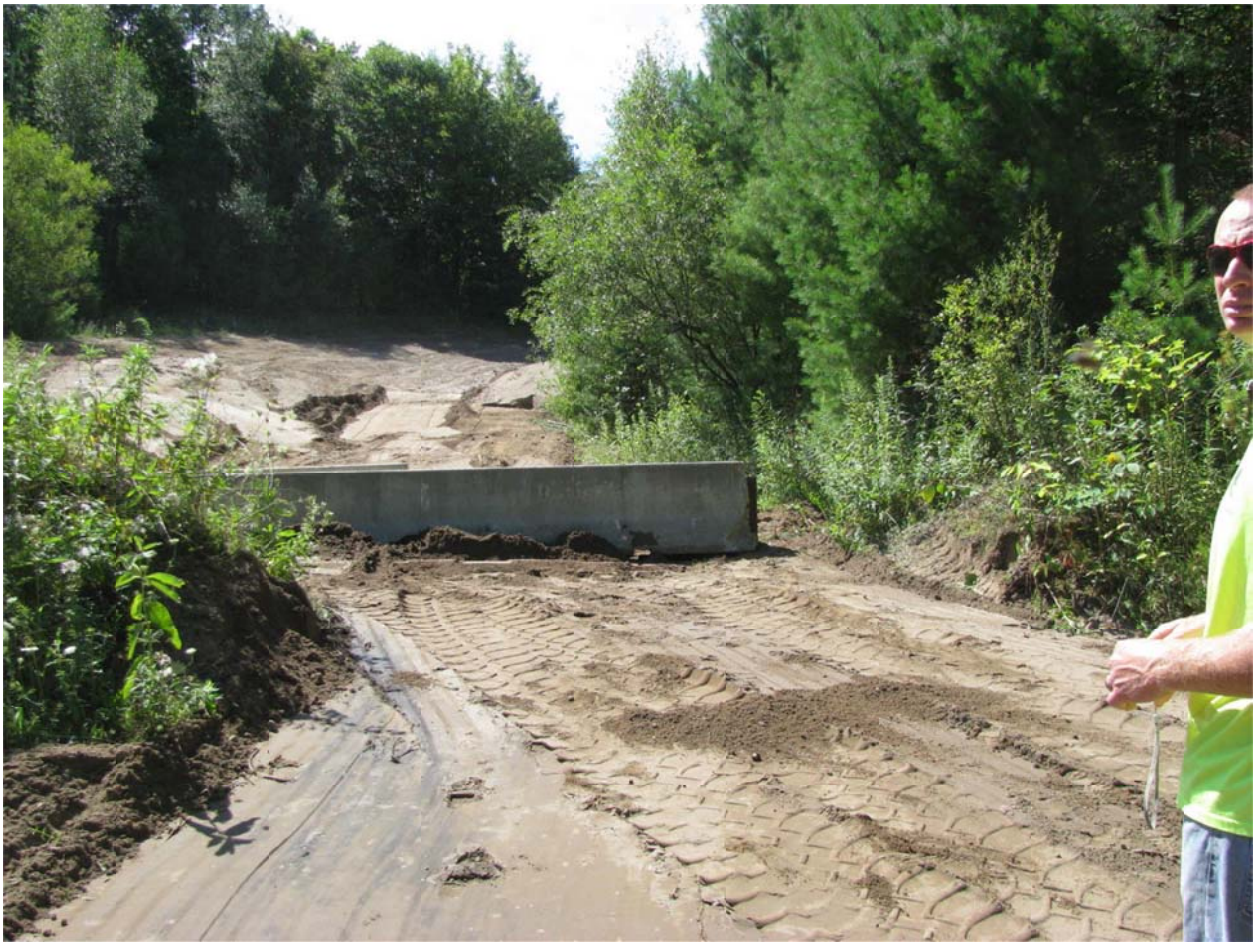
PHOTO 1: Jersey barriers across side accesss road leading onto landfill.

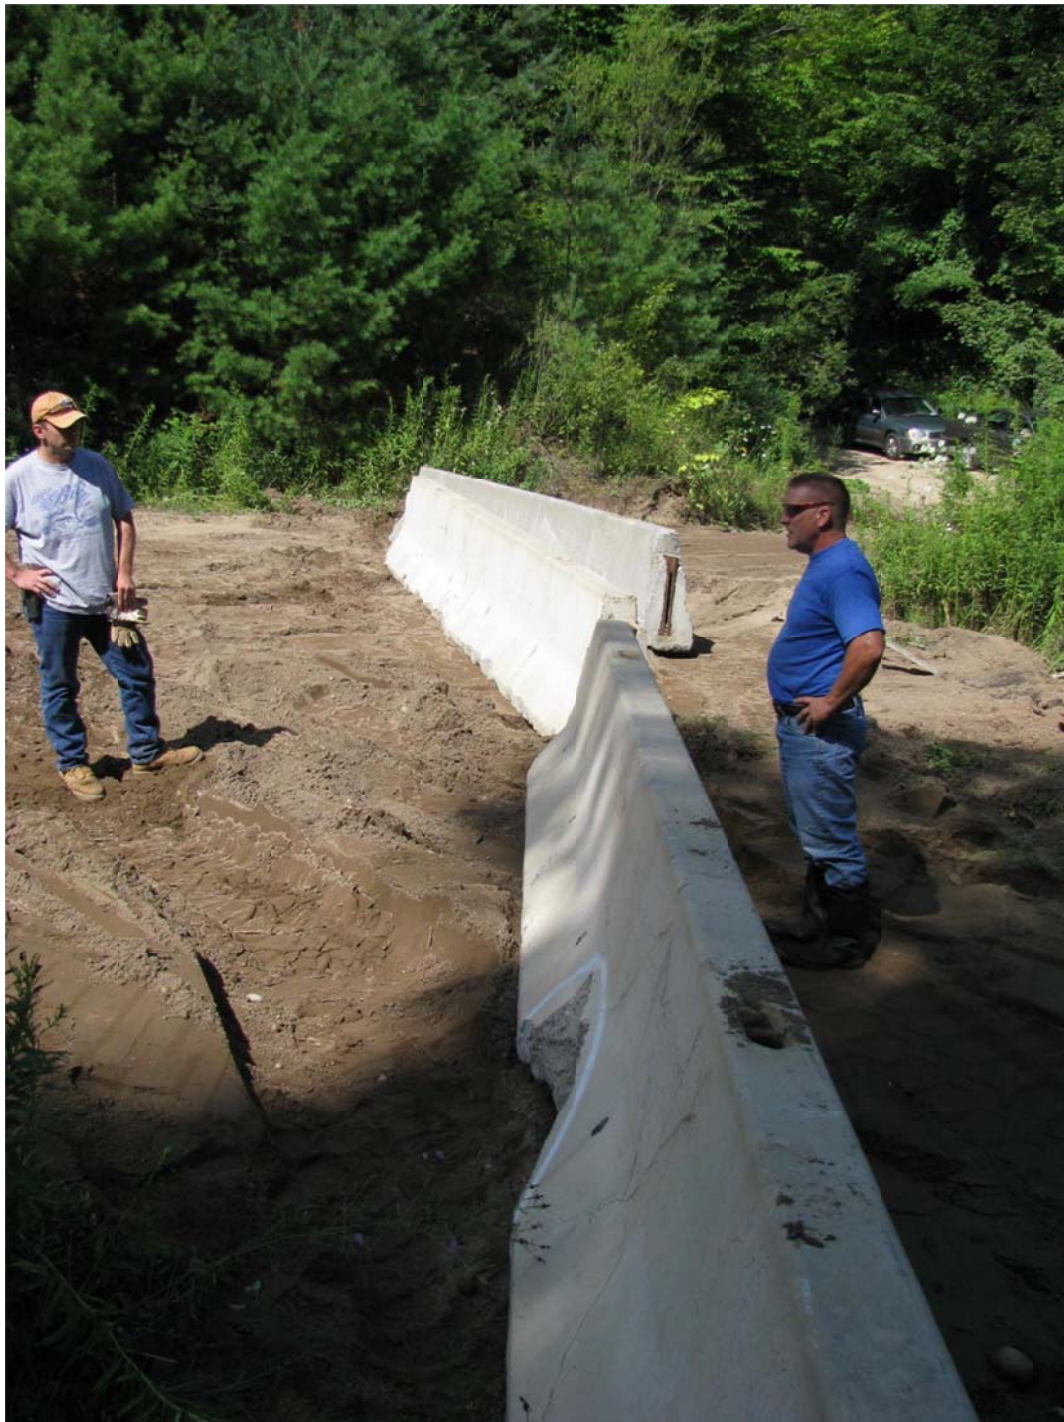
PHOTO 3: Jersey barriers in place, allowing for passage of smaller vehicles (ATVs, etc.), but not trucks

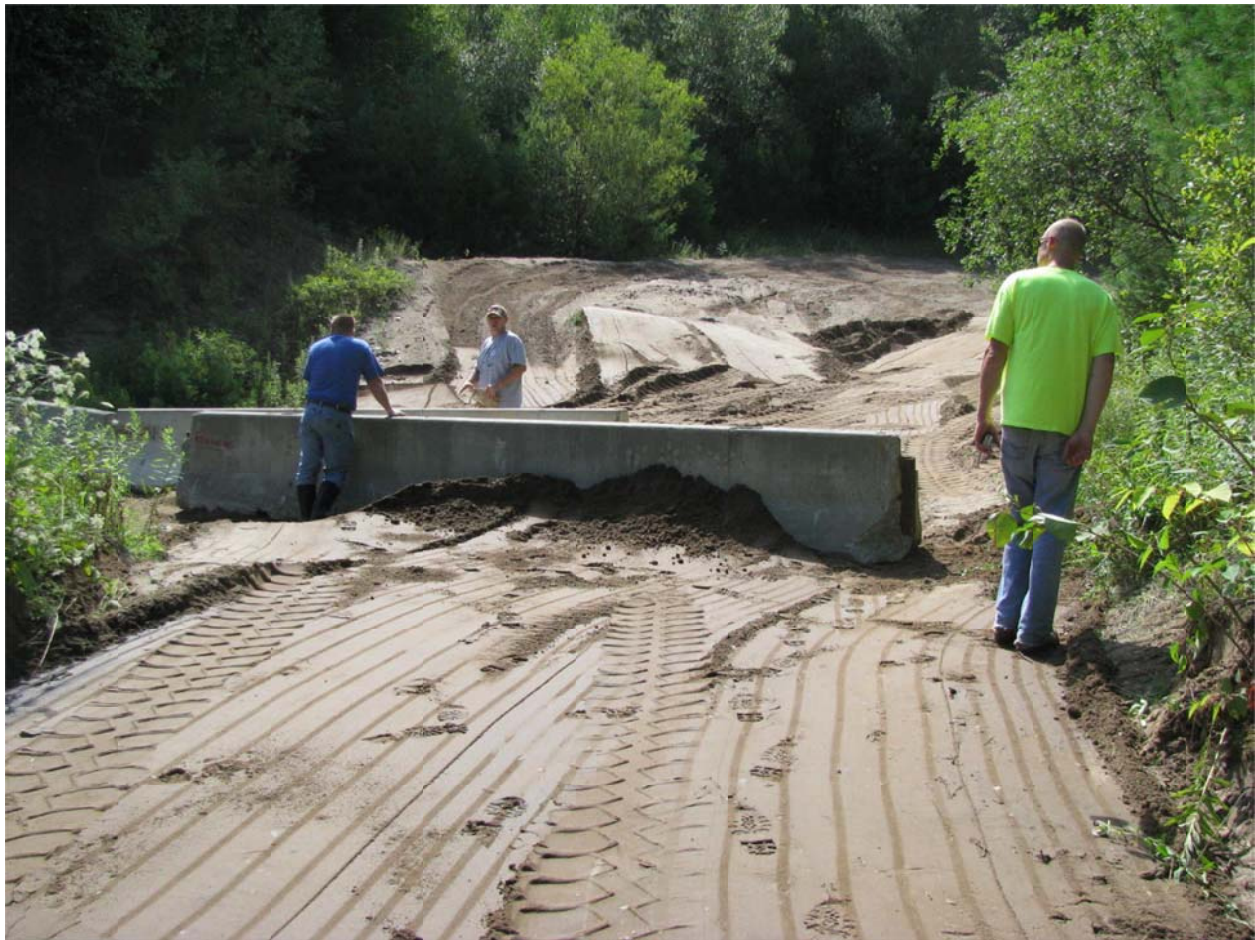
PHOTO 4: Same as in PHOTO 3. The front barrier was subsequently slid farther to the right to make passage on that side more difficult.

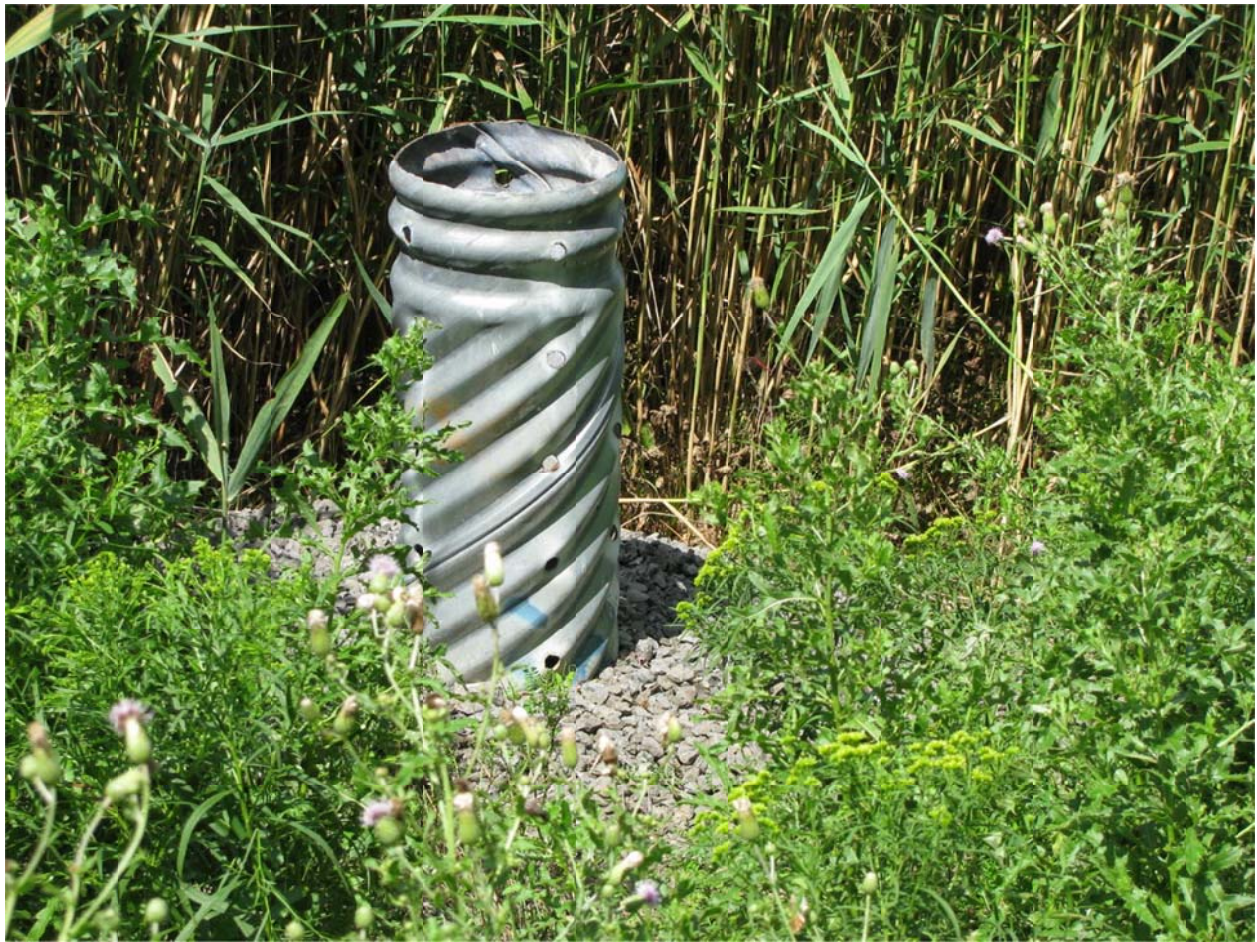
PHOTO 6: Outflow structure of south stormwater management pond. Note cleanliness of gravel blanket. The gravel does not appear to have been inundated.

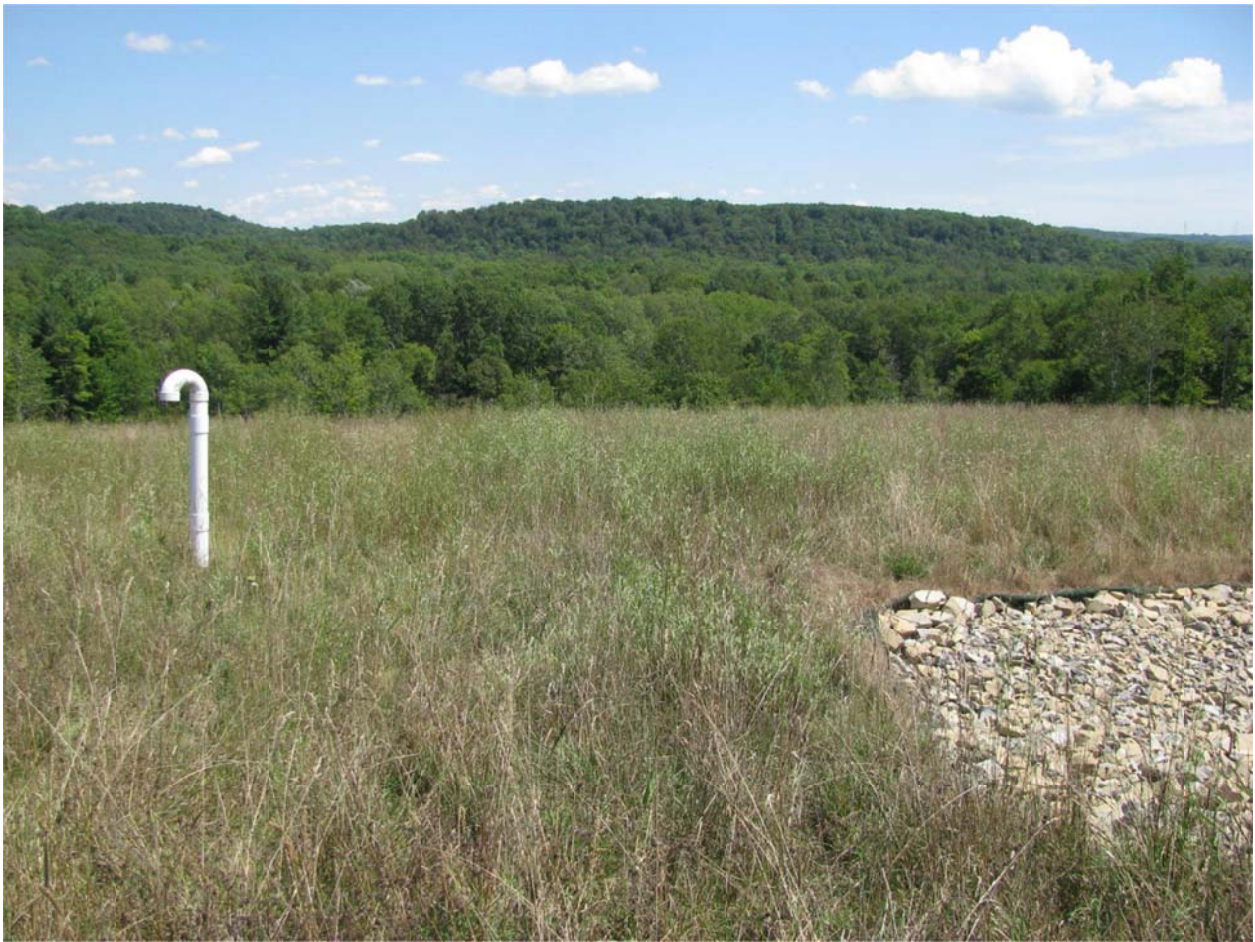
PHOTO 7: Repaired gas vent riser near mid-cap swale.

- Three landfill gas vents damaged by gun shots were repaired; and
- Additional jersey barriers were placed at the entrance to a side access road onto the landfill. The placement of additional jersey barriers were necessary in order to prevent dumping on the site.

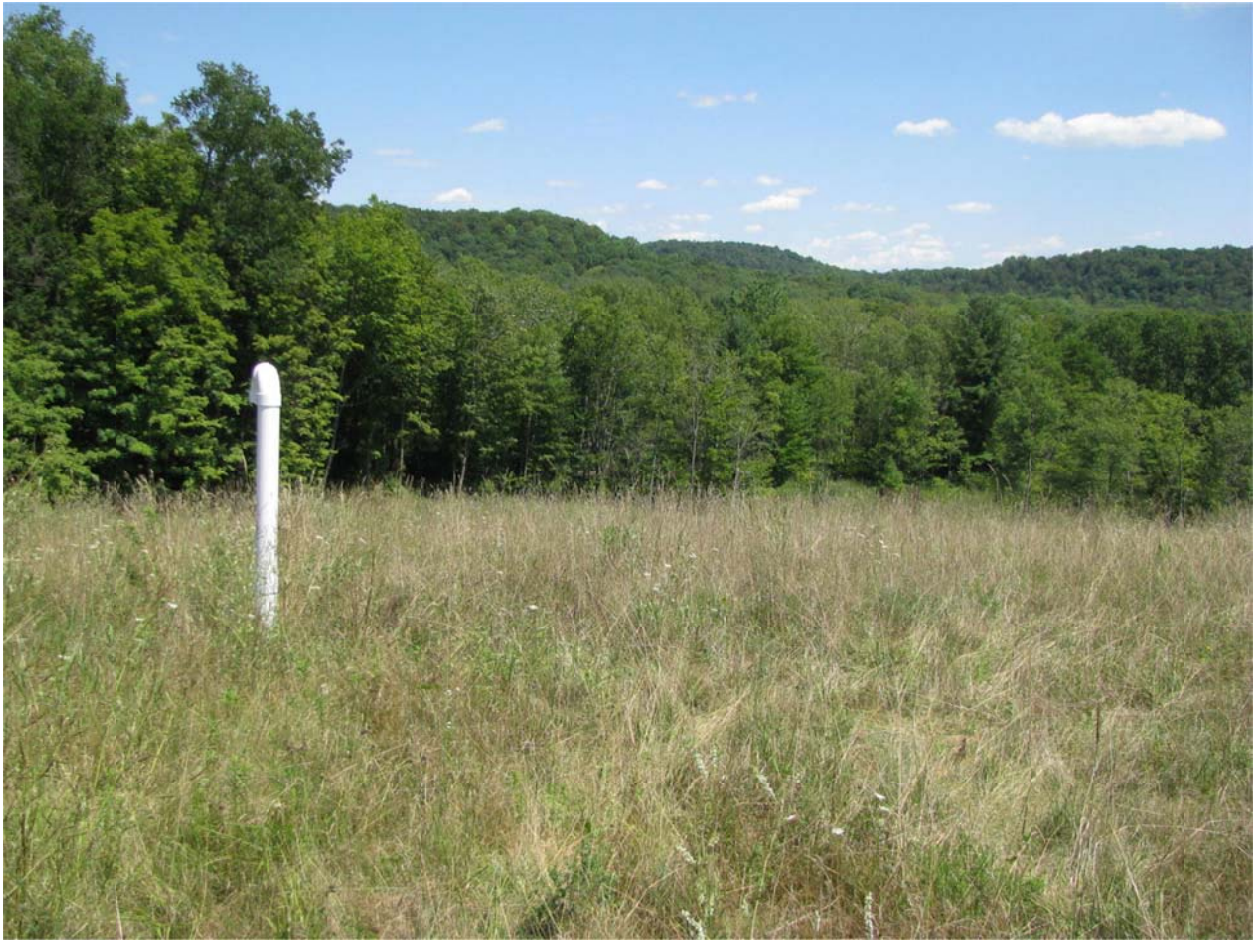
PHOTO 8: Second repaired gas vent riser.

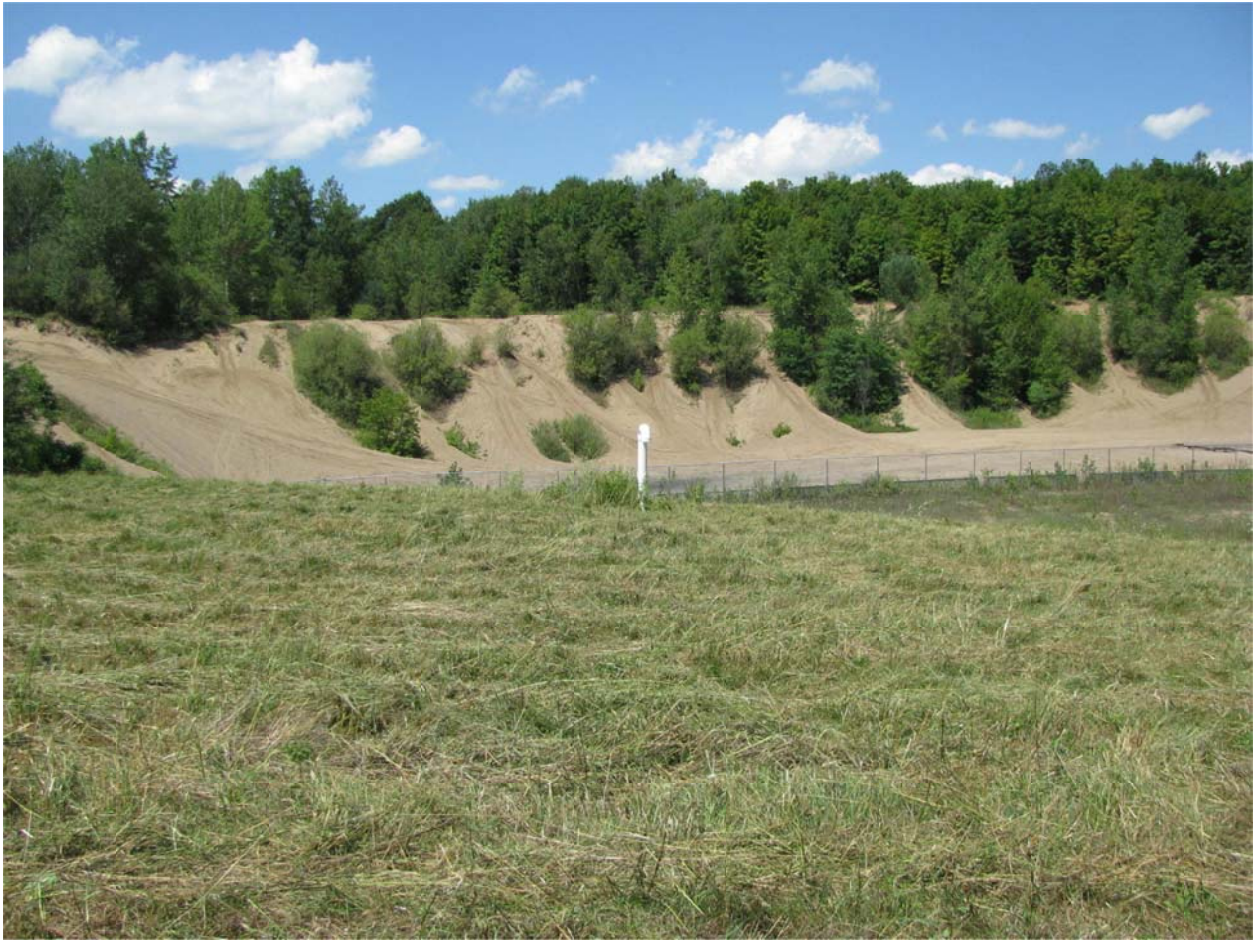
PHOTO 9: Third repaired gas vent riser in area just mowed

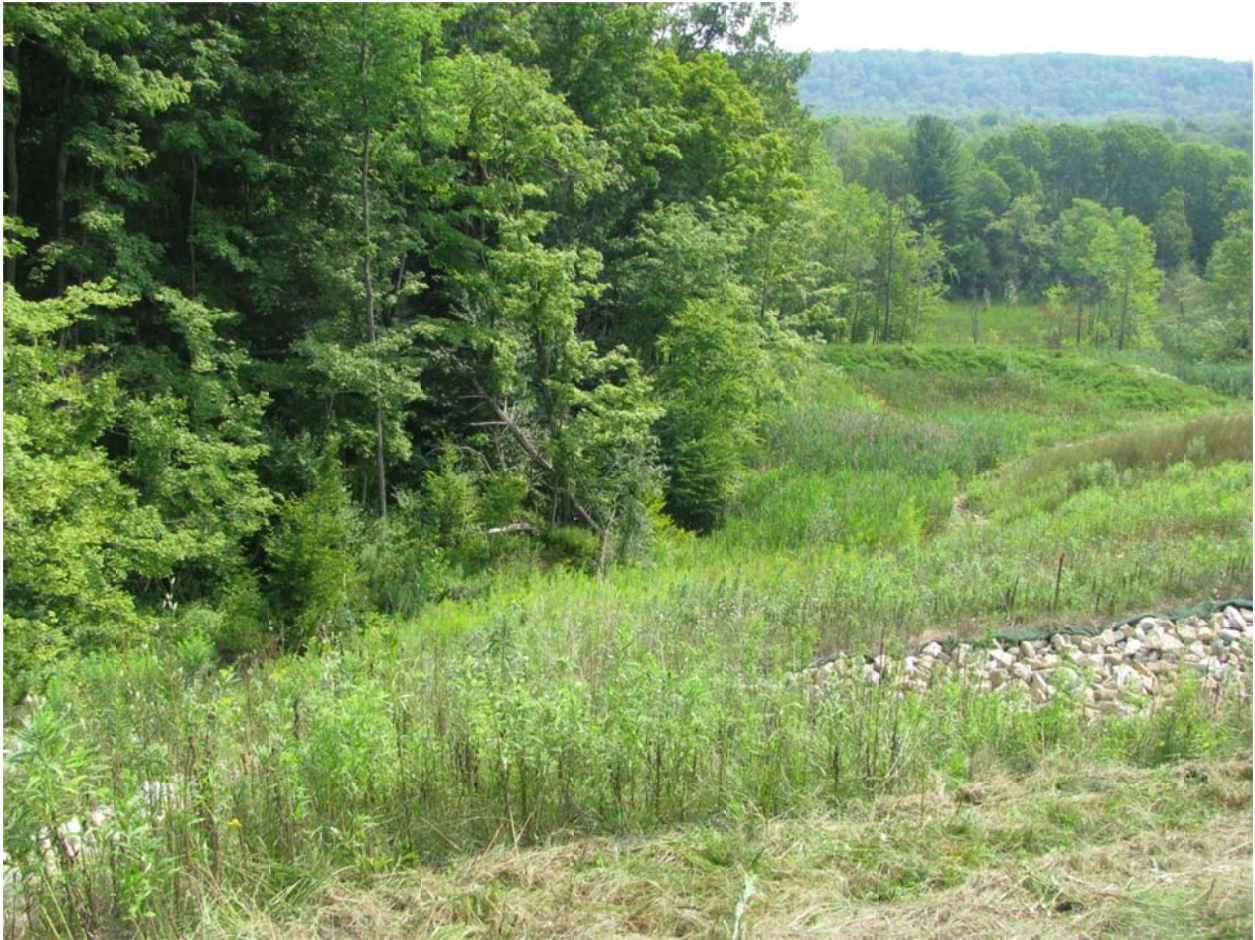
PHOTO 4: Look east along the northern edge of the landfill at the north stormwater management pond. The erosion problem discussed in the report occurs at about the midpoint of this picture.

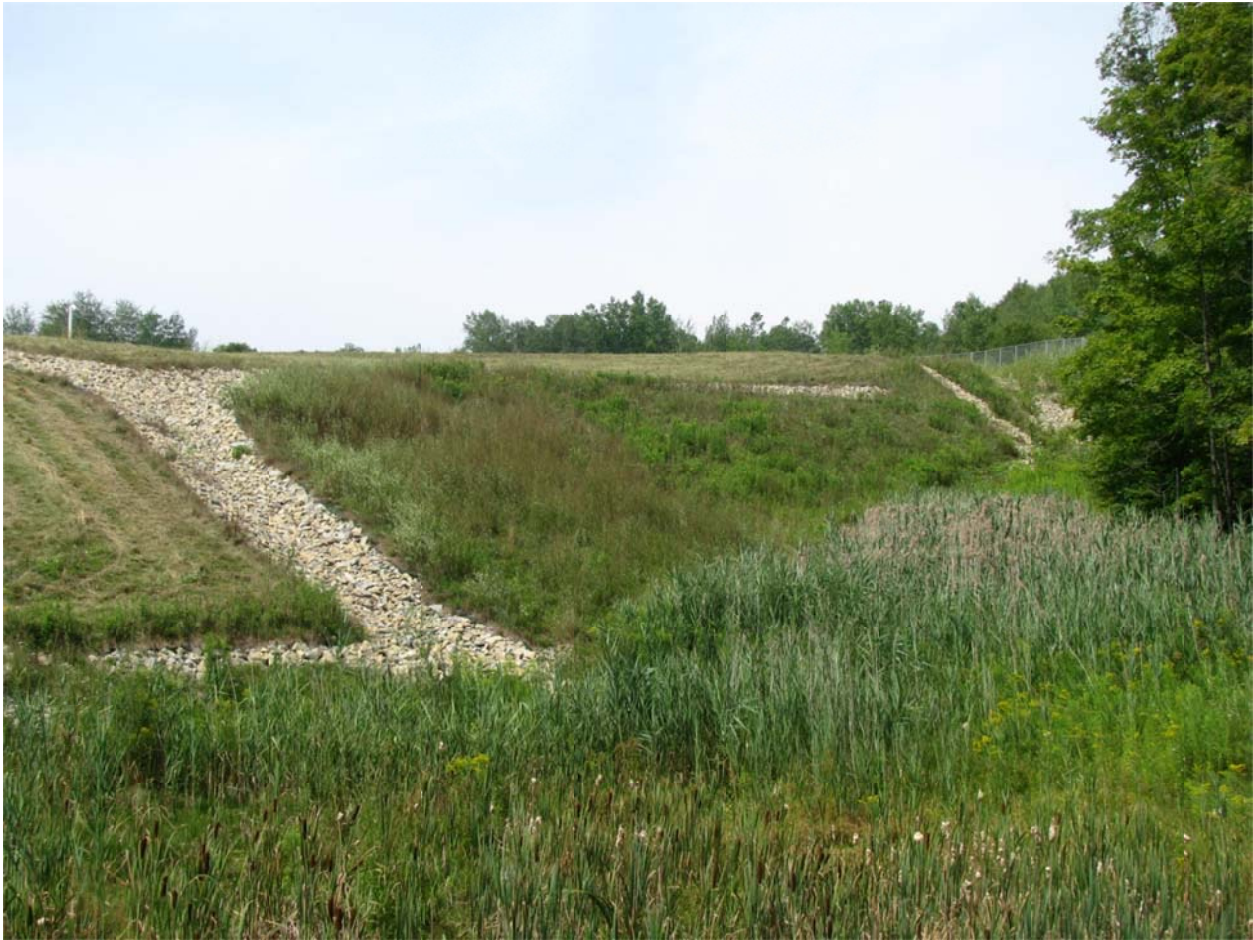
PHOTO 5: Look west from the north stormwater management pond at a portion of the final cover that Marcy did not mow. Note that this is the area in which there were two slides during construction. I discussed with Marcy's man on-site, and did not raise any objection to the area remaining un-mowed at the time. Given the steepness of the slope, this area should be minimally maintained, only to correct any erosion that may occur (none was noted) and to remove woody vegetation..

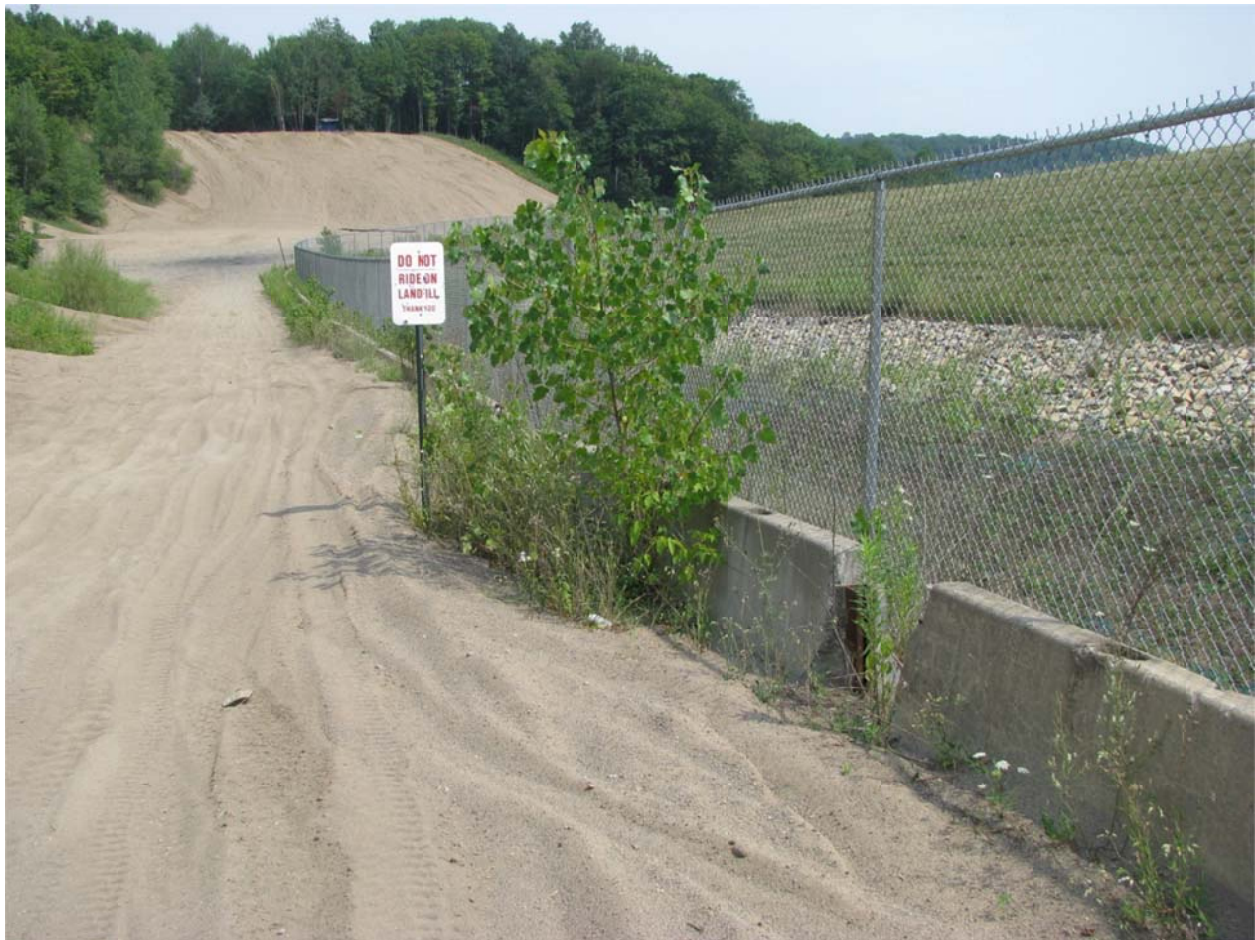
PHOTO 7: Look north along the western fence and vandalism barrier. Note the degree to which the sand has accumulated against the barriers.
