SITE MANAGEMENT

ANNUAL REPORT 2012 CALENDAR YEAR

ROSE VALLEY LANDFILL
RUSSIA (T)

SITE NO. 622017
HERKIMER (C), NY

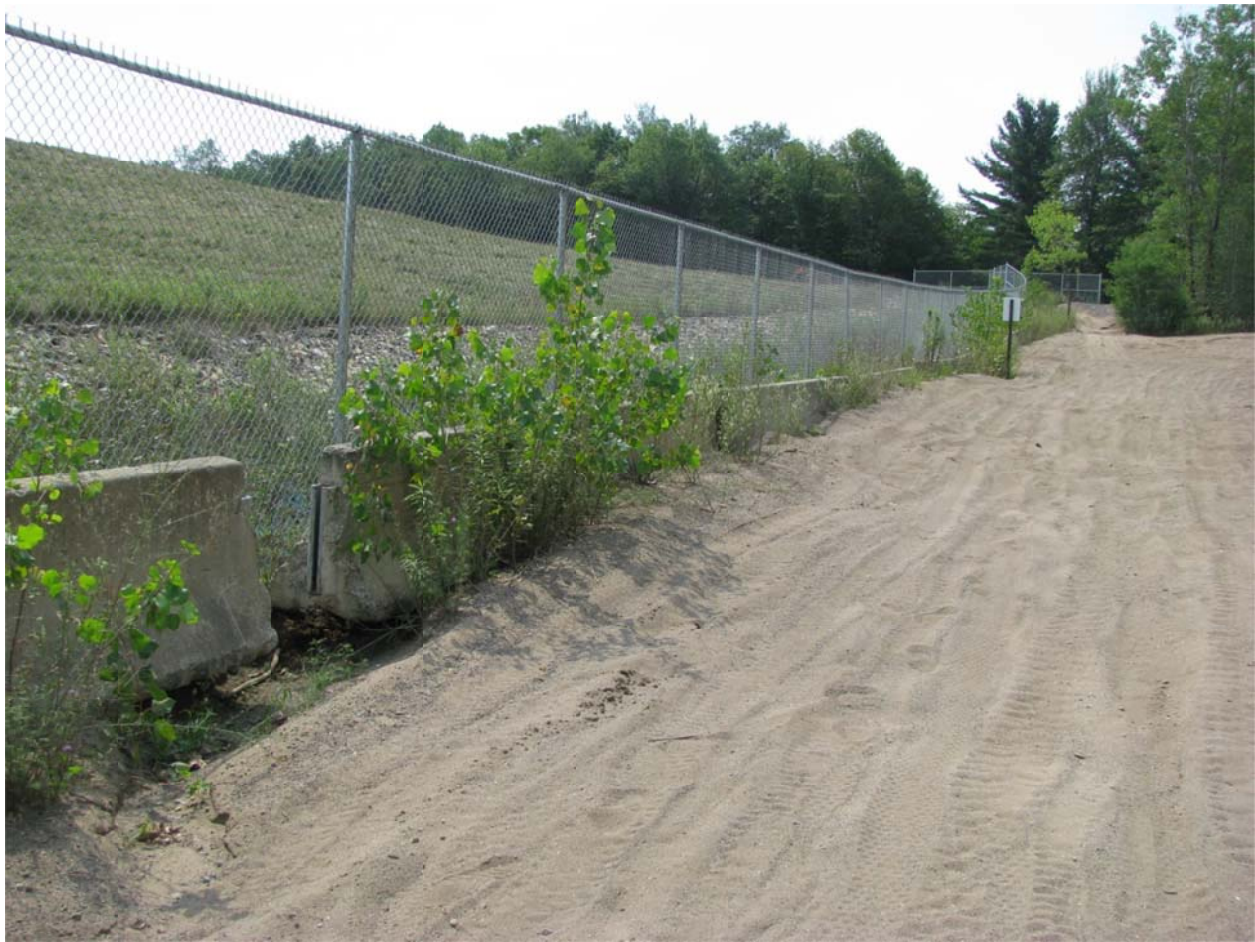
PHOTO 8: Look south along the western fence and vandalism barrier. Note the degree to which the sand has accumulated against the barriers.

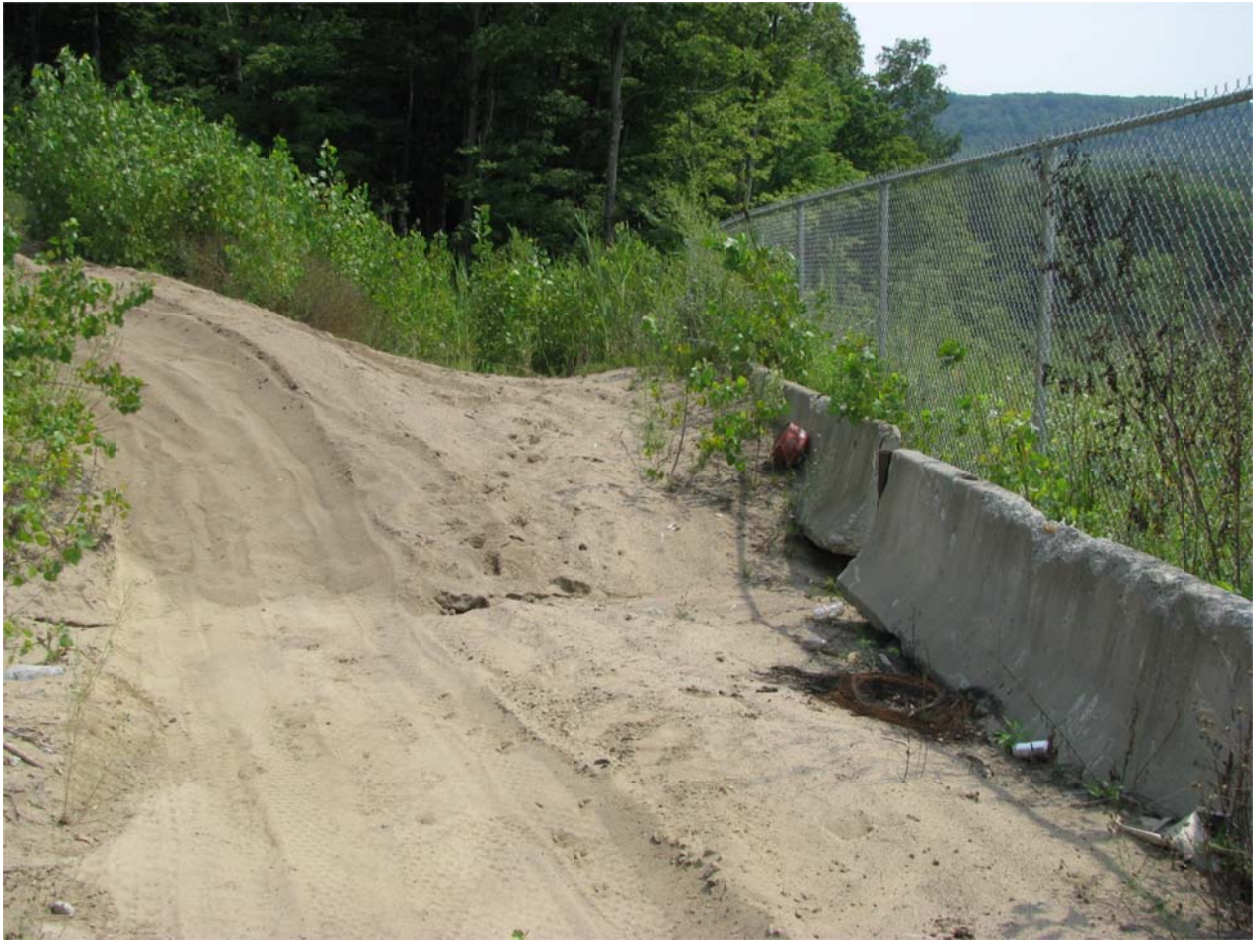
PHOTO 9: The northeast corner of the landfill perimeter. Beyond the small rise, the ground slopes steeply down, ultimately to the north stormwater management pond. The erosional problem discussed in this report occurs about halfway to the pond. Note the channel cut under barrier by stormwater runoff from the adjacent hill to the north (left). That stormwater flows under the fence and then is picked up and carried downhill by the channel whose end has collapsed as can be seen in the next photo. Thus, this flow pattern appears to be contributing to the above-mentioned erosion problem, though to an uncertain degree.

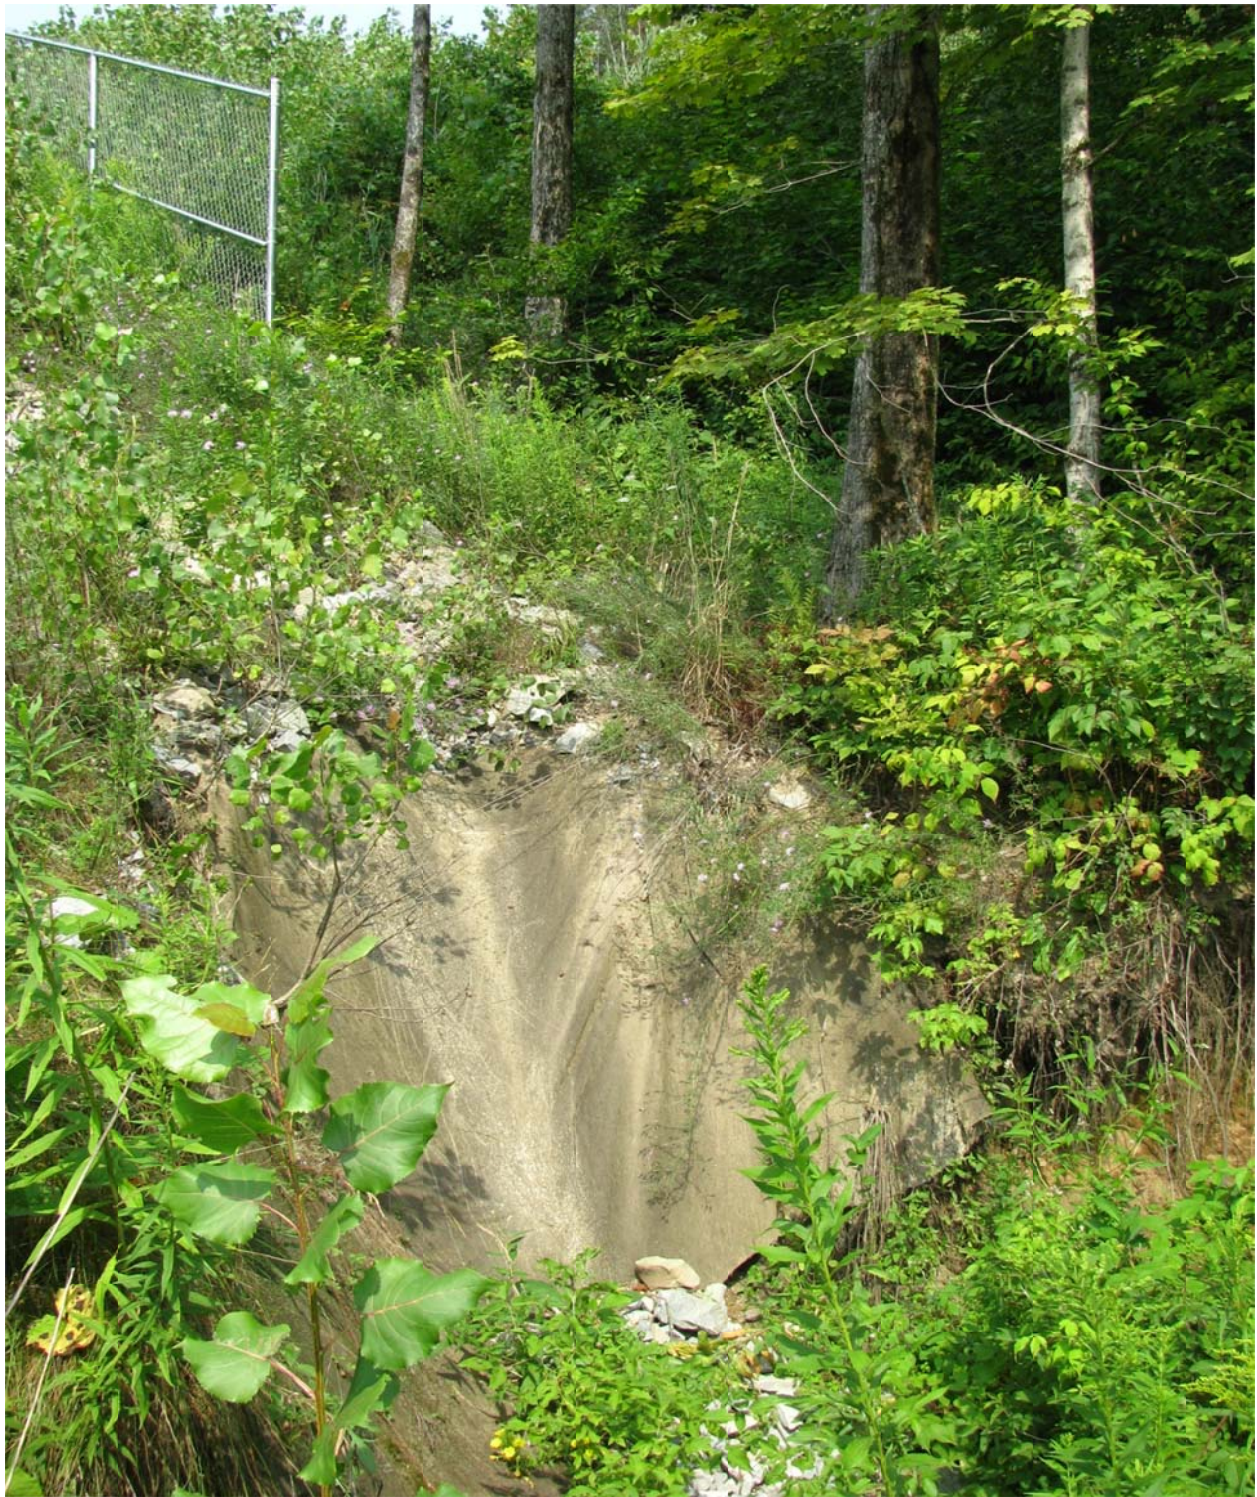
PHOTO 10: Look northwest at the erosion problem discussed in this report. Note the location of the fence and trees for future reference.
