### **ANNUAL REPORT 2013 CALENDAR YEAR**

**ROSE VALLEY LANDFILL  
RUSSIA (T)**

**SITE NO. 622017  
HERKIMER (C), NY**

**2013 ANNUAL REPORT**

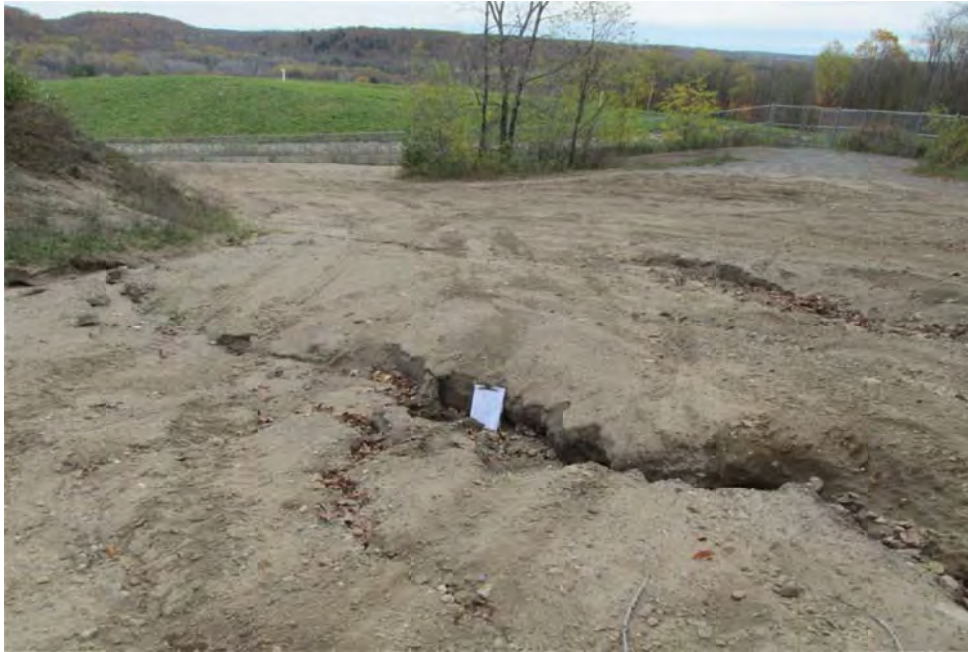
**Photo 1:** 10/16/13 Looking east towards the landfill. The erosion/rilling in this area is starting to re-occur.

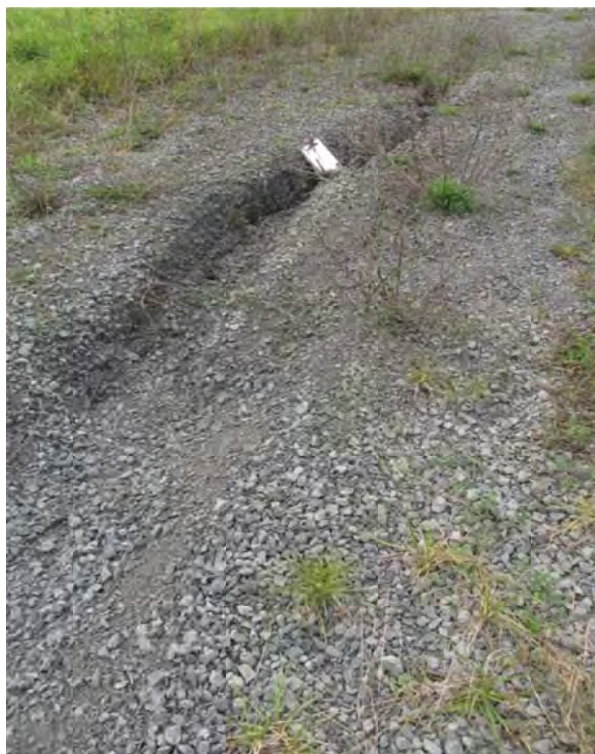
**Photo 5:** 10/16/13 Erosion/rilling in access road on top of landfill. In some areas the erosion is approximately 12 inches deep.

gravel on the landfill road. URS recommends that approximately 20 cubic yards of gravel be brought on site and used to fill the ruts in an effort to fix the perimeter access road from Rose Valley Road all the way to the landfill. URS and the Department discussed the recommendation of placing approximately 120 linear feet of concrete jersey barrier at the top of the landfill from the west fence, near the southwestern gate, west to the hill to prevent ATVs from riding through the area and creating tracks which promote erosion and rilling. As an additional deterrent, URS also recommends welding the existing concrete barriers together that are currently located at the back site entrance along Military Road. This would help prevent site access and minimize the disposal of solid waste and construction and demolition debris.

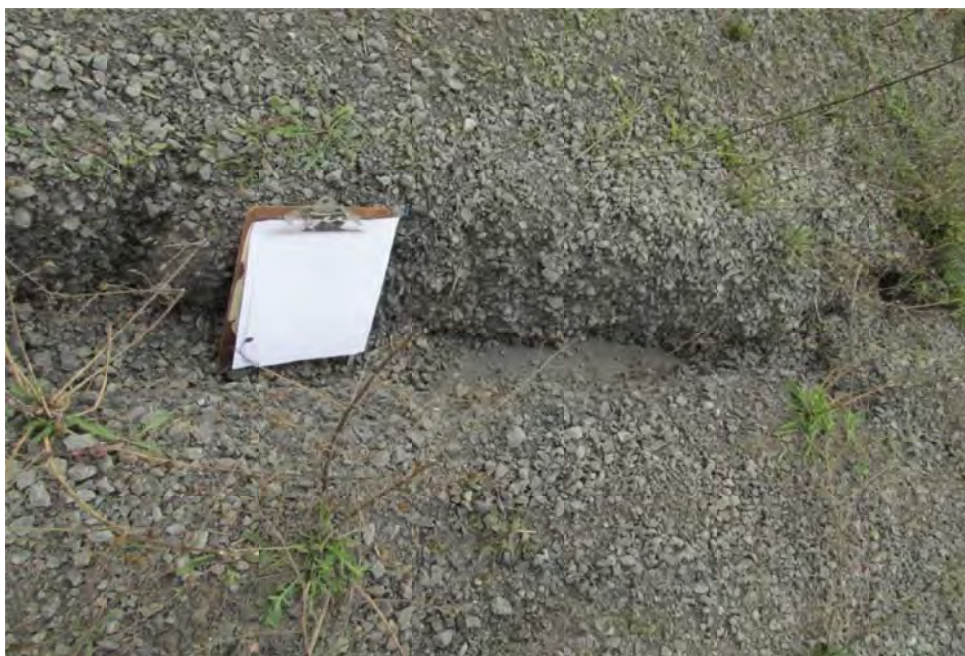
**Photo 6:** 10/16/13 Close-up of erosion/rilling occurring in access road on top of landfill. Note fabric has been exposed.

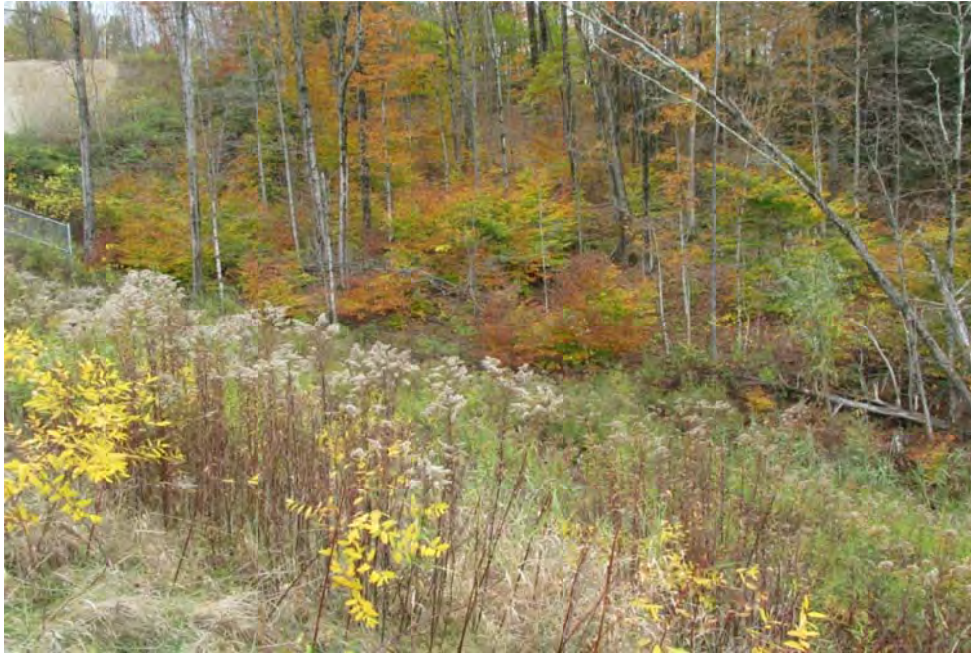
- As noted initially during the August 9, 2012 site inspection and observed during the July and October inspections, the diversion channel around the north side of the landfill is head cutting. There is now an approximately 6-foot high vertical discontinuity in the channel bottom at about the mid-point of the landfill. There appears to be no significant change to the extent of the head cutting since the August 9, 2012 site inspection.

- It appears that the head cutting has been stopped by the geotextile that underlay the downstream end of the channel armor, of which a length of about 10 feet has failed. It is unclear if this equilibrium will persist as the geotextile degrades. It is also unclear, even assuming that the head cutting has stopped, if the adjacent

sides of the landfill will hold during run-off events. It was observed that the north bank of the channel appears to be eroding. Thus, the erosion is occurring on the side of the channel away from the landfill. If the head cutting continues, there could be significant erosion of and damage to the landfill cap. The situation can be monitored by noting the tree in the center of Photo 11 of the Periodic Inspection Report (July 10, 2013) in Appendix G and in Photos 9, 10, and 11 in Appendix C.

**Photo 9:** 10/16/13 Location of erosion occurring north of the landfill.

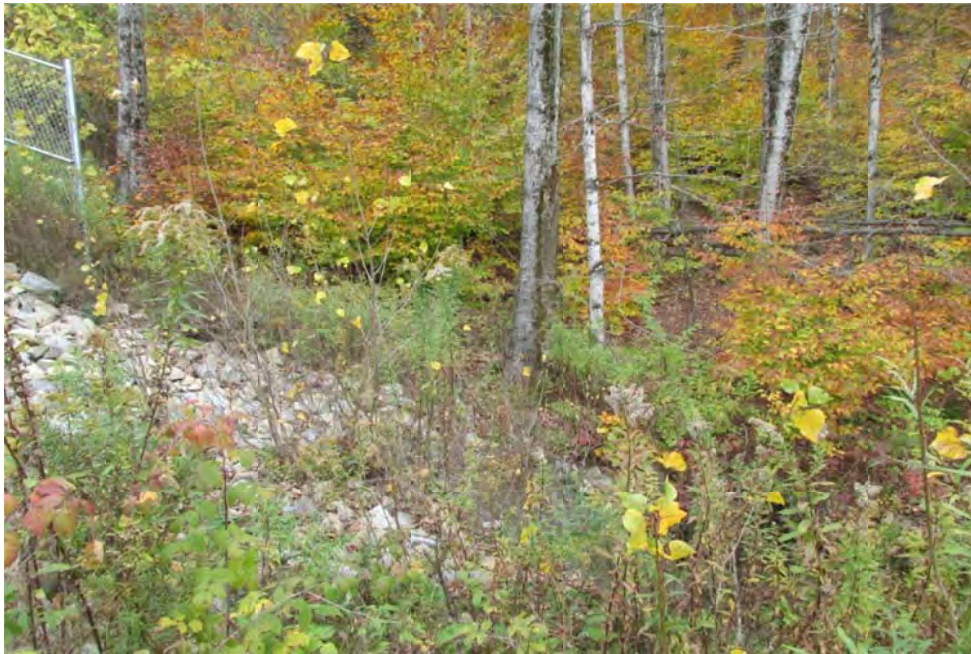
**Photo 10:** 10/16/13 Location of erosion occurring north of the landfill.

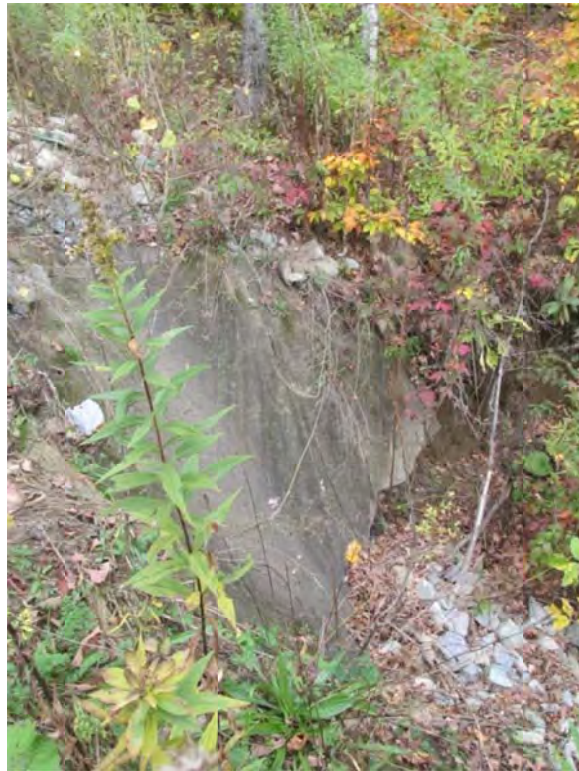
**Photo 11:** 10/16/13 Erosion occurring north of landfill, exposing fabric.

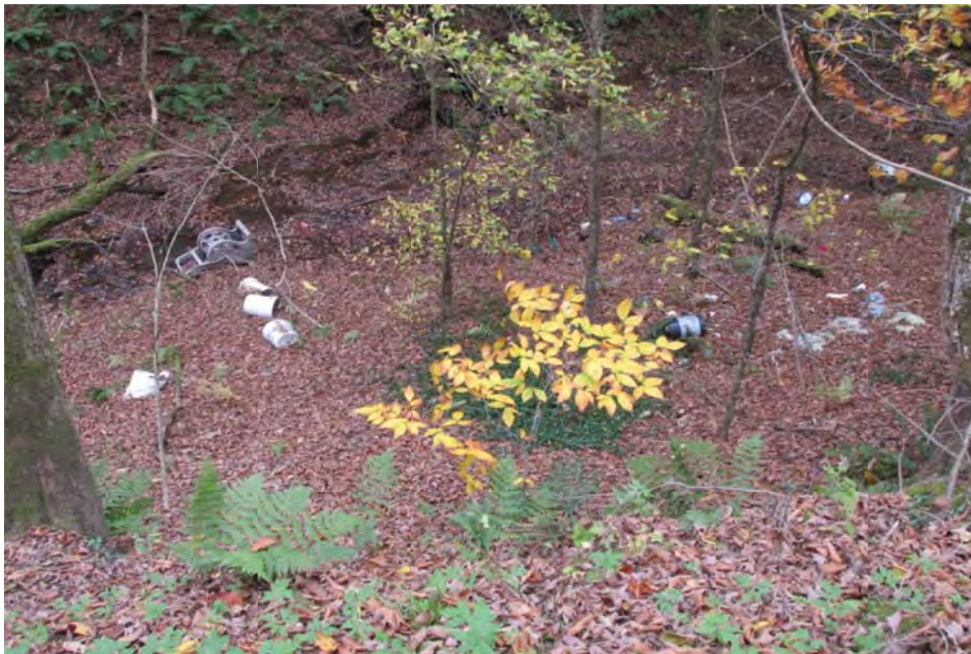
Trash and asphalt have been illegally dumped near the jersey barriers along Military Road. Several tires have also been illegally dumped in the ravine north of the landfill along Military Road. In July 2013, it was noticed that trespassers had removed the double swing gate panels from the gate located at the southwest corner of the landfill to gain access for ATV riding. One gate panel was found lying in the grass next to the gate opening. The second gate panel was found lying up against the northern perimeter fence. On July 22, 2013, the gates were replaced and secured by URS subcontractor, Brady Fence Co. Inc., prior to the October 2013 site inspection.

**Photo 16:** 10/16/13 Trash in ravine along south side of Military Road.

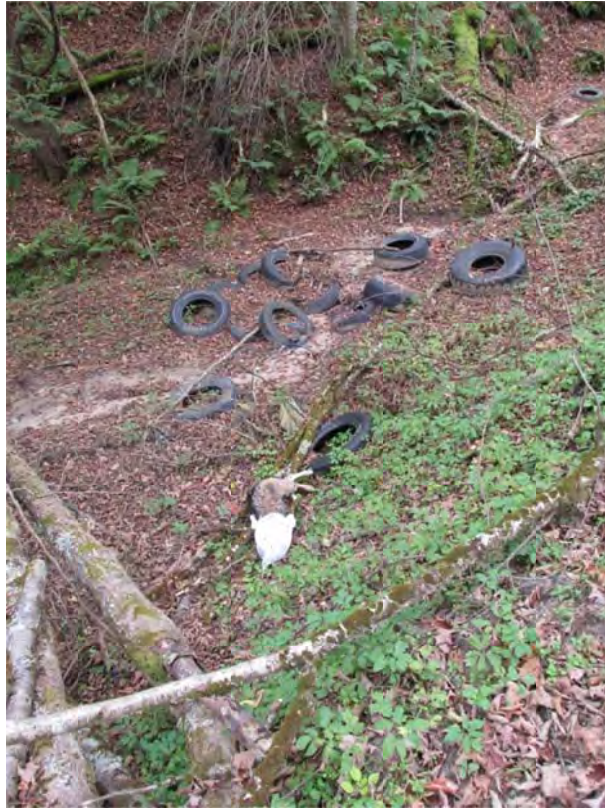
**Photo 17:** 10/16/13 Discarded tires and carcass in ravine along Military Road.

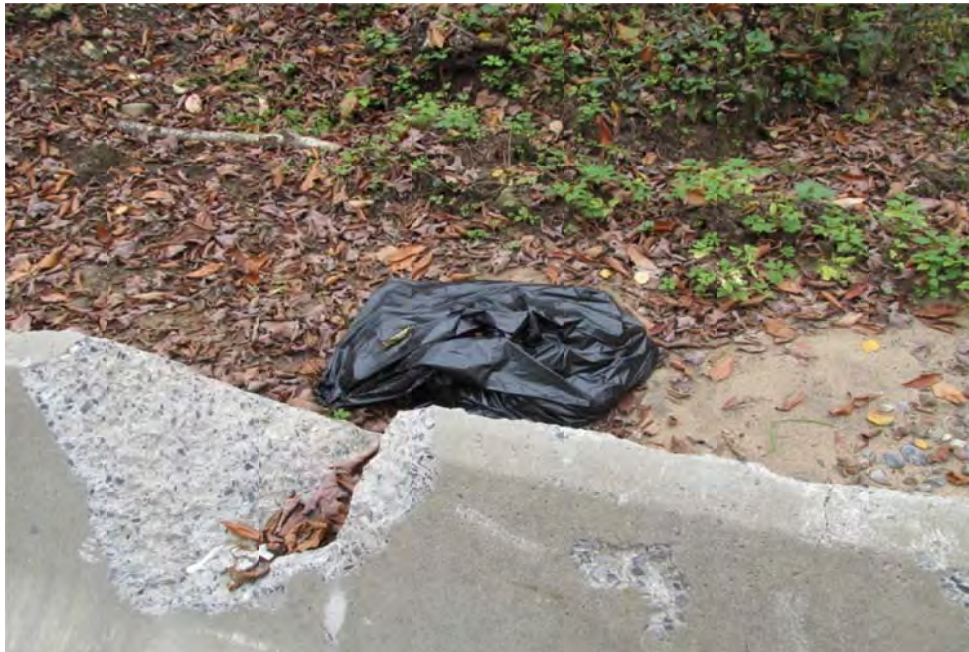
**Photo 18:** 10/16/13 Trash and damaged jersey barrier along Military Road.

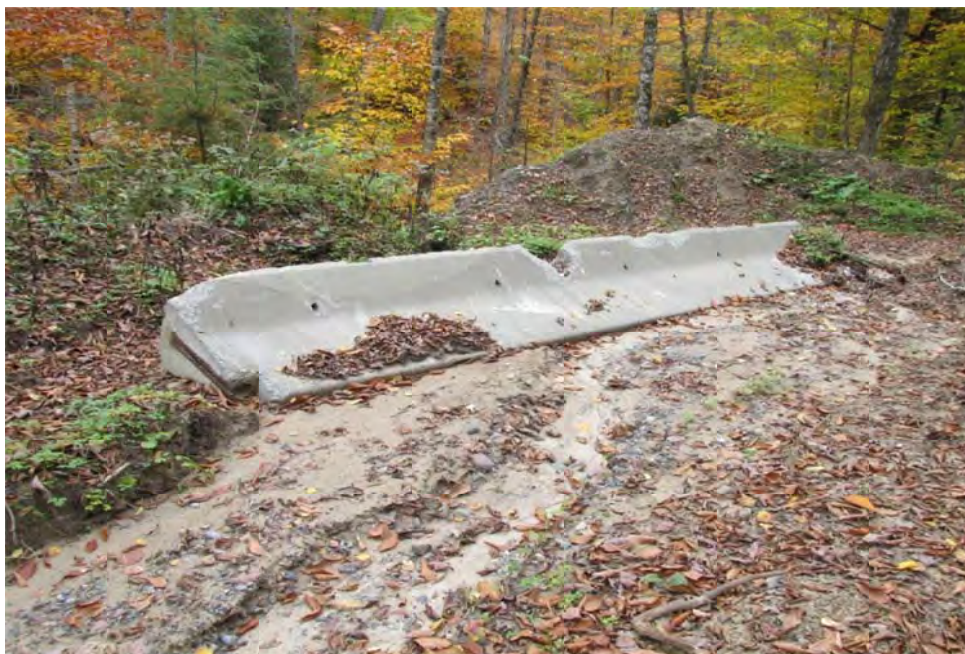
**Photo 19:** 10/16/13 Jersey barrier that was moved from the north landfill access road further down Military Road to allow access to the landfill for ATV riding.

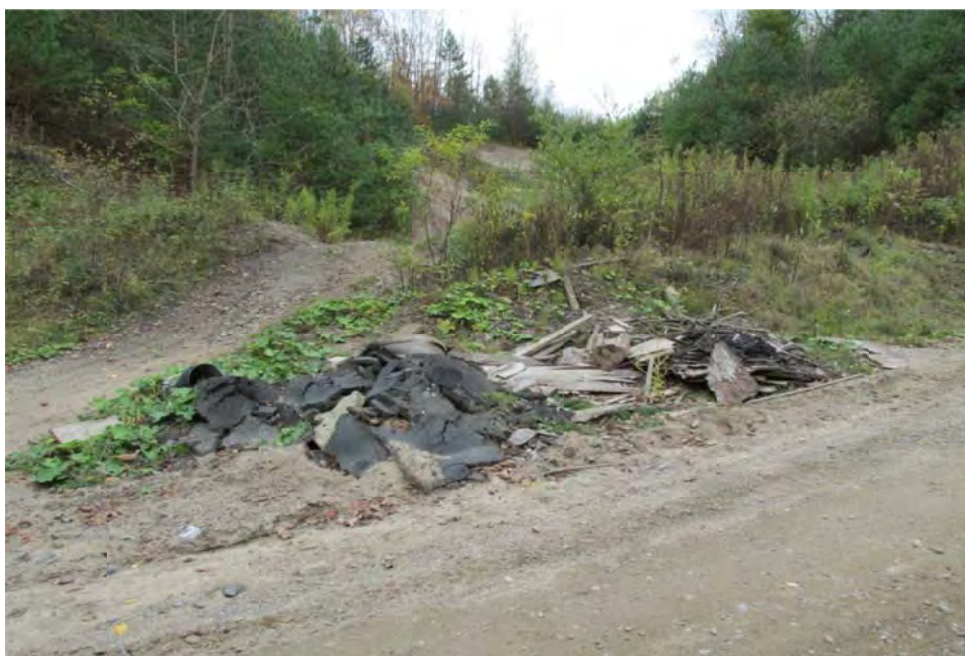
During the October 16, 2013 site inspection, new trash dumping piles were observed at the back entrance from Military Road. The trash piles included an old toilet, paint cans, and municipal solid waste along with construction and demolition debris. In the area where the Department had previously removed over 500 discarded tires, more tires have been discarded, along with wildlife carcasses and other municipal trash. The NYSDEC will monitor erosion and dumping during the next monitoring event. Corrective action may be necessary to mitigate the erosion and to remove the trash based on future observations.

**Photo 20:** 10/16/13 Construction and demolition debris along Military Road.

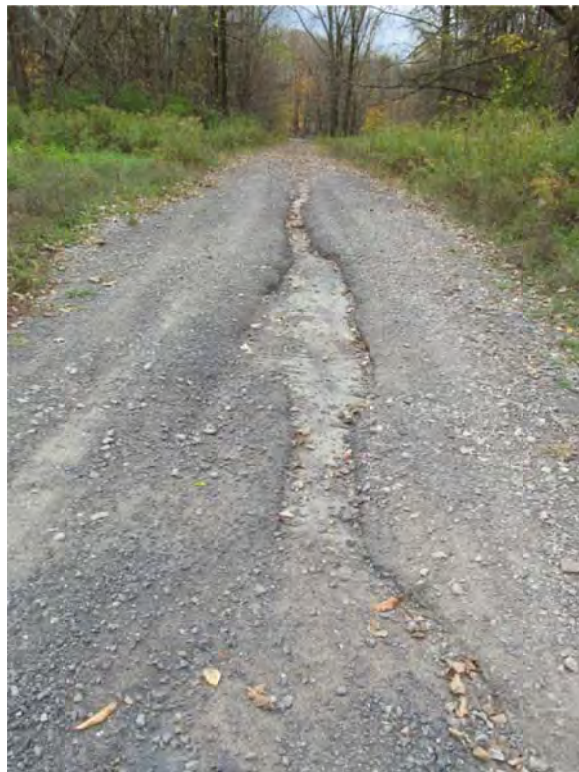
**Photo 24:** 10/16/13 Erosion/rilling in gravel access road west of landfill.

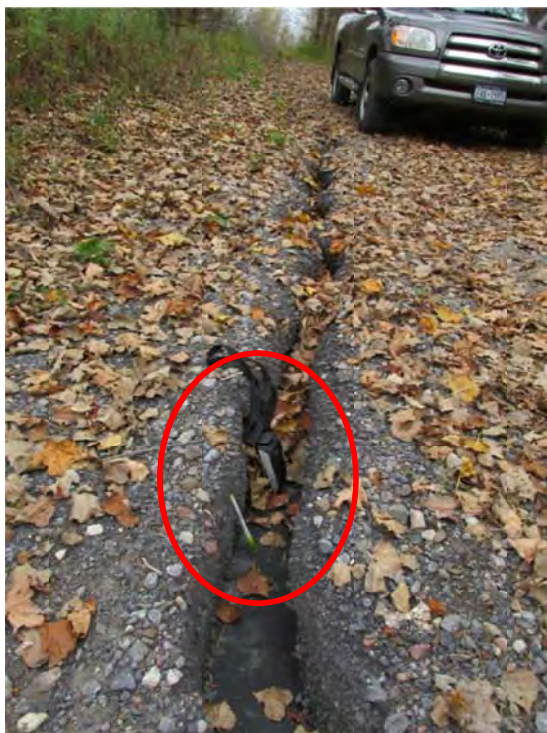
**Photo 25:** 10/16/13 Erosion/rilling in access road west of landfill. Note camera case and pen for scale.

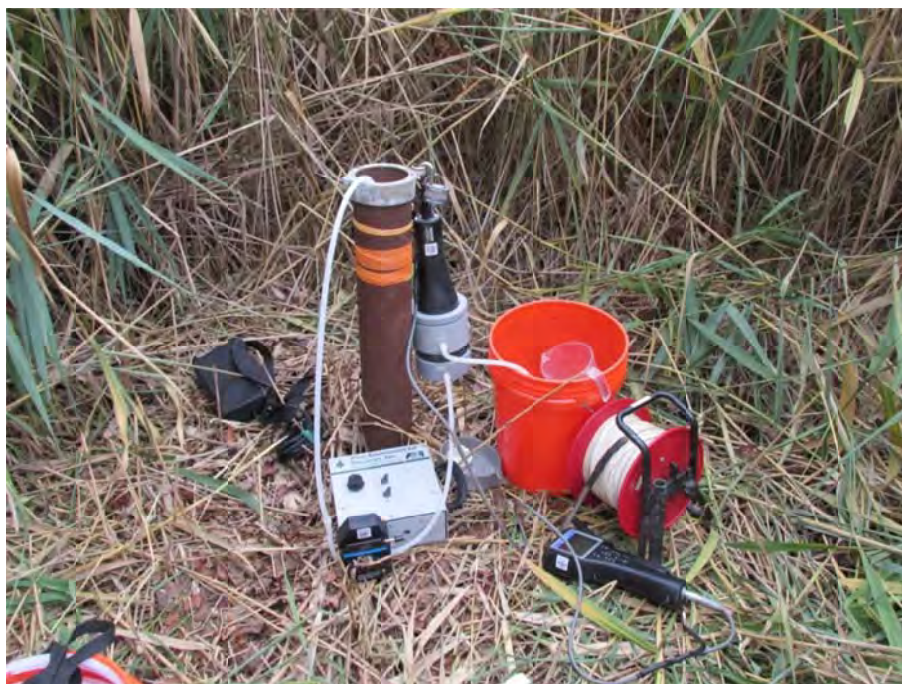
**Photo 26:** 10/16/13 Typical low-flow groundwater sampling set-up. Photo taken at location MW-03.

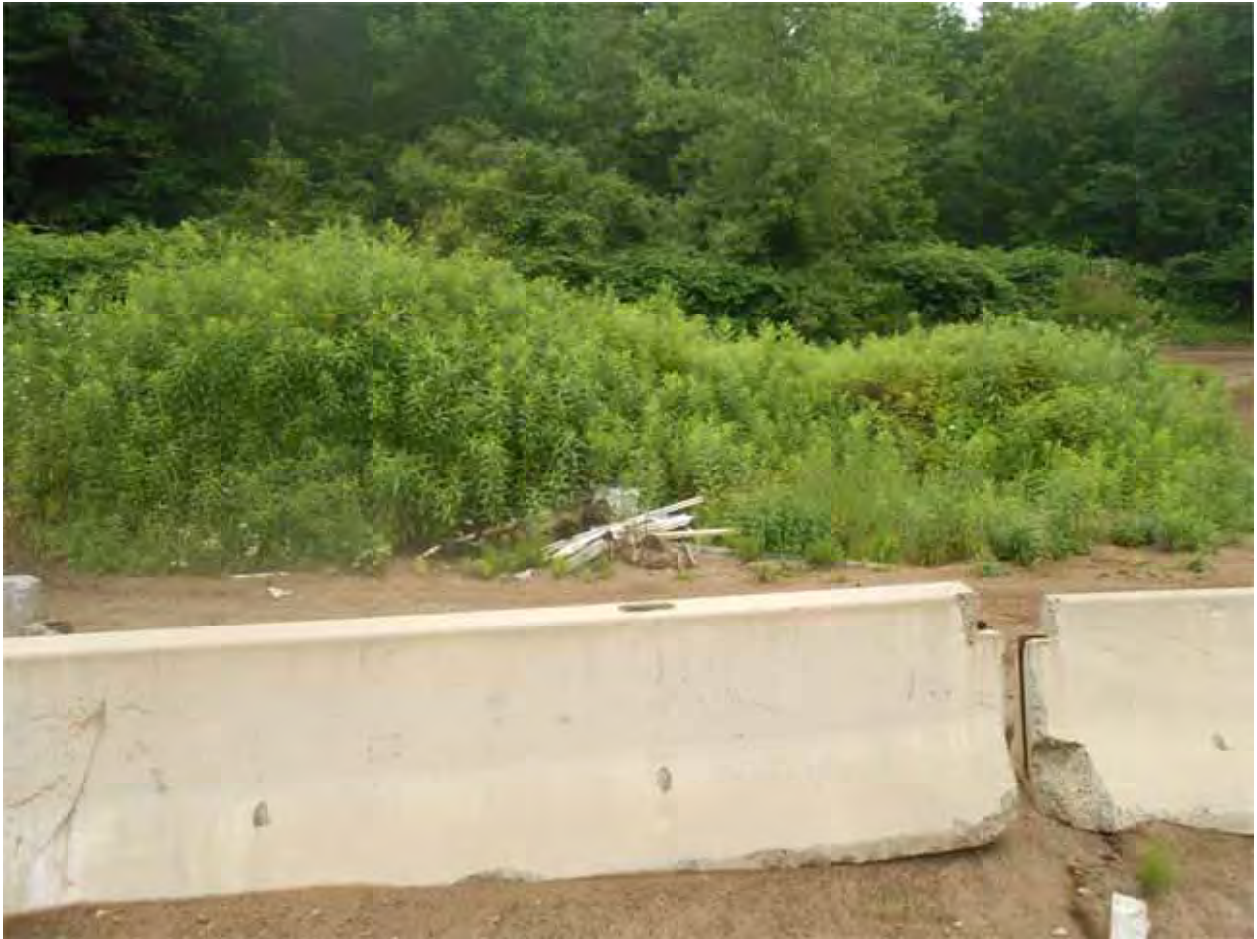
- Trash and asphalt have been illegally dumped near the jersey barriers along Military Road (Photos 1 and 2). Several tires have also been illegally dumped in the ravine north of the landfill along Military Road (Photo 3). Trespassers have removed the double swing gate panels from the gate located at the southwest corner of the landfill to gain access for all terrain vehicles (ATV) riding. One gate panel was found lying in the grass next to the gate opening (Photo 4). The second gate panel was found lying up against the northern perimeter fence (Photo 7).

**Photo 1:** 07-10-13 Trash dumped on the northern side of the Jersey barrier between the barrier and Military Road.

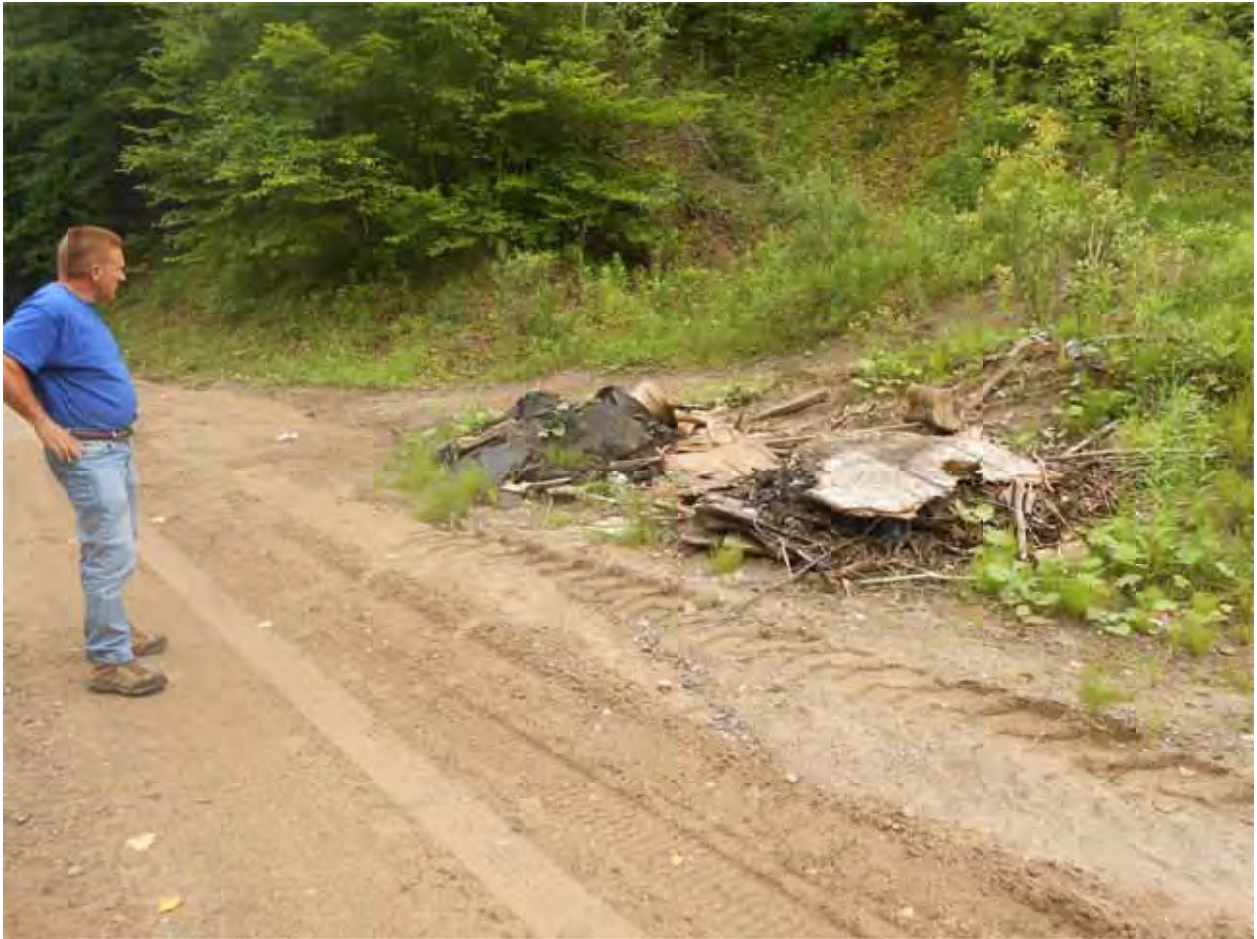
**Photo 2:** 07-10-13 Trash and asphalt dumped along Military Road near the Jersey barrier.

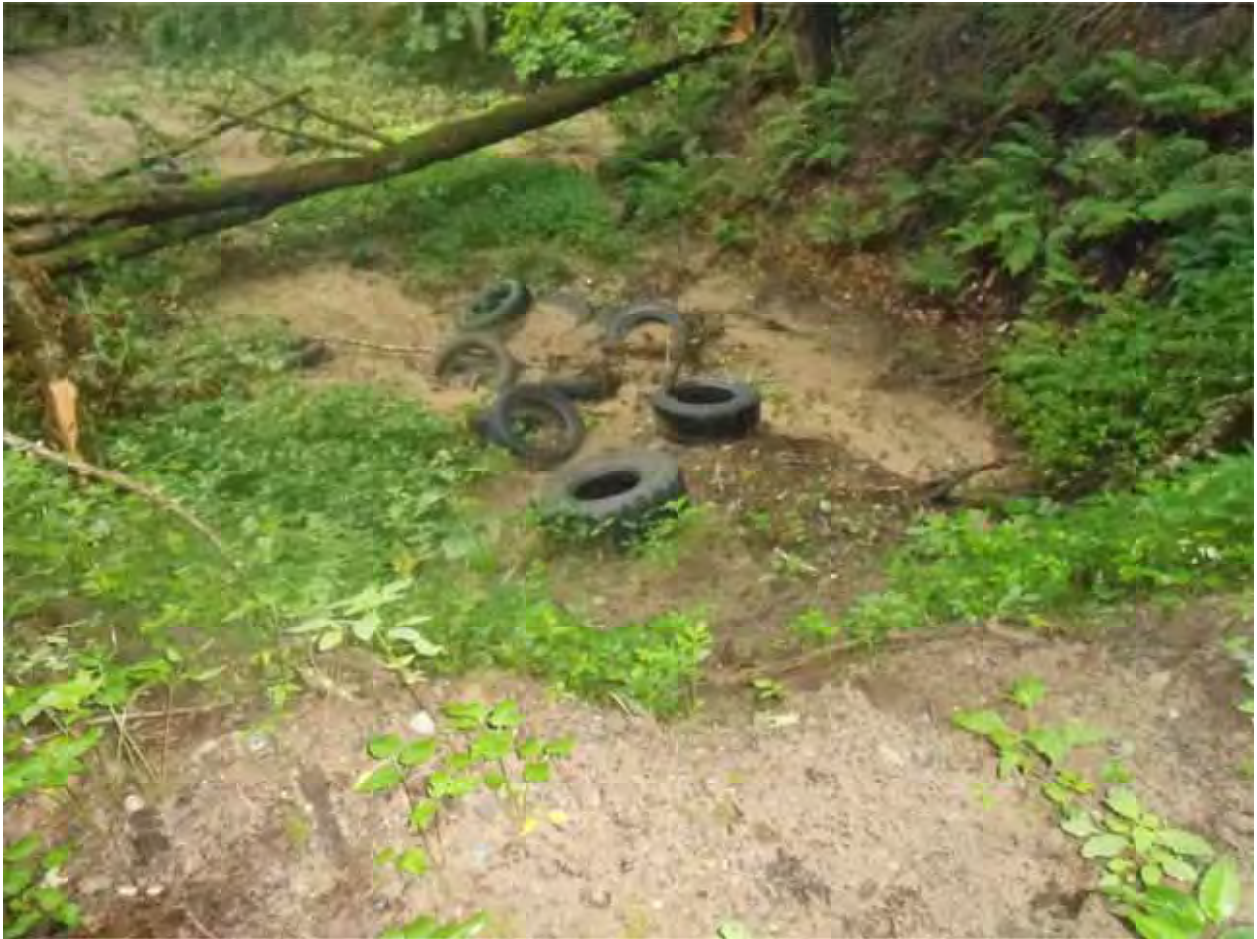
**Photo 3:** 07-10-13 Tires continue to be discarded in ravine along Military Road. The NYSDEC had removed and disposed of several hundred discarded tires from this location. Note that the tires are slightly covered by silt and sand.

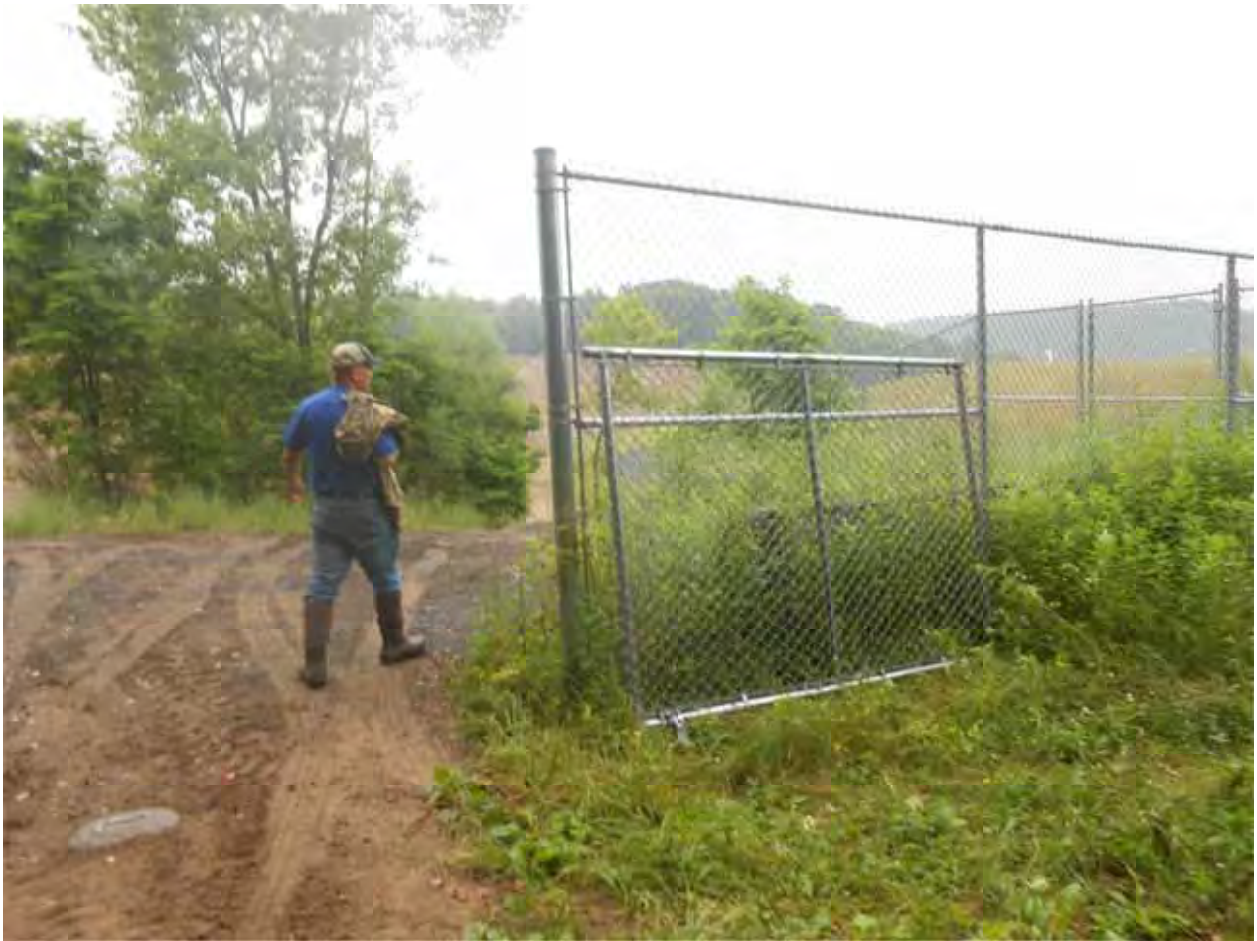
**Photo 4:** 07-10-13 The double swing gate located at the southwest corner of the landfill was removed. One side of the gate was found lying in the grass to the side of the gate opening.

The double swing gate panels located at the southwestern corner of the landfill were replaced and secured by Brady Fence Co. Inc., prior to the October 2013 site inspection. No other intermittent maintenance was performed at the time this report was prepared.

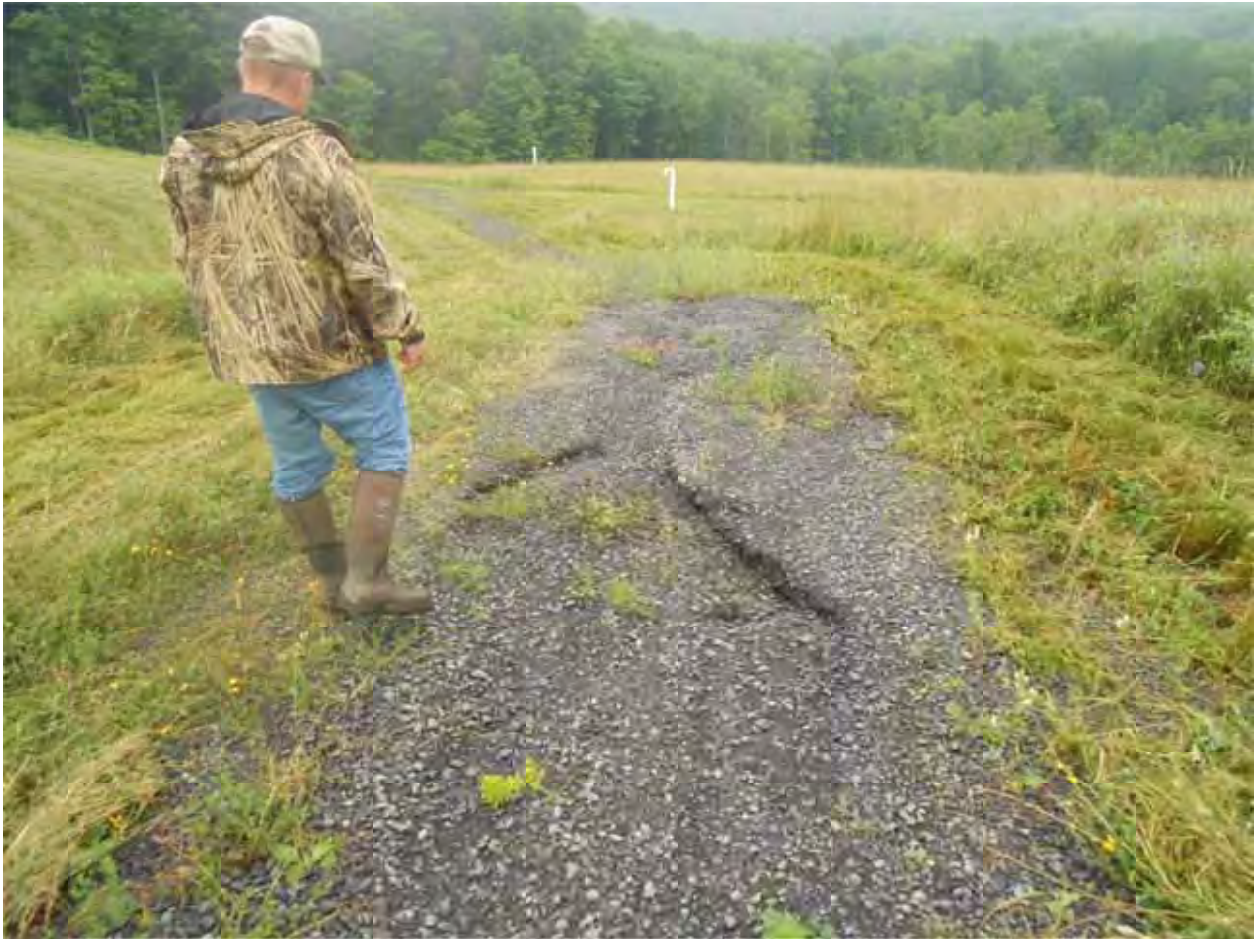
**Photo 5:** 07-10-13 Looking northeast at top of landfill. Erosion rills approximately 10 inches deep are forming on the access road on top of the landfill.

- The addition and grading of crushed stone to the main access road from Rose Valley Road to maintain access to the site.
- The addition and grading of crushed stone to the access road on top of the landfill.
- The replacement and securing of the double swing gate panels from the gate located at the southwest corner of the landfill.
- The placement of jersey barriers across the access road at the western access gate to the landfill to inhibit ATV traffic. The ATV traffic has caused erosion rills to form on the access road.
- The grading of the access road west of the landfill.
- The repair of the diversion channel around the north side of the landfill.

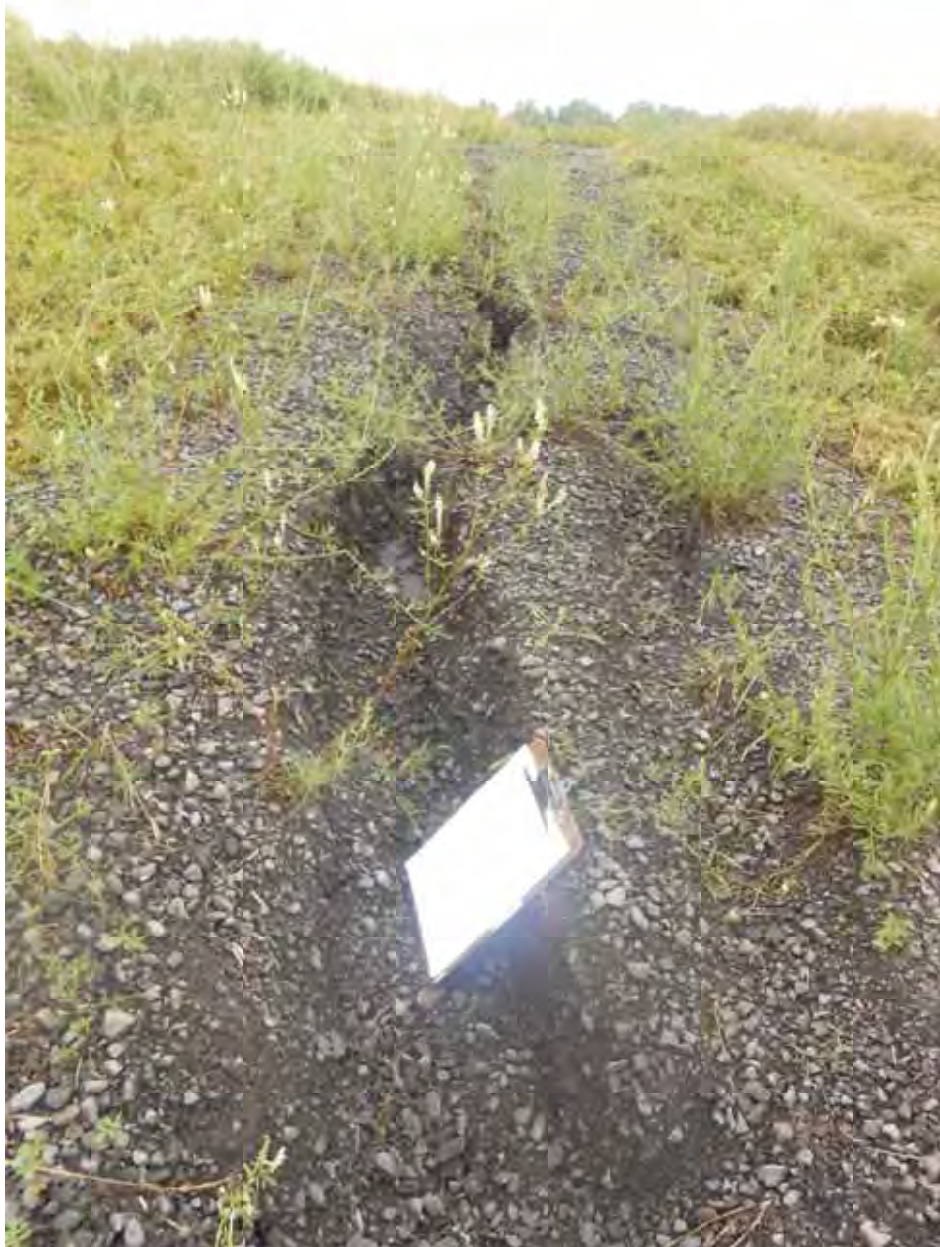
**Photo 6:** 07-10-13 Looking southwest at top of landfill. Erosion rills approximately 10 inches deep are forming on the access road on top of the landfill.

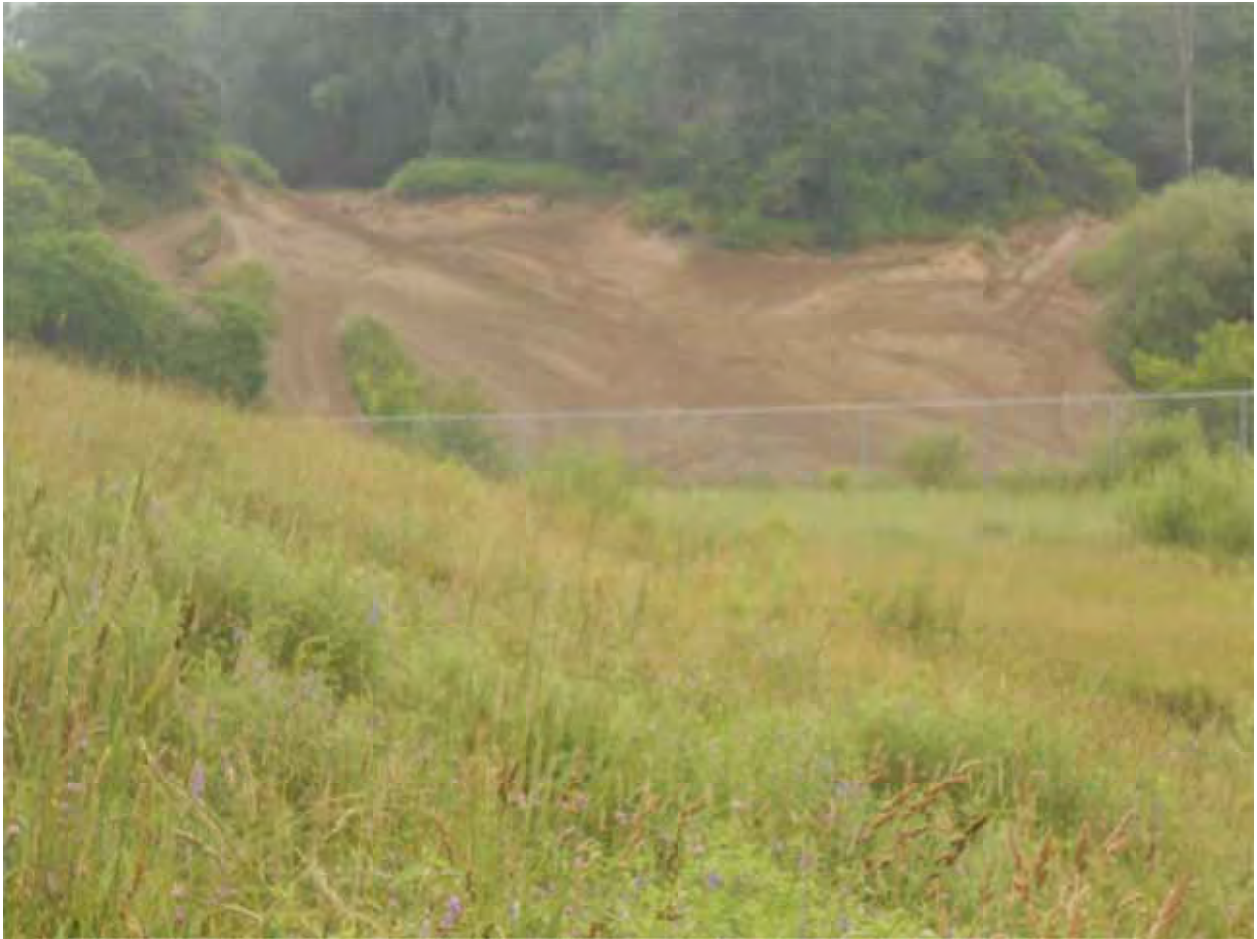
**Photo 7:** 07-10-13 The double swing gate located at the southwest corner of the landfill was removed. One side of the gate was found lying against the western perimeter fence (center of picture).

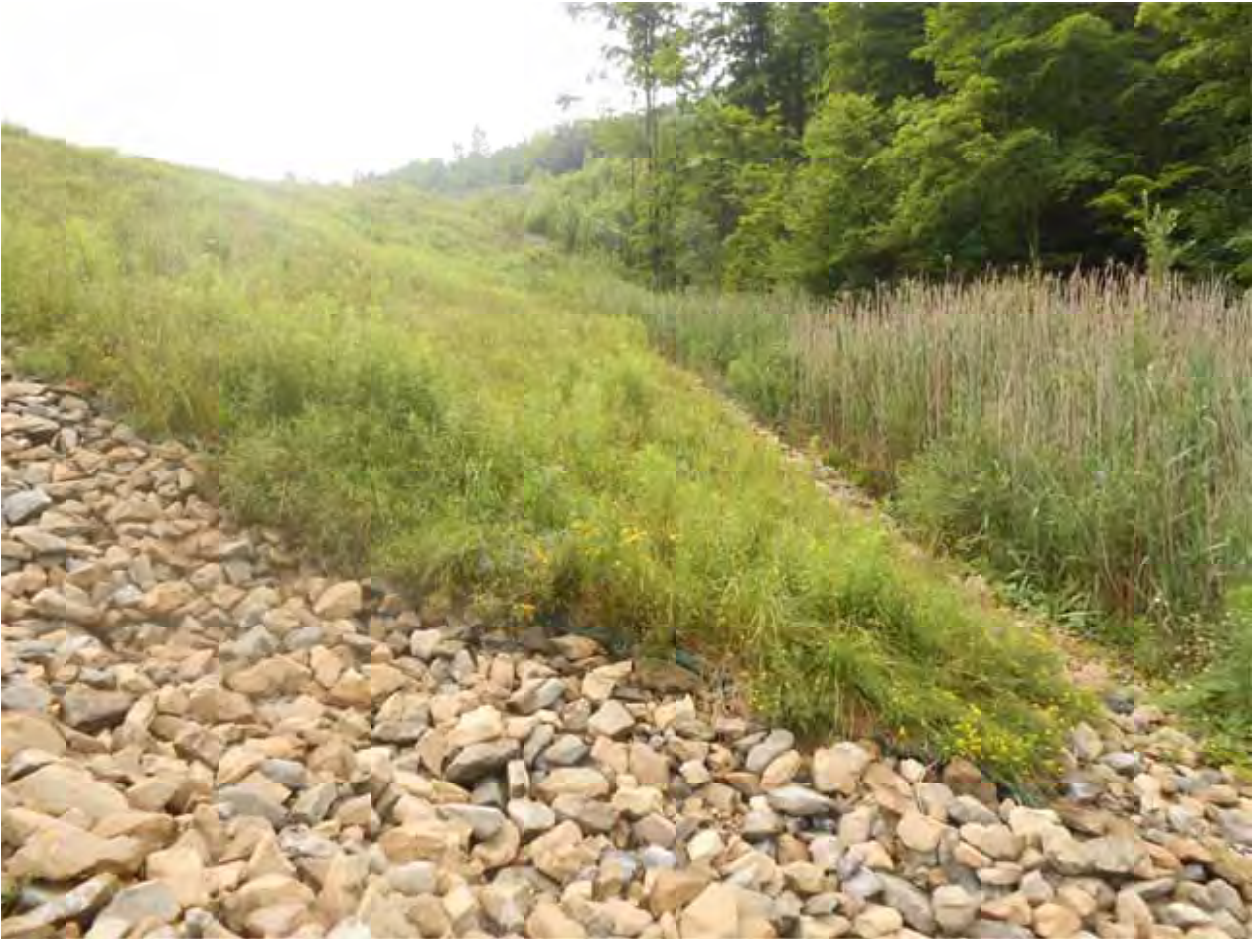
**Photo 9:** 07-10-13 Looking west from the bottom of the landfill near the north stormwater management pond at a portion of the final cover that Marcy did not mow. Note that this is the area in which there were two slides during construction. Given the steepness of the slope, this area should be minimally maintained, only to correct any erosion that may occur (none was noted) and to remove woody vegetation.

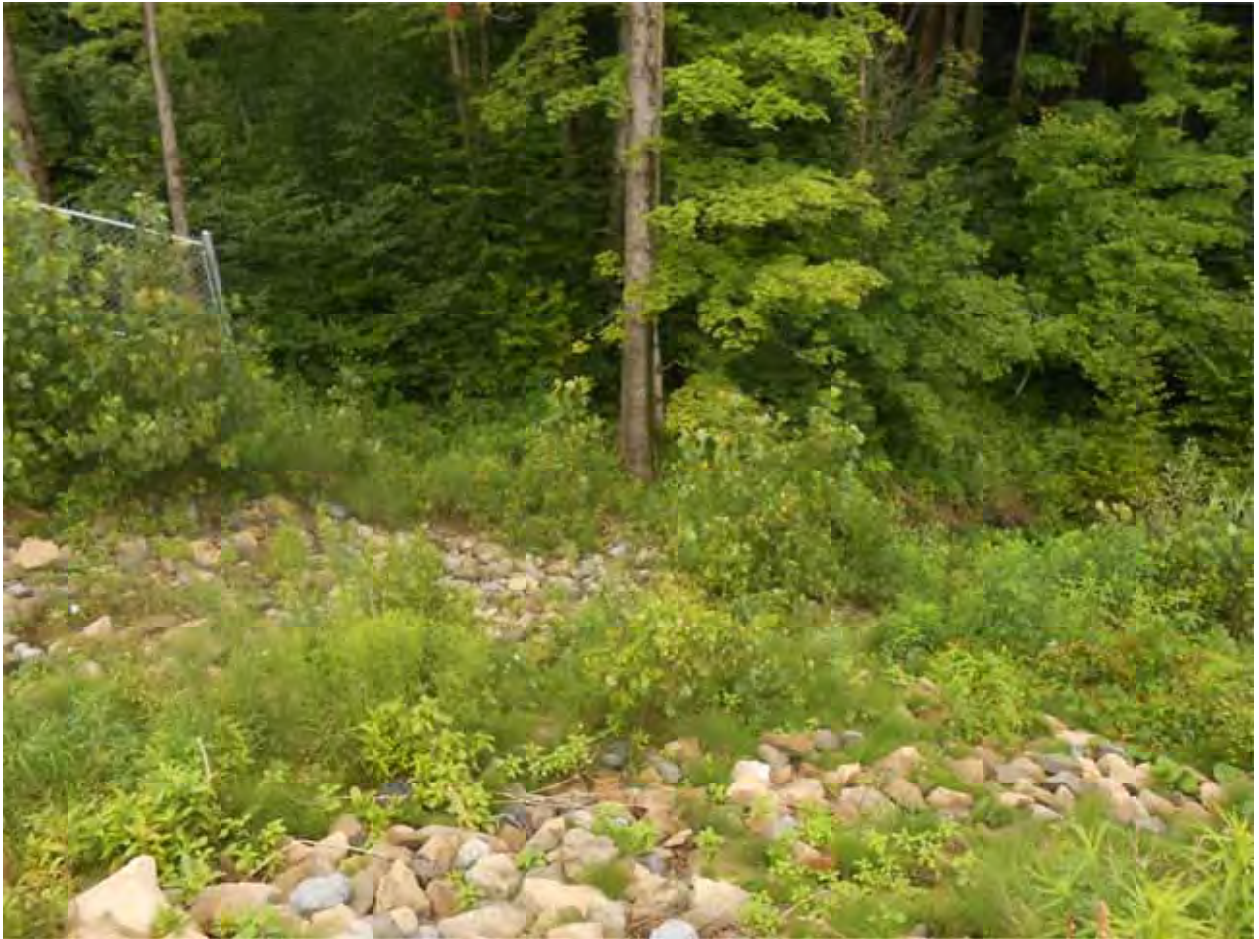
- As noted initially during the August 9, 2012 site inspection and observed during this current inspection, the diversion channel around the north side of the landfill is head cutting, so that there is now an approximately 6-foot high vertical discontinuity in the channel bottom at about the mid-point of the landfill. There appears to be no significant change to the extent of the head cutting since the August 9, 2012 site inspection.

- It appears that the head cutting has been stopped by the geotextile that underlay the downstream end of the channel armor, of which a length of about 10 feet has failed. It is unclear if this equilibrium will persist as the geotextile degrades. It is also unclear, even assuming that the head cutting has stopped, if the adjacent sides of the landfill will hold during run-off events. It was observed that the north bank of the channel appears to be eroding. Thus, the erosion is occurring on the side of the channel away from the landfill. If the head cutting continues, there could be significant erosion of and damage to the landfill cap. The situation can be monitored by noting the tree in the center of Photo 11.

**Photo 11:** 07-10-13 Looking north at the approximate location of erosion (to the right of the tree) along the northern edge of the landfill.

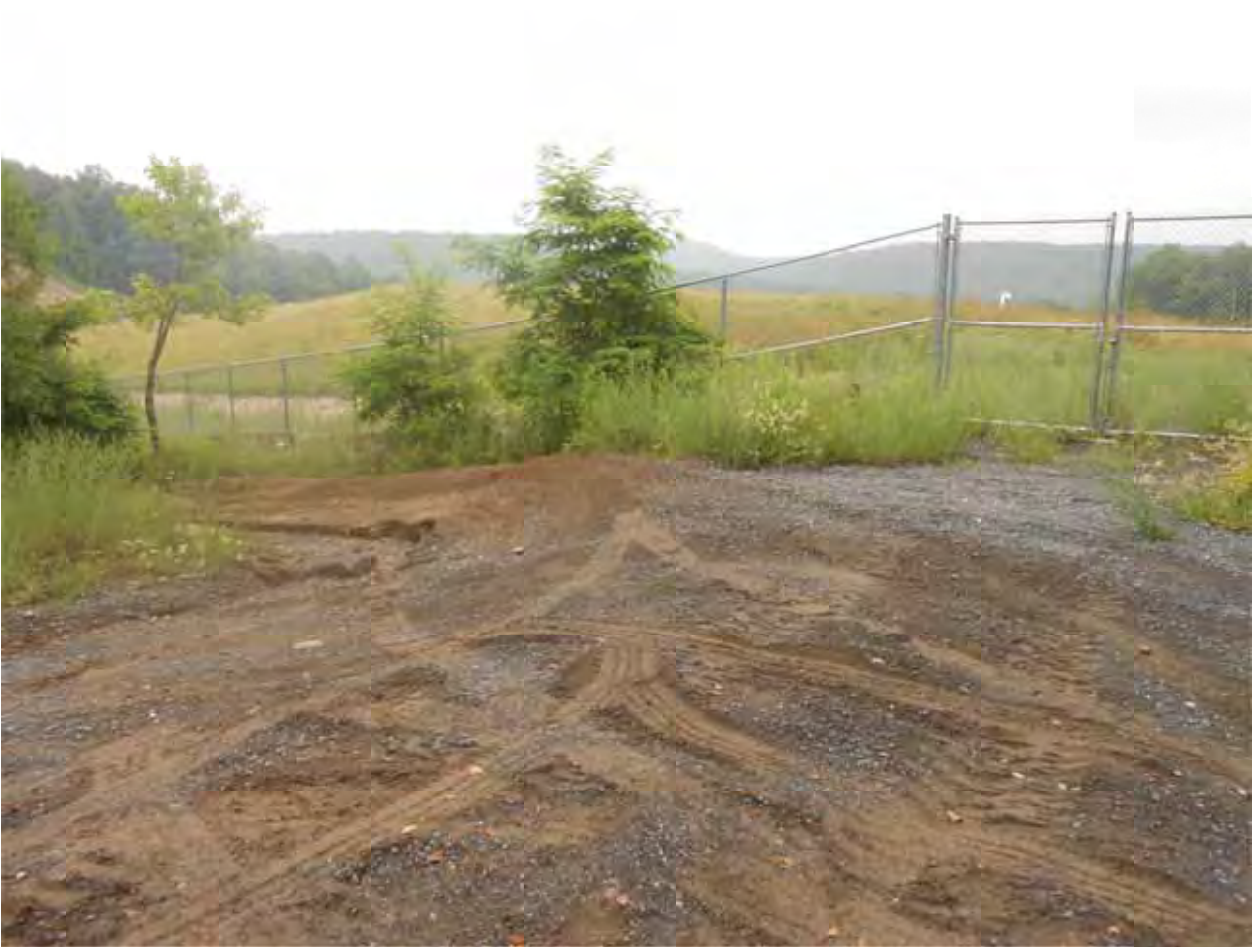
**Photo 13:** 07-10-13 Looking east towards top of landfill. Traffic from all-terrain vehicles are causing erosion rills to form on the access road.
