### **ANNUAL REPORT 2013 CALENDAR YEAR**

**ROSE VALLEY LANDFILL  
RUSSIA (T)**

**SITE NO. 622017  
HERKIMER (C), NY**

**2013 ANNUAL REPORT**

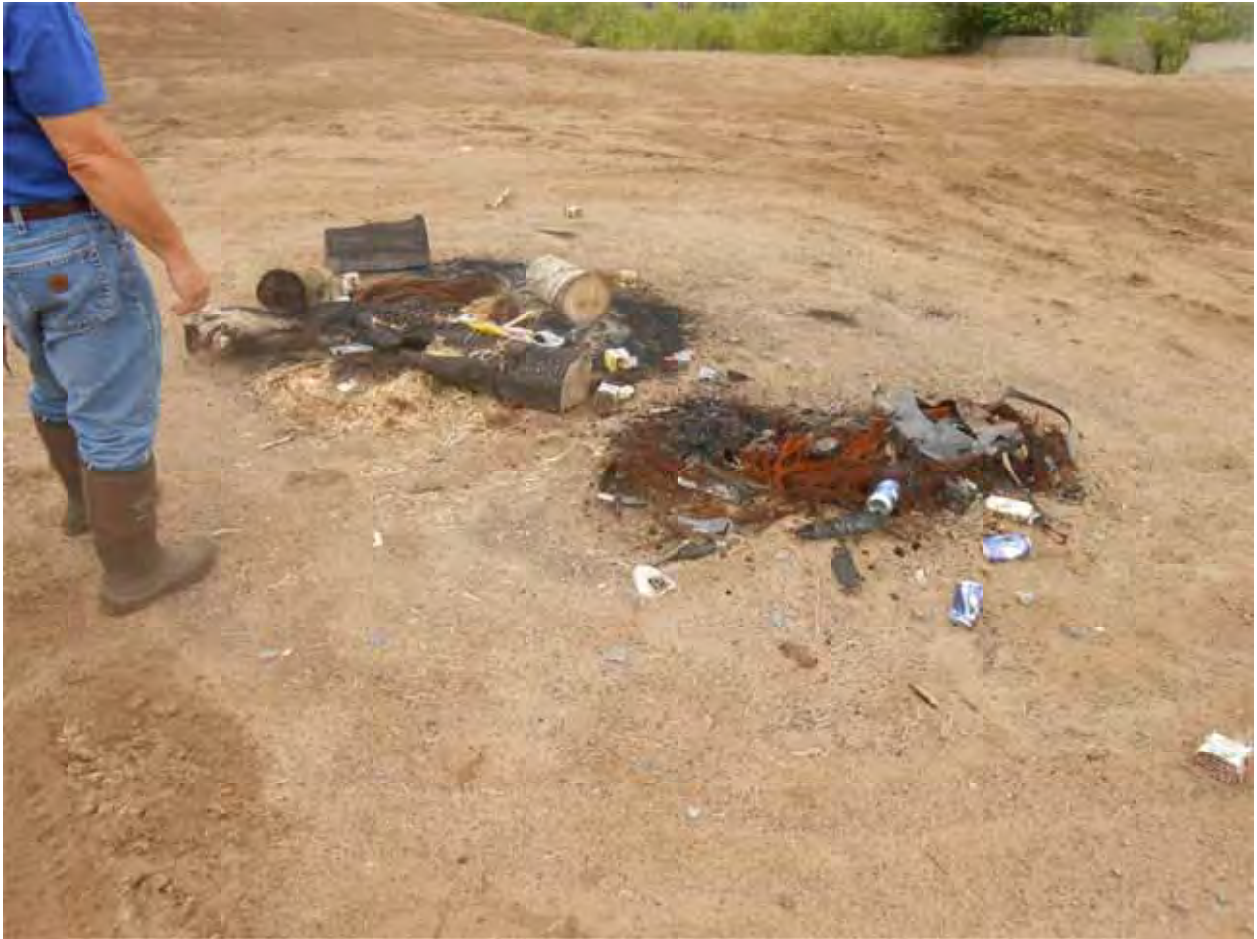
**Photo 15:** 07-10-13 Camp fire locations were discovered near the main all-terrain vehicle recreation area/hill.
