**RE: National Grid Former Manufactured Gas Plant Site
1 East Street, Ilion, New York
Annual Groundwater Monitoring Report**

Annual Groundwater Monitoring Report

National Grid Ilion Former MGP Site
1 East Street, Ilion, NY 13357

GES Project:
0603200.133570.221

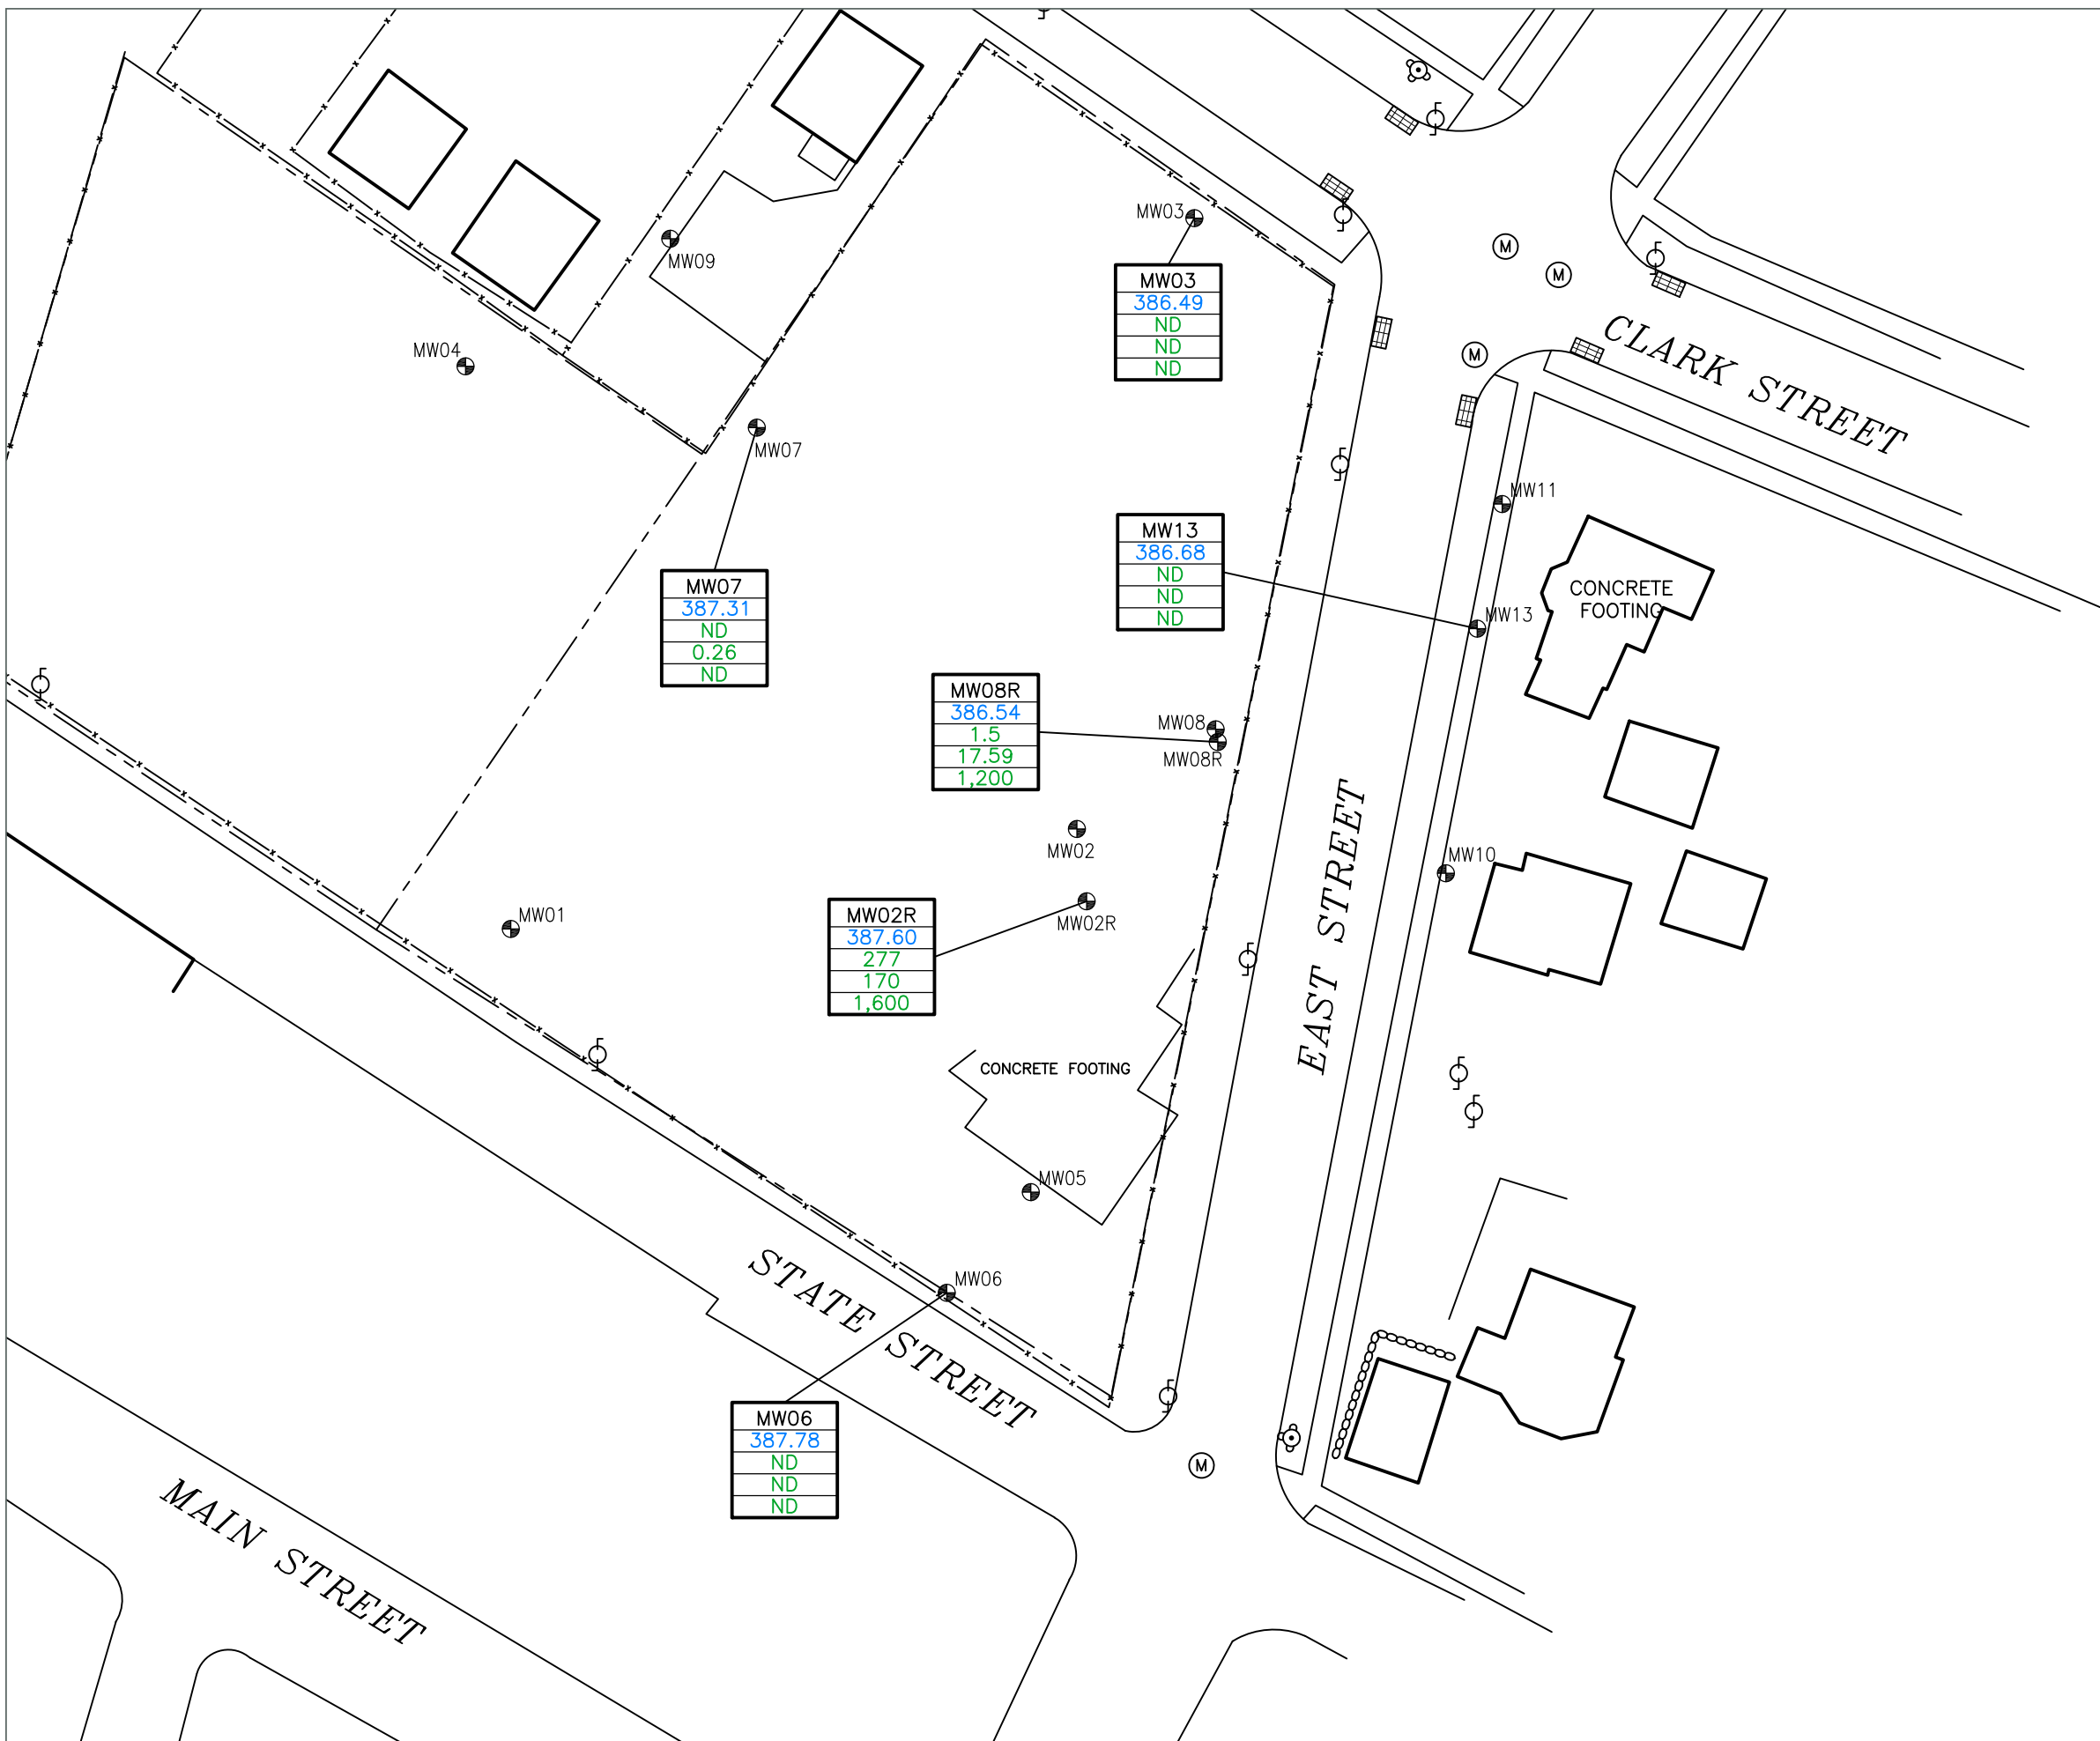
Groundwater Contour Map October 25, 2019	
National Grid 1 East Avenue & State Street Illion, New York	
Drawn W.G.S. Designed	Date 11/18/20 Figure 3
Approved	  Scale In Feet  
  Groundwater & Environmental Services, Inc.

The fluid level measurements obtained from each monitoring well were converted to groundwater elevations using the surveyed well elevations. The calculated groundwater elevations for each monitoring well are listed in Table 1. Table 1 also includes groundwater elevation measurements obtained during previous groundwater monitoring events, and is depicted on Figures 3, 5, and 7.
