**RE: National Grid Former Manufactured Gas Plant Site  
1 East Street, Ilion, New York  
Annual Groundwater Monitoring Report**

# Annual Groundwater Monitoring Report

National Grid Ilion Former MGP Site  
1 East Street, Ilion, NY 13357

GES Project:  
0603275.133570.221

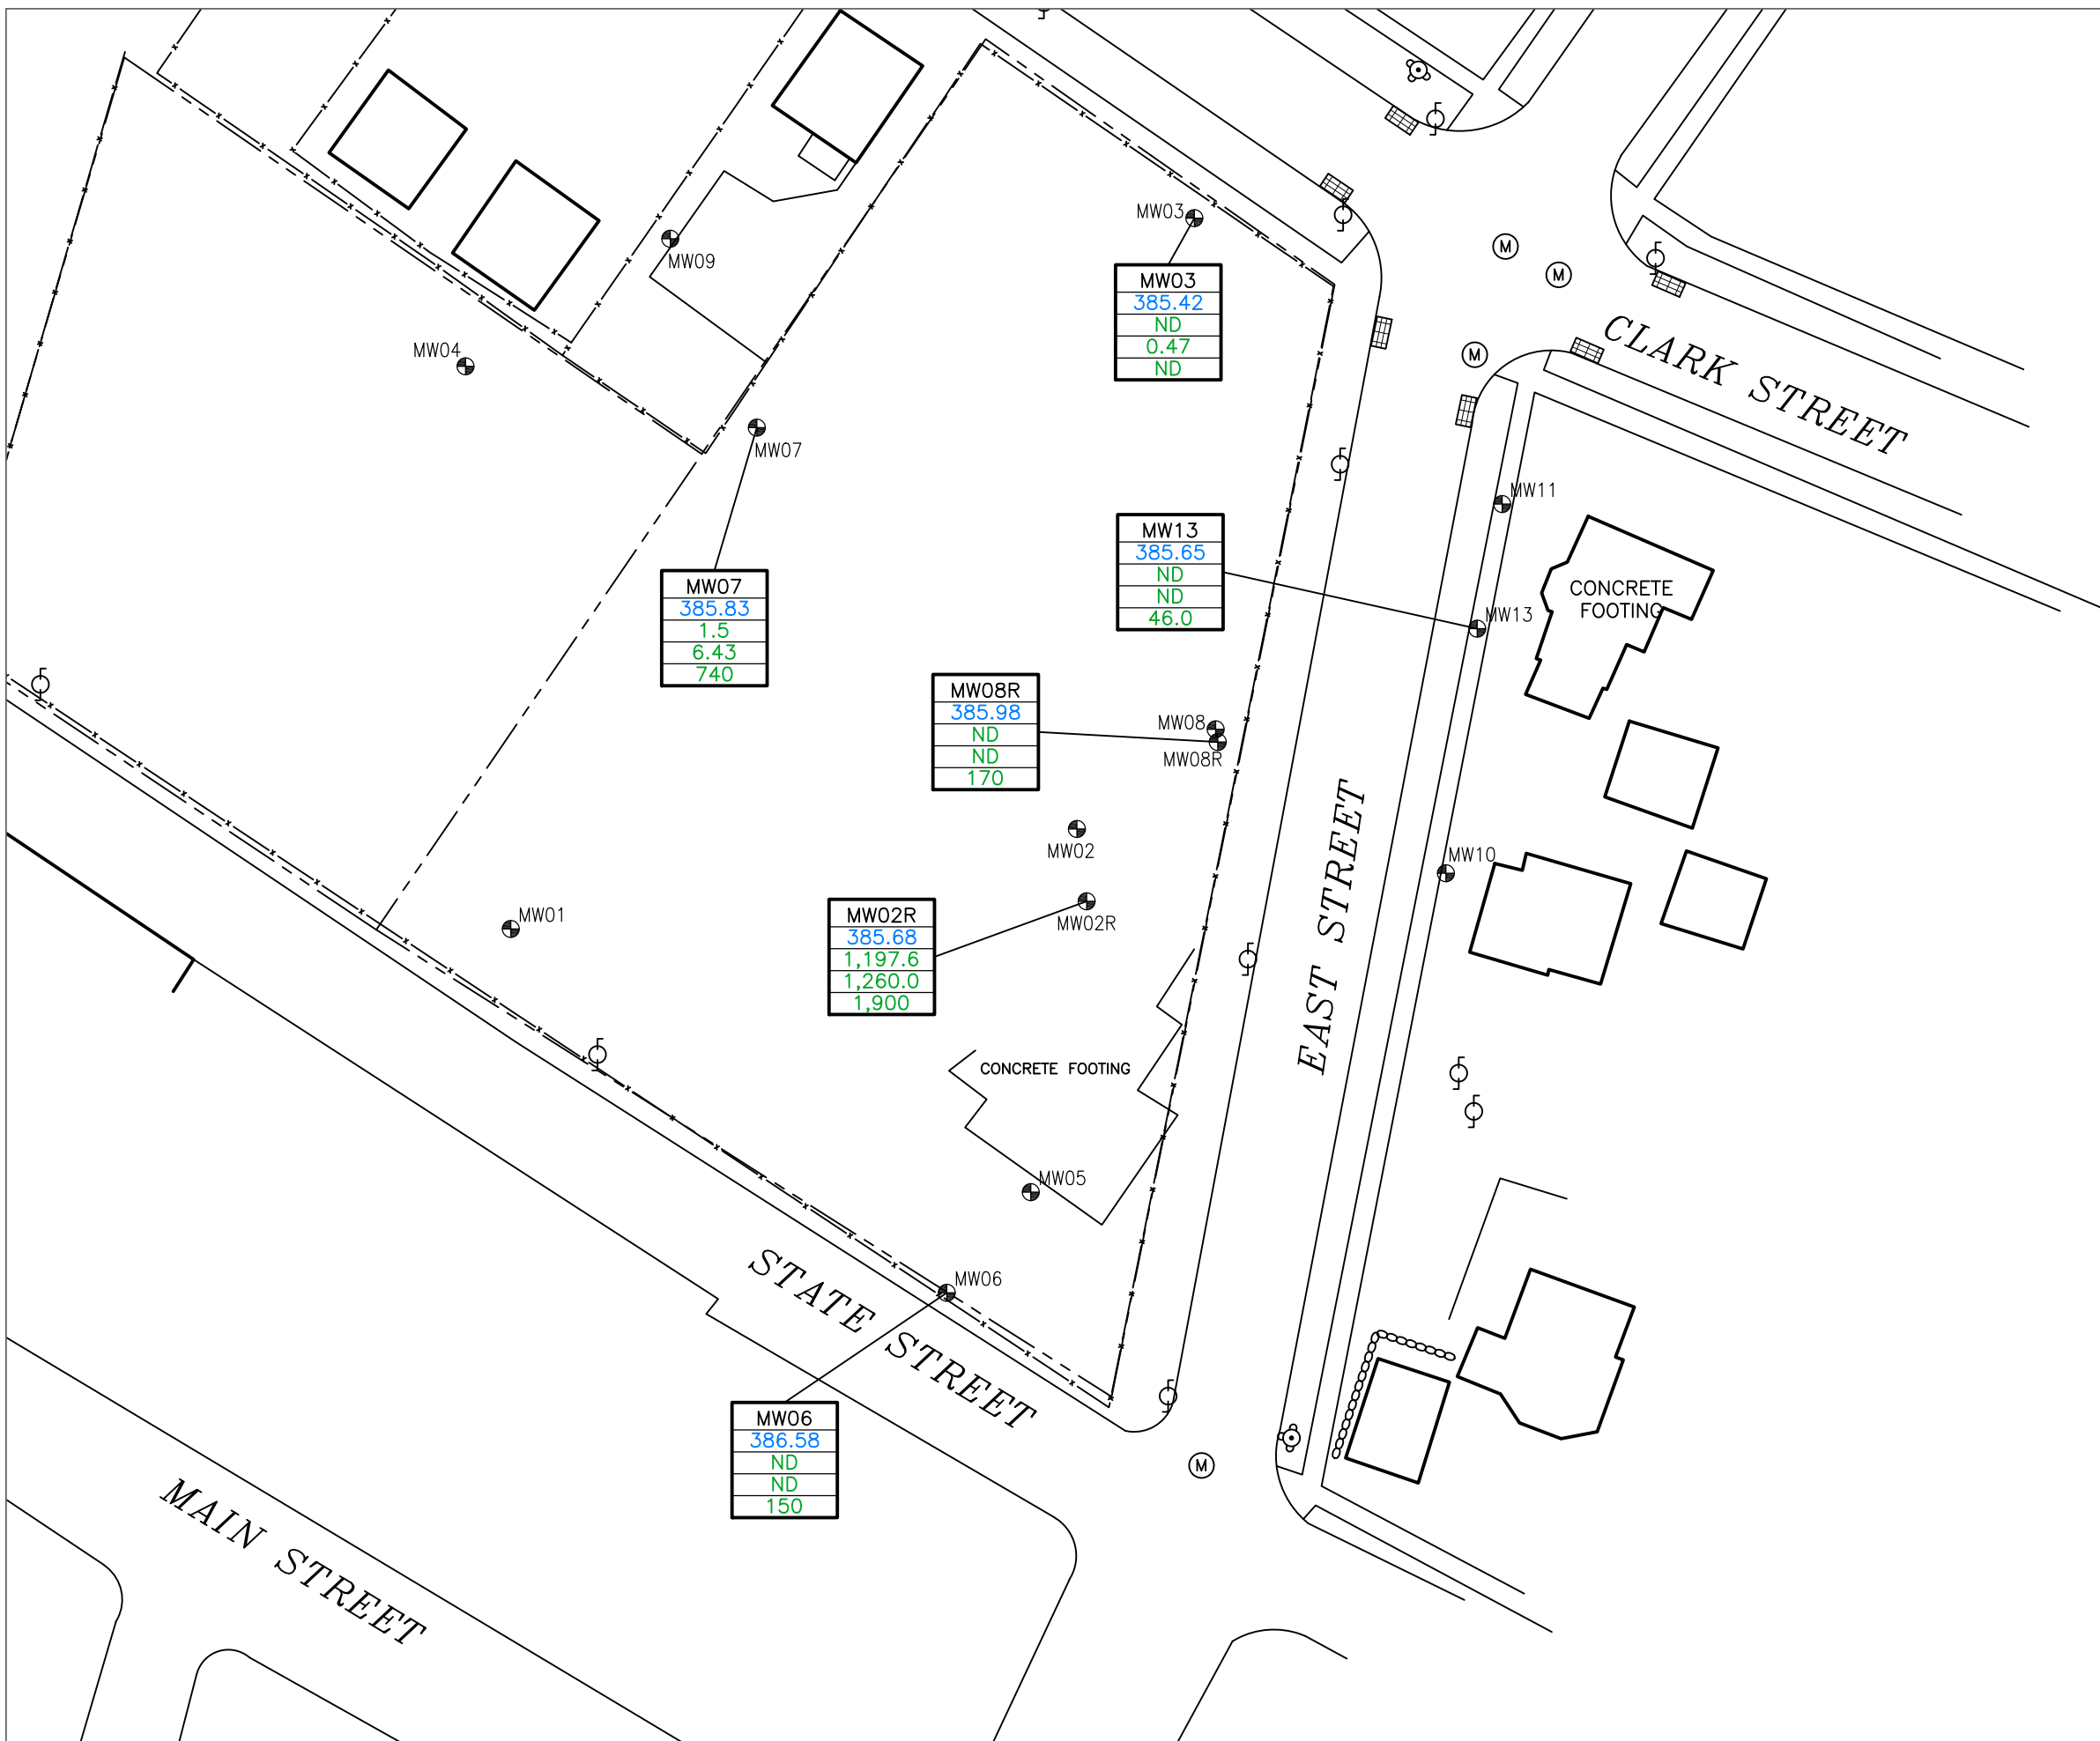
Groundwater Monitoring Map  
April 22, 2021

There were BTEX and/or PAH detections in all the monitoring wells sampled in April 2021 and October 2021, with the exception of MW-06, MW-08, and MW-13 in April and October 2021 and MW-03 in October 2021. In April 2021, BTEX, acenaphthene, benzo(a)anthracene, benzo(a)pyrene, benzo(b)fluoranthene, benzo(k)fluoranthene, chrysene, indeno(1,2,3-cd)pyrene, and naphthalene were detected above the regulatory criteria in one or more samples. Cyanide was detected in MW-02R, MW-06, MW-07, MW-08R, and MW-13 in April 2021. In October 2021, BTEX and acenaphthene were detected above the regulatory criteria in one or more samples. Cyanide was detected in MW-02R MW-07, and MW-08R during the October 2021 sampling event.

Analytical results from the laboratory analysis report are summarized in Table 2 and compared to the Class GA groundwater standards and guidance values presented in TOGS 1.1.1. VOC exceedances are bolded on Table 2 and further shown on Figures 4, and 6. The Data Usability Summary Report (DUSR) is included in Appendix C.
