**RE: National Grid Former Manufactured Gas Plant Site
1 East Street, Ilion, New York
Annual Groundwater Monitoring Report**

Annual Groundwater Monitoring Report

National Grid Ilion Former MGP Site
1 East Street, Ilion, NY 13357

GES Project:
0603324.133570.221

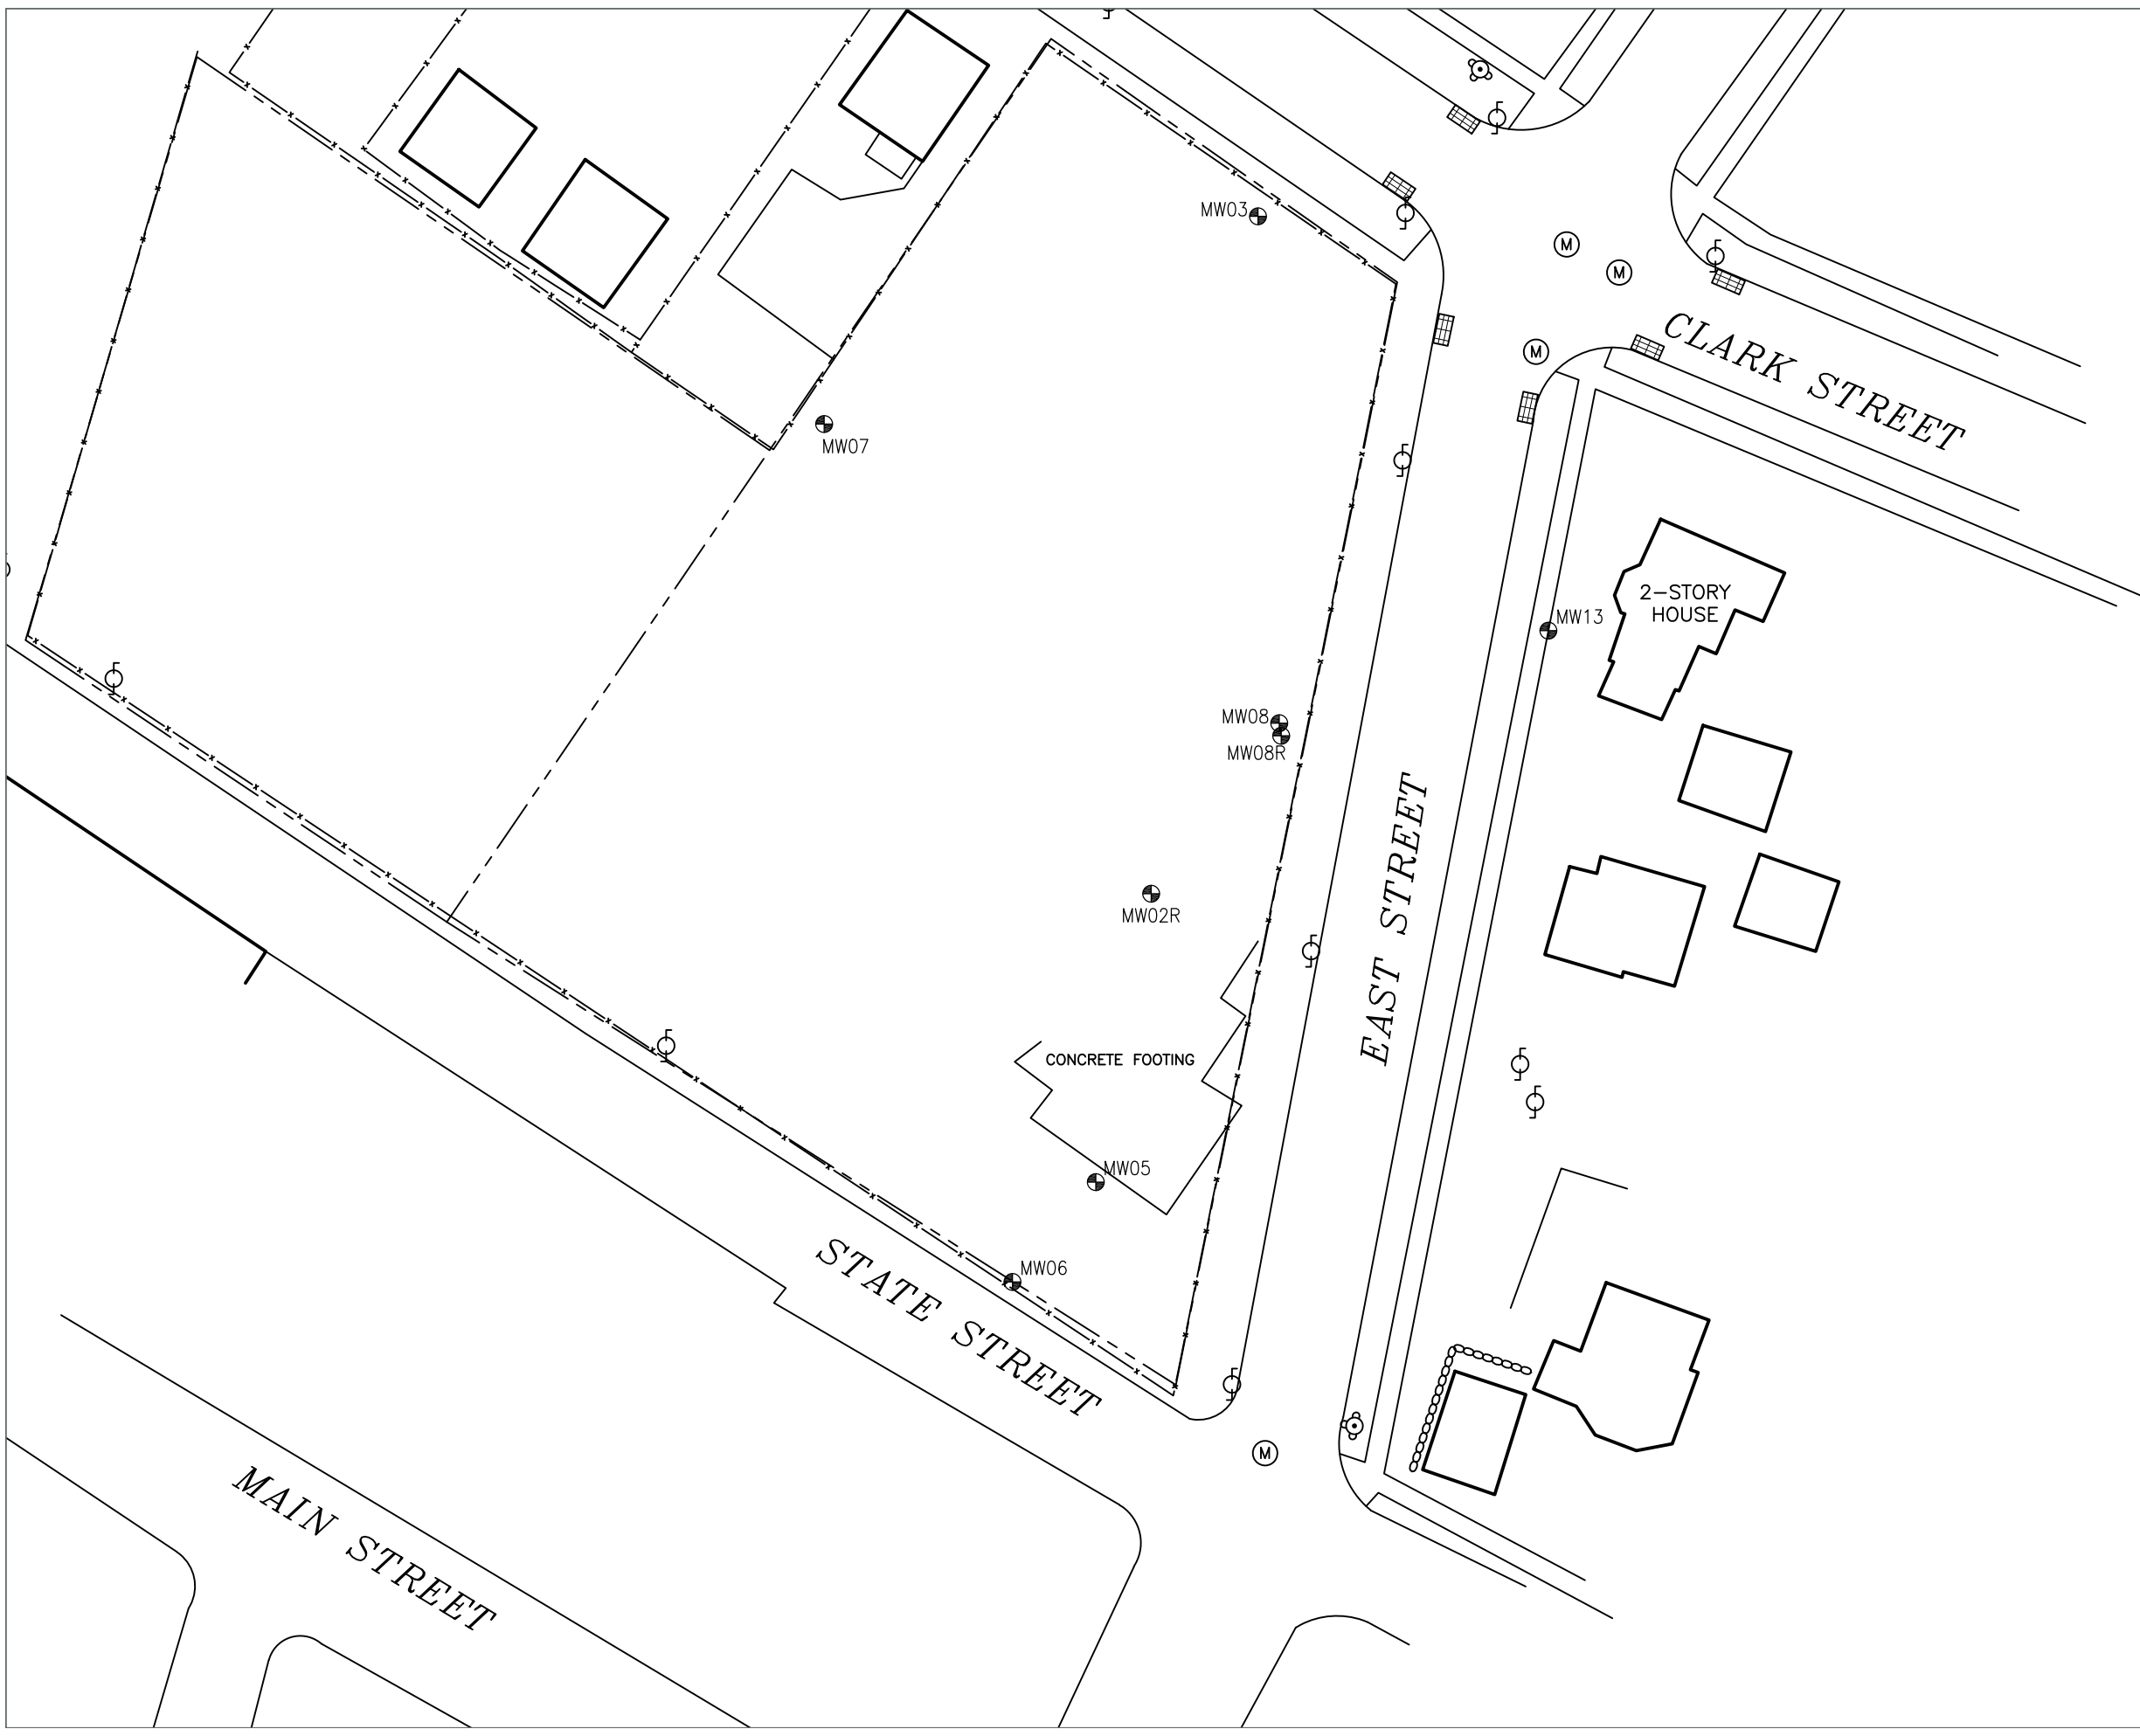
Site Map	
National Grid 1 East Avenue & State Street Illion, New York	
Drawn W.G.S. Designed Approved	Date 2/16/22 Figure 2
  Scale In Feet  	
  <small>Groundwater & Environmental Services, Inc.</small>

Groundwater samples were collected by GES from six (6) monitoring wells on April 28, 2022, and October 26, 2022 (including MW-02R, MW-03, MW-06, MW-07, MW-08R, and MW-13). Low-flow sampling techniques were used to purge groundwater from each monitoring well prior to collecting groundwater samples. Field parameters (consisting of turbidity, temperature, pH, conductivity, oxidation reduction potential [ORP], and dissolved oxygen) were measured approximately every 5 to 10 minutes during well purging, and the depth to water was monitored throughout the pumping process to minimize drawdown within the well. Well purging activities continued at each well until the field parameters stabilized and the turbidity of the water in the wells was reduced to less than 50 nephelometric turbidity units (NTUs). Groundwater field data is presented in Appendix B.

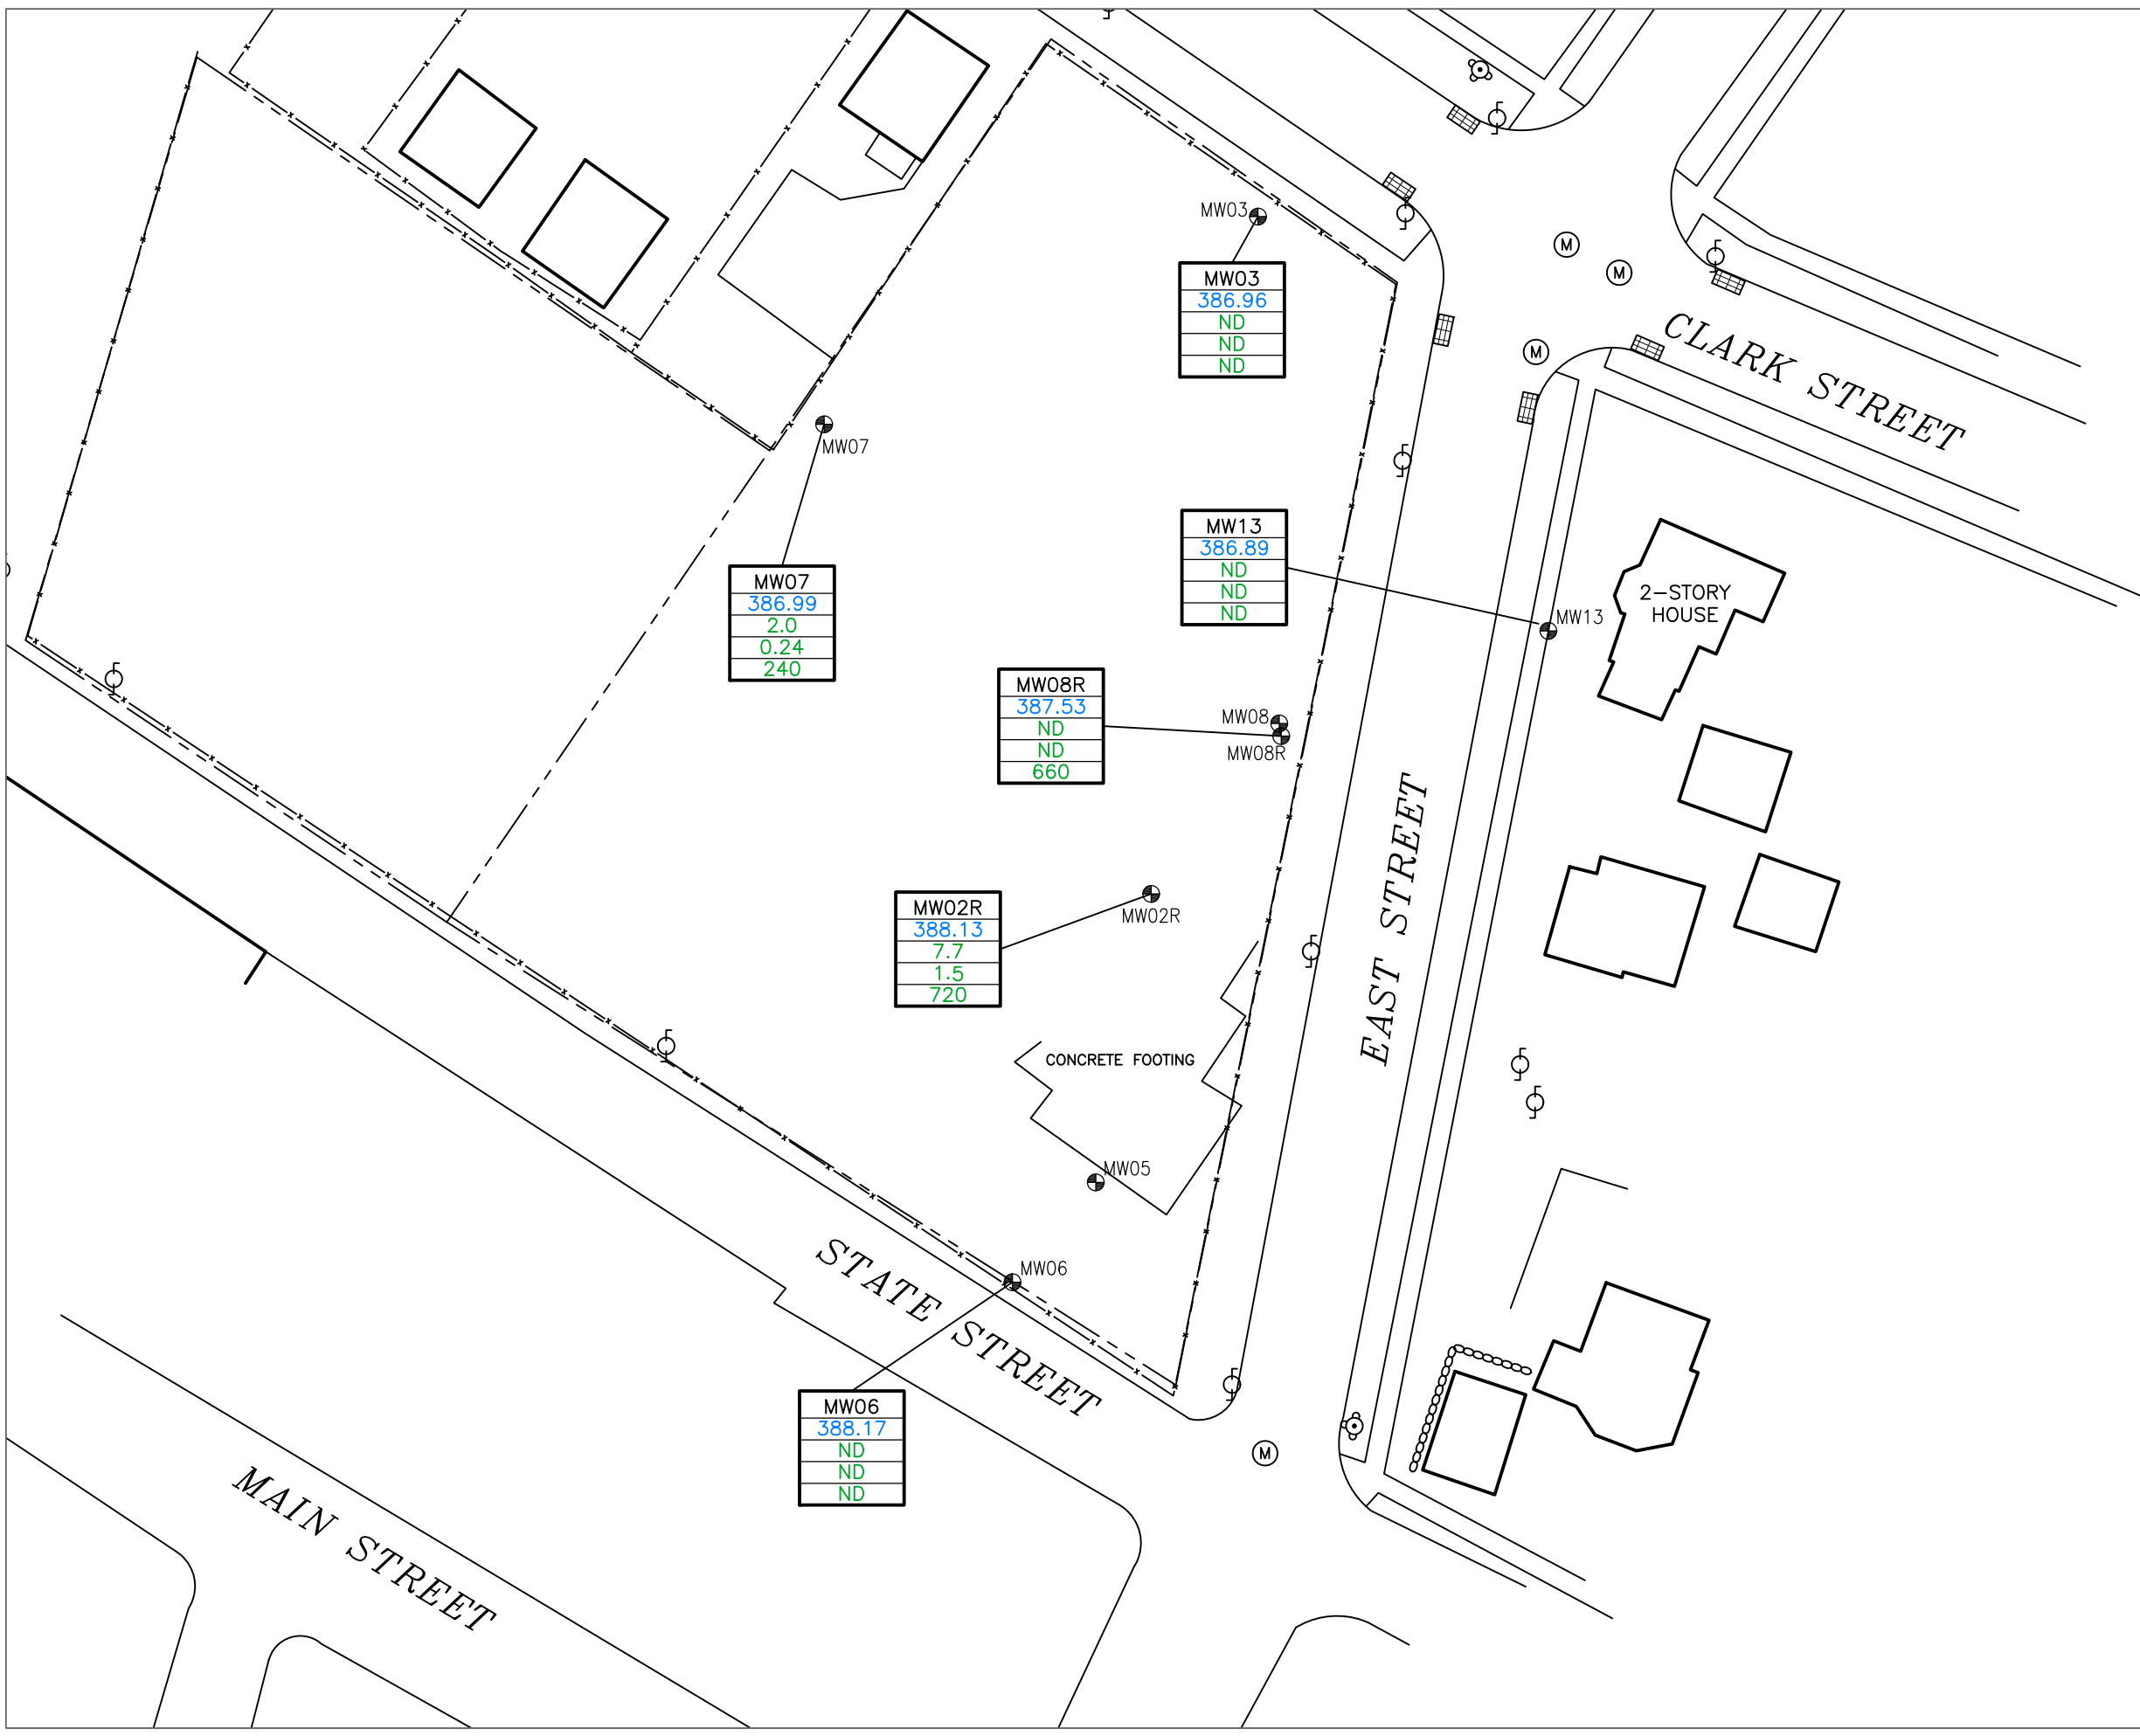
Drawn J.D.B. Designed	  Scale In Feet  	Date 12/18/22 Figure 4
Approved	  <small>Groundwater & Environmental Services, Inc.</small>

There were BTEX and/or PAH detections in all the monitoring wells sampled in April 2022 and October 2022, with the exception of MW-03 during both events, and MW-06, MW-08R, and MW-13 during the April 2022 event. In April 2022, BTEX and acenaphthene were detected above the regulatory criteria in one or more samples. Cyanide was detected in MW-02R, MW-07, and MW-08R in April 2022. In October 2022, BTEX, acenaphthene, and naphthalene were detected above the regulatory criteria in one or more samples. Cyanide was detected in MW-02R, MW-07, and MW-08R during the October 2022 sampling event.

Well ID	Groundwater Elevation (feet)	BTEX Concentration (ug/L)	TOTAL PAHs Concentration (ug/L)	Cyanide Concentration (ug/L)
MW02R	388.13	7.7	2	720

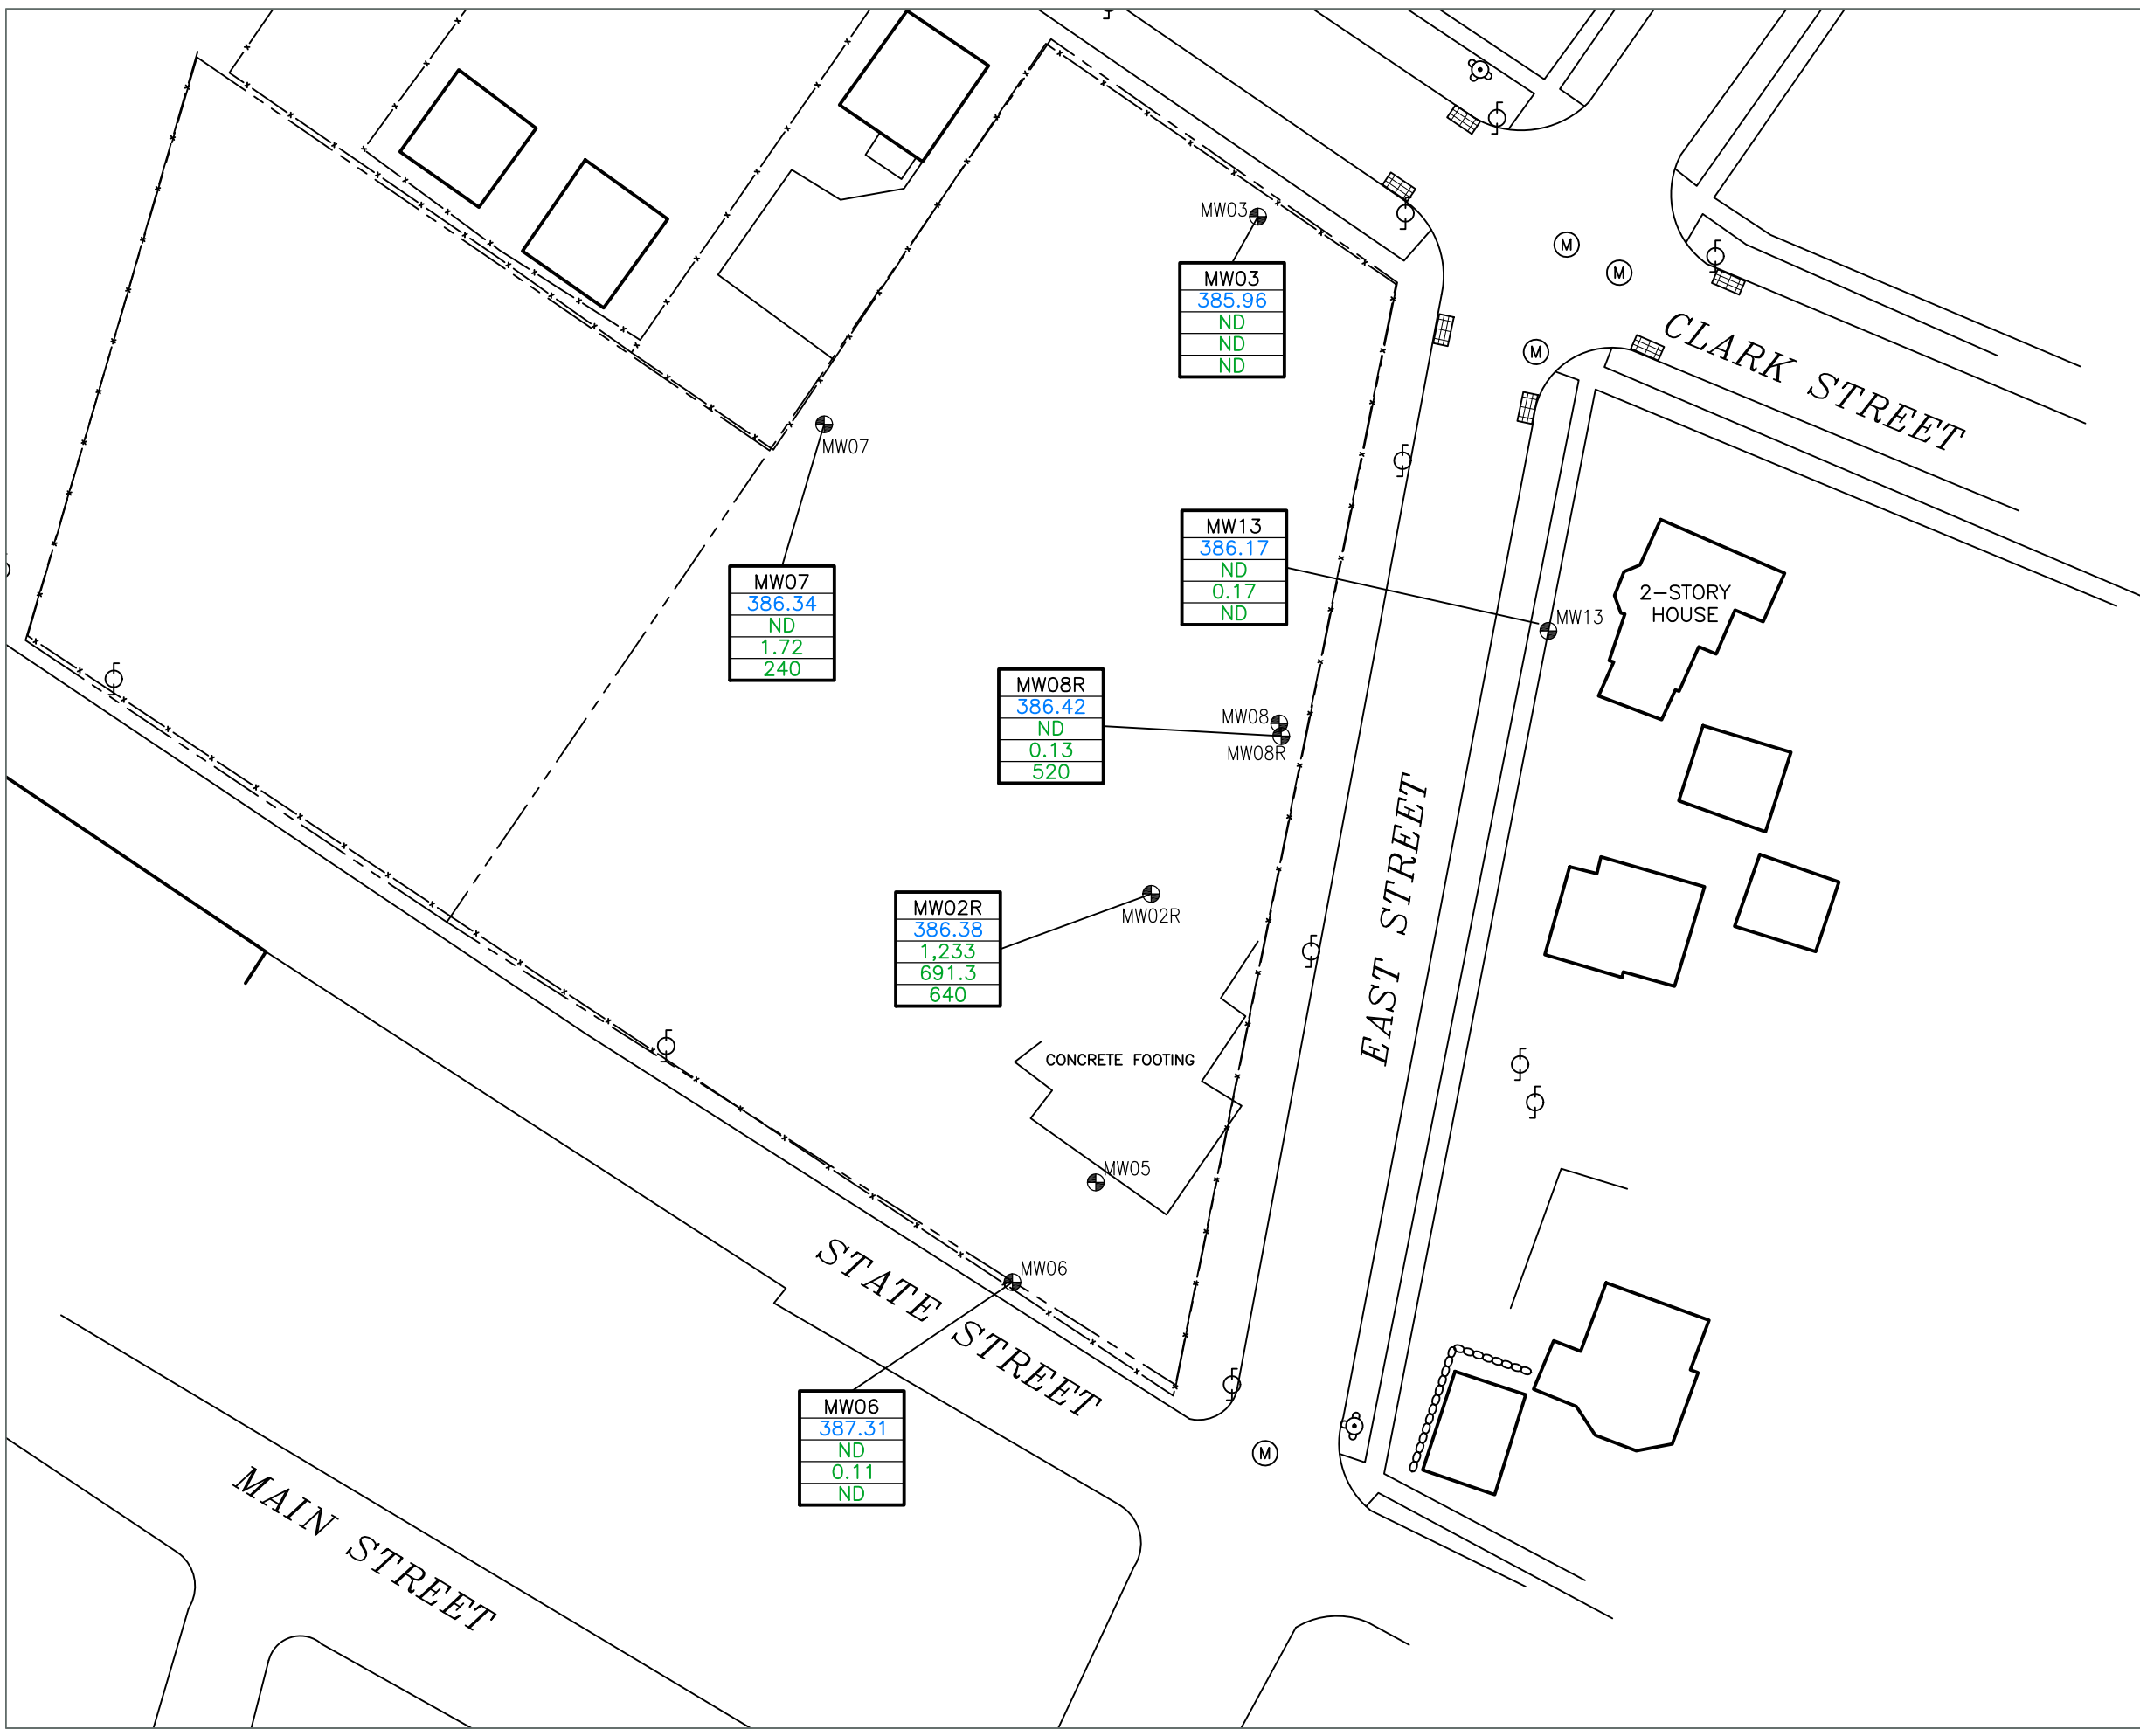
Drawn J.D.B.	  Scale In Feet     <small>Groundwater & Environmental Services, Inc.</small>	Date 12/18/22
Designed		Figure 6
Approved

MW02R	WELL IDENTIFICATION
386.38	GROUNDWATER ELEVATION (feet)
1,233	BTEX CONCENTRATION (ug/L)
691.31	TOTAL PAHs CONCENTRATION (ug/L)
640	CYANIDE CONCENTRATION (ug/L)

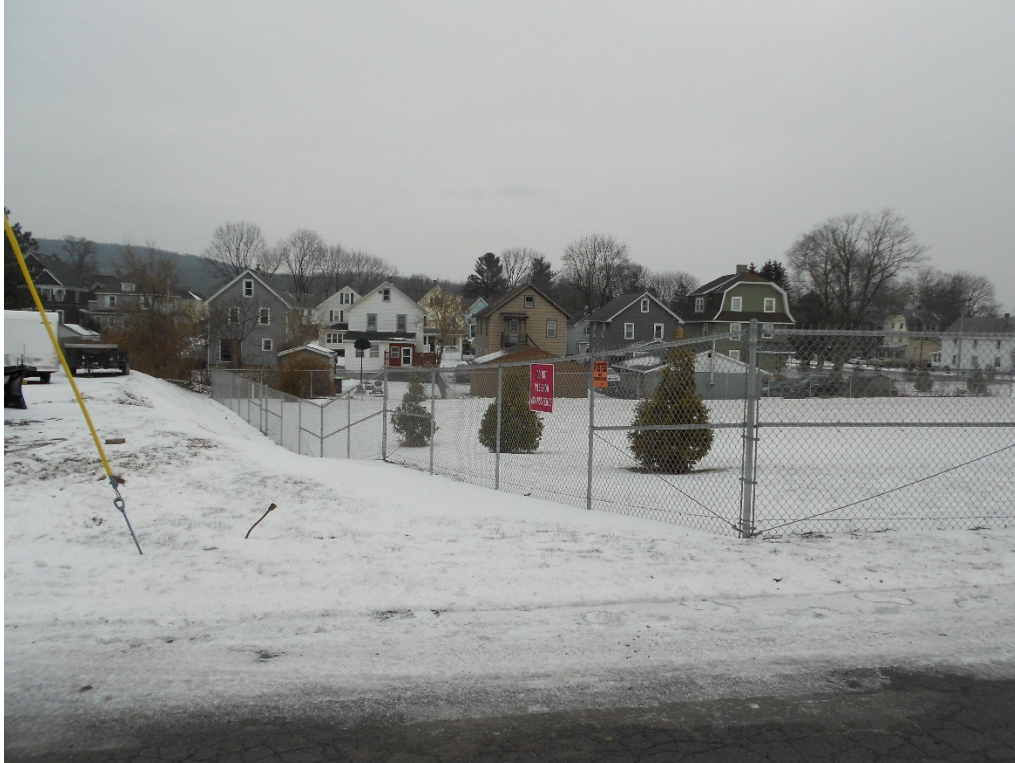
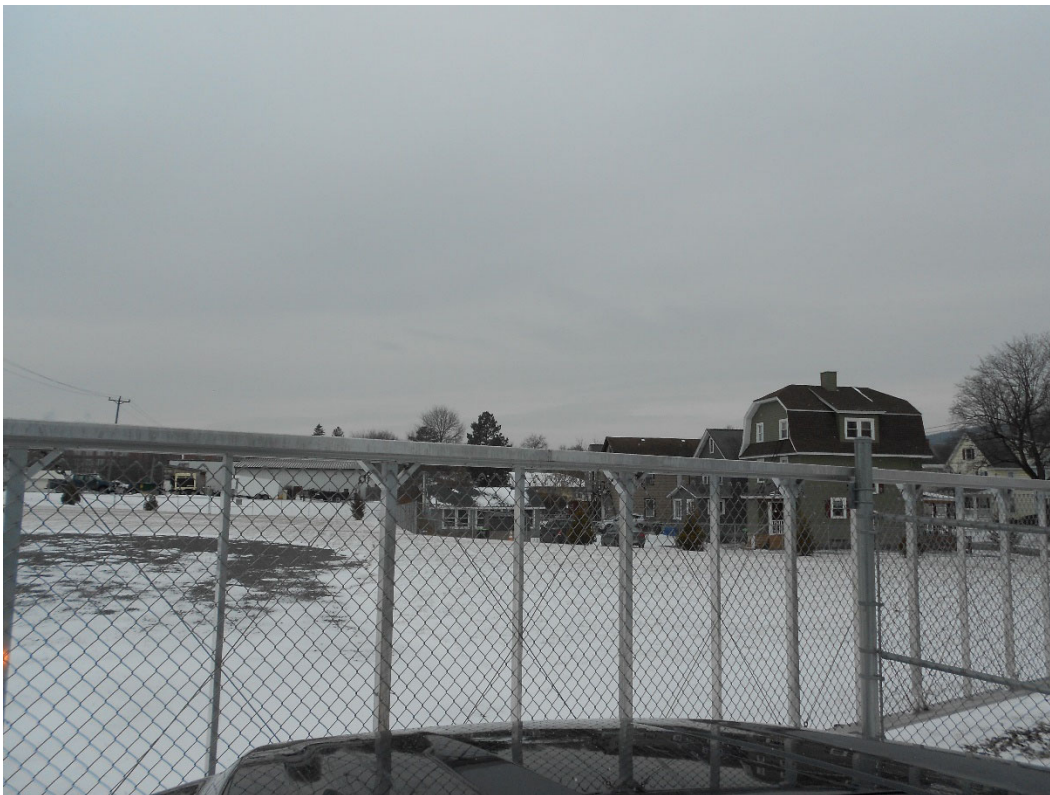
Ilion – Site Conditions on January 13, 2022

The quarterly site-wide inspections were completed on January 13, April 28, July 14, and October 26, 2022. The Site Inspection Forms are presented in Appendix A. In general, the Site is in compliance.

At this time, National Grid recommends continuing the semi-annual monitoring activities. The next semi-annual groundwater sampling event would be in April 2023. Semi-annual site-wide inspections are required; however, for internal security purposes, National Grid will continue to conduct quarterly site-wide inspections.
