**Re:           National Grid  
              Little Falls (Mill Street) Non-Owned Former MGP Site  
              NYSDEC Site No. 622034  
              Little Falls, New York  
              2023 Periodic Review Report**

## National Grid- Little Falls MGP Site (NYSDEC Site No. 622034)

# 2022 Groundwater Monitoring Report

National Grid Little Falls (Mill Street) Site  
575 Mill Street  
Little Falls, NY

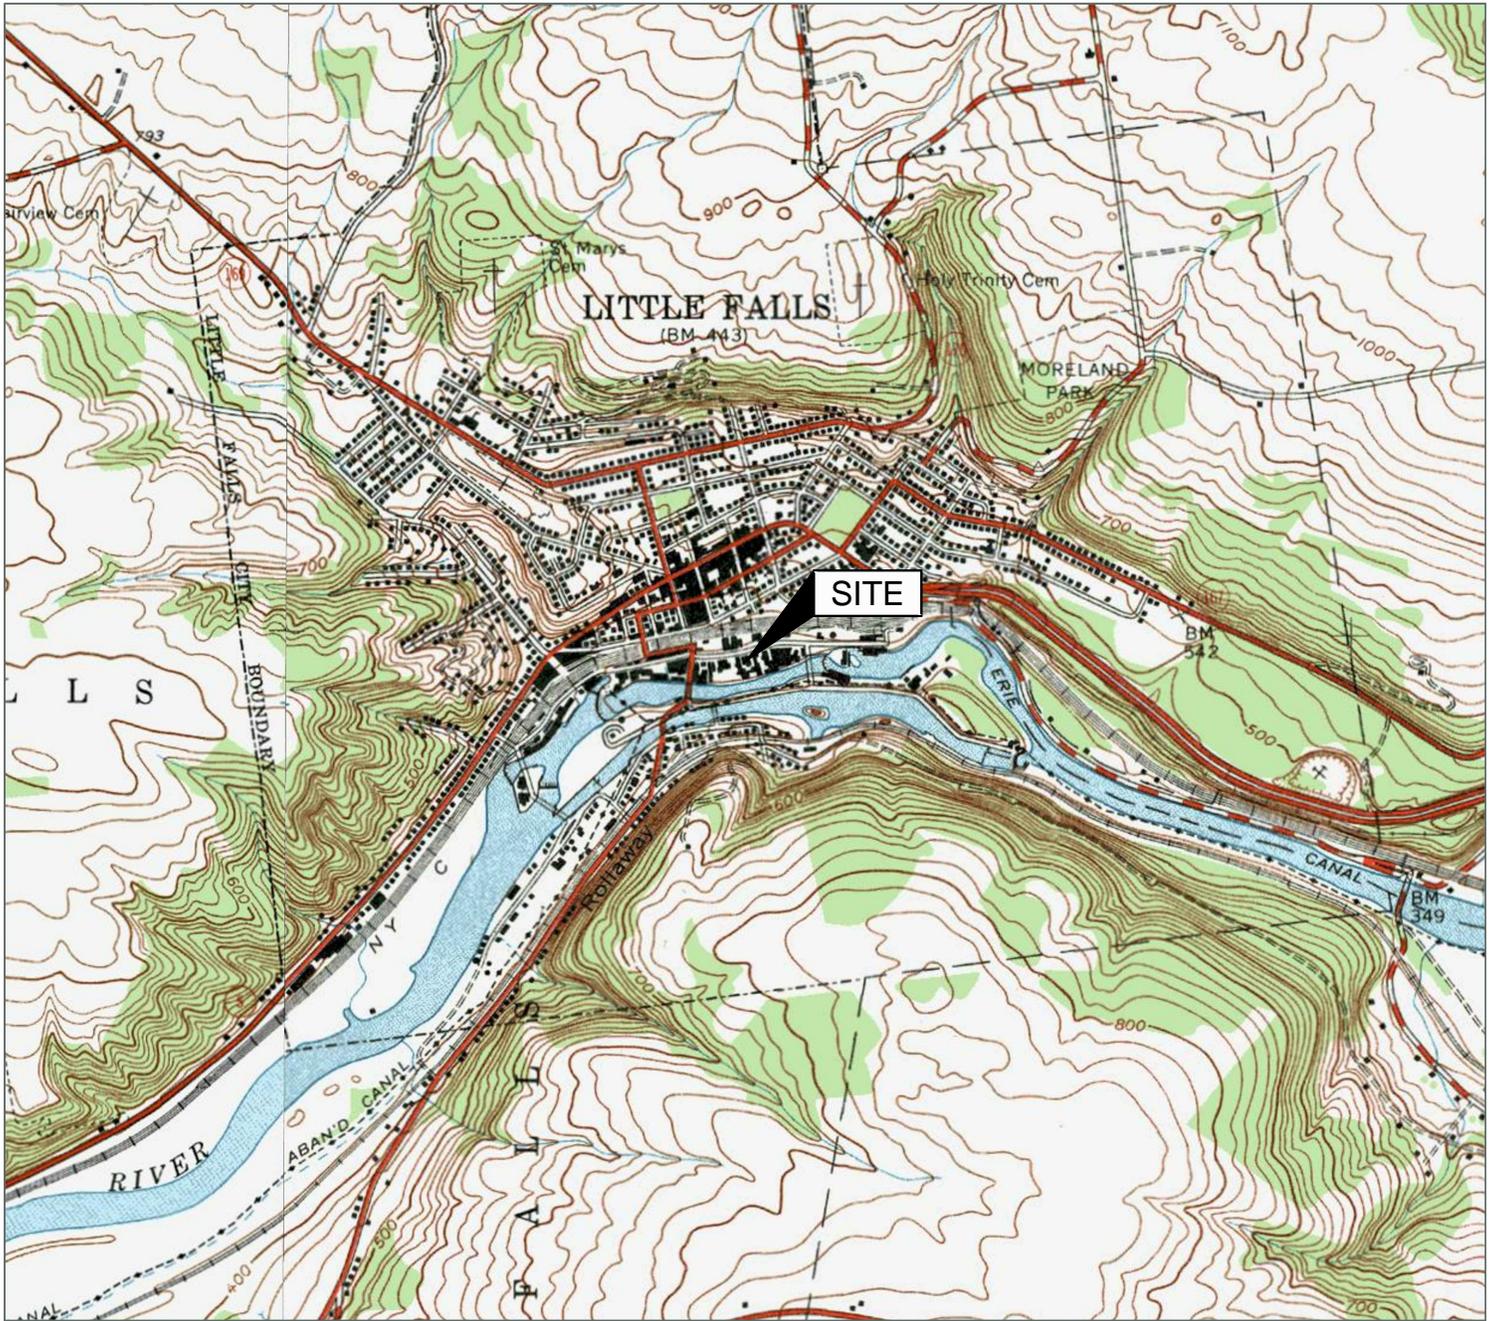
Site Location Map	
National Grid Former MGP Site 575 Mill Street Little Falls, New York	
Drawn W.G.S. Designed  Approved	Date 12-27-17 Figure 1

Source:  
 USGS 7.5 Minute Series  
 Topographic Quadrangle, 1943  
 Little Falls, New York  
 Contour Interval = 20'

The Little Falls Former Manufactured Gas Plant (MGP) Site (the Site) is located on an approximate 1.35-acre lot, located on the south side of East Mill Street in Little Falls, New York (refer to Figure 1 Site Location Map). The Site is the western portion of an approximately 6.5-acre property currently owned by the Feldmeier Equipment, Inc. (Feldmeier). Manufactured gas was produced at the Site from approximately 1853 until 1907. The MGP was decommissioned in the early 1900's, and since then the site has been used for various industrial purposes, which include the manufacturing of furniture and stainless-steel tanks. Currently a paved parking lot and the western portion of the Feldmeier tank manufacturing building occupy the former MGP. The site was previously owned by a predecessor company of Niagara Mohawk Power Corporation.

The Site is located on the south side of East Mill Street in Little Falls, County of Herkimer, New York (Figure 1 presents the site location map). The Site is an approximate 1.35-acre area and is bounded by East Mill Street to the north, George Lumber and Building Materials Company to the west, the Mohawk River to the south, and extends into the tank manufacturing building to the east. Currently, the property is a paved parking area, and the western portion of the Feldmeier tank manufacturing building.

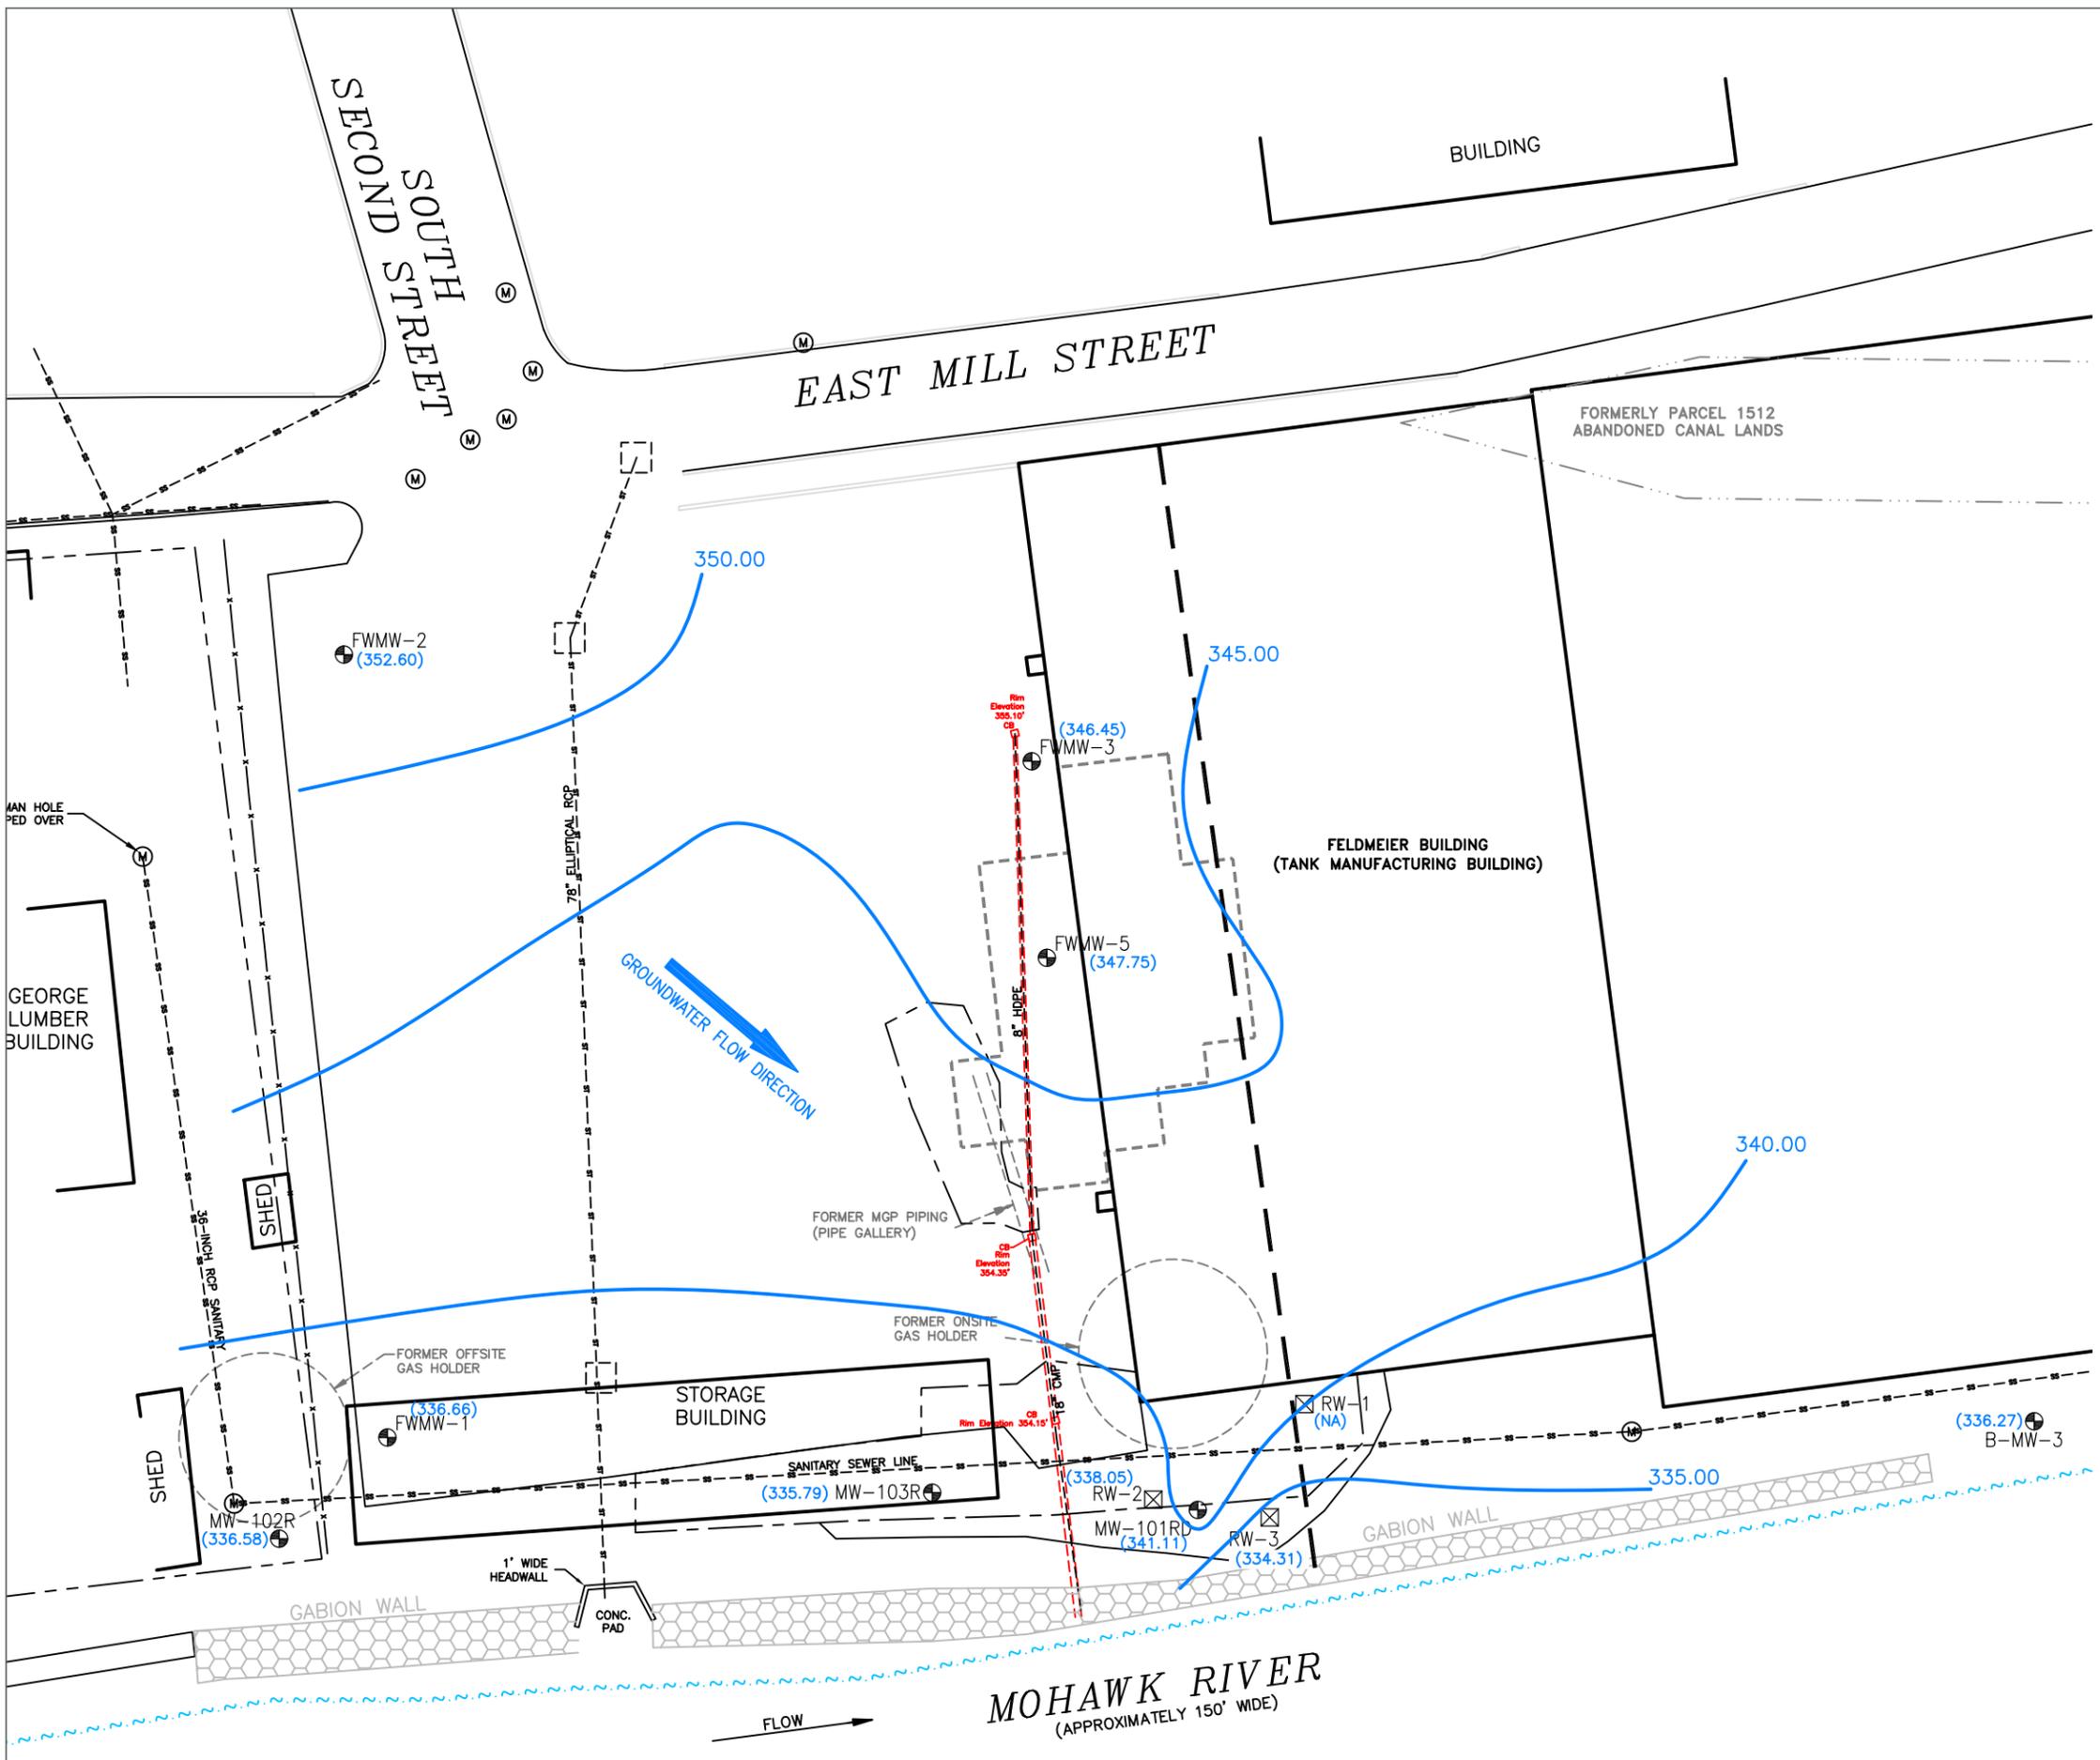
Groundwater Contour Map  
September 8, 2022

Annual gauging field data is presented in **Table 1**. Based on the September 2022 groundwater level measurements, groundwater in the overburden/shallow bedrock beneath the Site flows to the south (which is consistent with the local groundwater flow direction observed during the RI and previous monitoring events). There is a groundwater depression observed near the Mohawk River near recovery well RW-3, where the groundwater is likely mimicking the drop in the bedrock surface as it approaches the Mohawk River. A potentiometric surface map for overburden/shallow bedrock groundwater developed from the September groundwater elevations is presented on **Figure 3**. Based on the September 2022 groundwater level measurements from the one deep bedrock well at the Site (well MW-101RD), an upward hydraulic gradient exists between the deep bedrock unit and the overburden/shallow rock unit at the Site, indicating that the groundwater from the deep bedrock unit likely discharges to the Mohawk River.
